## **NATIONAL TRANSPORTATION SAFETY BOARD**

### **Group Chairman's Factual Report**

## **AIR TRAFFIC CONTROL**

**CEN14FA300**

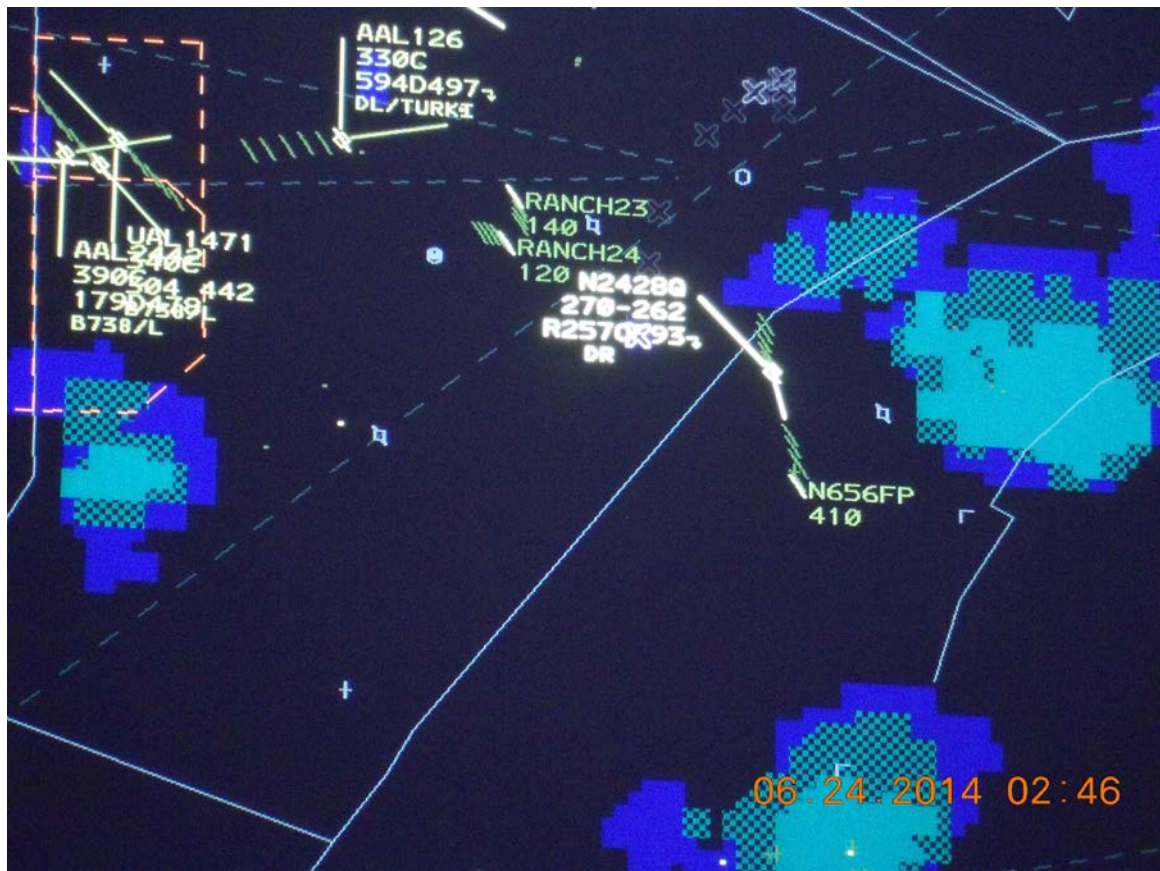
Figure 1 – En Route Automation Modernization (ERAM) screen shot from ZAB displaying N656FP at FL410 south bound after passing N2428Q at FL262. Weather depicted indicate moderate, severe, and extreme levels of precipitation.

See figure 1, in the radar data block of N2428Q. “DR” indicates that the aircraft is authorized to deviate to the right of the filed route of flight.

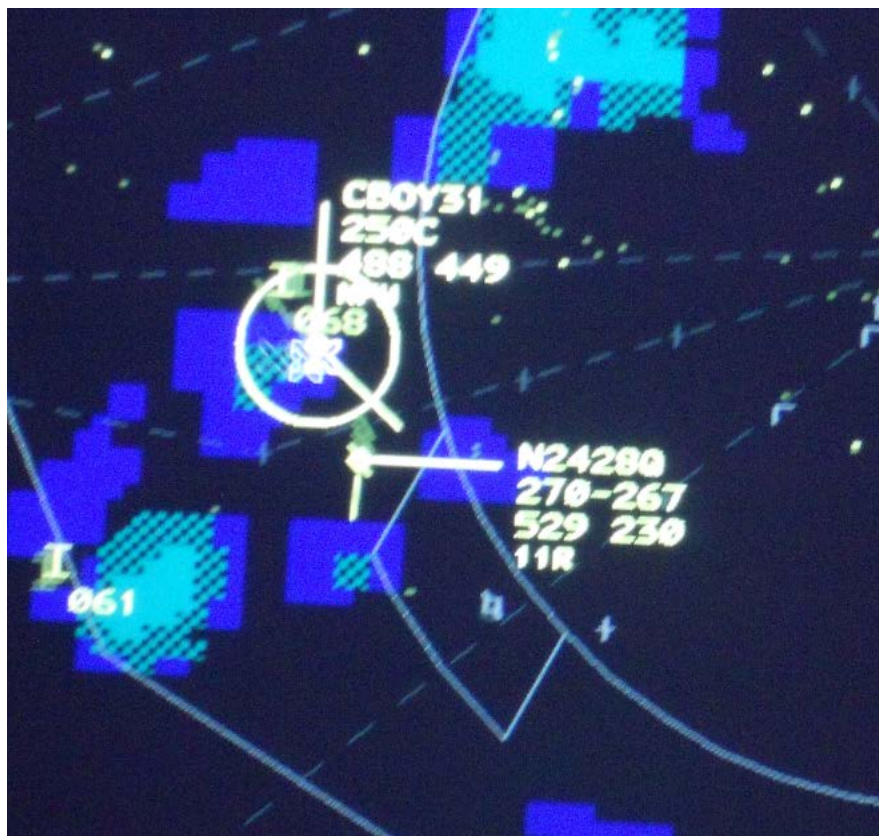
Figure 2 – En Route Automation Modernization (ERAM) screen shot from ZAB displaying Cowboy 31 at FL250 southeast bound passing behind N2428Q at FL267. Weather depicted indicate moderate, severe and extreme levels of precipitation.

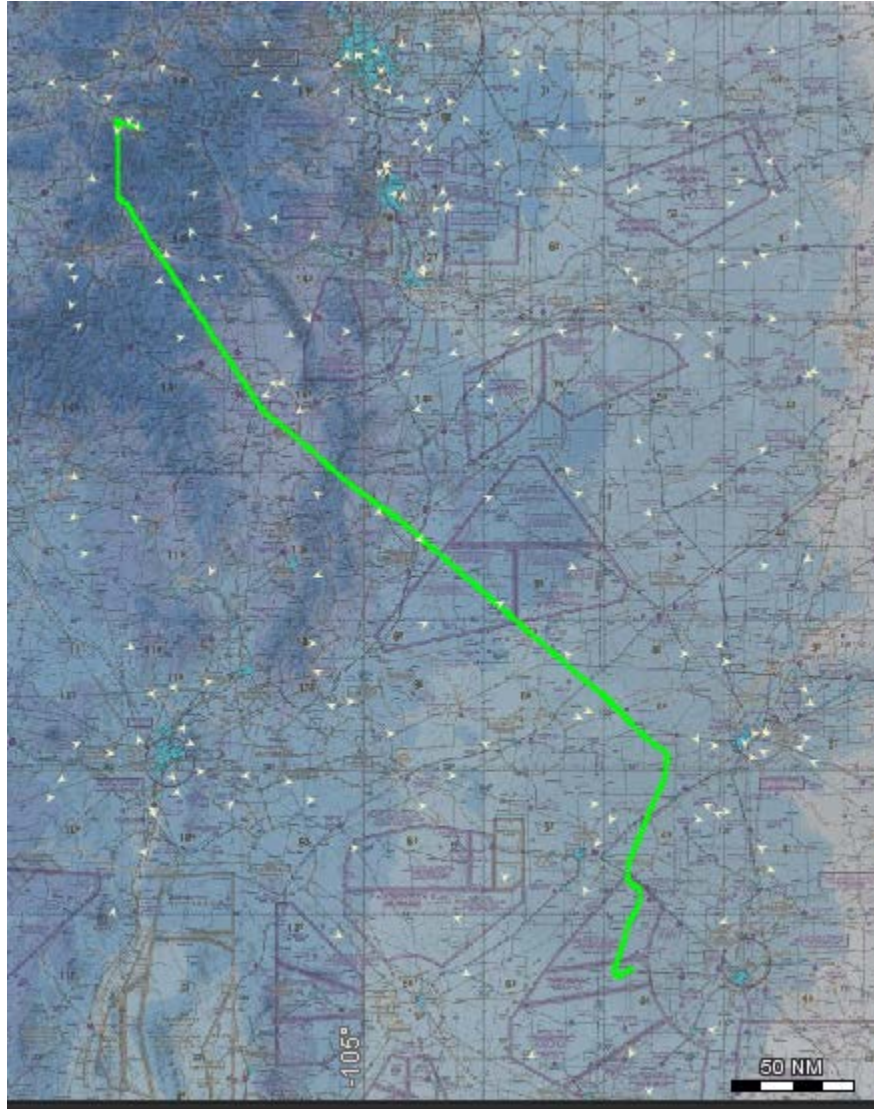
At 1549, the R15 controller issued convective SIGMET 86C for Texas. Between 1552 and 1607, N2428Q’s altitude indicated 300 feet to 400 feet above and 400 feet below the assigned altitude of FL270 eight times. After each altitude deviation, N2428Q leveled at FL270. At 1554, after the second altitude deviation, the R15 controller queried the pilot about the altitude changes. N2428Q reported that they were having autopilot issues. At 1556, during the altitude deviations, N2428Q requested and was authorized to deviate to the east for weather avoidance, but then deviated to the west. (see figure 3)

Figure 3 – Green line indicating the flight track of N2428Q.

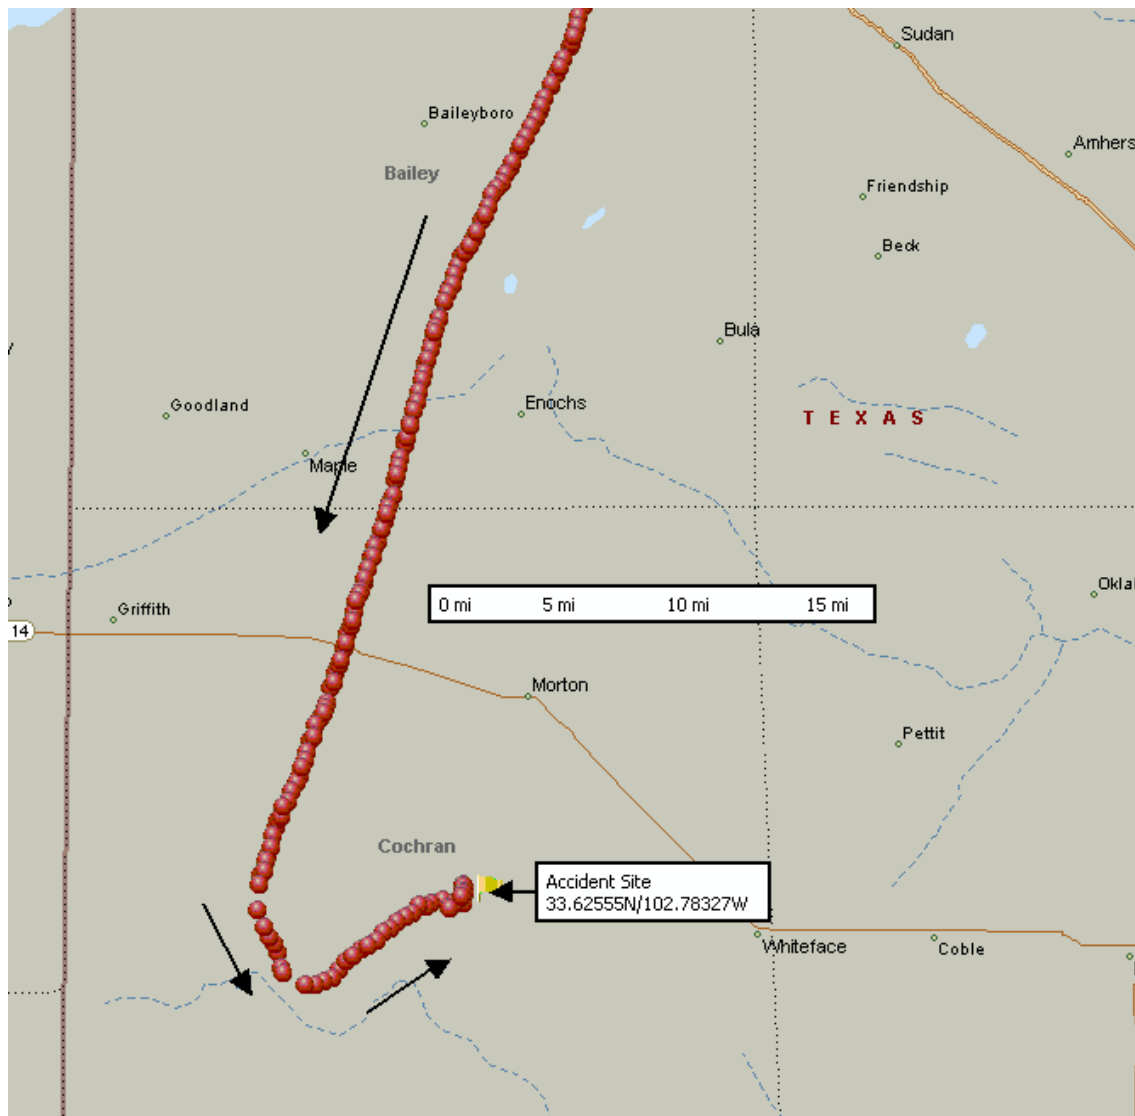
Figure 4 – Radar flight track of N2428Q from 1620 to the end of flight. The accident site is indicated by a yellow flag. Radar returns are indicated by red dots. Direction of flight is indicated by black arrows.

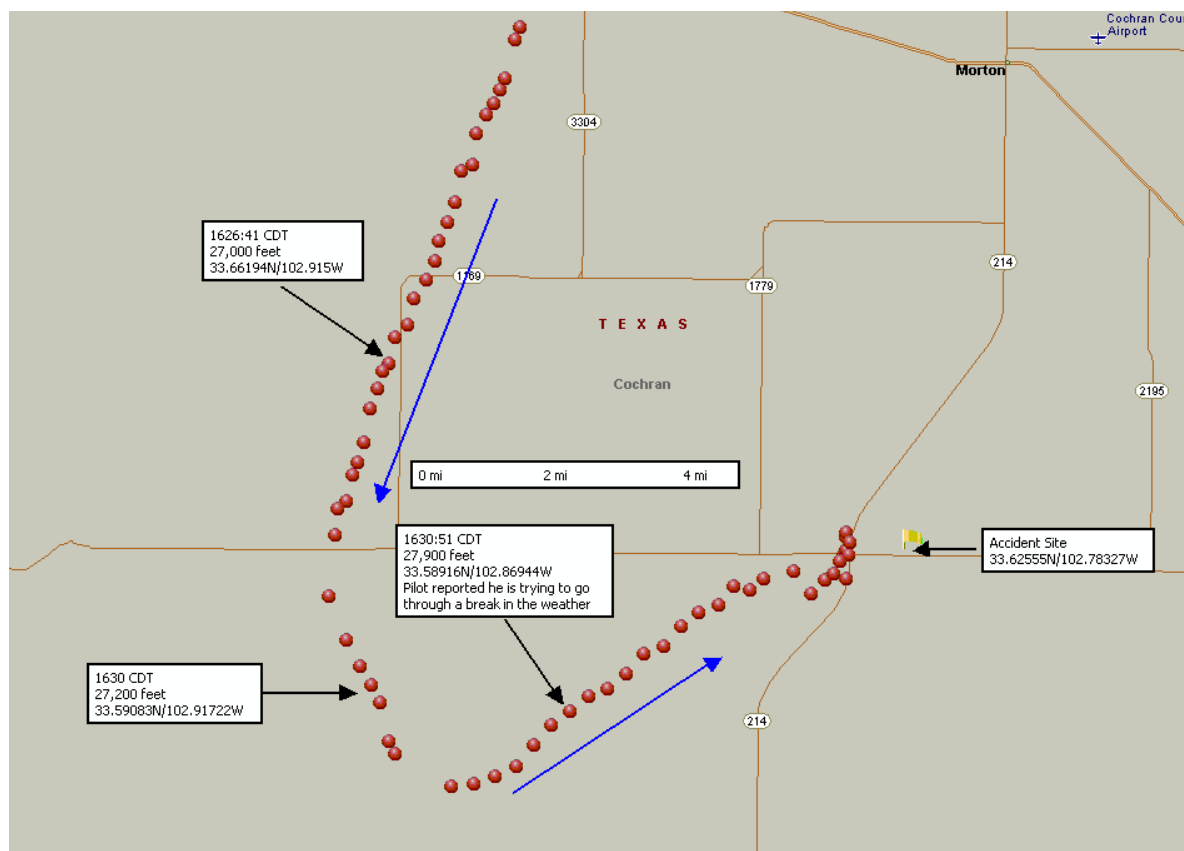
Figure 5 - Radar flight track of N2428Q. The accident site is indicated by a yellow flag. Radar returns are indicated by red dots. Direction of flight is indicated by blue arrows.

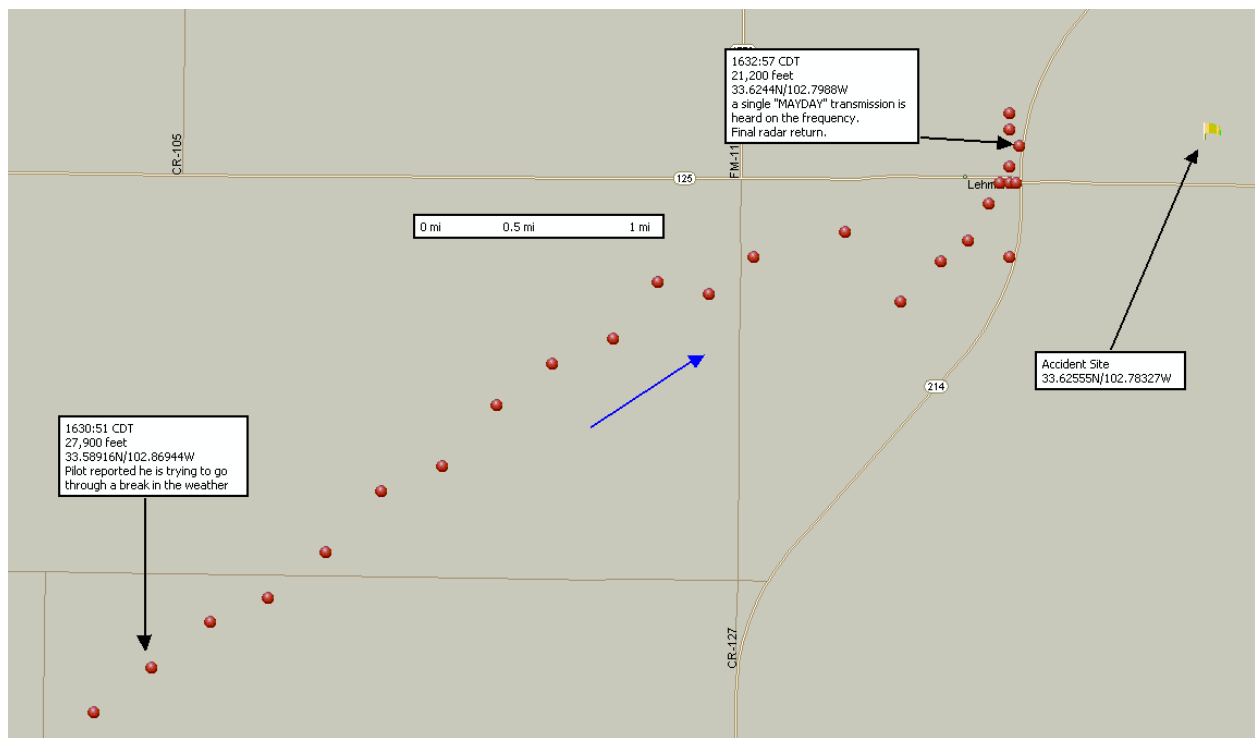
Figure 6 - Radar flight track of N2428Q. The accident site is indicated by a yellow flag. Radar returns are indicated by red dots. Direction of flight is indicated by a blue arrow.
