Re: CEN14FA300, 1985 Piper Malibu PA-46-310P, S/N 46-8508088, N2428Q (JetPROP conversion SN 002)  
Autopilot equipment examination at Honeywell, 2/11, 2/12 & 3/23/2015 (Olathe, Kansas)  
Flight Computer crystal examination at Honeywell, 4/13/2015 (Phoenix, Arizona)

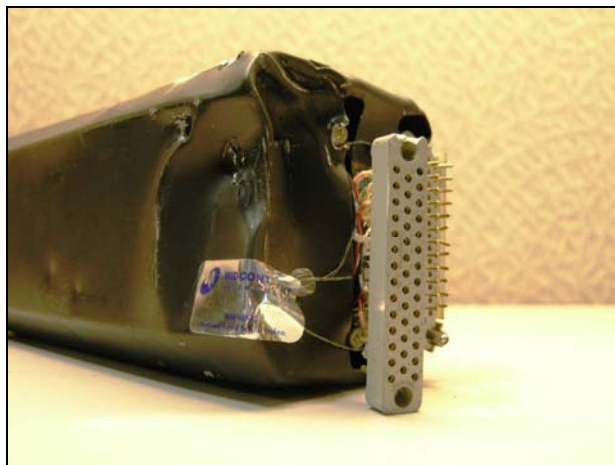
The KI 525A Pictorial Nav Indicator is impact damaged which precludes functional testing. The damage, in part, includes broken connectors on the back of the unit, case/chassis deformation, loose parts, damaged circuit boards/components, and damaged stepper motor.

Connectors damaged; Midcontinent Instruments seal intact

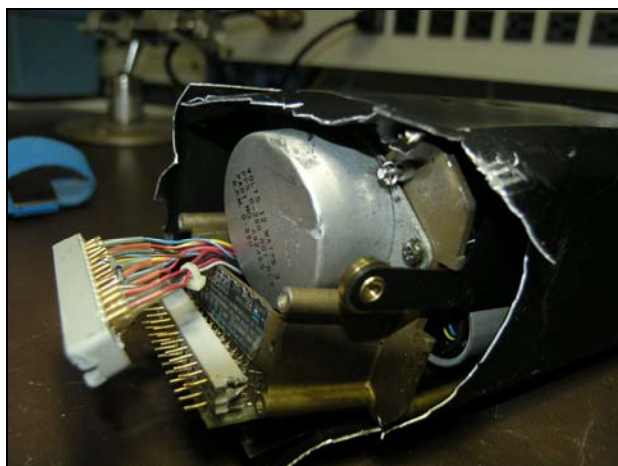
Rear view – connectors, stepper motor and other internal damage

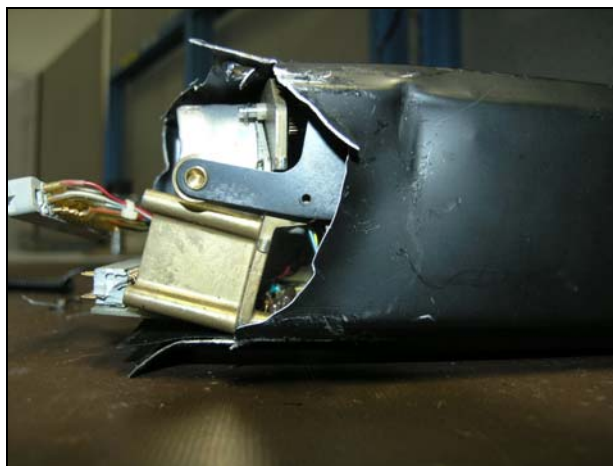
KI 525A internal structure/chassis bent/deformed

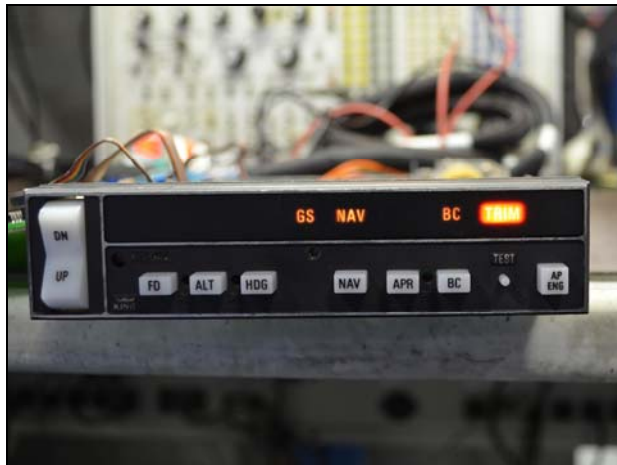
KC 192 self test: YD, FD, ALT, HDG, APR and AP lamps out

The KC 192 Flight Computer was inoperative during initial power-up. Troubleshooting found a bad clock crystal for the microprocessor. The crystal was replaced. The unit passed self test with the exception of several bad mode annunciation bulbs (broken filaments). The KC 192 was subjected to functional testing – passes all functional tests except altitude hold (mode will not engage). The altitude hold fault was traced to a bad output from I120. No determination was made as to whether I120 was bad or the result of a damaged circuit board. The mode annunciator bulb filaments were examined – **YD**, **FD**, **ALT**, **APR**, and **AP** bulb filaments were broken and consistent with “cold breaks” (no snaking or spaghetti appearance of the filaments). The remaining mode annunciation bulb filaments contained no breaks or stretched filament coils – consistent with being cold at time of impact. The crystal was removed and subjected to computerized tomography scan (CT scan). The CT scan revealed that the piezoelectric disk (crystal) was broken in half – consistent with impact damage.

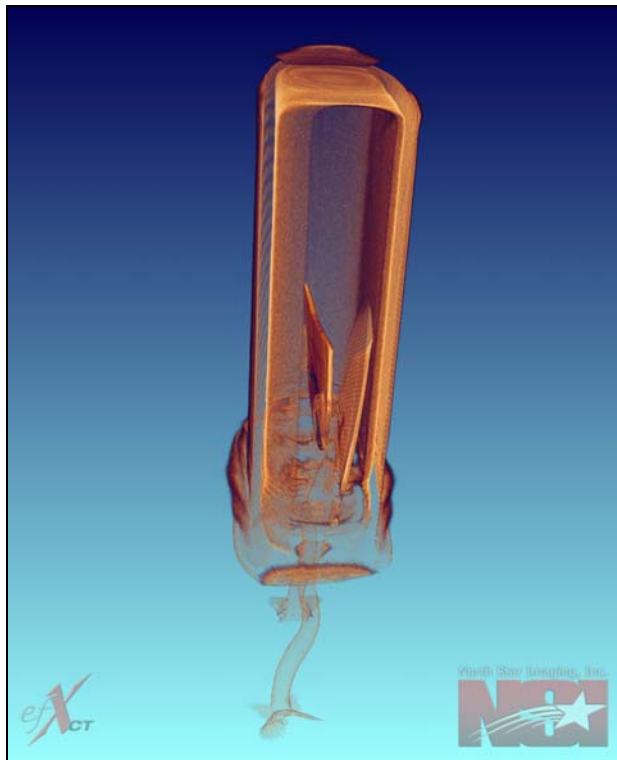
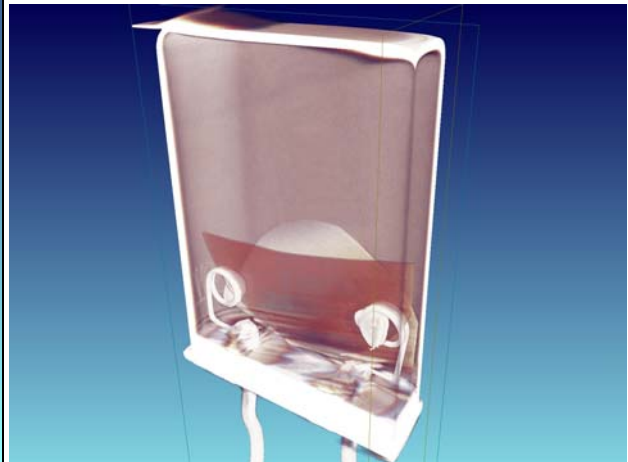
KC 192: Y101 crystal CT scan images show that the piezoelectric disk is broken – consistent with impact forces (conducted in Phoenix, Arizona)

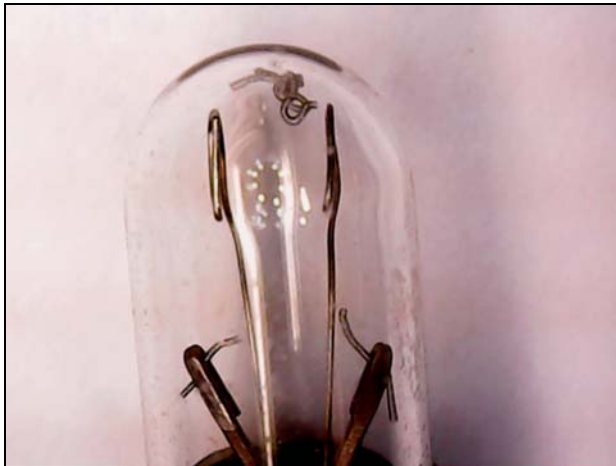
**YD lamp:** filament broken, no stretching (no spaghetti appearance)

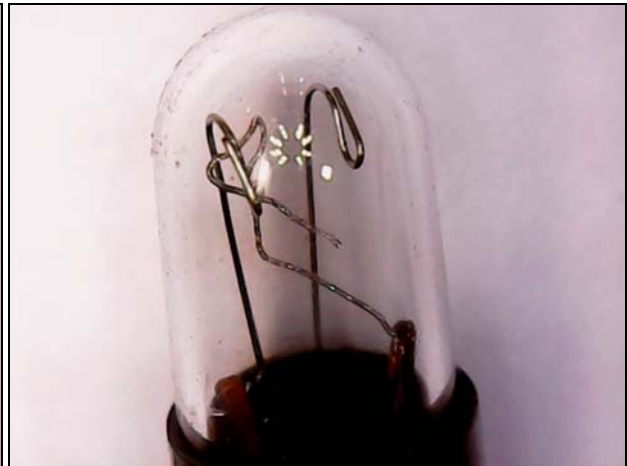
**FD lamp:** filament broken, no stretching (no spaghetti appearance)

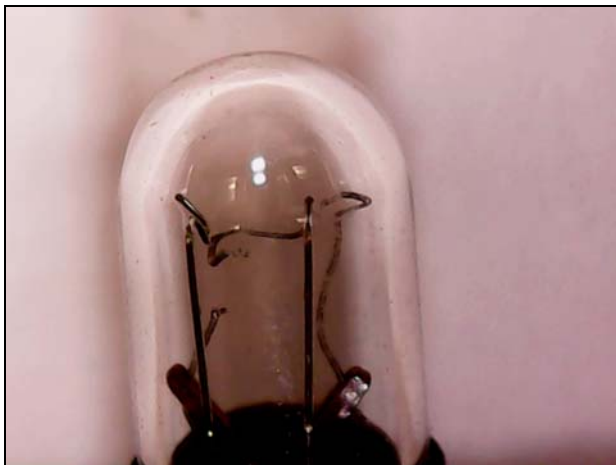
**ALT lamp:** filament broken, no stretching (no spaghetti appearance)

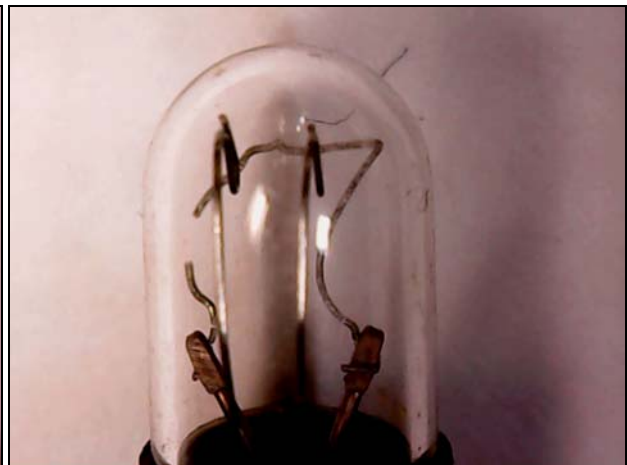
**HDG lamp:** filament broken, no stretching (no spaghetti appearance)

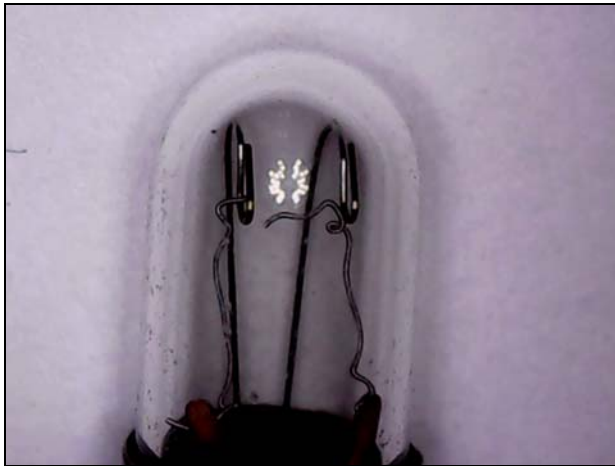
APR lamp: filament broken, no stretching (no spaghetti appearance)

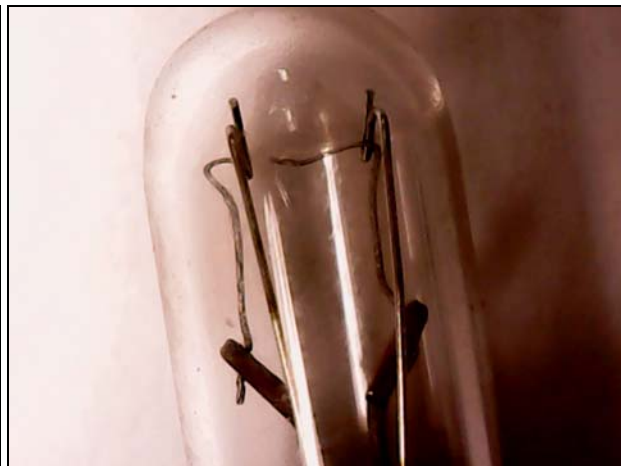
AP lamp: filament broken, no stretching (no spaghetti appearance)

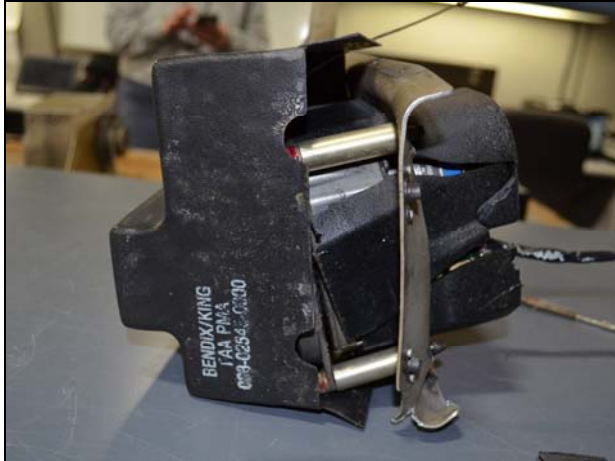
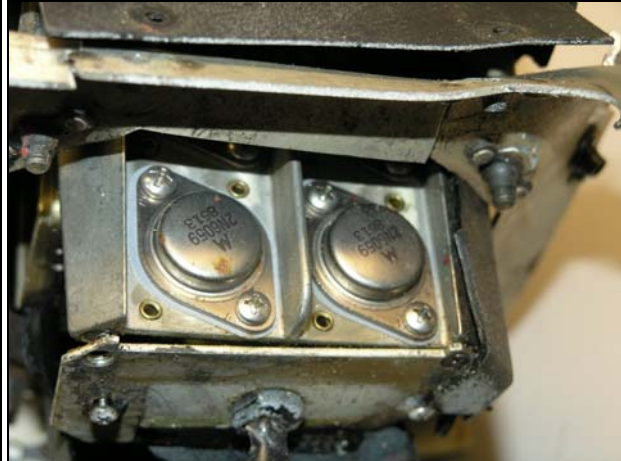
The KS 271A Primary Servo (yaw) was received in a “not engaged” state and attached to aircraft mounting bracket. The dataplate is damaged which precludes part number and serial number identification. The correct part number for the yaw servo installation is 065-0060-04. The servo is impact damaged – cover broken and partially missing. The unit was subjected to final acceptance tests – no defects observed.

KS 271A Primary Servo (Yaw): cover damaged and partially broken away exposing internal parts/structure

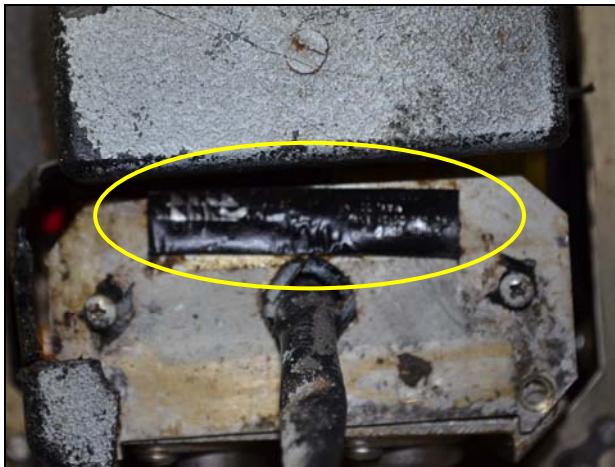
KS 271A Yaw Servo: dataplate unreadable

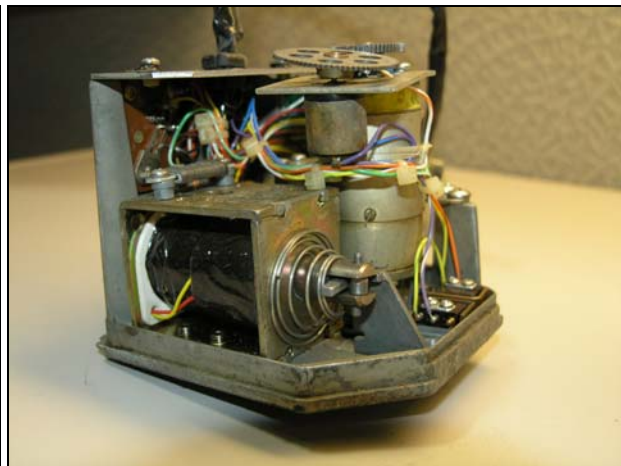
KS 271A Pitch Servo: cover missing

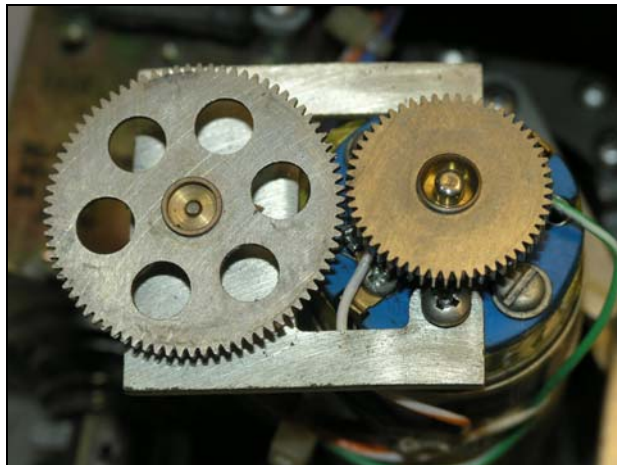
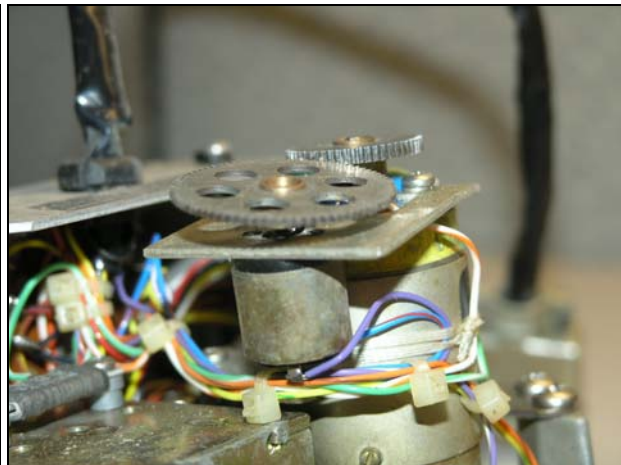
- Plastic cover for servo broken away – missing.
- Pitch Servo received attached to associated aircraft bracket and KM 275 Servo Mount. The servo was separated from the mount and bracket to allow inspection and testing.
- Pitch Servo received in a “not engaged” state.
- Tach motor mounting bracket bent causing tach motor gear to not mesh with the servo motor gear.
- Tach motor shaft is bent.
- Trim spring bars and micro switches intact – no damage observed.
- Servo baseplate partially broken away.
- The tach motor shaft and mounting bracket were straightened to allow testing.
- The Pitch Servo was subjected to final acceptance tests. No defects were noted.

KS 271A Pitch Servo: tach motor shaft and mounting bracket bent – straightened later to allow gear engagement and testing

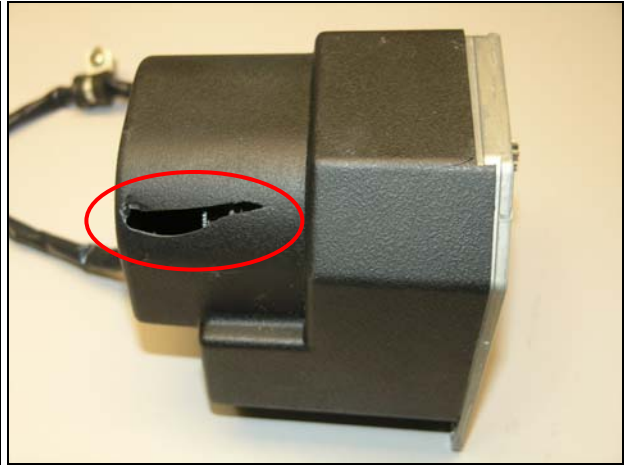
KS 271A Roll Servo: cover damaged

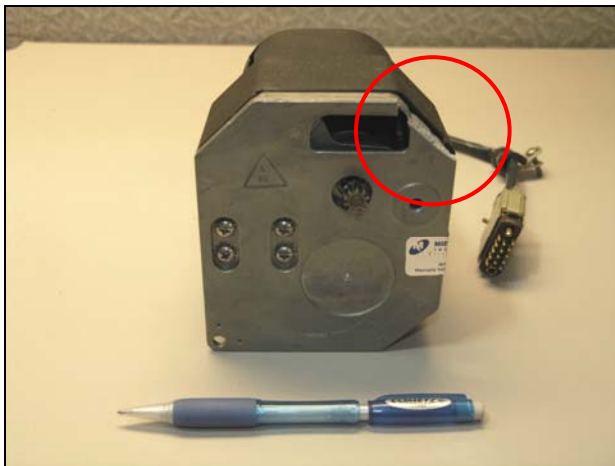
KS 271A Roll Servo mounting ear broken away

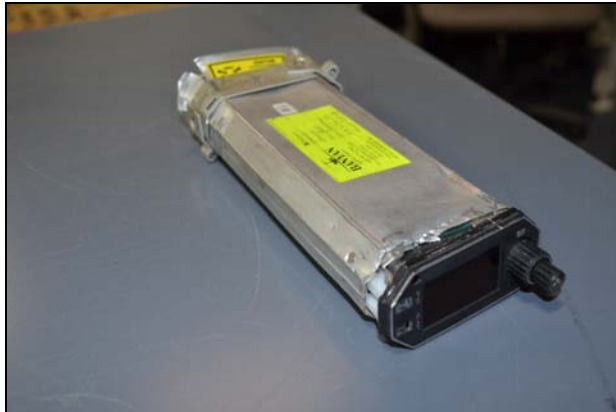
The KAS 297B is impact damaged – bezel and rear connector damaged. The testing was limited to data recovery from the non-volatile memory (NVM). The KAS 297B stores the last altitude and vertical speed selected by the flight crew. The unit covers were removed to allow removal of the NVM device, I316. I316 was installed into an exemplar unit. Upon power-up, the last selected altitude of 27,000 feet with a vertical speed descent of 500 feet/minute was displayed.

KAS 297B Altitude/VS Selector: cover, connector, bezel, and chassis damage/deformation

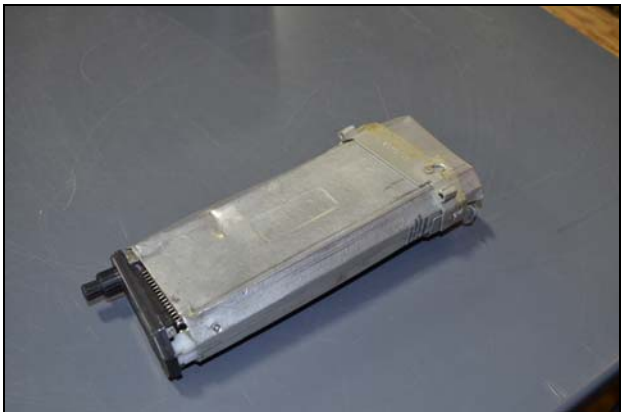
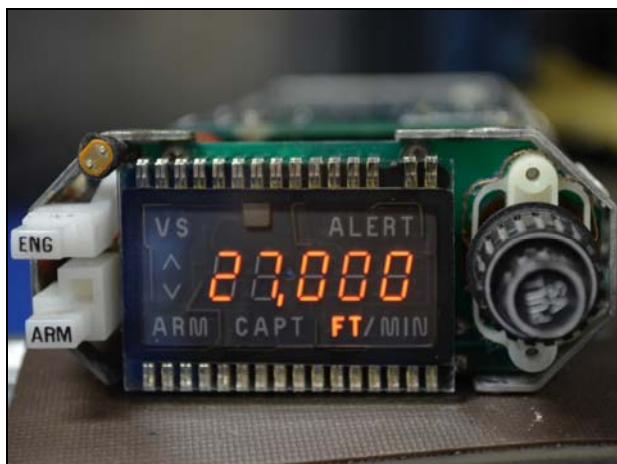
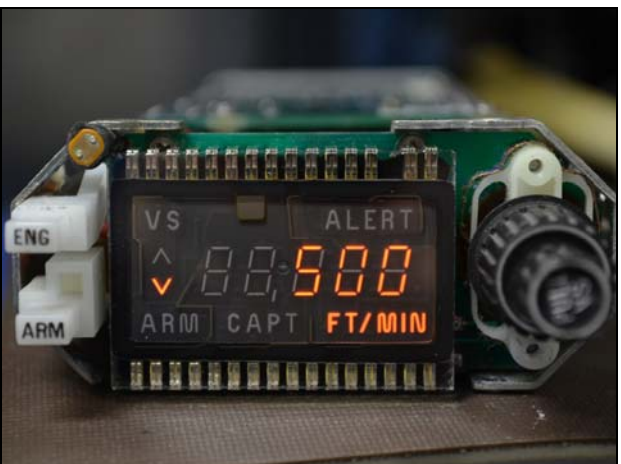
KAS 297B Altitude/VS Selector: last altitude and vertical speed selected by flight crew – 27,000 feet and 500 feet/minute descent, respectively

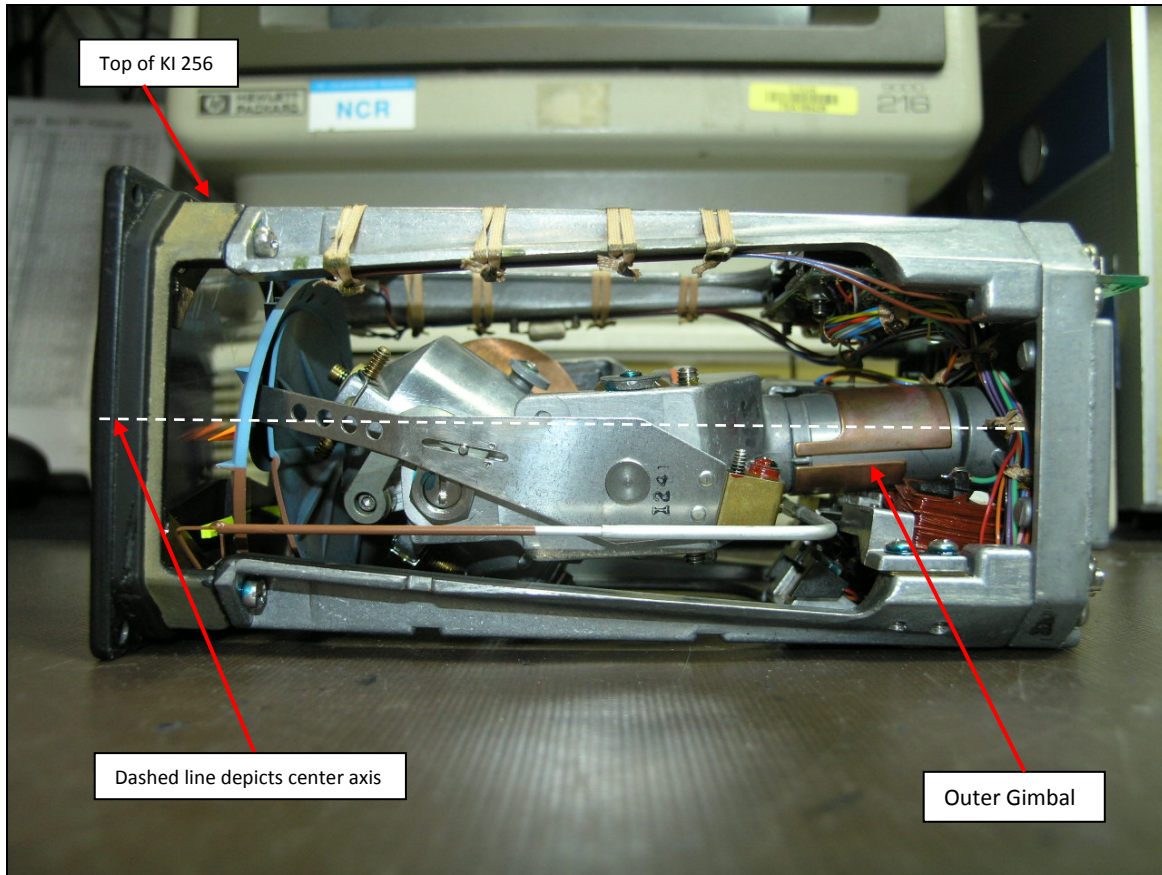
- The cover was removed to allow visual inspection. The Outer Gimbal shaft is bent downward and will not move freely -- consistent with impact forces.
- The fast erect vanes were dislodged from impact forces.
- The gyro assembly was removed for visual inspection. The rotor turns freely. No rotational scoring observed on the rotor or rotor housing.

KI 256 right side view with cover removed: outer gimbal shaft bent downward in direction of impact

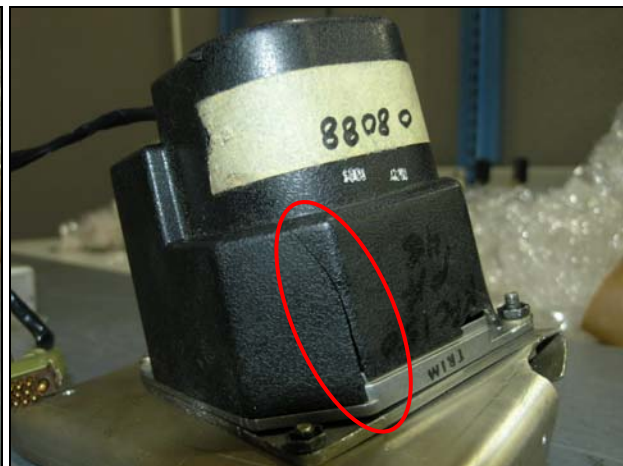
KS 272A Trim Servo: cover cracked

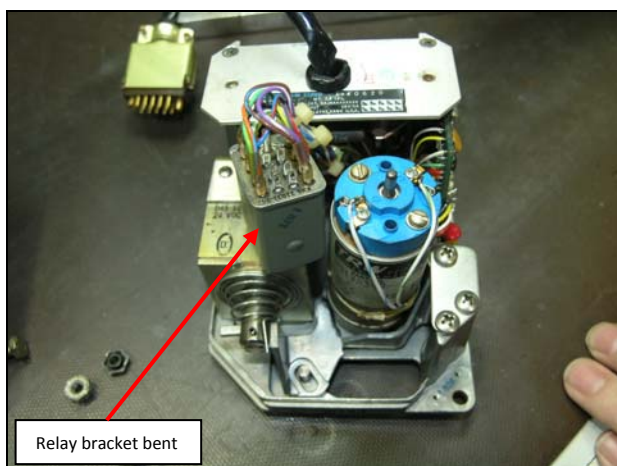
- Plastic cover for servo damaged.
- Trim Servo received in a “not engaged” state.
- Removed cover to allow visual inspection. Found the engage plate, P/N 073-00513-0003, broken. Relay K201, P/N 032-00029-0001, displaced (mounting bracket/tab bent).
- Unit was subjected to functional testing – solenoid engages/disengages, motor runs in both directions; Manual trim CW inop, autotrim inop – found K201 bad (consistent with impact forces).

KS 272A Trim Servo impact damaged: removed cover to allow inspection – clutch engage plate broken and relay displaced (bracket bent)

The KS 272A Trim Servo was impact damaged and only limited testing was possible. The KS 272A Trim Servo was subjected to functional testing. The clutch engage solenoid engaged/disengaged and the motor runs in both directions. The clutch engage plate is broken and will not physically engage the servo as a result; however, the electrical operation of the solenoid was confirmed. Manual trim CW and autotrim were inoperative. These faults were traced to a defective mechanical relay, K201 (consistent with impact forces).
