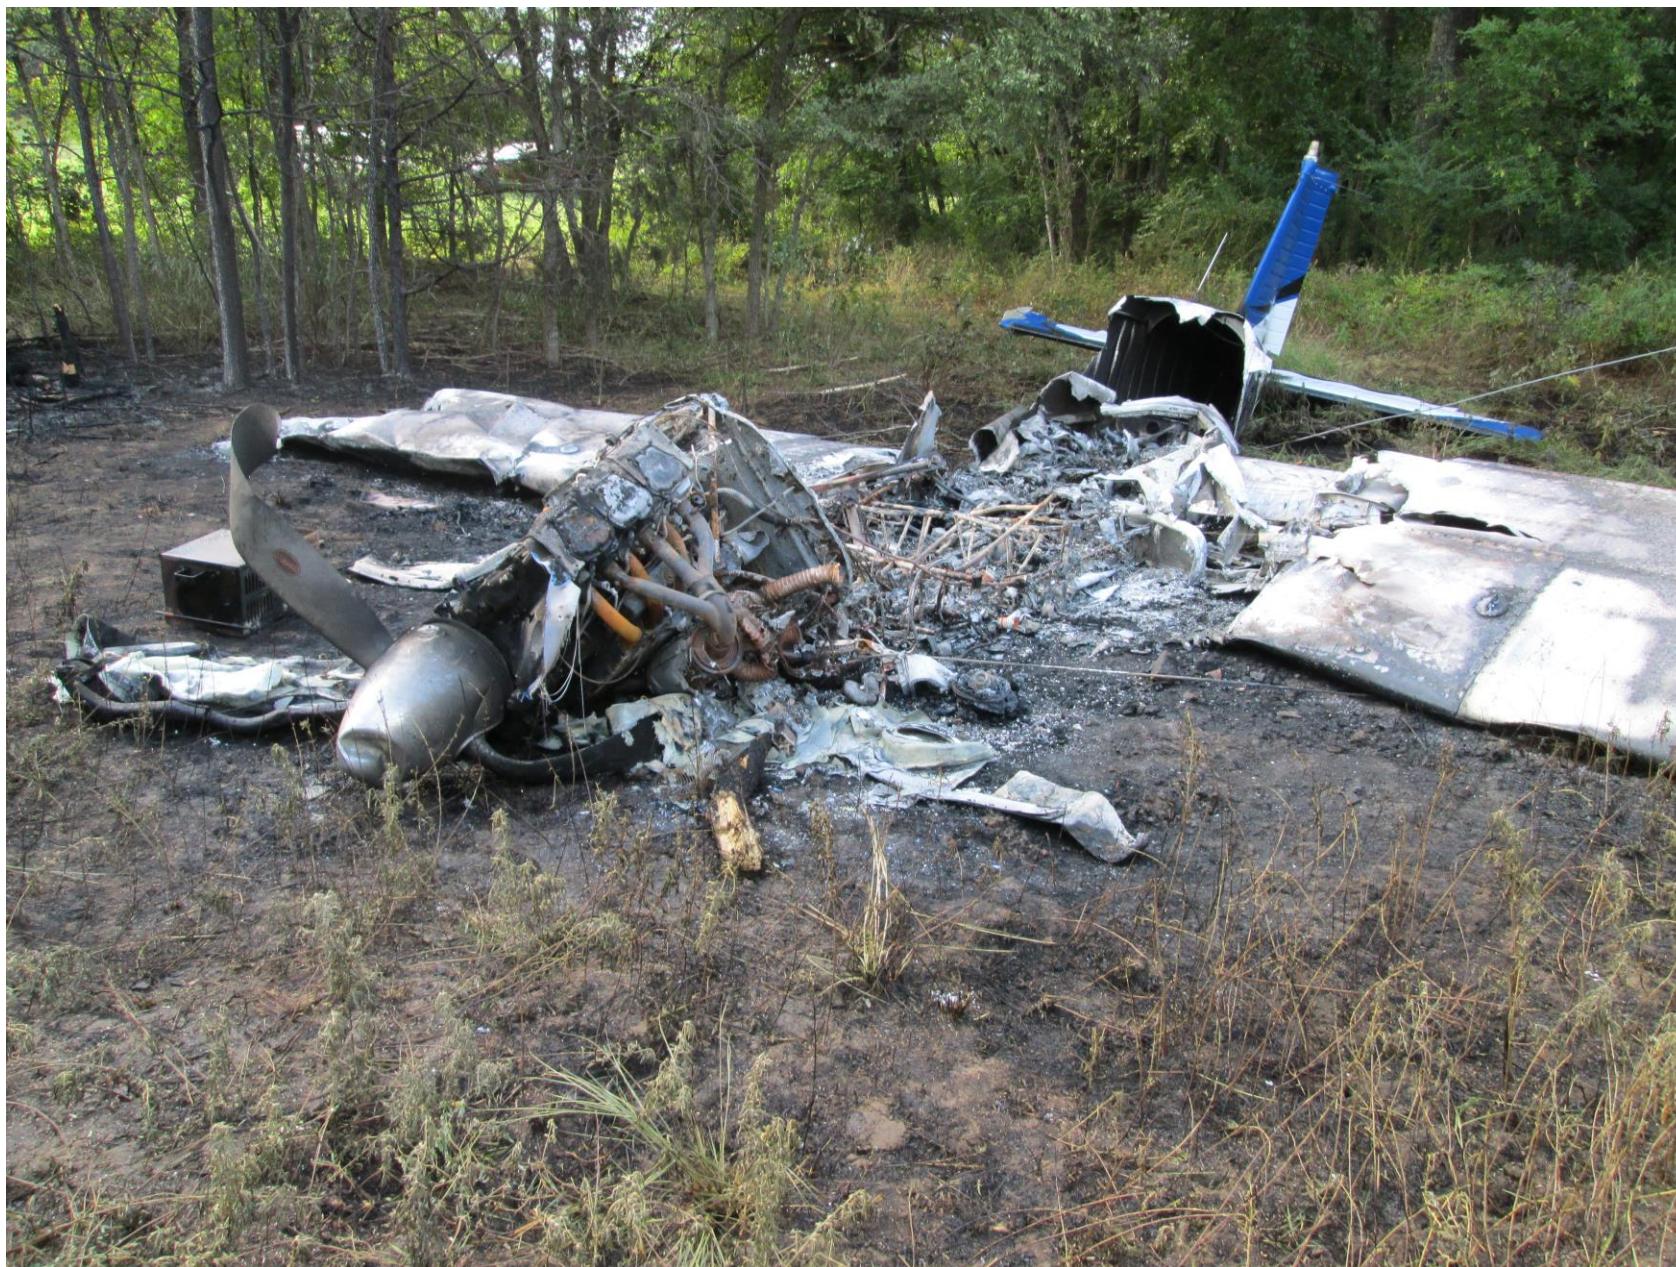
**Photo 1 – View of wreckage from left front. The wreckage is in a small clearing; the engine, wings, and tail section are easily identified. The cabin area has been mostly consumed by fire.**

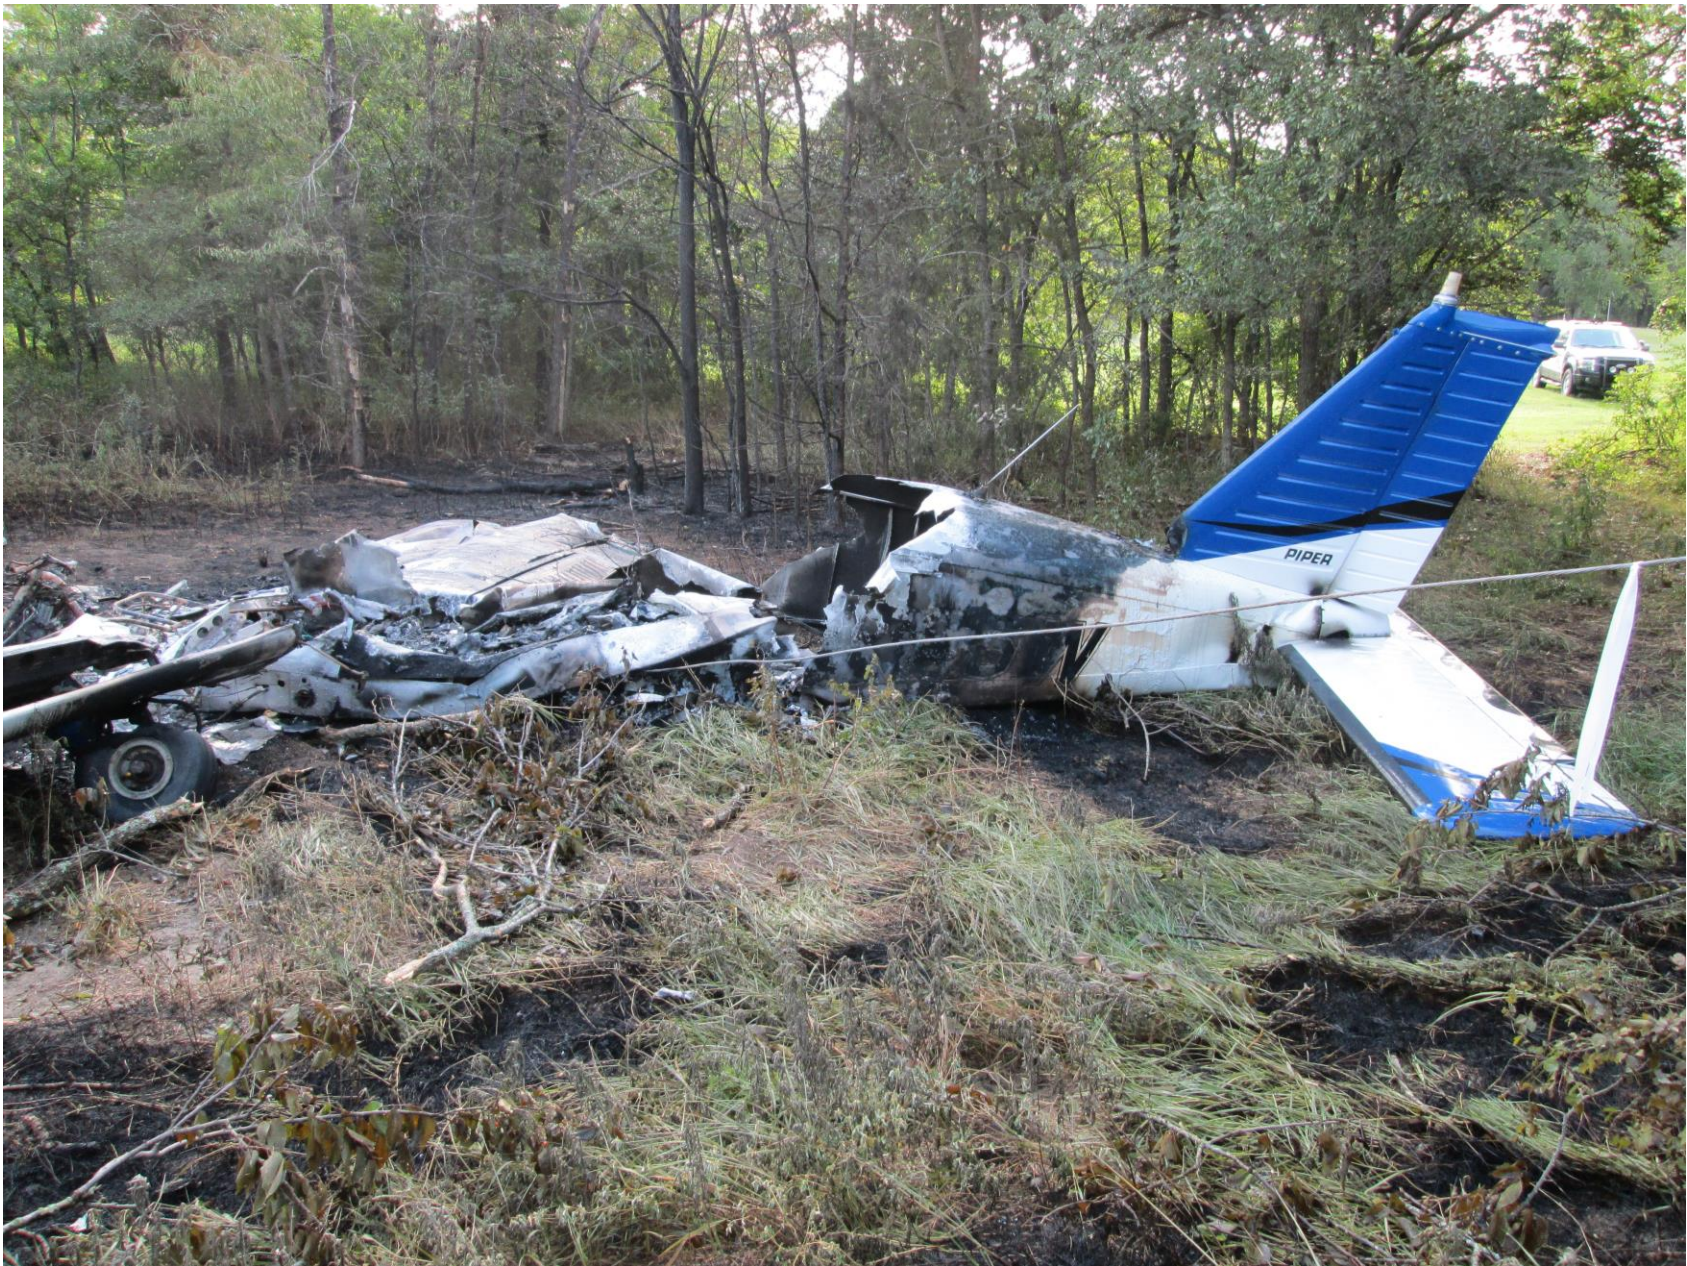
**Photo 2 - A left side view of the wreckage. Much of the cabin has been consumed by fire. A power cable can be seen, in the photograph.**

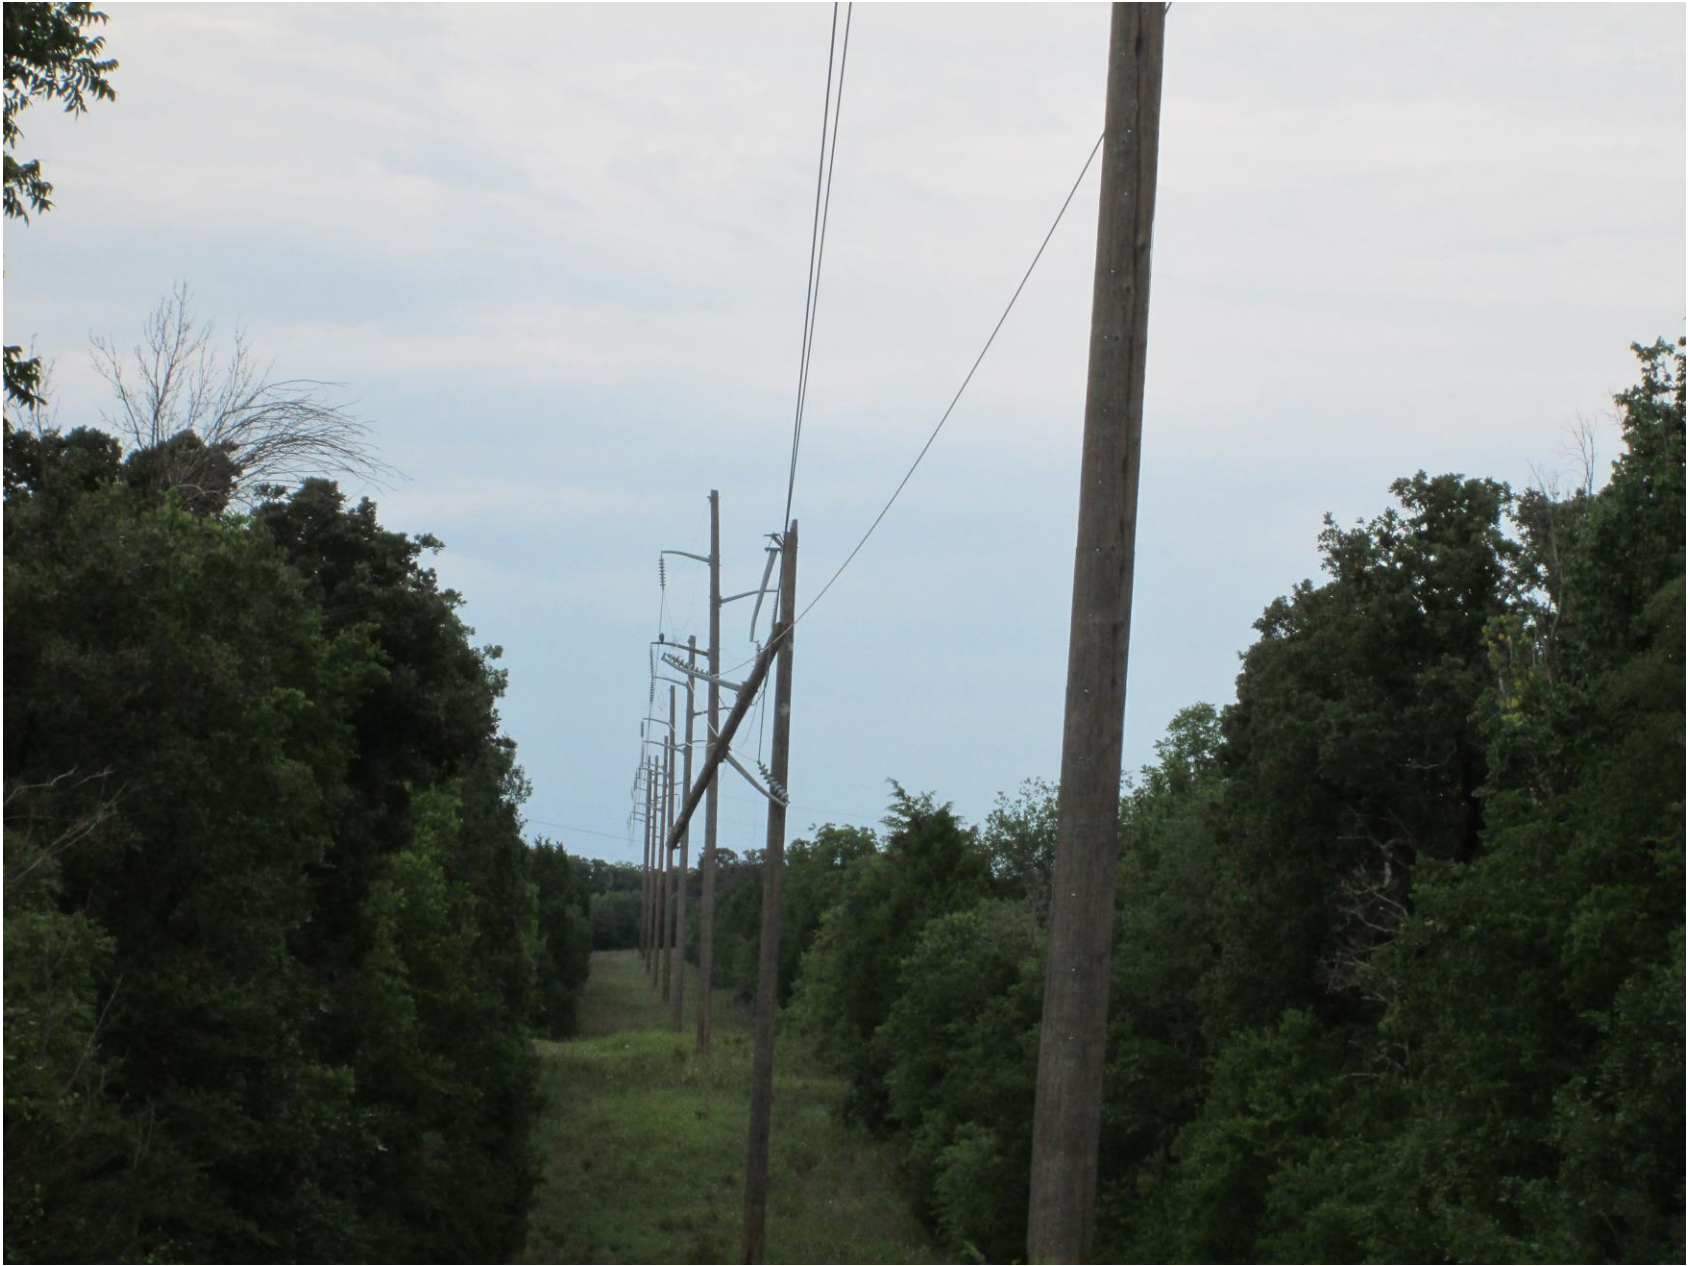
**Photo 3 - A powerline is seen, with several cables strung along each pole. One of the poles is broken, near the top, and the cable appears to be pulled down.**
