# Continental Motors

## ENGINE EXAMINATION REPORT

| ENGINE MODEL | GTSIO-520-L 4B |
| FILE NUMBER | 14-177 |

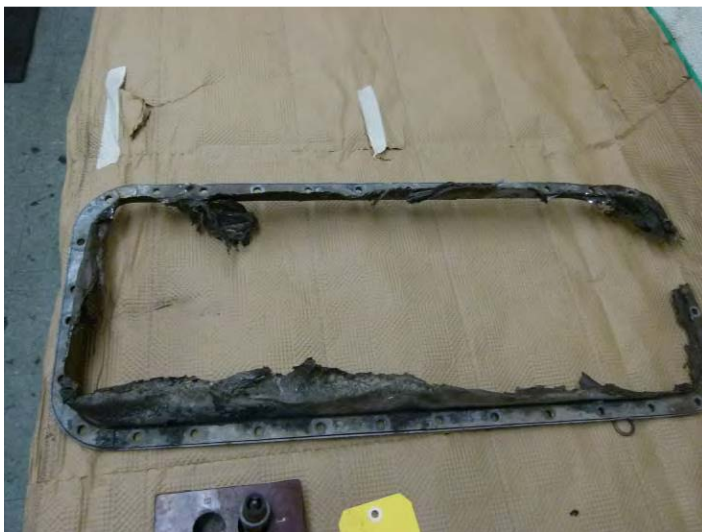
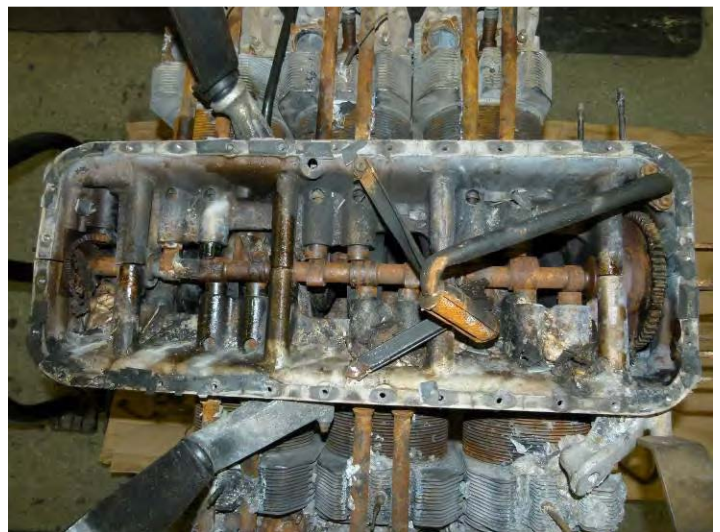
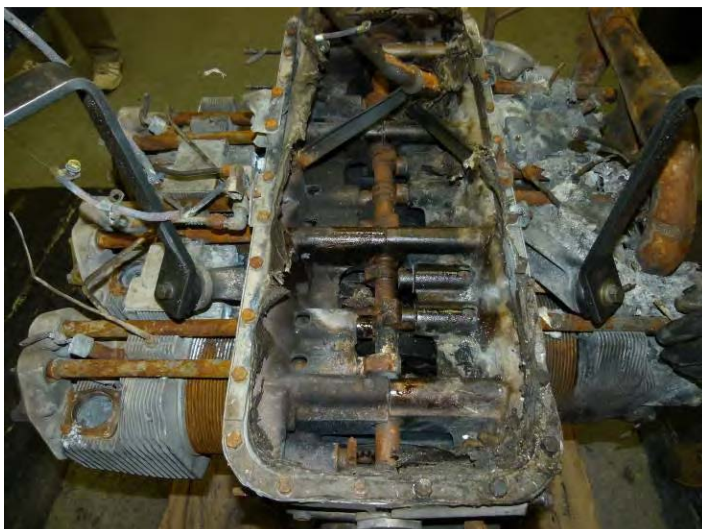
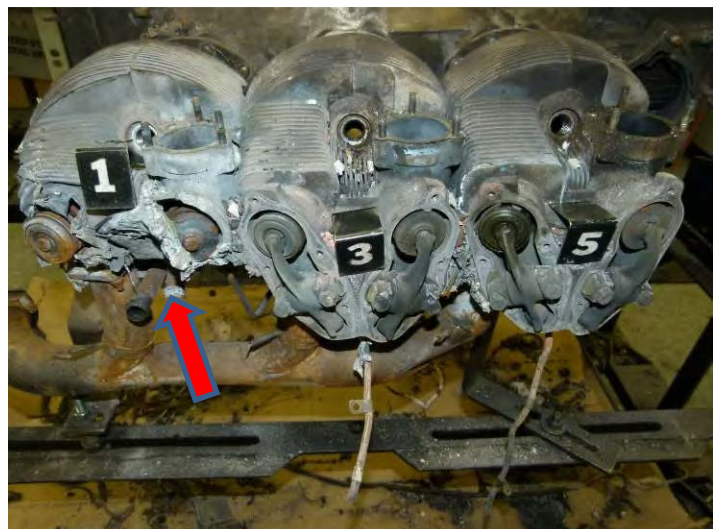
Cylinder one exhibited signatures of thermal damage with the lower portion of the cylinder head melted away. The engine oil sump melted away due to an extensive post impact fire. The internal components of the engine were thermally damaged. All of the internal components show signs of thermal damage but no signs of lubrication distress. The cylinders exhibited heat damage and detonation signatures. All pistons exhibited scuffing and heat signatures on the skirt. Pistons two, five and six exhibited detonation signatures on the face of the piston with portions melted away on the outer edge. The main and rod bearings exhibited normal operating signatures with thermal heat signatures from the post-crash fire. The crankshaft, camshaft, gears, connecting rods and reduction gears all exhibited thermal damage but normal operating signatures. The crankcase exhibited normal operating signatures along with impact and thermal damage. The fuel system components were impact and fire damaged. The engine accessories were intact and exhibited thermal damage. Only portions of the induction system remained attached to the engine. The remainder was melted away by the post-crash fire.
