# Continental Motors

## ENGINE EXAMINATION REPORT

| ENGINE MODEL | GTSI520L(4)B |
| FILE NUMBER | 14-177 |

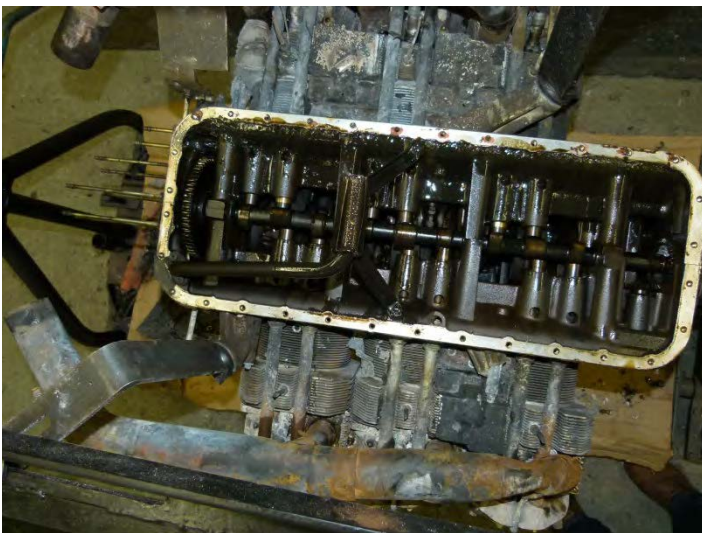
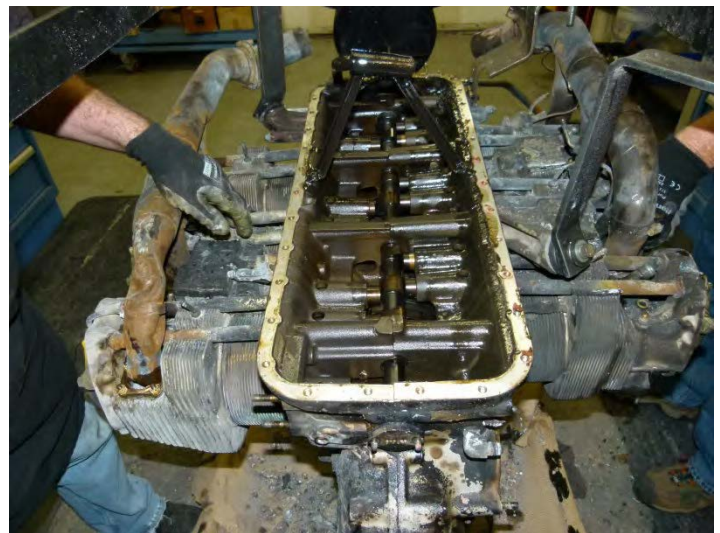
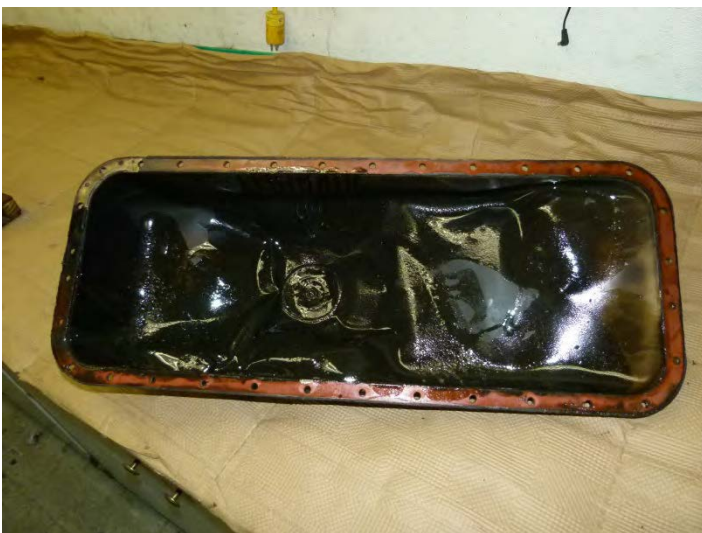
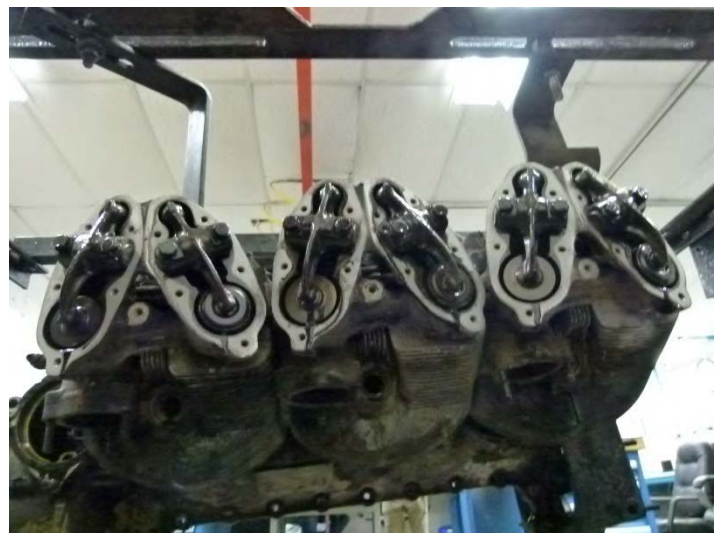
The aircraft was reported to have been miss-fueled with Jet A instead of 100LL. The damage to the internal components of the engine, in particular the cylinders and pistons were consistent with detonation. A mixture of jet fuel and 100LL will reduce the octane rating for the fuel and lead to detonation. The remainder of the engine components exhibited normal operating signatures with thermal damage from the post-crash fire.

The internal components of the engine were thermally damaged by the post-crash fire. All of the internal components show no signs of lubrication distress. The cylinders exhibited heat damage and detonation signatures. All pistons exhibited scuffing and heat signatures on the skirt. Pistons one, two, and five exhibited detonation signatures on the face of the piston with portions melted away on the outer edge. The main and rod bearings exhibited normal operating signatures with thermal heat signatures from the post-crash fire. The crankshaft, camshaft, gears, connecting rods and reduction gears all exhibited normal operating signatures. The crankcase exhibited normal operating signatures along with impact and thermal damage. The fuel system components were impact and fire damaged with portions melted away. The engine accessories were intact and exhibited thermal damage. Only portions of the induction system remained attached to the engine the remainder was melted away by the post-crash fire.
