**INCIDENT INVESTIGATION REPORT IIRN000101 Issue 1**

| MEGGITT RETURN No | RMA8905 | PART No | DAP00100-07 | QTY | 1 |
| AIRCRAFT | EMB-505 | DATE OF INCIDENT | 19/09/2014 | | |

**1. INTRODUCTION****Event Details as reported by the NTSB:**

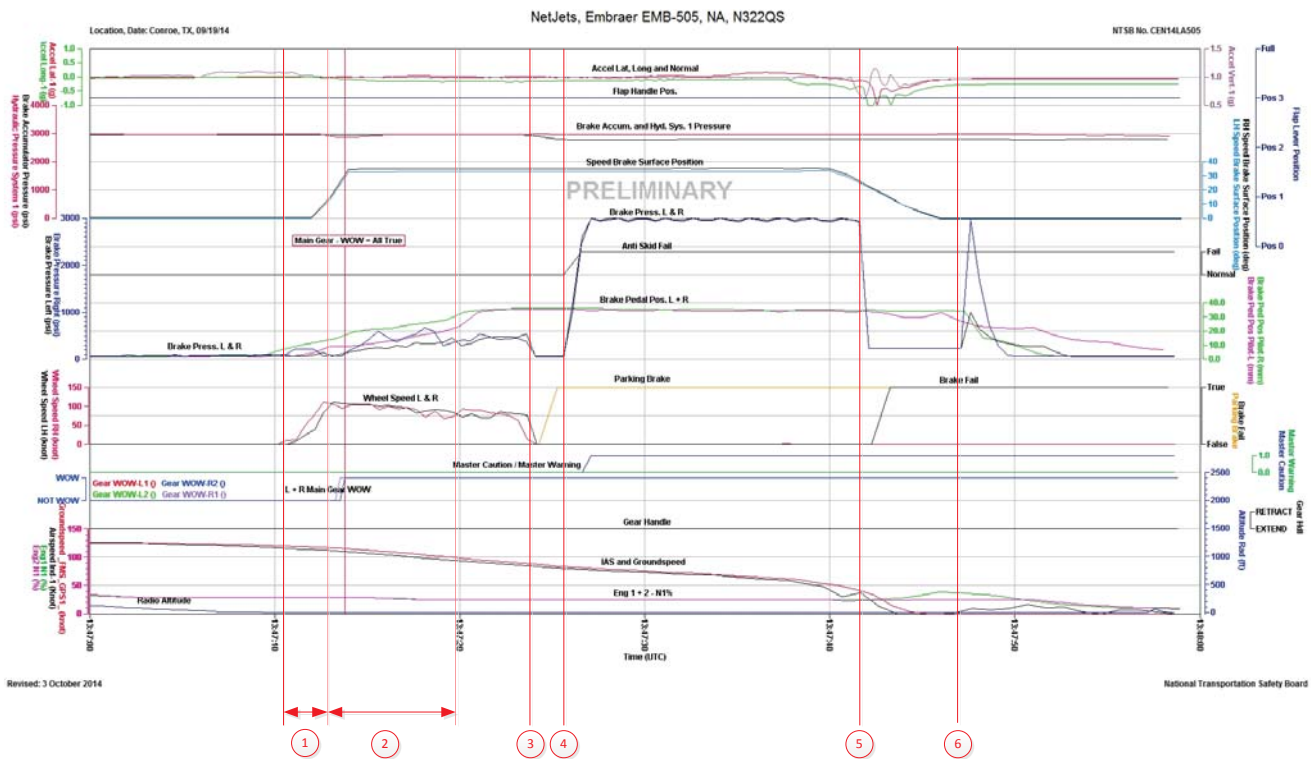
## Approximate Time Line

Right pedal has been applied prior to touchdown (wheel spin-up).

Wheel spin up is relatively slow – indicates low mu/light landing (spin up starts at 13:47:10 – spun up at approximately 13:47:12.5).

Pressure applied for right side is as expected for wet runway - evidence of anti-skid activity observed very shortly after spin up.

Pressure for left side is tracking pedal demand– starts to antiskid at approximately 13:47:19.

Rough estimate deceleration rate is 0.16g (lower than System Integration wet runs – approximately 0.22g) however left pressure is very low and therefore left brake not generating much deceleration force for much of the initial part of the landing.

At approximately 13:47:24 park brake is applied and both wheels lock.

After park brake applied deceleration reduces to approx. 0.1g.

- 1) Slow wheel spinup
- 2) Gradual braking demand – left demand below skid level pressure
- 3) Park Brake applied
- 4) BCU detects prolonged full dump (l/r) and triggers hardware bypass (within 200msecs) –sets AntiSkid\_Fail
- 5) BCU detects left/right BCU faults – sets Brake\_Fail
- 6) This is evidence that the BCU issue (open/short circuit) has recovered – Pressure is re-applied.

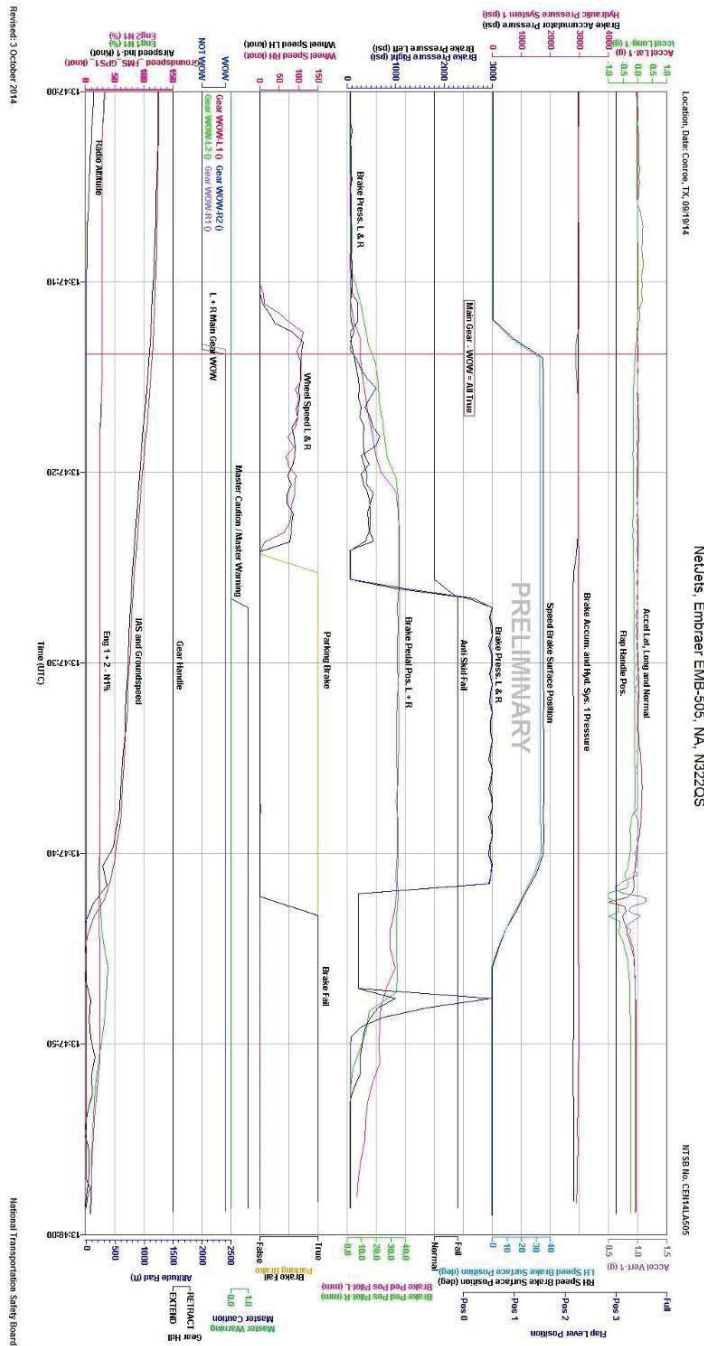
**Plot 10032014 v2 1 Minute Accident Landing**

### **Observations from CVDR data supplied plot 10032014\_v2\_1 Minute Accident Landing.jpg**

Right pedal ramps up to max over approximately 10 seconds.

Left pedal has been applied during wheel spin up - approximately 13:47:11.

Left Pedal applied slowly 'lagging' right pedal.

Both pedals are applied to max deflection at approximately 13:47:22.
