## NTSB Party Submission

NetJets Aviation Inc.

Investigation: CEN14FA505

N322QS, Embraer Phenom 300s

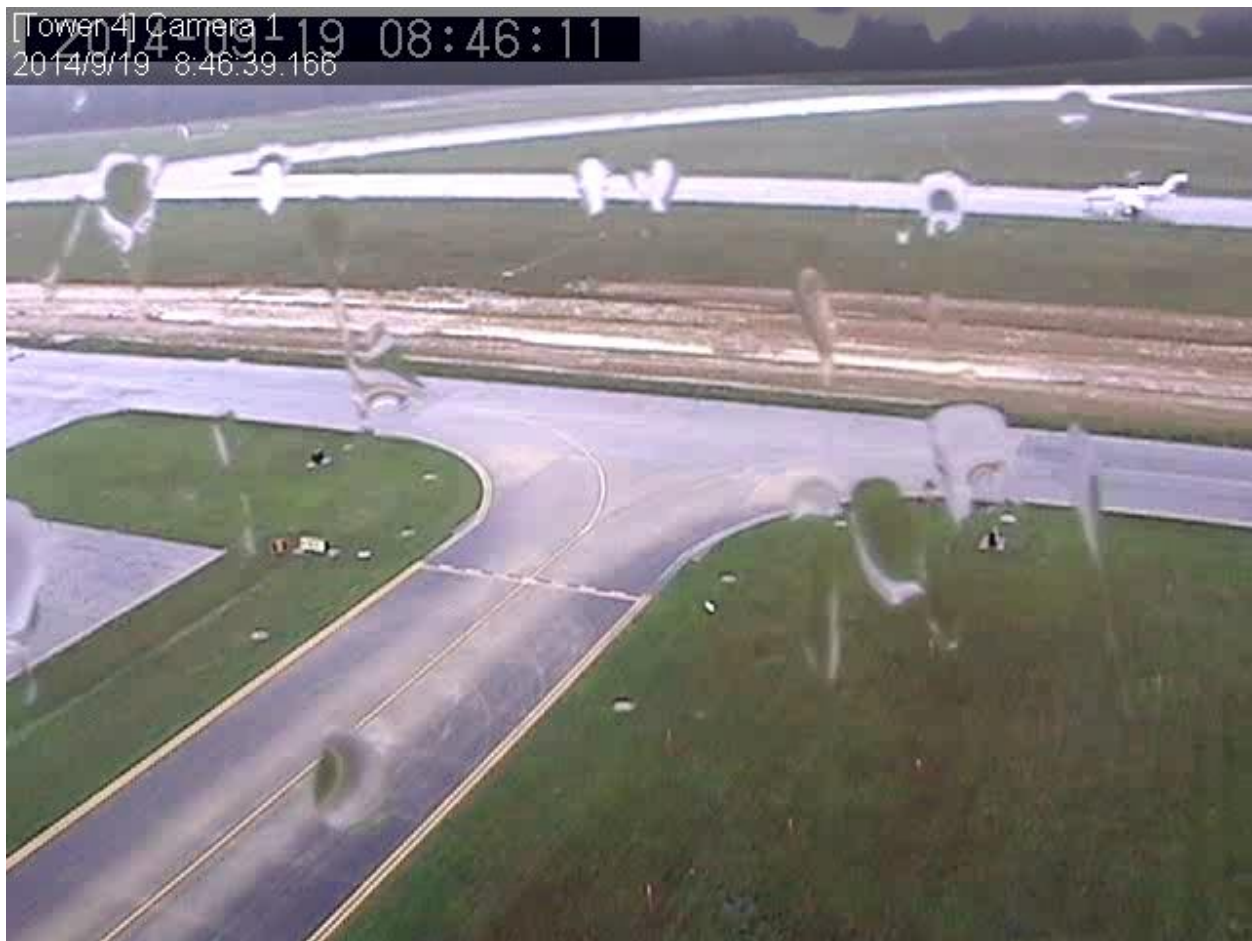
Figure 1. Accident Aircraft during landing roll out.

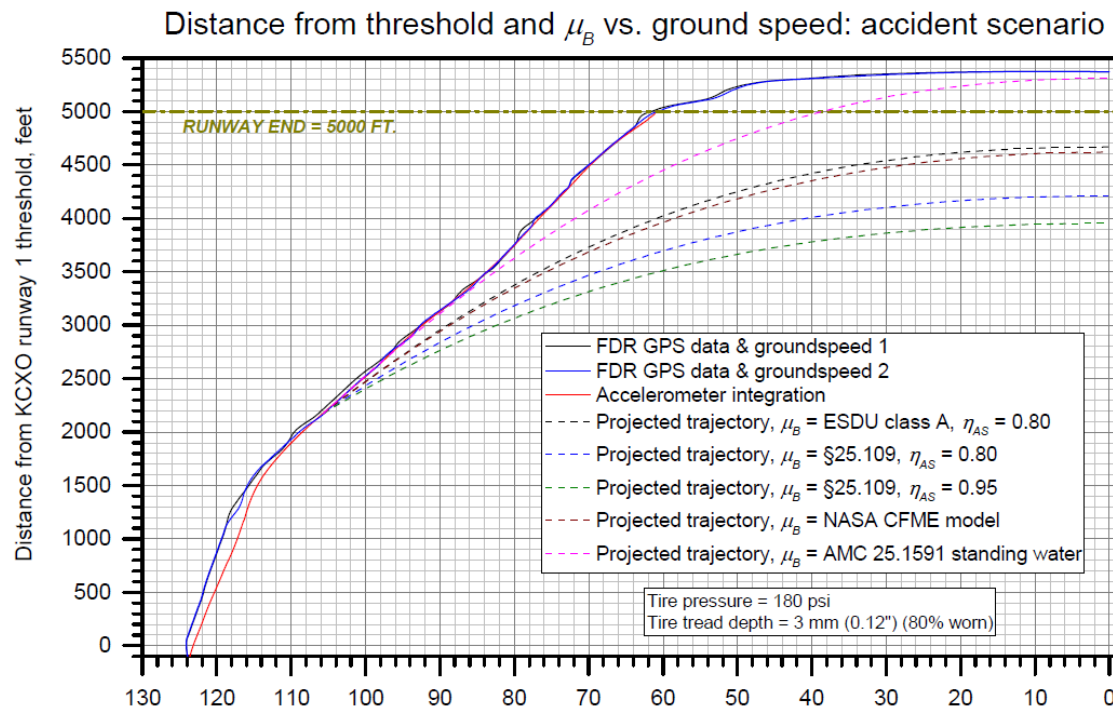
The chart shown below from the performance report illustrates the difference in the models and actual performance of the aircraft. The NASA CFME model most accurately matched the aircraft performance in this event and has been validated in a number of other runway overrun events documented by the NTSB. The resulting difference between actual and expected braking performance on the wet runway was approximately 23 percent. This difference exceeded the LPA safety factor and directly contributed to the accident.

Figure 2. Landing distance performance actual vs. modeled
