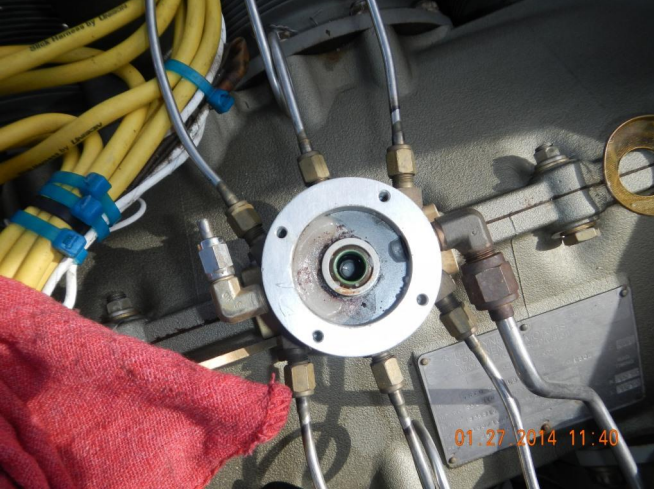
Photo 3. Ice in right fuel manifold valve  
(Photo Courtesy of Continental Motors)
