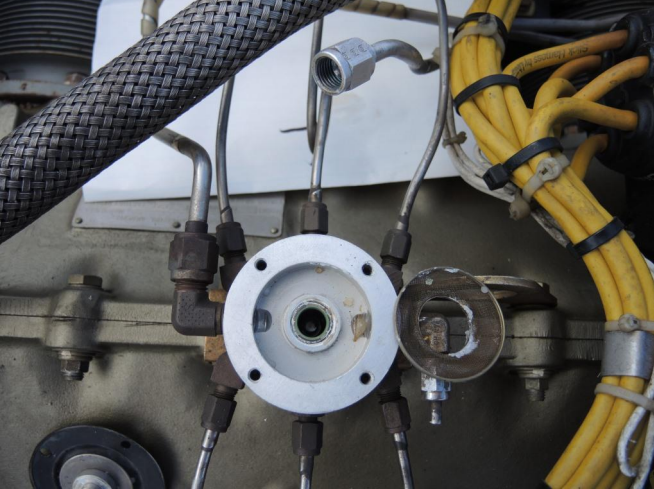
Photo 4. Ice in left fuel manifold valve (Photo courtesy of Continental Motors)
