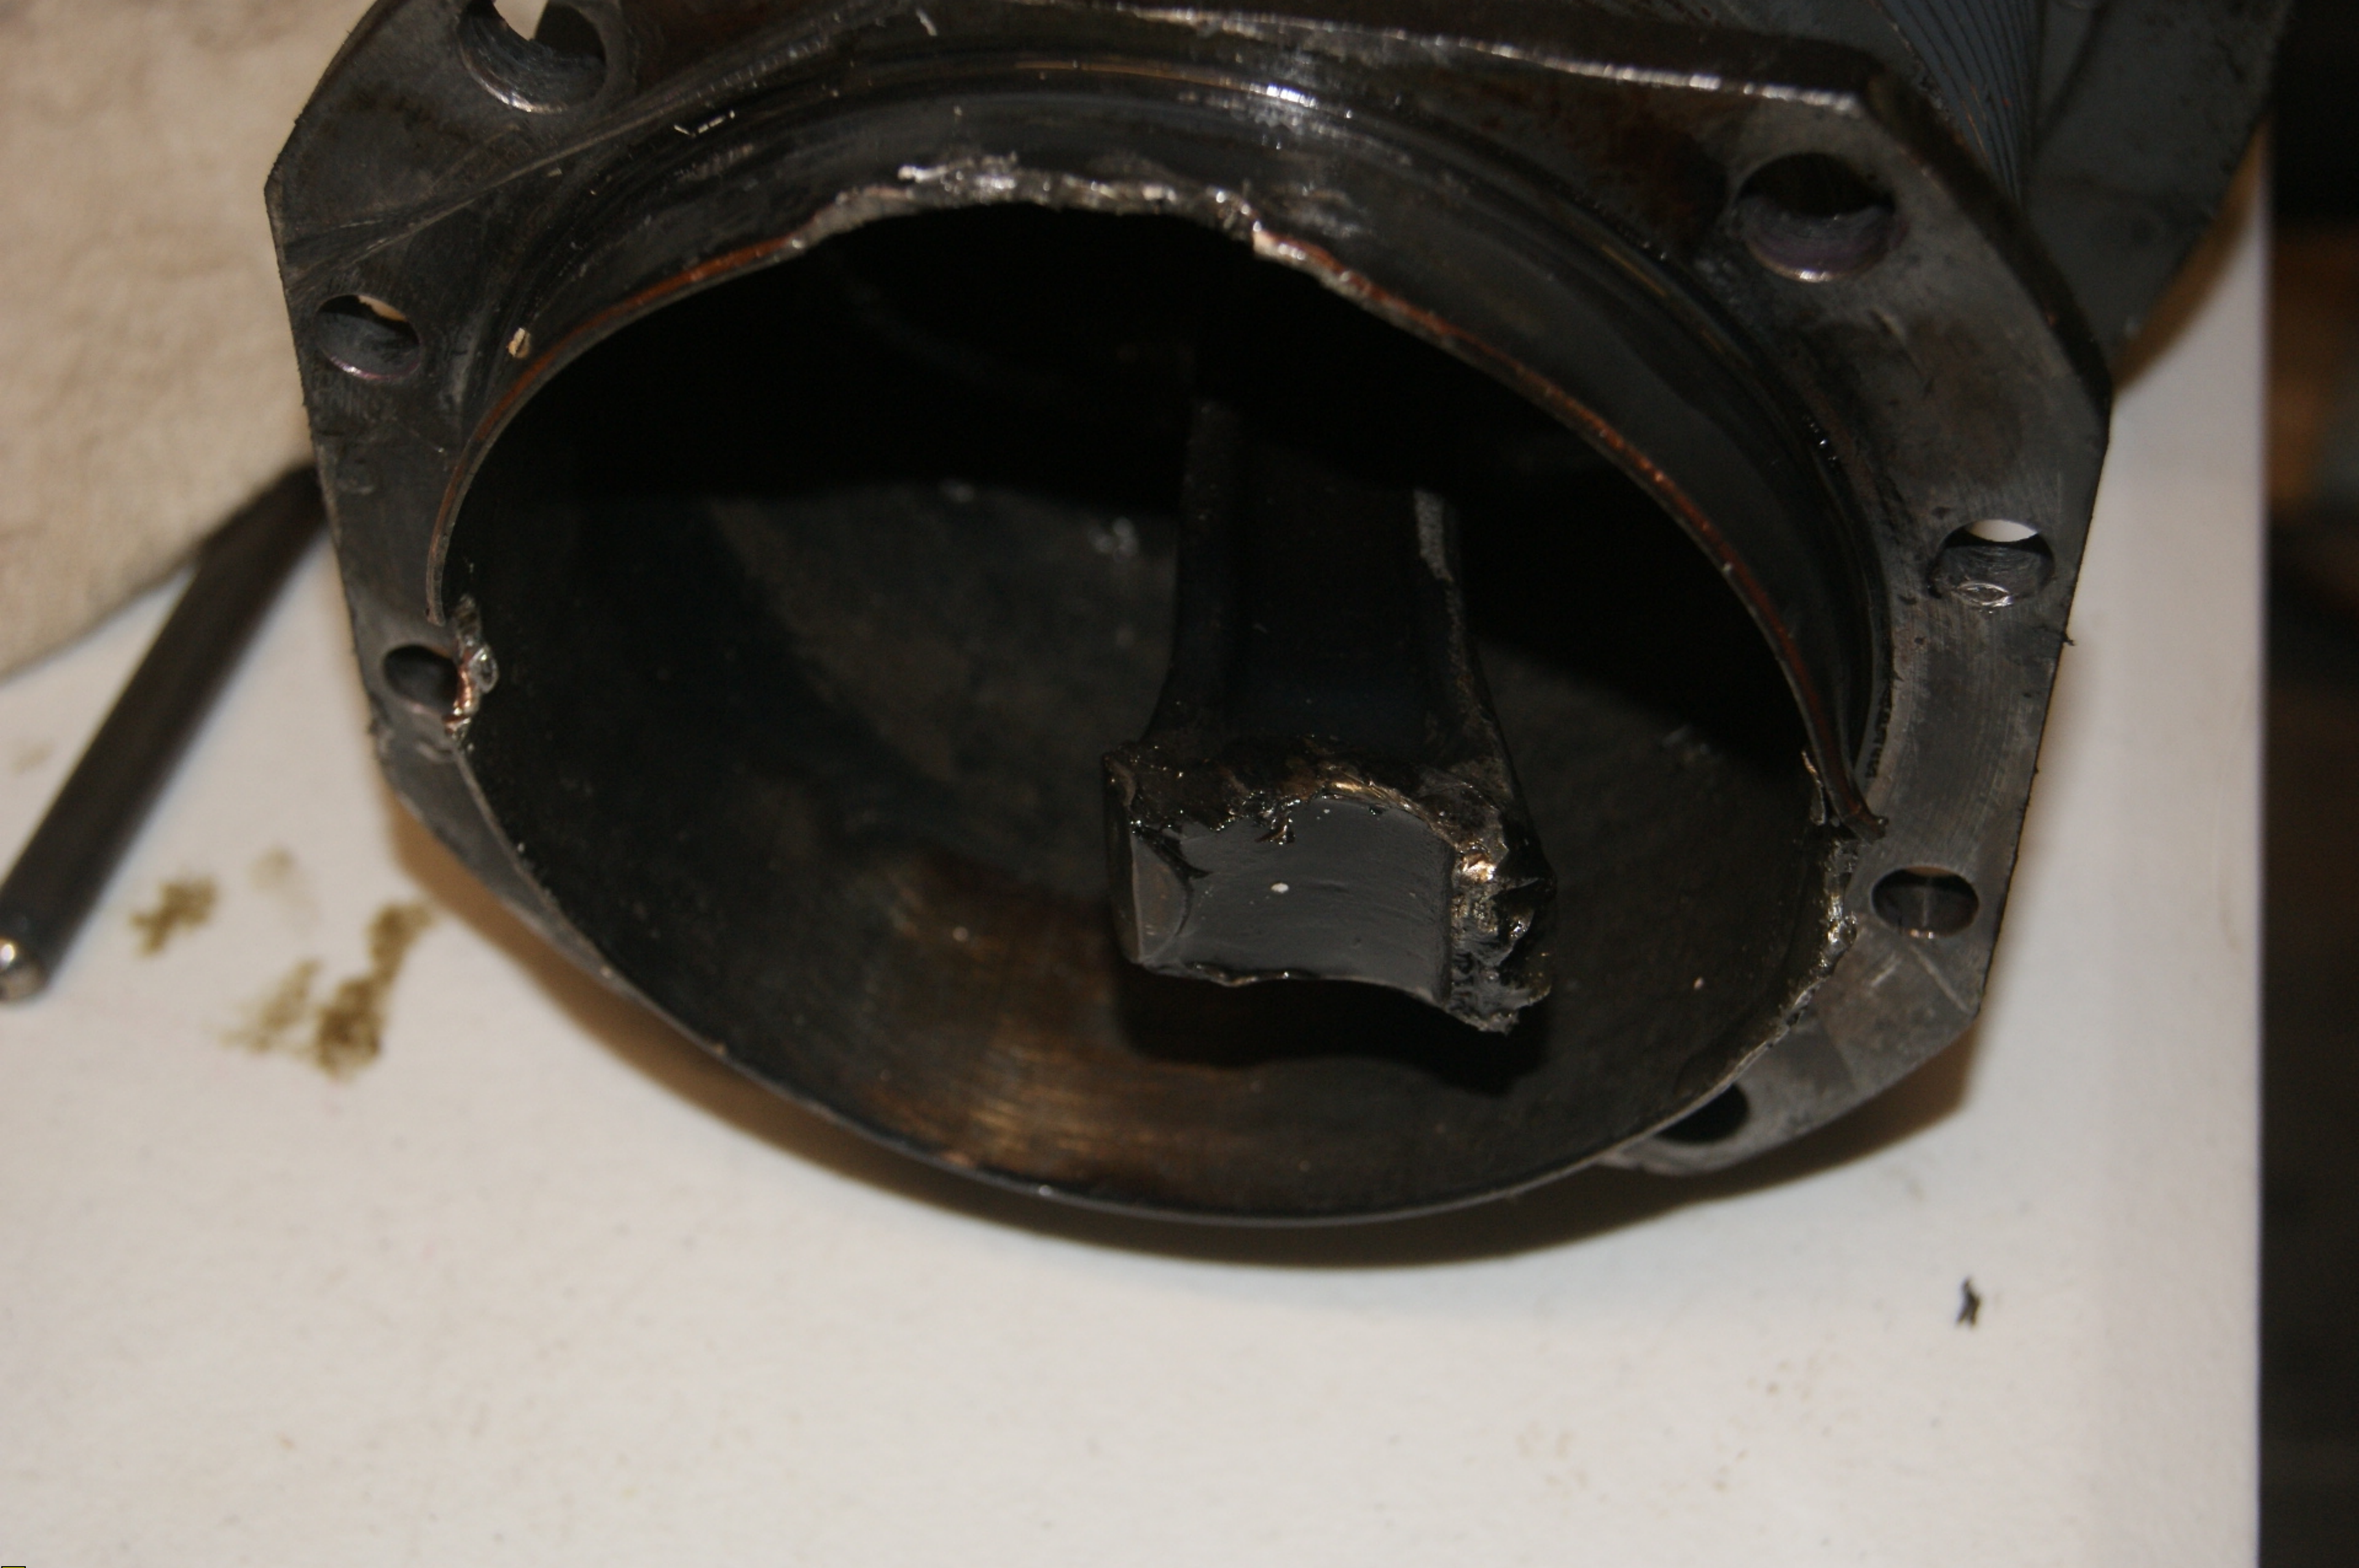
Photo 6 - Number 5 cylinder, seized piston, and fractured connecting rod cap
