# **NATIONAL TRANSPORTATION SAFETY BOARD**

## **MATERIALS LABORATORY FIRE FACTUAL REPORT**

Report No. 14-059

Place : Wapakoneta, Ohio  
Date : March 8, 2014  
Vehicle : Cessna 310  
NTSB No. : CEN14LA159  
Investigator : Courtney Liedler  
AS-CEN

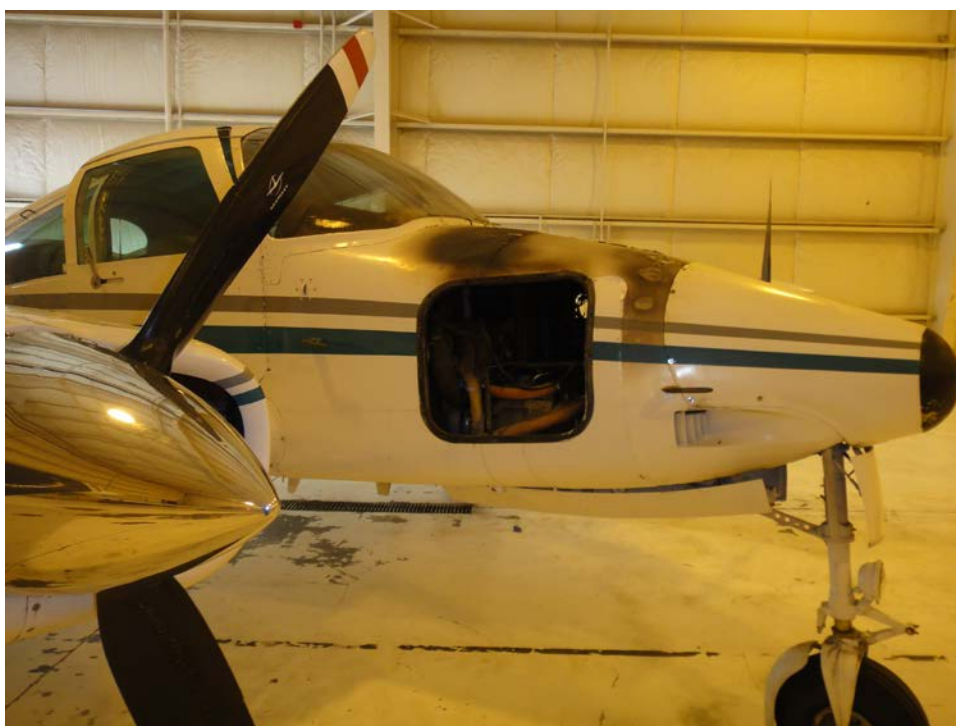
The accident aircraft is shown in Figure 1. The aircraft was intact and the fire damage was limited to the nose compartment and the lower forward portion of the instrument panels and cockpit. The exterior damage was located on the upper portion and right side of the nose compartment. The upper section of fuselage exhibited large areas of thermal discoloration of the exterior paint as well as bubbling and peeling of the outer layers of the paint as shown in Figures 2-4. This damage continued down the right side of the nose compartment. The lower right exhaust louvers and the fuselage skin near the heater exhaust exhibited sooting and some thermal discoloration as shown in Figure 5-7.

**Figure 2. Photograph of exterior of nose compartment.**

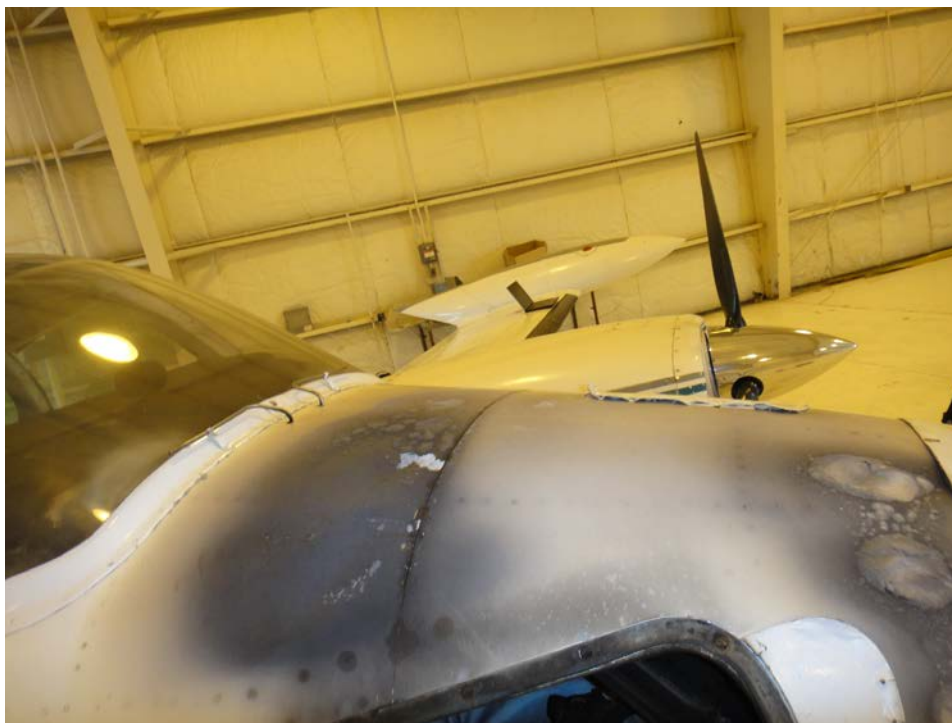
**Figure 3. Close-up photograph of upper nose fuselage skin.**

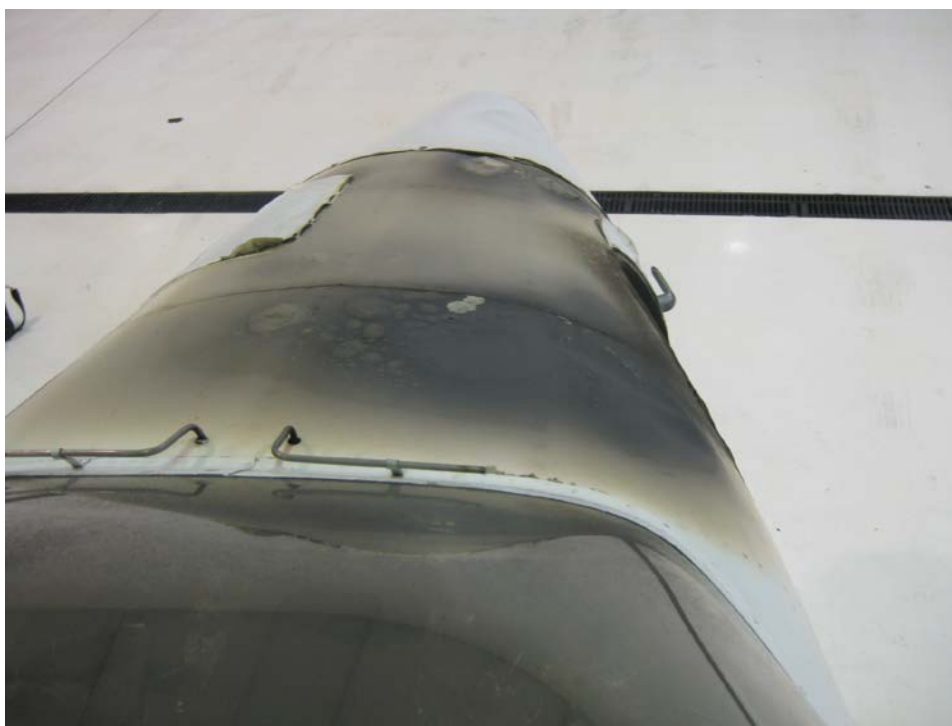
**Figure 4. Close-up photograph of upper nose fuselage skin facing forward.**

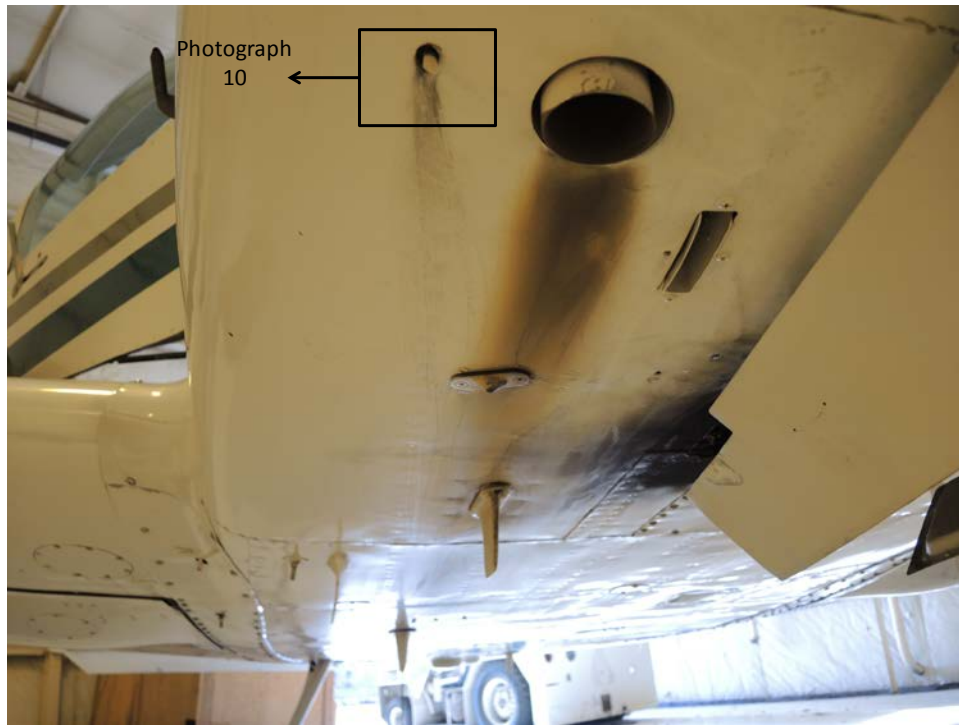
**Figure 5. Close-up photograph of cabin heater exhaust and drain.**

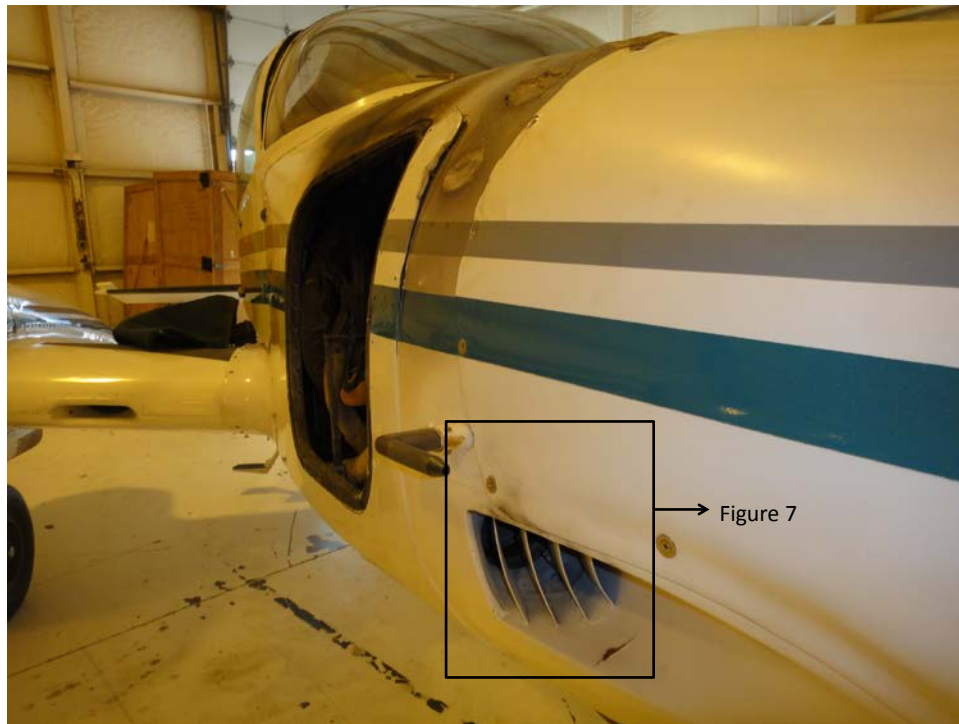
**Figure 6. Photograph of right side of nose compartment with exhaust louver.**

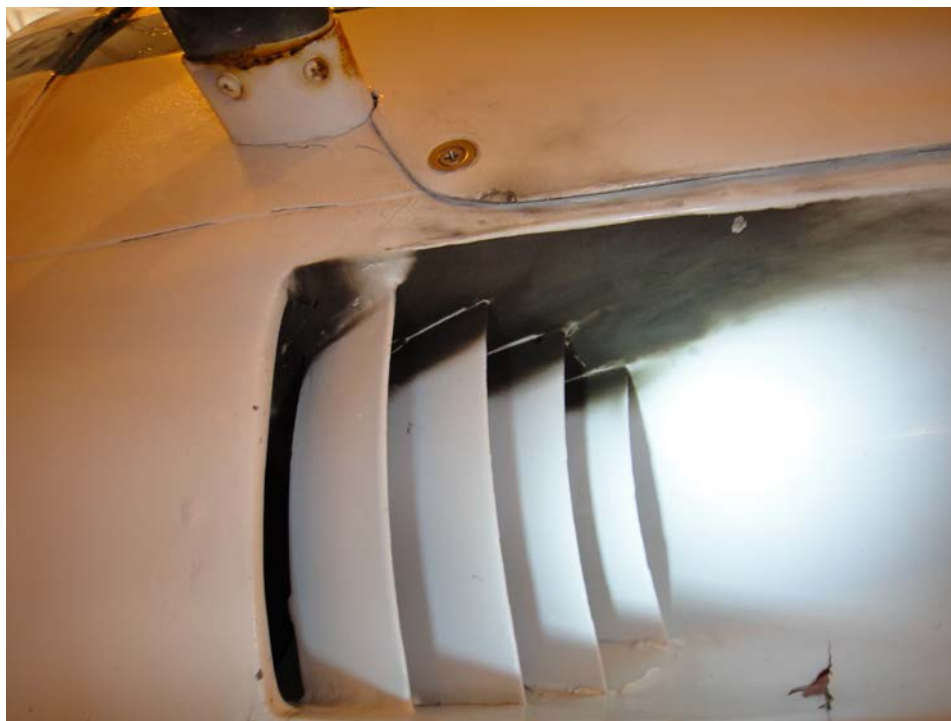
**Figure 7. Close-up of sooting on lower right exhaust louver.**

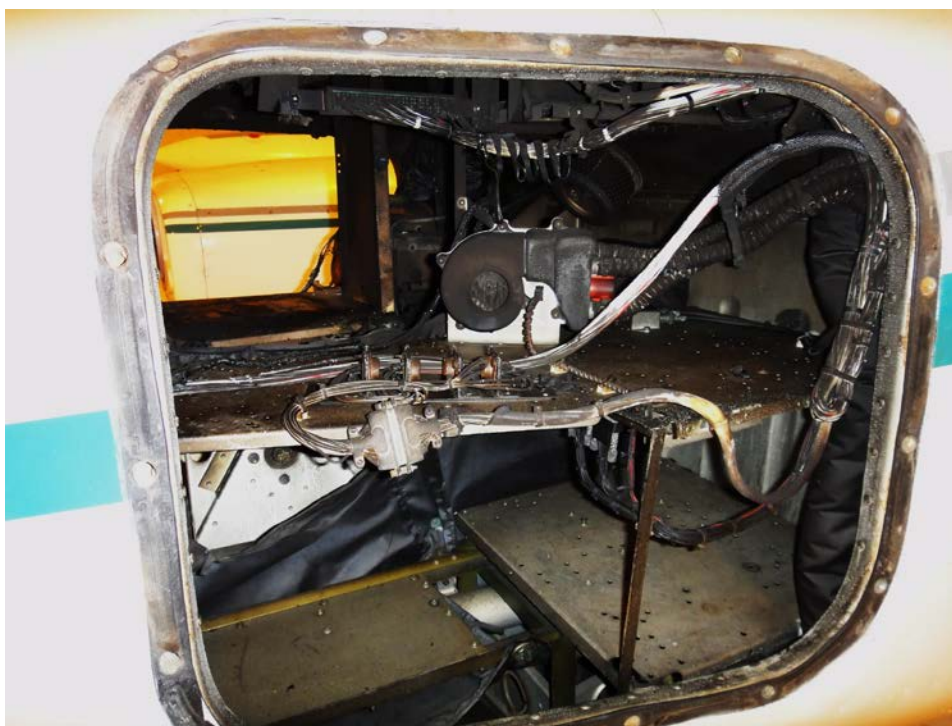
The interior of the nose compartment was heavily sooted and exhibited thermal damage particularly in the area of the cabin heater, which was located on the rear right side of the nose compartment. The left side of the compartment is shown in Figure 8 and the right side is shown in Figure 9. The left side of the compartment was heavily sooted with some generalized melting and sagging of wire insulation. On the right side, nonmetallic components (such as wire insulation, tubing and ducts) adjacent to the heater showed melting and thermal discoloration. Several rubber components of the heater assembly were missing and presumed destroyed by the fire. The exterior of the heater and adjacent metallic assembly components were sooted and had evidence of thermal discoloration. During the removal of the heater assembly from the aircraft, the heater assembly drain line was found to be blocked as shown in Figure 10. There was limited fire damage to the cabin. There was some thermal discoloration of the floor on the right side of the cockpit as shown in Figure 11.

**Figure 8. Photograph of the left side interior of the nose compartment.**

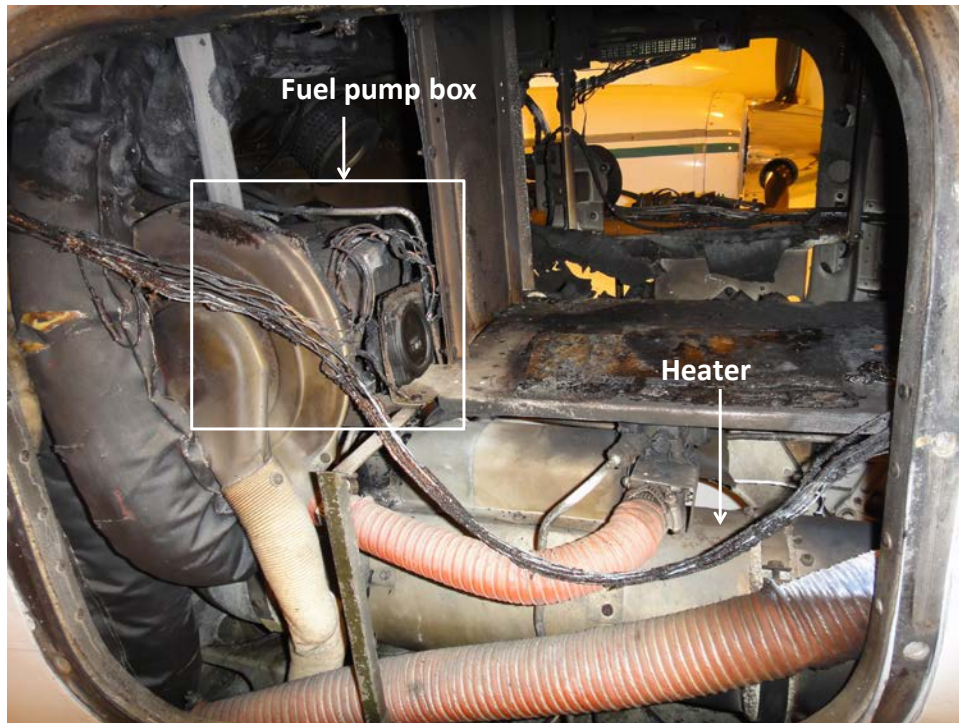
**Figure 9. Photograph of the right side interior of the nose compartment.**

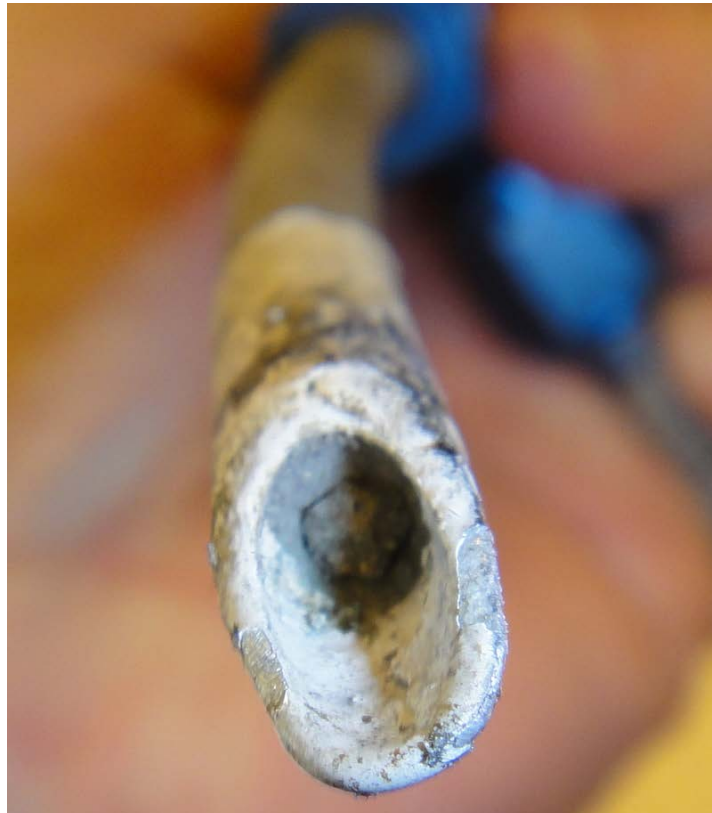
**Figure 10. Close-up photograph of the end of the heater drain line.**

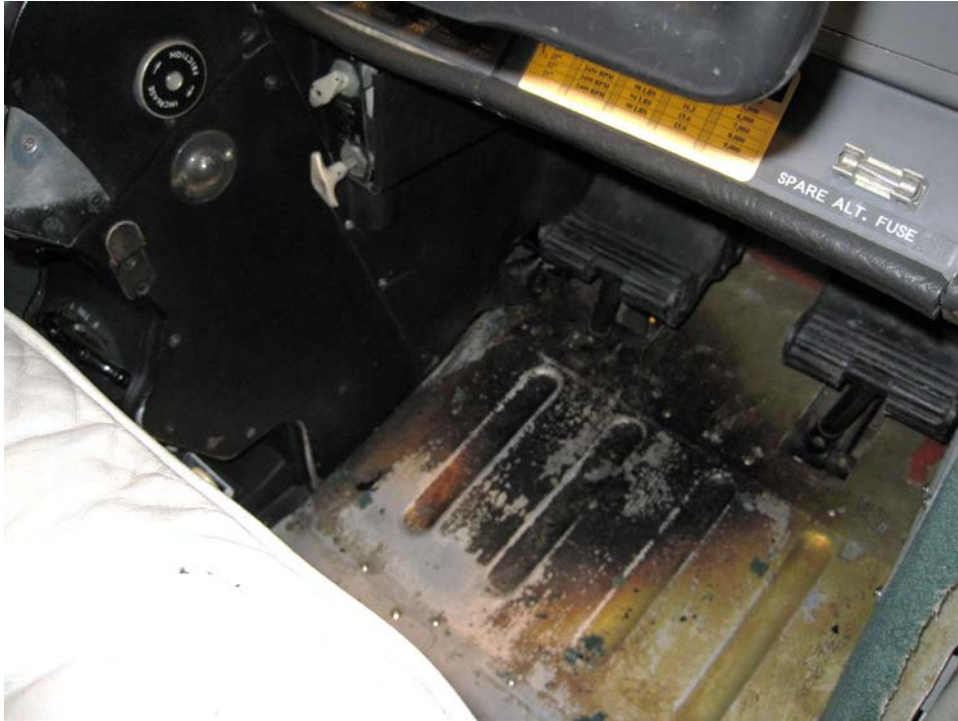
**Figure 11. Photograph of cockpit floor with carpeting removed.**

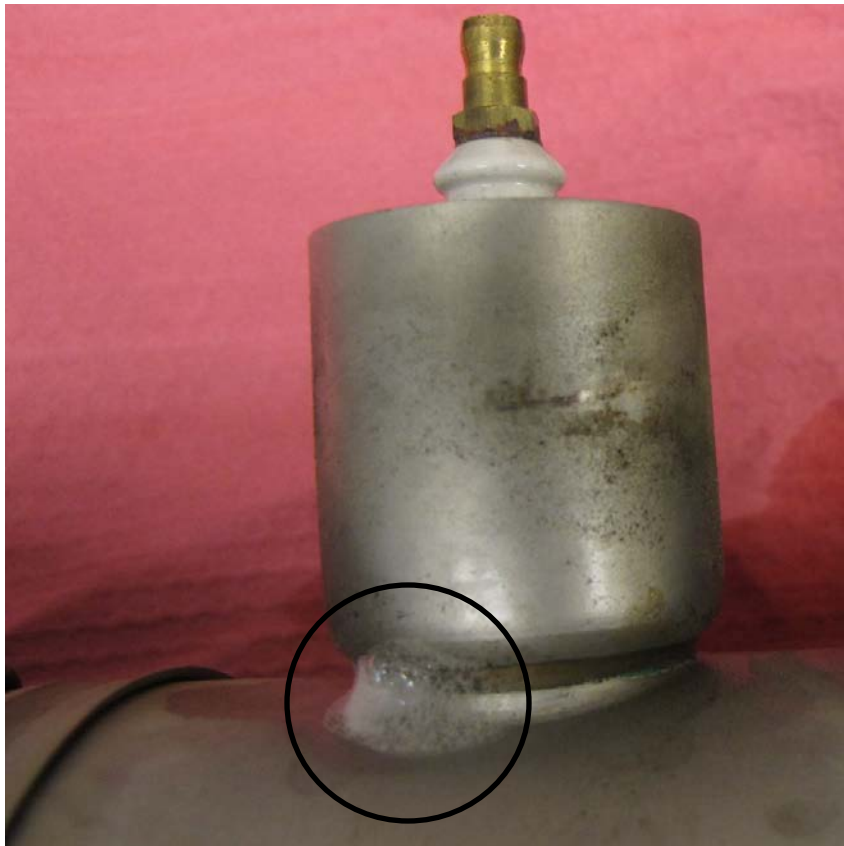
The exterior case of the heater was removed during the examination as shown in Figure 13. No anomalies were initially found during the removal. A pressure test of the combustion chamber and associated heat exchanger muff was then performed. Four separate leaks were found. One leak was found in the igniter plug port weld as shown in Figure 14. One leak was found in the heat muff end weld, as shown in Figure 15. Two leaks were found in the welds that attach the combustion chamber to the heat exchanger muff as shown in Figure 16. One of those leaks had a visible crack as shown in Figure 17.

**Figure 14. Photograph of leak in igniter plug port weld. The leak (circled in black) is made visible by the bubbling leak detector liquid.**

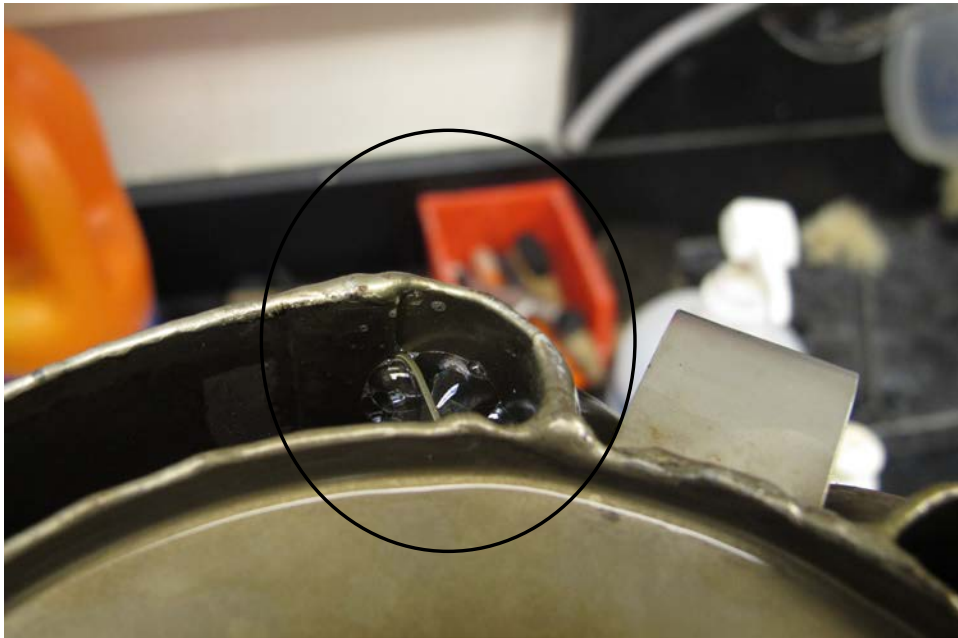
**Figure 15. Photograph of leak in heat muff end weld. The leak (circled in black) is made visible by the bubbling leak detector liquid.**

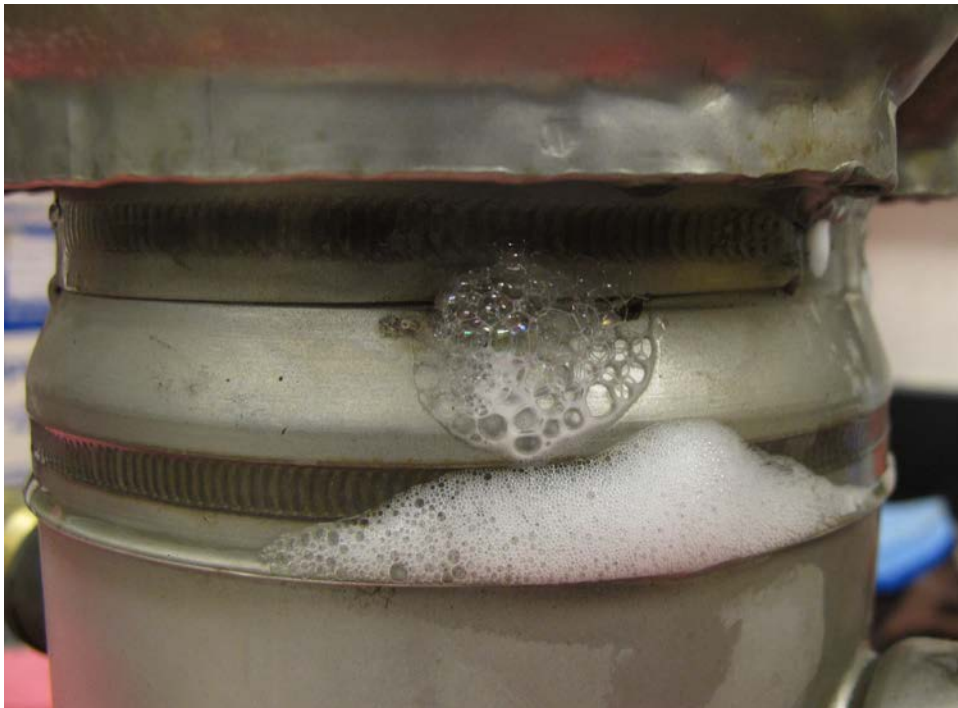
**Figure 16. Photograph of leaks in combustion chamber-heat muff weld. One leak was made visible by the bubbling leak detector liquid.**

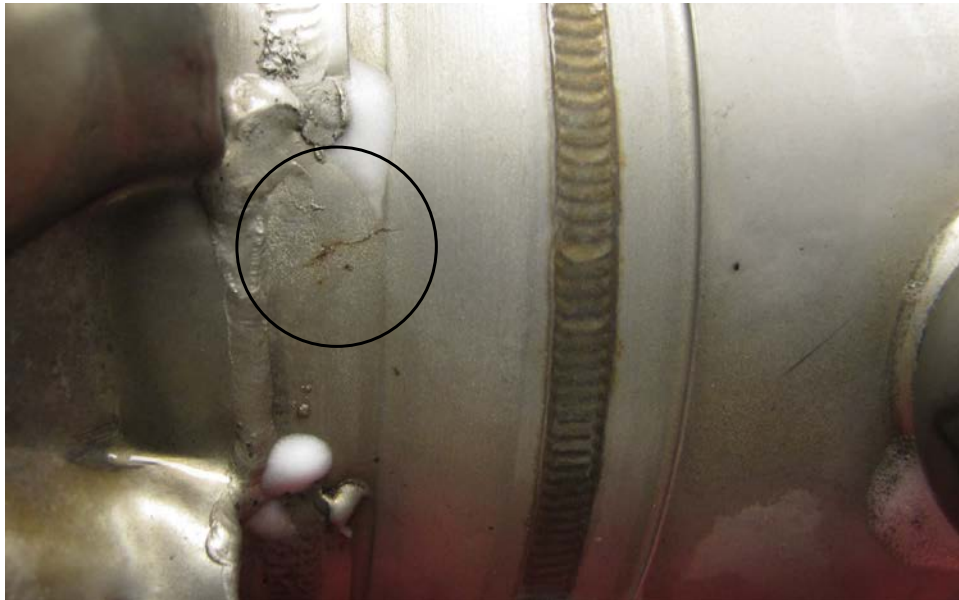
**Figure 17. Photograph of visible crack in combustion chamber-heater muff weld (highlighted by black circle).**

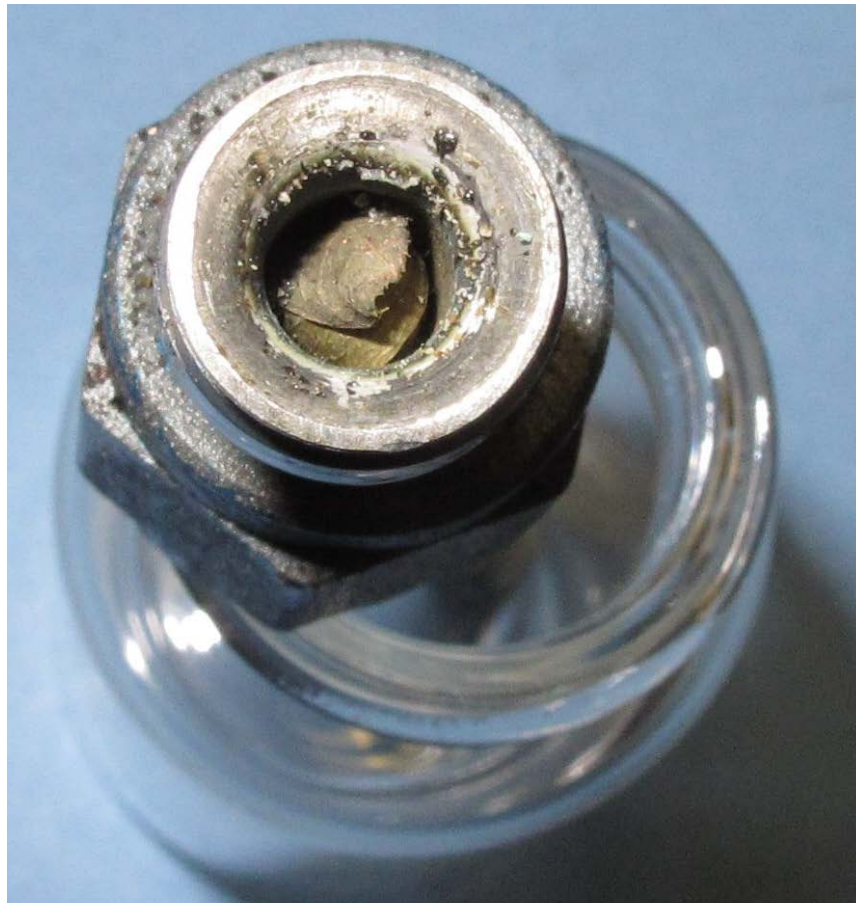
The blocked drain line was examined. It was determined that the material in the drain line was densely packed from the open (drain) end to the end fitting as shown in Figure 18. Approximately 0.4 grams of material was removed from the drain line using a thin wooden scraper. The material was brownish gray in color and had a powdery consistency as shown in Figure 18. A sample of the material removed from the drain line was examined using a Fourier Transform Infrared (FTIR) spectrometer with a diamond

**Figure 18. Close-up photograph of fitting end of cabin heater drain line (opposite end of line in Photograph 10).**

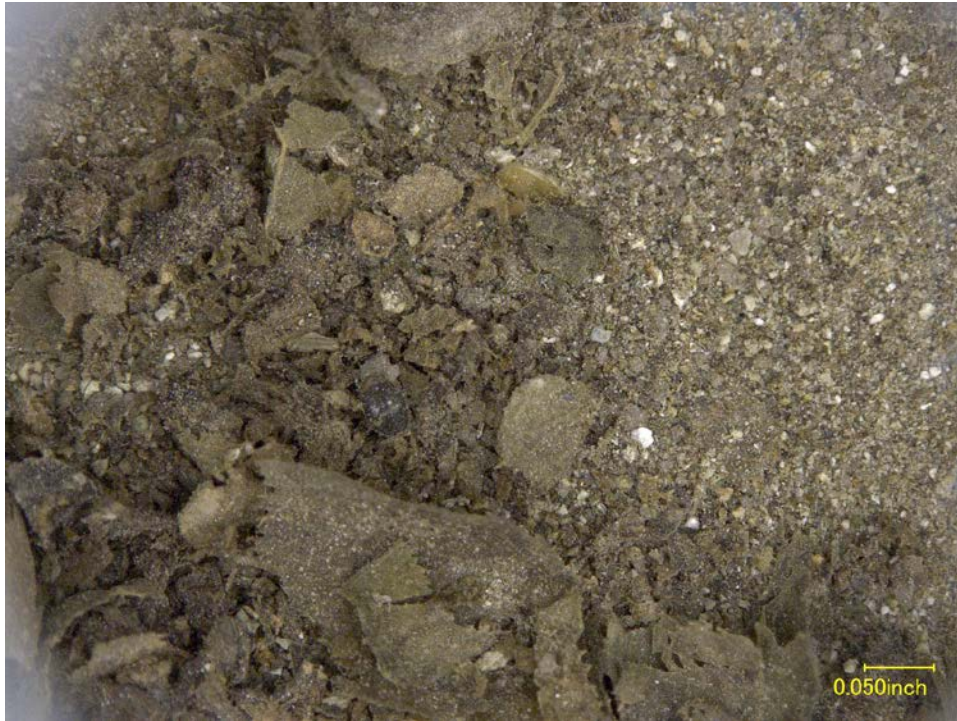
attenuated total reflectance (ATR) accessory<sup>1</sup> in accordance to ASTM E1252-98 and ASTM E334-01<sup>2</sup>. The spectrometer was used to collect and process infrared wavelength absorbance spectrum of the sample<sup>3</sup>. The spectral pattern was similar with an amine carboxylate. The spectrum of the unknown material was processed through a spectral library search engine. The search found several matches to the unknown material. The matches were materials used as surfactants often used as fuel additives (mostly corrosion inhibitors, detergents, antioxidants and emulsifiers) in aviation fuels. A solid powdery residue, similar in appearance to the blockage material, recovered from the inside of the heat exchanger was also examined by FTIR. The spectrum from this material had no significant spectral patterns indicating that little or no organic material was present.

The blockage material sample was then analyzed by scanning electron microscopy (SEM) and quantitative standardless energy dispersive x-ray spectroscopy (EDS) in accordance with ASTM E1508<sup>4</sup>. The EDS analysis showed the presence of carbon (C), aluminum (Al), oxygen (O), and lead (Pb). These constituents are consistent with lead oxide and aluminum oxides often found in aviation fuel combustion byproduct and other materials found within the aircraft engine compartment and fuel system. The EDS spectrum of material from the drain line was compared to material found in the heat exchanger and the two materials were found to be of similar composition.

Figure 19. Photograph of material removed from cabin heater drain line.

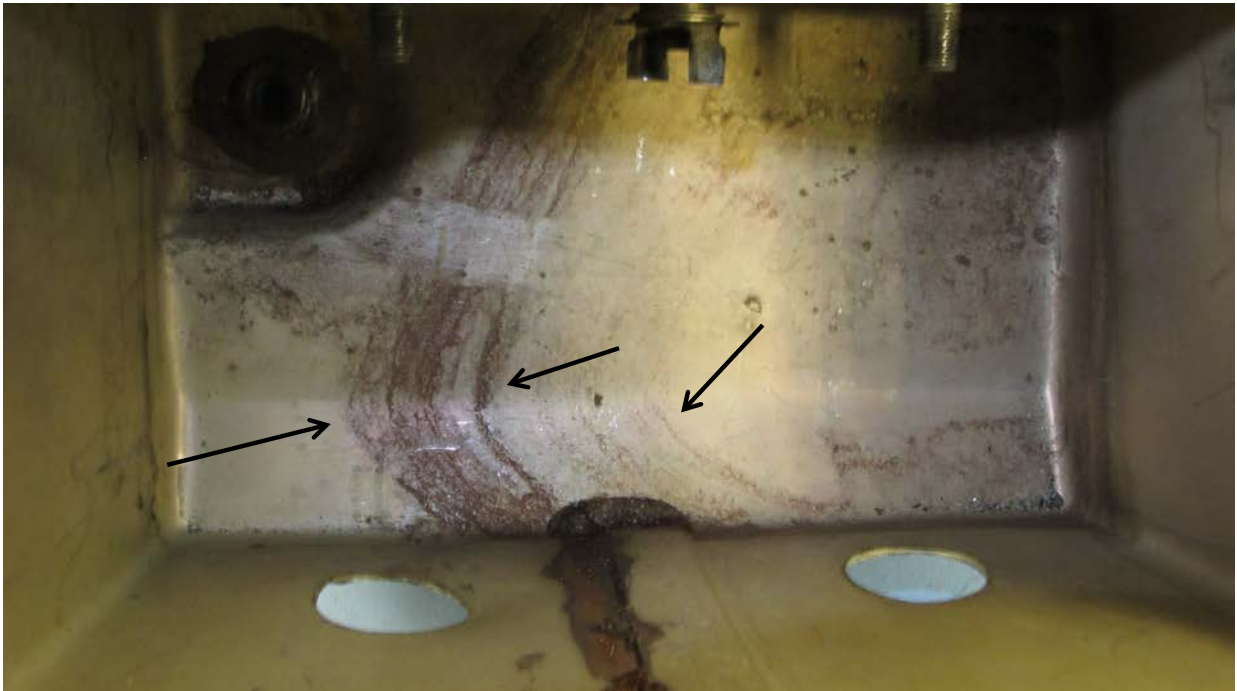
There was evidence of fuel leakage in the fuel pump box as shown in Figure 20. There were evaporation marks where the fuel accumulated and the evaporated off leaving behind the nonvolatile residue. There were several bands of evaporation marks consistent with multiple evaporation cycles. Because the fuel pump box had visible thermal discoloration, indicating that the fuel pump had been exposed to heat, pressure testing of the fuel pump was not done due to the inability to recreate a pre-accident condition for the fuel pump.

Figure 20. Interior of cabin heater fuel pump box. Evaporation lines are marked with black arrows.

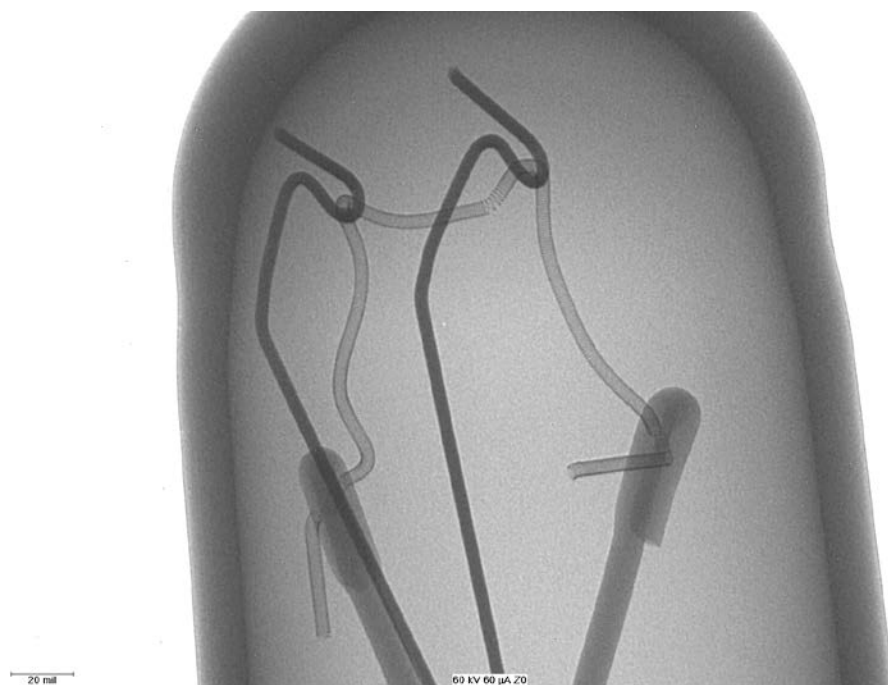
The filament in the heater annunciator light was examined by x-ray. No anomalies were found and the filament was unstretched and intact as shown in Figure 21.

**Figure 21. Radiograph of cabin heater light bulb filament.**
