# NATIONAL TRANSPORTATION SAFETY BOARD

## MATERIALS LABORATORY FACTUAL REPORT

Report No. 15-070

Place : Greenville, Texas  
Date : April 25, 2014  
Vehicle : Flight Design GMBH CTLS, N106SF  
NTSB No. : CEN14LA226  
Investigator : Timothy Sorensen, AS-CEN

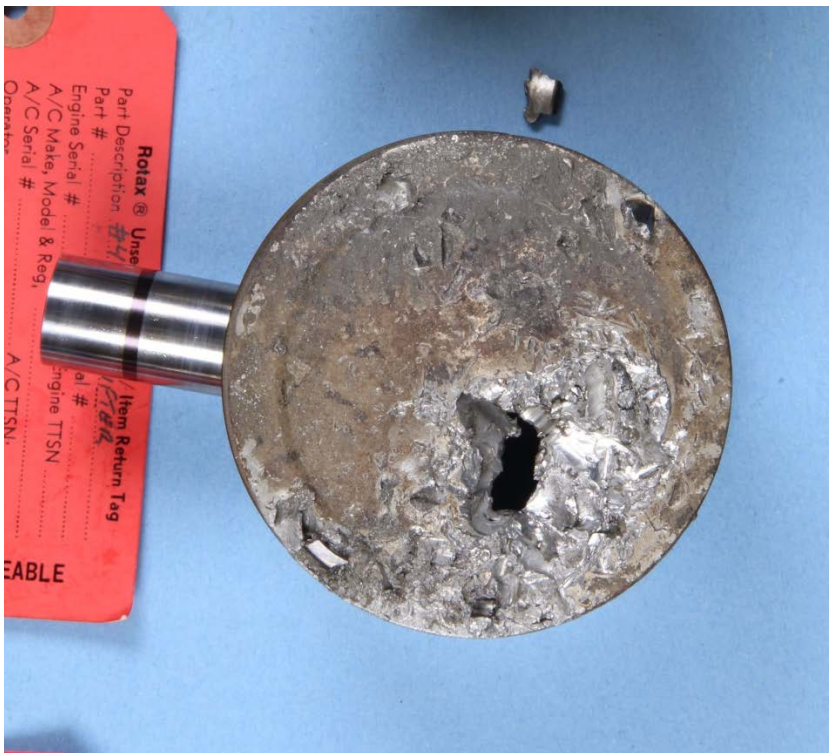
Initial examinations of these components found the #4 exhaust valve was fractured just above the head. The piston crown and cylinder head dome were severely damaged by impacts consistent with the valve separation, as shown in figure 2. The #4 exhaust tappet was missing the retaining ring with the push rod seat and oil metering plate separate. The cam faces of several tappets showed spalling and the cam face of the #4 was severely worn. The #4 exhaust valve lobe was severely worn and damaged. Other components were unremarkable.

Figure 2. Views showing the impact damage to the cylinder crown and piston top.

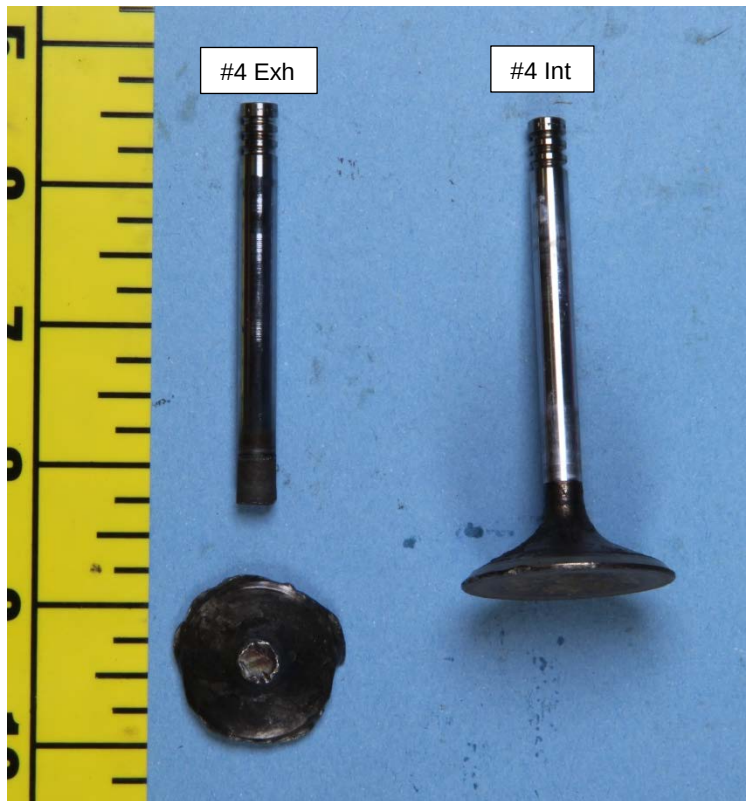
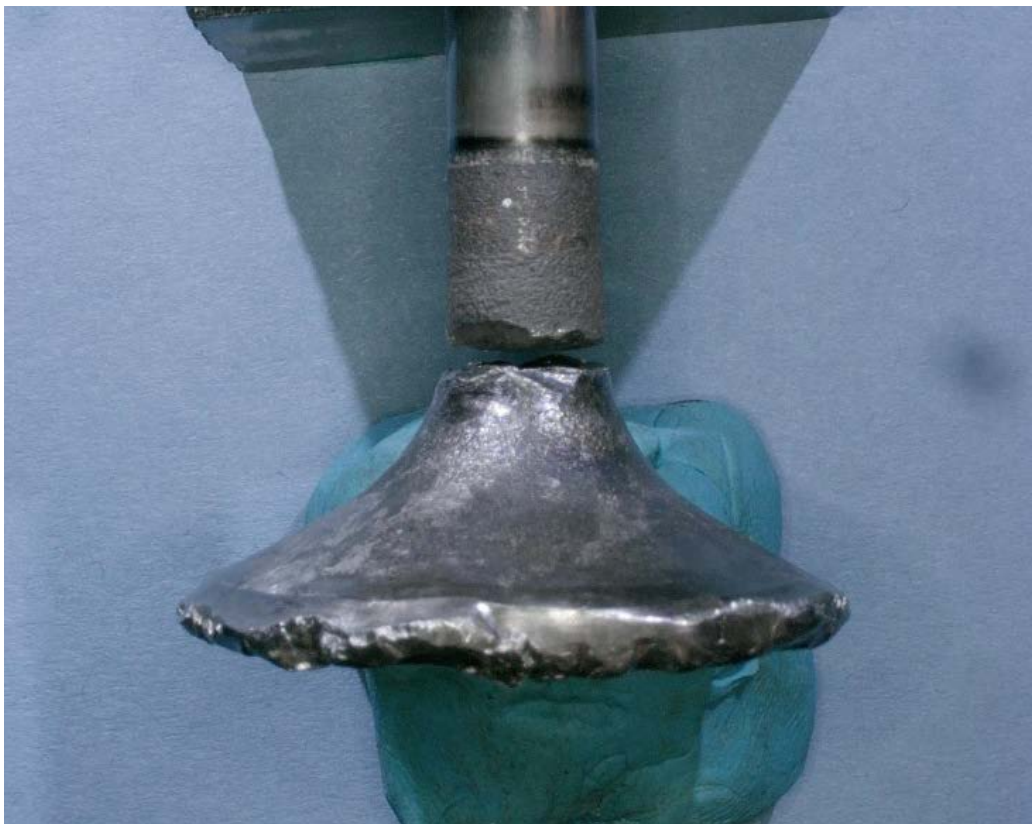
The exhaust valve was fractured through the exposed portion of the stem just above the head as shown in figure 3. The separated head was severely damaged consisted with continued engine rotation after separation. Both fracture faces were also extensively damaged with the stem side face almost entirely obliterated. The head side fracture face, shown in figure 4, was also extensively damaged but showed sufficient features to establish the fracture mode as bending fatigue. Macroscopic beach mark on the fracture indicated fatigue initiation on one side of the stem with progression directly across and through the remaining visible stem cross section. Scanning electron microscope (SEM) viewing found that the beach mark indicated fatigue origin region was obliterated and much of the fine fracture details were also damaged.

Figure 3. At left, the intake and fractured exhaust valves. A closer side view of the fractured area of the exhaust valve is shown below.

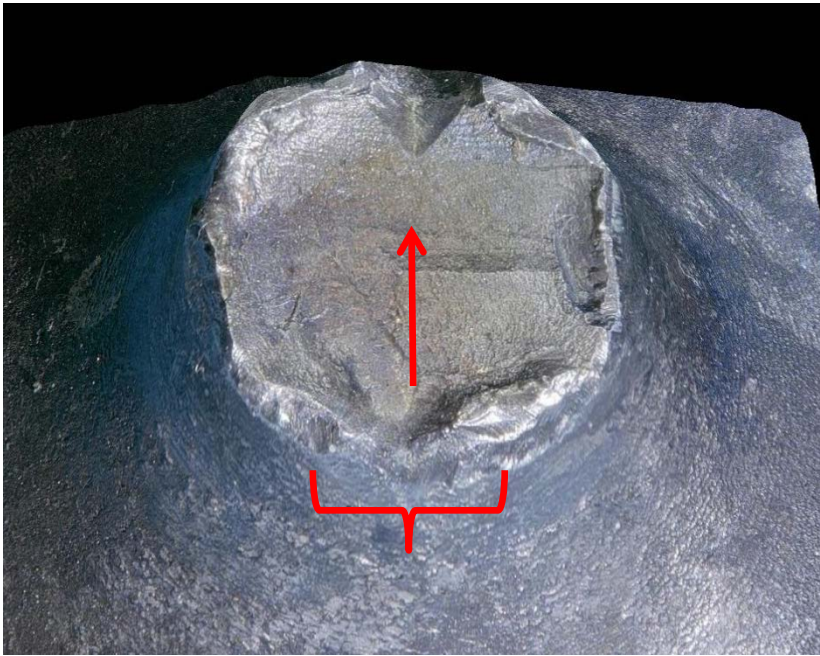
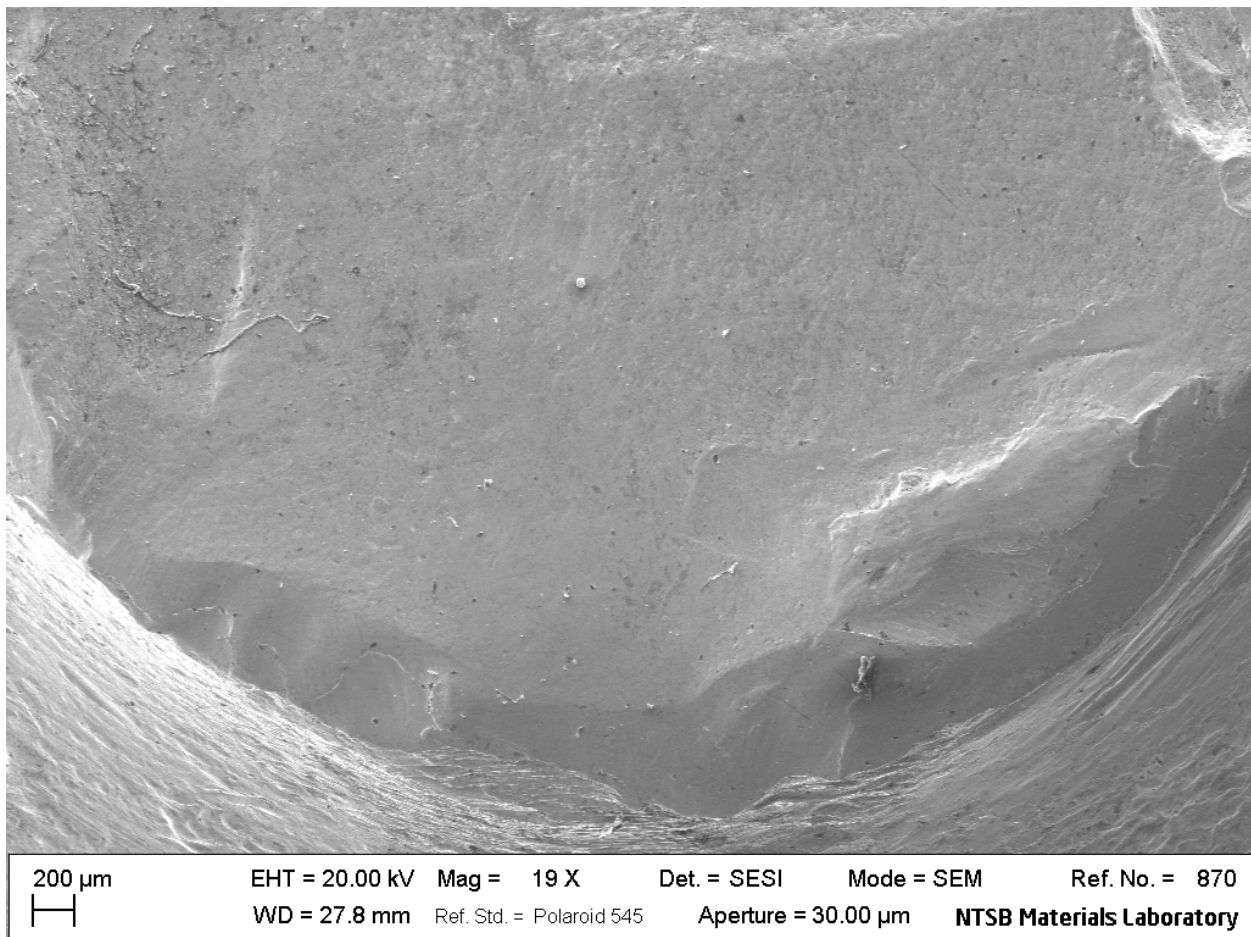
Figure 4. An optical view of the fatigue fracture of the exhaust valve, at left, with the damaged origin area denoted by the red bracket and progression direction indicated by the red arrow. An SEM view of the fatigue origin area, below, showing the extensive macro and microscopic damage.

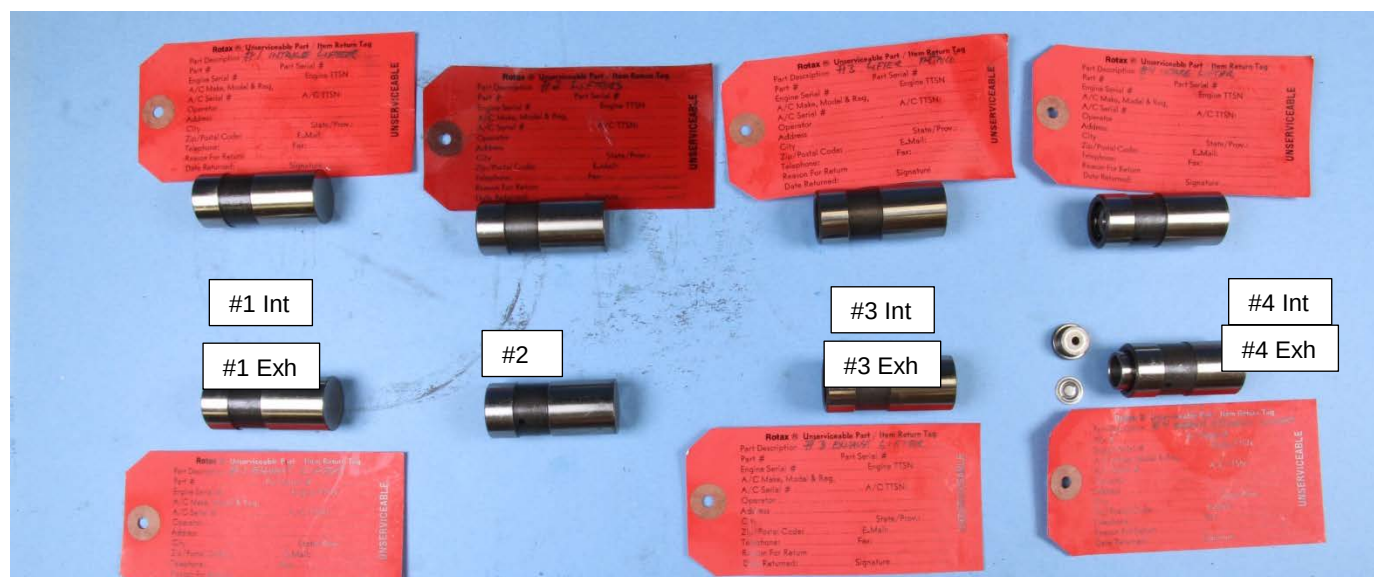
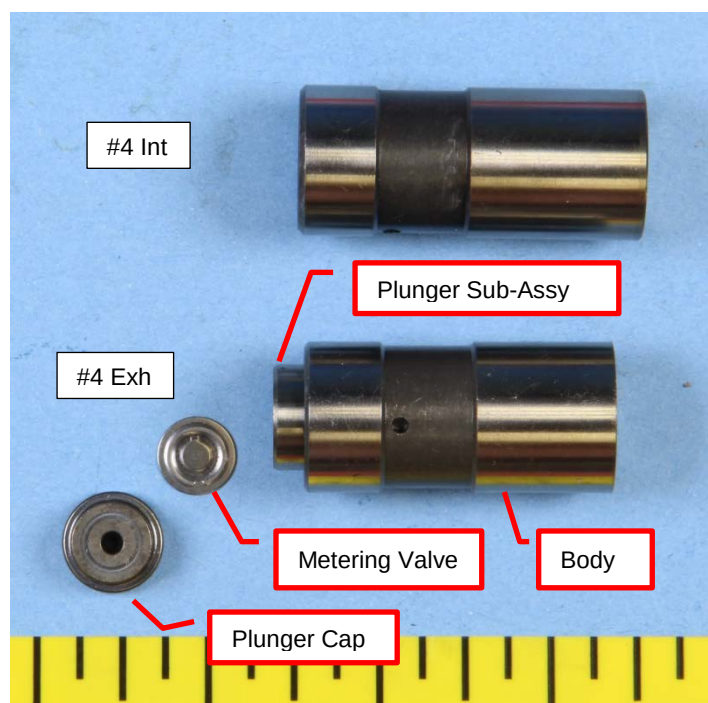
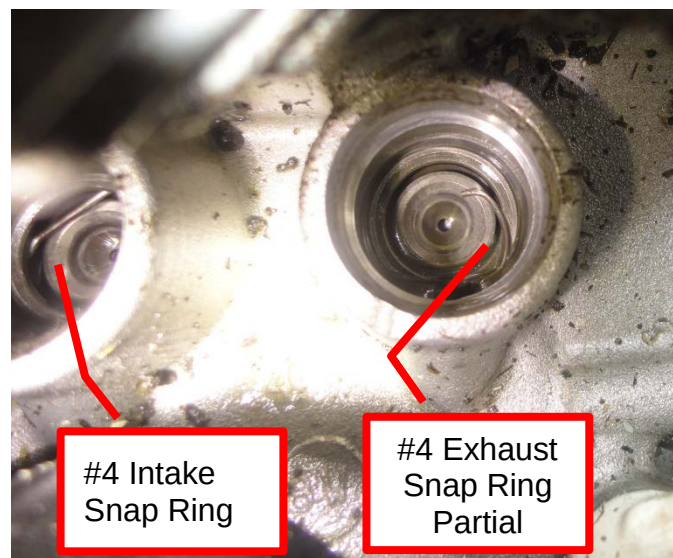
All of the hydraulic tappets are displayed in figure 5 in their as-received conditions. The tappets from the #1, #2, #3 cylinders and the intake side of the #4 were received intact and fully assembled. The #2 tappets were not individually identified as to their original positions. The #4 exhaust valve tappet was partially disassembled. As shown in the lower views of figure 5, the plunger cap and metering valve (plate) were separate from the tappet body and the plunger subassembly was displaced and partially exposed. The retaining snap ring was not received. Images from the engine teardown showed a large portion of the snap ring displaced but present in the tappet cavity. No further disassembly of the tappets was reported by the facility tearing down the engine.

Figure 5. The as-received tappets at top. The #4 cylinder tappets are at left with sub-components labeled. At right, images (from teardown) showing the dislodged partial snap ring in the exhaust tappet and the in-place full snap ring in the intake tappet.

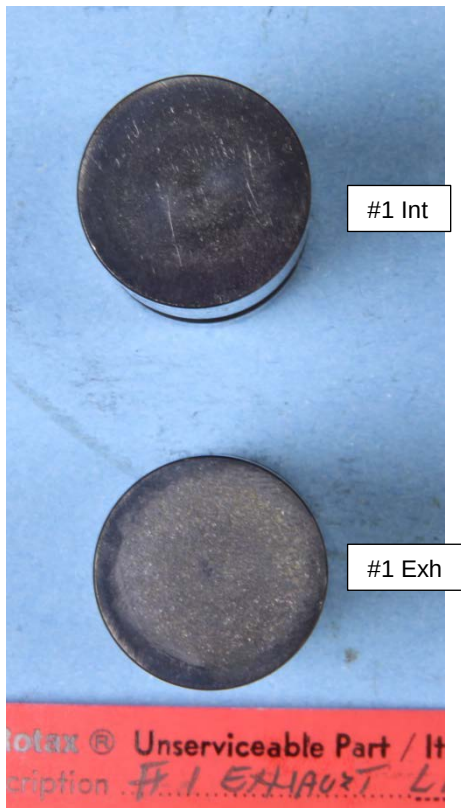
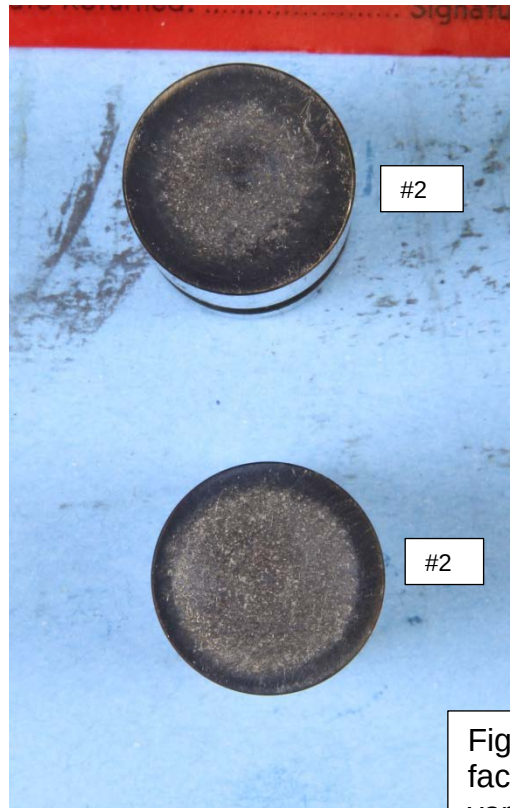
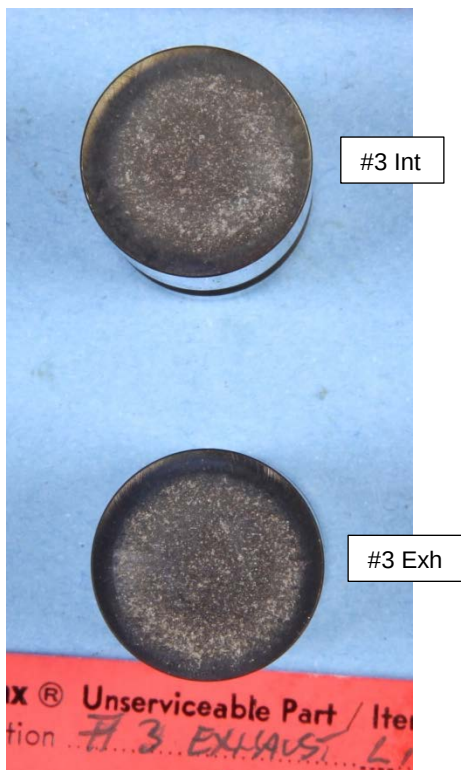
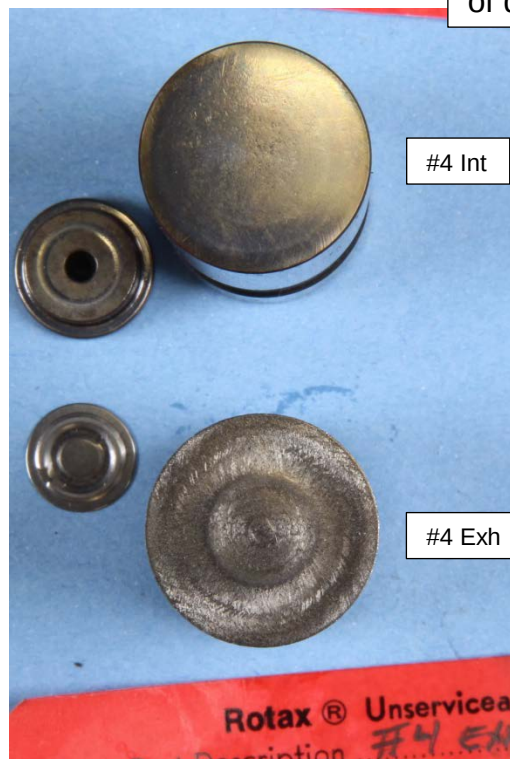
Visually, the tappets from cylinders #1, #2 and #3 displayed moderate spalling of the cam faces with the exception of light spalling on the intake side of #1. The cam face of the #4 intake tappet also showed light spalling as seen in the upper right view of figure 7. The exhaust tappet in contrast displayed severe wear in a circular pattern as shown in the left view of figure 7. The wear had reduced the height of the tappet by more than 5 mm compared to the intake tappet as displayed in the lower view of figure 7. The intake tappet measured nominally 50.43 mm while the exhaust tappet measured nominally 45.22 mm.

Figure 6. Views of the cam faces of the tappets showing various amounts and types of damage.

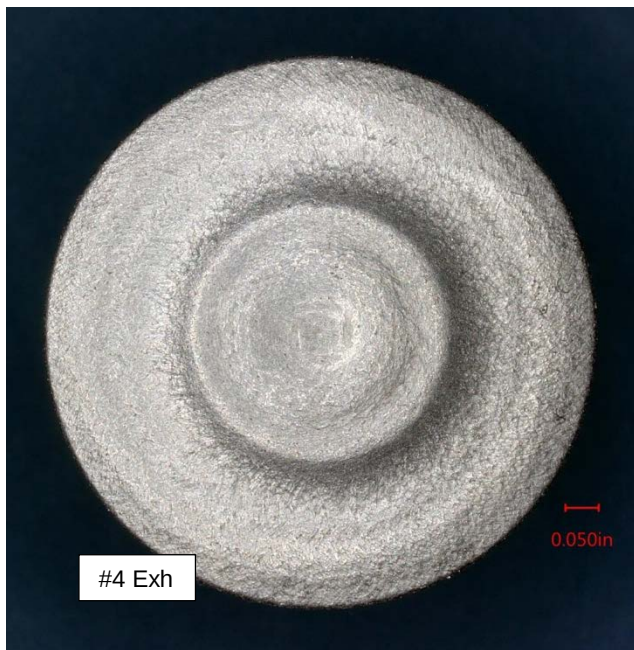
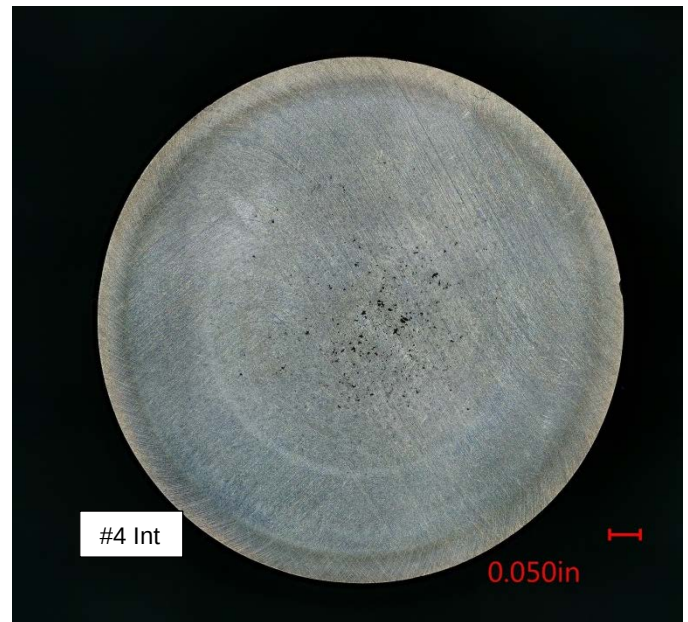
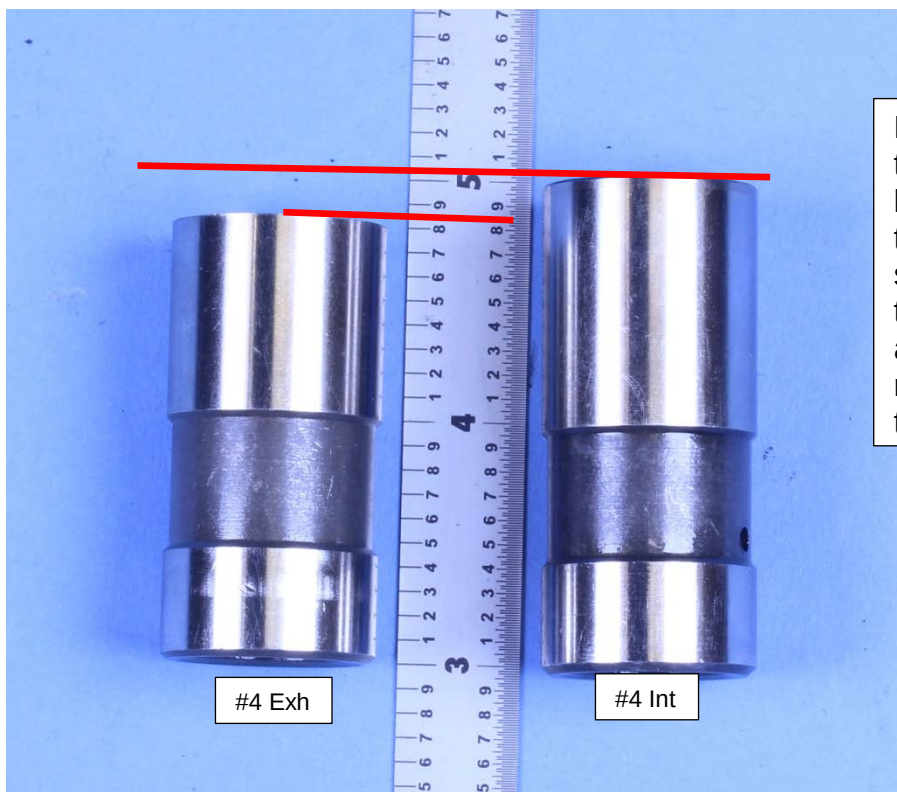
Hardness measurements on the cam face of the #4 intake tappet averaged 59.12 HRC. Measurements on the cam face of the #4 exhaust tappet averaged 55.15 HRC. The engineering drawing specified a minimum cam face hardness of 55 HRC measured 1.54 mm off center.

Figure 7. Closer views (top) of the cam faces of the #4 tappets, heavy circular wear pattern on the exhaust tappet and light surface spalling on the intake tappet. Left view illustrates the amount of wear and material removed from the exhaust tappet.

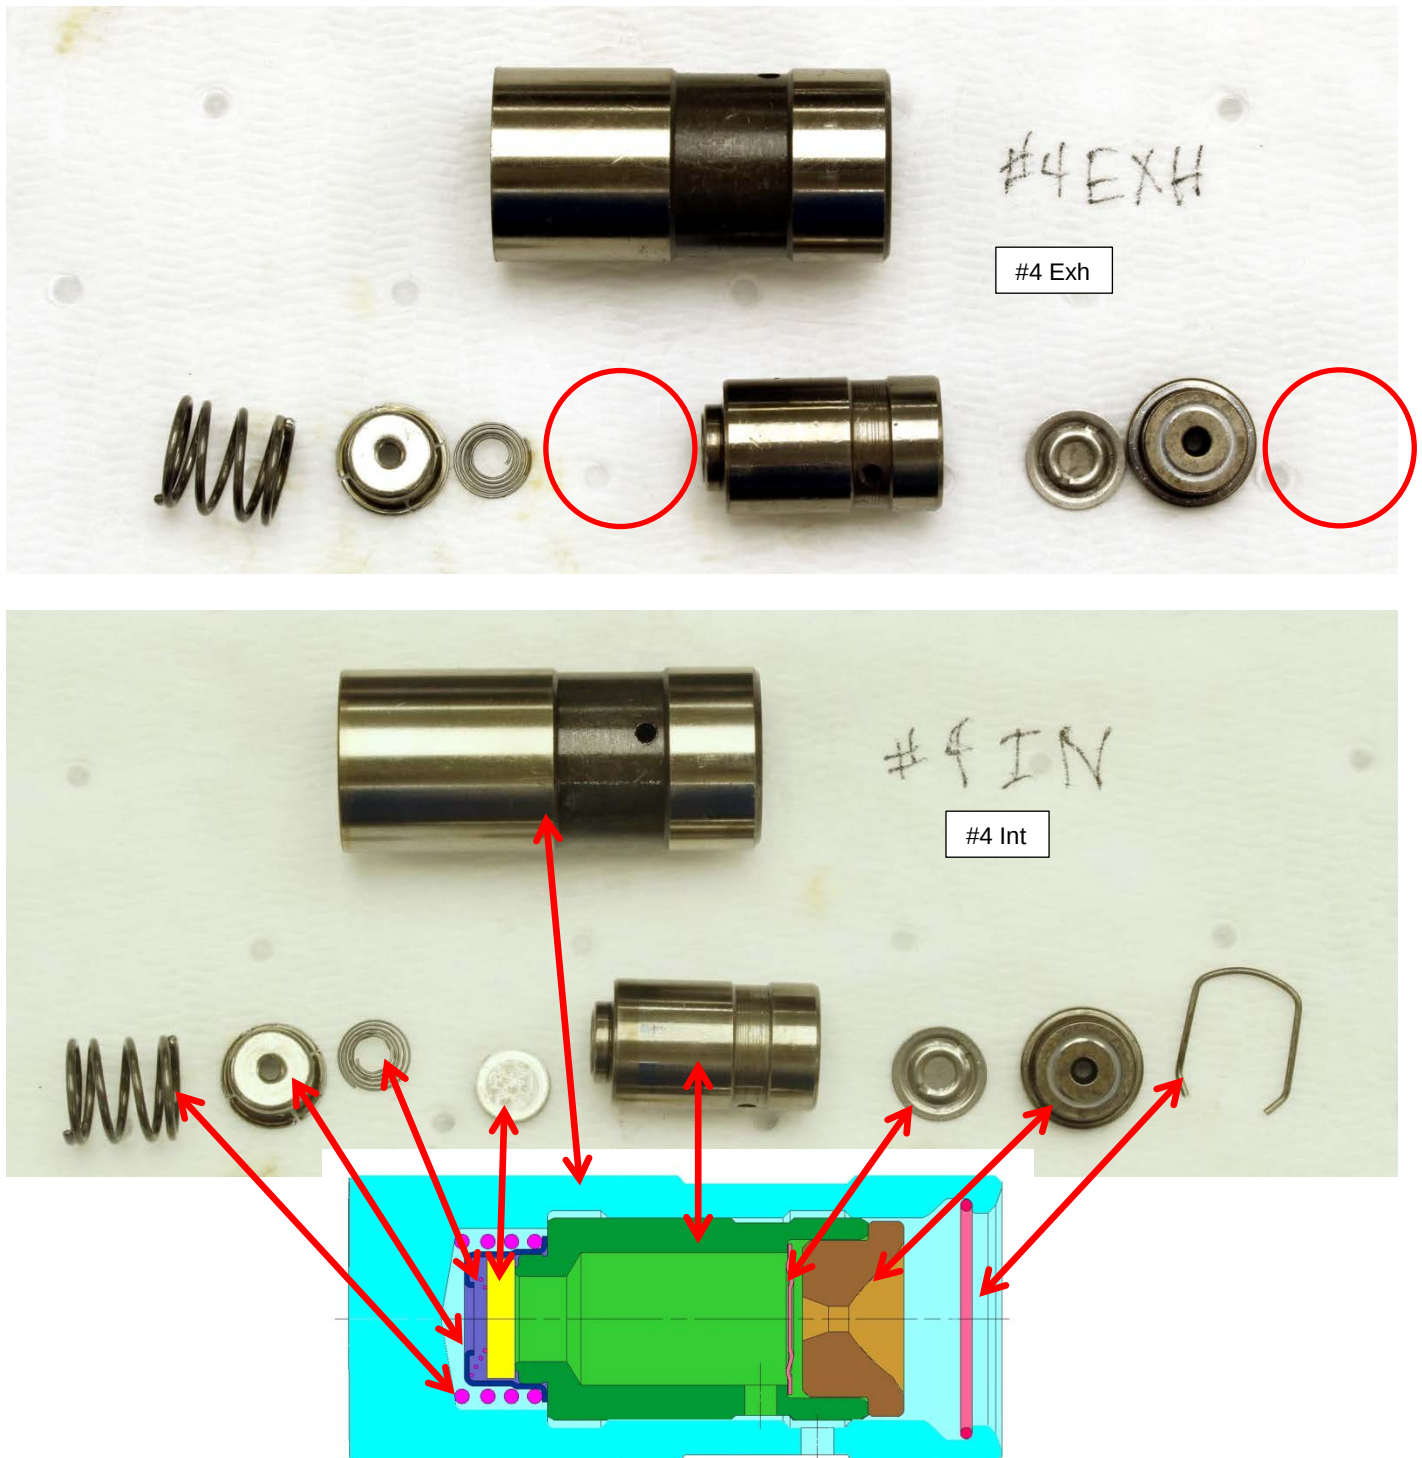
When the tappets were disassembled, the disc (yellow in illustration) in the plunger check valve assembly of the #4 exhaust tappet was missing as shown in the upper view of figure 8. The disc was present in the #4 intake tappet shown in the lower view of figure 8 and in all other tappet as seen in figure 9.

Figure 8. Views of the disassembled #4 exhaust valve tappet (top) showing the missing components (red circles) and the #4 intake valve tappet (middle). A cross sectional illustration is shown at the bottom with arrows to the related component of the intake tappet. Components from the left to right are: plunger spring, check valve cap, check valve spring, check valve disc, tappet body, plunger, metering valve, plunger cap and snap ring.

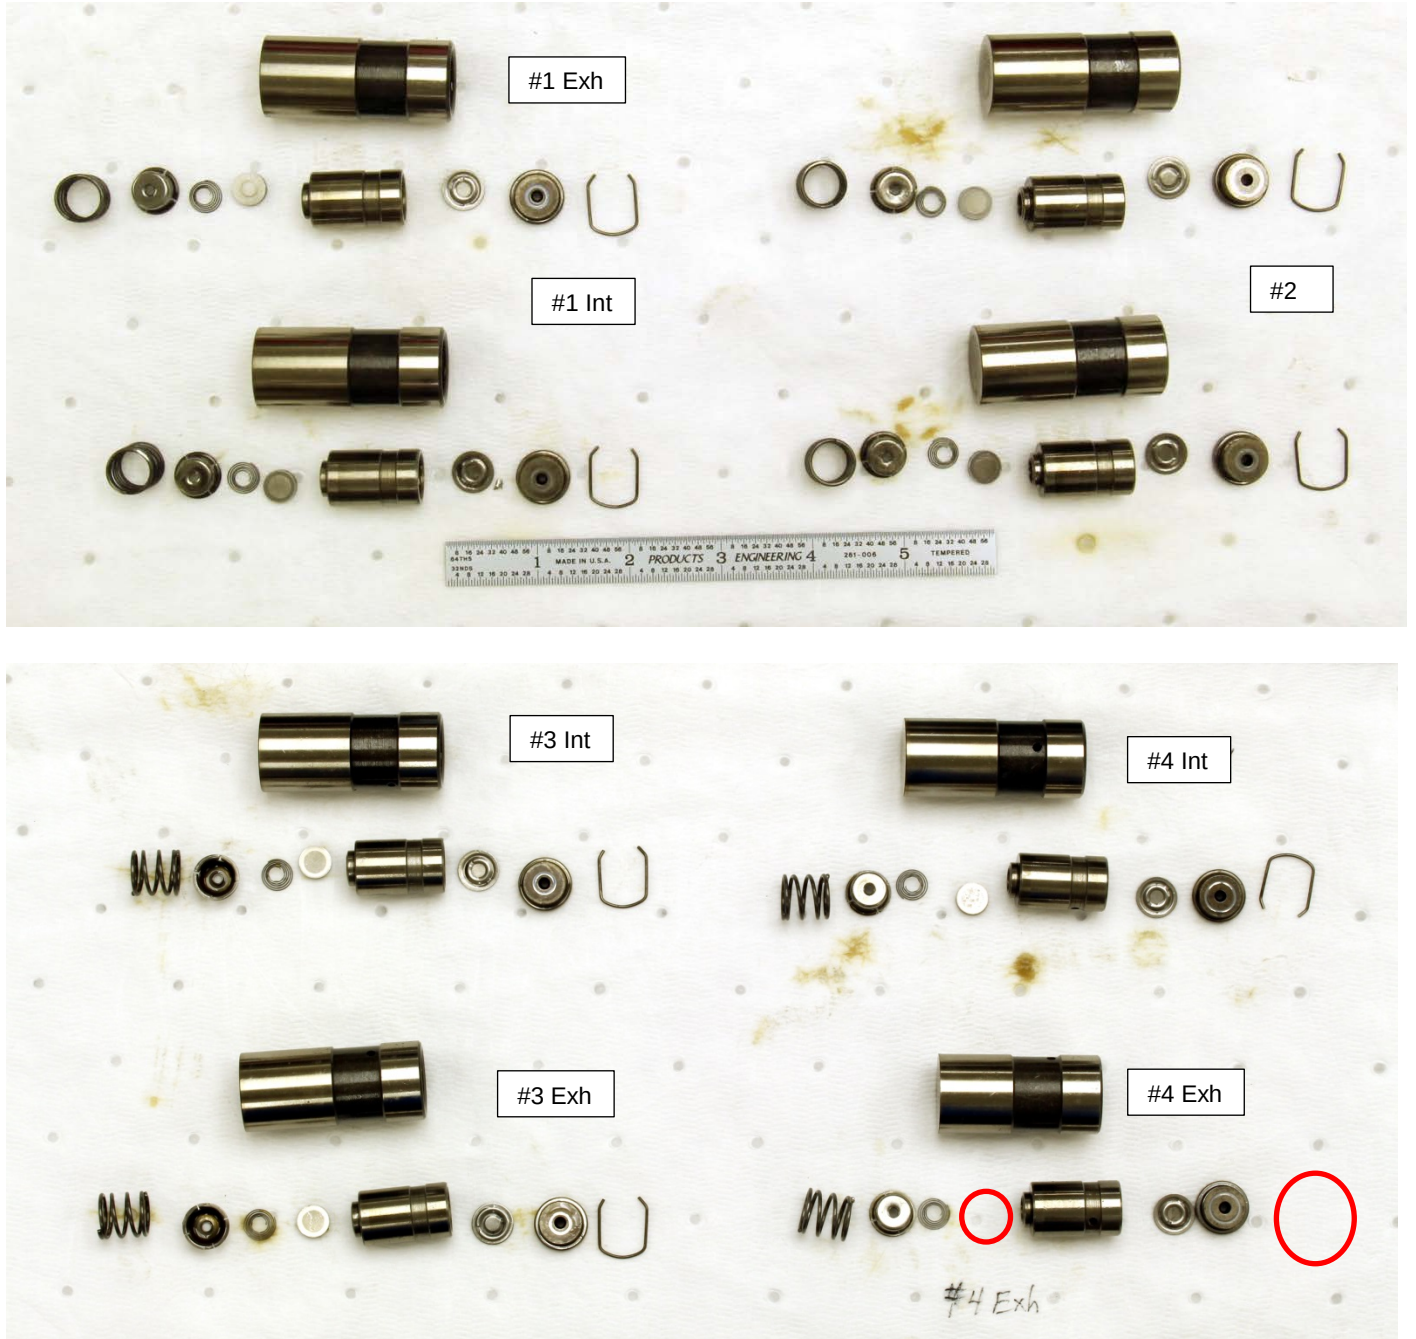
Figure 9. All disassembled tappets. Red circles denote missing components.

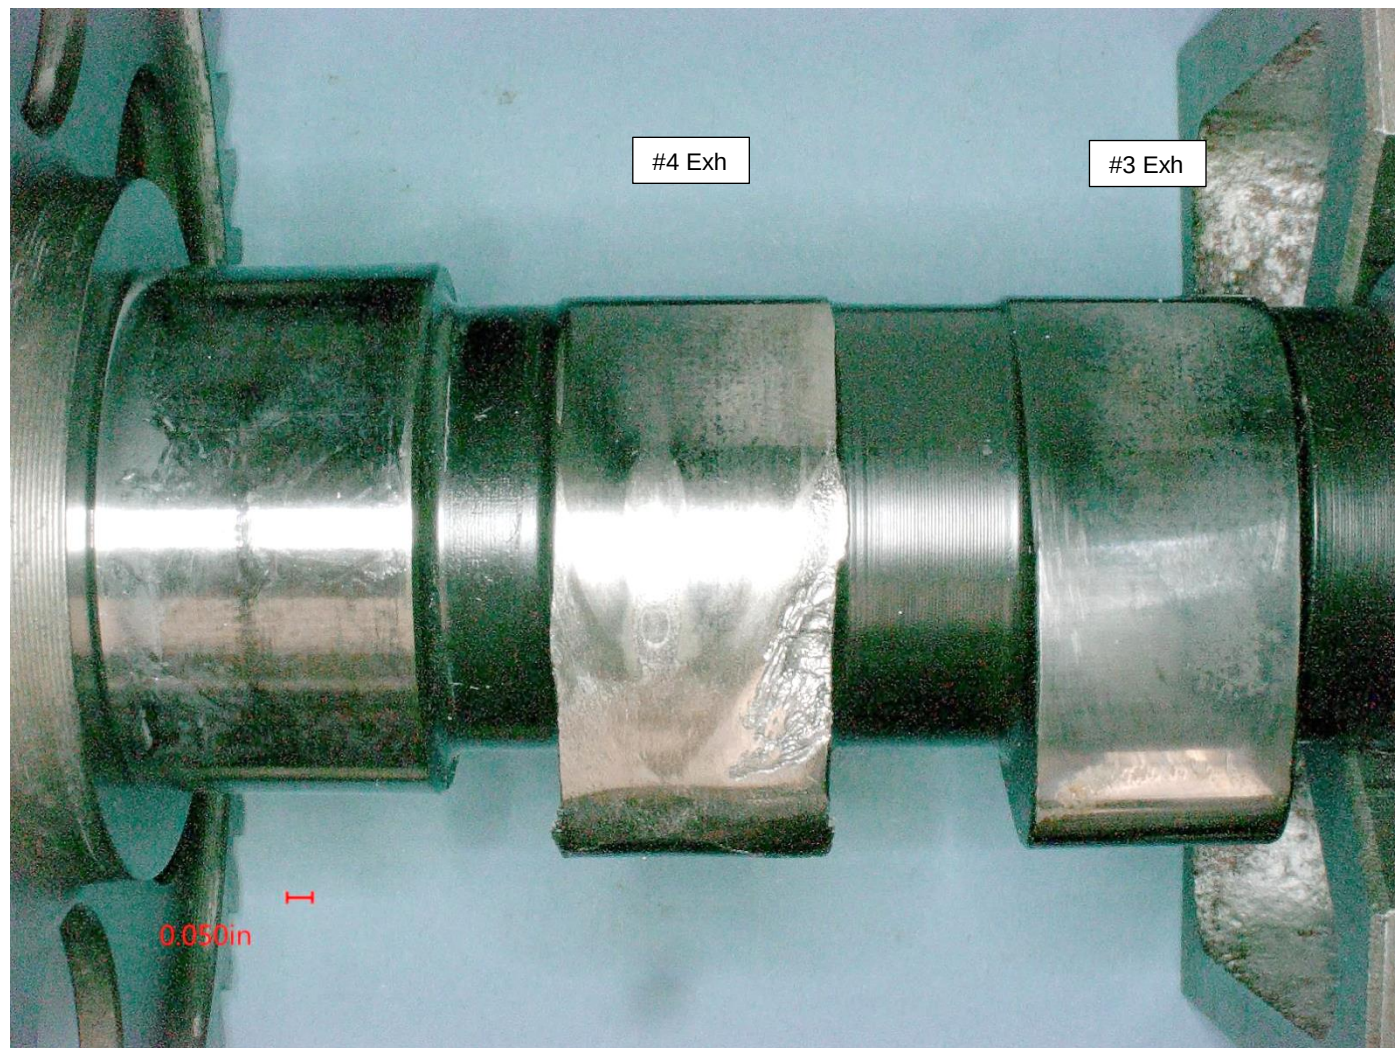
The cam lobes for the #3 and #4 exhaust valves are displayed in figure 10. The #4 lobe was severely damaged with large spalls visible on both the opening and closing sides. The total lift of the lobe was also reduced, compared to other lobes, by about 0.6 mm.

Figure 10. A view of the #4 exhaust cam lobe showing damage.

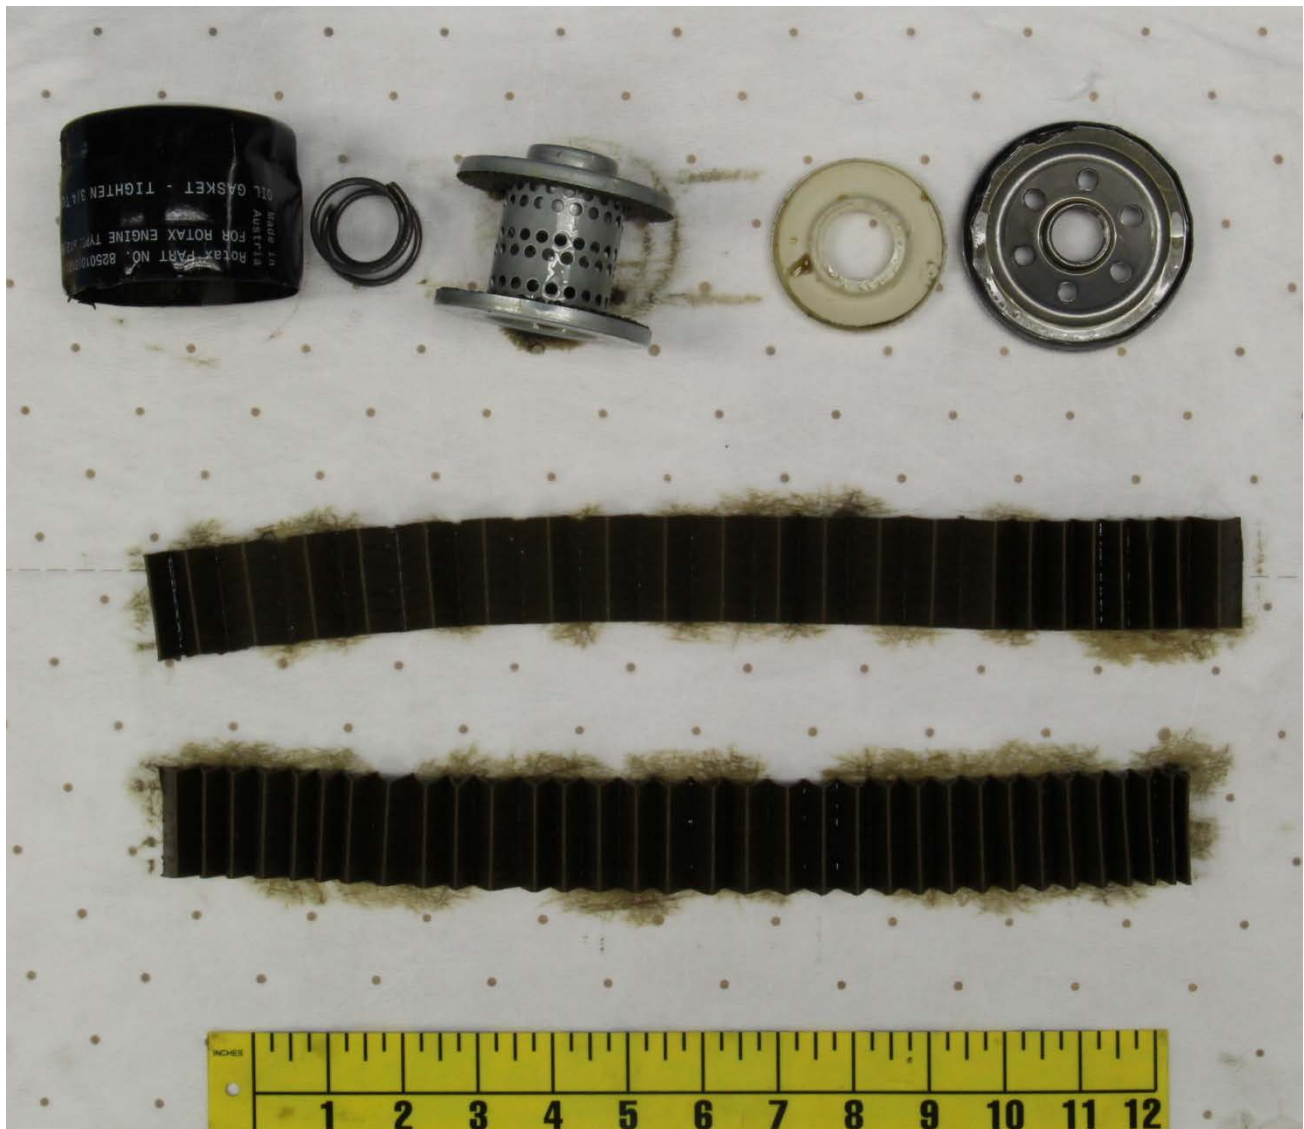
The oil filter was cut apart and the filter paper removed as shown in figure 11. Residual oil in the filter cup and on the filter paper was heavily contaminated with metallic appearing particles. A sample of the particles was removed and washed in toluene and filtered. Visually the particles appeared as fine flakes of metal of various sizes as shown in the upper view of figure 12. A small portion, see lower view of figure 12, was analyzed by energy dispersive spectroscopy and was found to be iron base materials consistent with the material of the #4 tappet.

Figure 11. The disassembled oil filter with the filter paper removed and expanded.

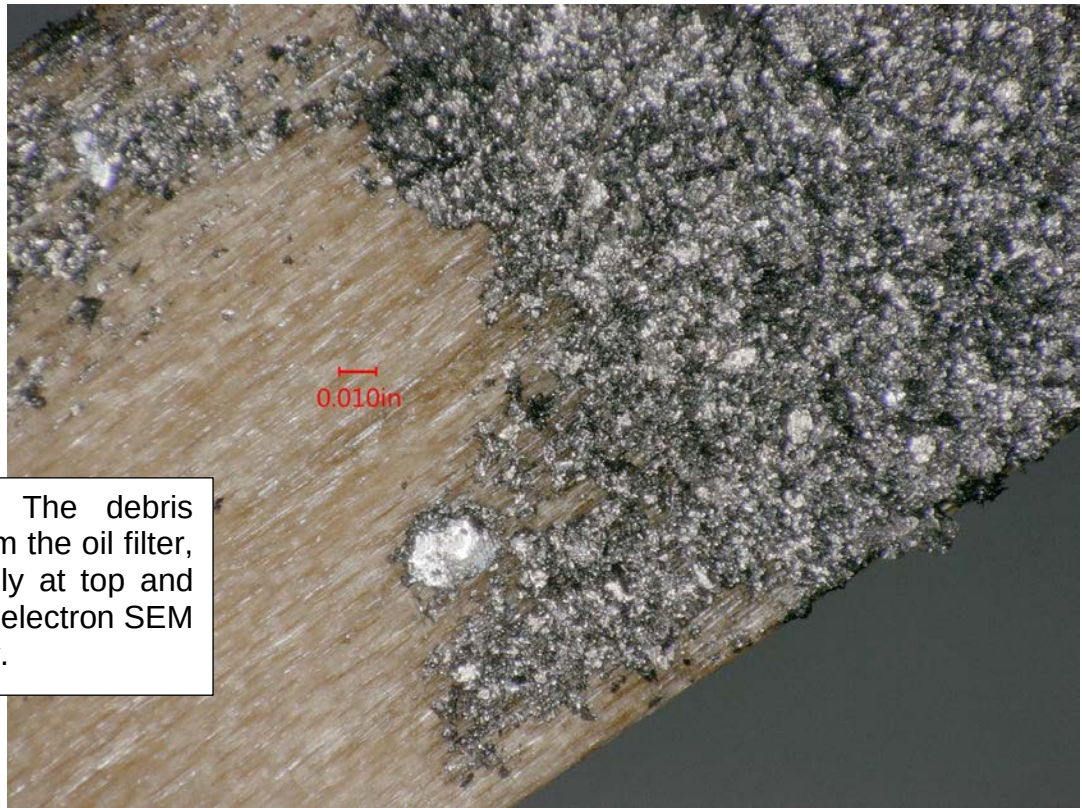
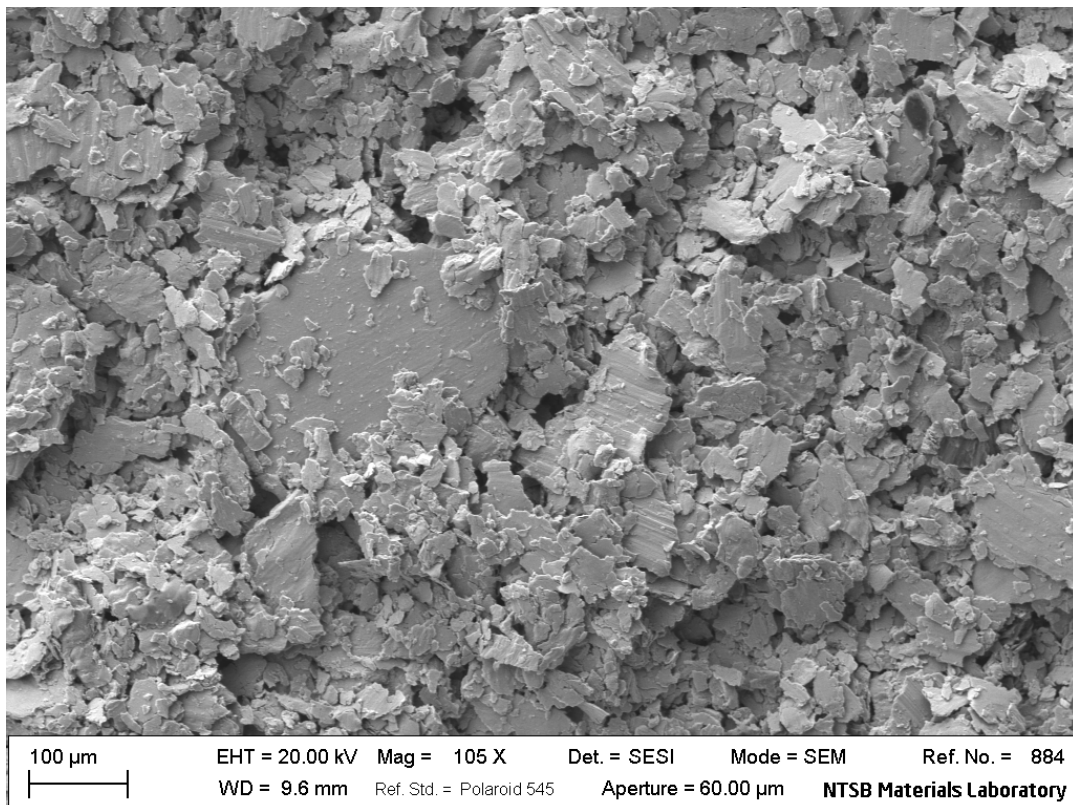
Figure 12. The debris recovered from the oil filter, shown optically at top and by secondary electron SEM viewing below.
