## **Engine Investigation Report**

**Allison Model250-C20B  
Engine CAE 822745**

**Bell 206B3  
Registration: N240SJ**

**Accident date: 26 July, 2014  
Investigation date: 5 August, 2014  
Report date: 15 January, 2015**

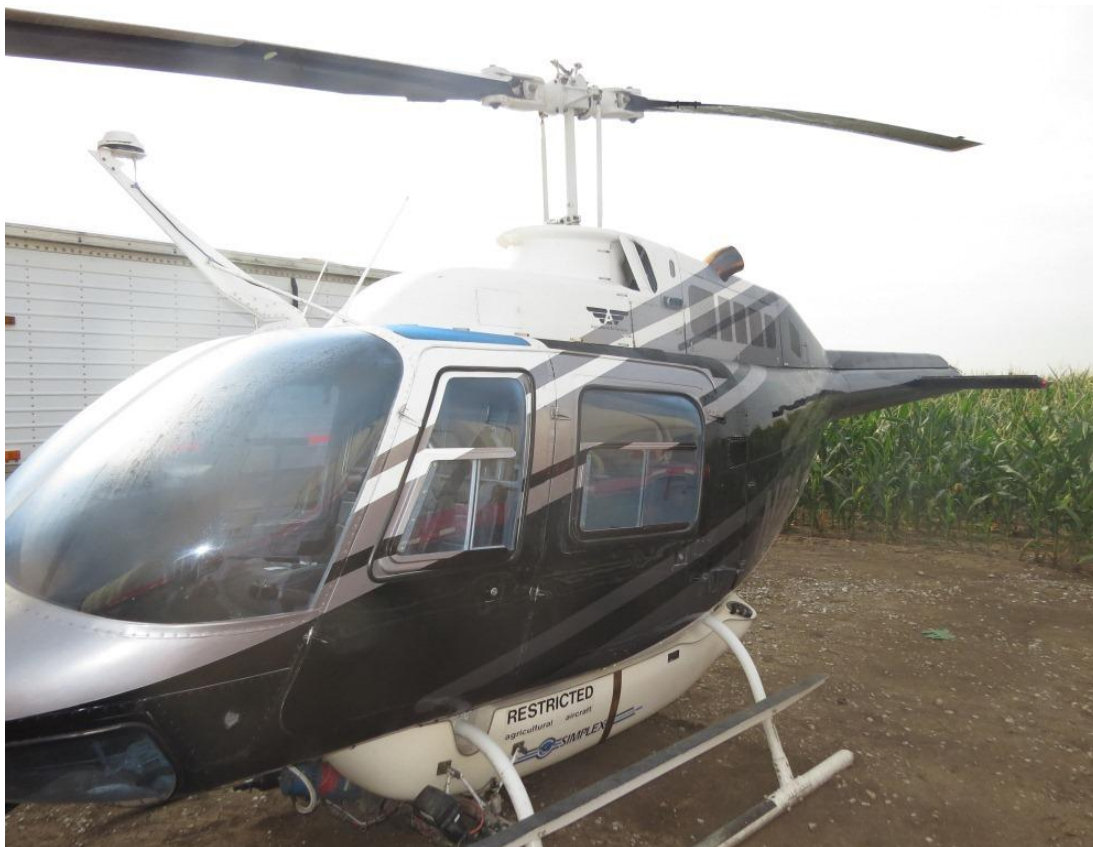
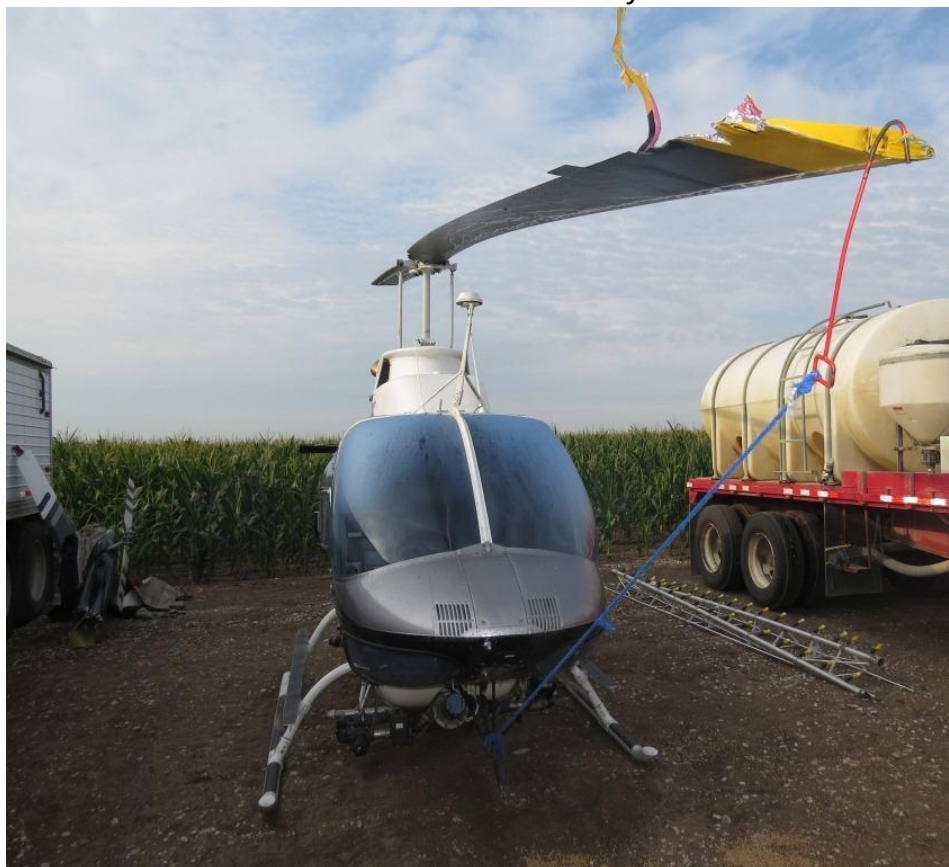
Aircraft at Recovery

On July 26, 2014, approximately 1:35 PM local time, a Bell 206B3 helicopter, N240SJ, was involved in an accident near Wahoo, Nebraska. The helicopter was registered to Samaritan Air Inc. The weather conditions were reported to be VFR. At the time of the accident the helicopter was conducting an aerial application flight of a cornfield when the engine reportedly lost power. The pilot stated that prior to the accident he had placed 25 gallons of fuel into the helicopter. He then departed and began spraying the cornfield. Approximately 12-15 minutes into the flight the engine lost power. The pilot entered an auto rotation to a soybean field directly in front of him. After landing the helicopter slid 10-15 feet prior to striking a berm. The tailboom struck the ground and separated from the helicopter.

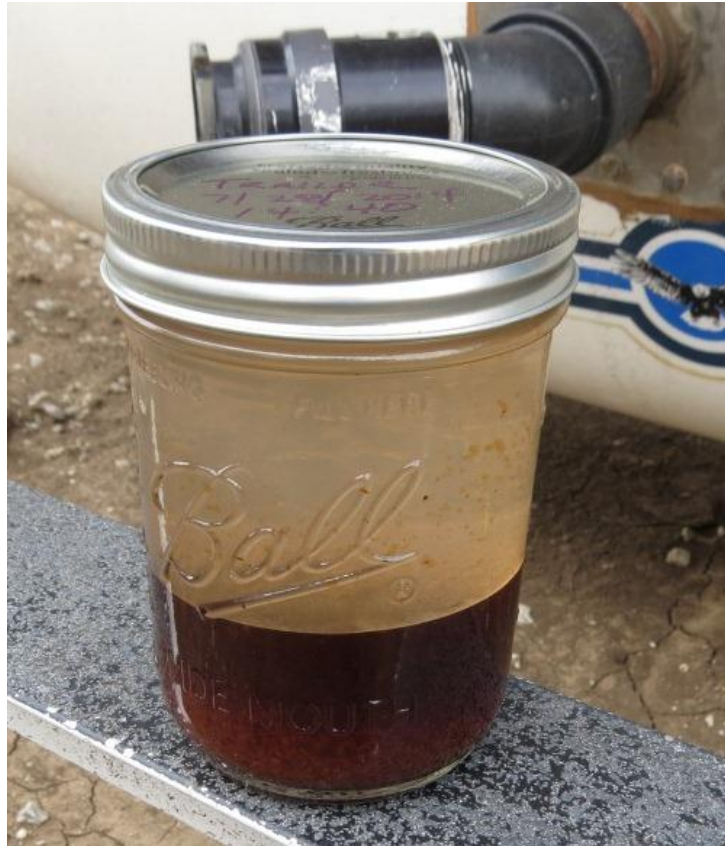
During the examination a large fuel sample was taken from the stationary main fuel supply tank. The fuel from the supply tank was dark brown in color with contaminants settling to the bottom of the container over time. The fuel samples taken prior to the examination were confirmed to contain contamination as previously stated by the pilot. Contamination could also be seen settled at the bottom of the aircraft fuel tank as viewed through the fuel supply port.

Fuel Sample from Mobile Fuel Supply Tank Filter Bowl

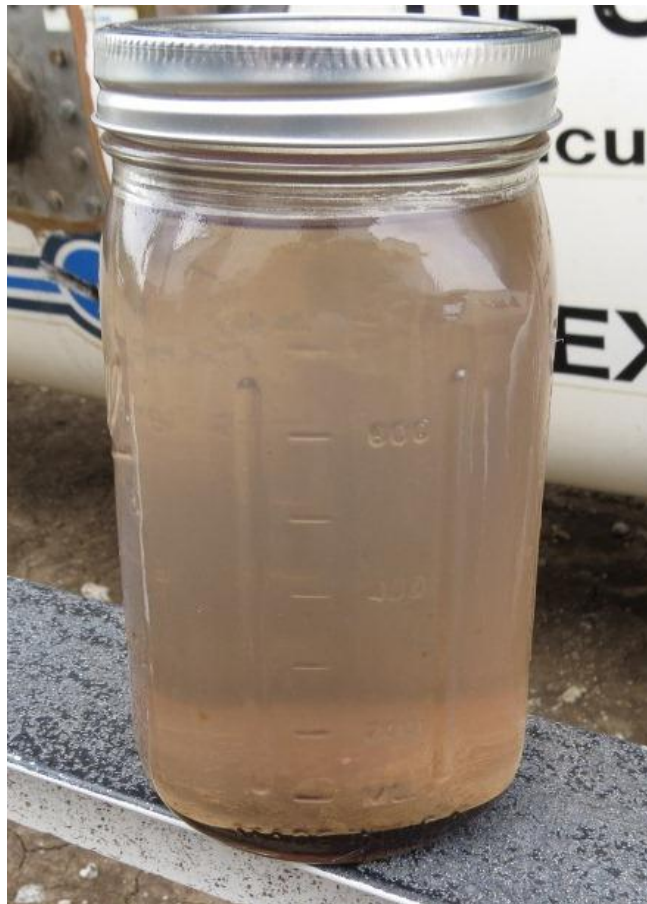
Fuel Sample from Aircraft Fuel Filter Bowl

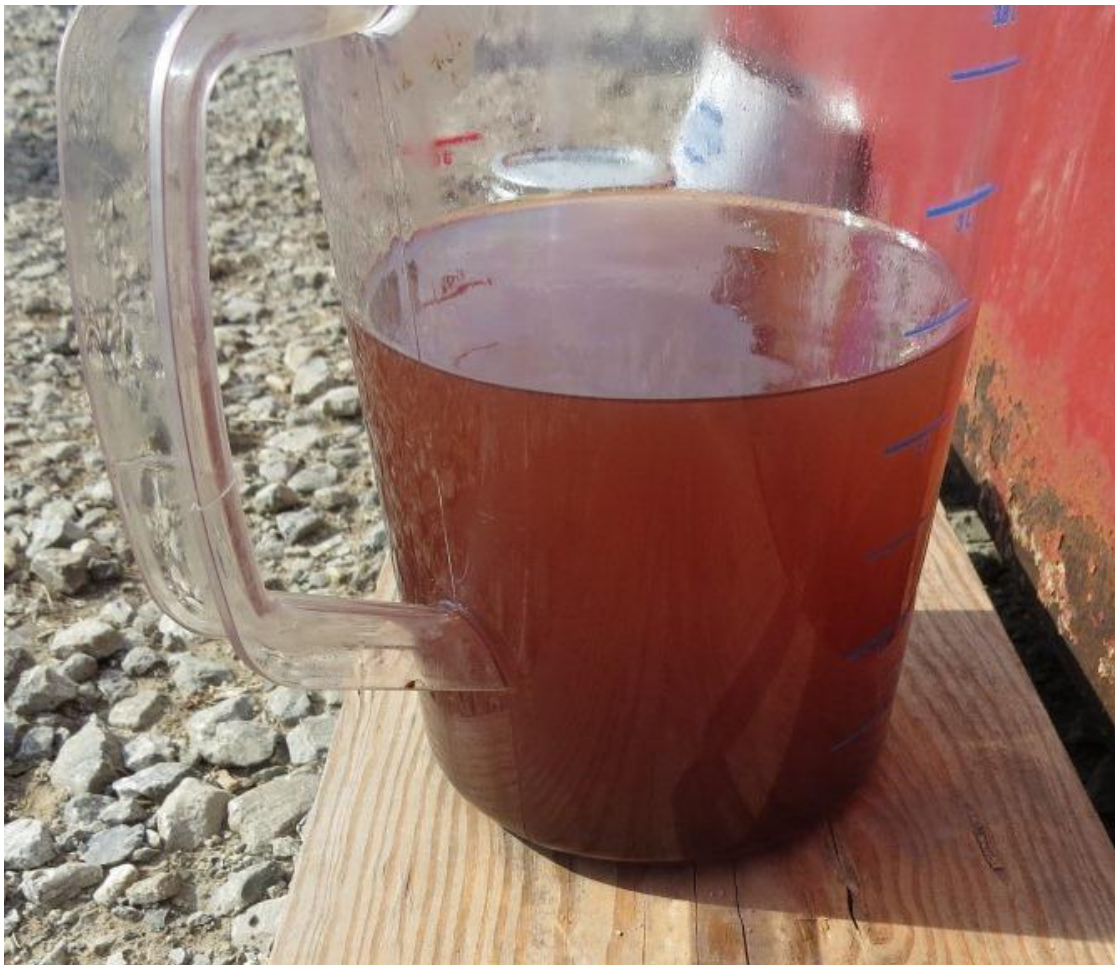
Fuel Sample from Main Fuel Supply Tank Filter Bowl

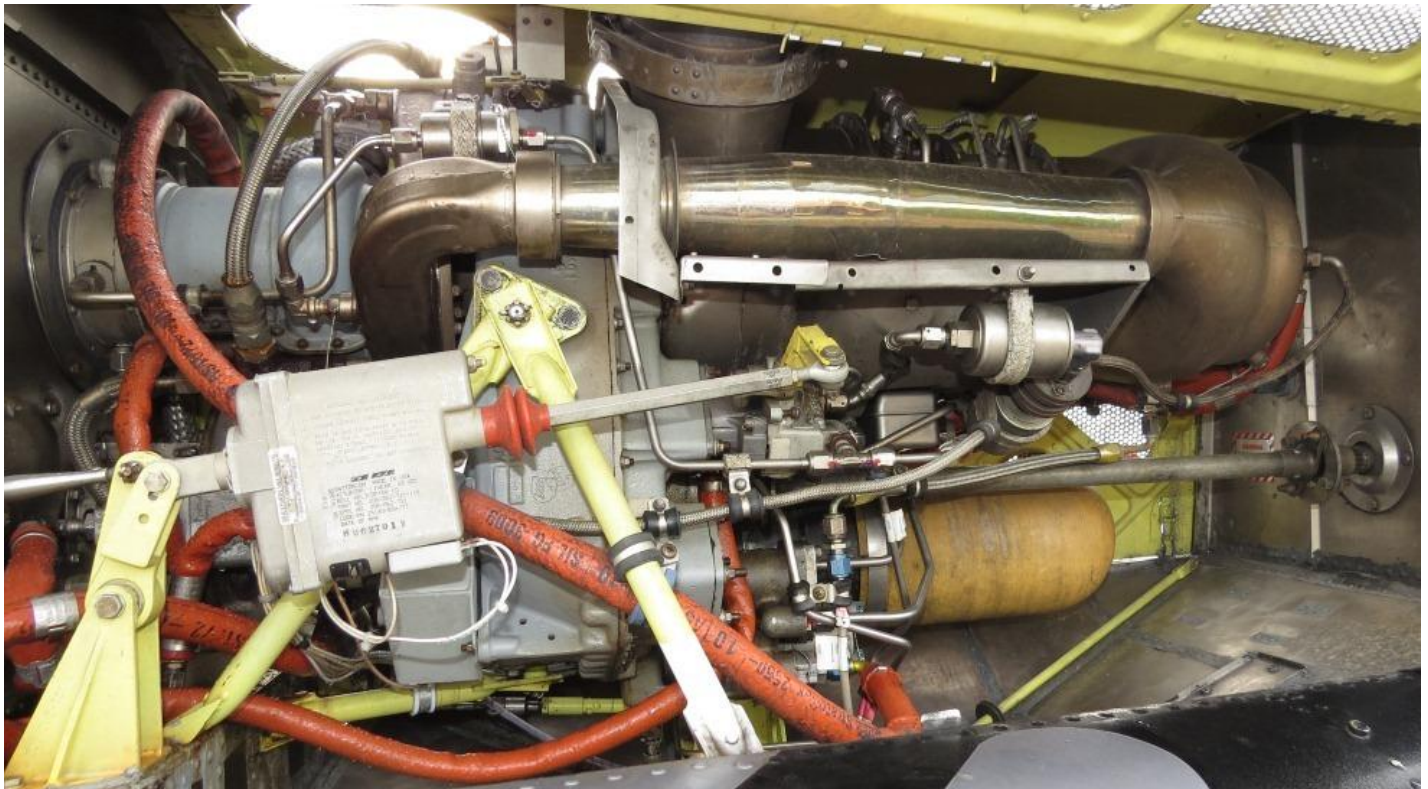
Engine as Installed – Left Hand Side

The engine remained securely mounted in the helicopter engine compartment. The engine was intact and did not display any signs of external damage. All engine mounts remained attached to both the engine and helicopter. The rigging was connected to both the fuel control throttle input lever and power turbine governor throttle lever. Both connections were free of binding and had full travel when moved with the throttle and collective pitch lever. The N2 drive train was free and continuous from the 4th stage turbine wheel to the tail and main rotor drive shafts. All engine external fuel and oil lines, along with their associated fittings, were secure when checked by hand with no cracks noted. All engine pneumatic lines were normal in appearance with "B" nuts and connectors at least finger tight. The engine fuel line between the check valve and fuel nozzle was removed from the fuel nozzle and a normal amount residual fuel drained out. The engine was motored and fuel flowed from the fuel manifold line as normal. The compressor also rotated freely with no unusual noise. The engine fuel filter bowl and filter were removed. The filter was normal in appearance, however remaining fuel in the filter bowl displayed contamination. The fuel nozzle was removed and disassembled. The fuel nozzle screen was completely covered with a hardened dark brown substance. The fuel nozzle was otherwise undamaged. No further examination of the engine was deemed necessary by the NTSB IIC.

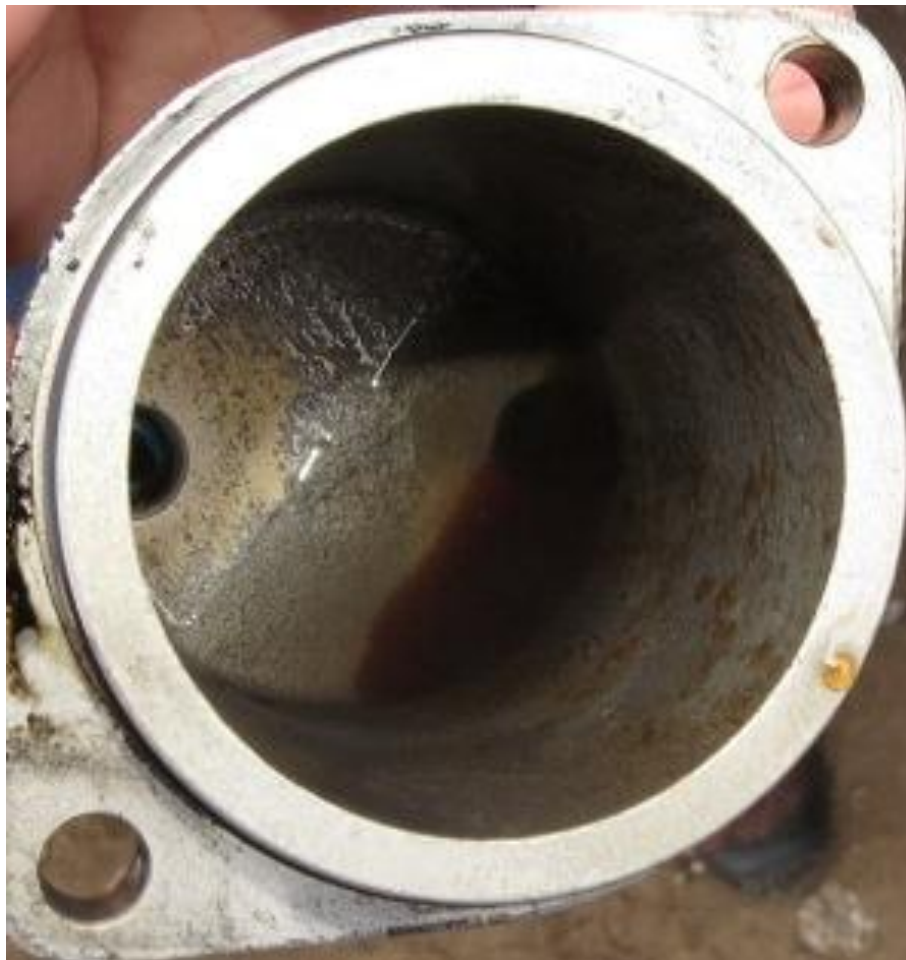
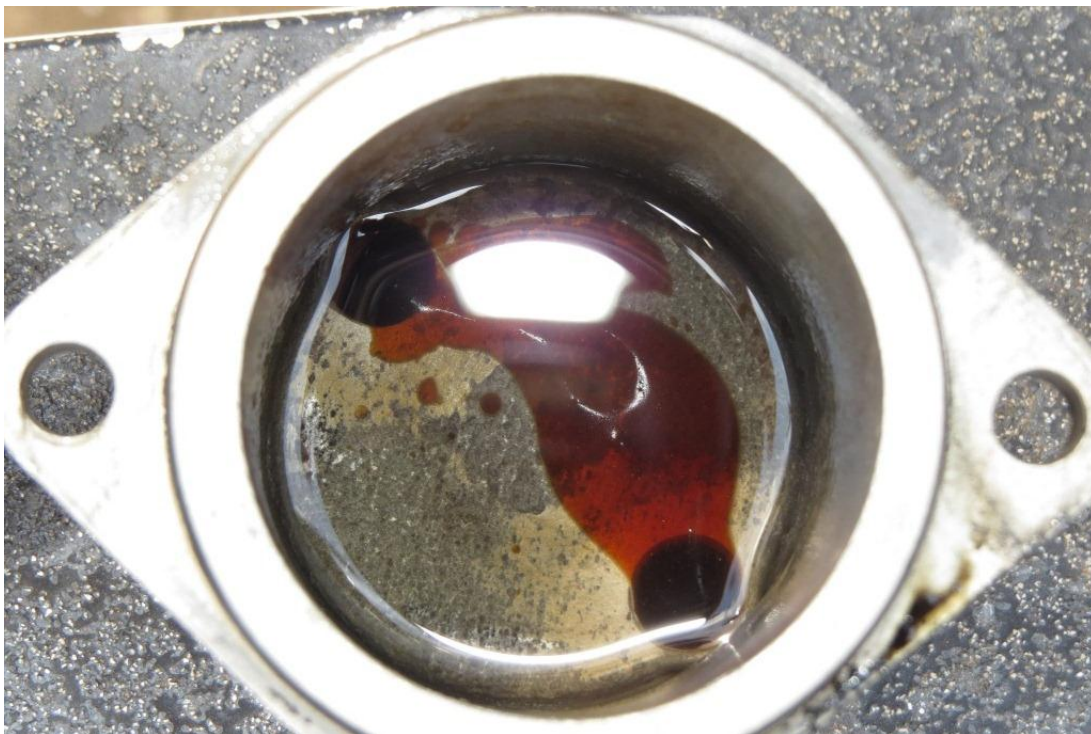
Engine Fuel Filter Bowl

Fuel contamination was found within the fuel storage/supply tanks and throughout the aircraft and engine fuel system. The amount of contamination observed throughout the aircraft and engine systems could have resulted in the reported loss of power. Other than the fuel contamination the engine did not reveal any damage or anomalies which would have prevented it from operating normally. Based on the fuel contamination present within the storage tanks and aircraft fuel system the NTSB IIC deemed it unnecessary to conduct further examination of the engine.
