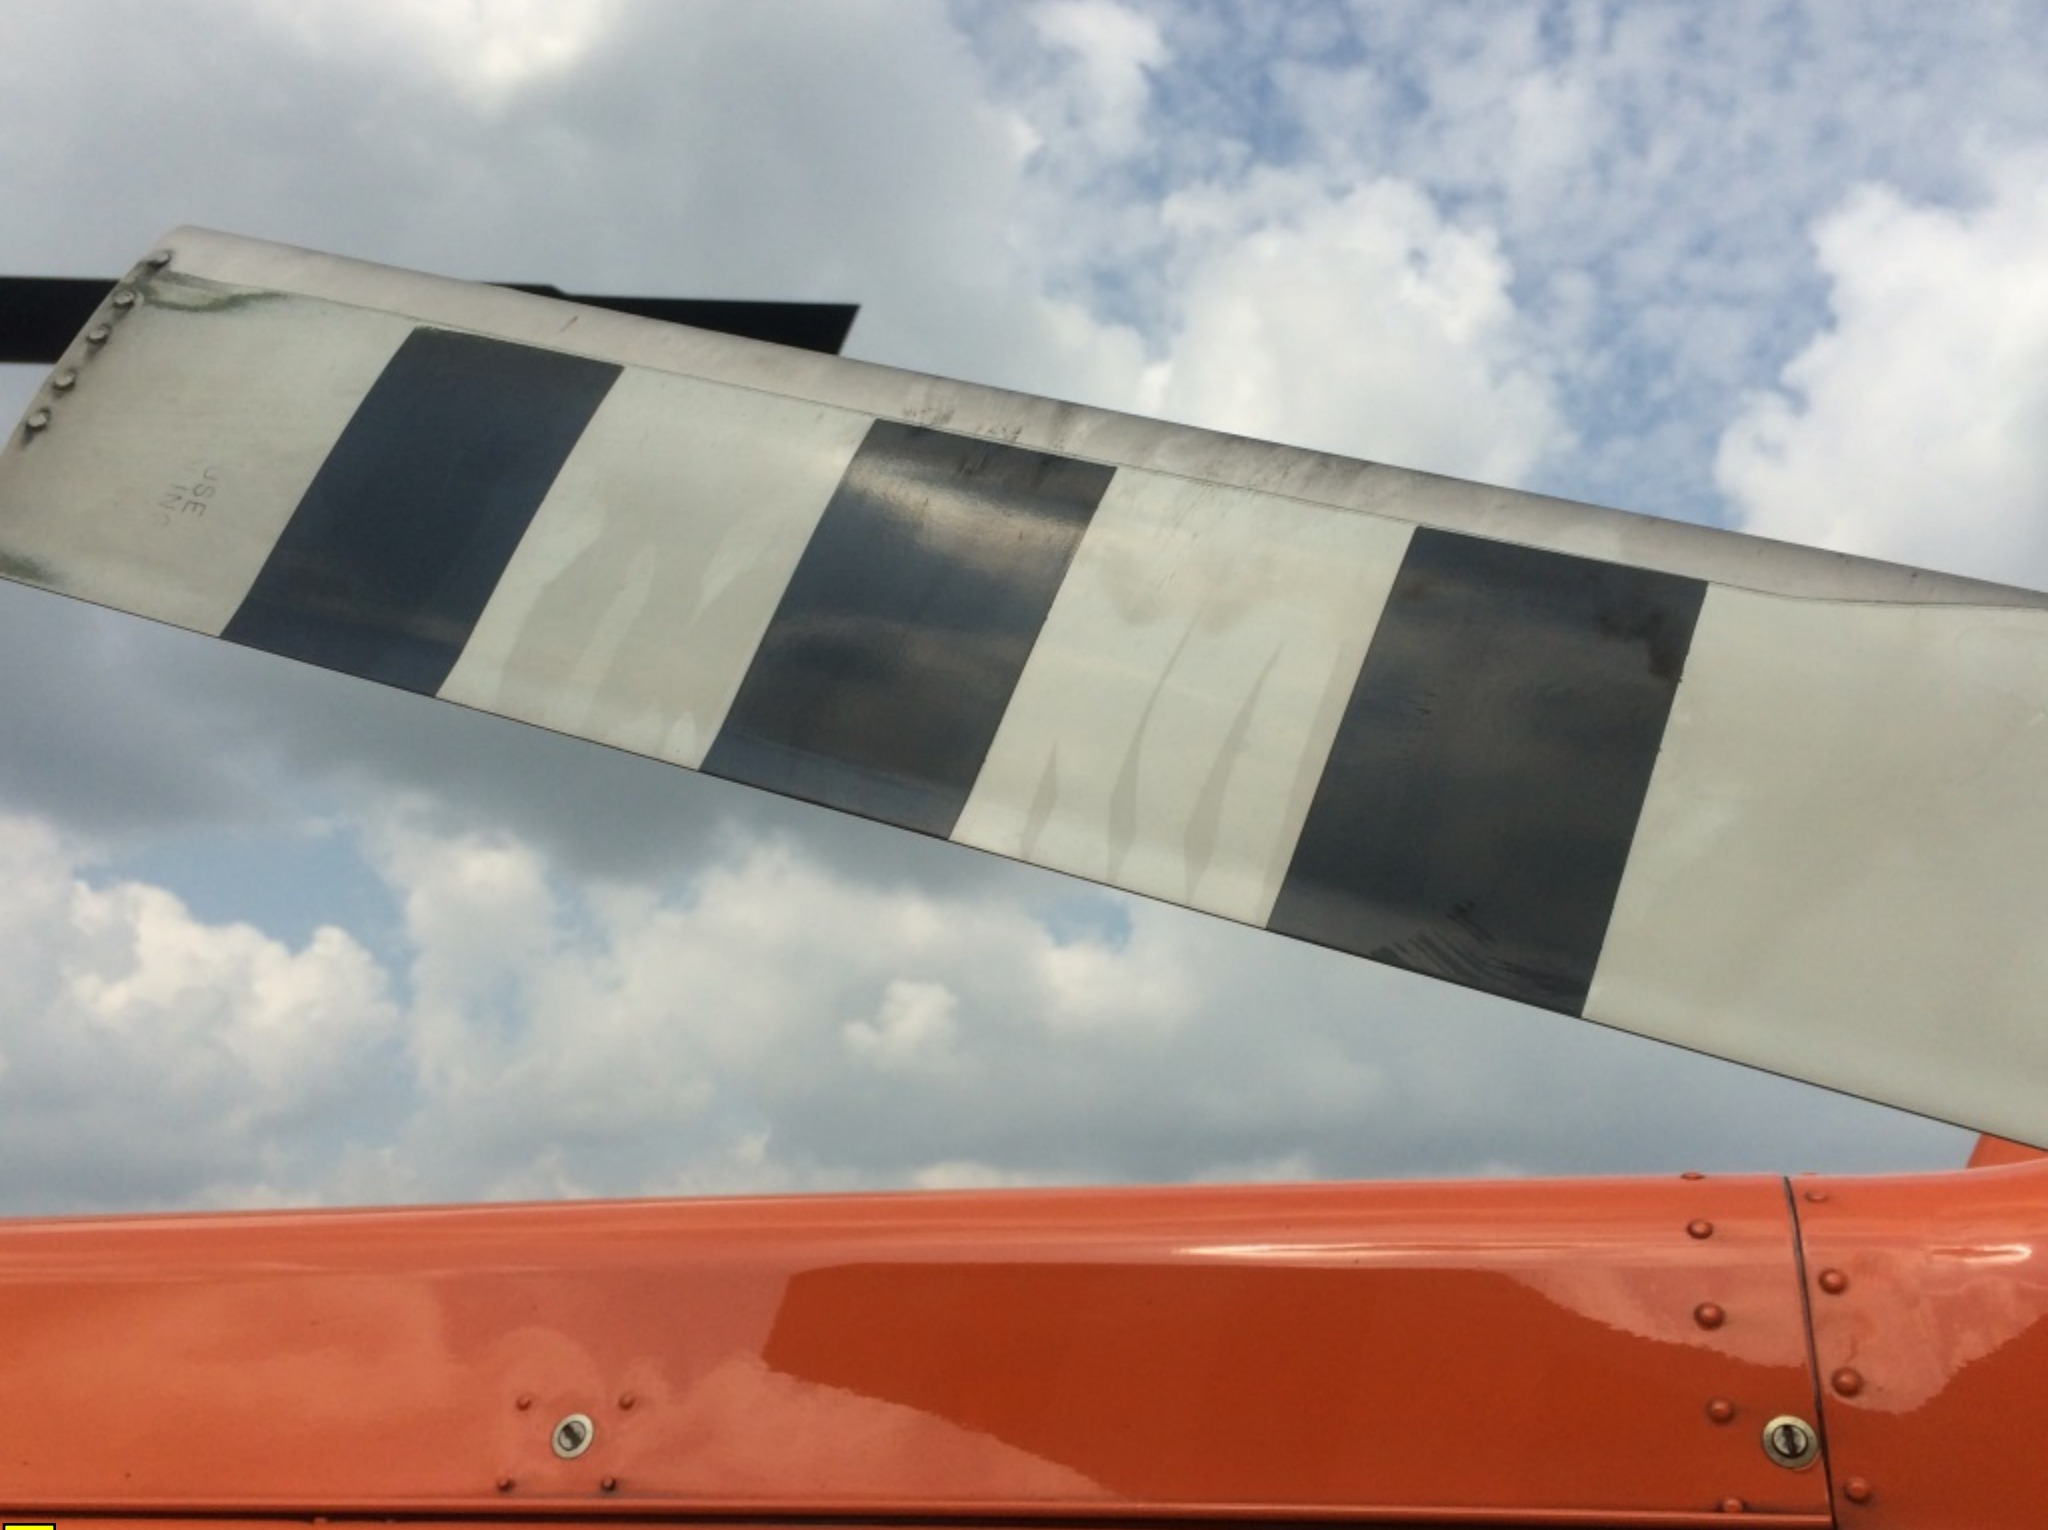
Photo 2 – View of tail rotor blade damage
