# **NATIONAL TRANSPORTATION SAFETY BOARD**

## **Global Positioning System Device**

### **Specialist's Factual Report**

Location: Macedonia, Iowa  
Date: September 6, 2014  
Aircraft: Robinson R44  
Registration: N699TQ  
Operator: Johnson Helicopter Services  
NTSB Number: CEN14LA487

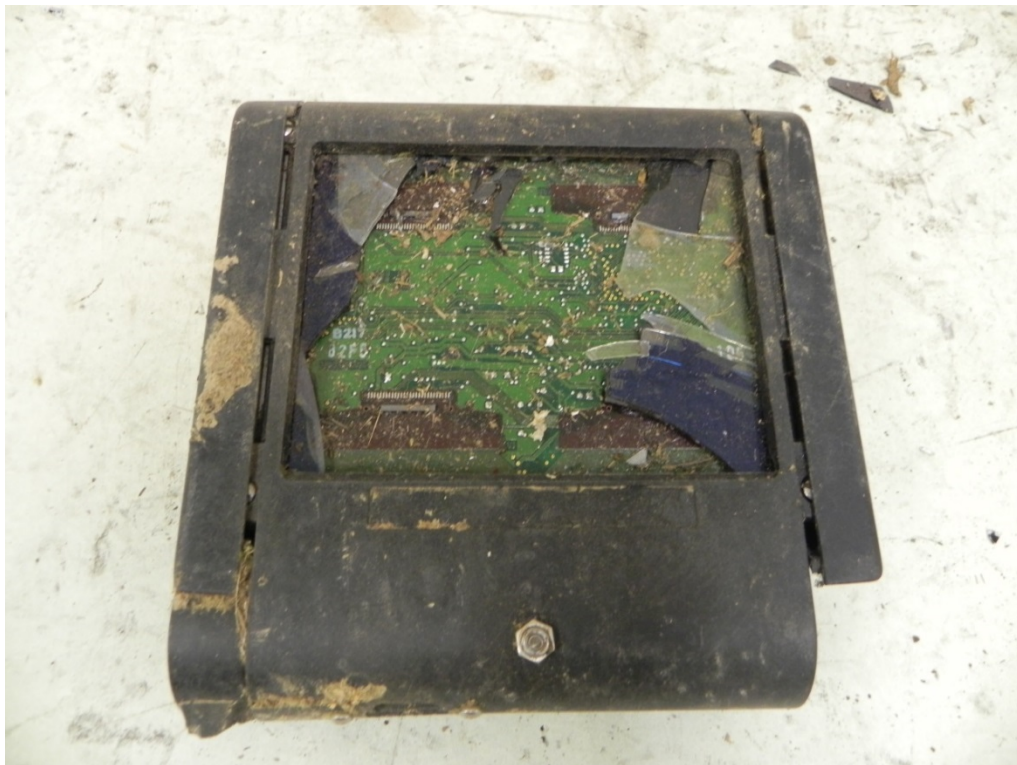
Upon arrival at the Vehicle Recorder Laboratory, an exterior examination revealed that the unit had sustained moderate damage. The device was covered with a coating of an unknown brown powdered substance. The glass protecting the screen on the front was broken. Figures 1 and 2 show the front and back of the device as received at the Vehicle Recorder Laboratory.

**Figure 1 : Front of DynaFlight AirAg-E**

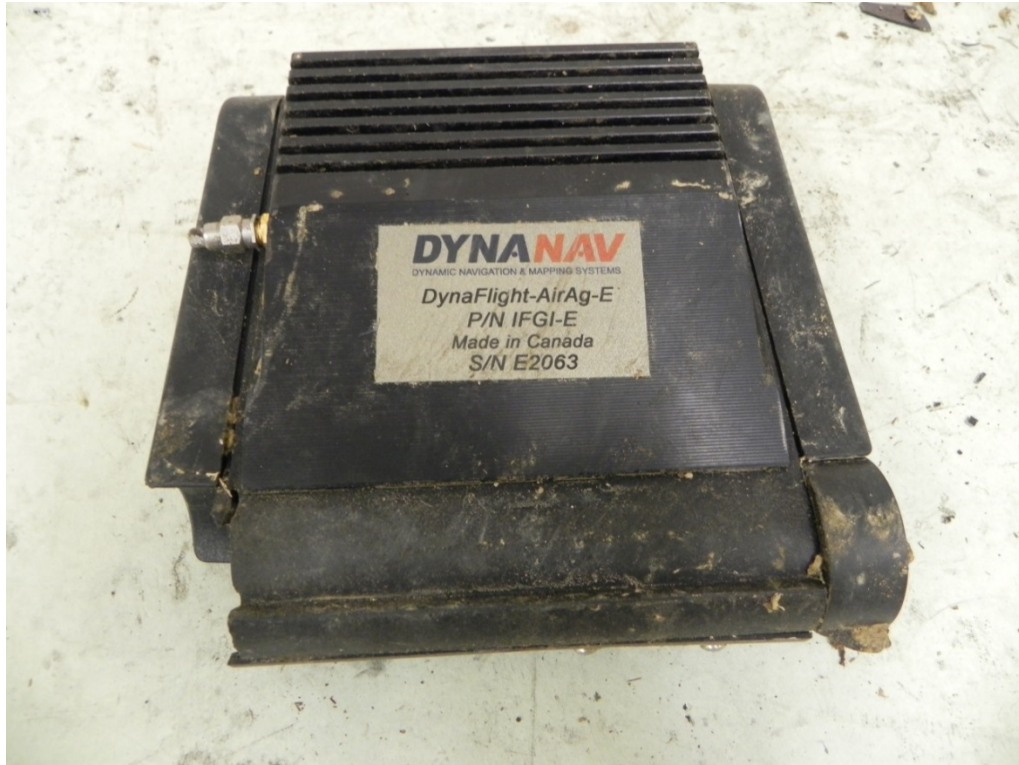
**Figure 2 : Back of DynaFlight AirAg-E**

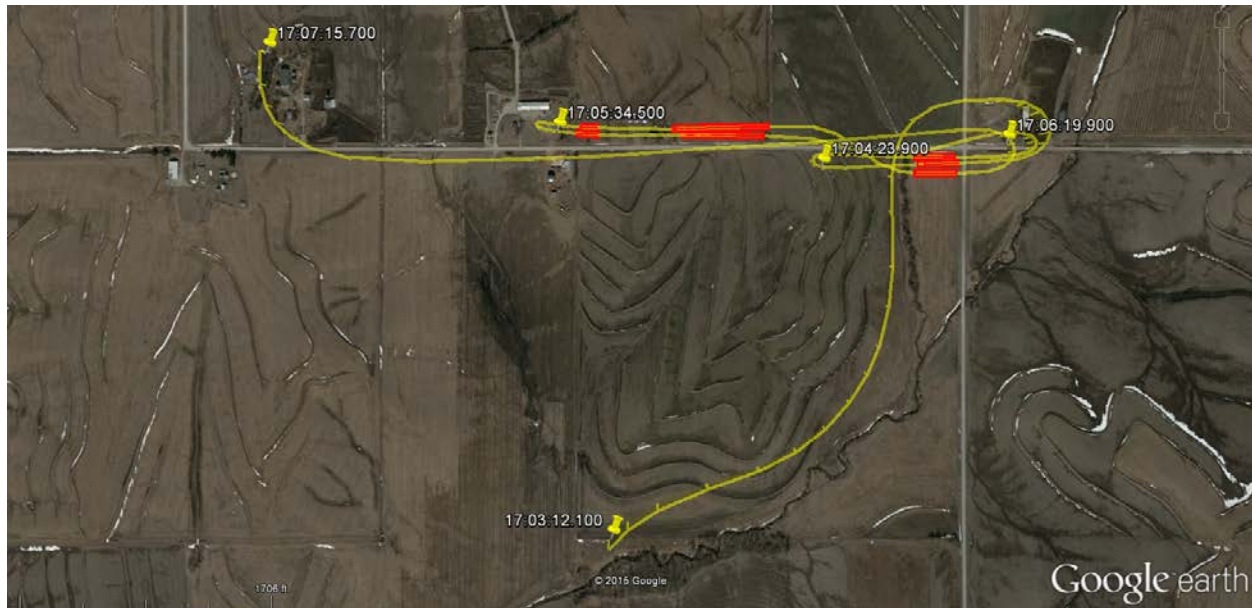
The data shows the flight moving northeast at the beginning of the flight, then moving further to the west as the last data point was captured. During the flight, crops were sprayed in the red zones as shown in Figure 3. The flight path is shown in yellow. Due to data buffering on the GPS unit, the data recording may have ended before the accident event.

**Figure 3 : Graphical overlay generated using Google Earth of the flight path**
