## ENGINE EXAMINATION REPORT

| <b>ENGINE MODEL</b> | TSIO-550-C1B |
| <b>AIRCRAFT MAKE &amp; MODEL</b> | Piper PA46-310P |

| <b>EXAMINATION</b> | | <b>ACCIDENT DATA</b> | |
|---|---|---|---|
| <b>DATE</b> | 06/16/2016 | <b>NTSB ACCIDENT #</b> | CEN15FA008 |

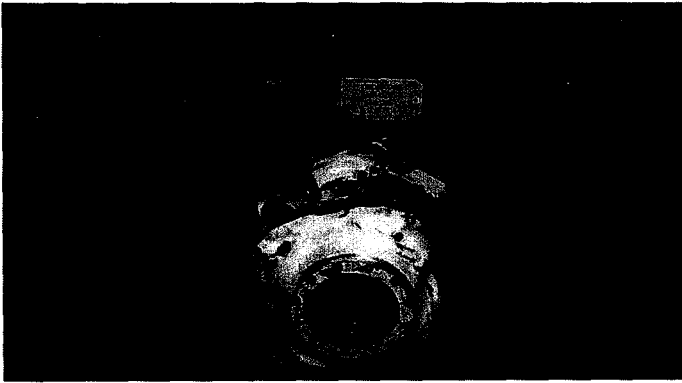
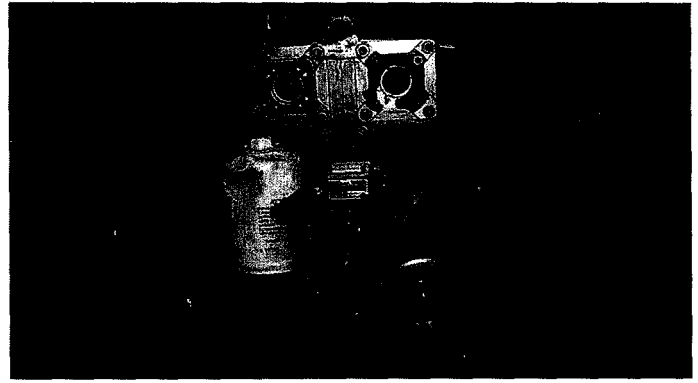
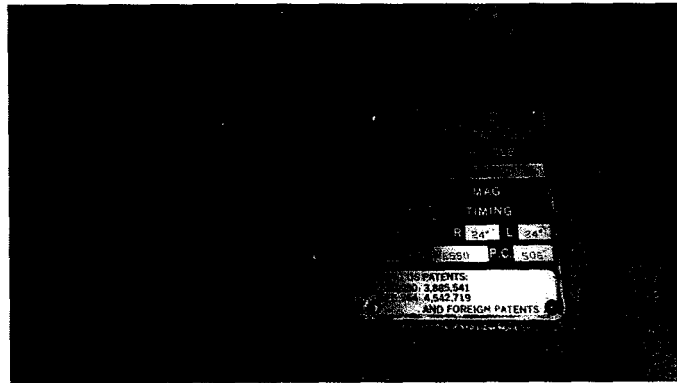
### AIRFRAME COMPONENTS RETURNED WITH ENGINE

The propeller hub, propeller spinner, propeller governor, and propeller deicing equipment remained attached to the engine. Portions of cooling baffle remained with the engine. The vacuum pump was separated from the engine, but was included in the shipping crate. Sections of the EGT and CHT probes and wiring remained attached to engine. Portions of the airframe mount remained attached to the fractured engine mounts as well.

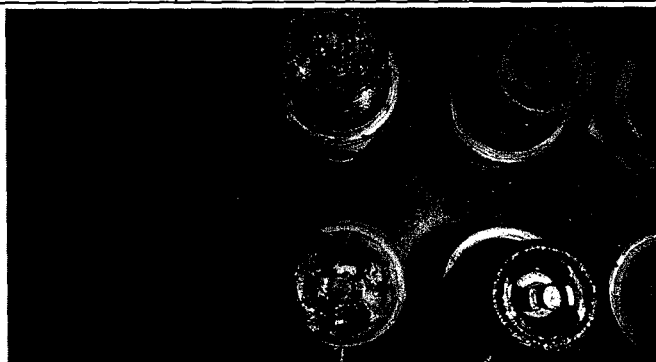
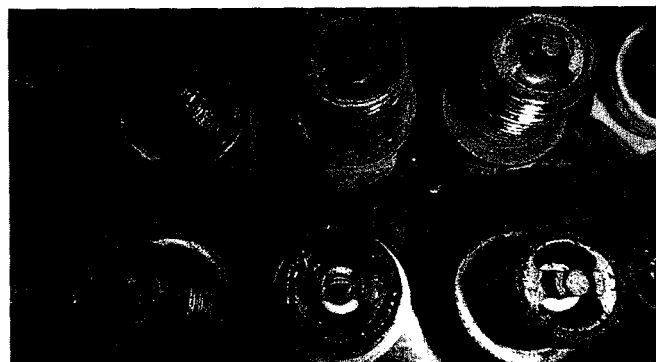
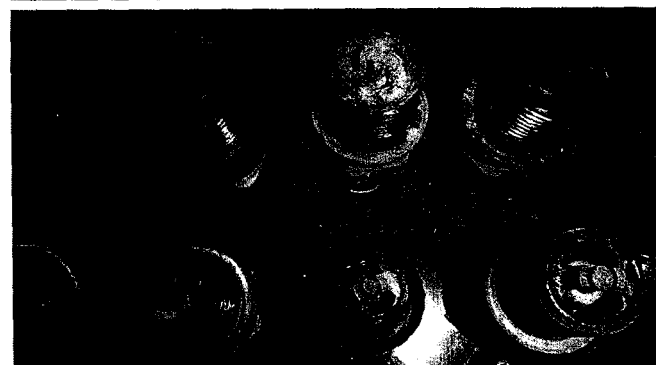
SPARK  
PLUGS

Condition: All of the sparkplugs were removed from their respective cylinders. The #1 and #4 sparkplugs were corroded and impacted with mud and debris. All of the electrodes displayed a normal worn condition when compared to the Champion Aviation Service Manual (AVR-6) and there was no evidence of carbon or lead fouling.

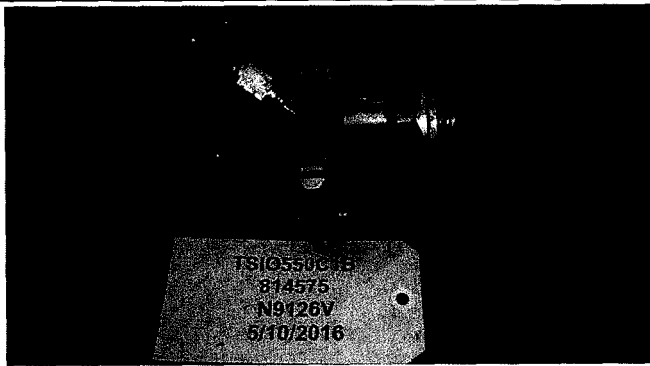
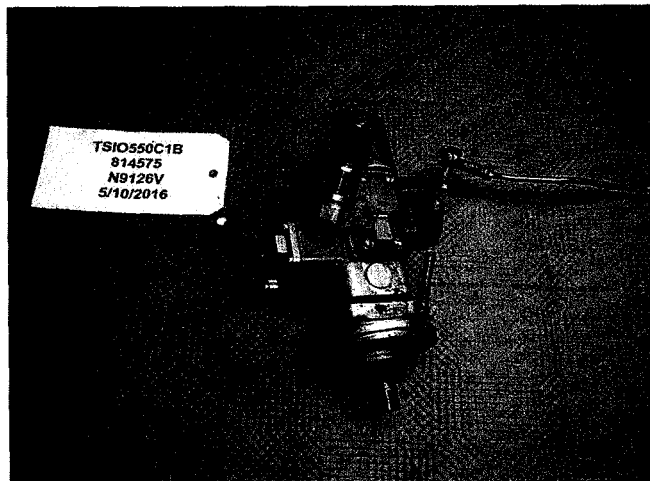
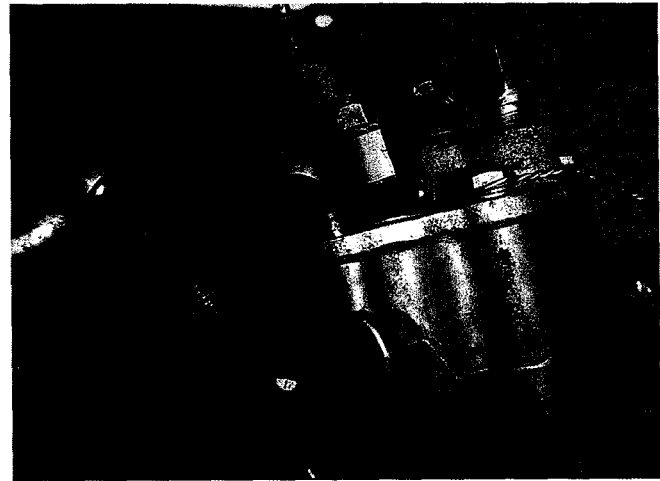
The fuel pump remained attached to the backside of the engine. The mixture control lever was deformed, but the mixture cable end remained attached to the lever. The mixture control shaft was deformed. The pump was removed from the engine and the drive coupling was found intact. The original torque seal was still present on the safety wire. Disassembly of the fuel pump revealed no pre-accident anomalies with any of the internal components. The fuel pump vanes and drive shaft were corroded and would not rotate freely.

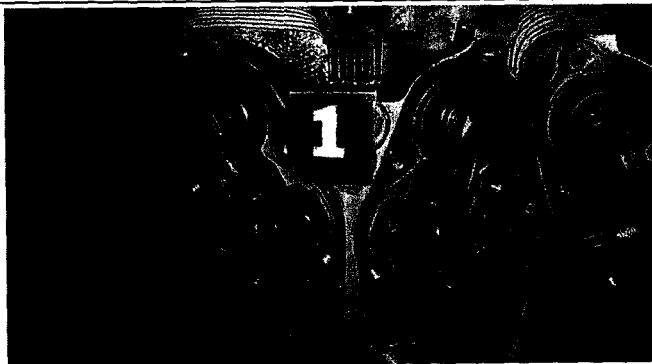
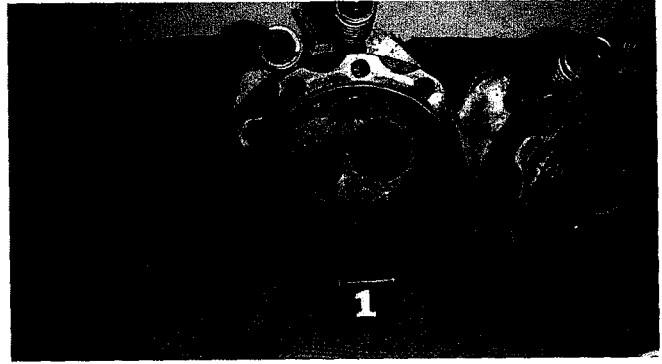
### CYLINDER #1

The cylinder remained attached to the crankcase with no external signs of operational distress noted. The rocker covers were removed and the rockers and springs were intact and appeared to be well lubricated. The cylinder was removed and organic debris and rust were noted internally. No pre-accident anomalies were noted with the valves, valves seats, barrel or cylinder head.

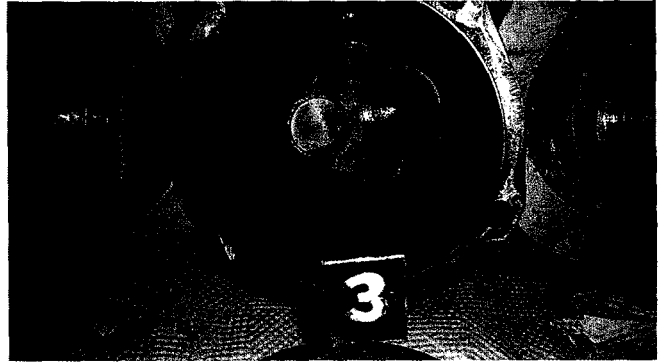
The cylinder remained attached to the crankcase with no external signs of operational distress noted. The rocker covers were removed and the rockers and springs were intact and appeared to be well lubricated. The cylinder was removed and oil coated the interior components. No pre-accident anomalies were noted with the valves, valves seats, barrel or cylinder head.

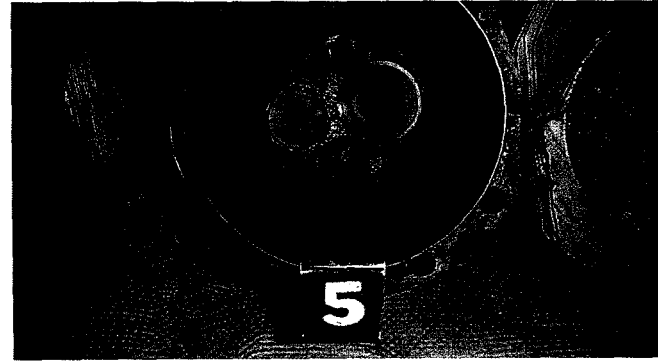
**CYLINDER #5**

The cylinder remained attached to the crankcase with no external signs of operational distress noted. The rocker covers were removed and the rockers and springs were intact and appeared to be well lubricated. The cylinder was removed and organic debris and rust were noted internally. No pre-accident anomalies were noted with the valves, valves seats, barrel or cylinder head.

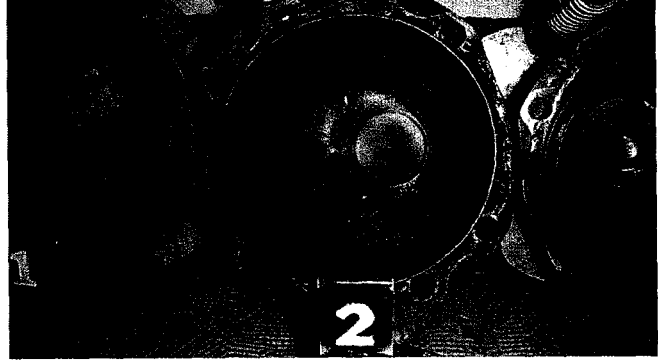
The cylinder remained attached to the crankcase with no external signs of operational distress noted. The rocker covers were removed and the rockers and springs were intact and appeared to be well lubricated. The cylinder was removed and organic debris and rust were noted internally. No pre-accident anomalies were noted with the valves, valves seats, barrel or cylinder head.

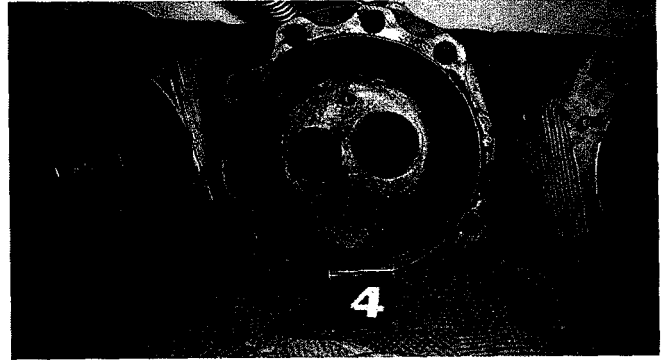
**CYLINDER #4**

The cylinder remained attached to the crankcase with no external signs of operational distress noted. The rocker covers were removed and the rockers and springs were intact and appeared to be well lubricated. The cylinder was removed and organic debris and rust were noted internally. No pre-accident anomalies were noted with the valves, valves seats, barrel or cylinder head.

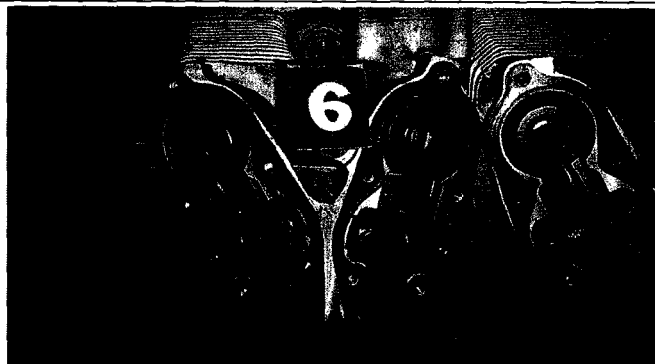
## CYLINDER #6

The cylinder remained attached to the crankcase with no external signs of operational distress noted. The rocker covers were removed and the rockers and springs were intact and appeared to be well lubricated. The cylinder was removed and organic debris and rust were noted internally. No pre-accident anomalies were noted with the valves, valves seats, barrel or cylinder head.

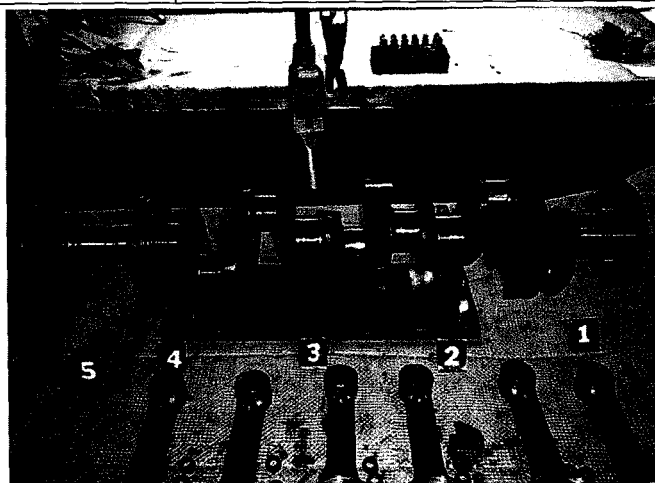
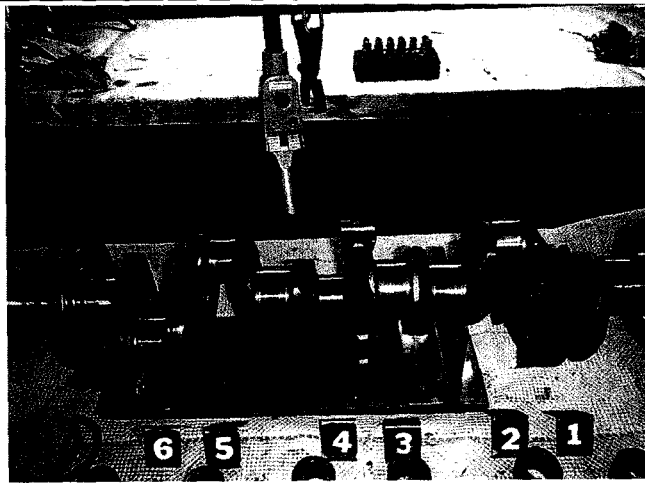
### CRANKSHAFT

The crankshaft was intact with no pre-accident anomalies noted with the main or connecting rod journals. Residual oil coated the entire crankshaft and the crankshaft gear remained in place and all the bolts' safety-wire was intact.

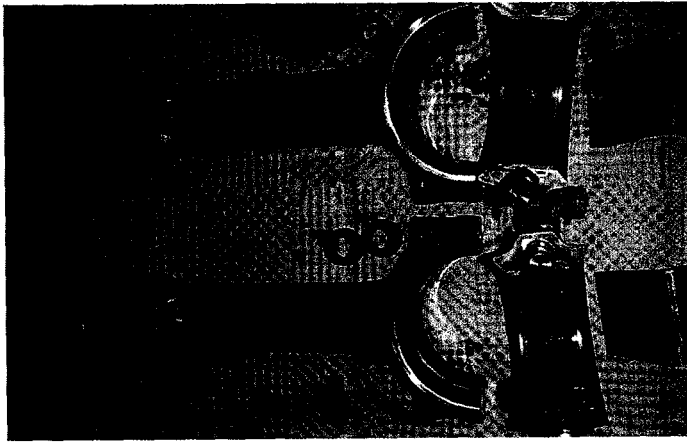
**Condition:** The connecting rod was intact and remained attached to the crankshaft and piston pin. No pre-accident anomalies or signs of operational distress were noted.

**Condition:** The bearing was in place and showed normal signs of wear. No pre-accident anomalies were noted.

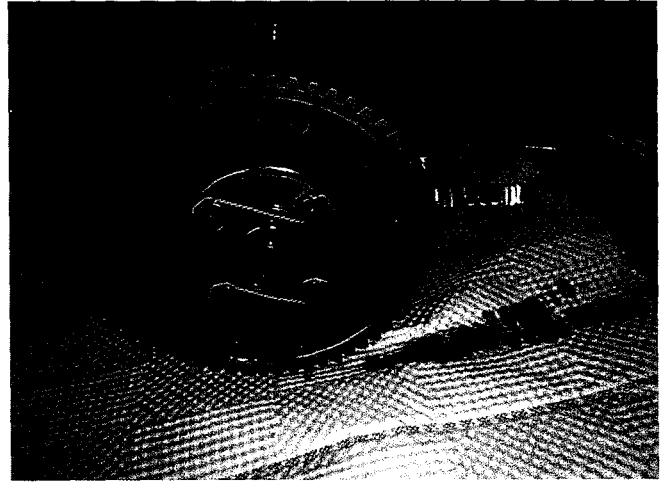
The camshaft was intact and the lobes displayed a normal wear. The camshaft gear was in place and the bolt safety-wire was intact. The bevel gear displayed normal wear. No pre-accident anomalies were noted.

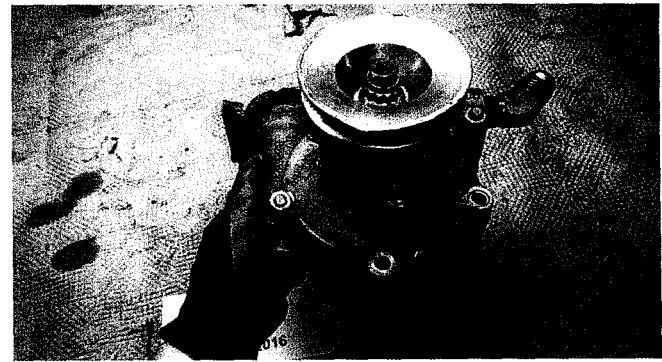
The starter adapter remained attached to the backside of the engine and the starter motor mounting pad was fractured. The starter gear was intact with no pre-accident anomalies noted.

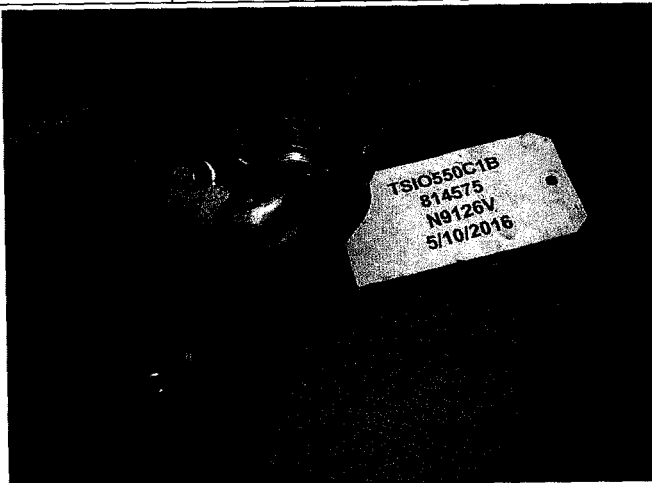
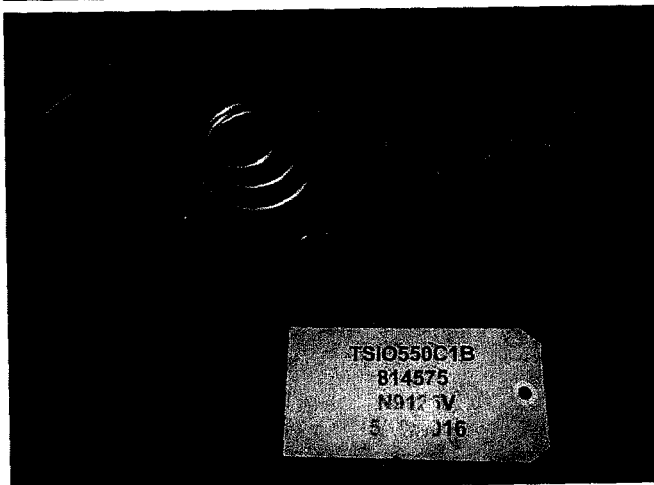
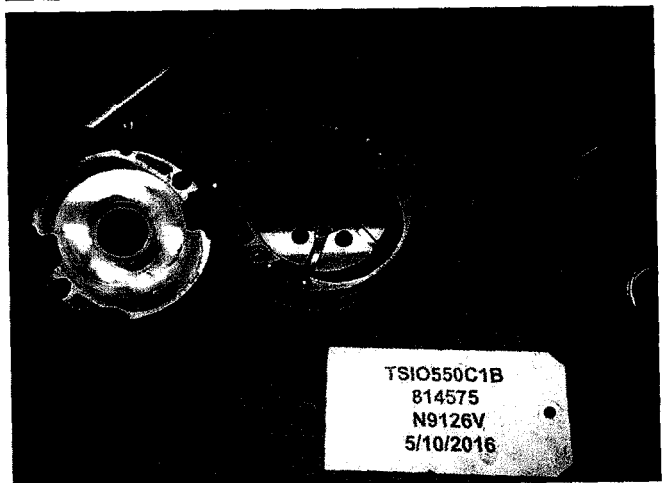
## VACUUM PUMP

The vacuum pump was separated from the engine and was found in a box located in the shipping crate. The housing sustained impact-related damage. Disassembly of the unit revealed that the vanes were intact and the rotor was fractured. No pre-accident anomalies were noted with the unit.

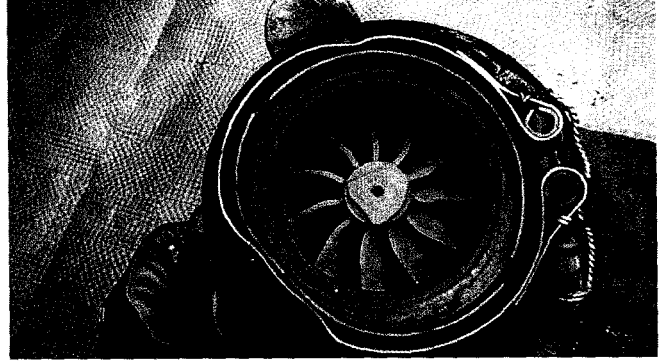
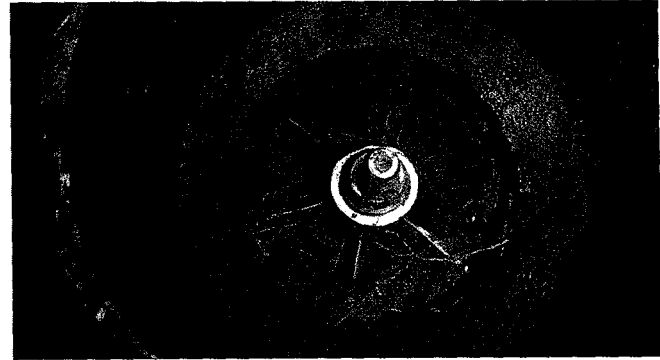
Condition: The left turbocharger was separated from the engine and was lying in the shipping crate. A letter "L" was written on the turbocharger shroud and it is assumed that it was the left turbocharger. Mud was impacted into the compressor impeller and rotation of the turbine and compressor was not possible. Rotational scoring was noted on behind the turbine. The compressor impeller blades were deformed.

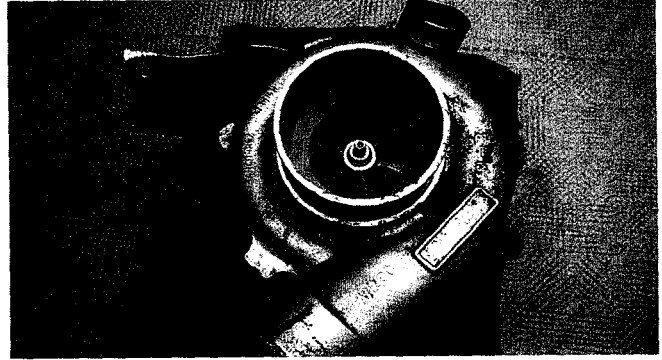
## RIGHT TURBO

Condition: The right turbocharger was separated from the engine and was lying in the shipping crate. A letter "R" was written on the turbocharger shroud and it is assumed that it was the right turbocharger. No pre-accident anomalies were noted with the turbine or compressor but the turbine was displaced within the shroud.
