**NATIONAL TRANSPORTATION SAFETY BOARD**  
Vehicle Recorder Division  
Washington, D.C. 20594

## **Enhanced Ground Proximity Warning System - Factual Report**

**Specialist's Report  
by George Haralampopoulos**

Location: Palos Hills, Illinois  
Date: October 12, 2014  
Aircraft: Beechcraft 58  
Operator: Private  
Registration: N31EW  
NTSB Number: CEN15FA009

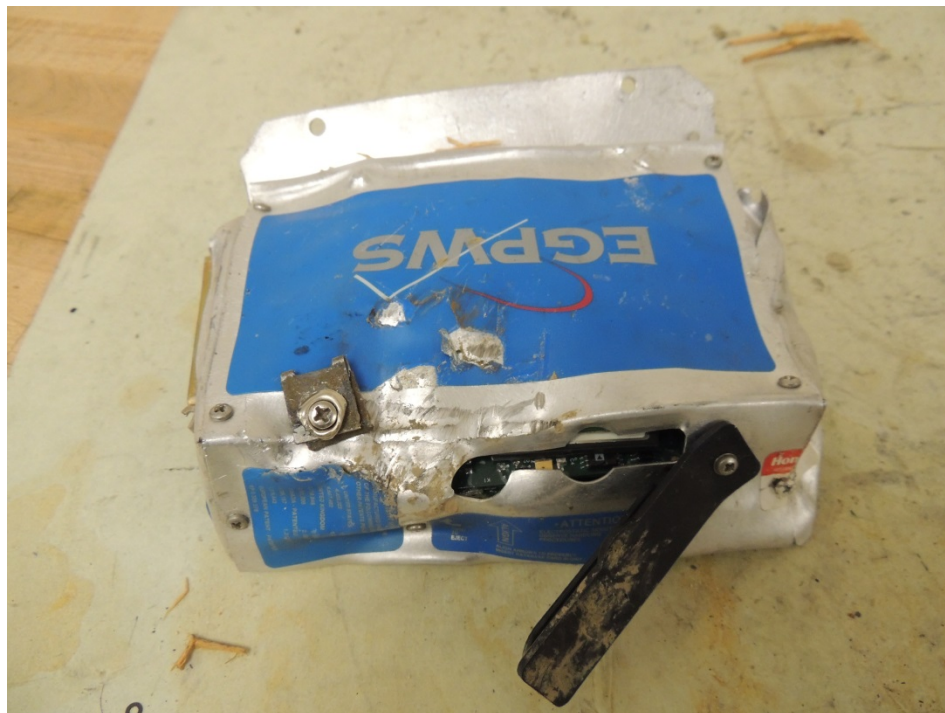
Upon arrival at the Vehicle Recorder Laboratory, an exterior examination revealed the unit had sustained severe impact damage, including crushing and abrasion to the unit's housing (figure 1). An interior inspection revealed integrated circuits on the top level internal circuit board had been ejected from the board. The Compact Flash card containing the unit's non-volatile memory was located; however, the internal memory chip was cracked (figure 2). Due to the crack, no data could be recovered and no further work to the KGP-560 was performed.

**Figure 1. Bendix King KGP-560 as received.**

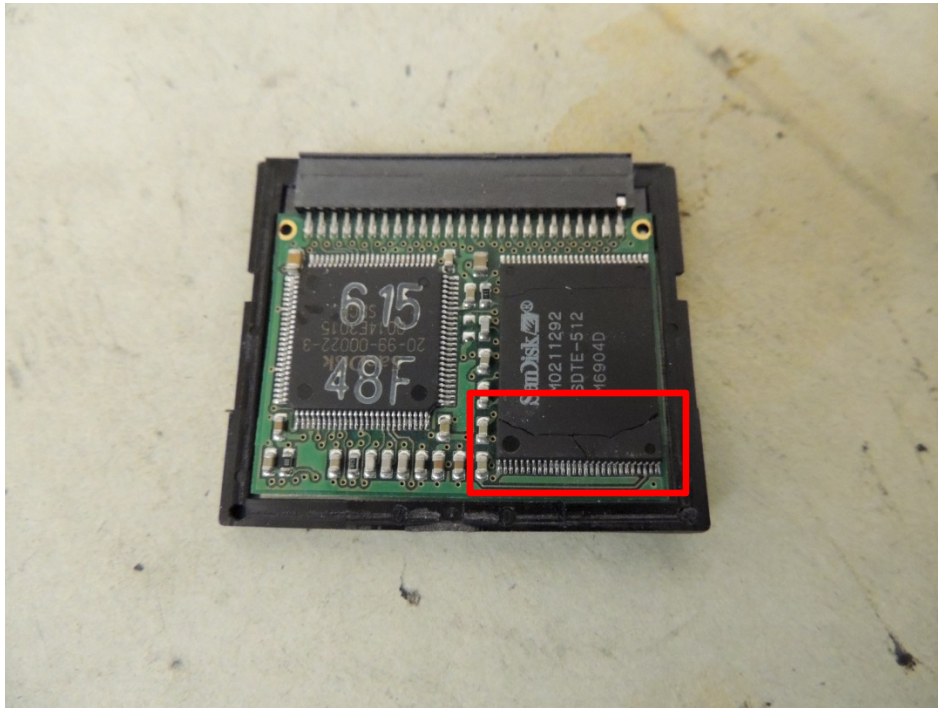
**Figure 2. Compact Flash card from Bendix King KGP-560 highlighting crack.**
