## **ACCIDENT**

Location : Lubbock, Texas  
Date : February 04<sup>th</sup>, 2015  
Aircraft : Piper PA46-500TP  
Aircraft Reg. No. N301D  
NTSB ID : CEN15FA135  
Pratt & Whitney Canada File # 15-008

## **SUMMARY**

## **DETAILS OF THE EXAMINATION**

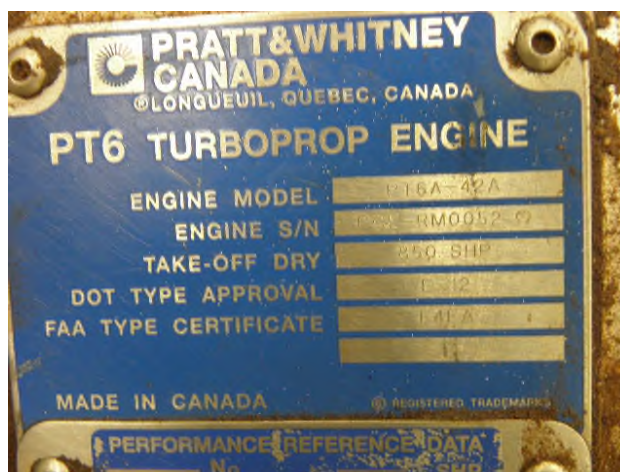
Photo No. 1, Engine data plate

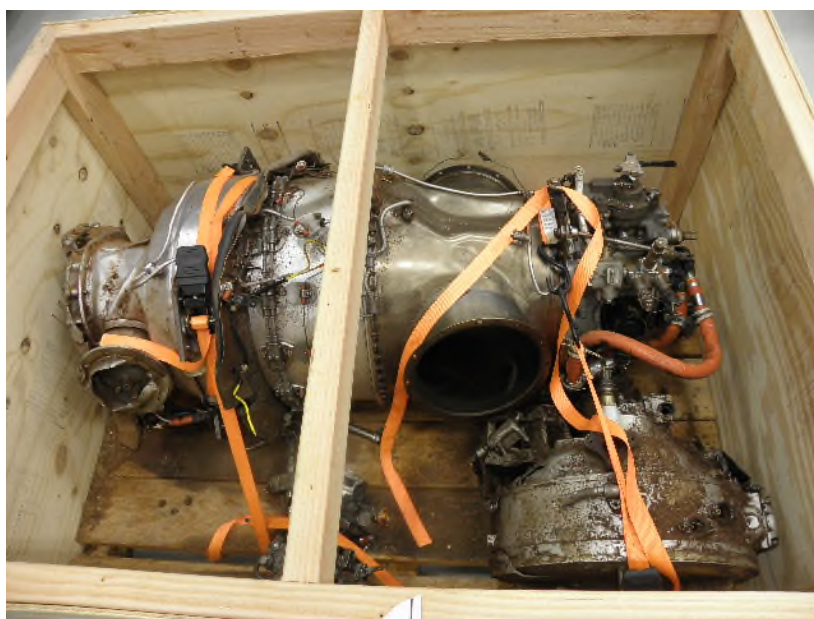
The engine was a Pratt & Whitney Canada PT6A-42A model, serial number PC-E RM0052 (Ref. Photo No. 1). The engine was received in a wood crate. The accessory gearbox was separated from the engine, and the fuel control and fuel pump assembly were separated from accessory gearbox (Ref. Photo No. 2). The fuel oil heat exchanger, the P3 filter assembly and the fuel flow divider valve were not received with the engine.

Photo No. 2, As-received condition of engine

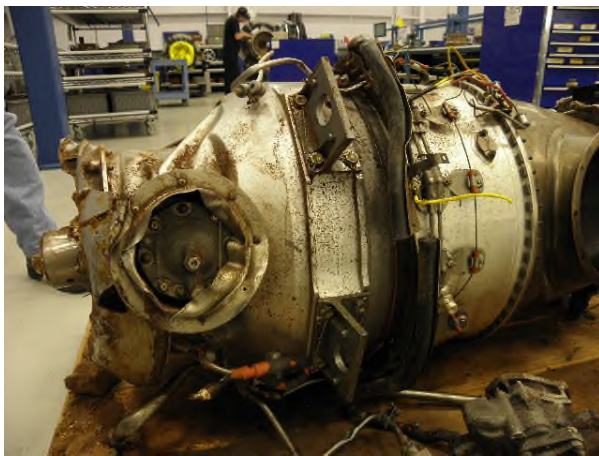
The gas generator case exhibited significant impact compressional deformation (Ref. Photo No. 3). The flow divider valve was missing. The remaining fuel nozzle manifold

Photo No. 3, Gas generator case

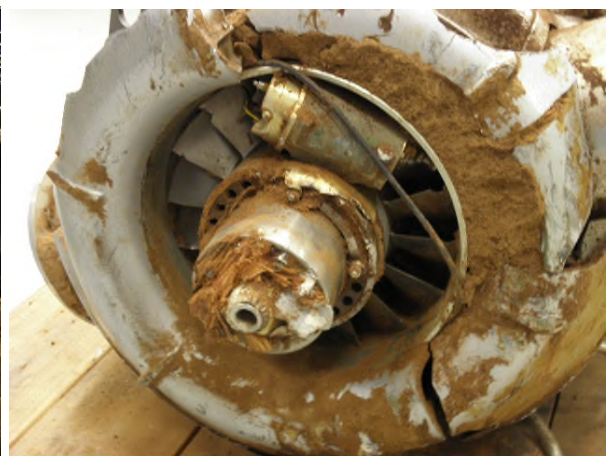
The compressor inlet case was fractured exposing the compressor inlet. An airframe component (flow control valve assembly) was found lodged in the compressor inlet (Ref. Photo No. 4). The blade leading edges were gouge and deformed due to contact with ingested debris. The blade tips and shroud exhibited light circumferential rubbing. The 1<sup>st</sup> stage stator airfoils were intact with the tips rubbed from radial contact with the adjacent spacer.

Photo No. 4, Compressor inlet

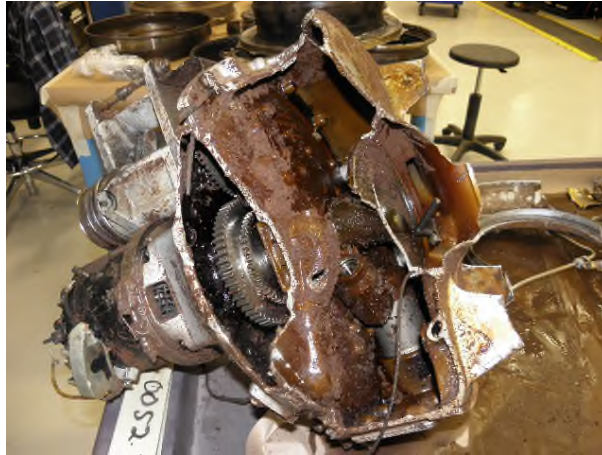
The accessory gearbox assembly, including a portion of the inlet case was separated from the gas generator case. The housings were fractured at the top, exposing the accessory gearbox internal components and the oil tank (Ref. Photo No. 5). The accessory gearbox was capable of manual rotation. The oil filter and chip detector were removed and found unremarkable in appearance.

Photo No. 5, Accessory gearbox

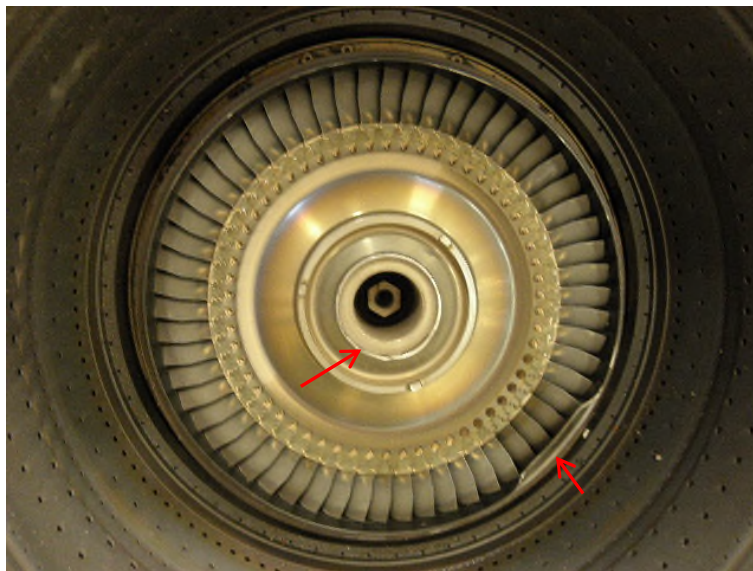
The engine was split at the “C” flange to expose the hot section components. The compressor turbine disk exhibited light circumferential wear from contact with the power turbine vane. The compressor turbine shroud housing was locally deformed inwards from impact/ compressional deformation of the power turbine vane (Ref. Photo No. 6). The compressor turbine shroud segments exhibited rotational scoring from the blade tips (Ref. Photo No. 7). The compressor turbine vane displayed no indications of operational distress.

Photo No. 6, Compressor turbine in-situ

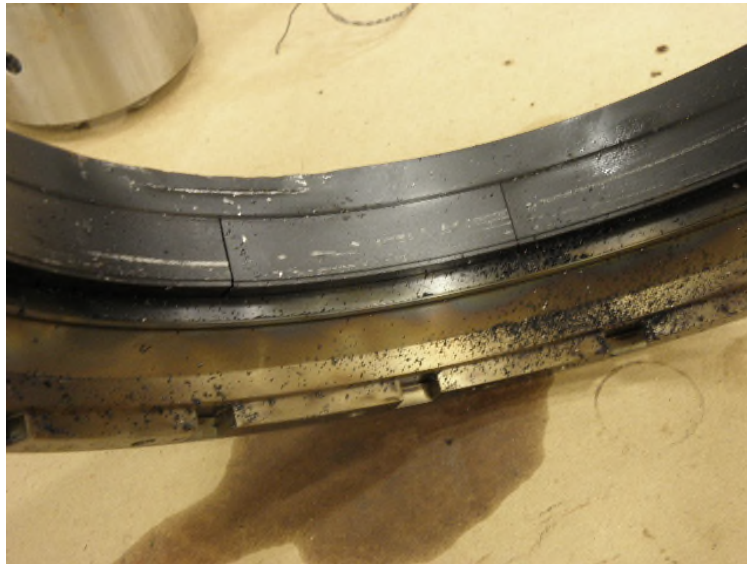
Photo No. 7, Compressor turbine shroud segment rubs

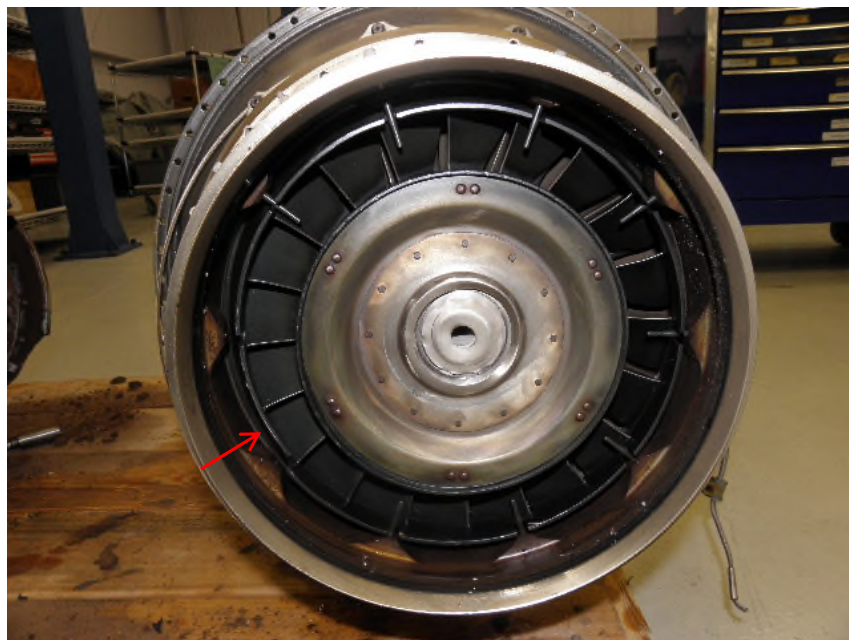
The power section was not capable of manual rotation. Two temperature probe ends were found fractured. The 1<sup>st</sup> stage power turbine vane exhibited localized deformation of the outer shroud, and all the vanes exhibited cracks/ fractures at the airfoil to inner shroud area. Circumferential scoring was evident on the downstream side of the inner shroud. The baffle exhibited contact marks from the power turbine shaft and retention nut (Ref. Photos No. 8 - 10). The power turbine disks were removed. Circumferential scoring was evident on the power turbine shrouds. Approximately half of the 1<sup>st</sup> stage power turbine blades had shifted forward in the disk (Ref. Photos No. 11 & 12). The 2<sup>nd</sup> stage power turbine disk assembly was relatively unremarkable in appearance. With the power turbines removed, the power section was capable of manual rotation. No further disassembly of the power section was performed.

Photo No. 8, 1<sup>st</sup> stage power turbine vane and housing

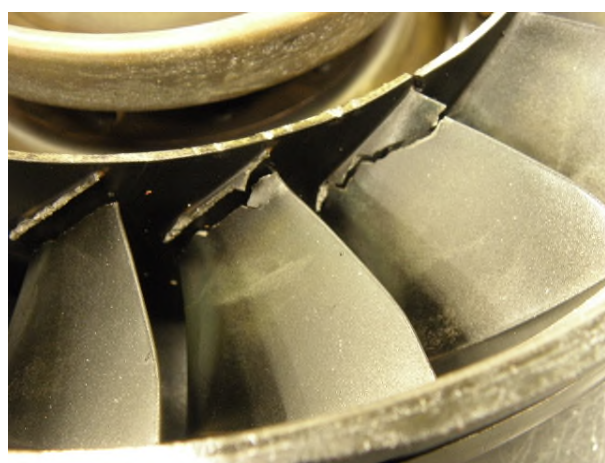
Photo No. 9, 1<sup>st</sup> stage power turbine vane

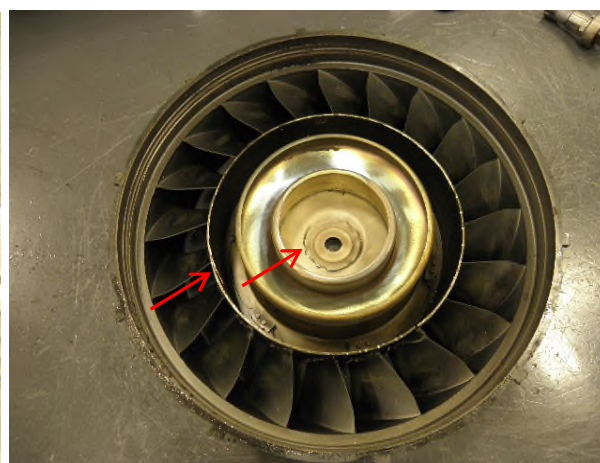
Photo No. 10, 1<sup>st</sup> stage power turbine vane

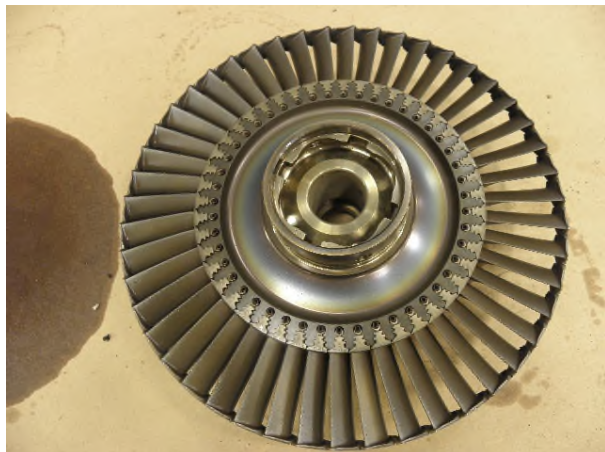
Photo No. 11, 1<sup>st</sup> stage power turbine disk

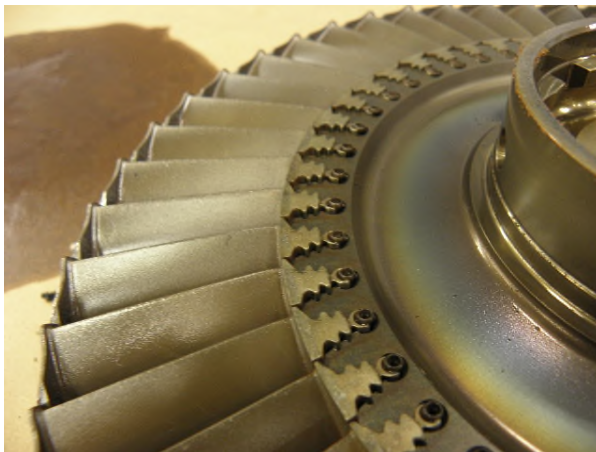
Photo No. 12, 1<sup>st</sup> stage power turbine disk

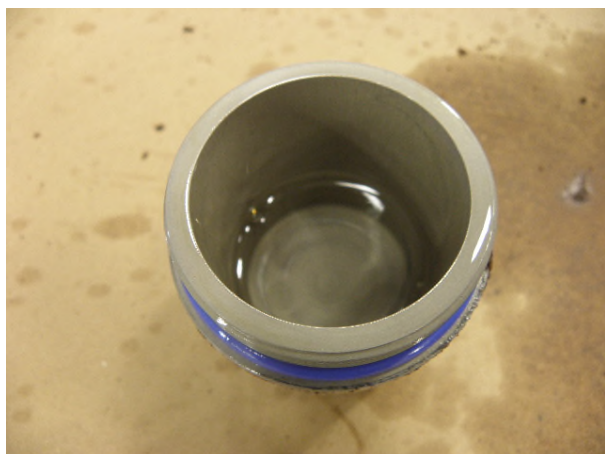
The fuel control unit and fuel pump were capable of manual rotation. The fuel filter was removed and the residual fuel in the filter bowl and the filter were clean (Ref. Photos No. 13 & 14).

Photo No. 13, Residual fuel in filter bowl

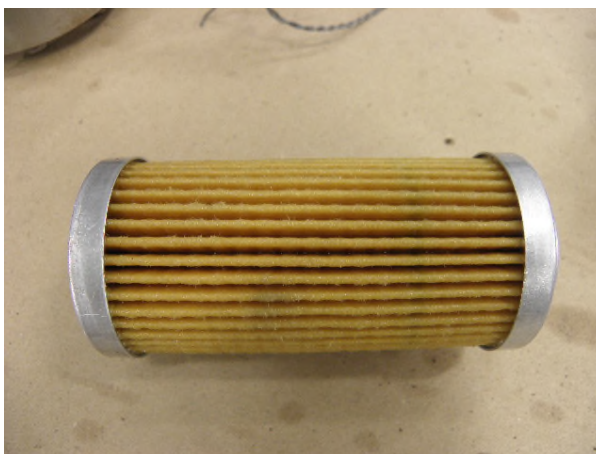
Photo No. 14, Fuel filter
