**From:** Richards Michael  
**Sent:** Friday, February 27, 2015 10:39 AM  
**To:** Fox Todd  
**Subject:** CEN15FA136 - WX factual email

Mike Richards  
Aviation Safety Investigator - Senior Meteorologist  
Operational Factors Division  
National Transportation Safety Board

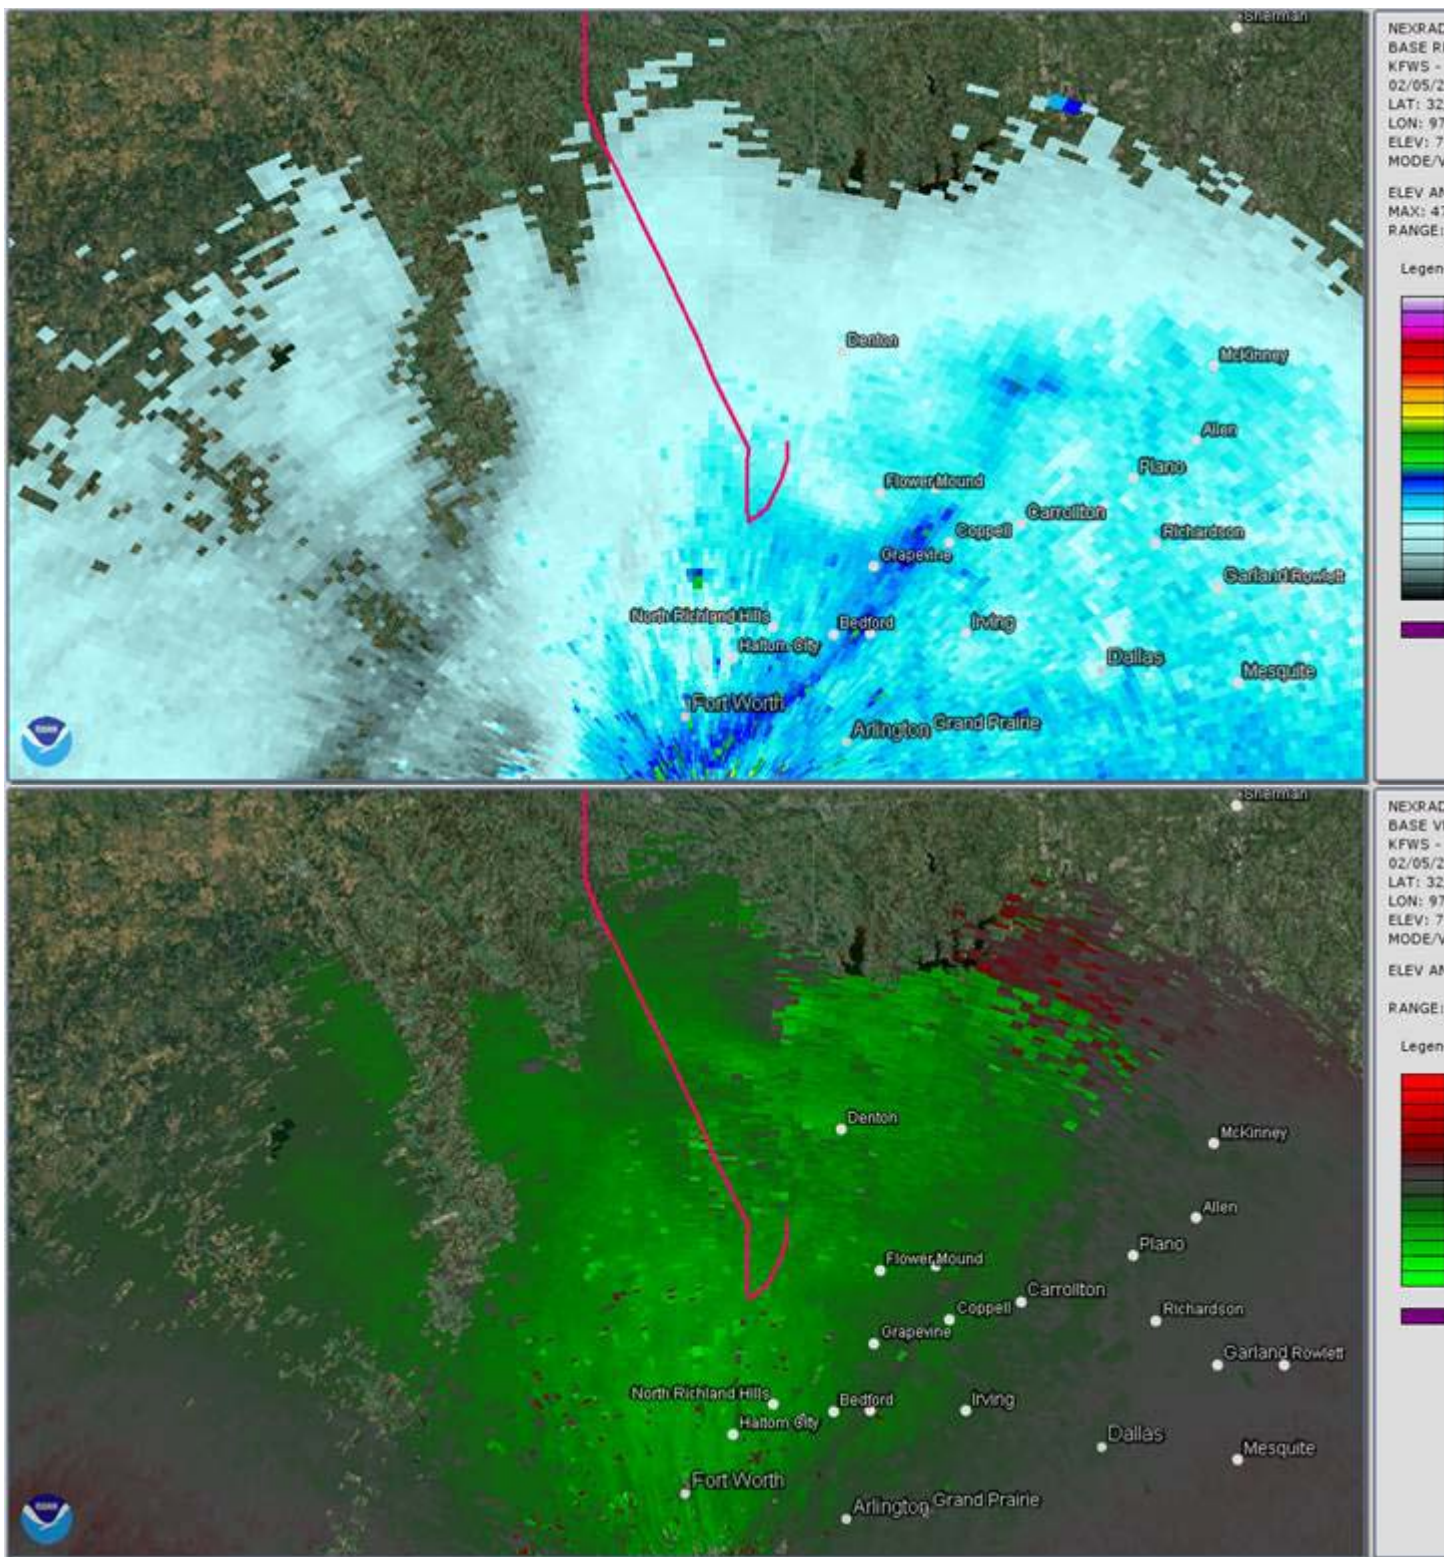
Weather radar imagery from a WSR-88d Doppler weather radar located about 31 miles from the accident site depicted very low, but positive reflectivity in the vicinity of the accident site at the accident time. Doppler velocity data identified 25-30 knots wind magnitudes within several thousand feet of the surface. Considering the 0.50° tilt of the weather radar for the imagery presented here, the radar would have seen altitudes between about 1,000 feet and 4,600 feet above msl above the accident site.
