SITE PHYSICAL ADDRESS

[REDACTED]  
St. Louis (St. Louis Co.), MO 63110

DATE OF INSPECTION

April 16, 2015

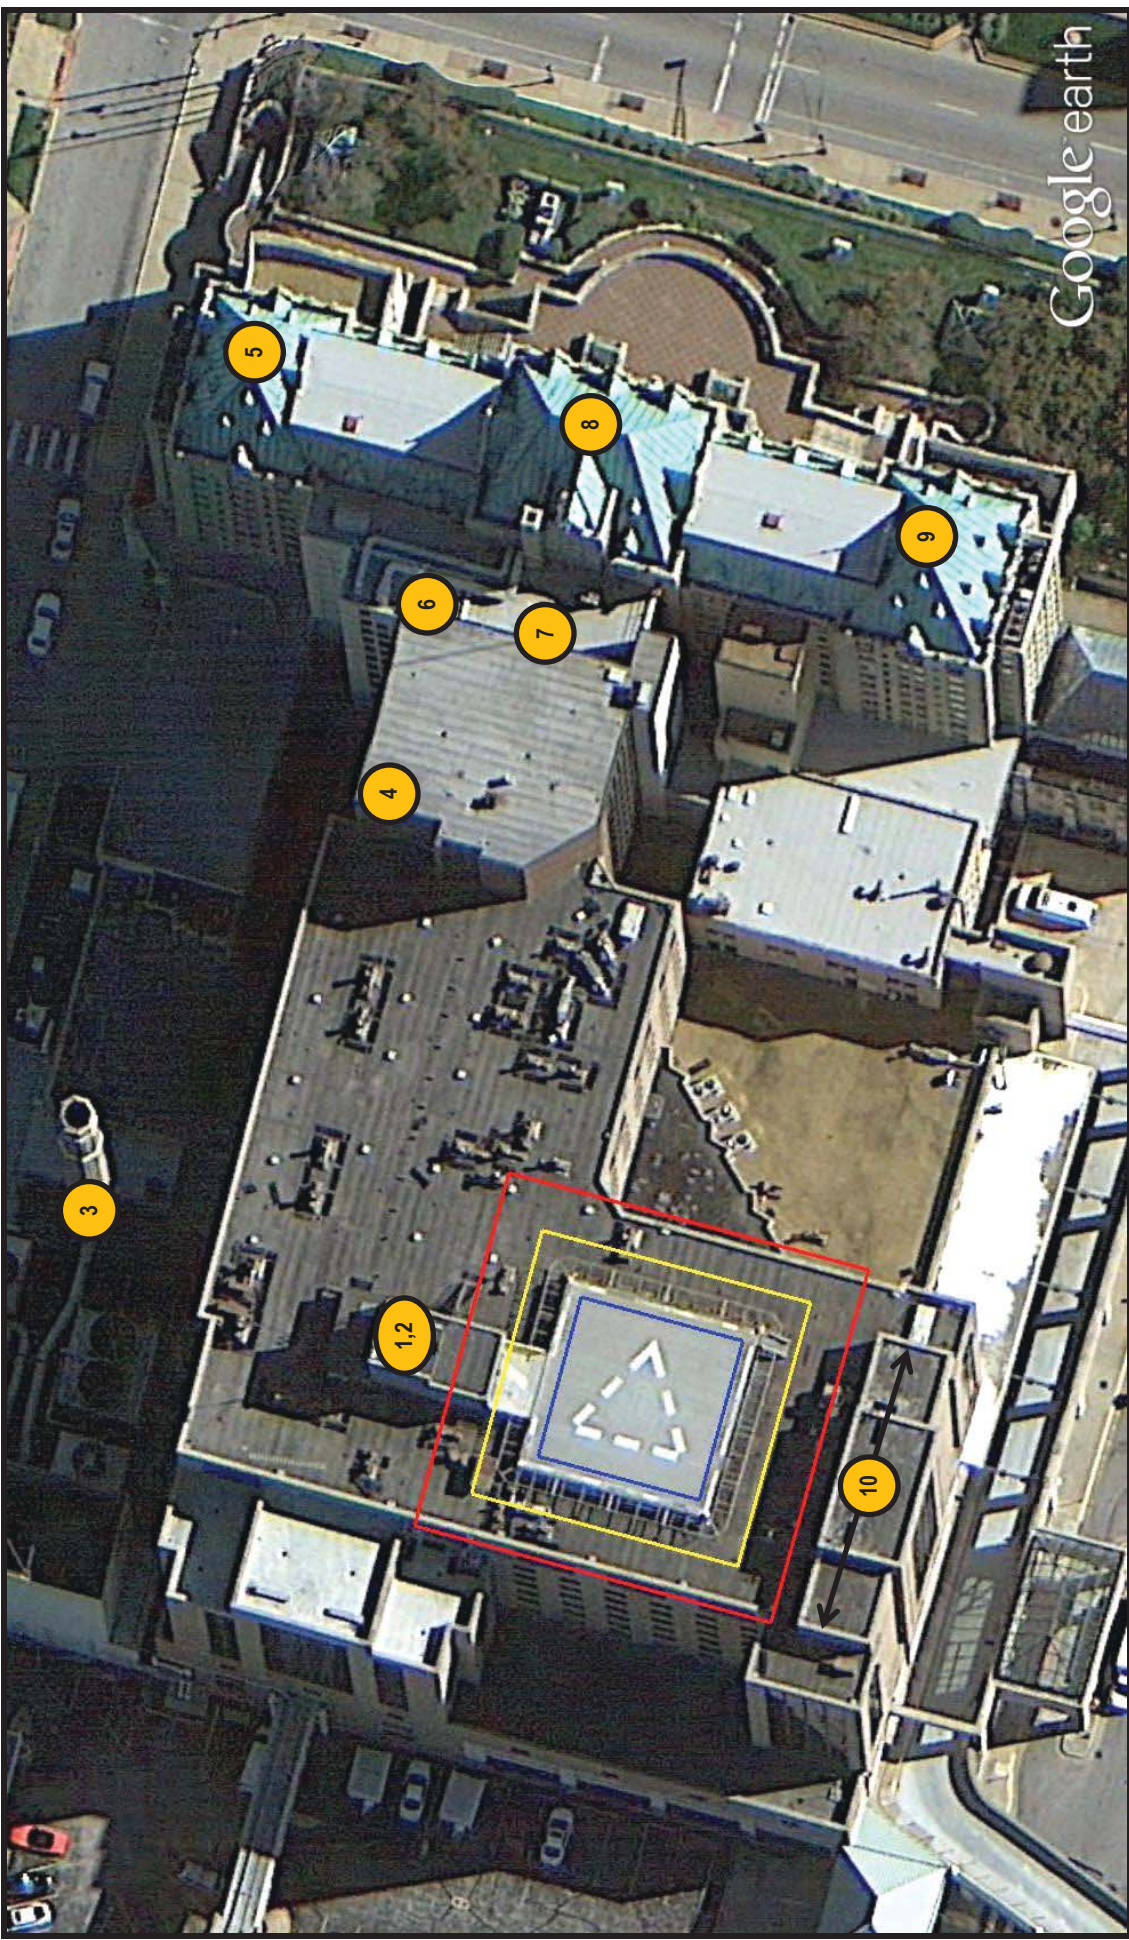
Figure 3: Obstructions Outside the Safety Area

| NO. | OBSTRUCTION TYPE | AZIMUTH FROM<br>TLOF CENTER<br>(TRUE NORTH) <sup>2</sup> | HEIGHT ABOVE<br>TLOF ELEV | DISTANCE<br>FROM FATO | MAXIMUM<br>PENETRATION |
|---|---|---|---|---|---|
| 1 | Elevator Shaft | 005°–020° | 25' | 17' | 22.8' |
| 2 | Wind Cone | 011° | 40' | 33' | 35.9' |
| 3 | Smoke Stack | 018° | 54' | 106' | 40.8' |
| 4 | Building | 064°–094° | 33' | 84' | 22.5' |
| 5 | Church Spire | 069° | 65' | 230' | 36.3' |
| 6 | Antenna | 075° | 70' | 161' | 49.9' |
| 7 | Antenna | 083° | 105' | 149' | 86.4' |
| 8 | Church Spire | 087° | ≅ 75' | 246' | 44.3' |
| 9 | Church Spire | 108° | 65' | 224' | 37.0' |
| 10 | Building | 164°–236° | 7'–14' | 19' | 11.7' |

<sup>1</sup> Except where otherwise noted, all obstructions listed in Table 1 penetrate the obstruction-free approach/departure surface ratio of 8:1 (7.125°).

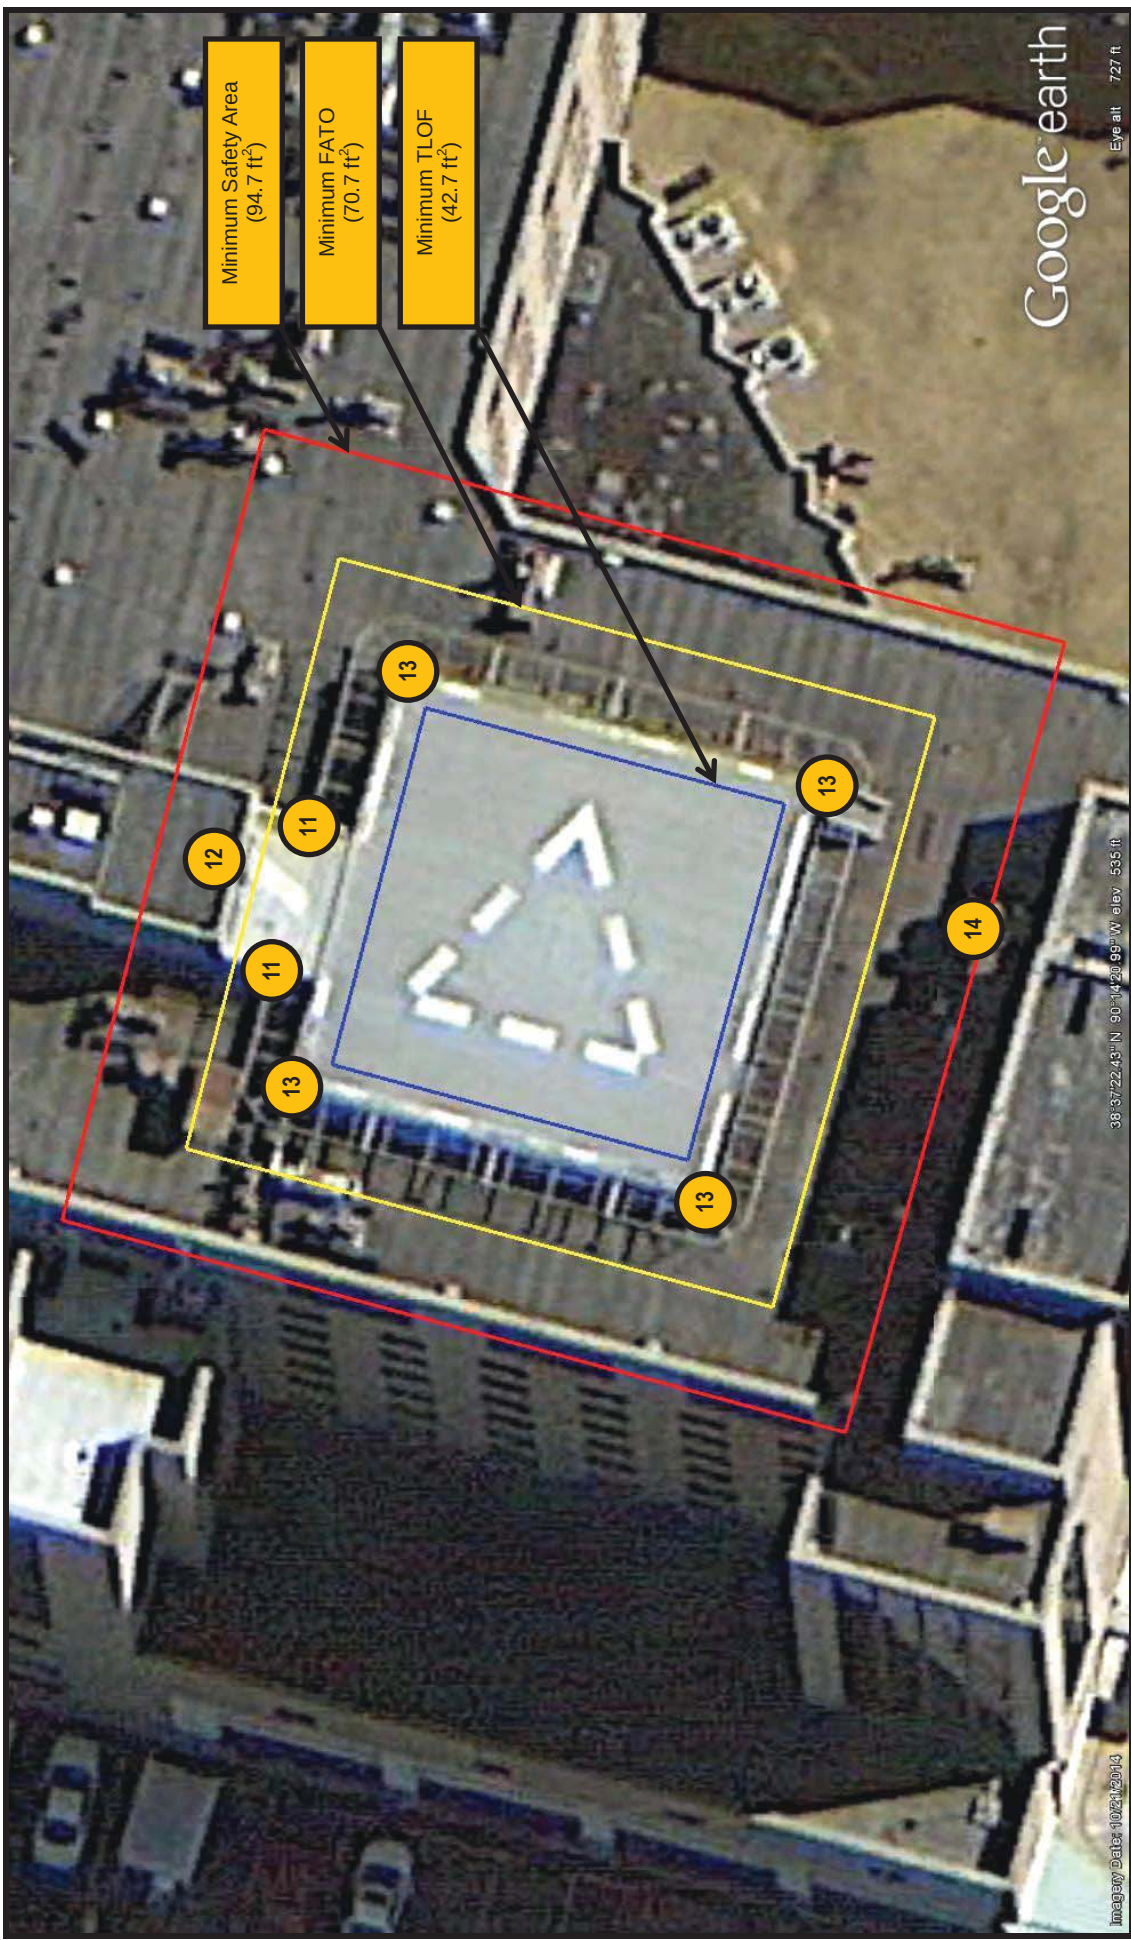
Figure 4: Obstructions Inside the Safety Area

| NO. | OBSTRUCTION TYPE | AZIMUTH FROM<br>TLOF CENTER | HEIGHT ABOVE<br>TLOF ELEV <sup>3</sup> | DISTANCE<br>FROM TLOF<br>CENTER | EXCEEDS<br>MAX HEIGHT<br>BY |
|---|---|---|---|---|---|
| 11 | Hand Rail (2) | 351° & 026° | 3.5' | 29' & 27' | 3.2' |
| 12 | Elevator Shaft Foyer | 357°–024° | ≅ 11.0' | 37' | 10.8' |
| 13 | Raised Flood/Perimeter Lights (4) | All Quads | 1.5' | 35' | 1.3' |
| 14 | Building Ventilation Equipment | 178° | 5.0' | 47' | 4.8' |

<sup>3</sup> Unless otherwise noted, objects listed in Table 2 exceed the maximum recommended height above FATO elevation of 2 inches (AC 150/5390–2C, Pars. 407[e] & 408[c]).

1. The final approach and takeoff area (FATO) and its associated safety area contain obstructions which significantly exceed the maximum height recommended for objects within this area: Notably, the structures and ductwork associated with the building ventilation systems, 4 raised perimeter/flood lights, an adjacent structure that houses an elevator shaft, and 2 handrails that extend from the entrance of the elevator shaft to the edge of the touchdown and liftoff area (TLOF).

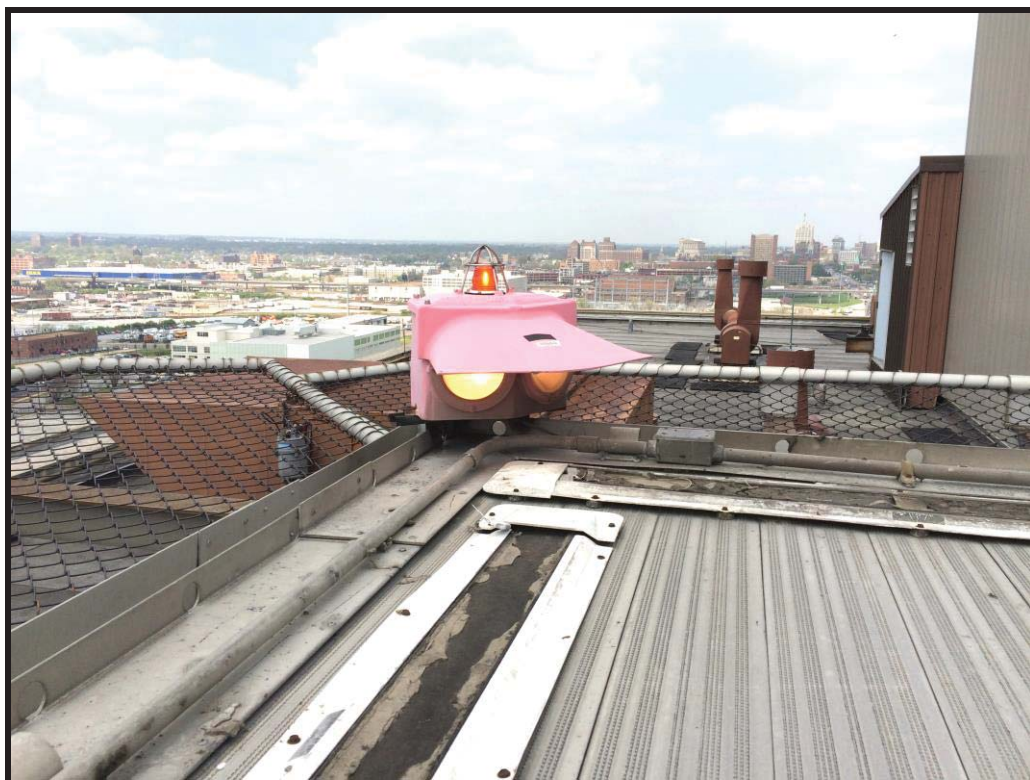
**Figure 19: Raised TLOF Perimeter/Flood Light (Table 2, Item 13)**

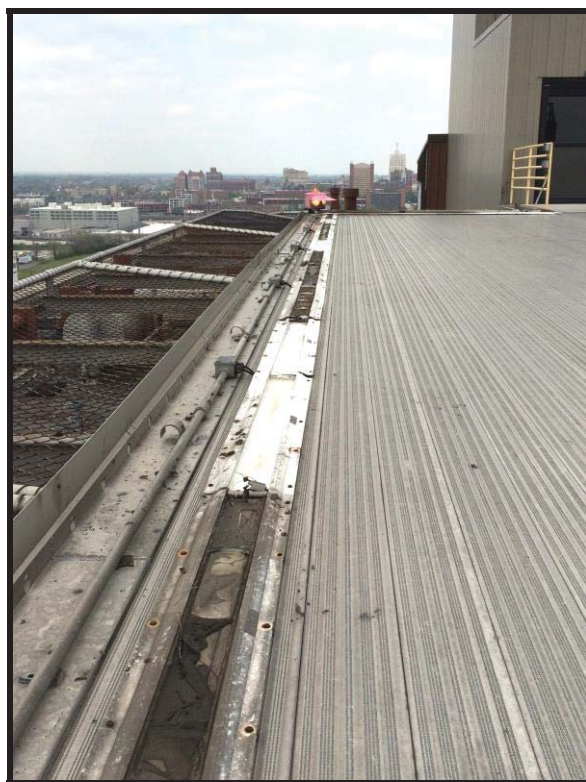
Except for walkway access, the entire surface of the structure comprises the TLOF and is marked with a non-standard white triangle. There is no hospital cross, “H” symbol, size/weight limitation box, or TDPC. The TLOF perimeter is marked with a dashed white line which appears to have—at one time—incorporated non-standard internal lighting (not functioning at the time of inspection). The triangle marking is in fair condition; the perimeter marking is in poor condition. The TLOF is oriented 015°–195° & 105°–285°, relative to true north. The TLOF corners are lighted with perimeter/flood lights incorporating 2 flood lamps and one amber

**Figure 20: TLOF Perimeter Marking; Safety Net**

NOTE: For the purposes of this study, it is assumed that the proponent would be willing to repaint the TLOF surface to conform to the recommendations of AC 150/5390–2C, Par. 414, and associated figures. The minimum TLOF recommended by the advisory circular for an elevated heliport is 1 times the overall length of the design helicopter (D), or 42.7 feet (4.8 feet smaller than the currently marked space). Since the size of the FATO/safety area, and obstruction penetrations calculated from them, are based on the size of the TLOF, use of the absolute minimum affords the greatest advantage to the proponent.

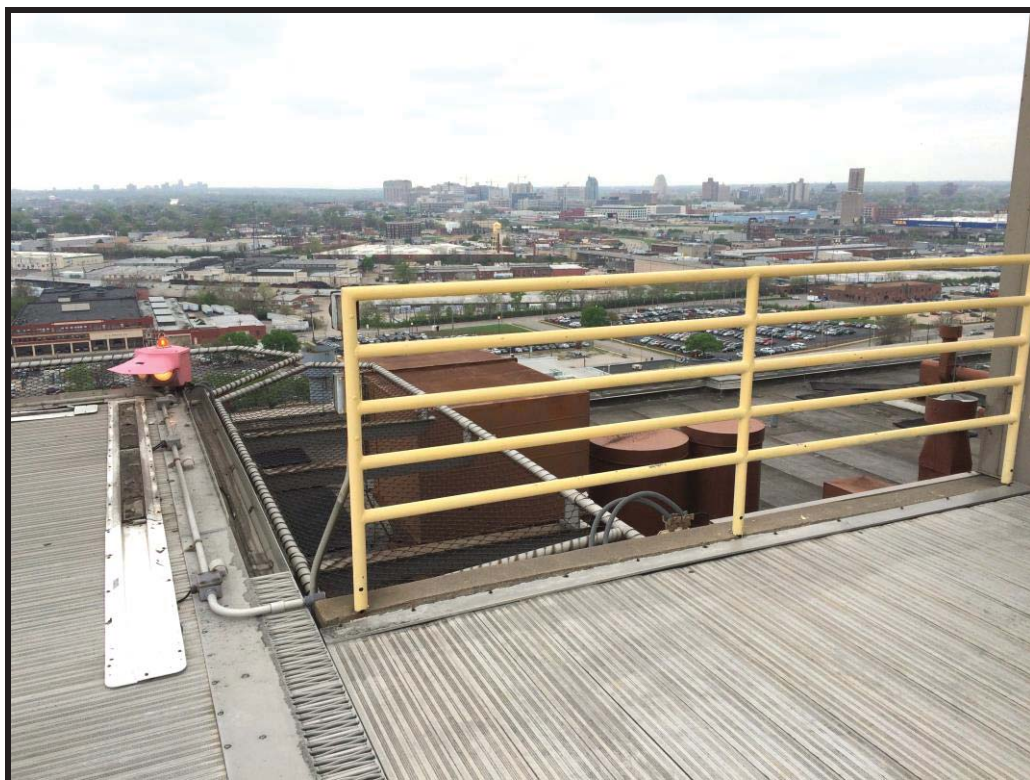
**Figure 21: Hand Rail (Table 2, Item 11); Safety Net; Perimeter Marking**

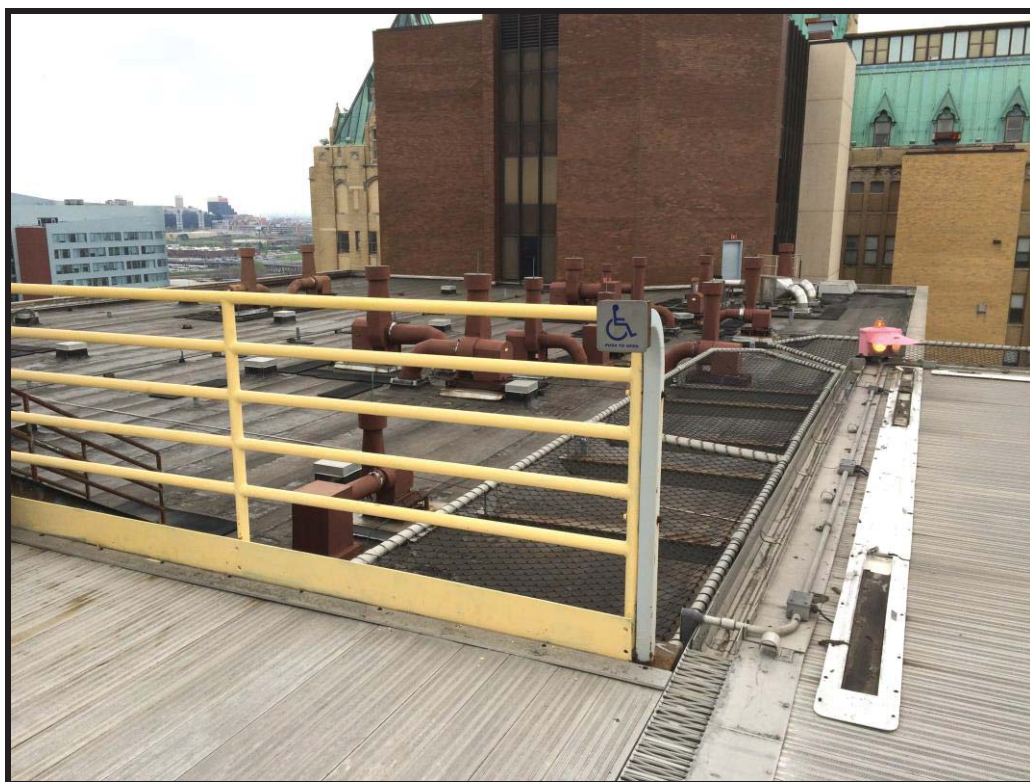
**Figure 22: Hand Rail (Table 2, Item 11); Safety Net; TLOF Perimeter Marking**

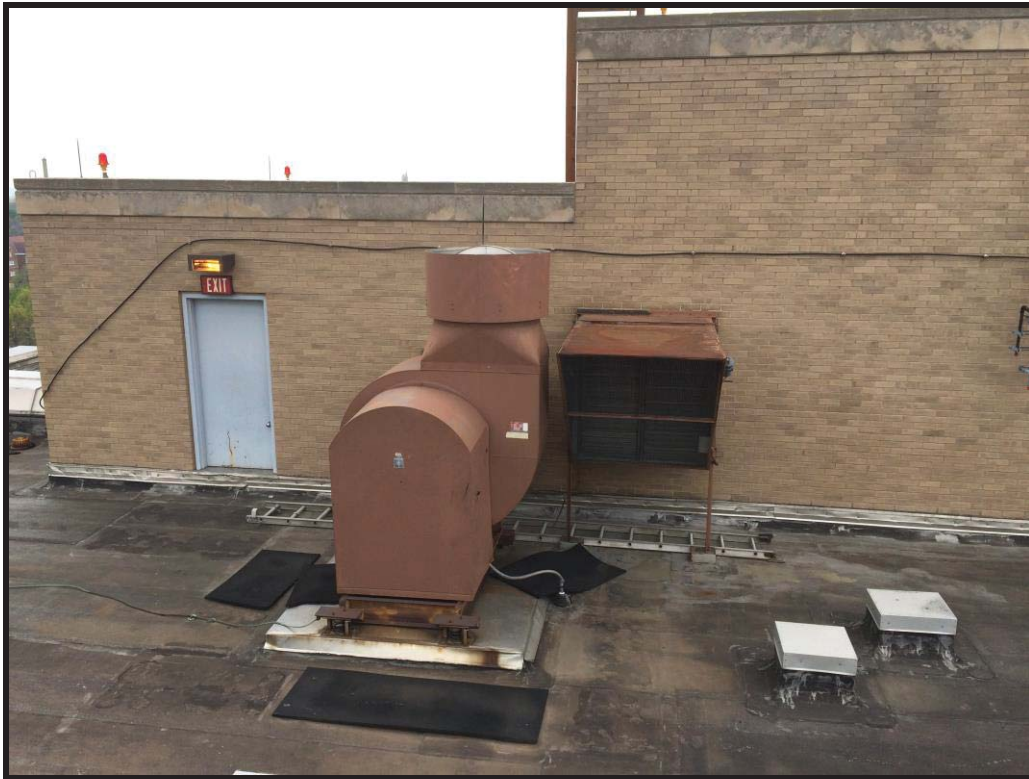
**Figure 23: Building Ventilation Equipment (Table 2, Item 14)**

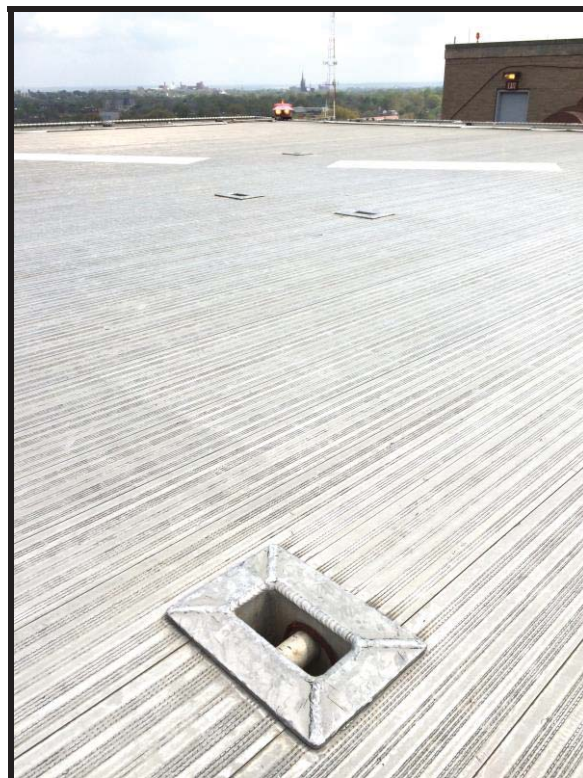
perimeter lamp in a single unit (4 total units; one in each corner). The TLOF surface also contains 6 flush-mounted aircraft tie-down fixtures.

**Figure 24: Aircraft Tie-down Fixtures**
