# Turbomeca On Site Examination Report

**CEN15FA171**

**AS350B2**

**Arriel 1D1**

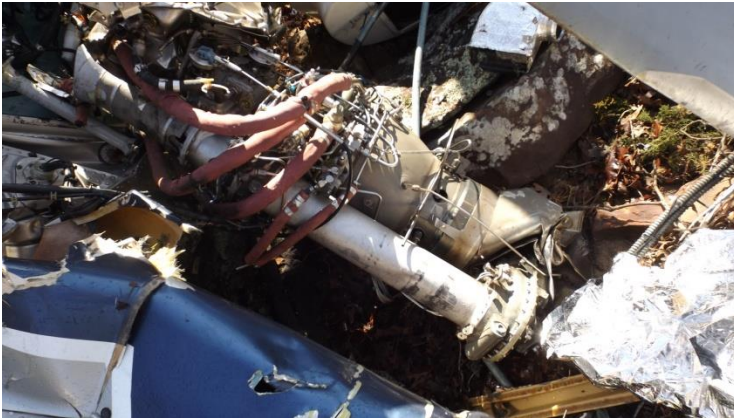
**Engine as found with no blade shedding encountered**

**The engine as found was partially separated from the airframe and sustained impact damage on the turbine case, linking tube, and exhaust pipe.**

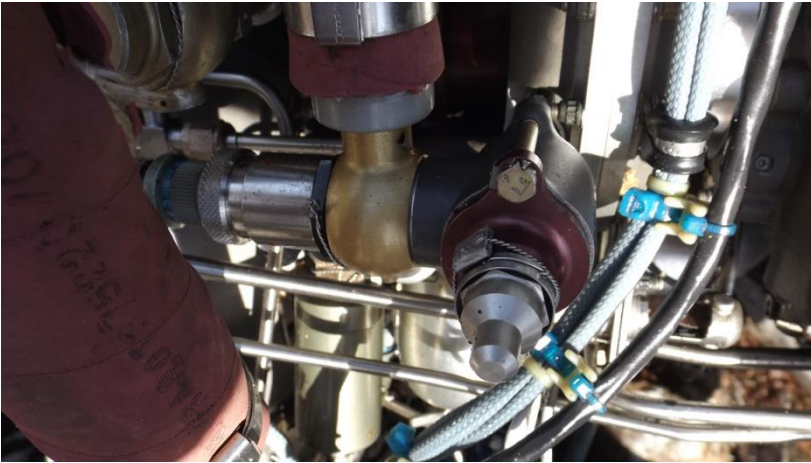
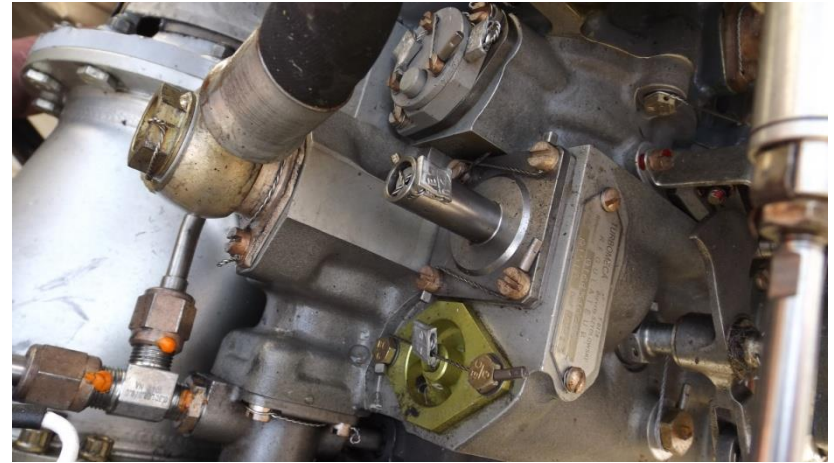
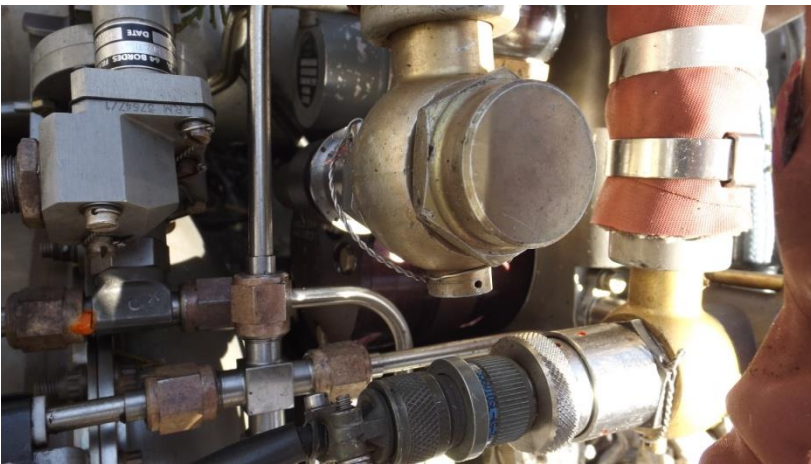
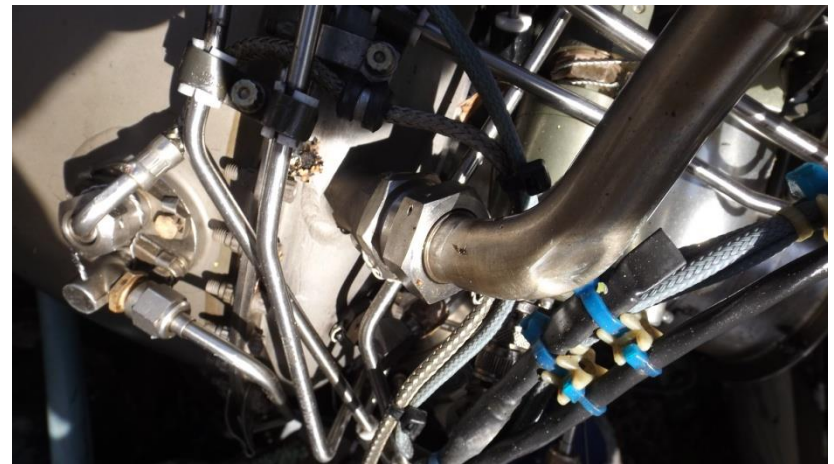
## Engine Fuel and Oil Connections

**All fuel, oil, and air connections were found installed with the proper safety wire.**

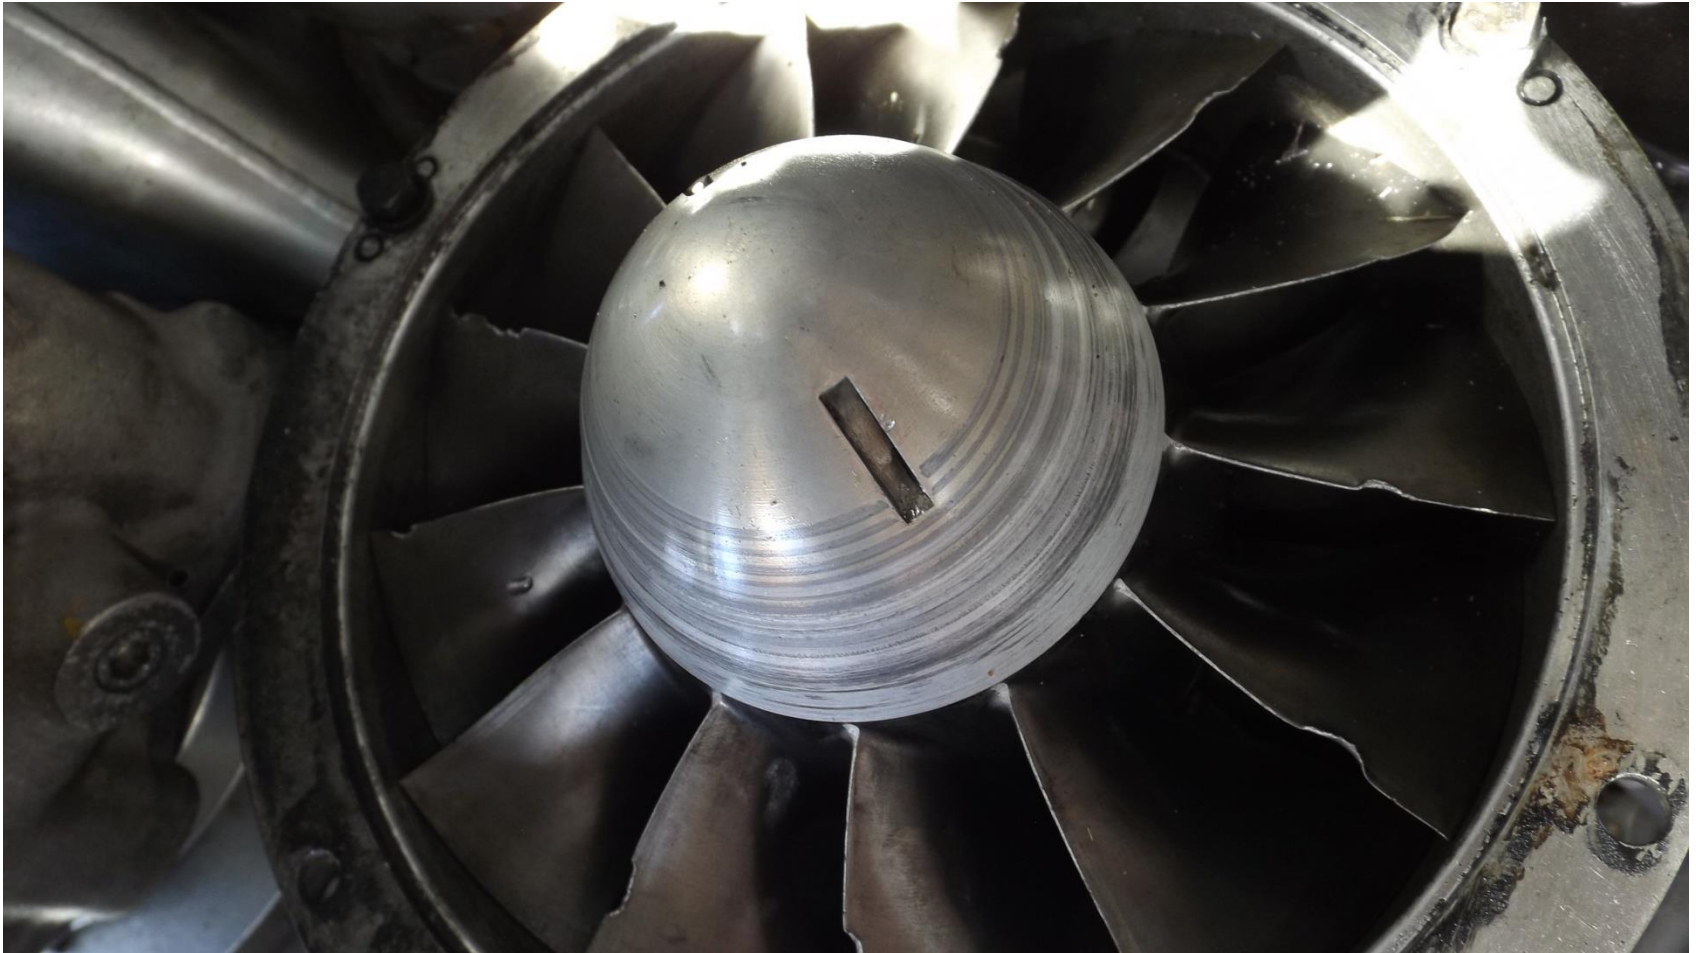
**The axial compressor showed FOD damage on several blades and the gas generator could be turned by hand. The nose cone showed rotational scarring.**

**Engine Axial Compressor with rotational scarring and FOD**

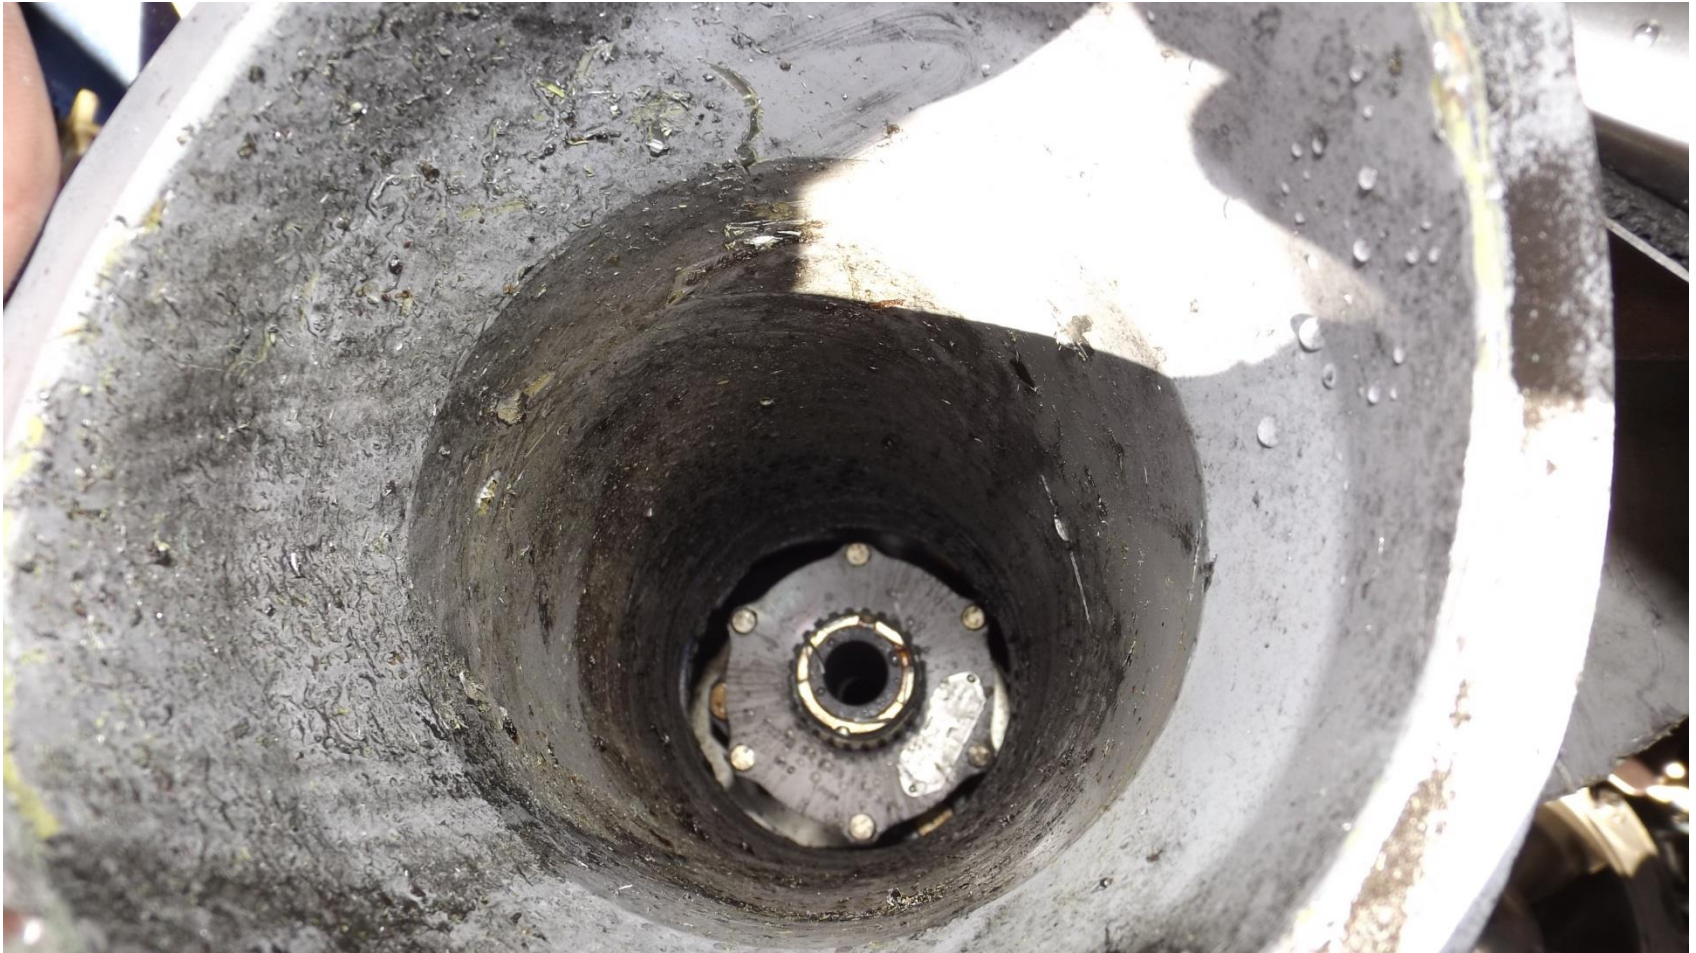
## Engine Power shaft / Freewheel Output

**The free turbine could not be seen due to the crushed exhaust pipe, however the freewheel shaft could be turned by hand to confirm continuity through the reduction gearbox to the free turbine. Proper freewheel operation was confirmed.**

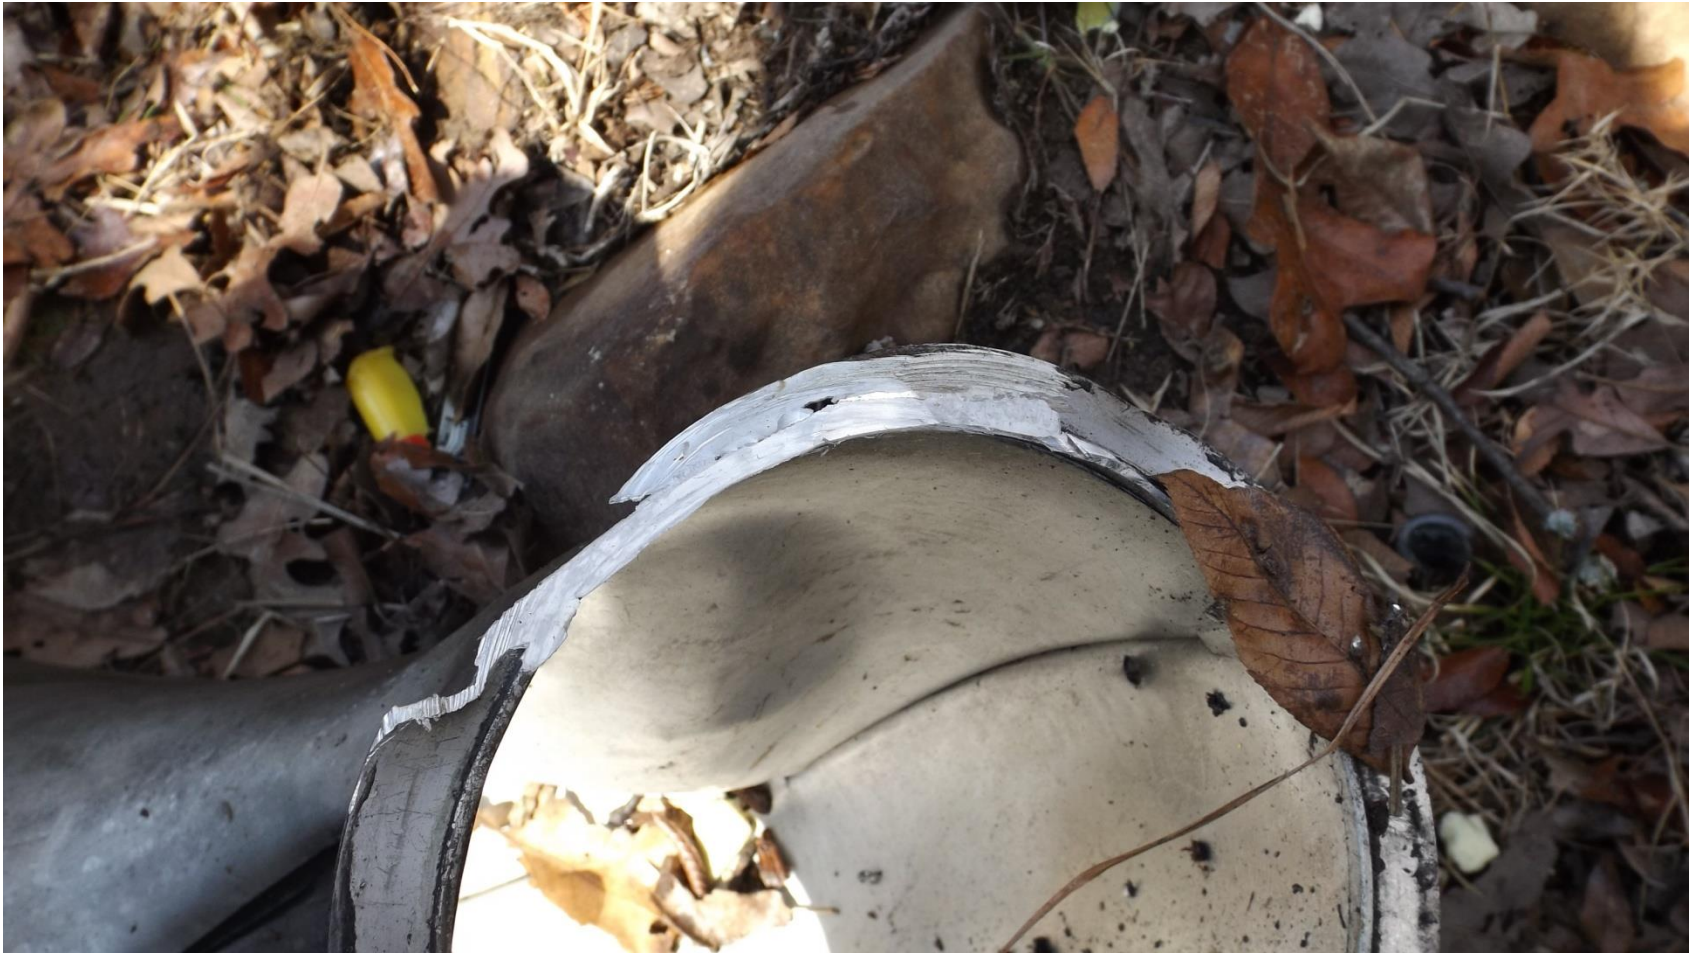
**Bellmouth showing contact with rotating axial**

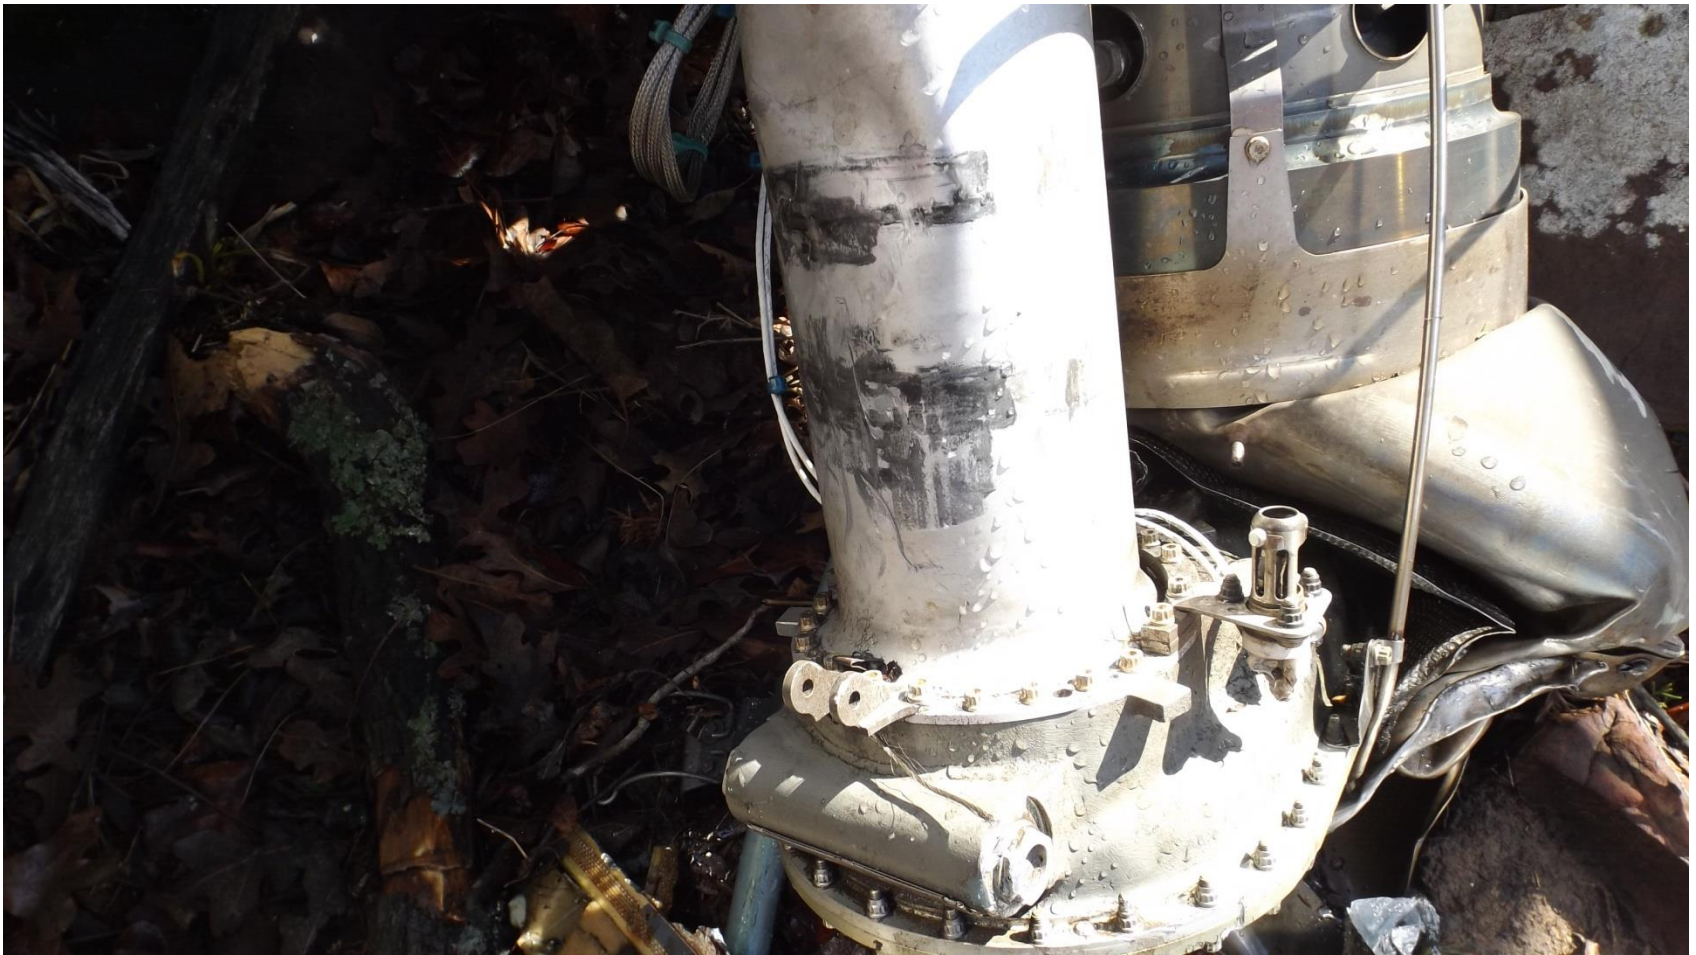
Linking tube impacts at rear mount attachment points

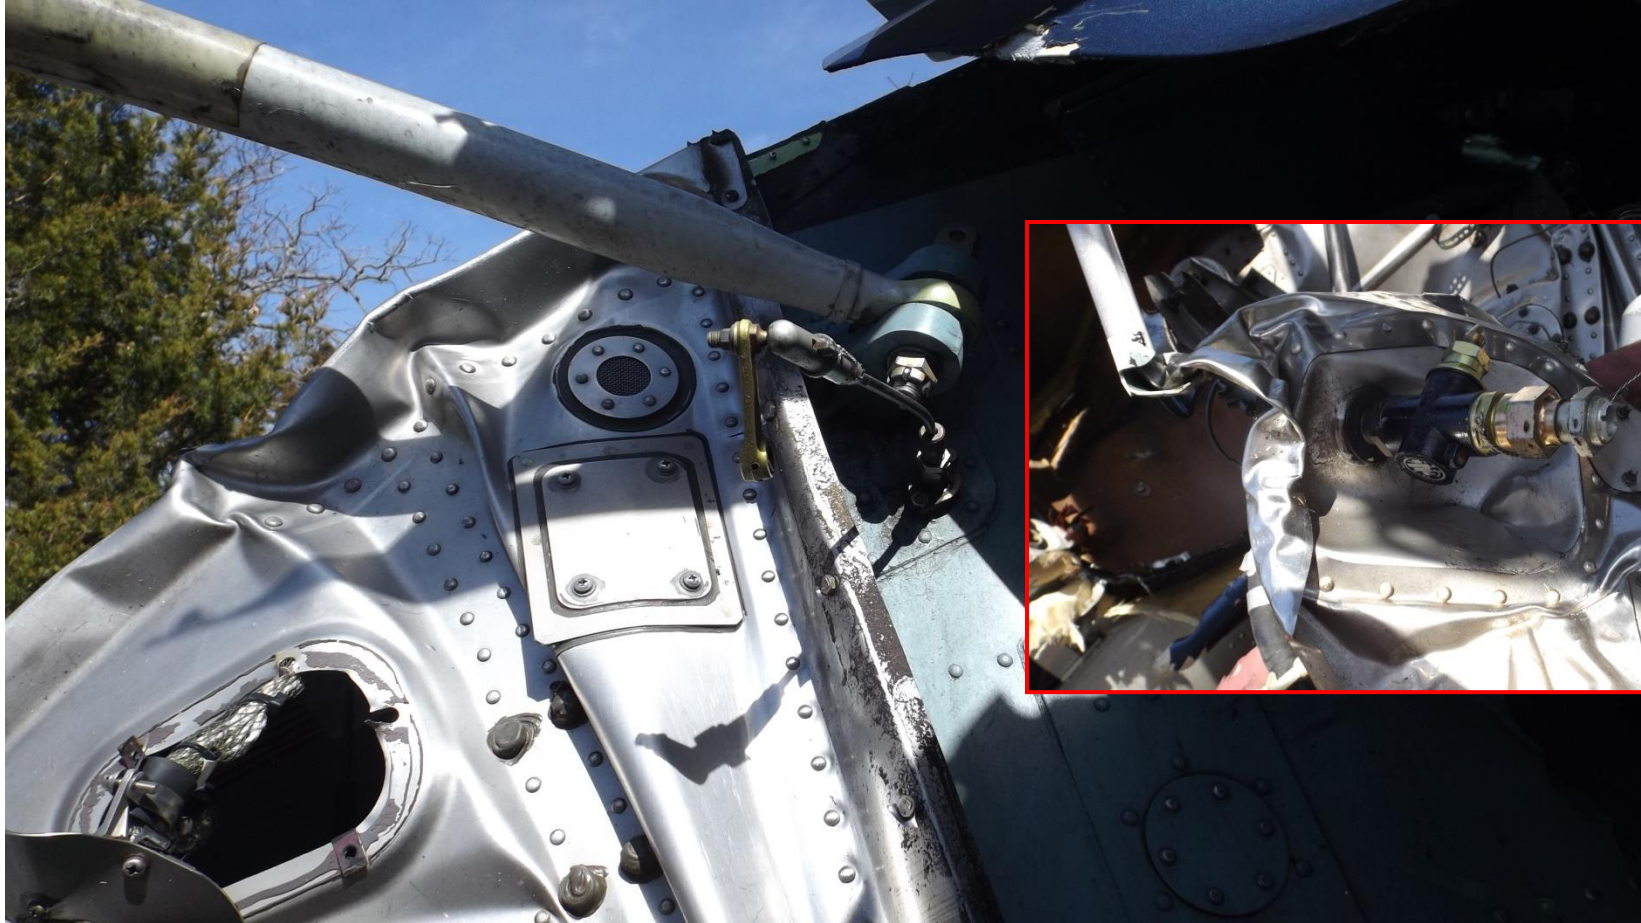
**Emergency fuel cutoff (arm broken in off position)**

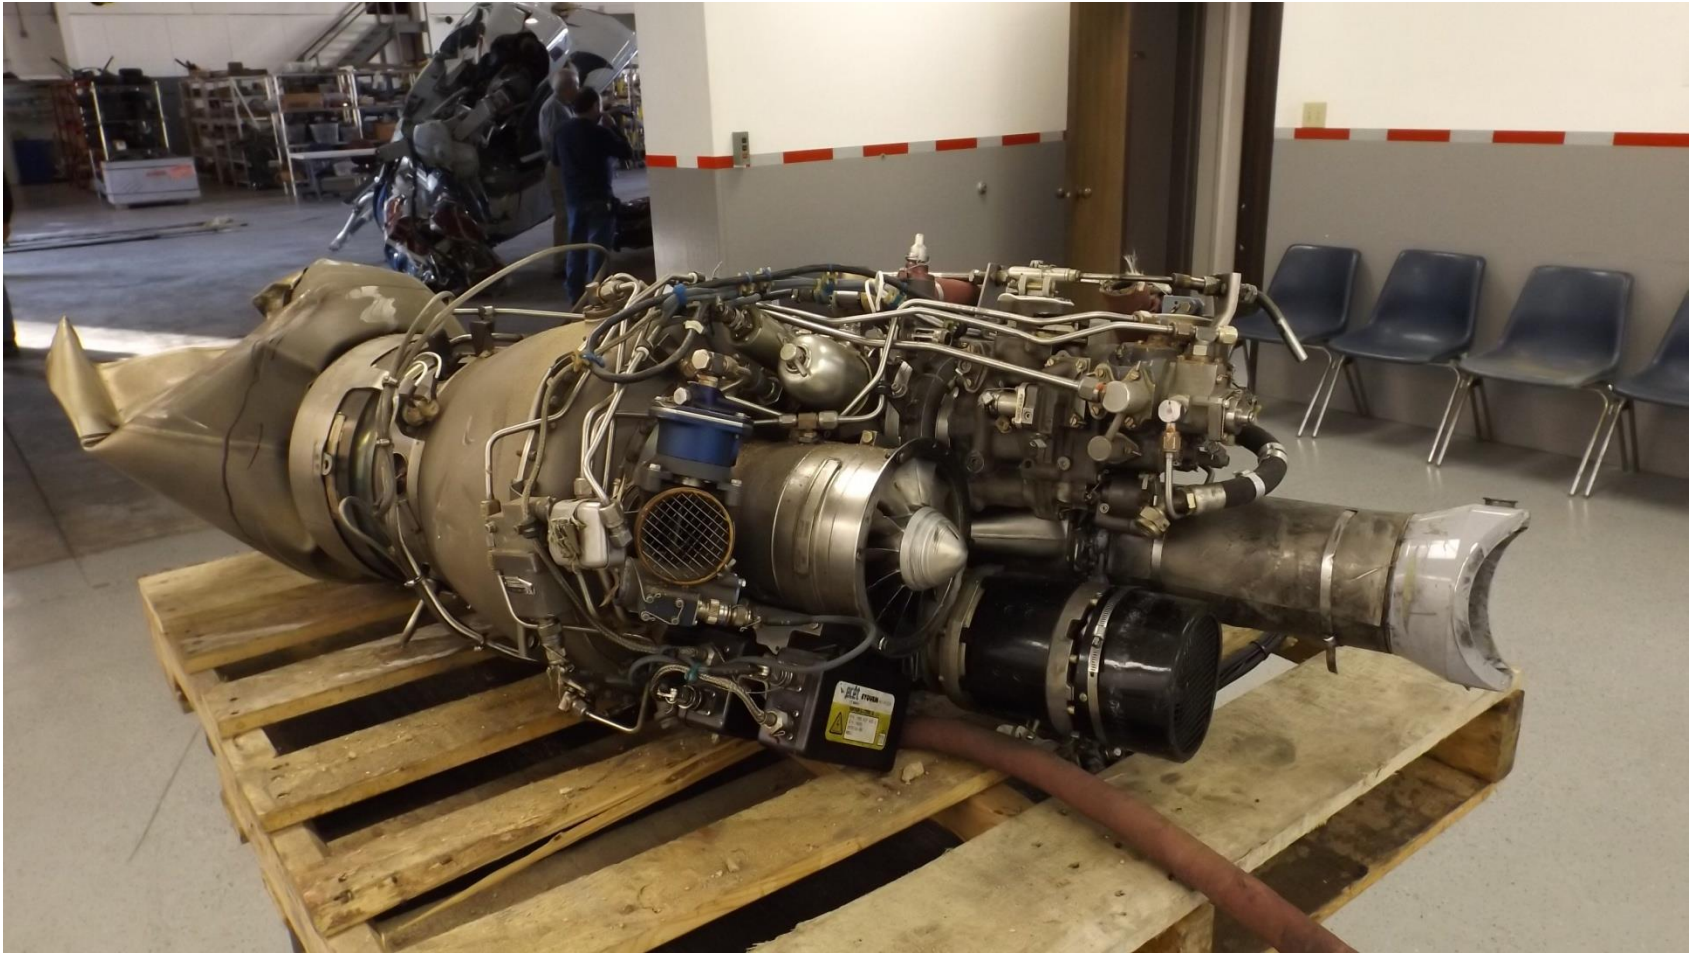
## Engine at salvage yard

**24MAR15 : Recovered aircraft was examined at Air Salvage of Dallas.**

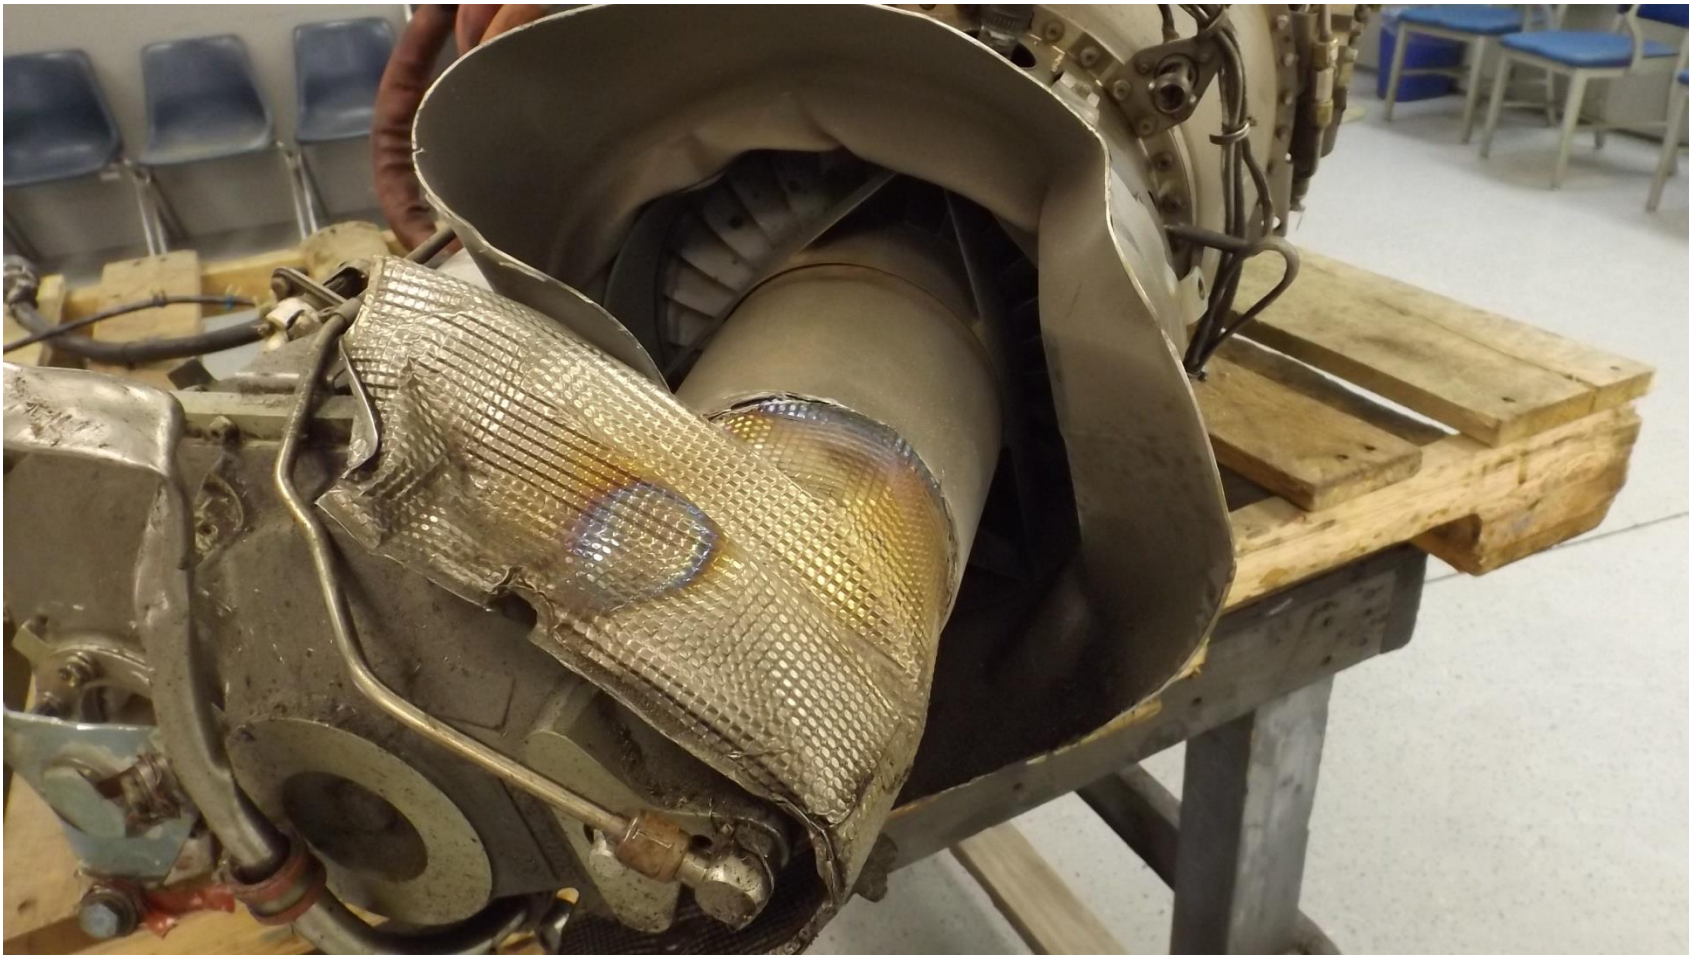
**The exhaust pipe had to be cut off in order to remove the module 5 reduction gearbox.**

Exhaust pipe removed

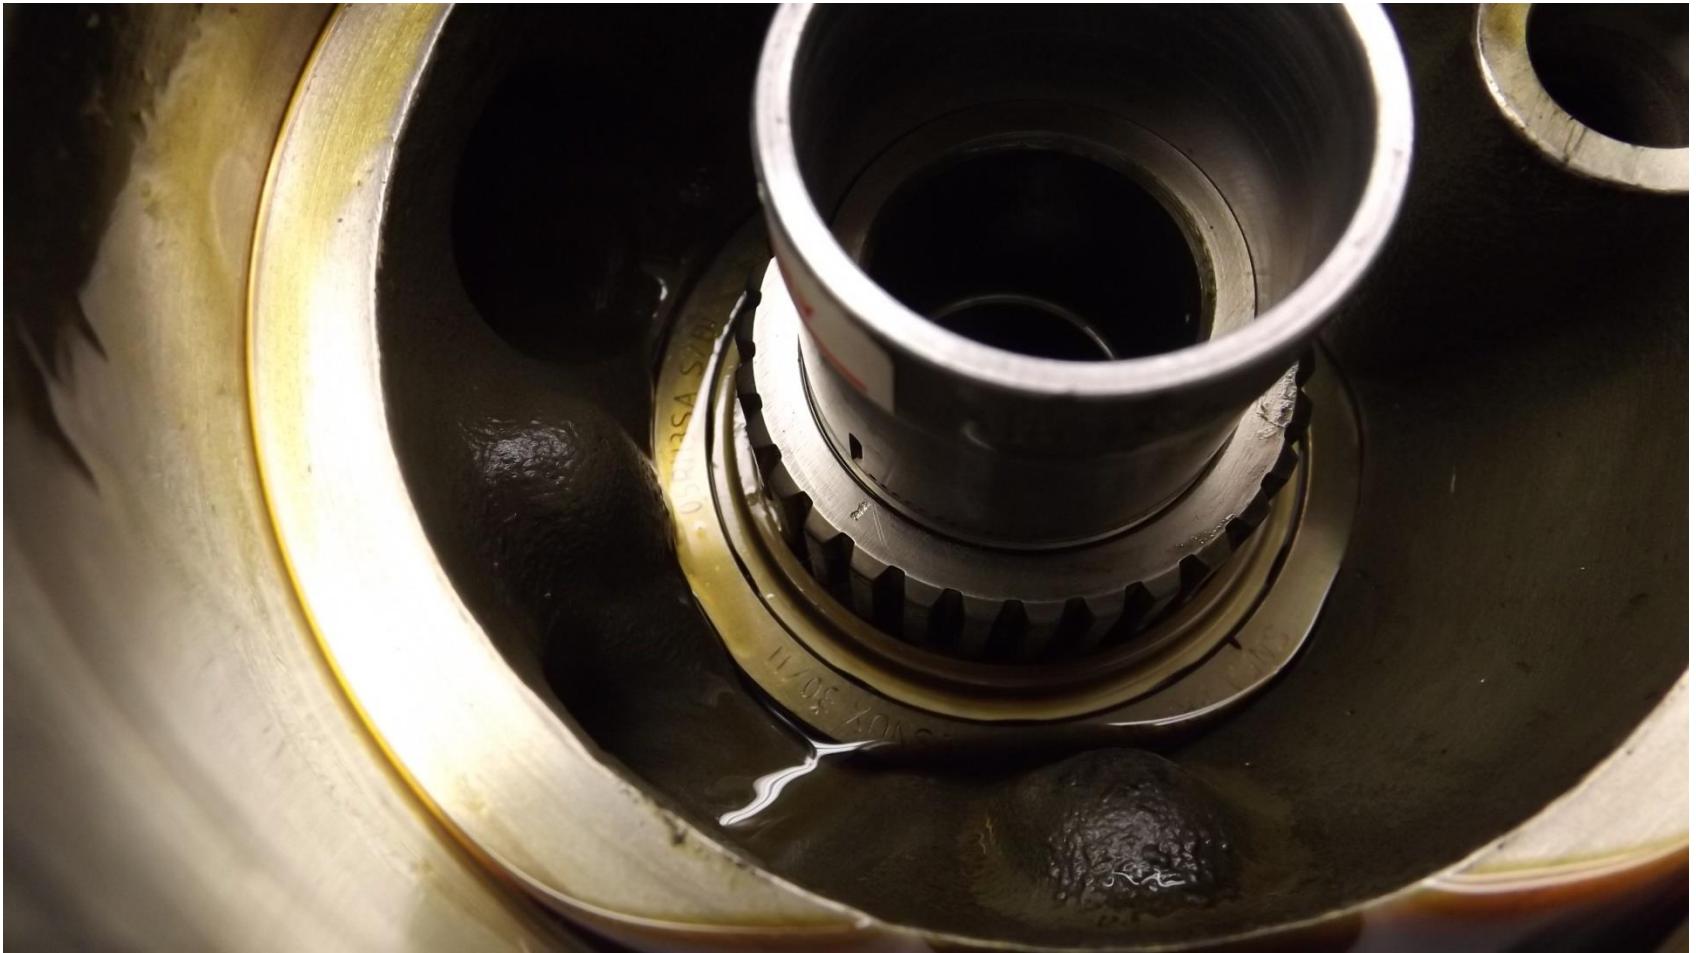
**The input pinion alignment mark showed a misalignment of 1.5mm in the overtorquing direction consistent with the engine producing power at the time of a main rotor blade strike.**

Input pinion mark with measuring tool
