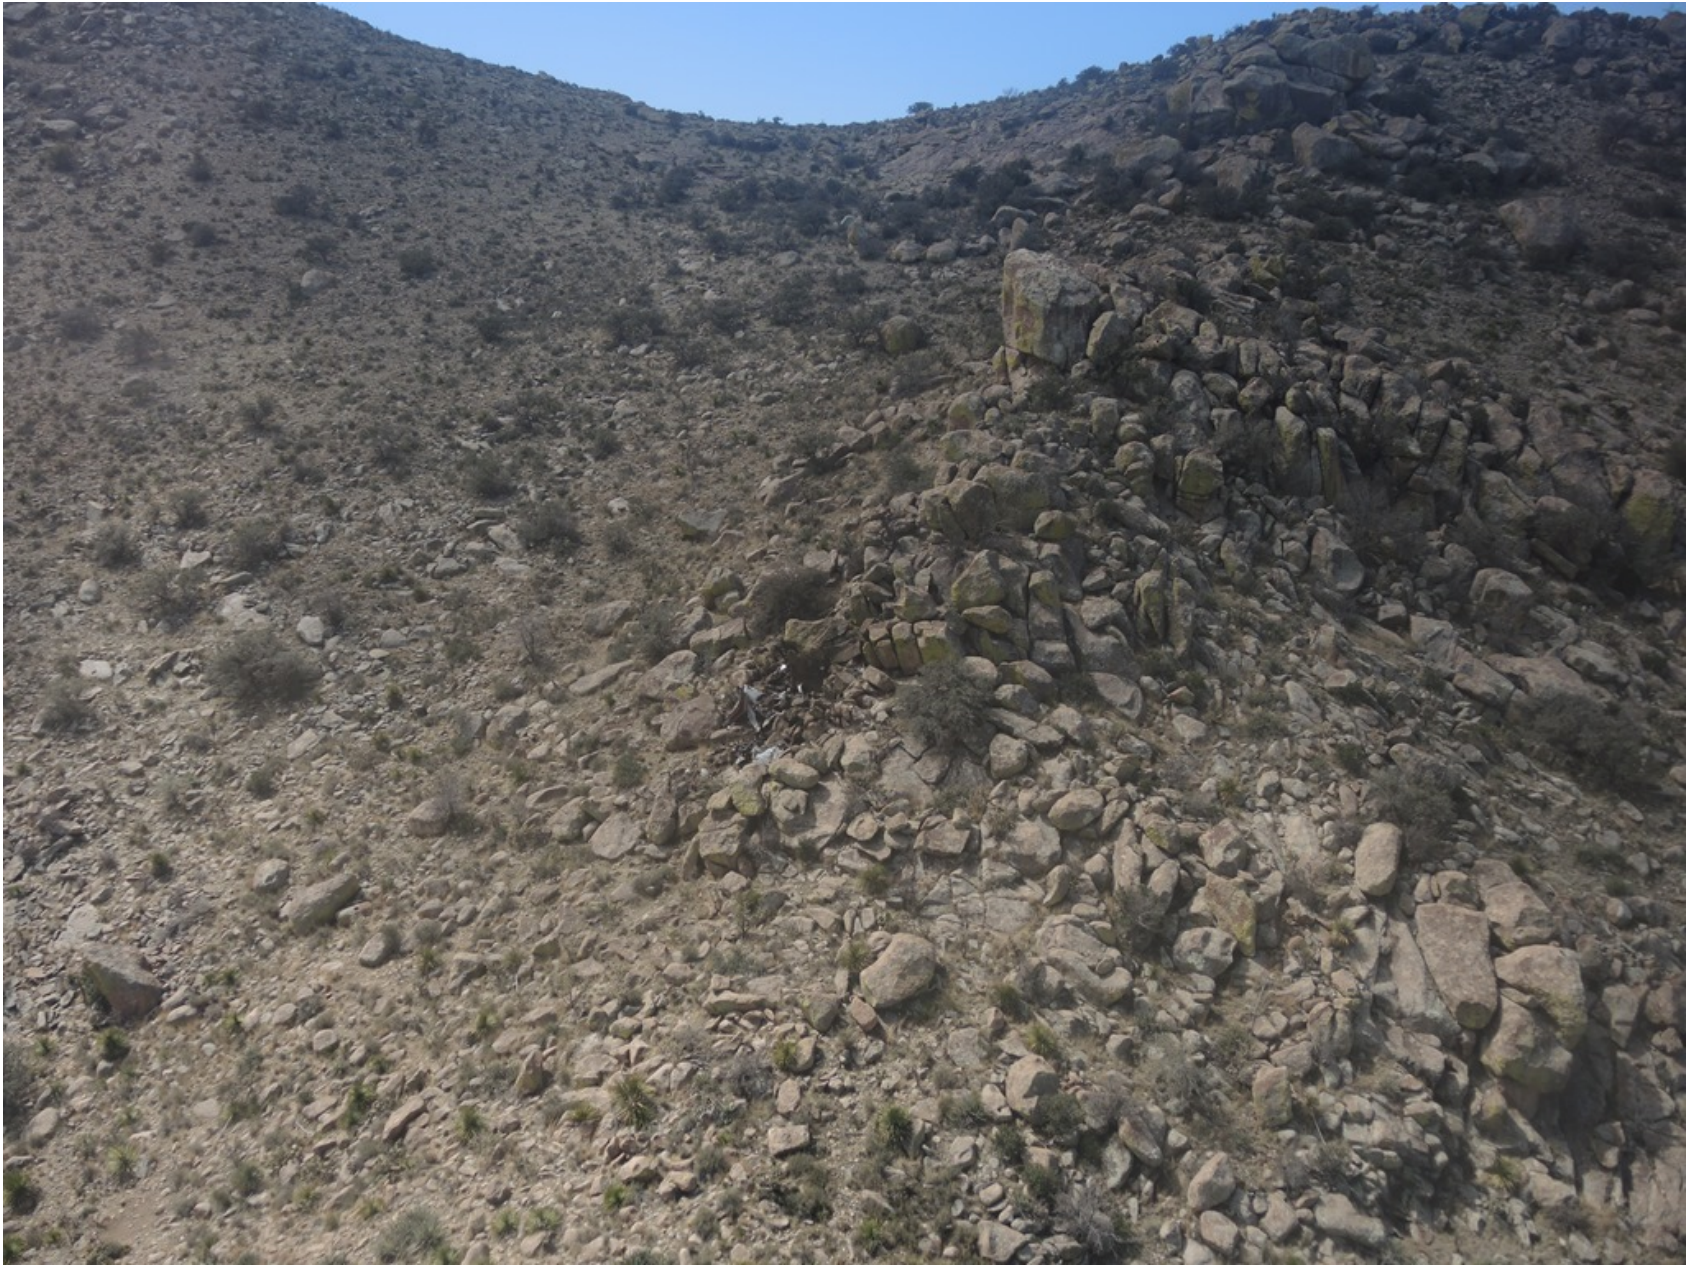
**Photo 1 – Aerial View of Accident Site (Textron)**

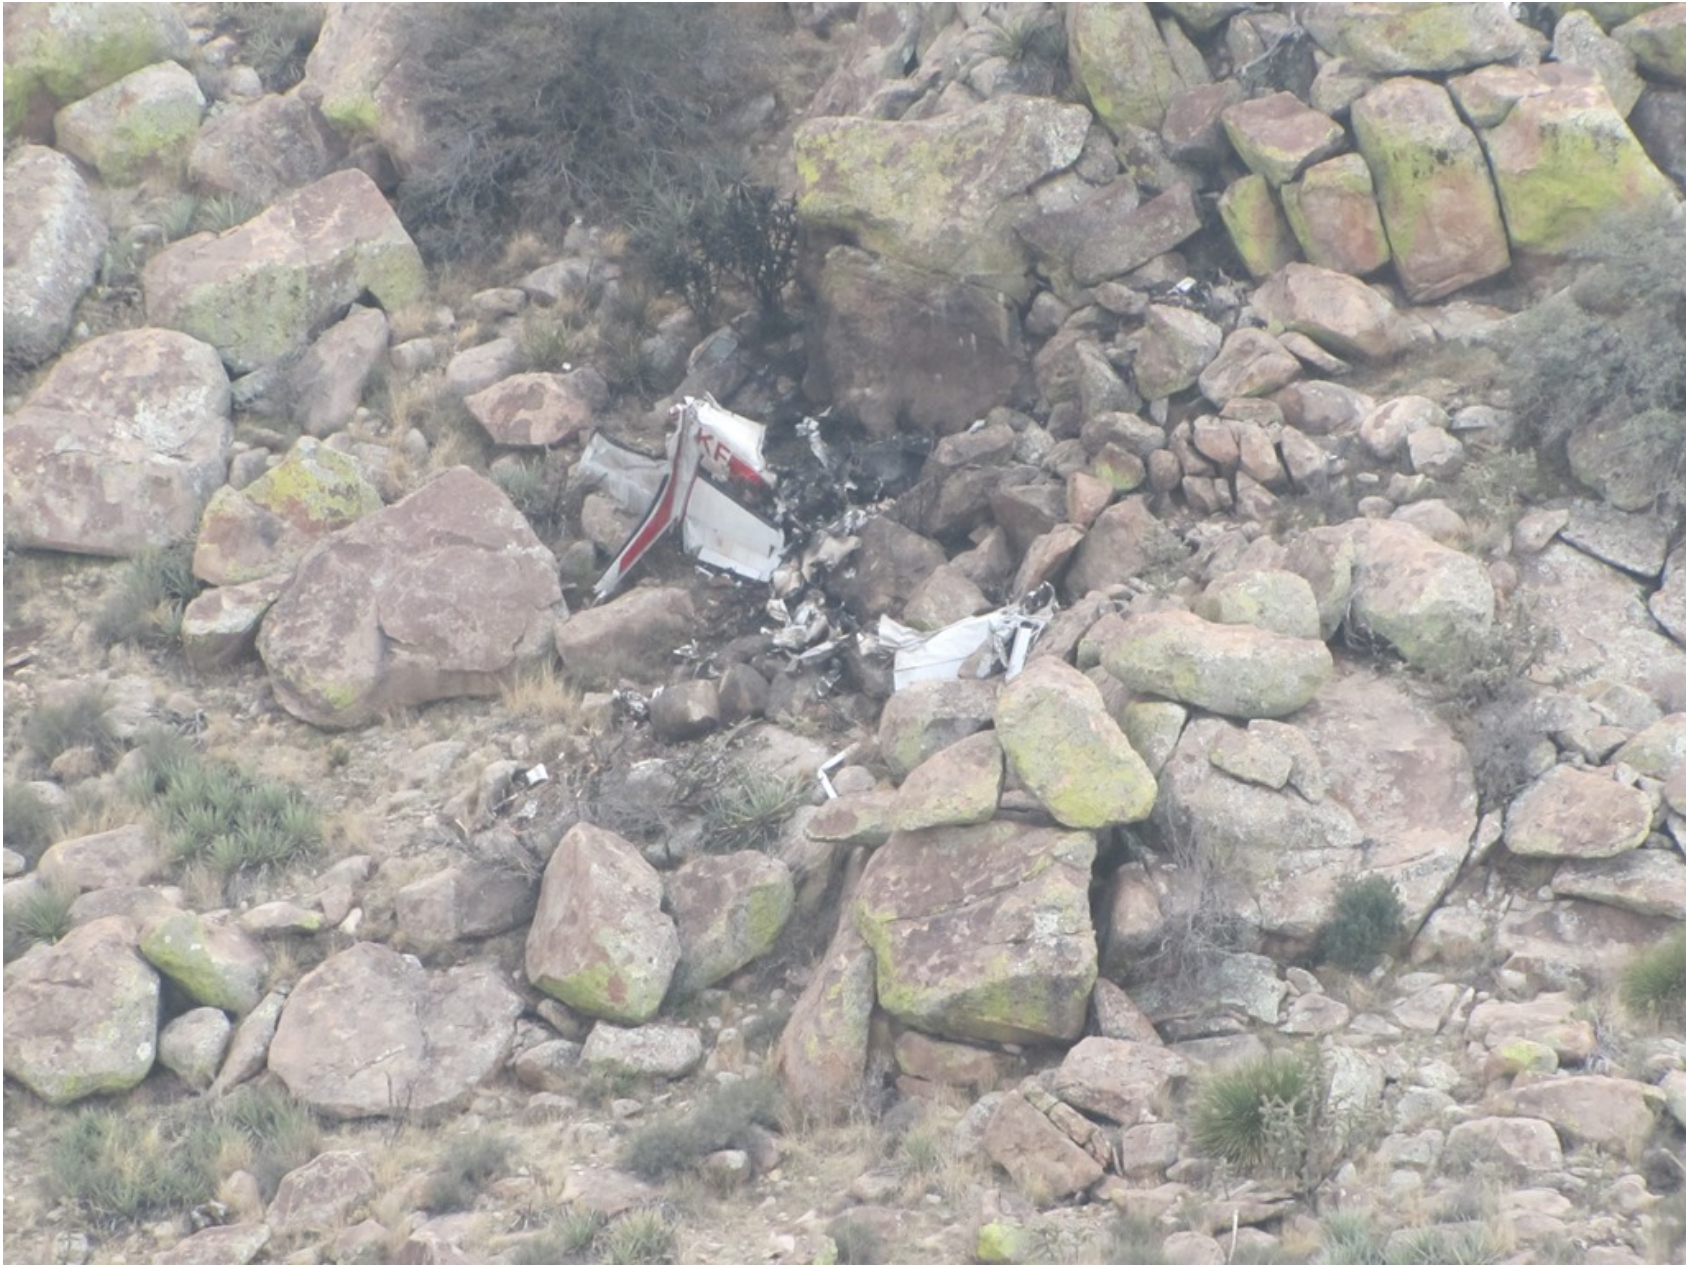
**Photo 2 – Aerial View of Accident Site (Texas DPS)**

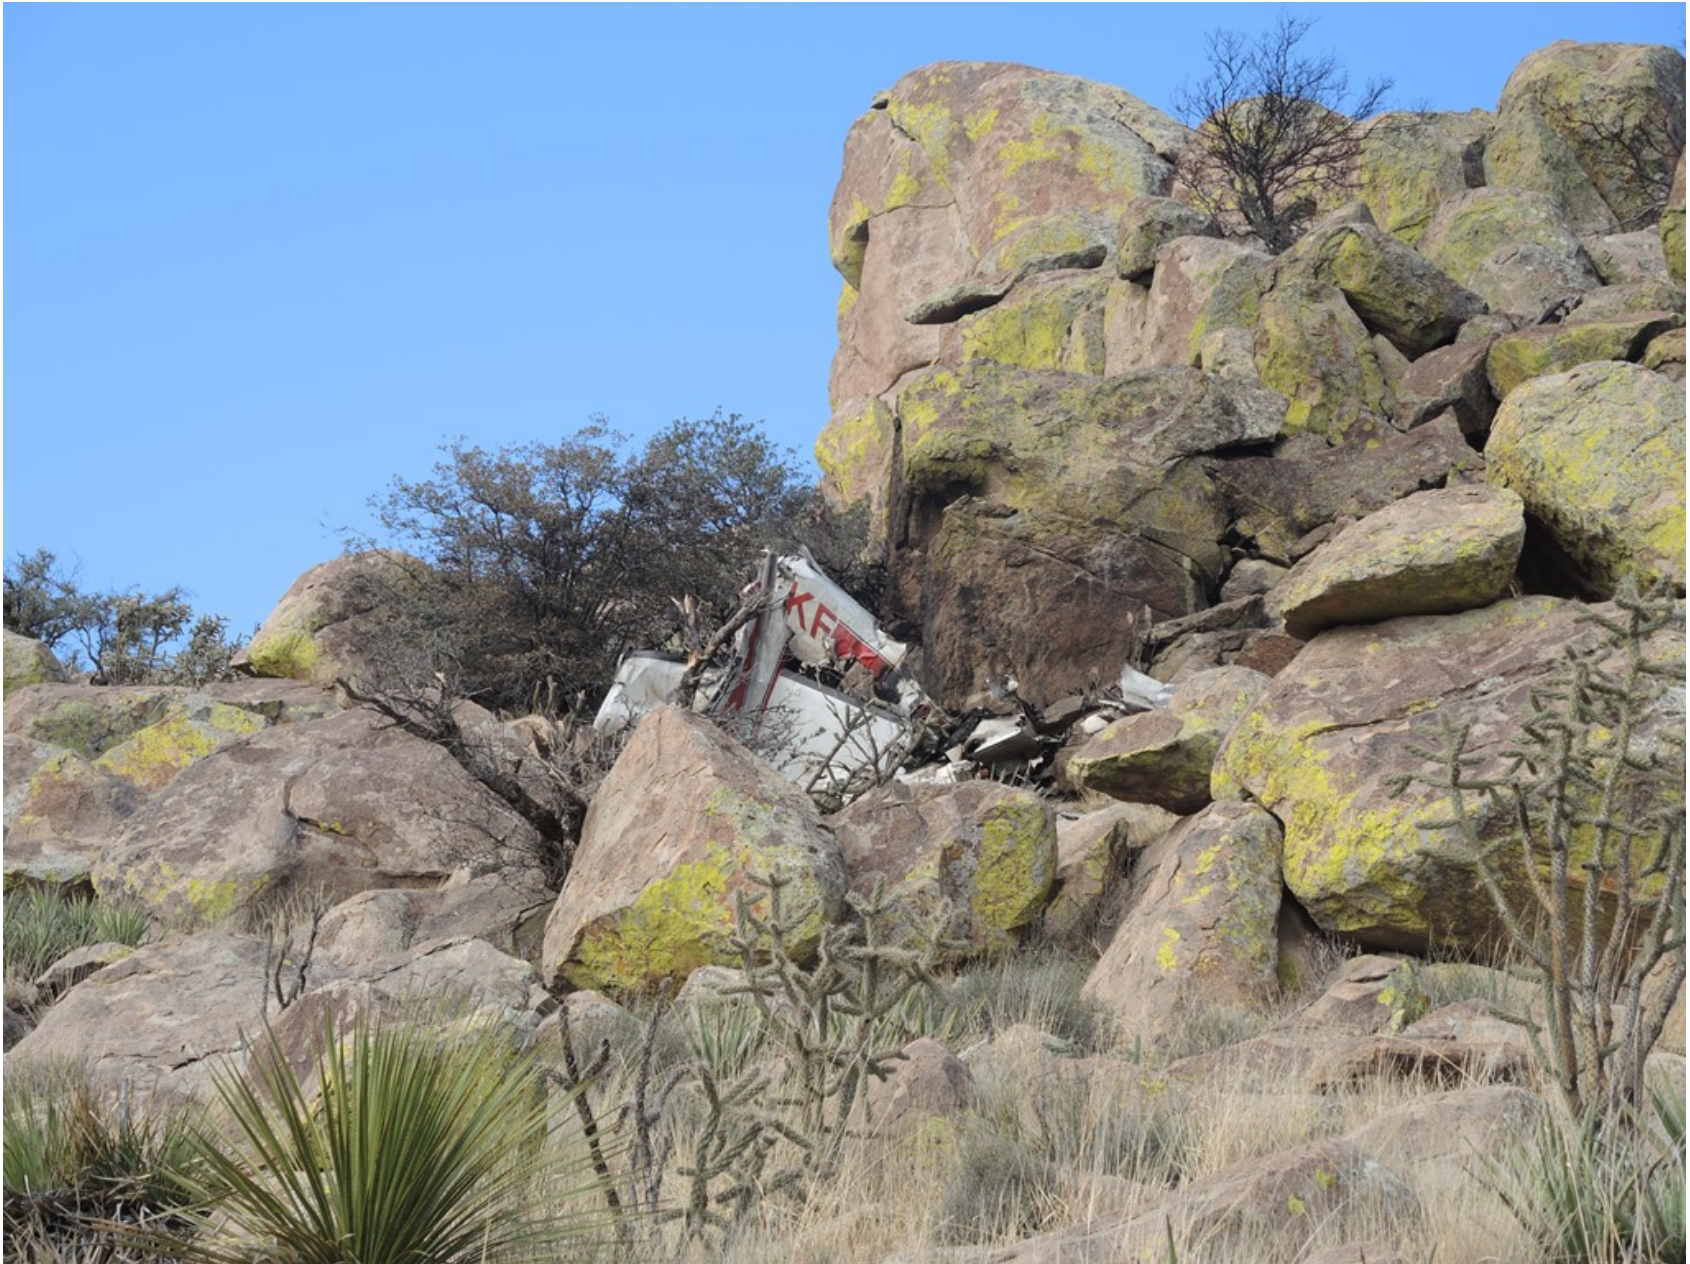
**Photo 3 – View of Main Wreckage**

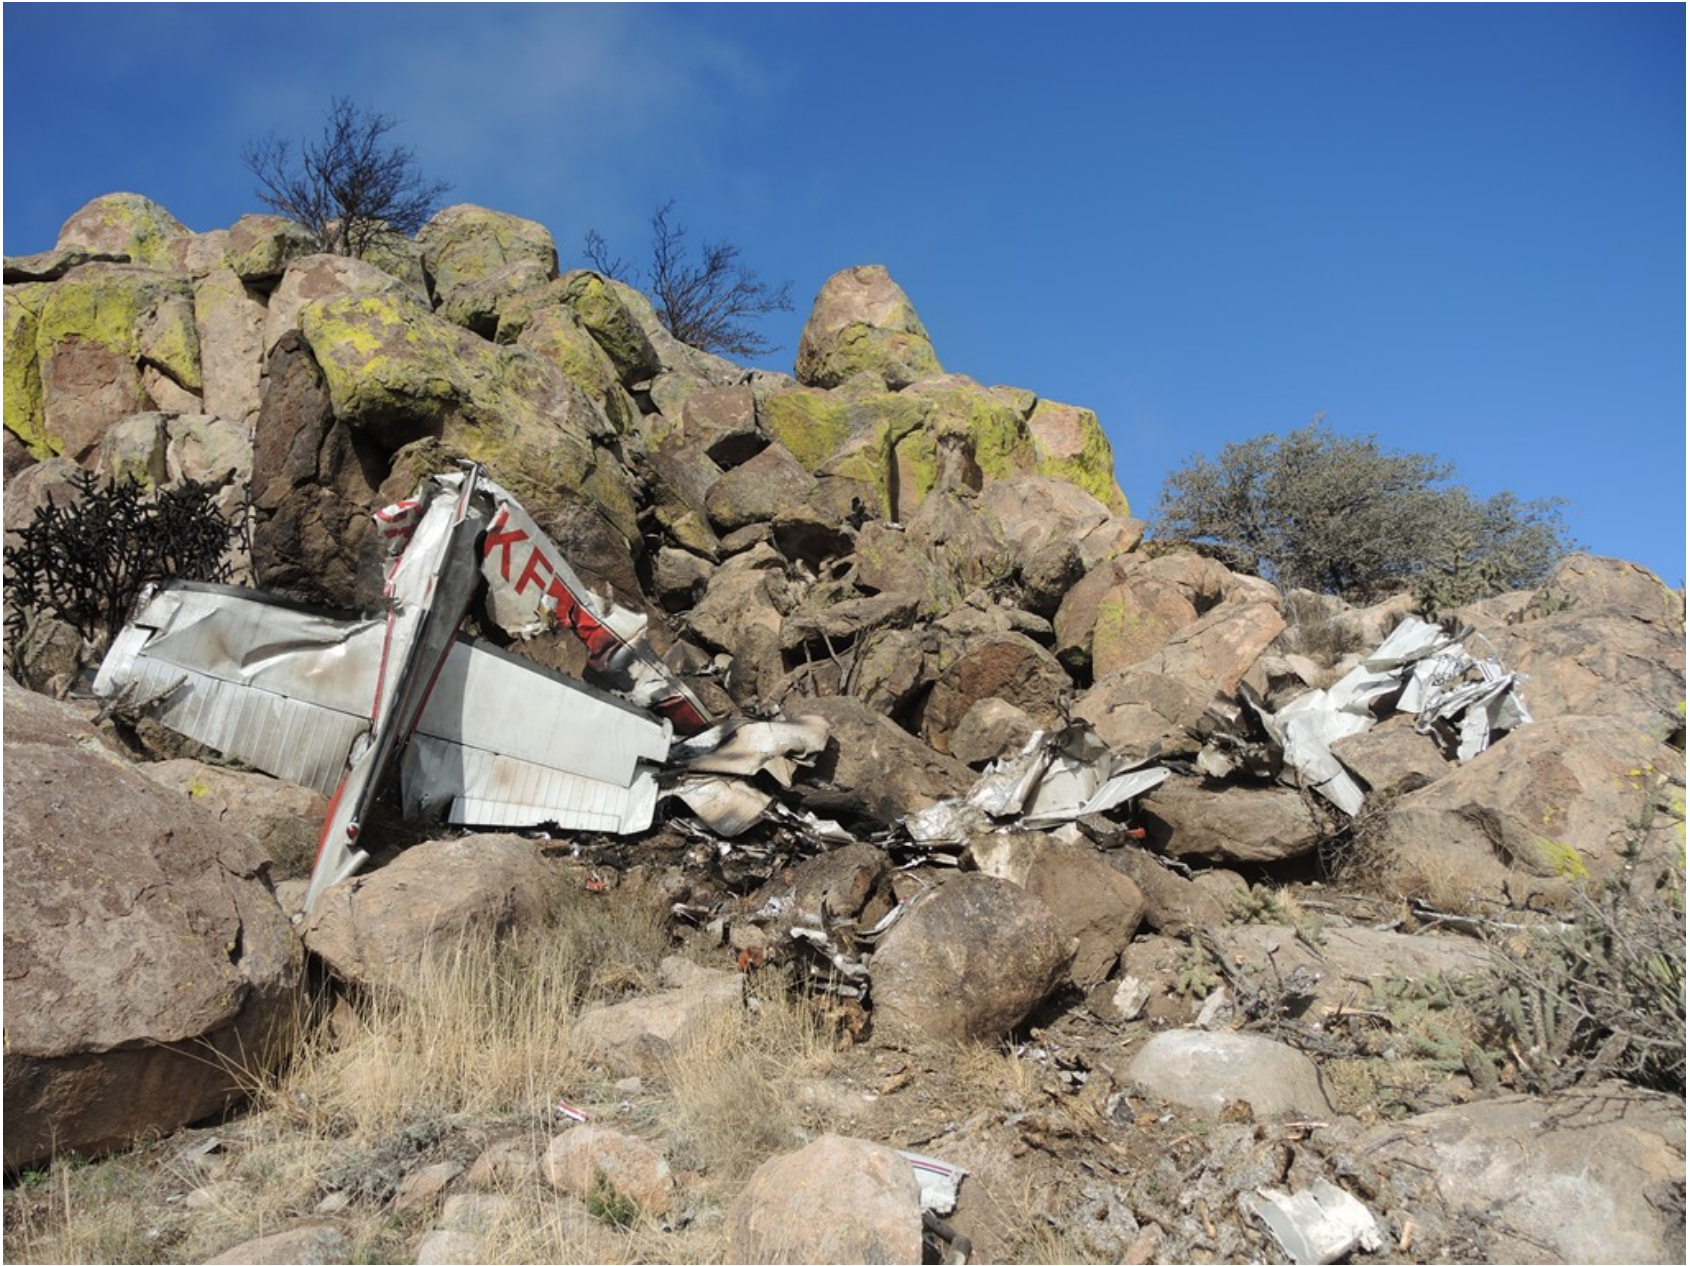
**Photo 4 – View of Main Wreckage**

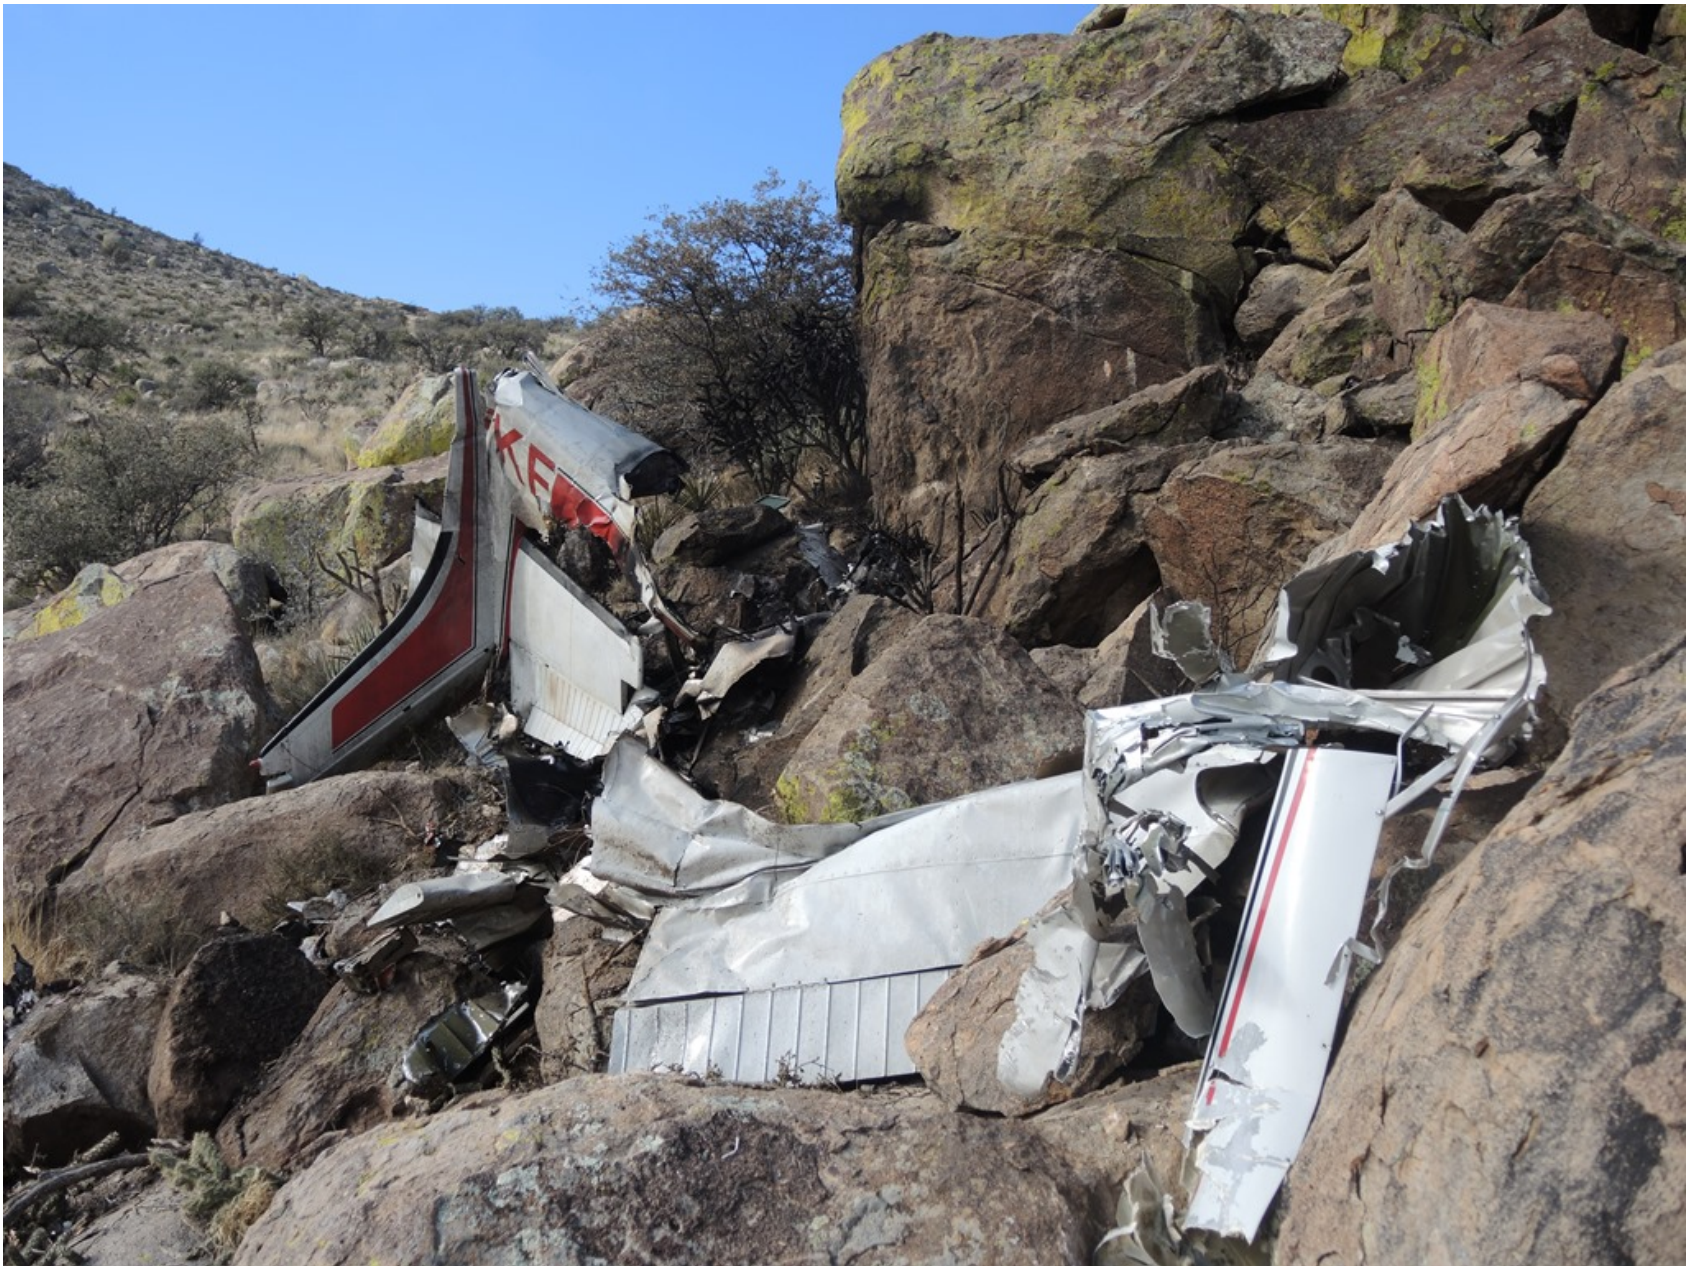
**Photo 5 – View of Main Wreckage**

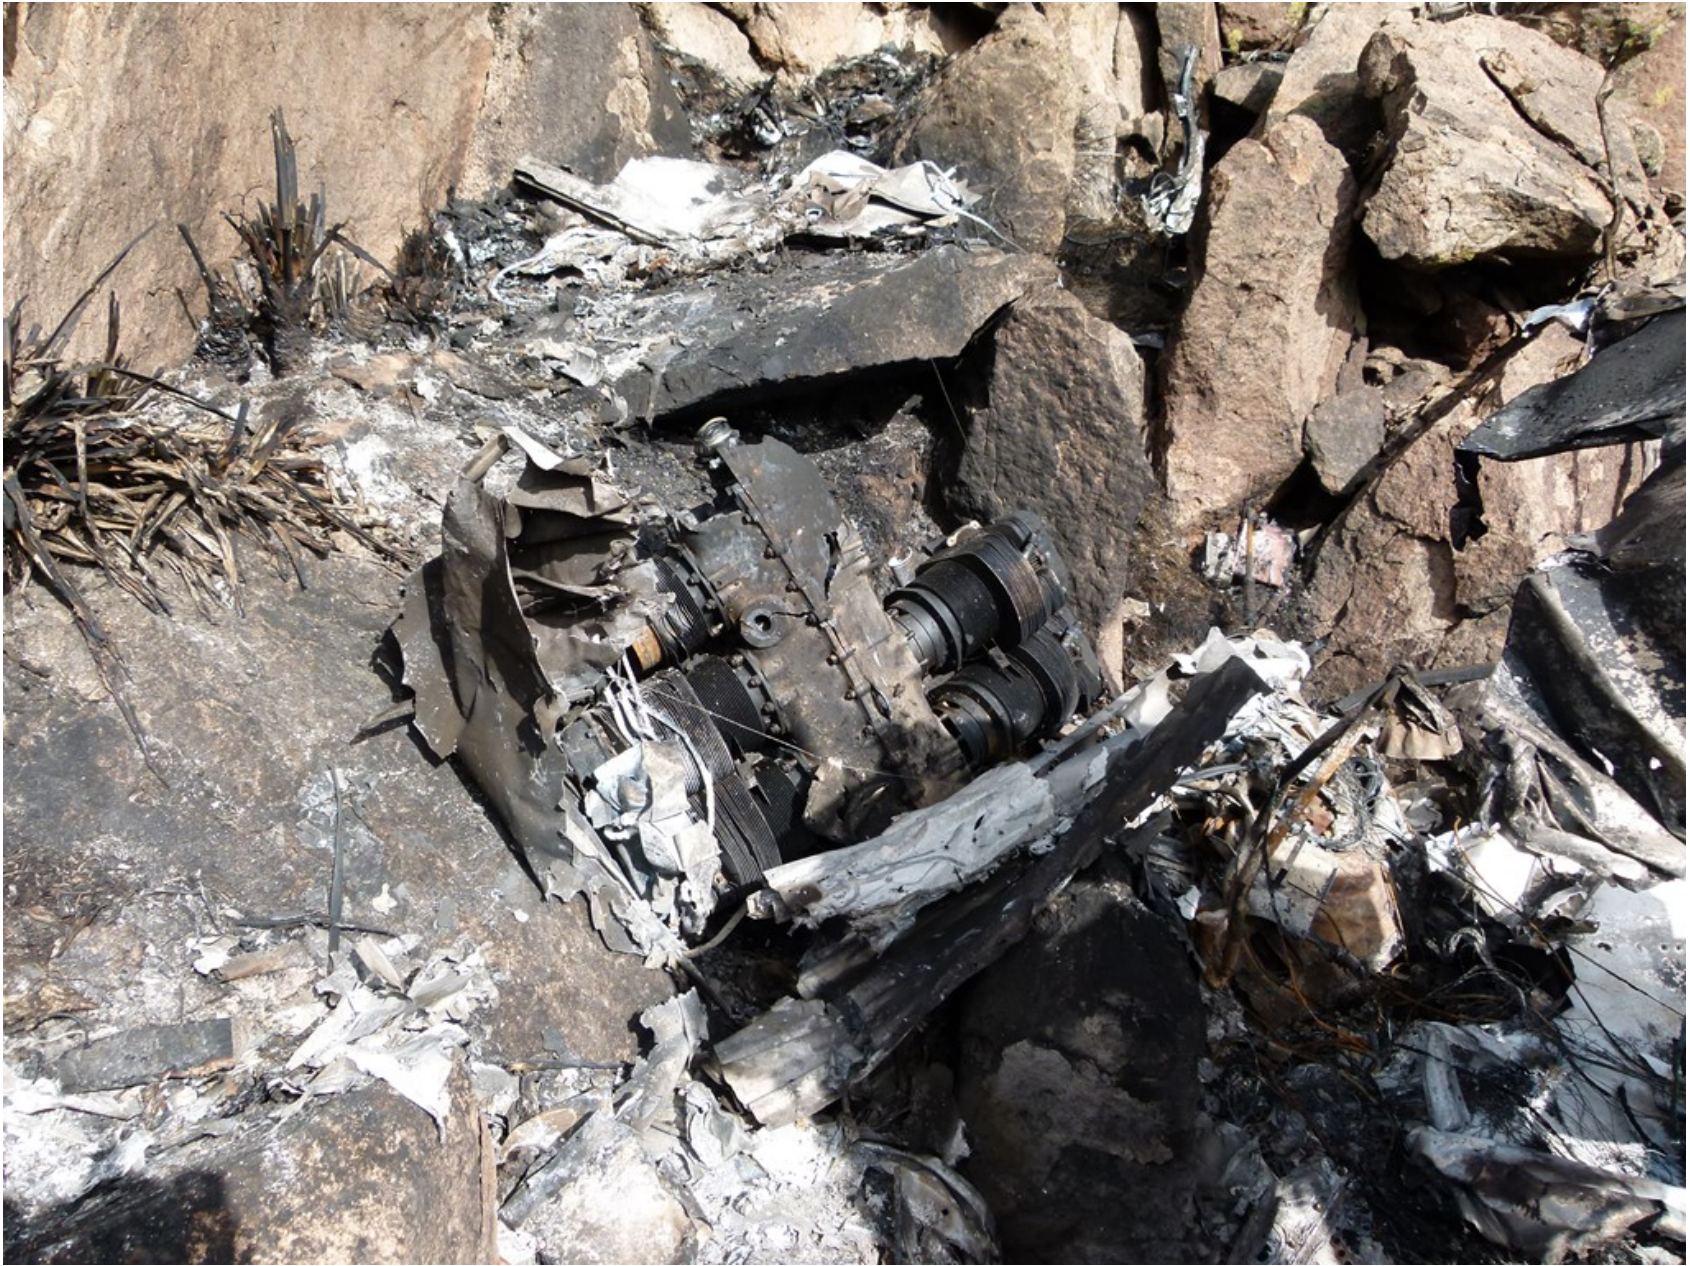
**Photo 6 – View of Engine (CMI)**

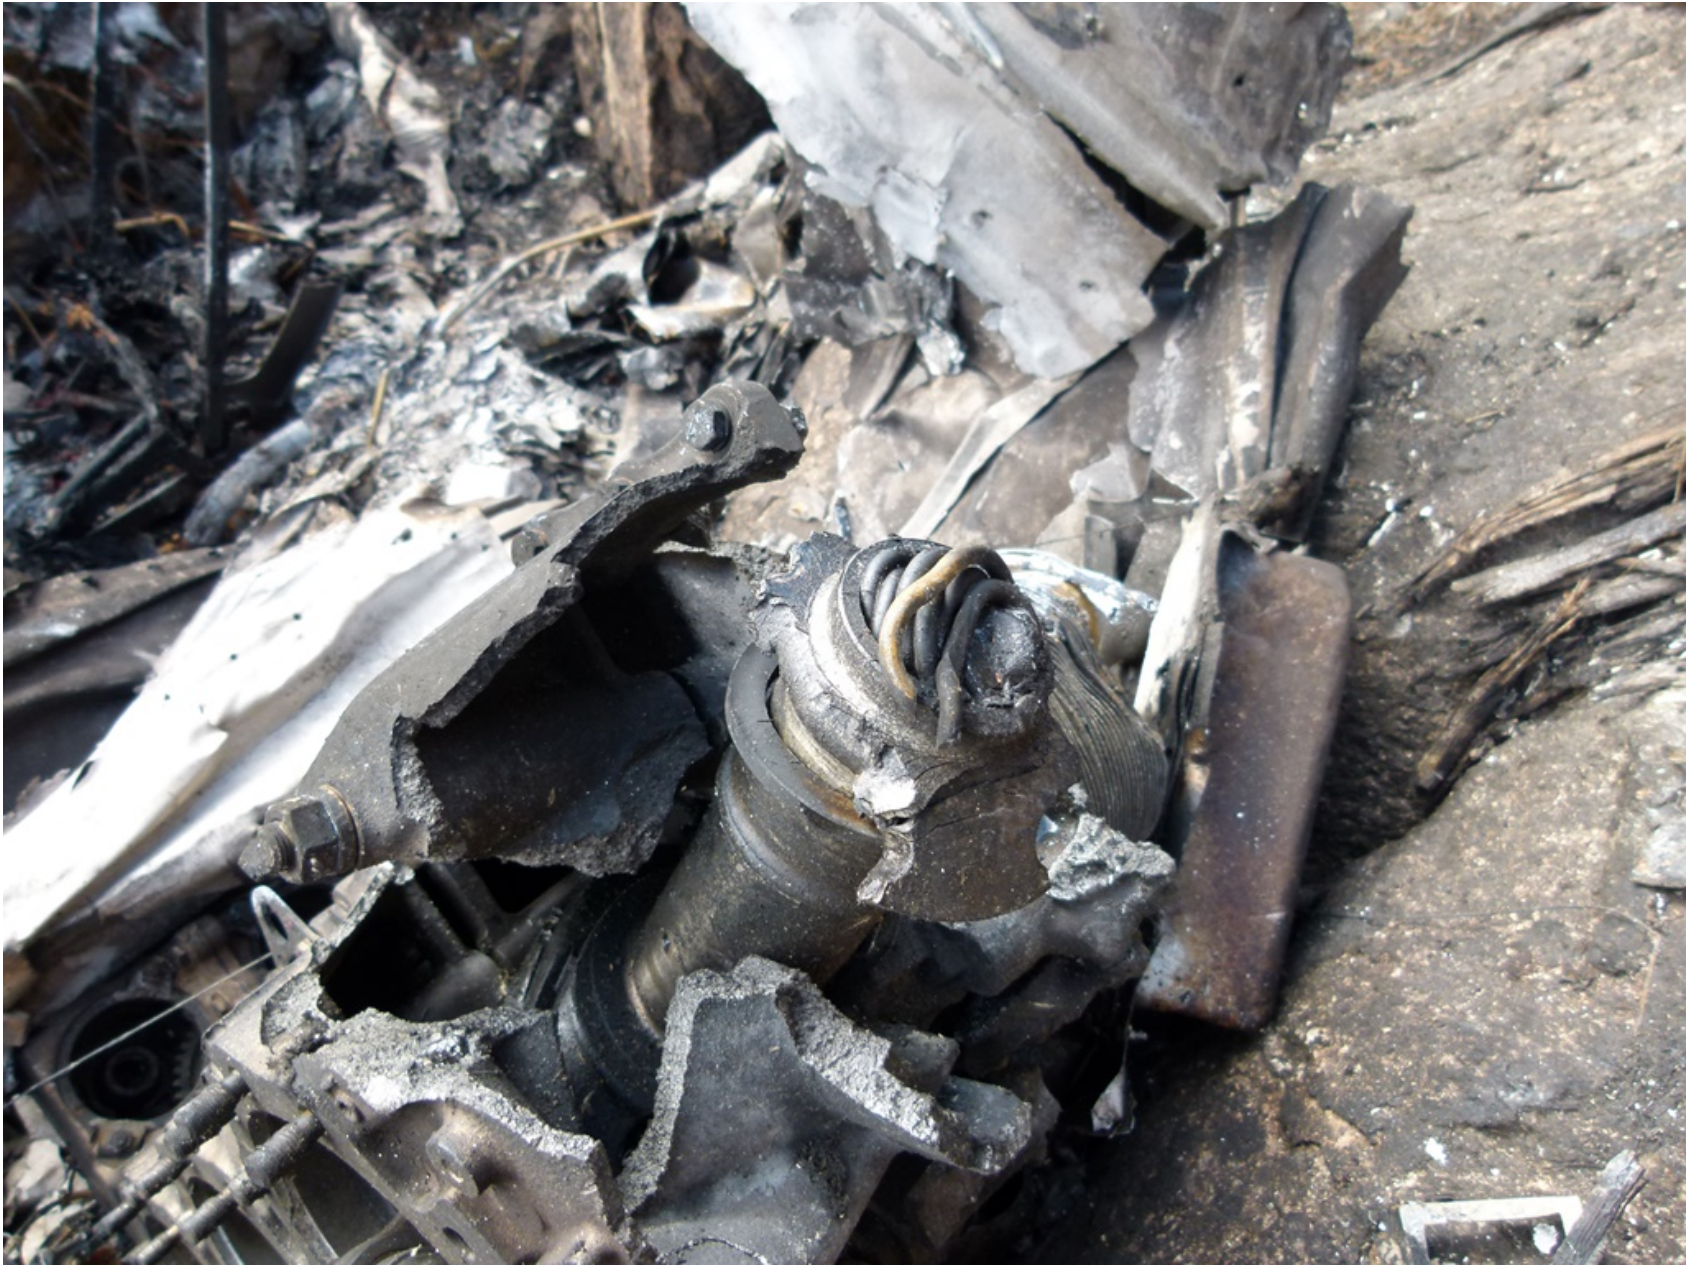
**Photo 7 – View of Propeller Flange (CMI)**

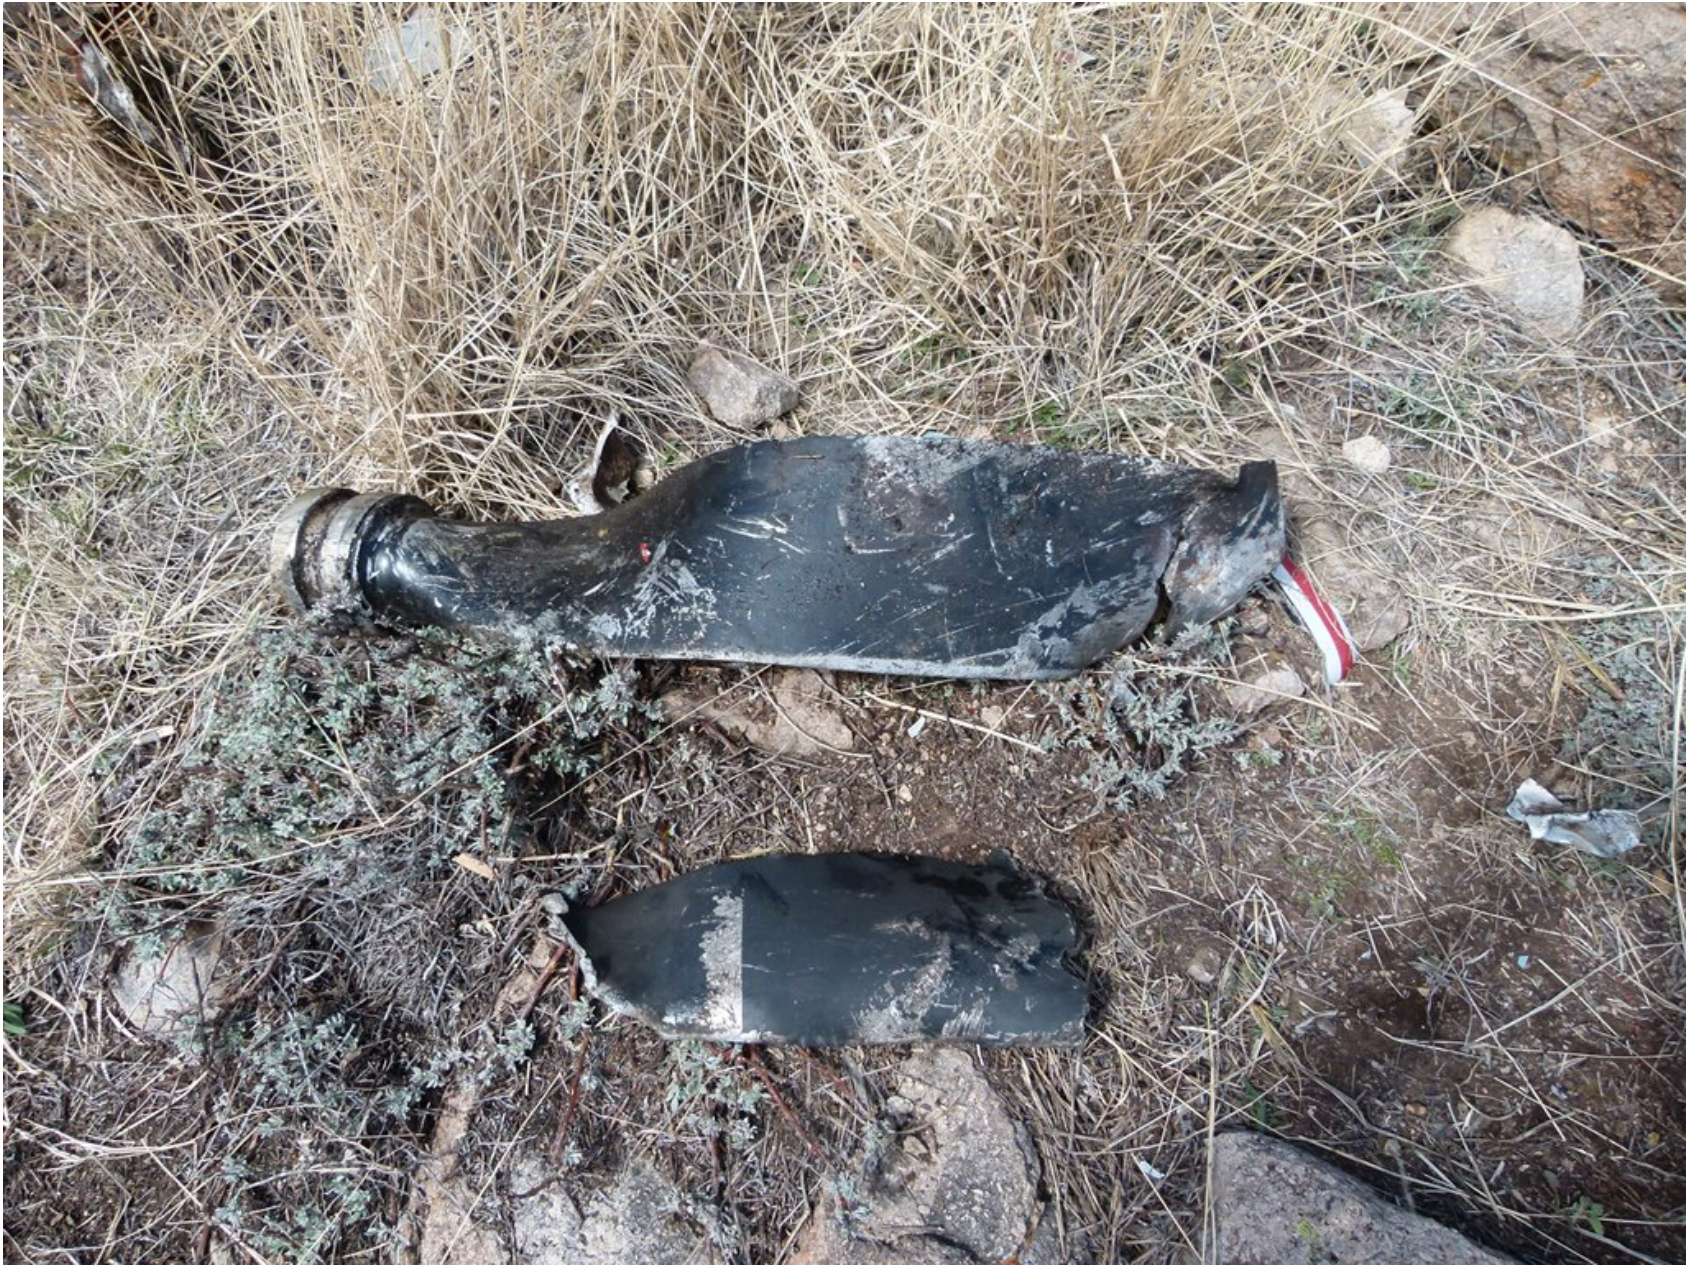
**Photo 8 – View of Propeller Blades**
