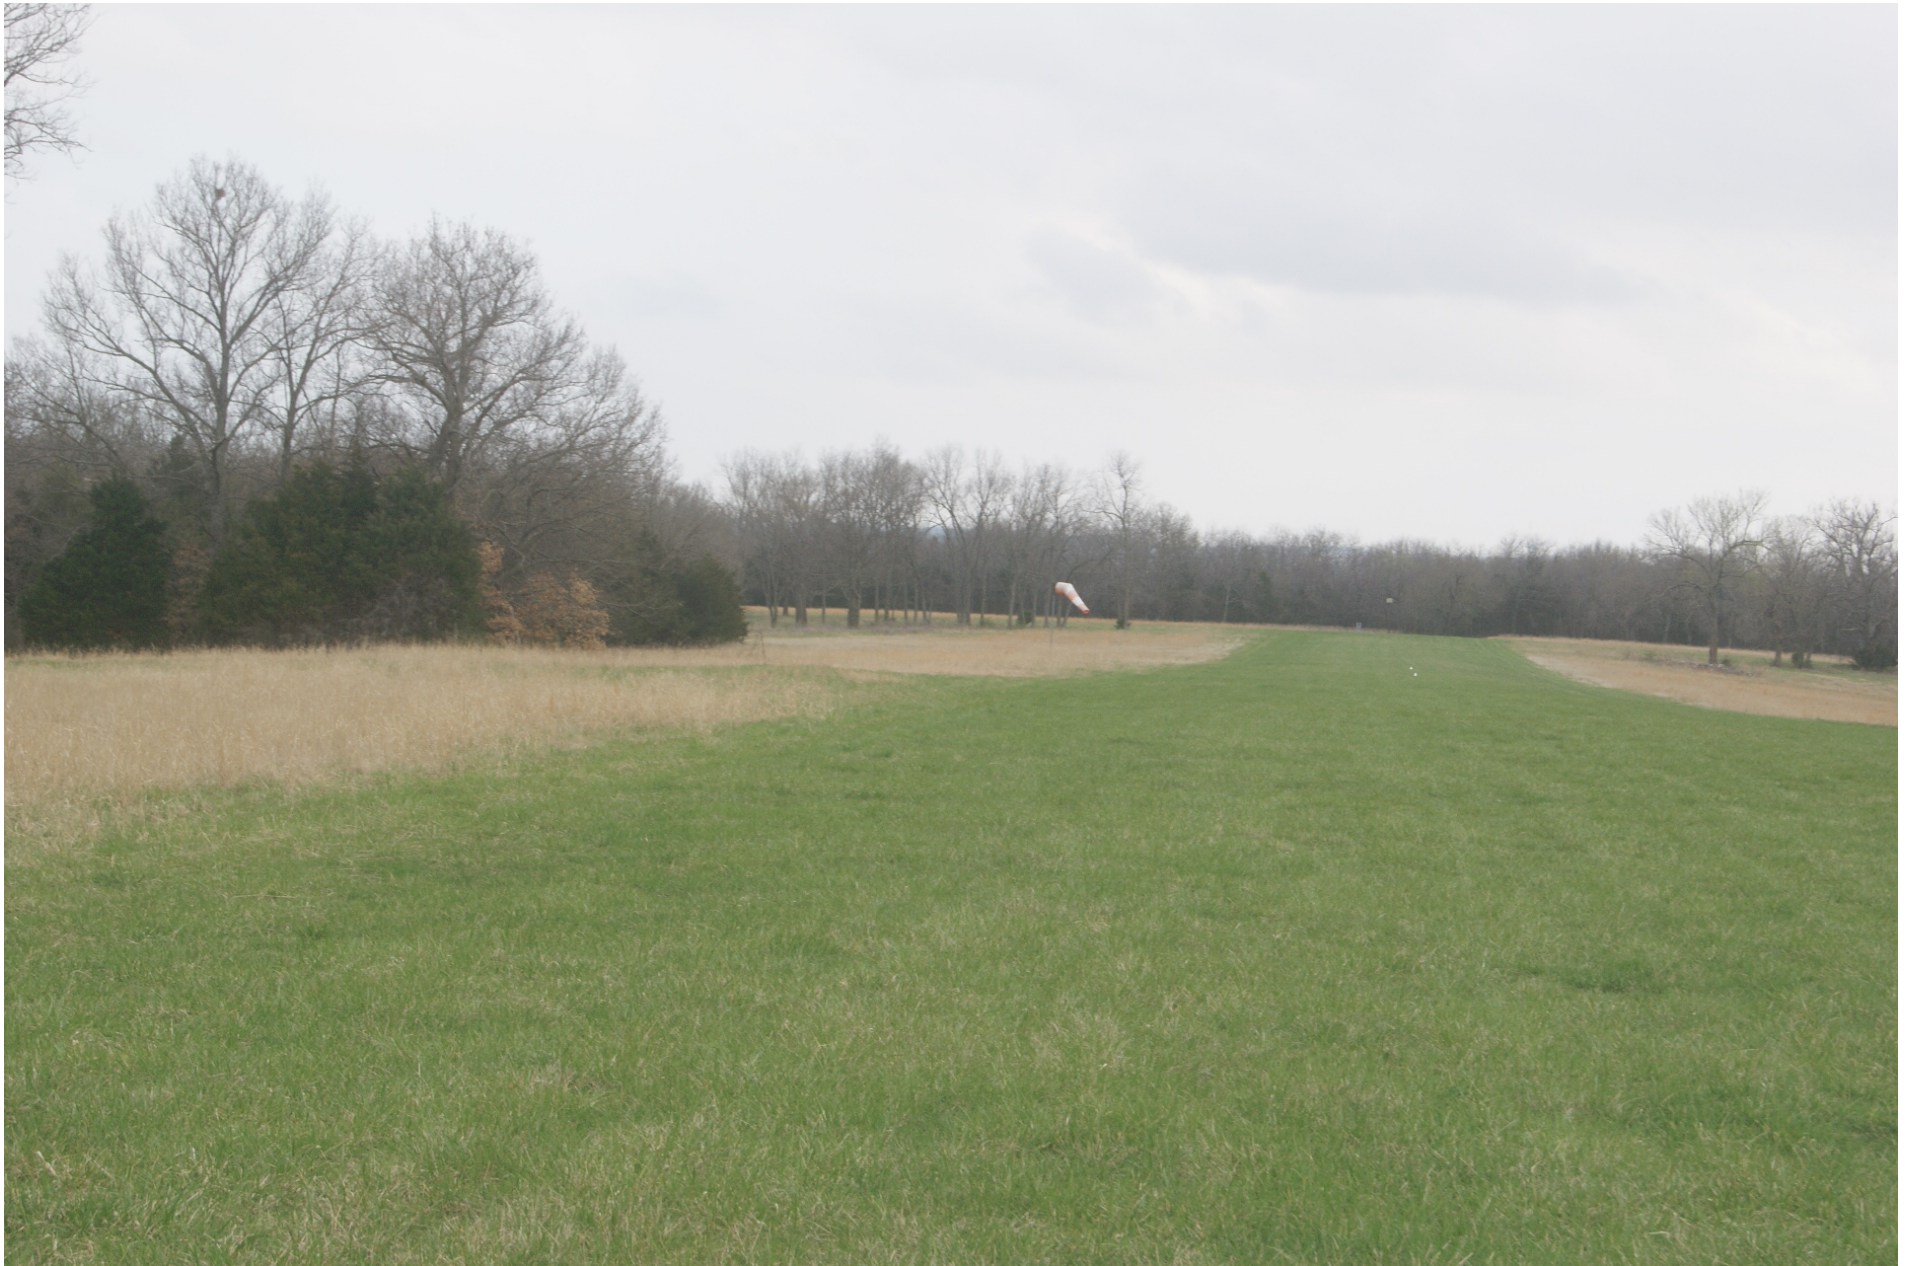
**Photo 1 – View to the south end of runway 33 and where N623HS began its takeoff roll.**

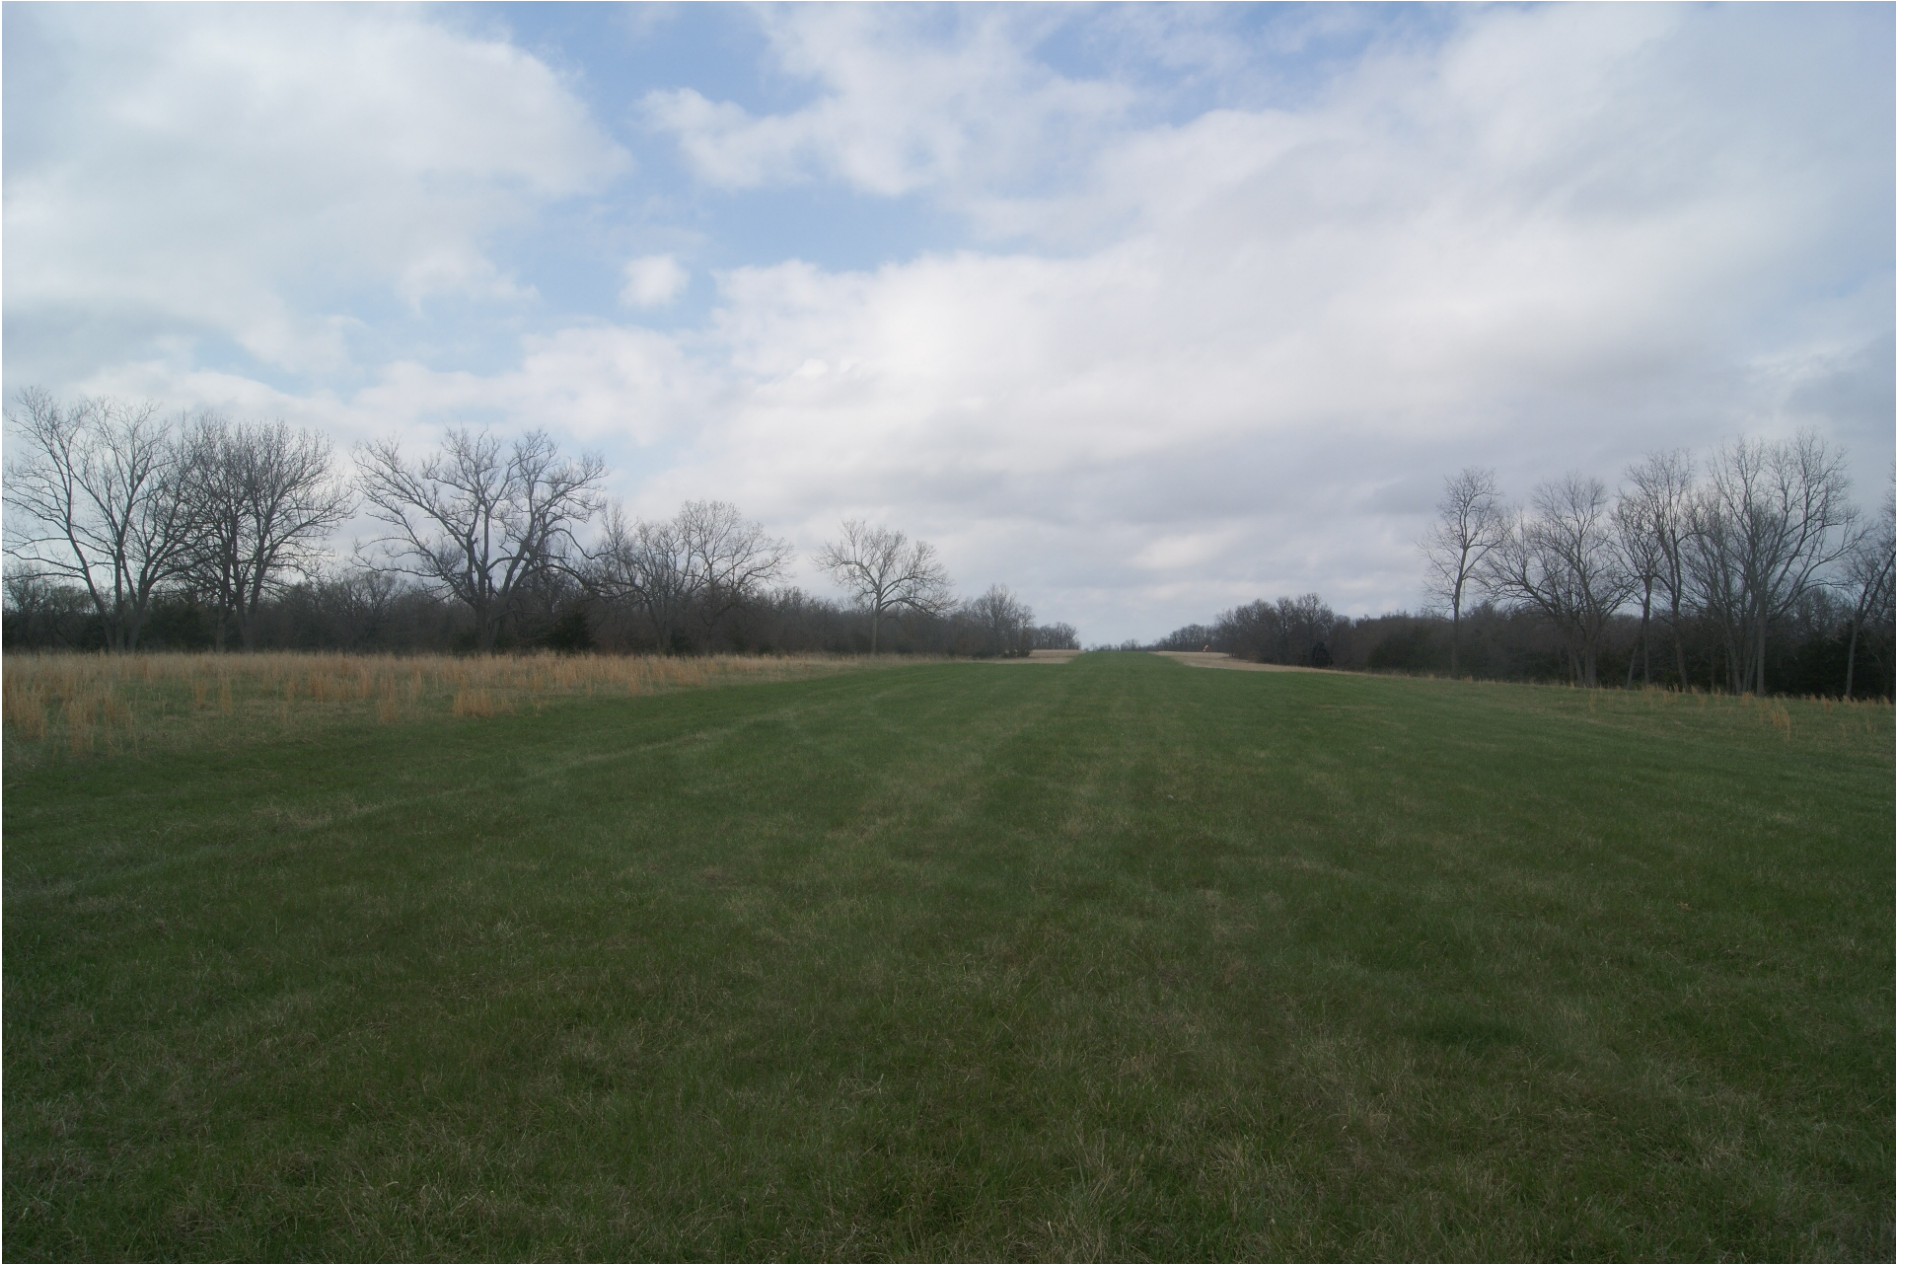
**Photo 2 - View to the north and the departure end of runway 34. Note the uphill slope.**

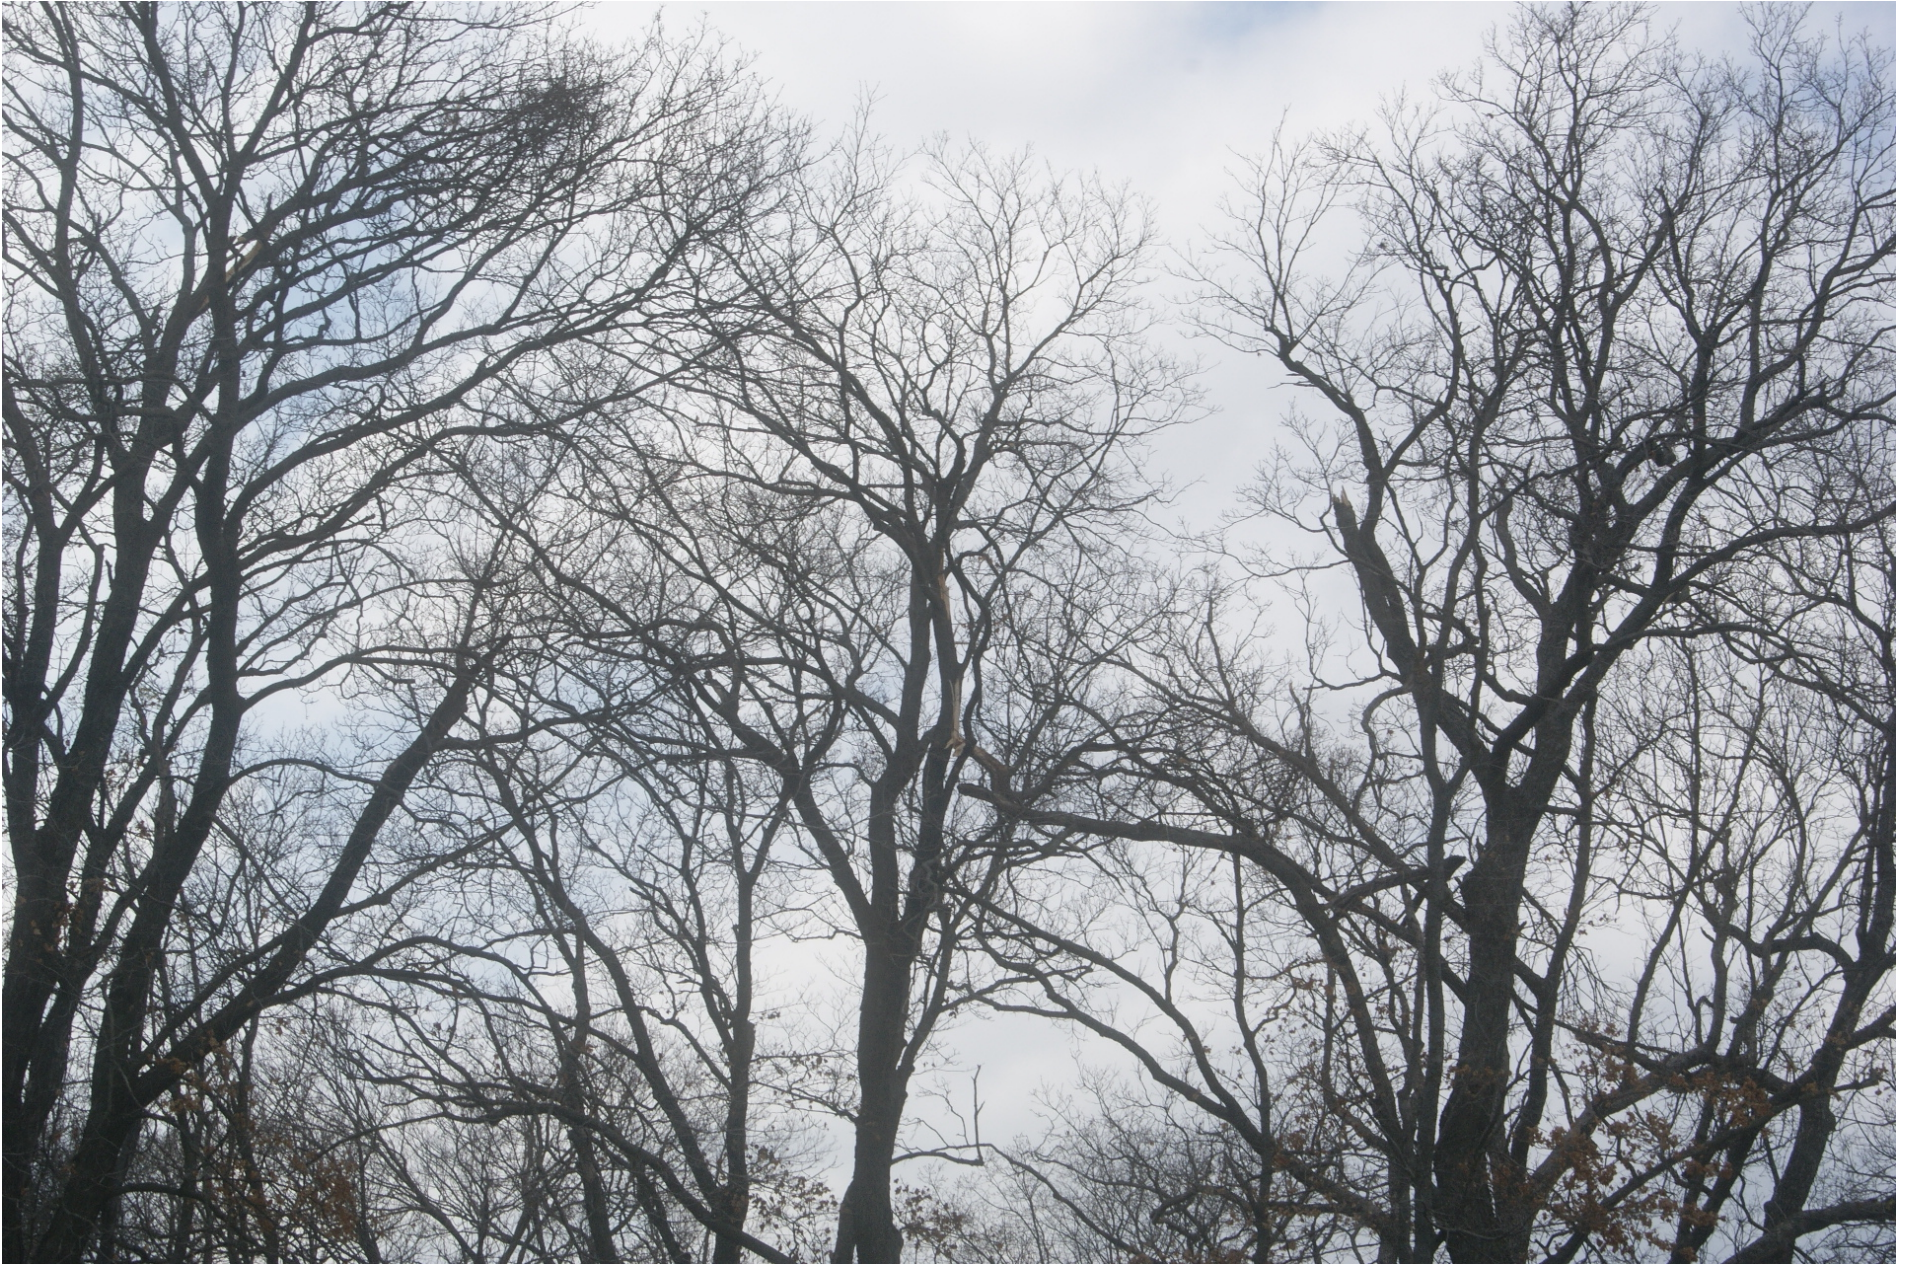
**Photo 3 - Severed branches at the top of 50-foot trees.**

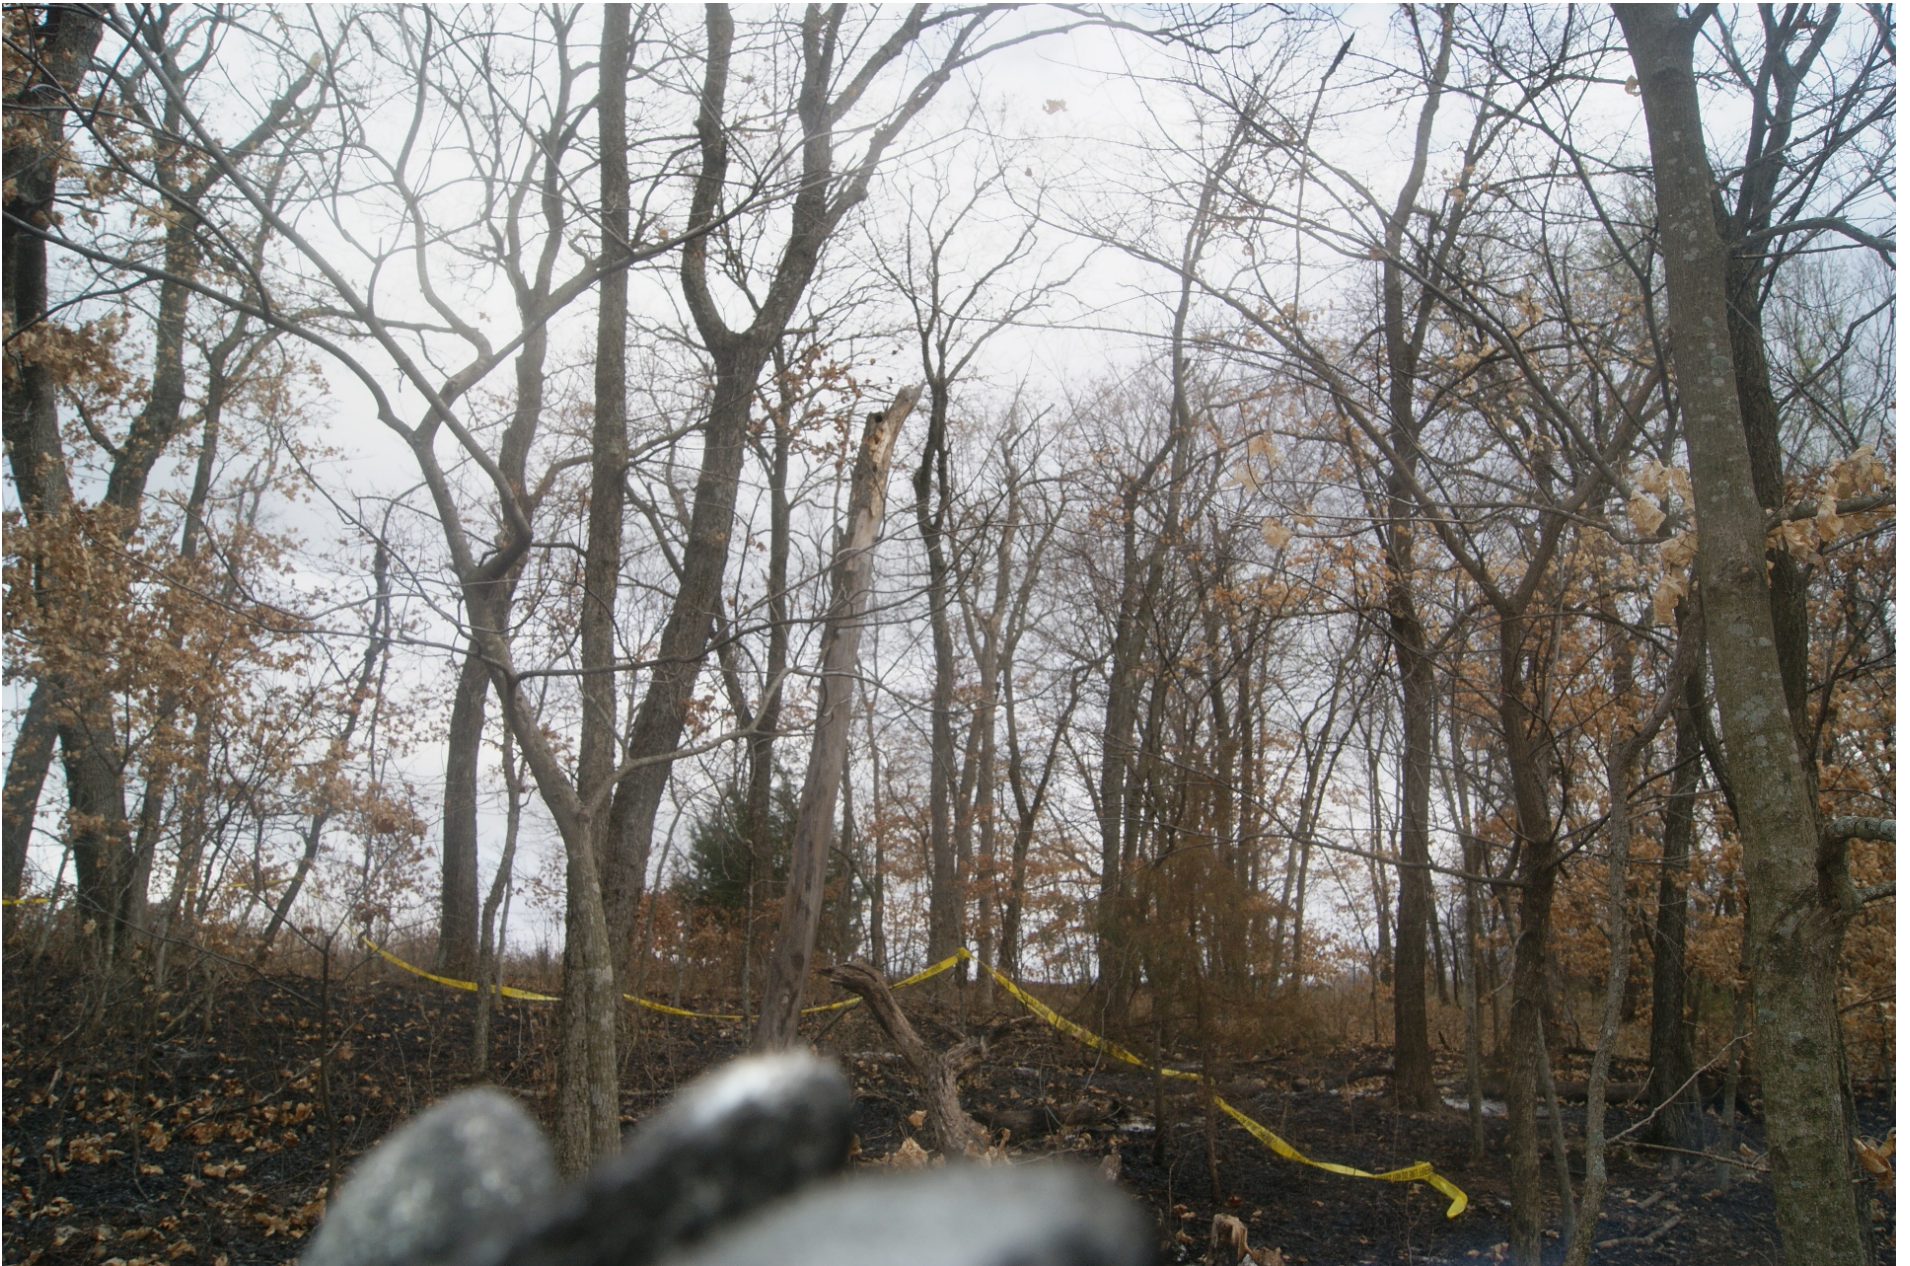
**Photo 4 - Severed tree trunk at the crash site. Note also the bark stripped from the trunk.**

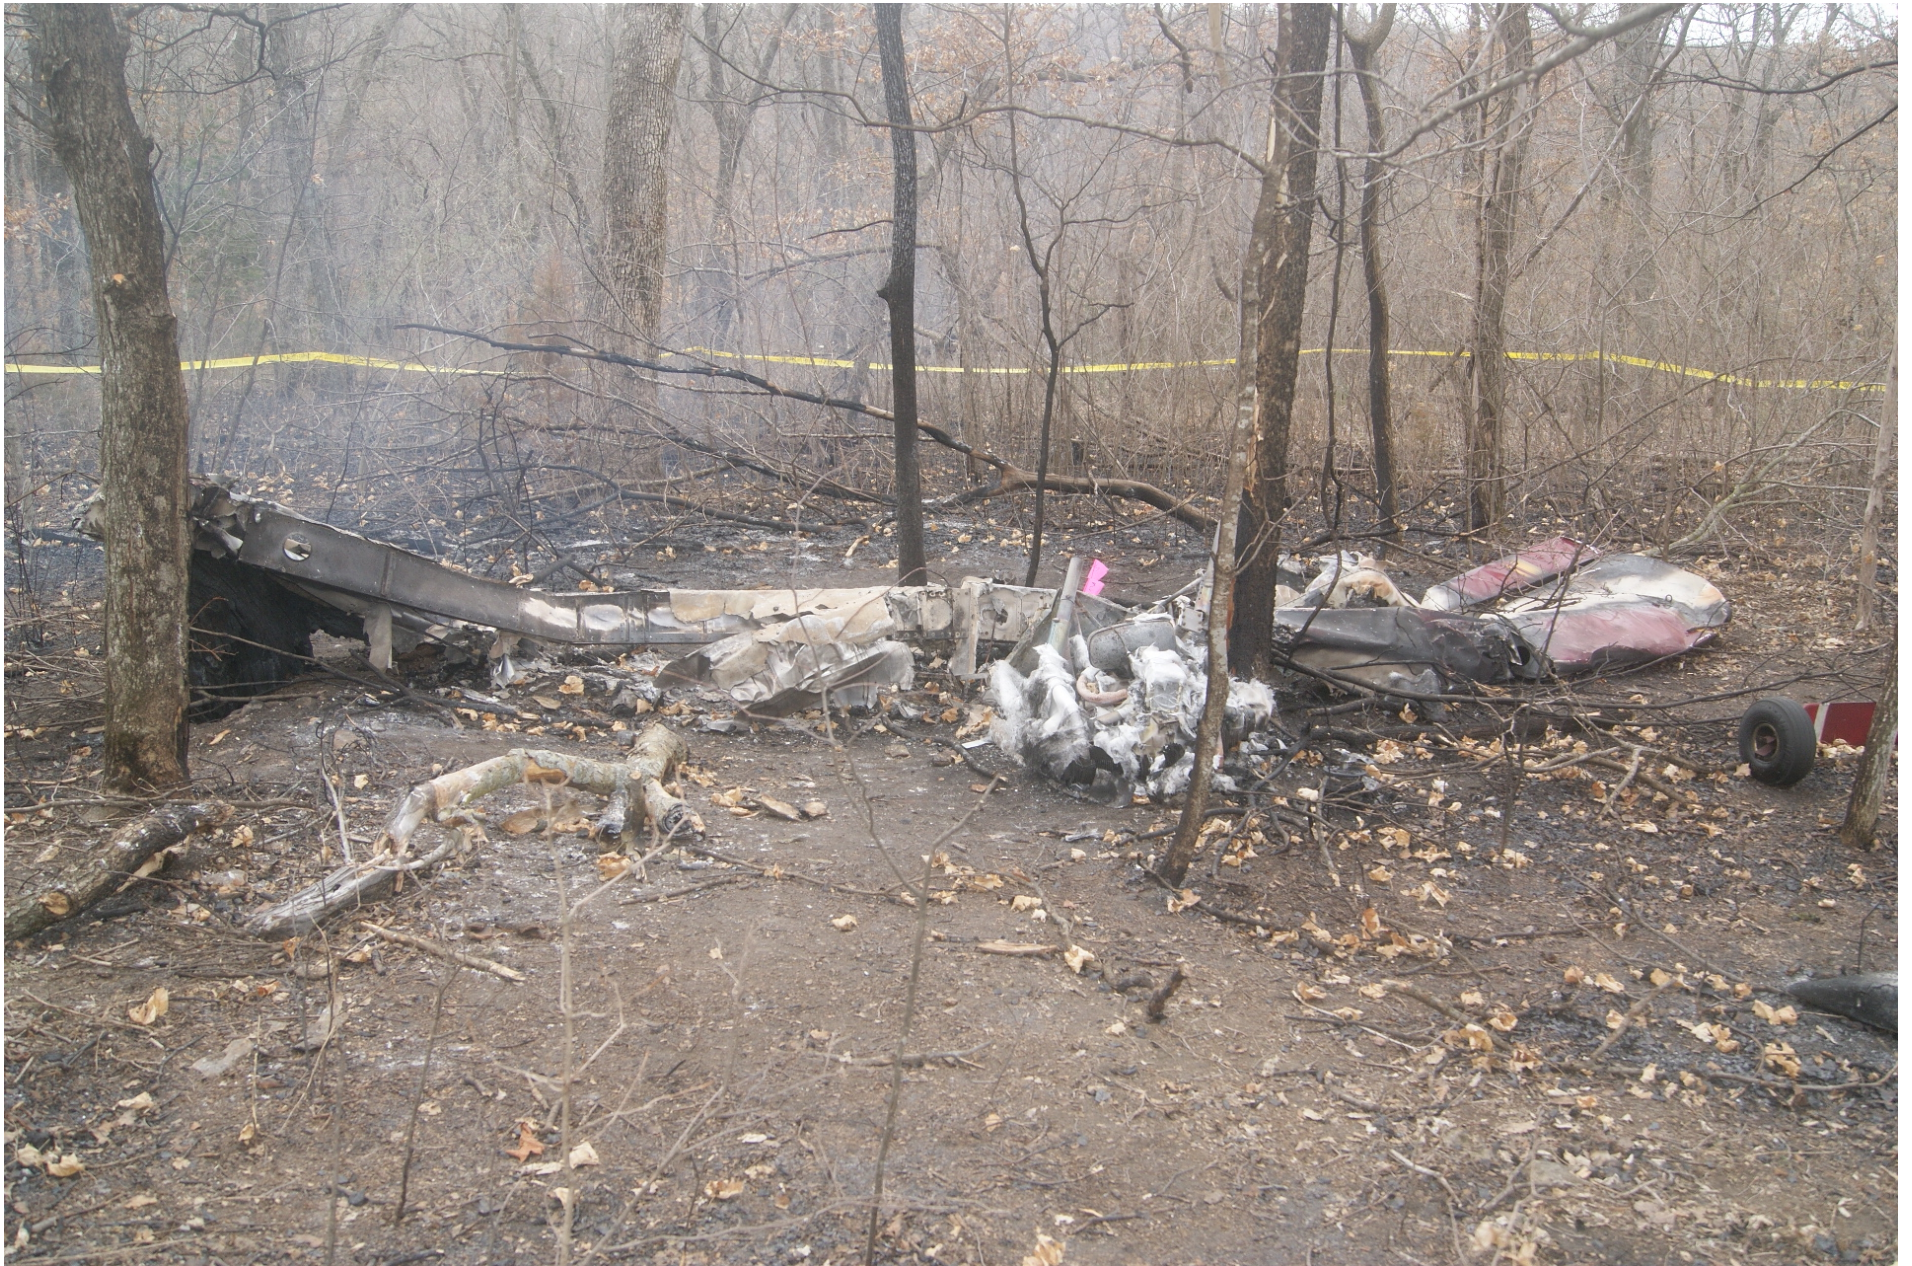
**Photo 5 - Inverted wreckage of N623HS, revealing both wings and engine. Note the smoke haze.**

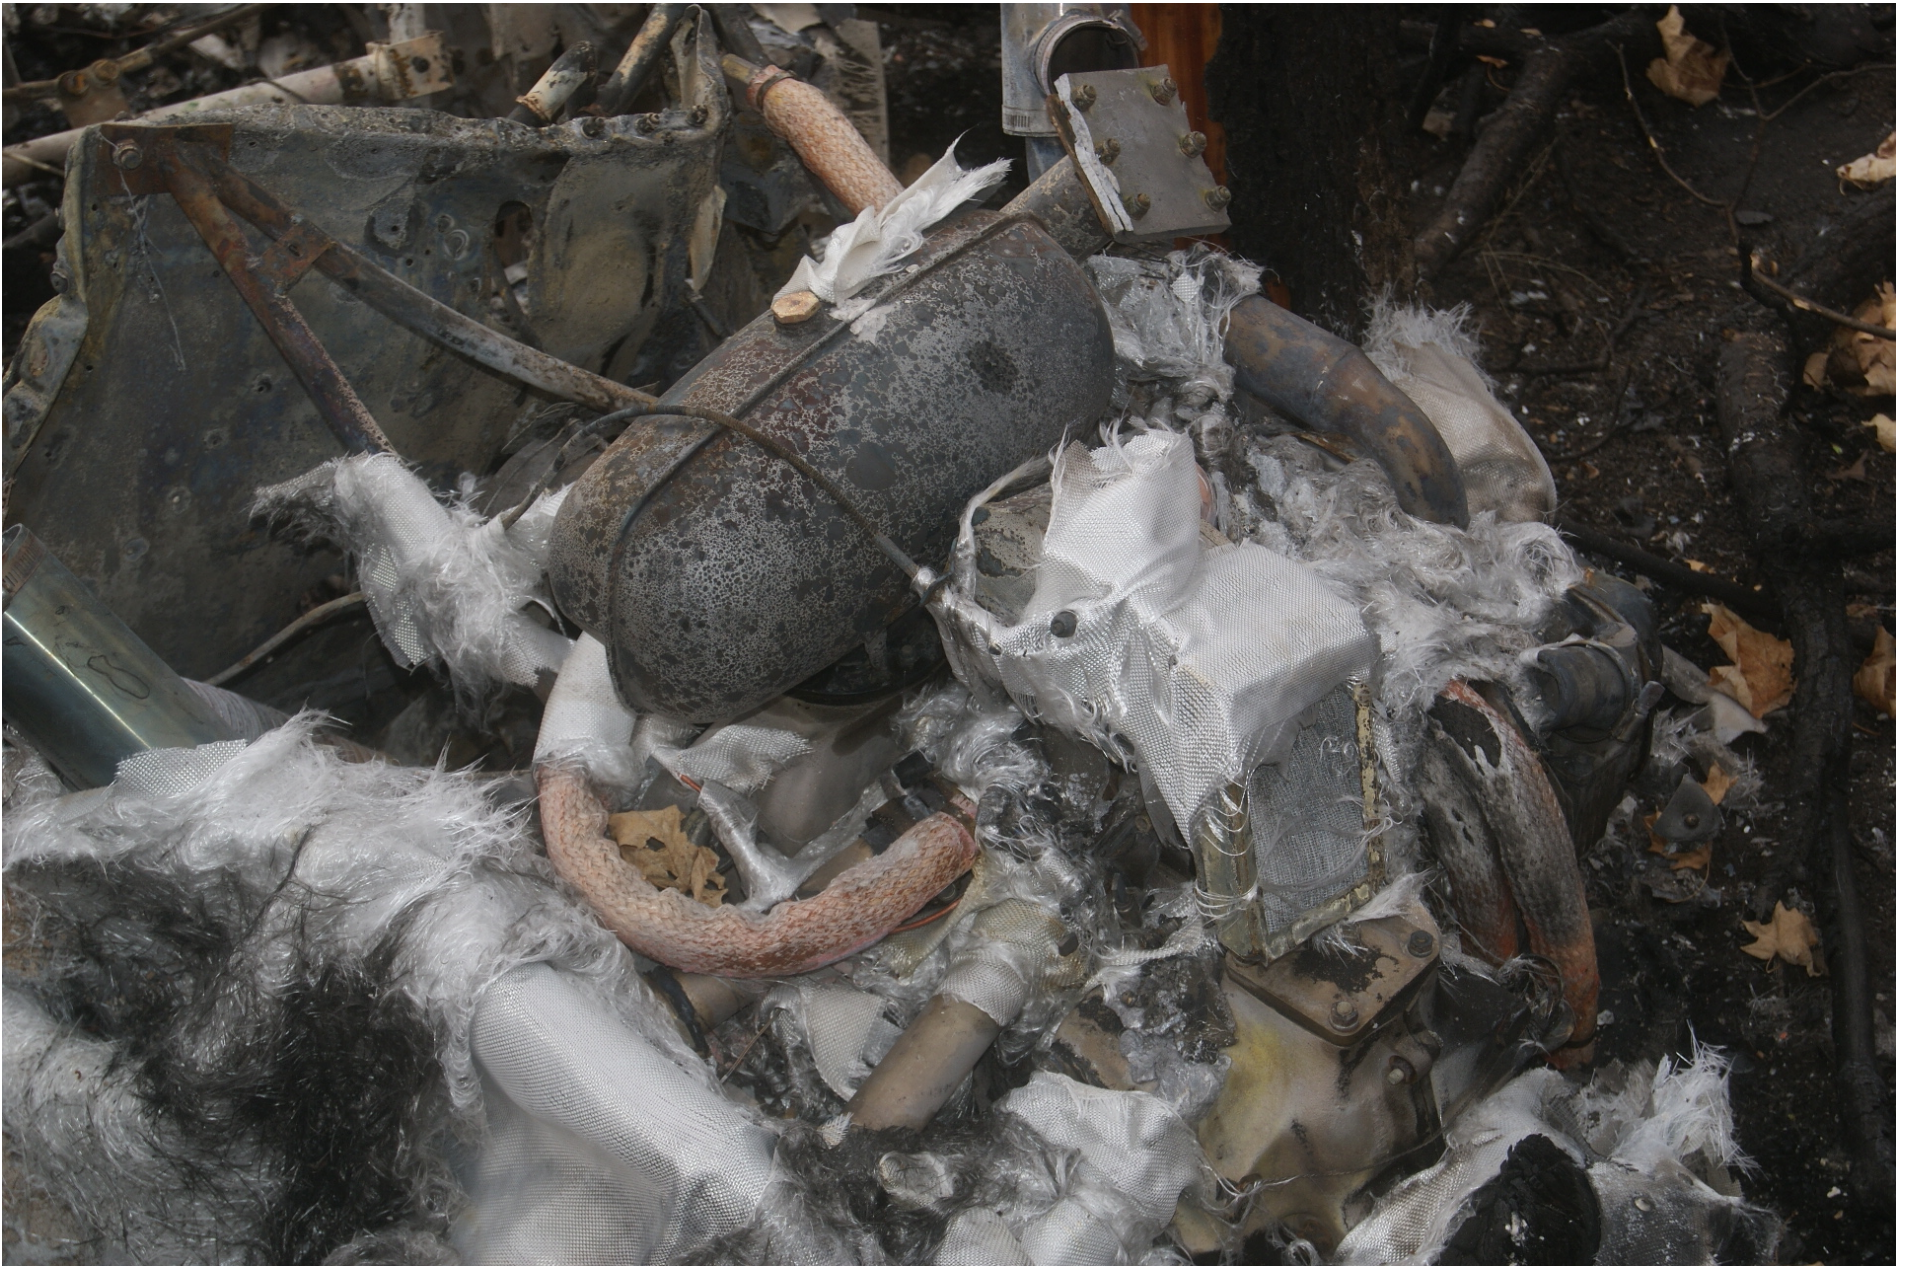
**Photo 6 - The inverted Continental O-200-A powerplant.**

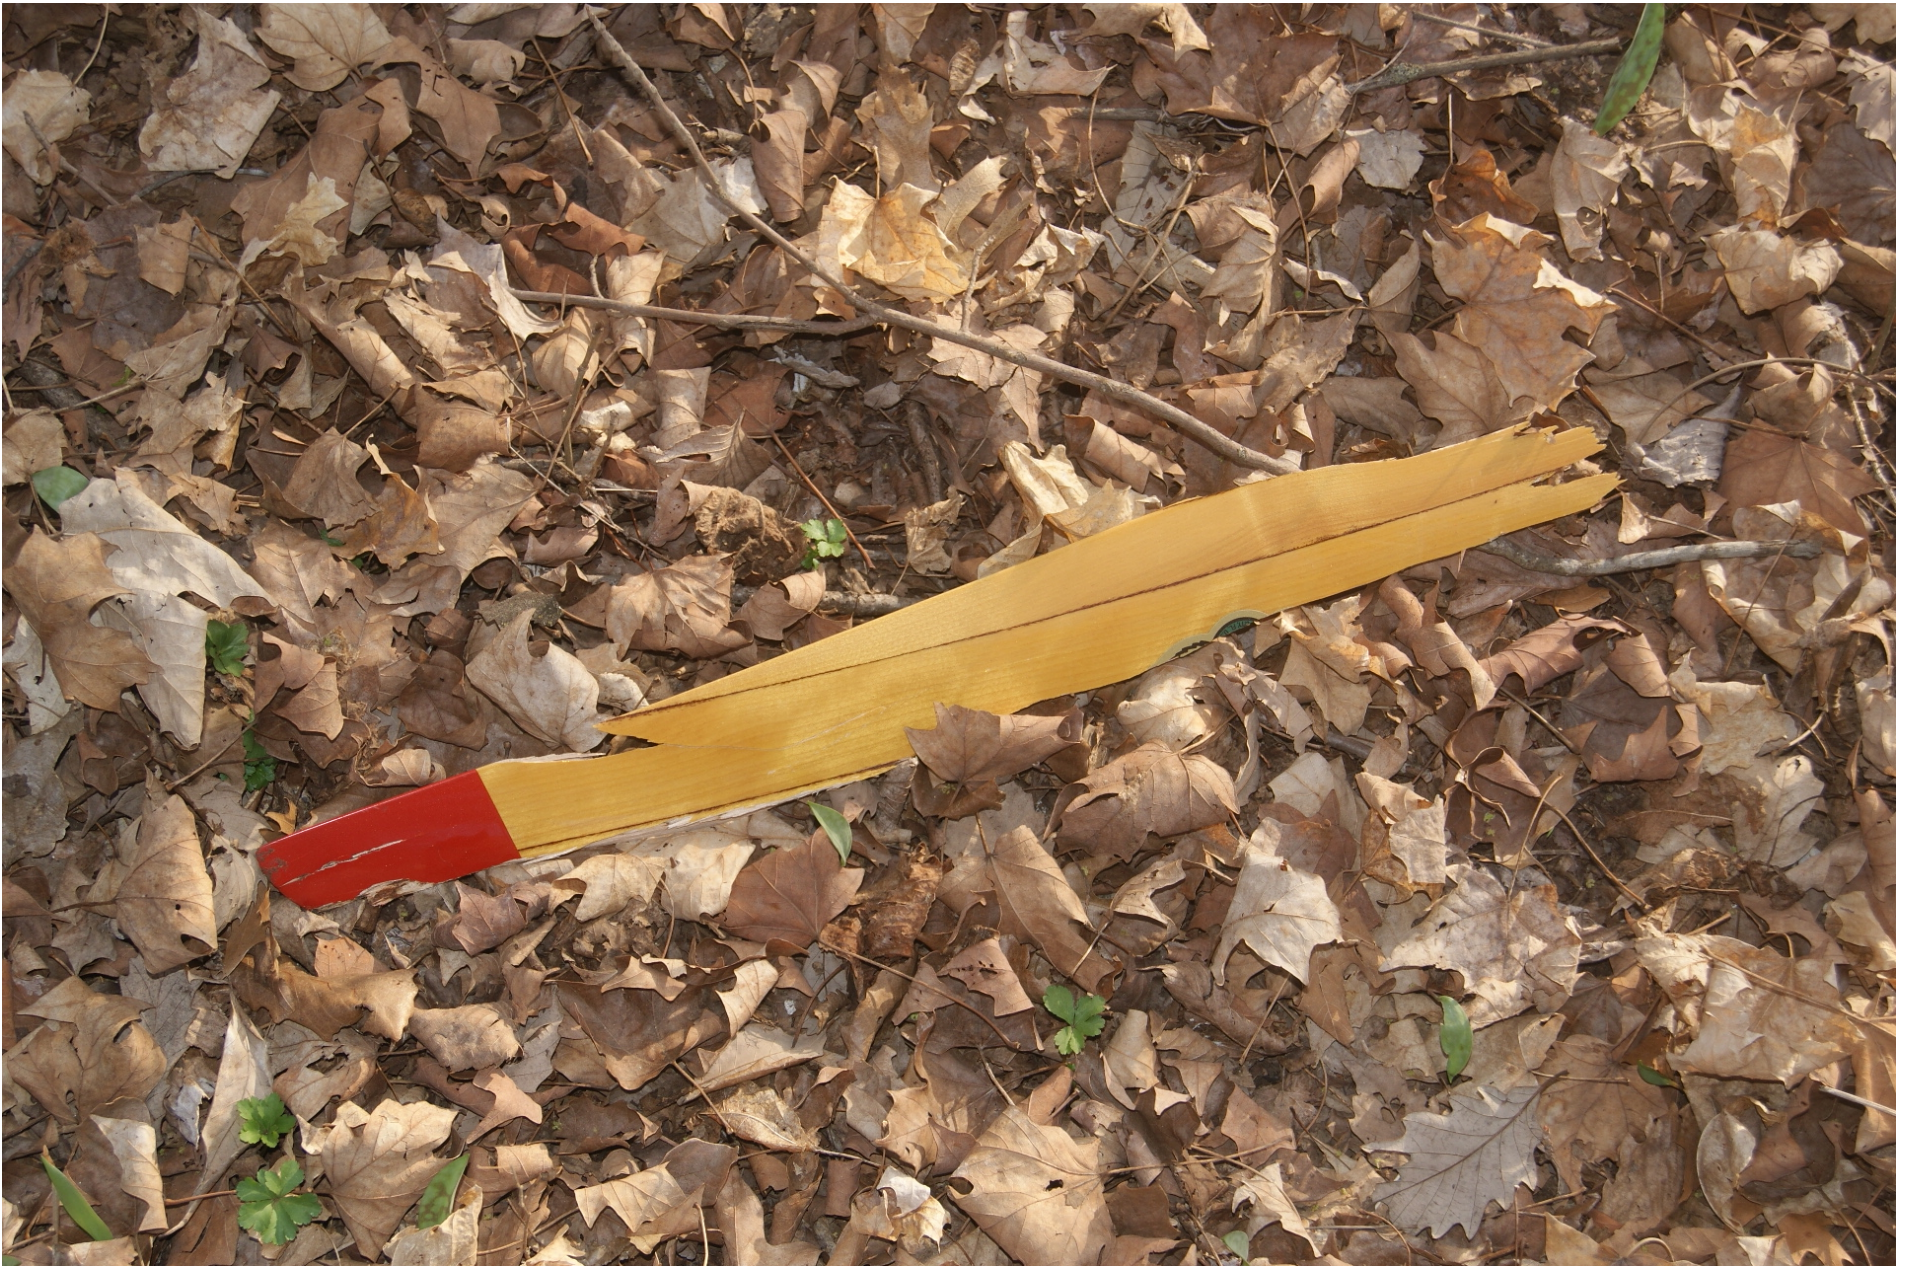
**Photo 7 - Substantive portion of propeller blade A.**

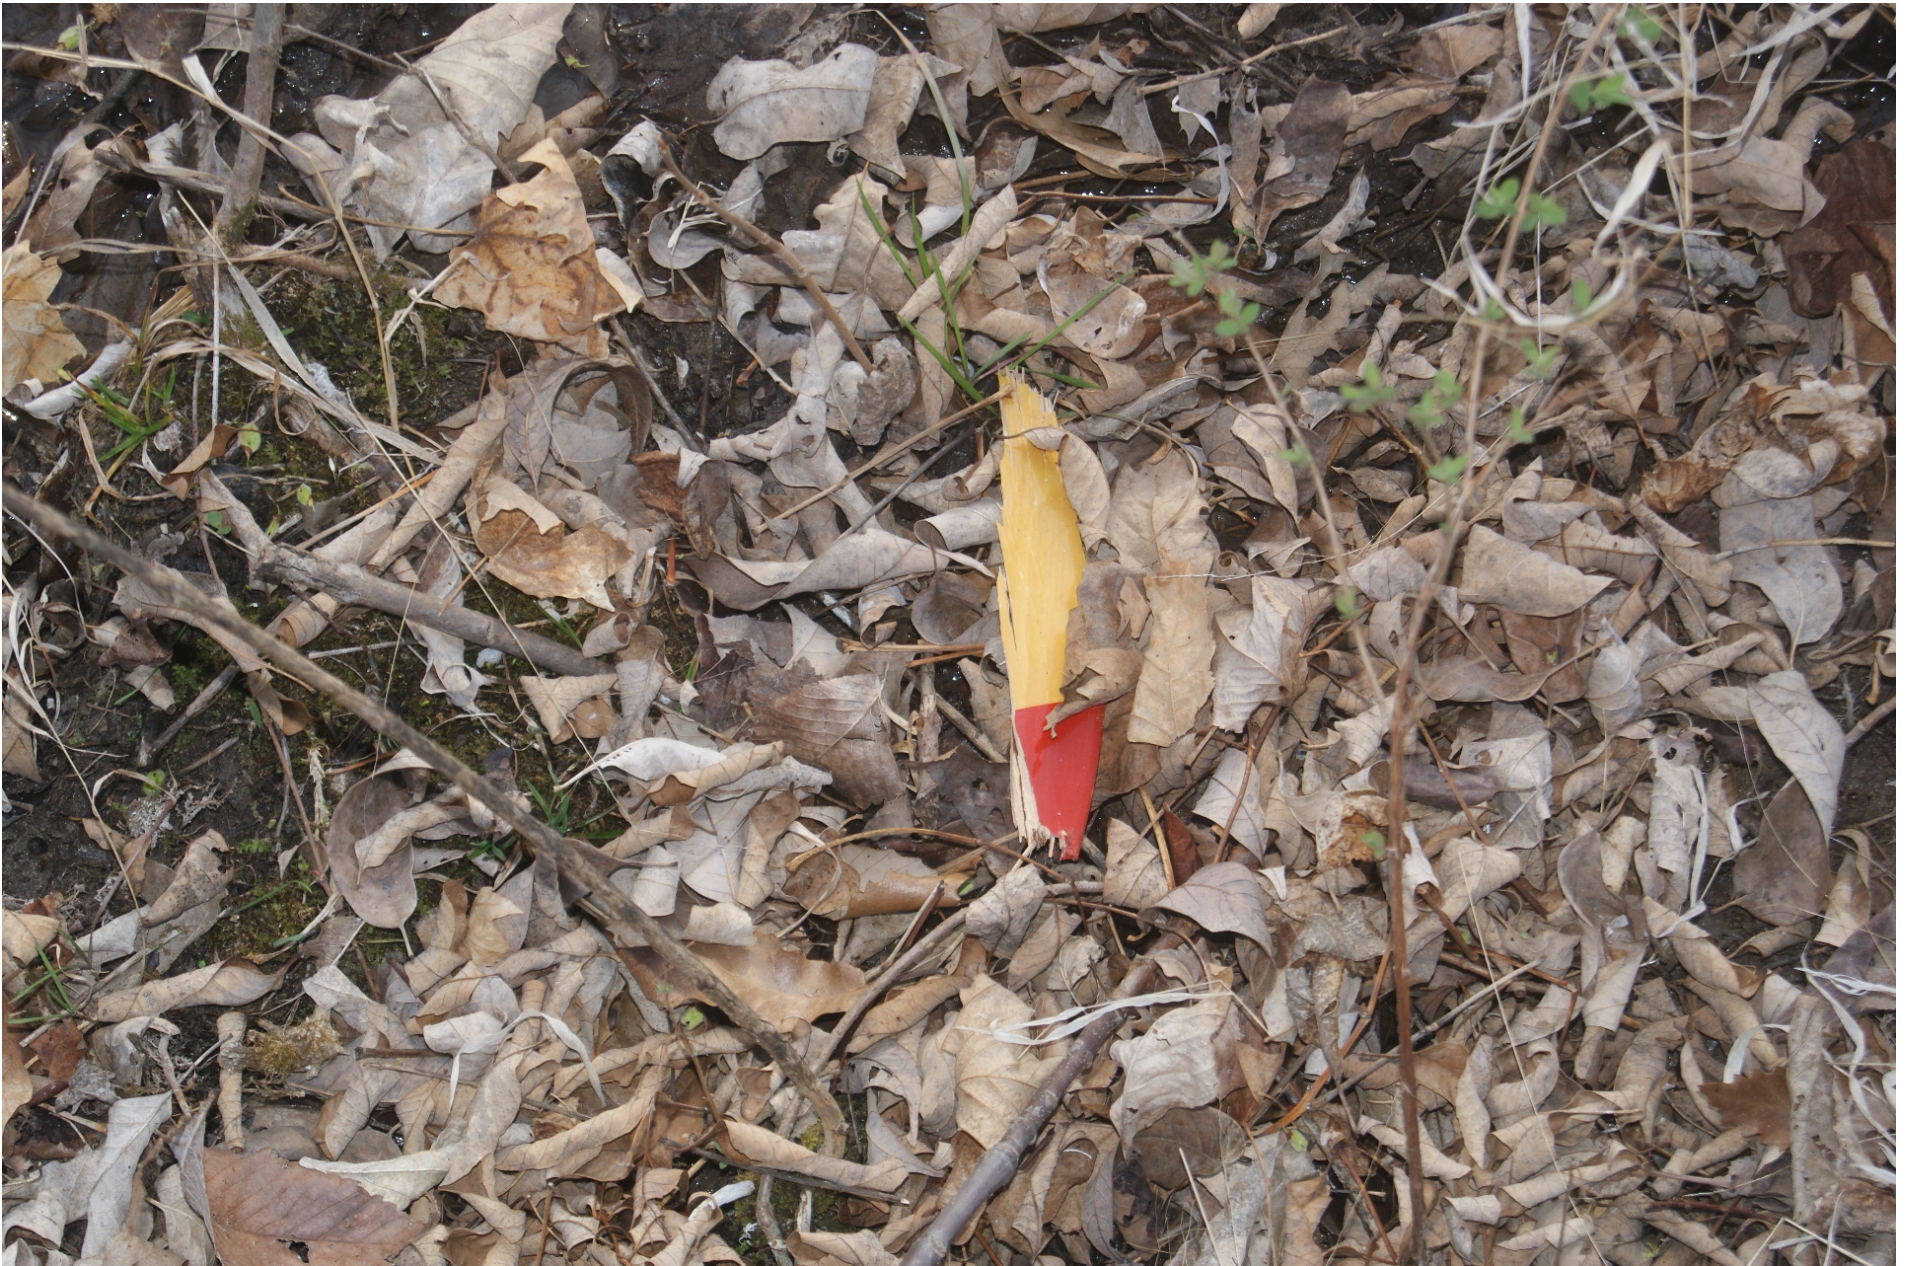
**Photo 8 - Fragmented blade tip from propeller blade B.**
