# **National Transportation Safety Board**

## **Performance Study**

### **Specialist Report**

| NTSB Number: | CEN15FA257 |

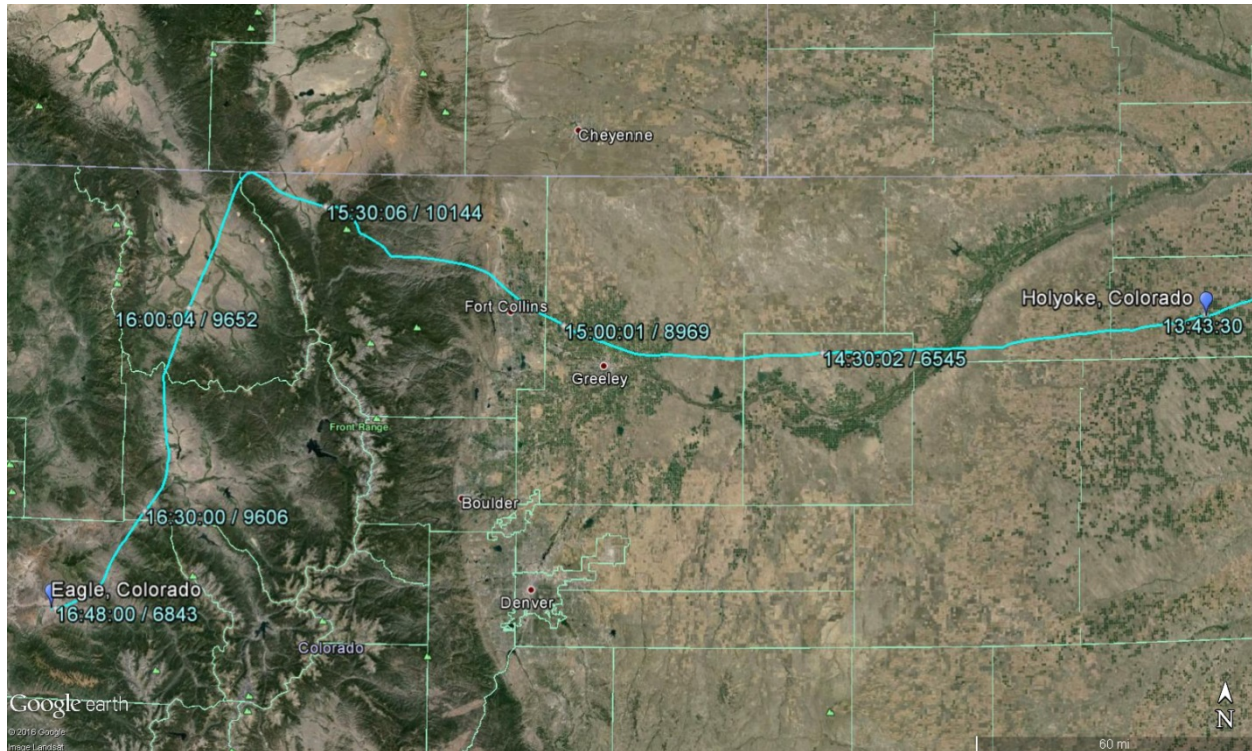
Data for the flight was available from an on-board Samsung Galaxy Tab. The flight originated in Holyoke Airport in Holyoke, Colorado at about 13:43 MDT as shown in Figure 1. The flight duration was three hours and five minutes. The weather at EGE at 1650 was reported as 10 statute miles visibility, overcast skies at 7,000 feet, light rain, and winds from 200° at 18 knots, gusting to 22 knots.

**Figure 1.** Aircraft flight path from Holyoke Airport in Holyoke, Colorado to Eagle, Colorado.

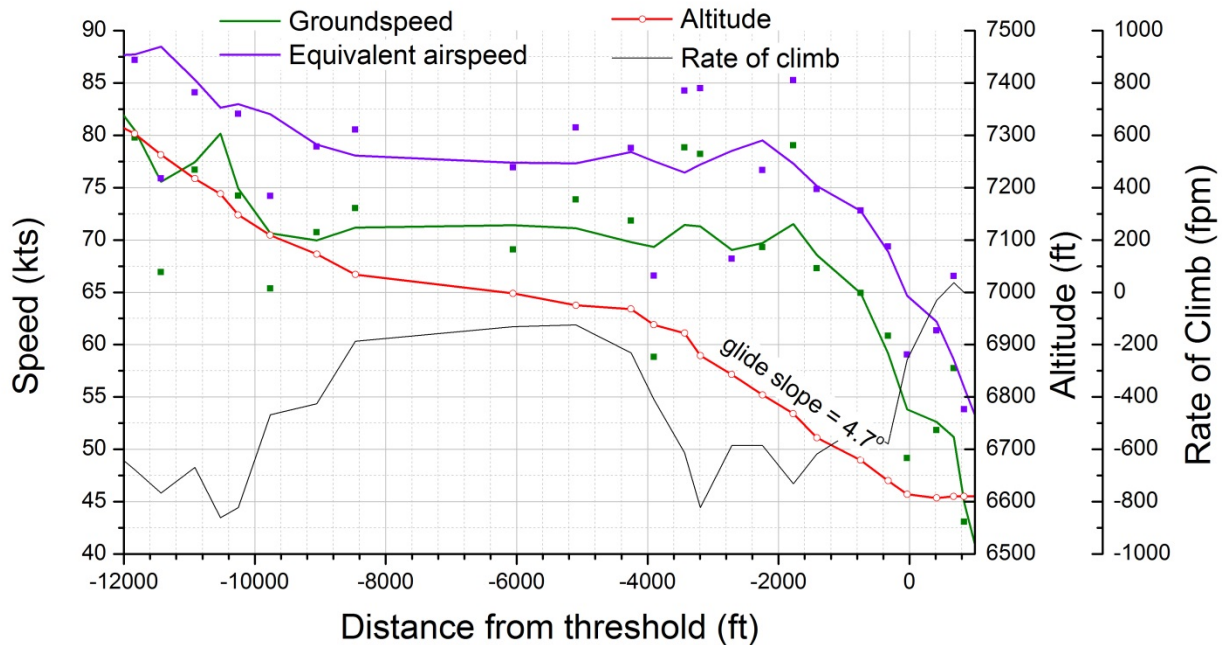
The aircraft approached runway 25 at an equivalent airspeed of 75 kts and slowed to 65 kts as it crossed the runway threshold (Figure 2). The equivalent airspeed calculation relied on the 18 kts wind report; the reported gusting winds up to 22 kts would change the equivalent airspeed. The final 400 ft of descent was done along a glide slope of 4.7°. Runway 25 has a four light precision approach path indicator (PAPI) with a 3.0° glide path. The aircraft's rate of climb (descent) during this final portion of the flight was between -600 and -800 ft/min.

**Figure 2.** Aircraft altitude, speed, and rate of climb versus distance to threshold.

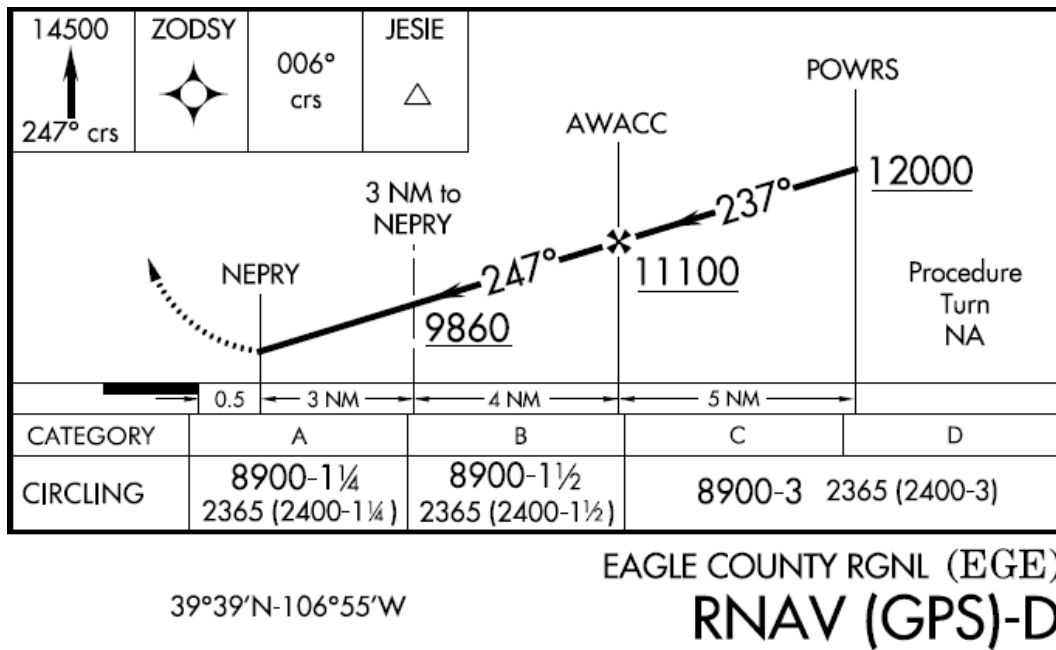
An excerpt for the flight profile from the EGE RNAV approach plate is shown below in Figure 3. The altitude for the point 3 NM before NEPRY (3.5 NM before the runway threshold) is 9,860 ft. The approach plate lists the airport elevation as 6535 ft. A continuous descent between the point 3 NM before NEPRY and the runway would have a glide slope of approximately 8.9°. While the airport PAPI has a 3.0° glide slope, a significant descent rate is required earlier in the approach to capture that glide slope. The RNAV chart is shown to indicate the potential difficulty of the approach; the Limitations Section of the Pilots Operating Manual [1] states the aircraft “must be operated only for [Visual Flight Rules] day flights”.

**Figure 3.** Profile excerpt from RNAV (GPS)-D approach plate for runway 25 at EGE.

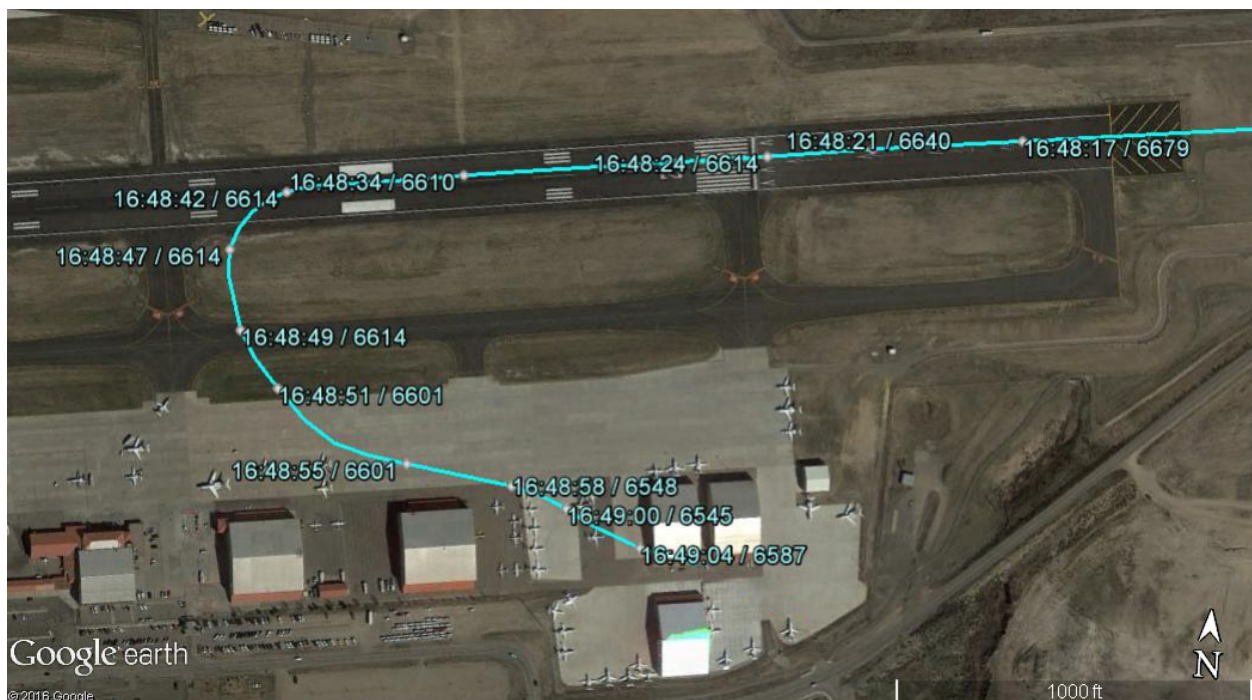
About 18 seconds after crossing the threshold, at 1,200 ft past the threshold, while still above the runway, the aircraft began to turn to the left. The aircraft left the runway, crossed a taxiway, and continued over the ramp before impacting a hanger. Figure 4 shows the aircraft's track with selected times and GPS recorded altitudes.

**Figure 4.** Aircraft flight path over runway 25 and ramp with selected times and altitudes.

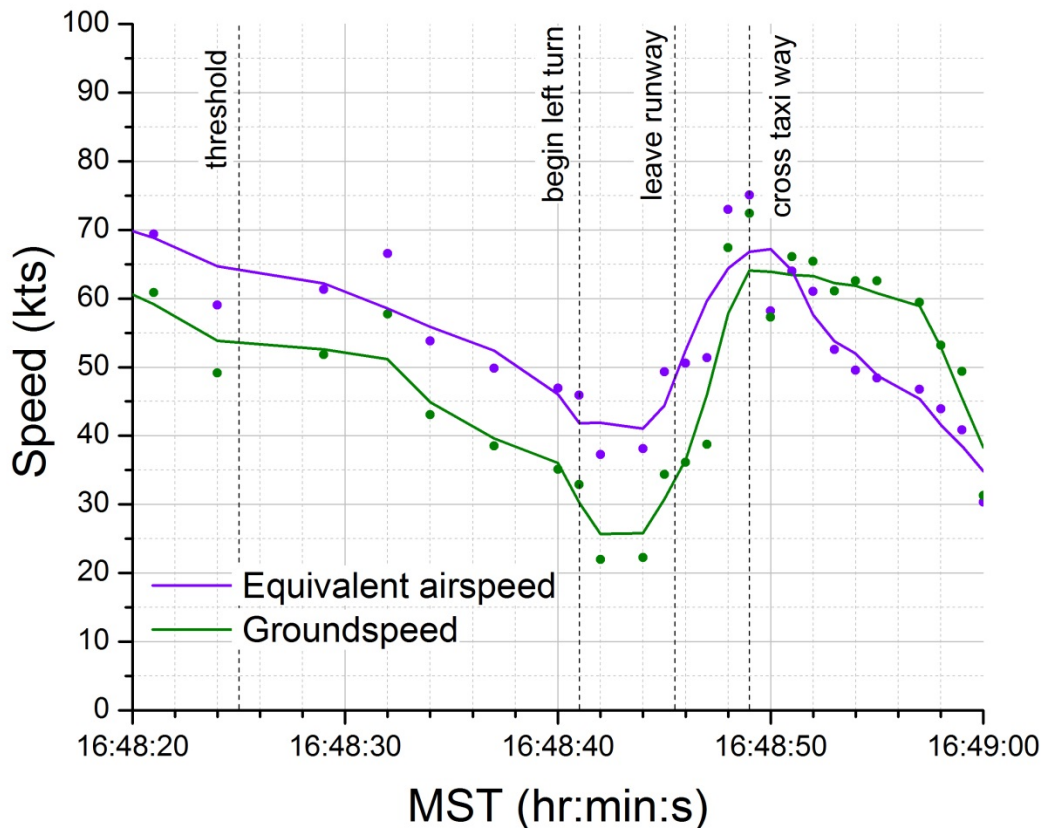
Figure 5 shows the groundspeed and equivalent airspeed for the final 40 seconds of flight. The aircraft crossed the threshold at an equivalent airspeed of 64 kts (groundspeed was 54 kts) and slowed to just above 40 kts (30kts groundspeed) when it began to turn to the left. As the aircraft left the runway, its airspeed increased until it was about 67 kts (64 kts groundspeed) as it crossed over the taxiway.

**Figure 5.** Airspeed for final portion of flight.

The aircraft approached runway 25 on a glide slope of  $4.7^\circ$  at an equivalent airspeed of 75 kts. This glide slope was higher than the runway's  $3^\circ$  glide slope. The aircraft crossed the threshold at 64 kts (groundspeed was 54 kts) and slowed to just above 40 kts before turning to the left and leaving the runway. The aircraft's ground and airspeed increased as it crossed the taxiway before impacting a hanger. The Pilots Operating Manual indicates that the stall speed at  $30^\circ$  flaps and no power is 34 kts [1].
