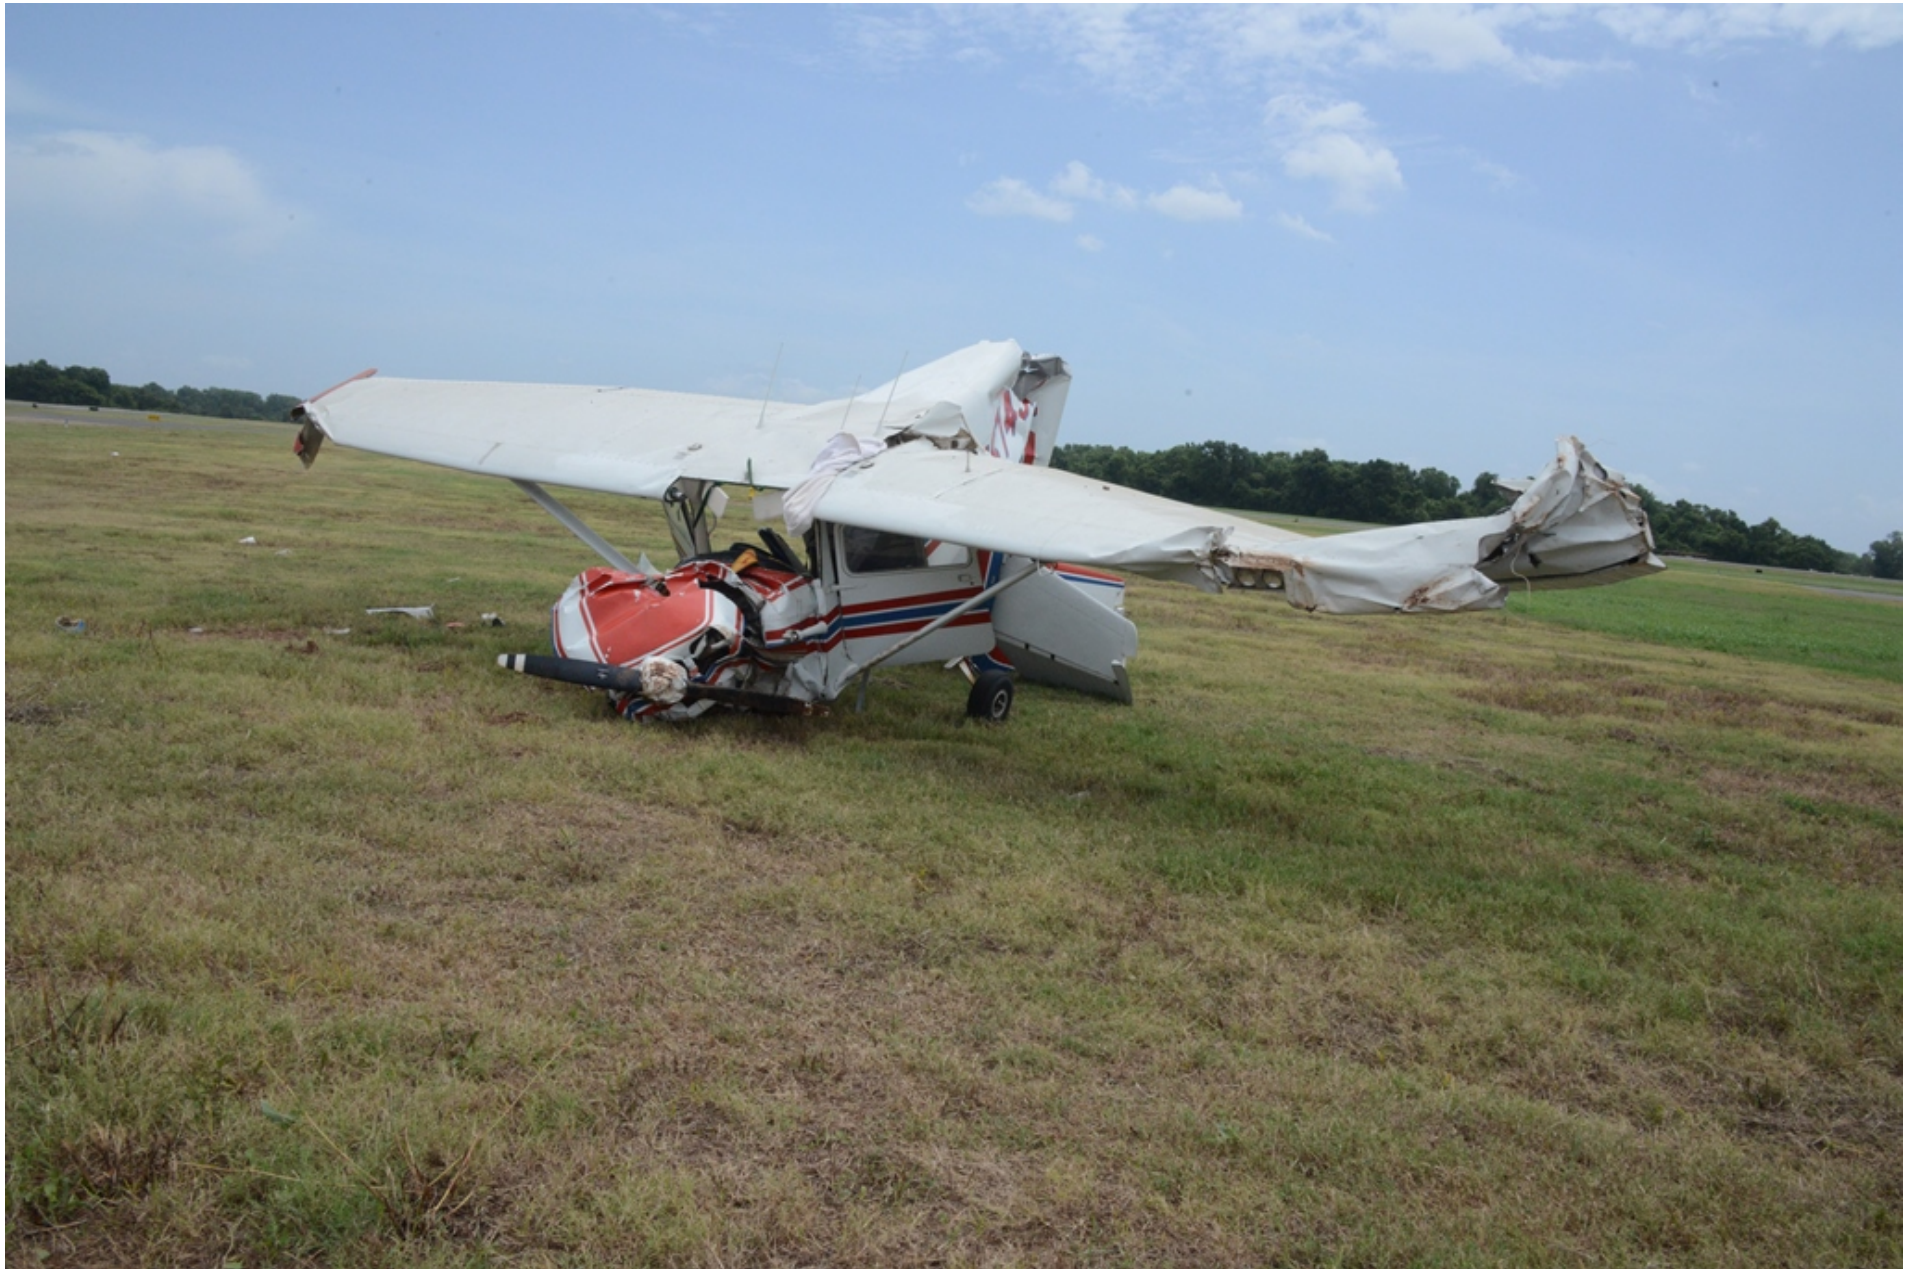
**Photo 1 – View of the airplane at the accident site.**

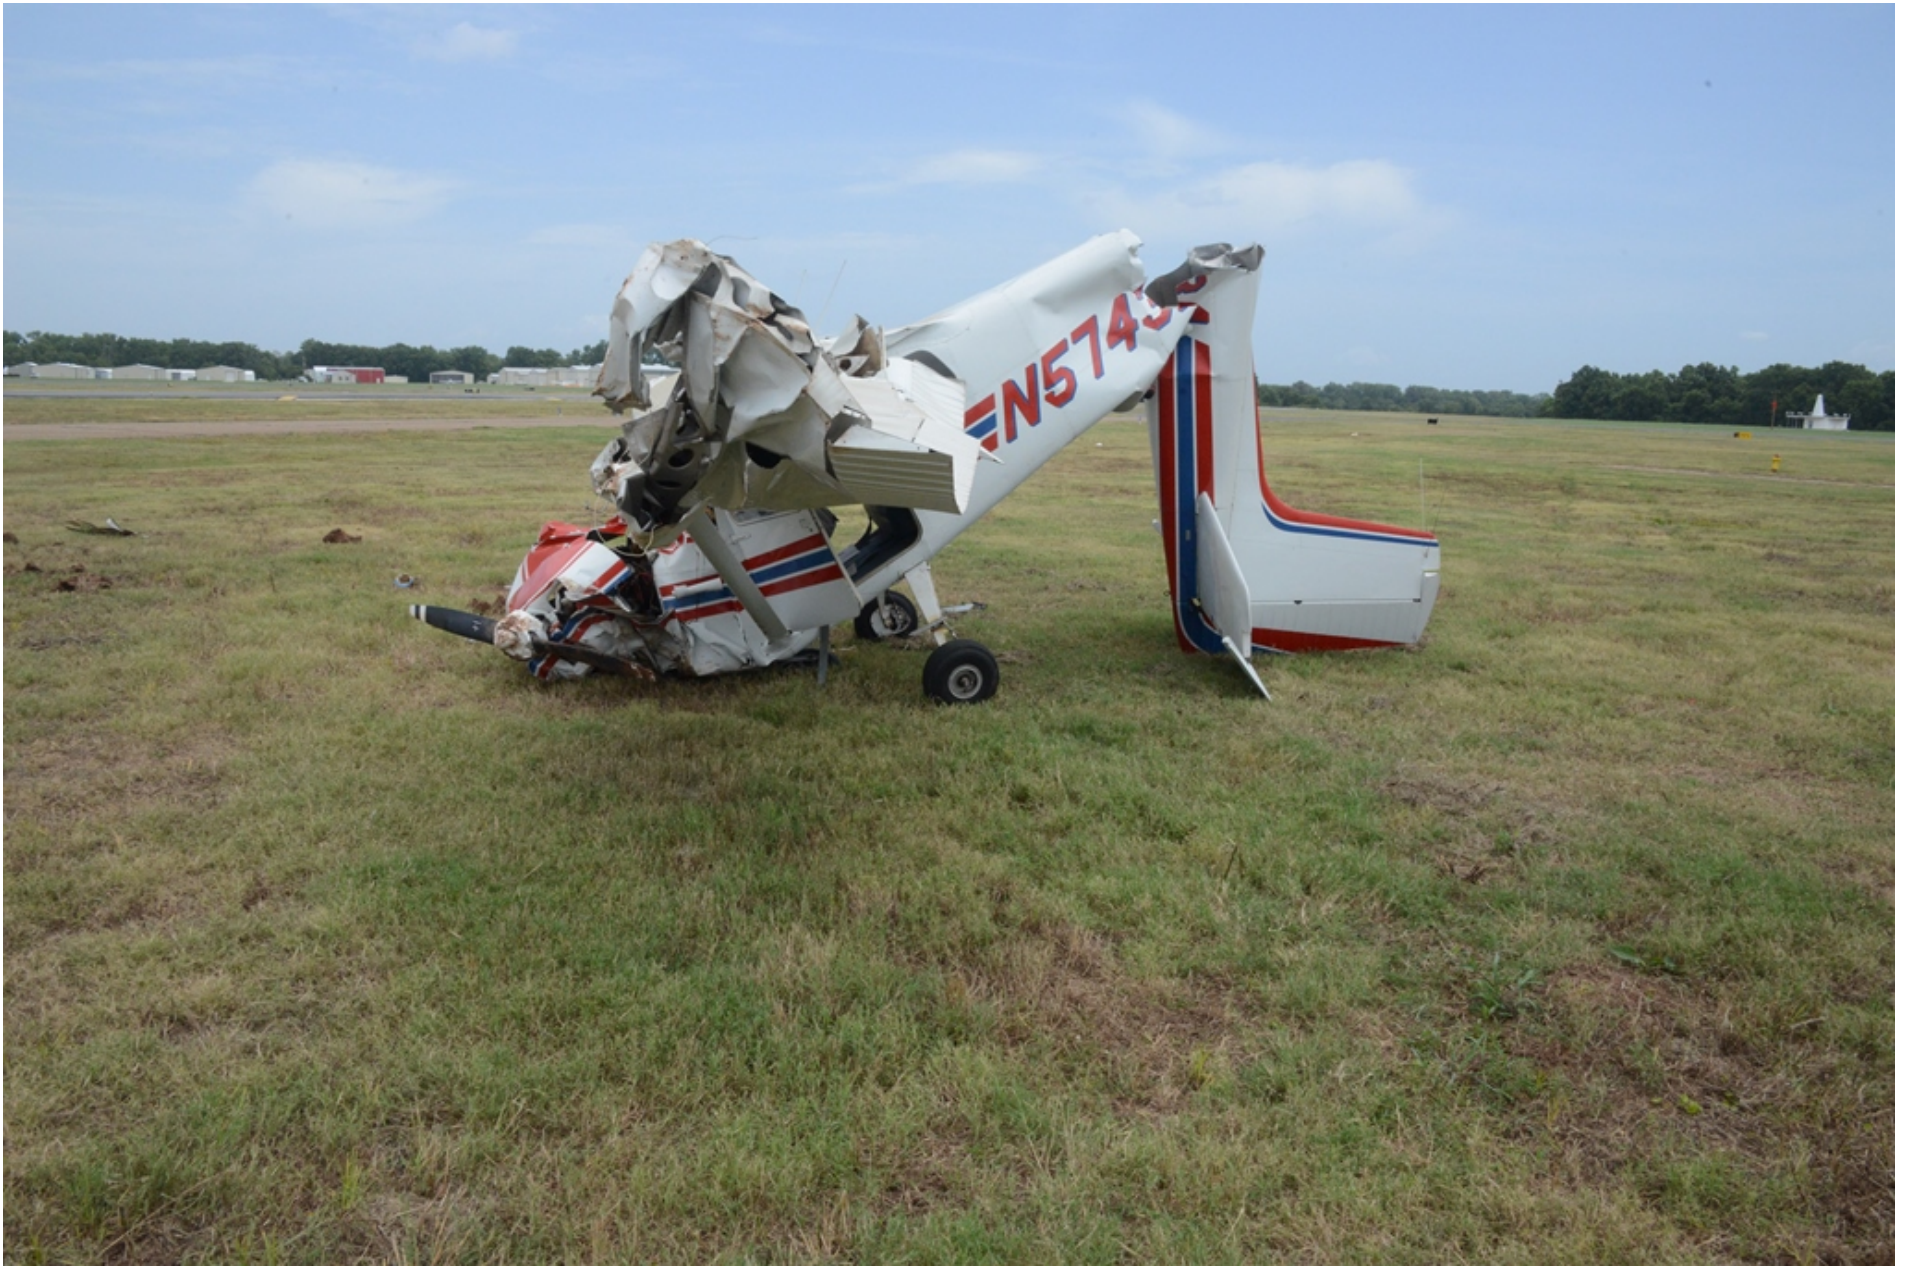
**Photo 2 - View of the airplane at the accident site.**

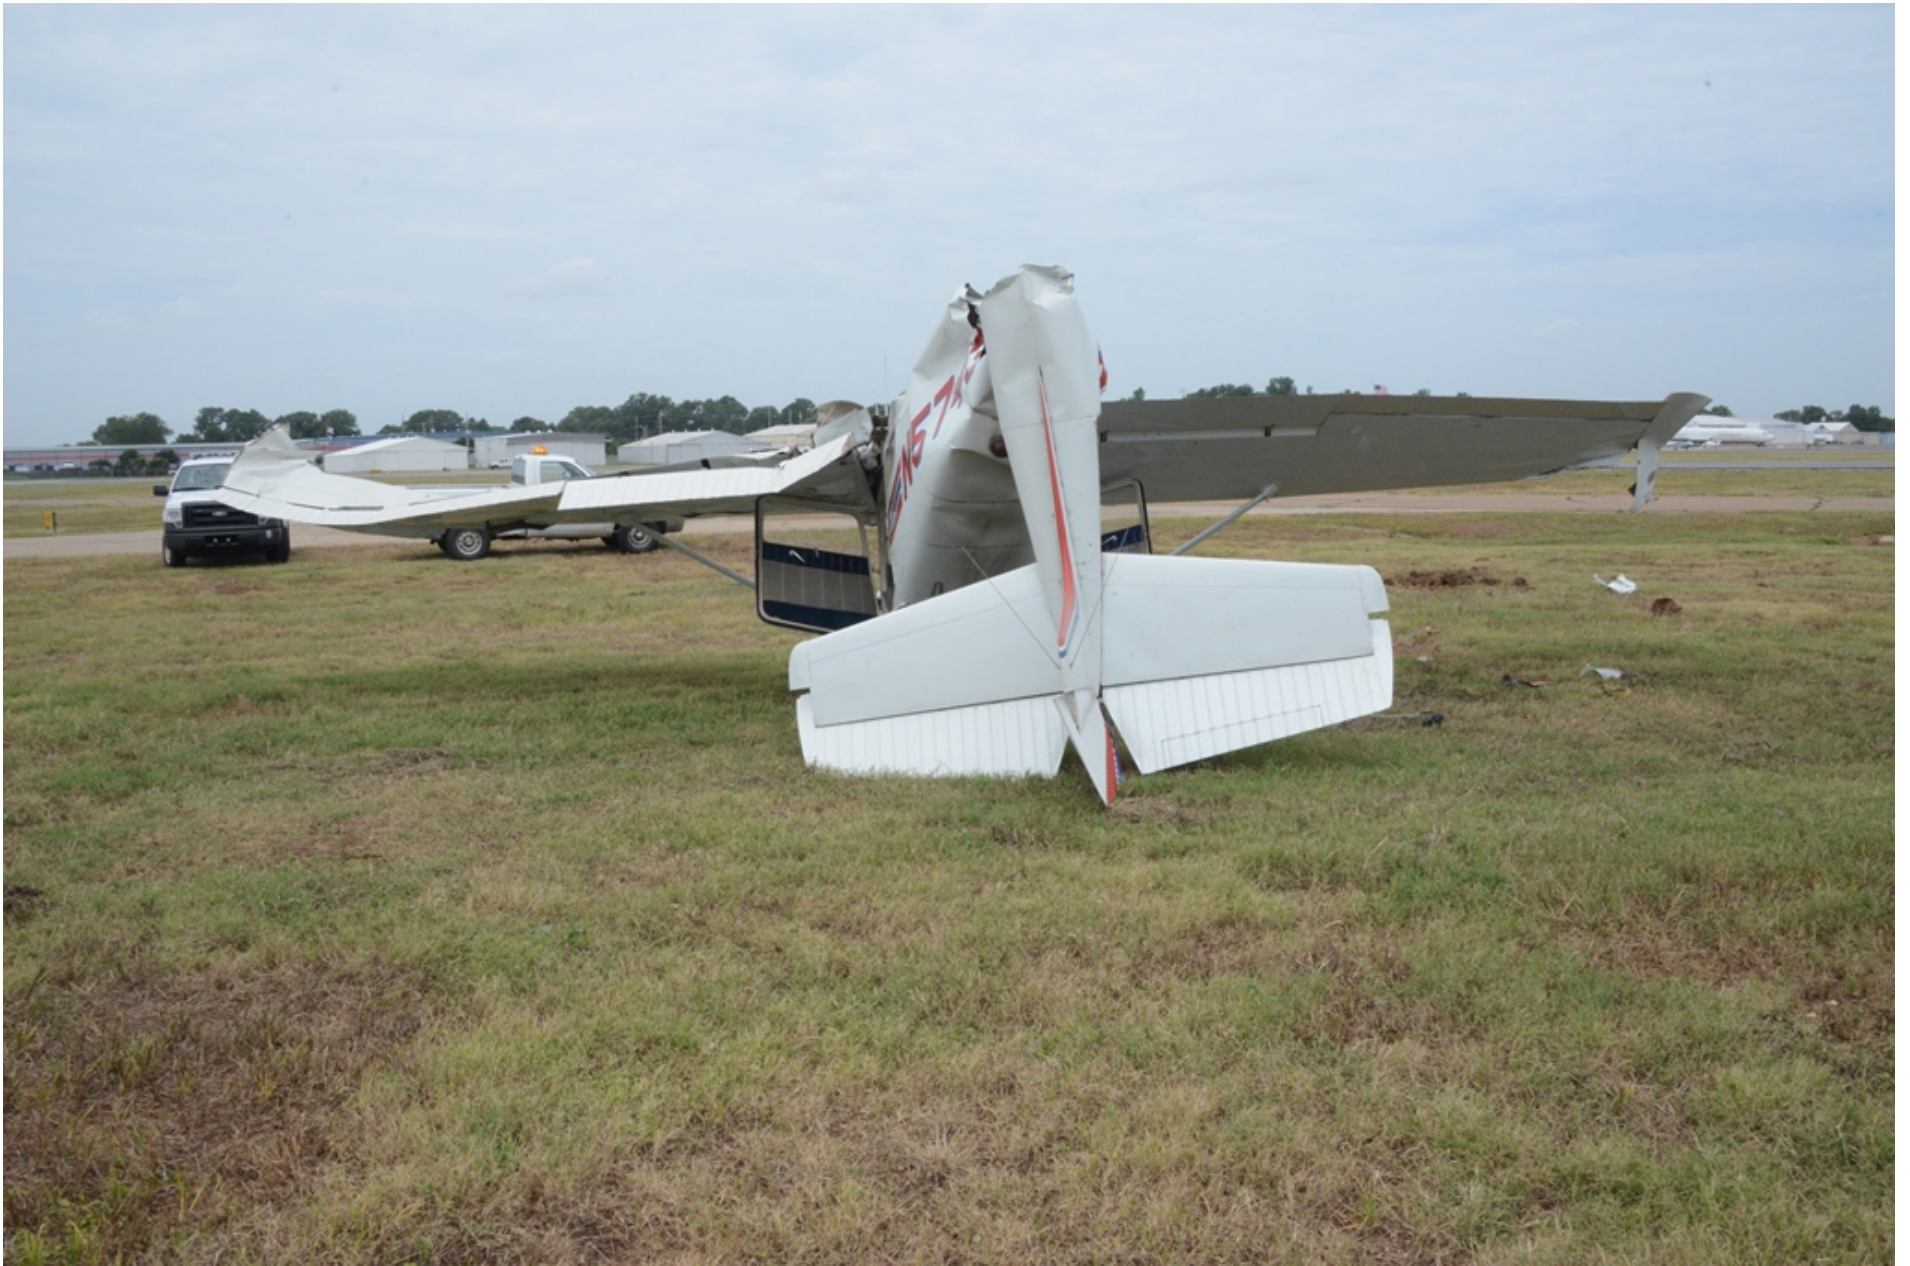
**Photo 3 - View of the airplane at the accident site.**

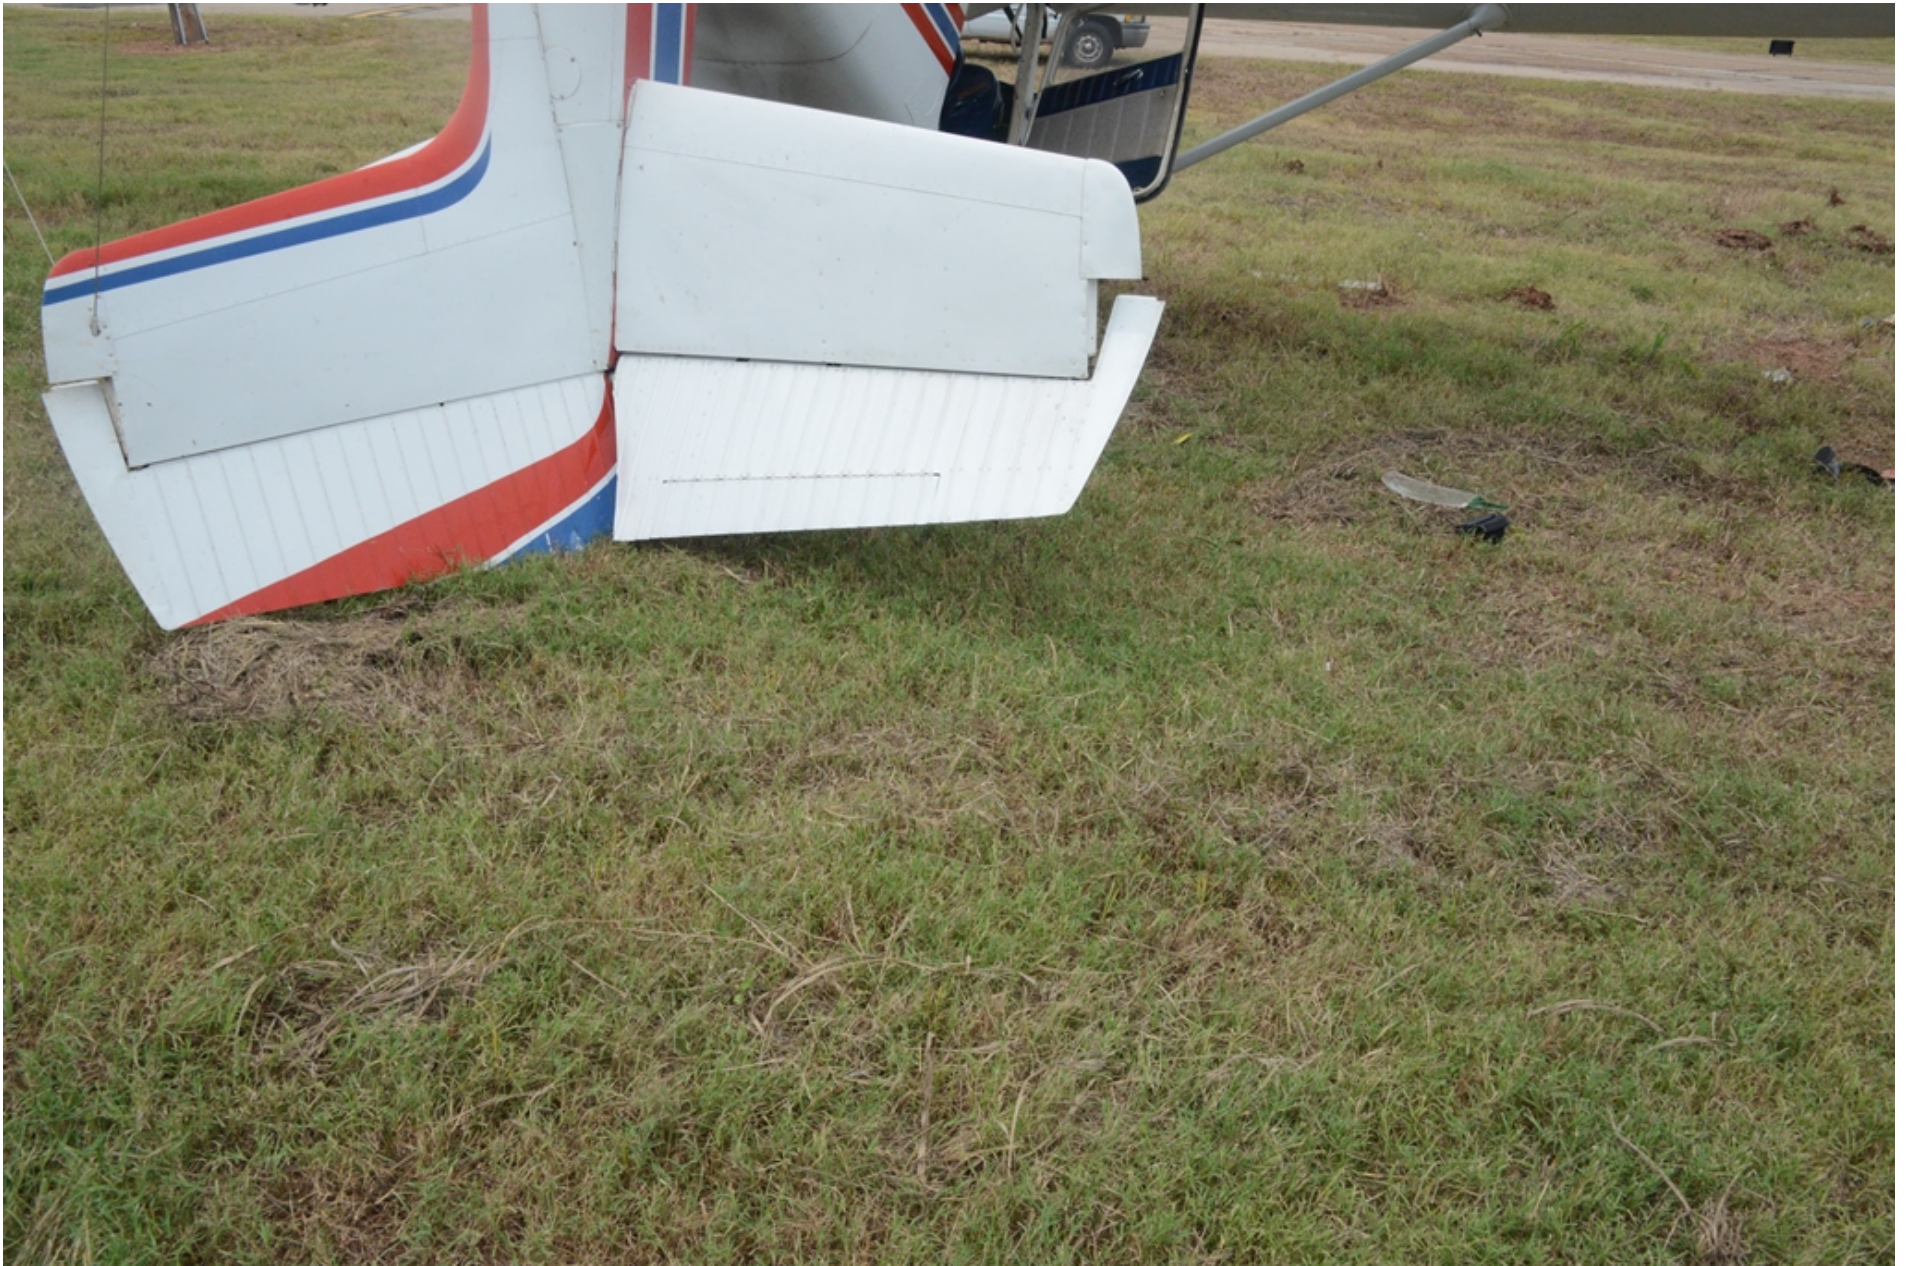
**Photo 4 - View of the airplane's empennage at the accident site.**

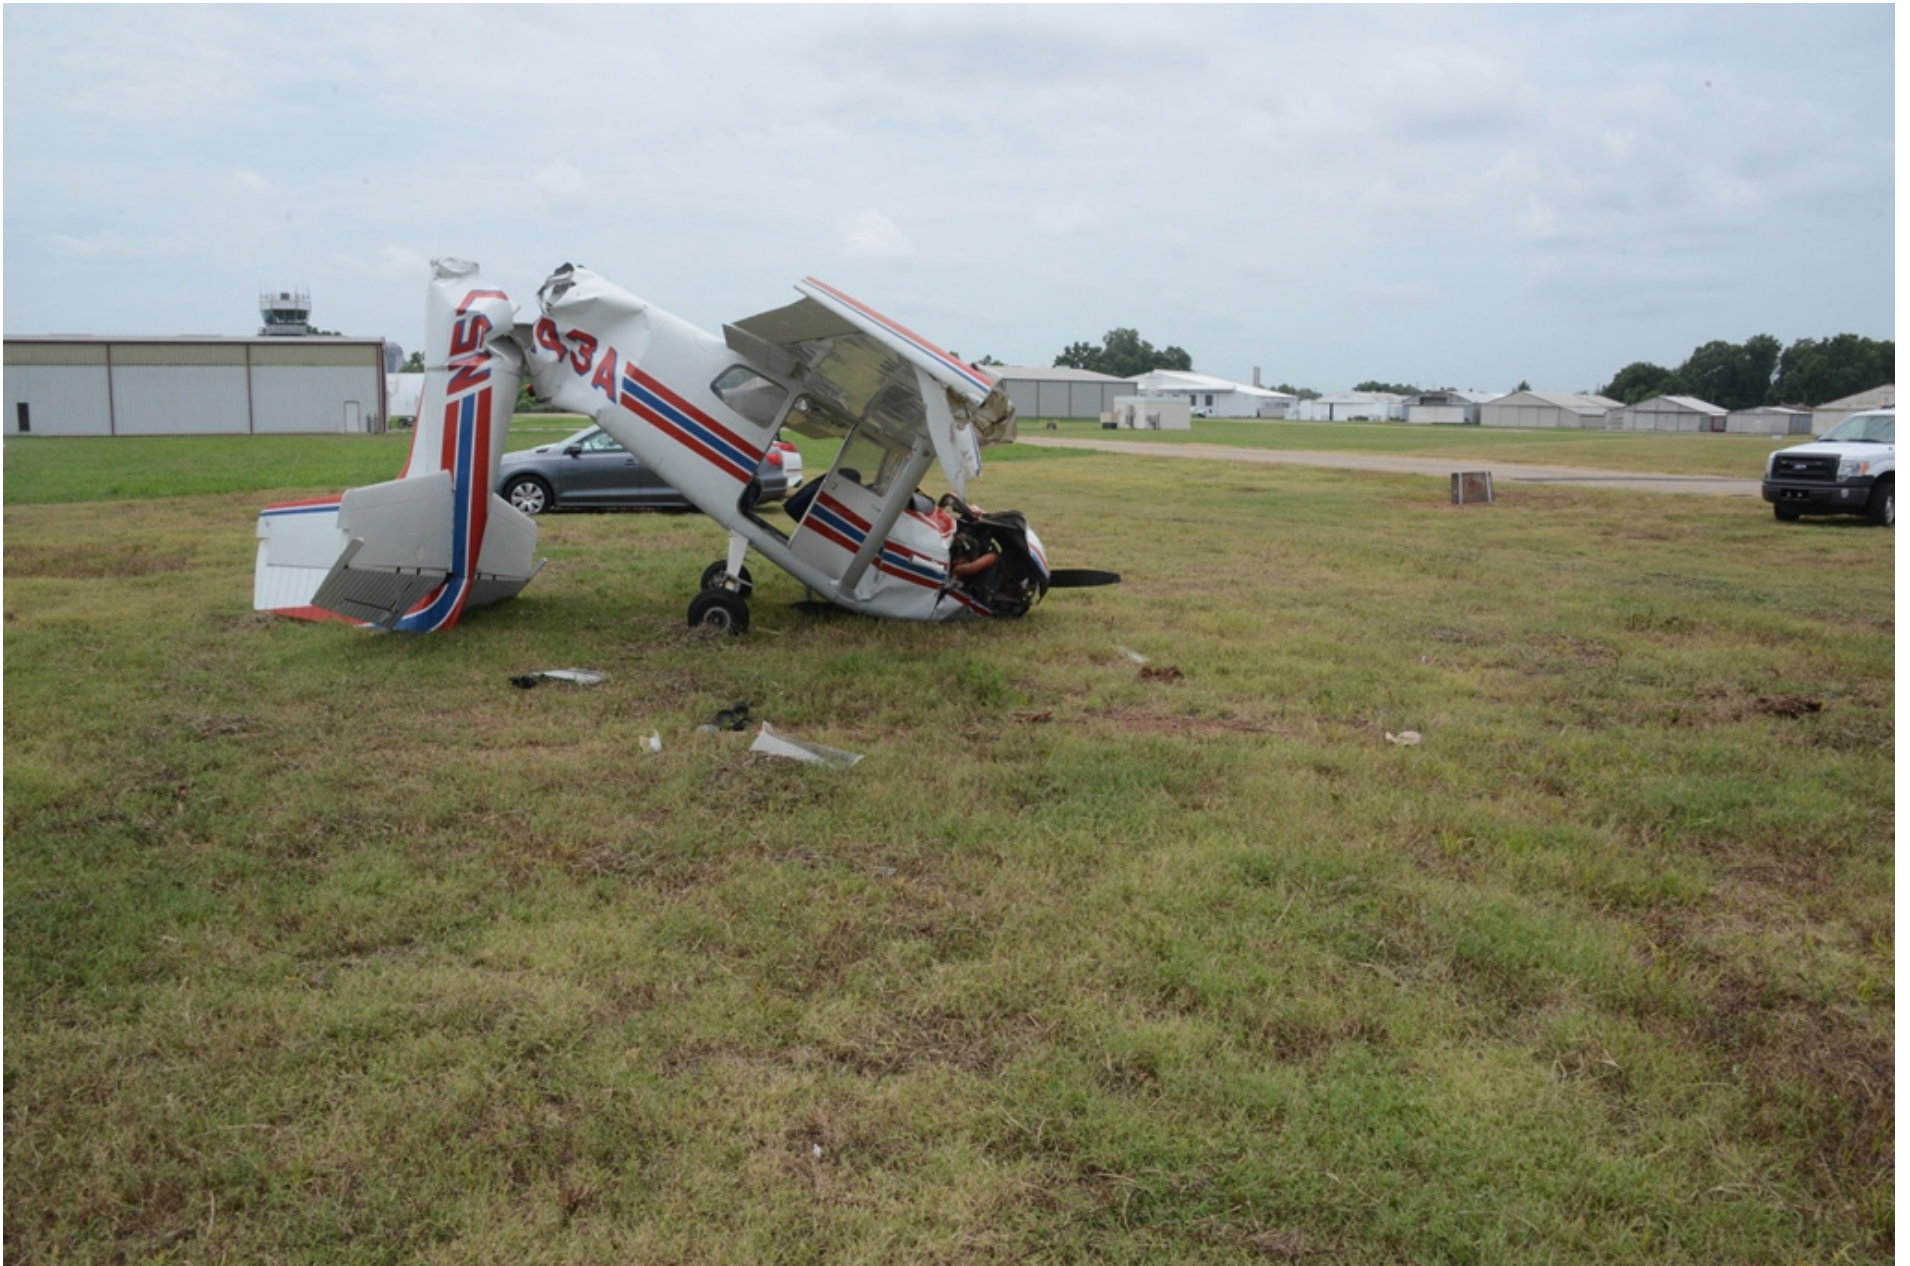
**Photo 5 - View of the airplane at the accident site.**

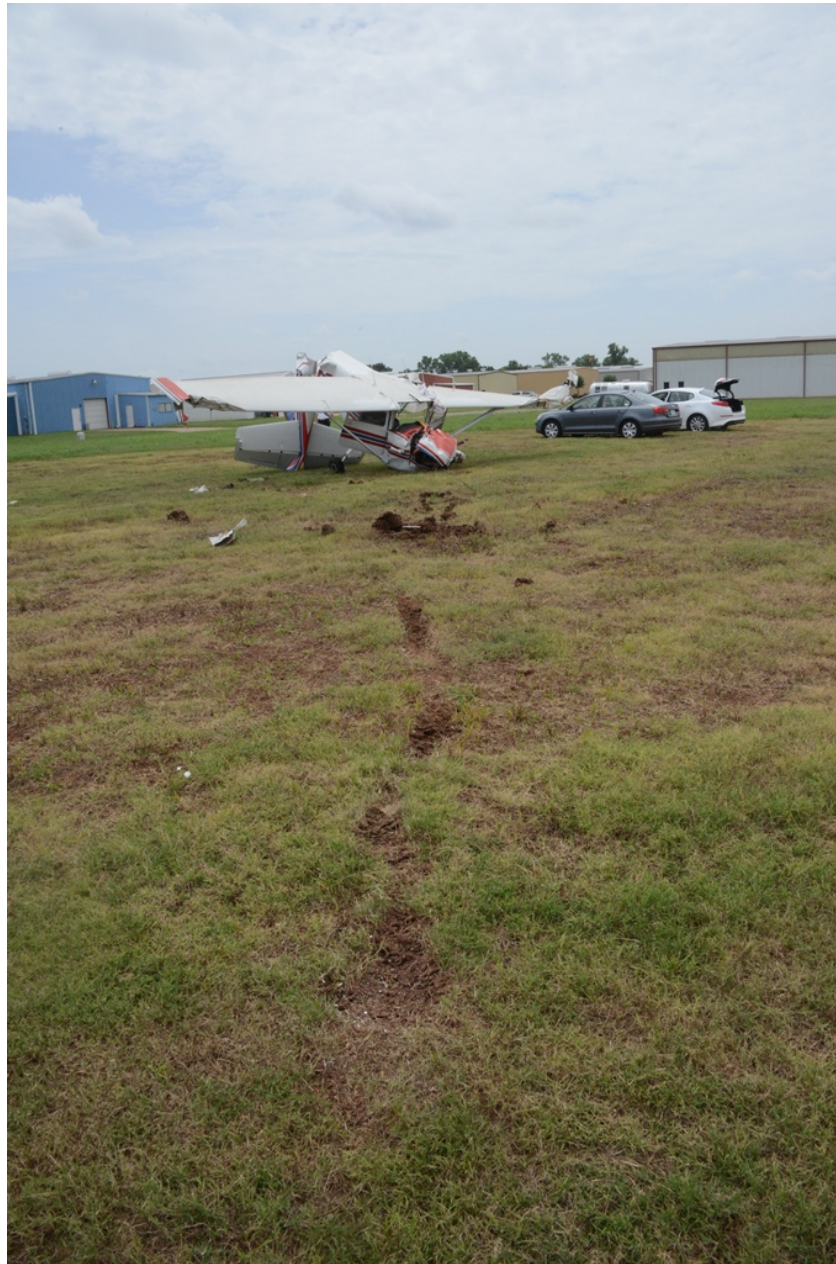
**Photo 6 - View of a ground scar at the accident site.**

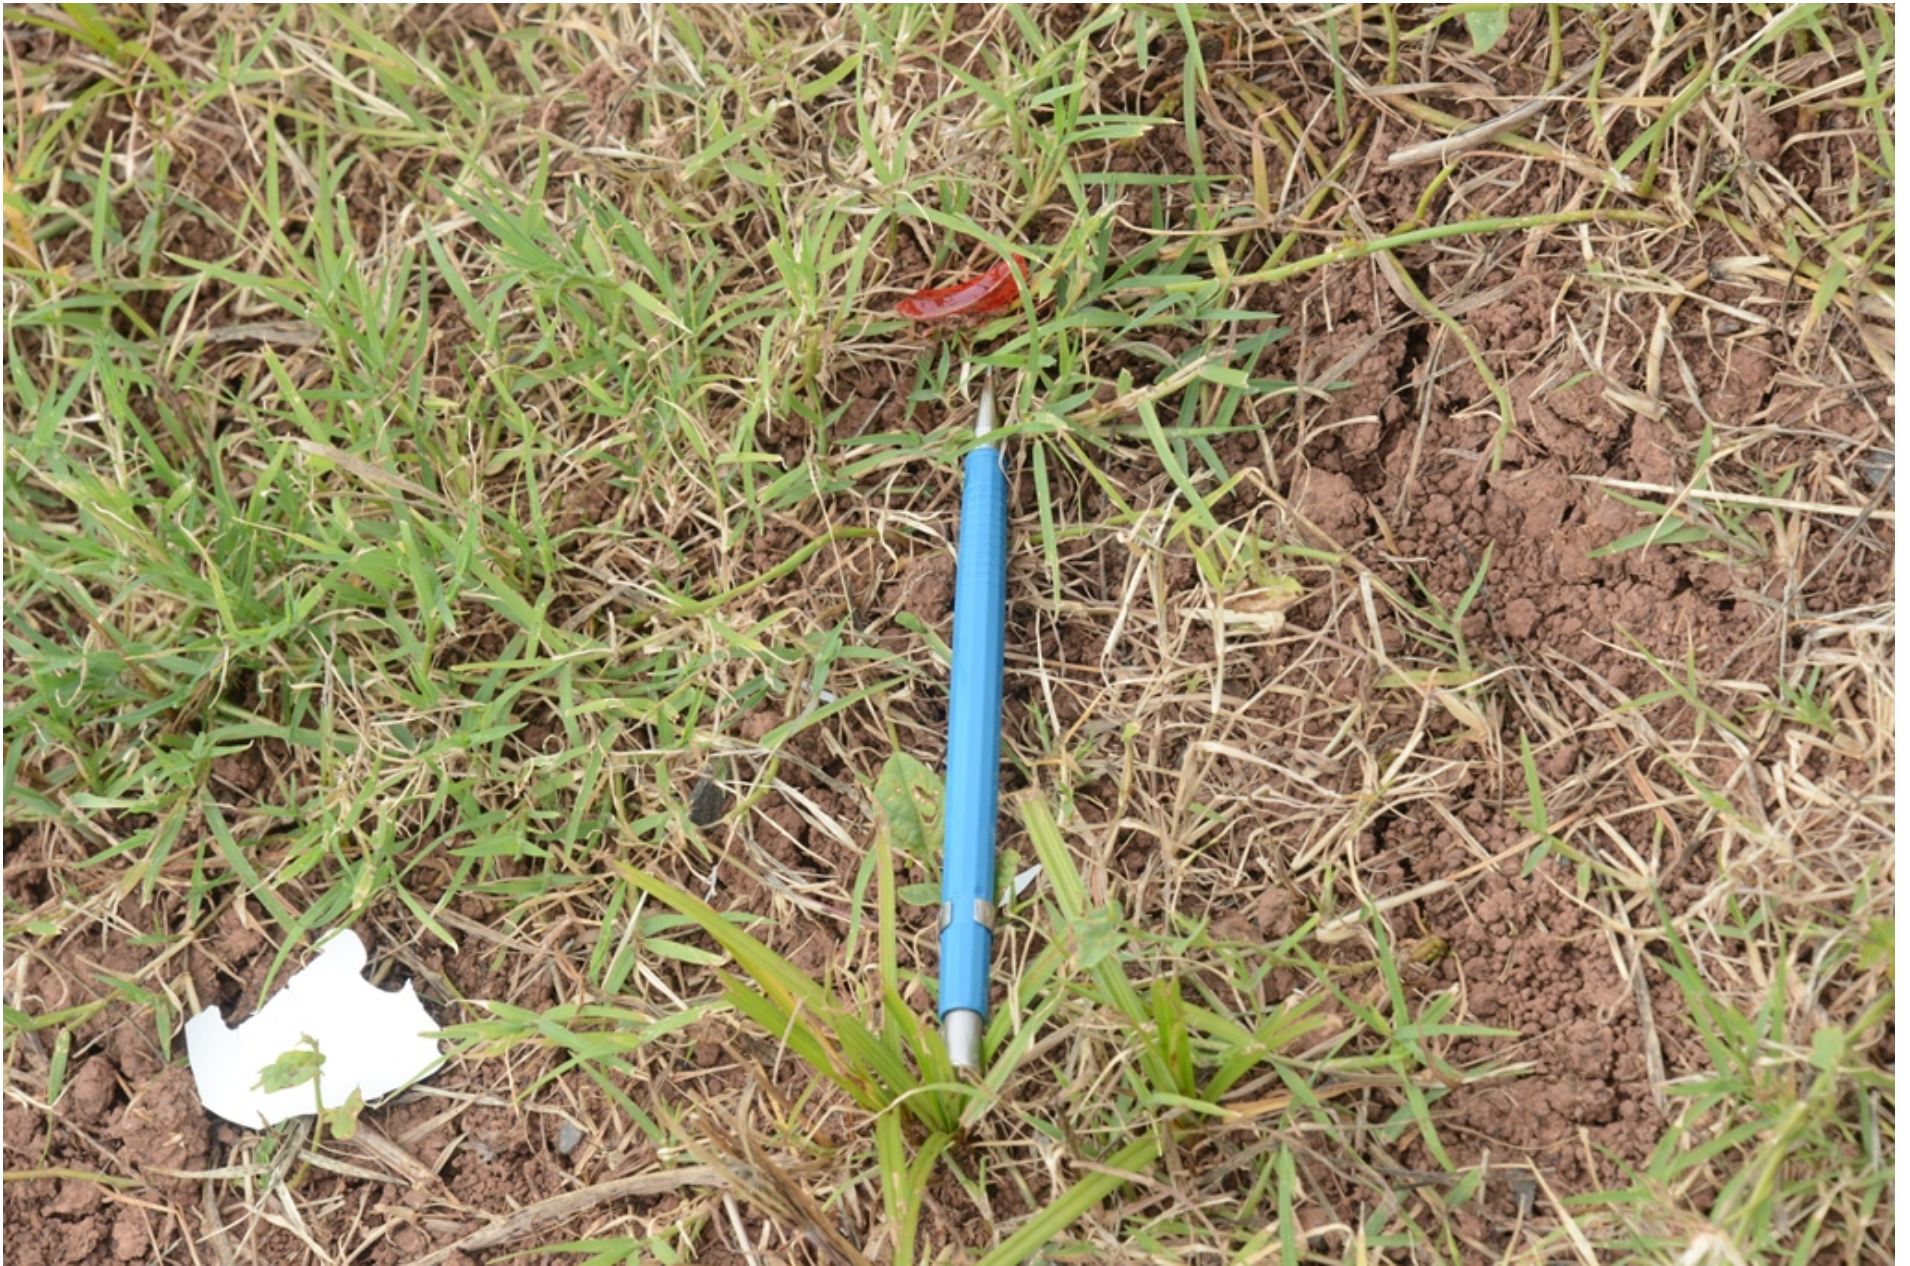
**Photo 7 - View of red media in a ground scar at the accident site.**

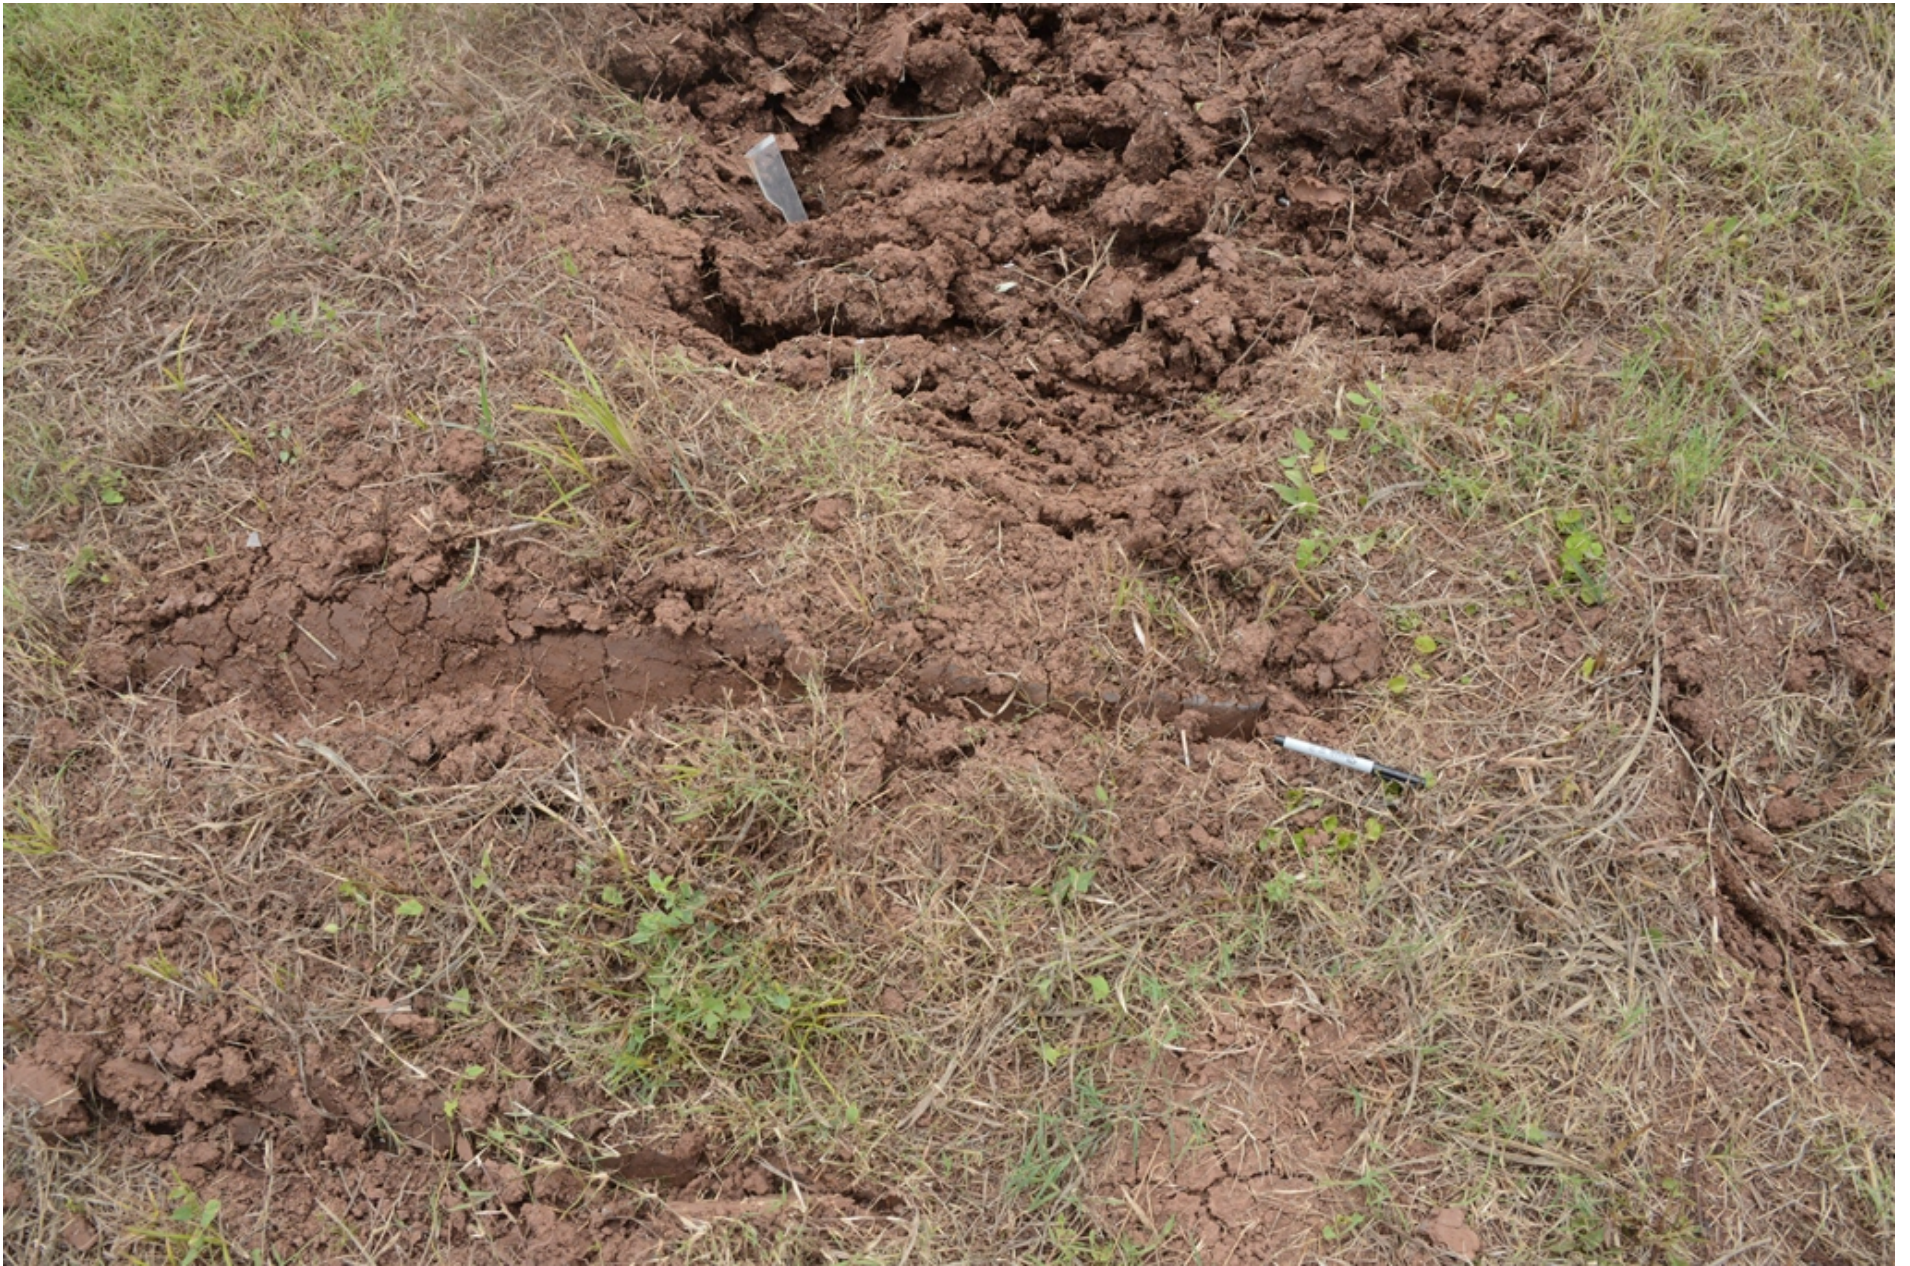
**Photo 8 - View of a linear witness mark near a ground scar at the accident site.**

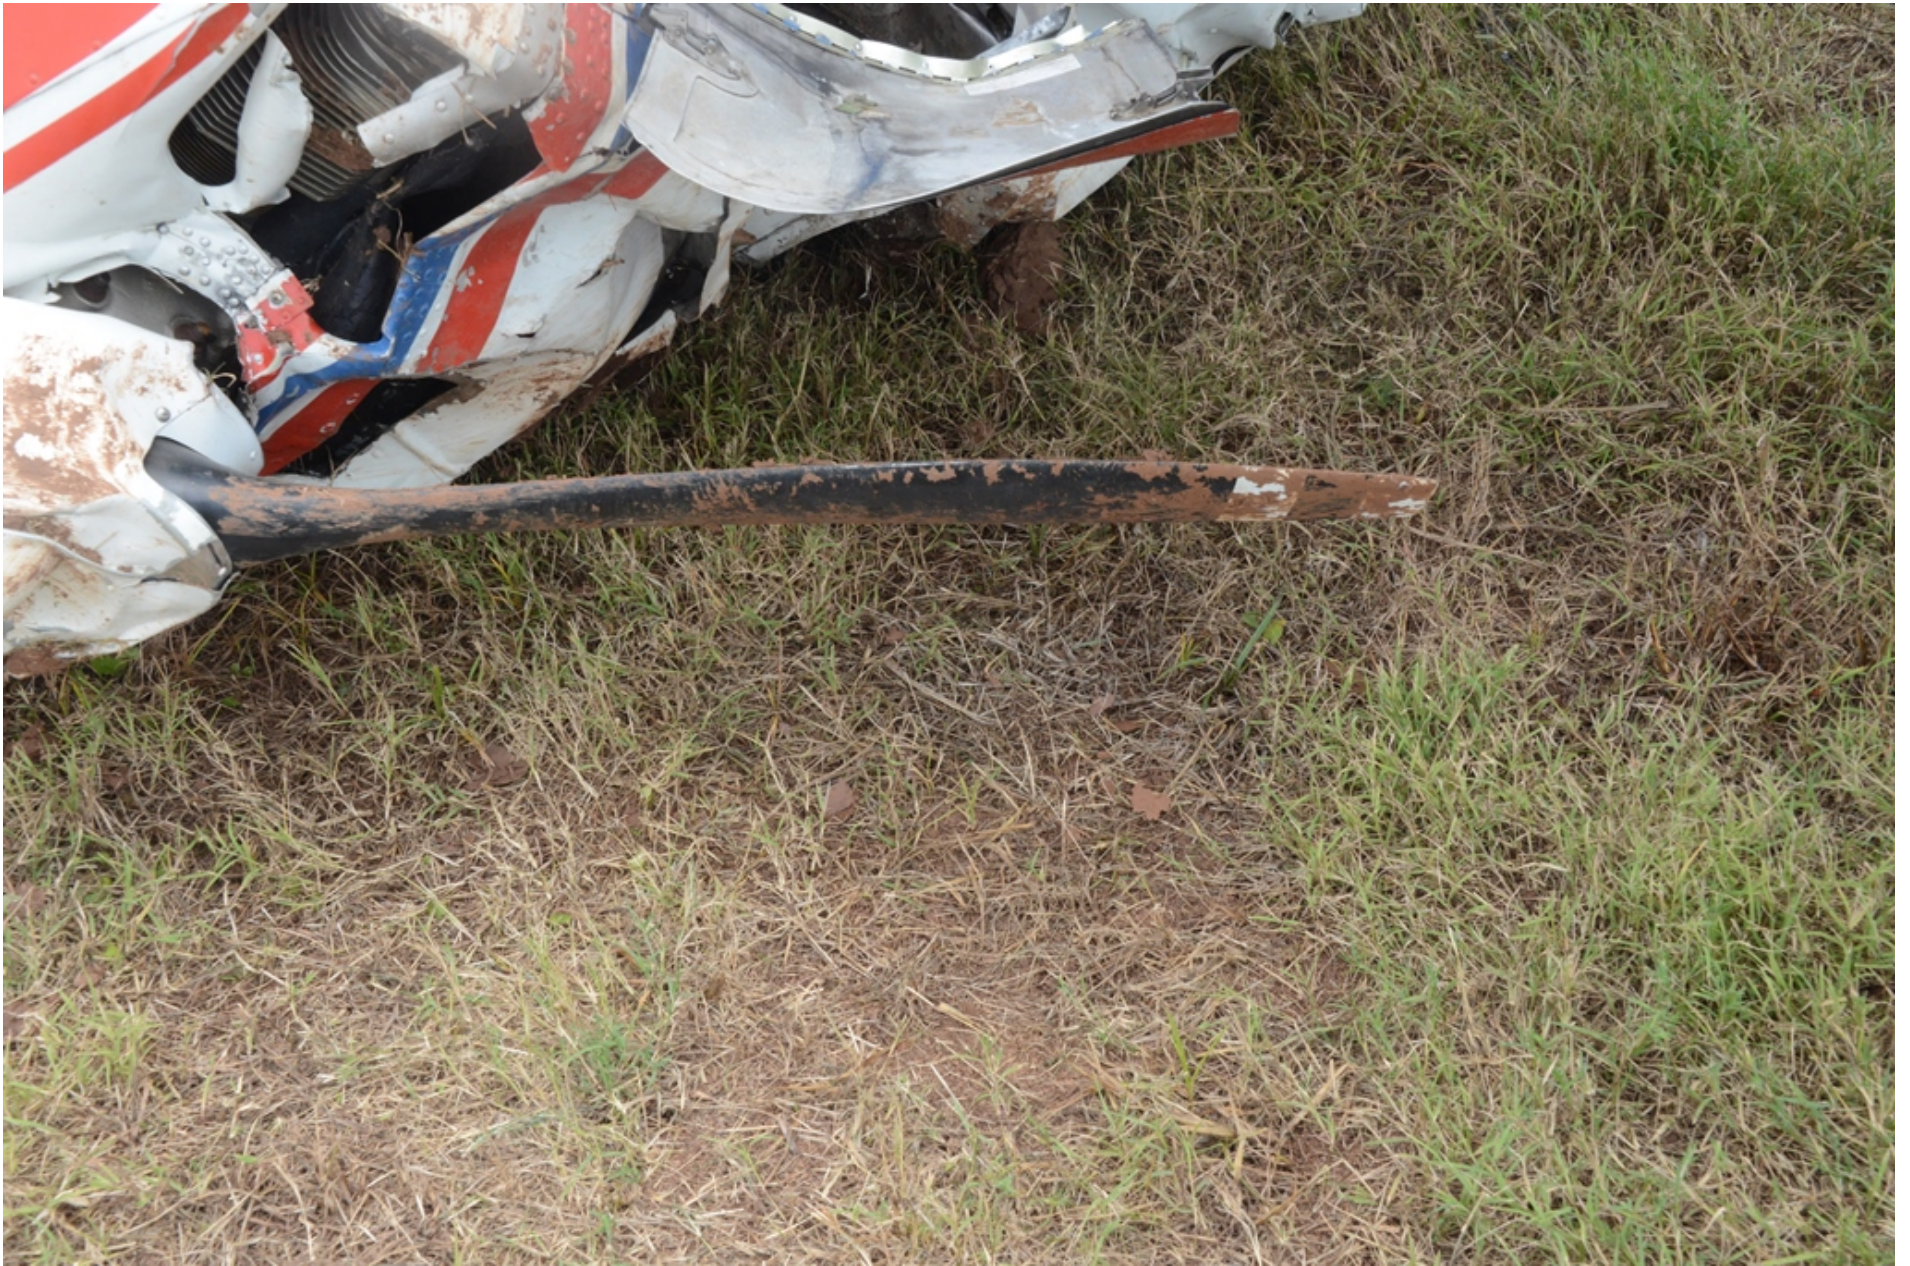
**Photo 9 - View of a propeller blade.**

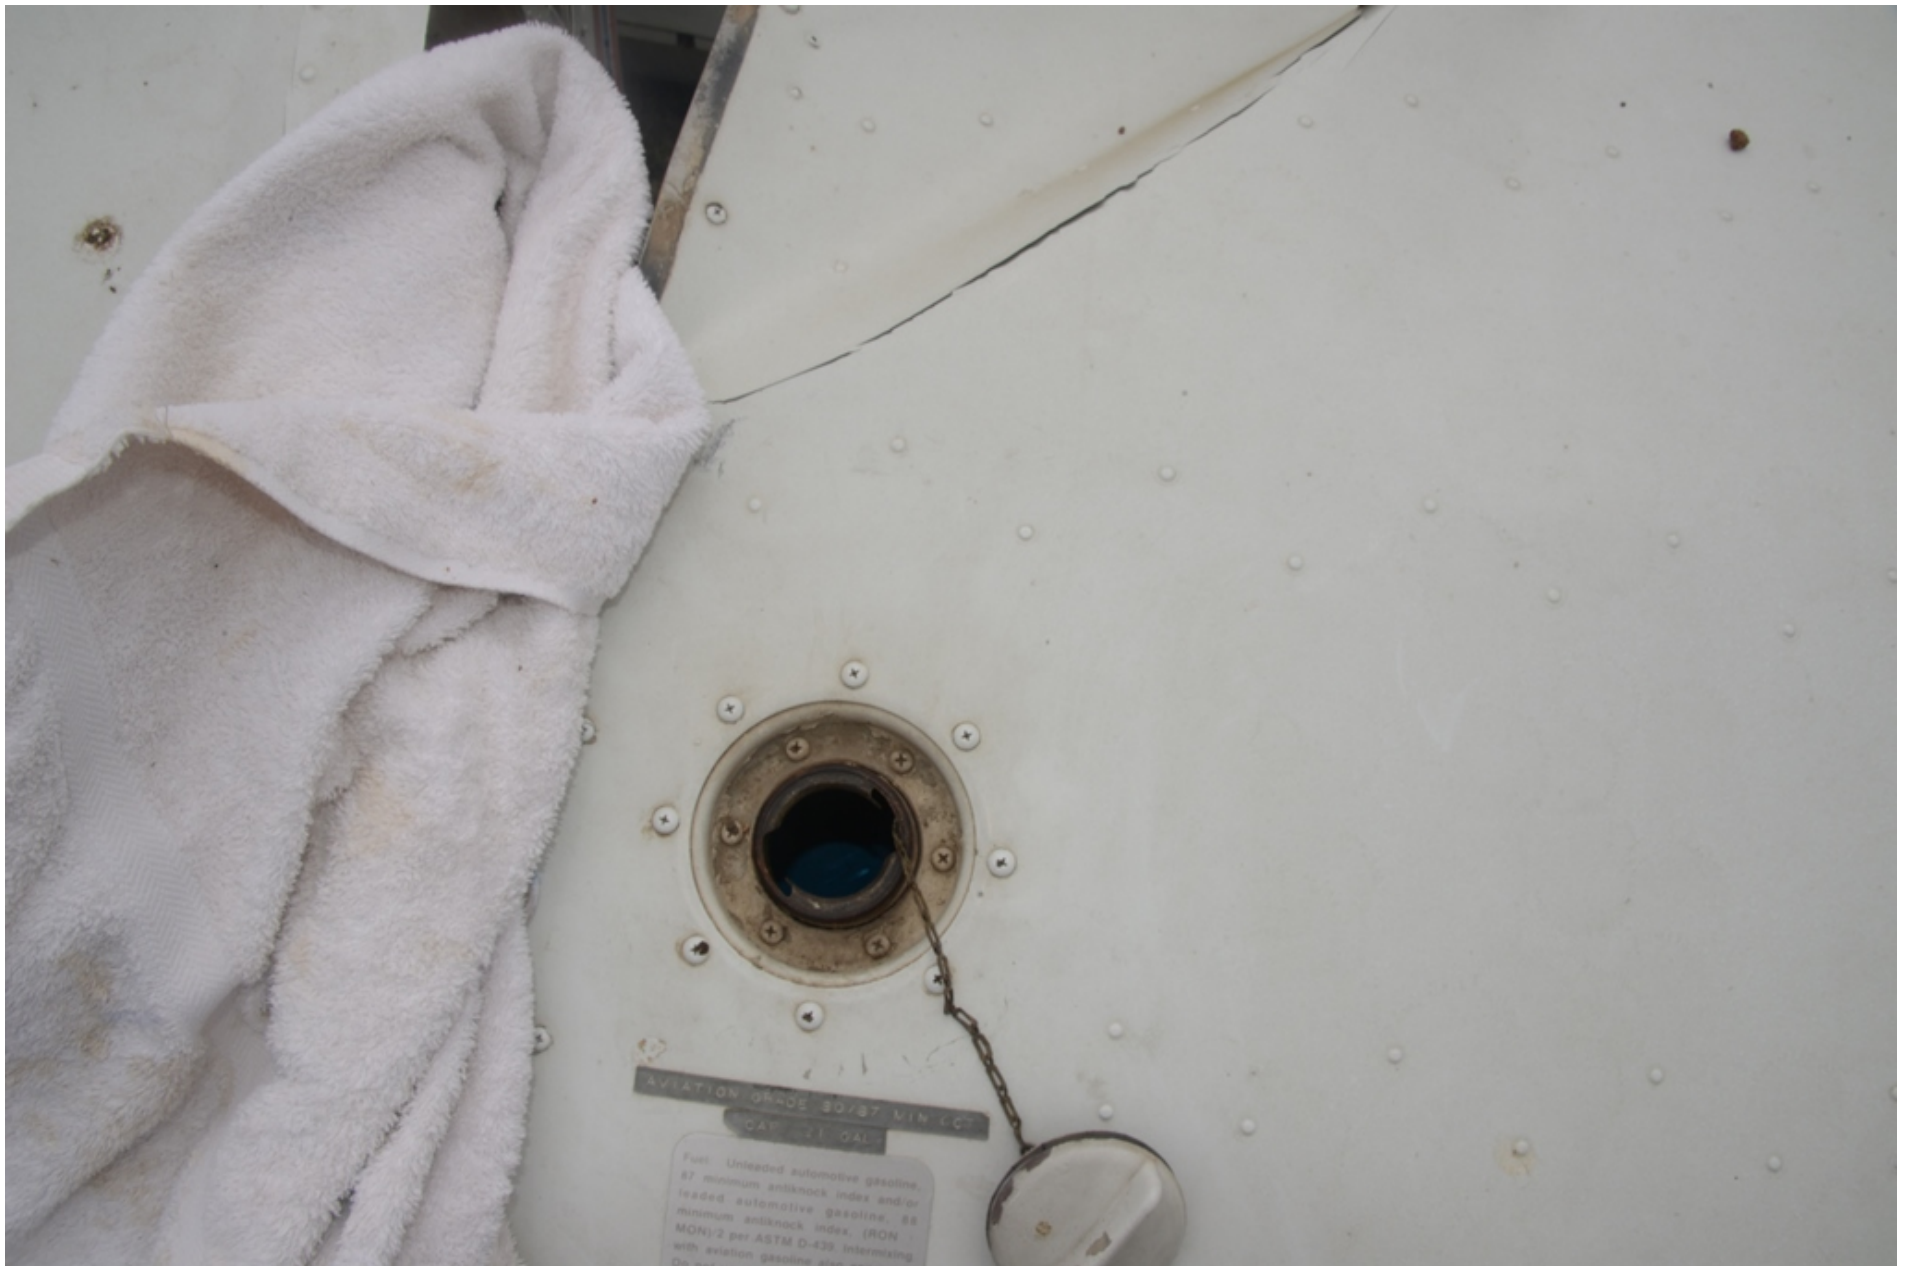
**Photo 10 - View of blue liquid below the left fuel tank's filler neck.**
