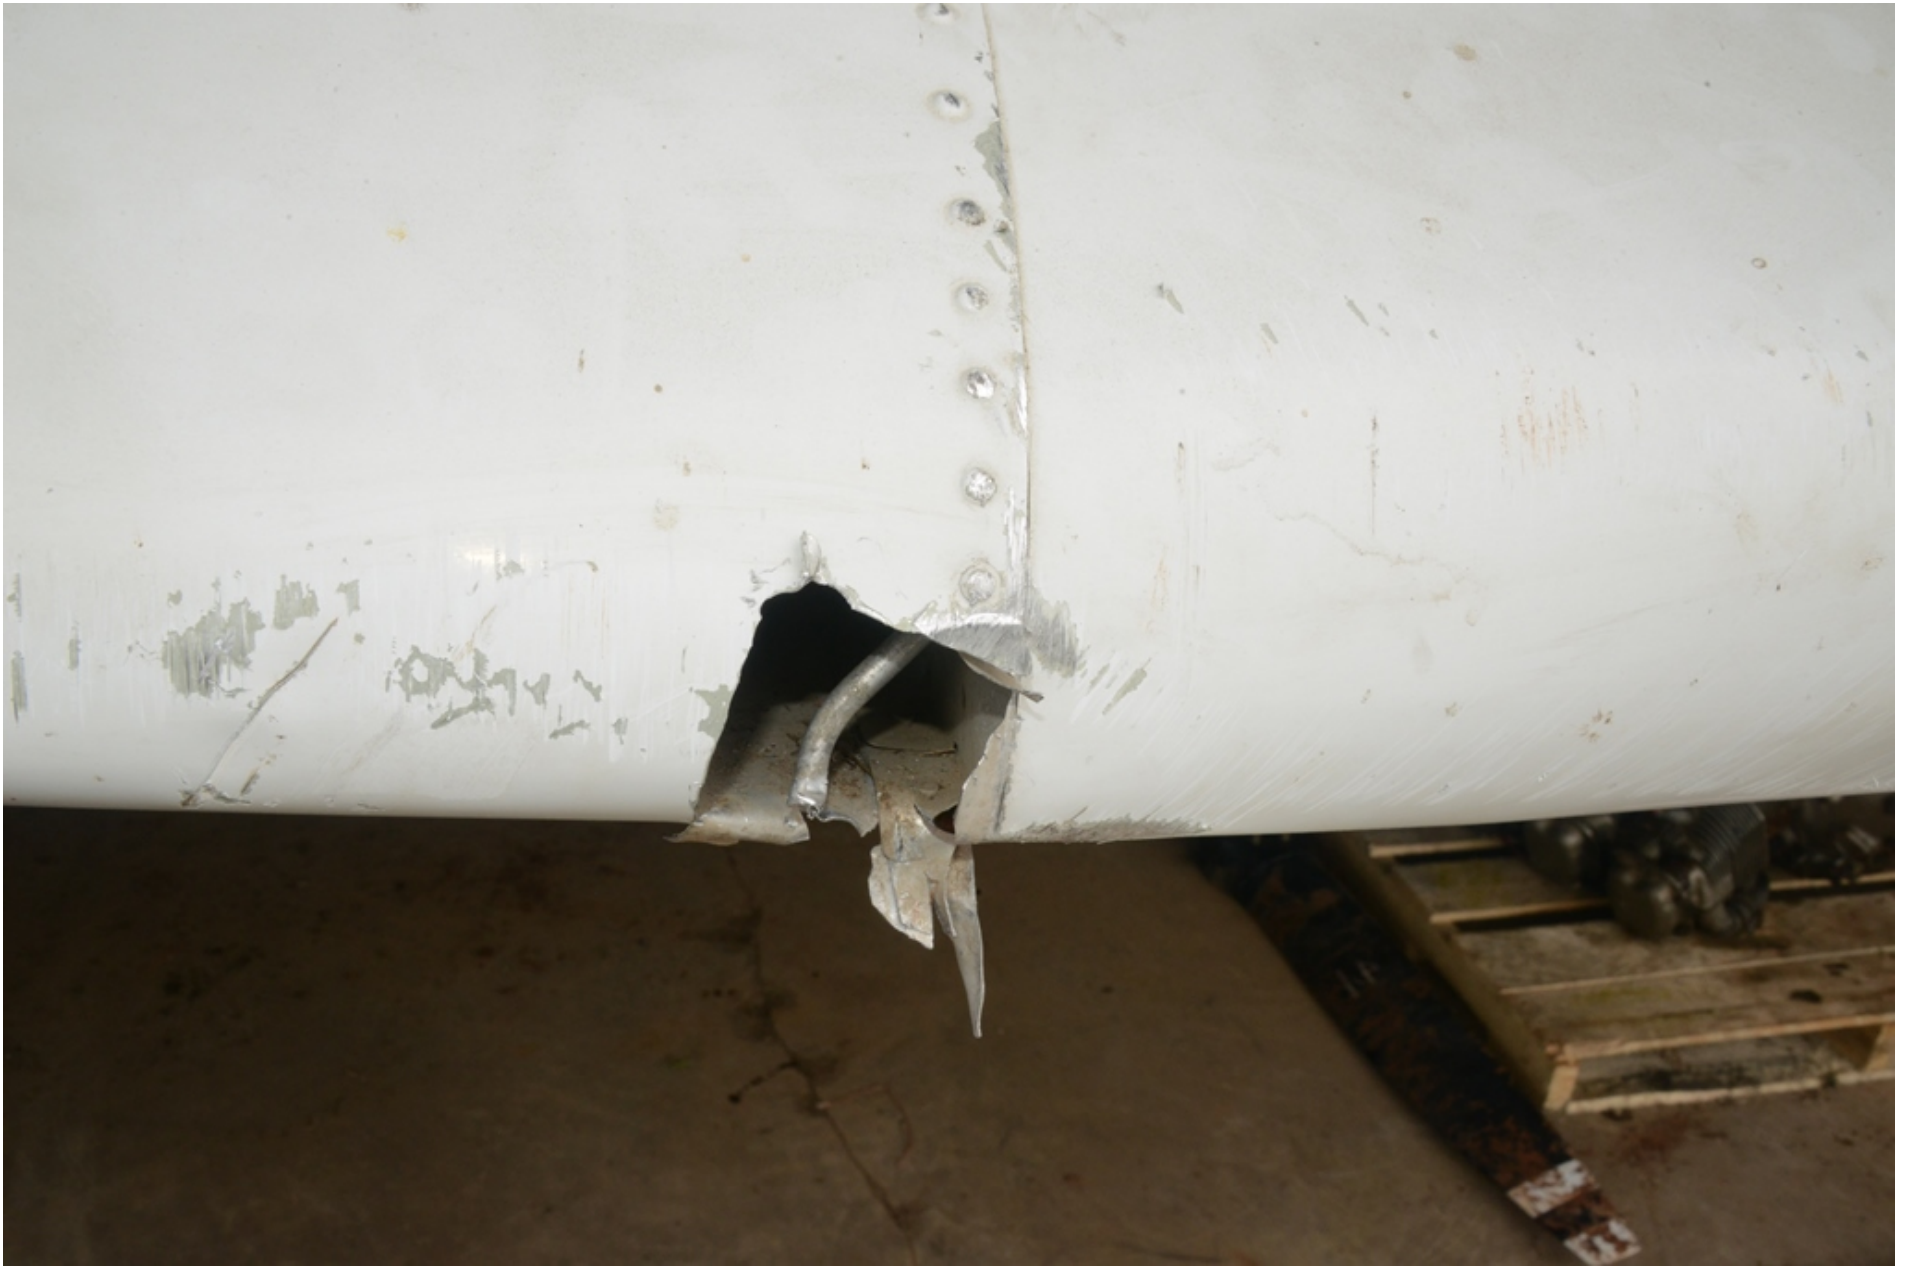
**Photo 11 - View of a tube within the pitot system.**

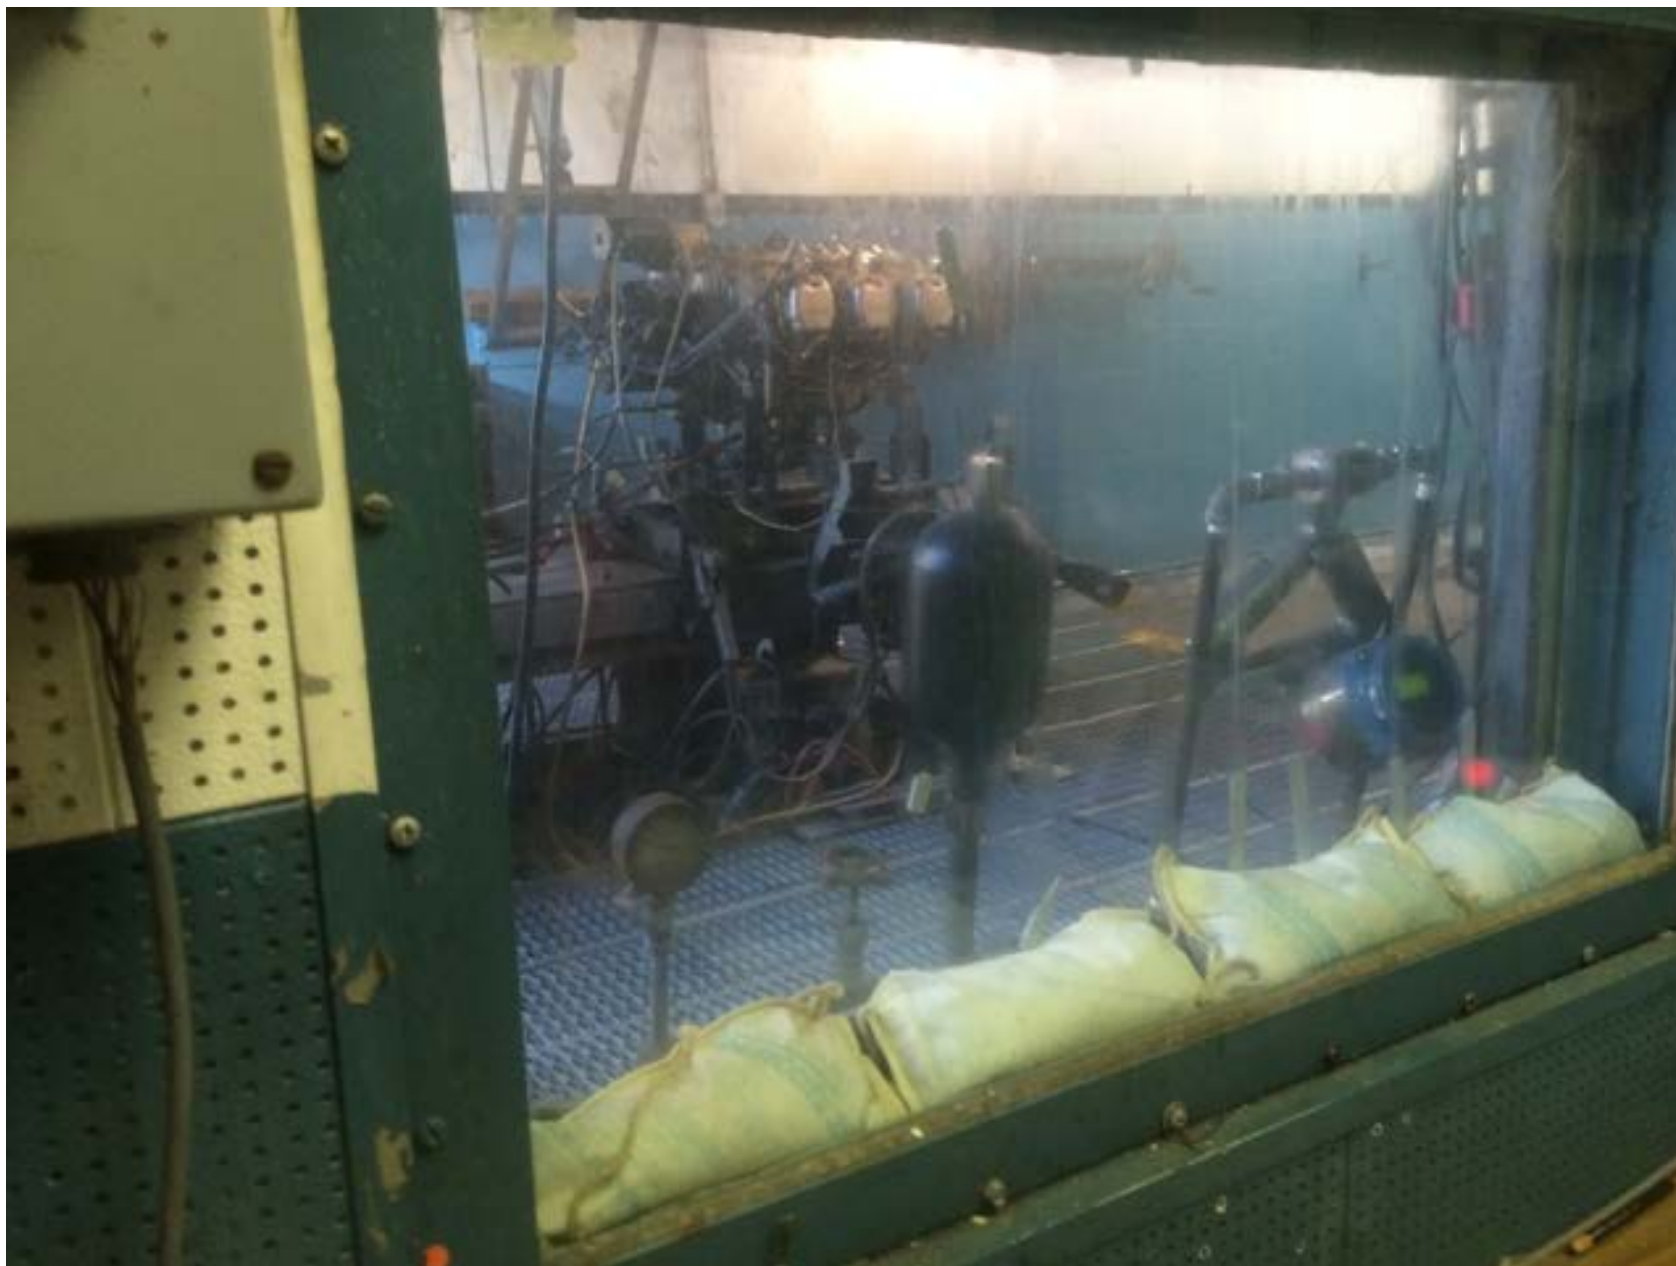
**Photo 12 - View of the accident engine operating in a test cell.**

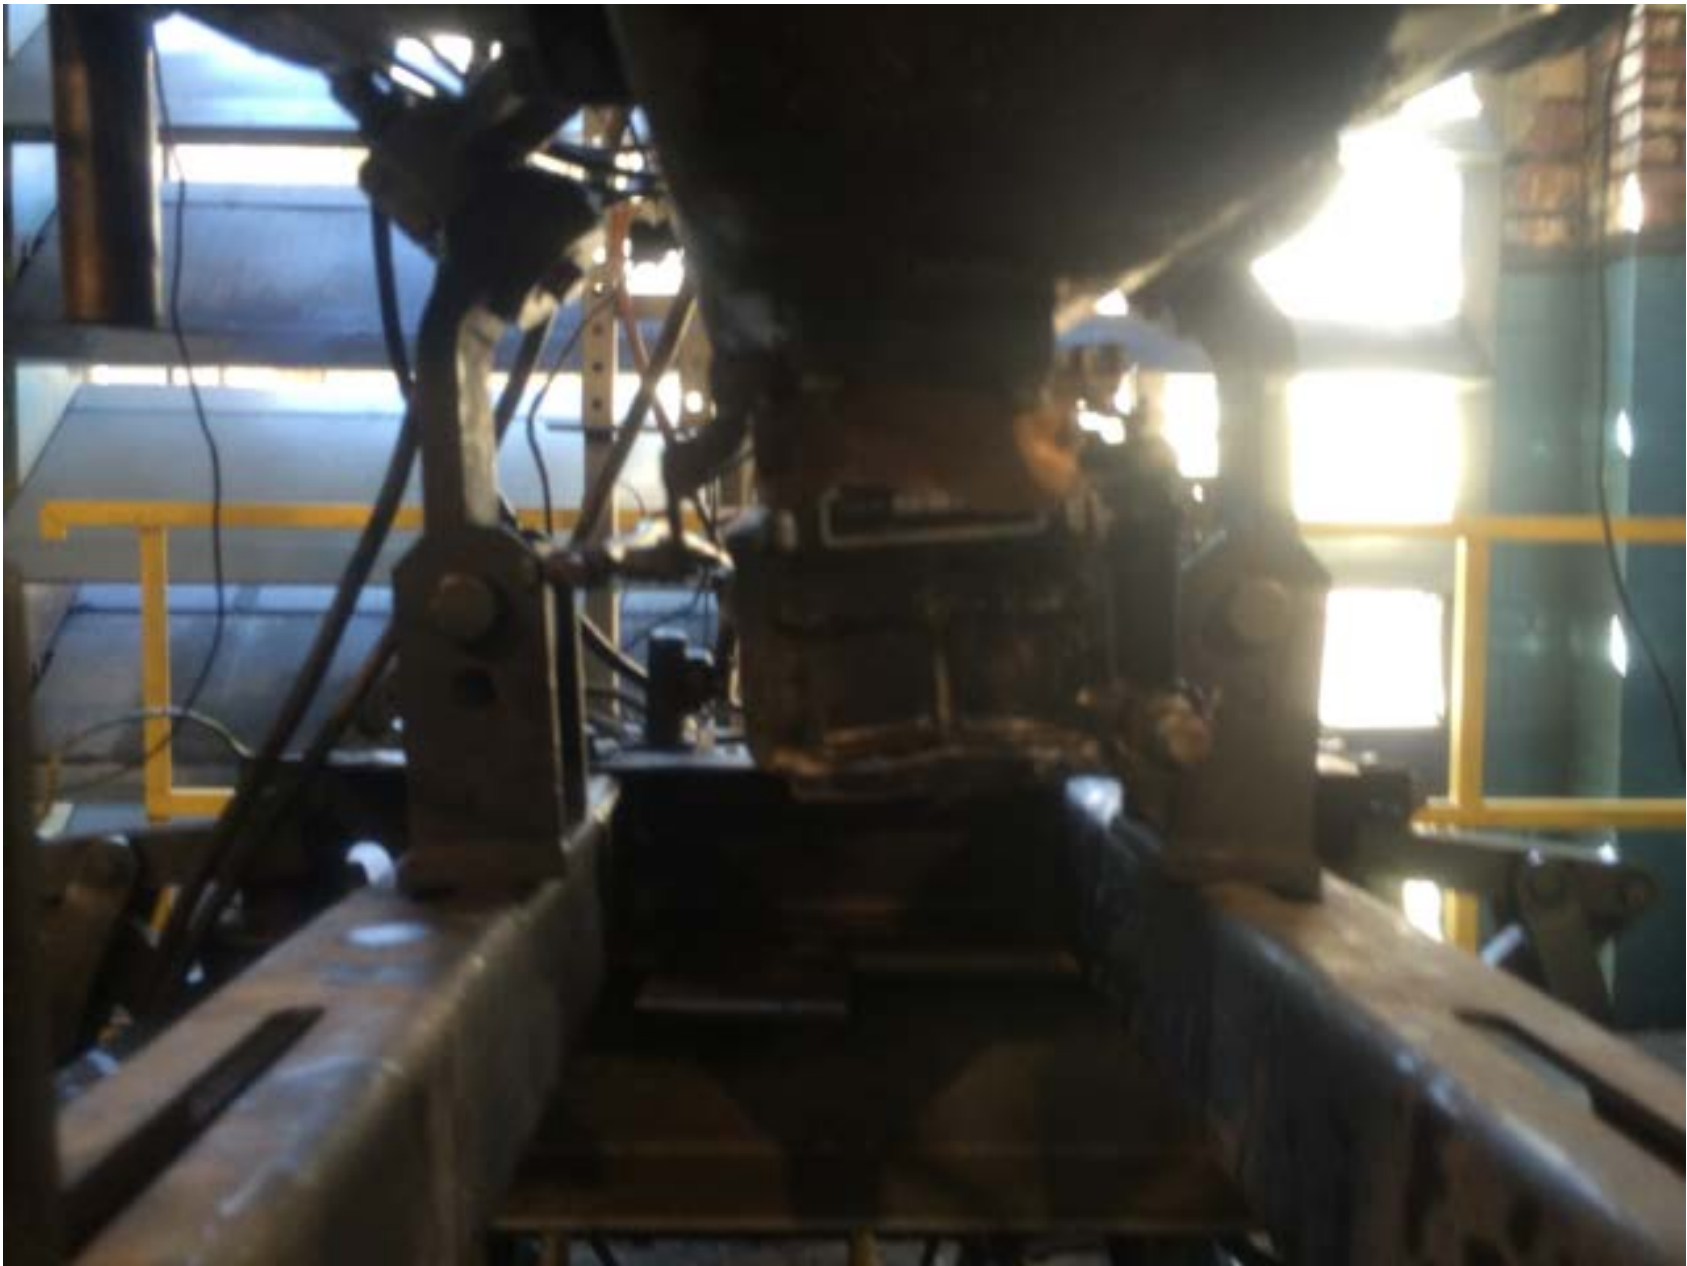
**Photo 13 - View of the repaired carburetor mounted on the accident engine within the test cell.**

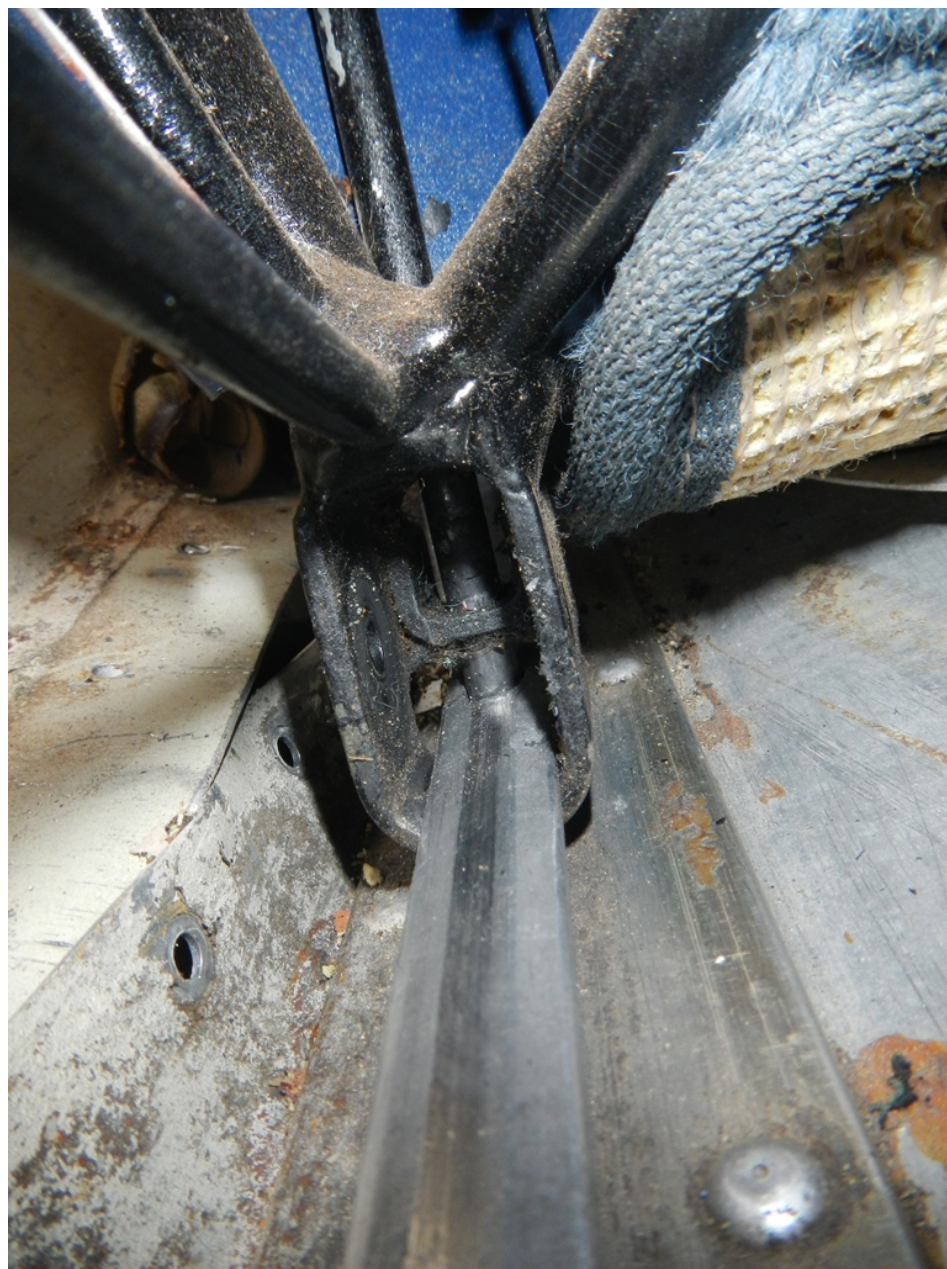
**Photo 14 - View of seat rail supplied by Textron Aviation.**
