## **NATIONAL TRANSPORTATION SAFETY BOARD**

### **Group Chairman's Factual Report**

#### **AIR TRAFFIC CONTROL**

**CEN15FA311**

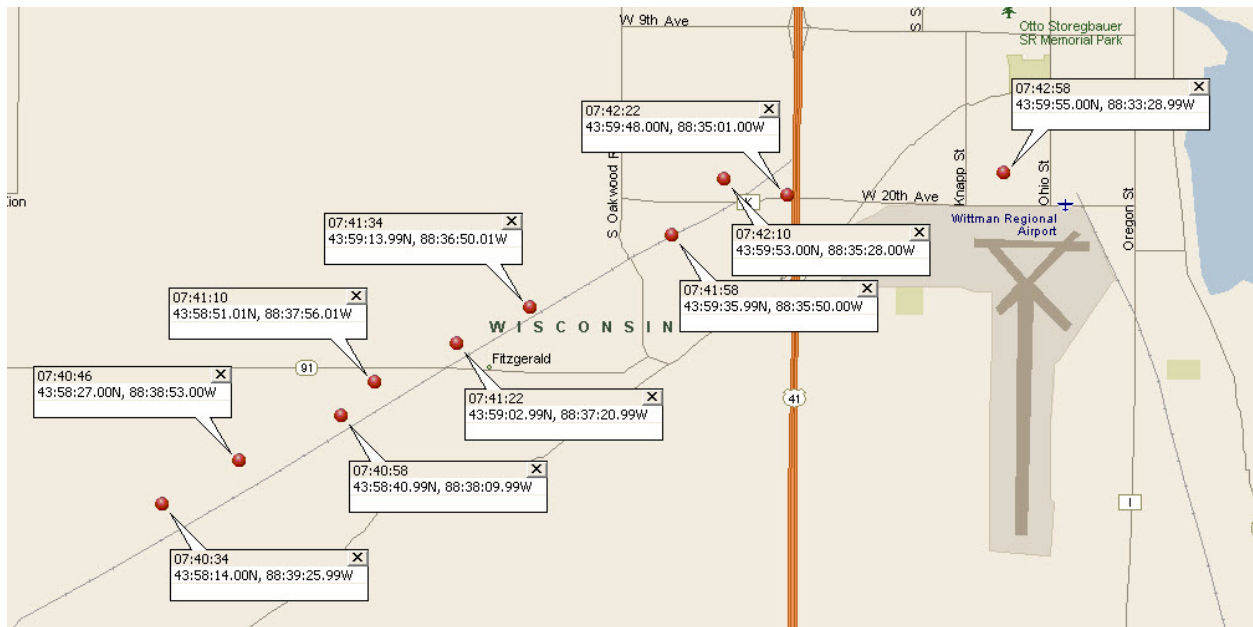
To prevent possible overloading of area ATC radar systems and controller displays by large numbers of transponder targets, the AirVenture NOTAM requests that aircraft using the Fisk arrival procedure set transponders to standby. The accident pilot did so: consequently, no transponder targets for N4BP in the vicinity of OSH were detected. Primary targets observed on the Fisk arrival entering downwind to runway 27 and consistent in timing with transmissions made to N4BP are shown in figure 2.

Figure 2: Primary radar targets from the Horicon radar site. The North Local communicator transmitted, “Malibu on downwind start your descent” at 0742:24, and at 0742:44 transmitted, “Turn abeam the numbers, runway 27 green dot cleared to land.”

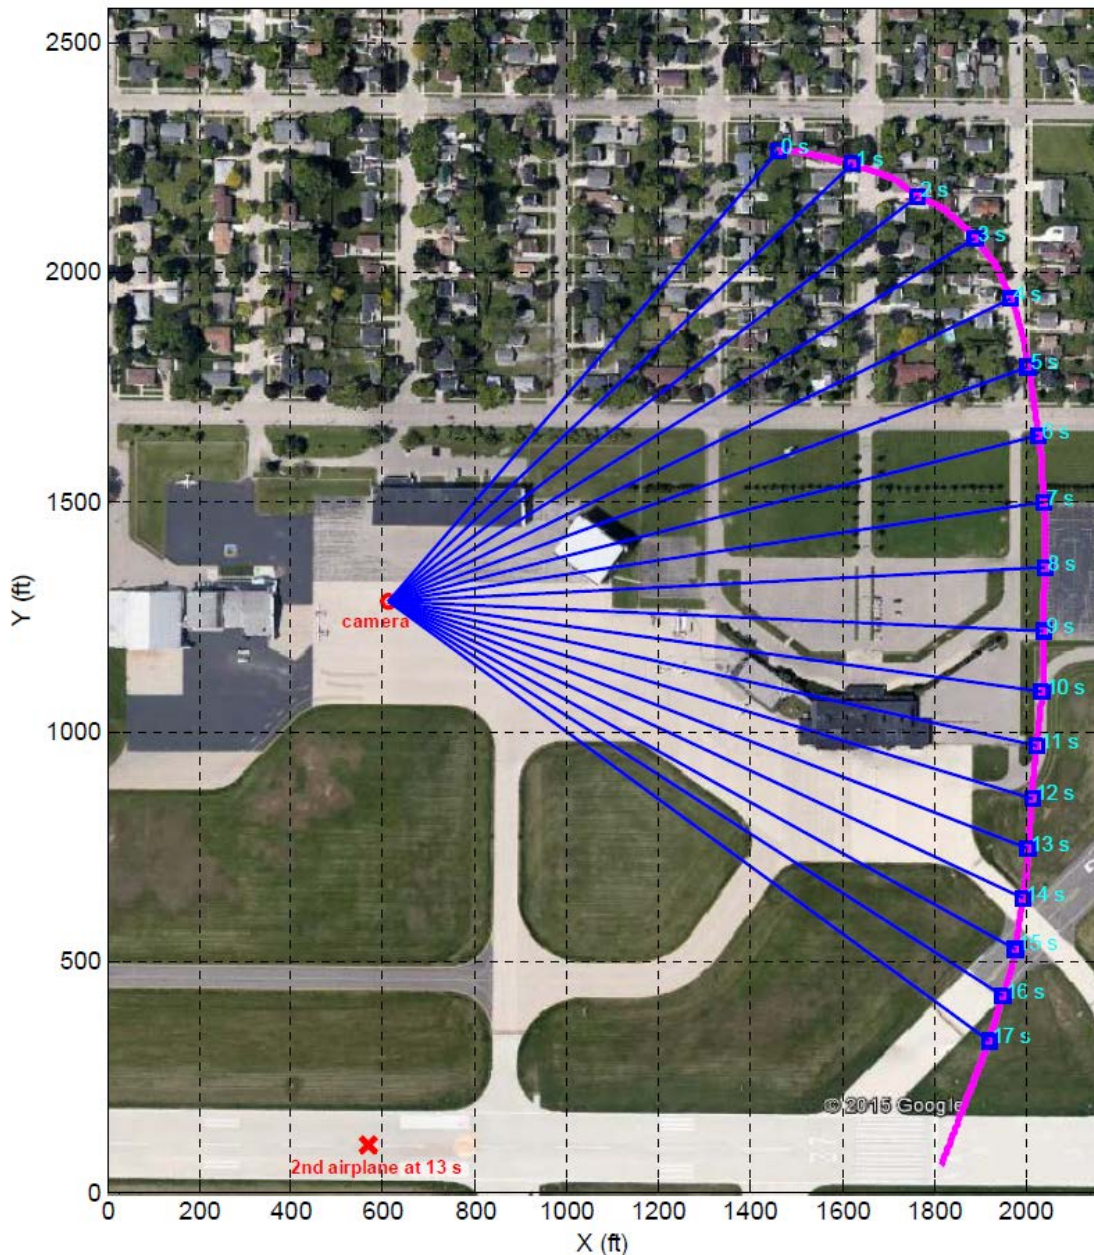
Figure 3: Graphic from video study showing estimated relative positions of N4BP and the preceding runway 27 departure.

At time 13 s on the graphic, the east/west lateral distance between the two aircraft was about 1450 feet. The departure was accelerating down the runway for takeoff, although the aircraft's exact speed at that time could not be established from the video and is unknown. For the remainder of the flight, N4BP's ground track was mainly southbound and moved only 100 feet to the west during the next 4 seconds, the equivalent of about 15 kts toward the departing aircraft. To the extent that the departing aircraft's speed was at or above 15 kts after time 13 s, the minimum east/west distance (equivalent to runway separation) between the two aircraft ground positions can be estimated as 1450 feet and increasing.

*The required radius of the turn is  $R=655$  ft (see Figure 3). The length of the  $\frac{1}{4}$  circle trajectory is  $(\pi/2)R=1029$  ft. The estimated speed at time 13 s was 109.7 ft/s. Therefore, the time required to complete the hypothetical  $\frac{1}{4}$  circle turn is  $1029/109.7=9.4$  seconds.*

*If the second airplane stayed at the location where it is shown in Figure 3, when the accident airplane completed its turn, the estimated distance between the airplanes would have been  $2000-570-655=775$  ft. However, the second airplane was departing and moving west. To keep the separation between the airplanes at 1500 ft when the accident airplane completed the turn, during the 9.4 seconds the second airplane would have to move west at the average speed of  $(1500-775)/9.4=77.1$  ft/s= $45.7$  kts.*
