## **NATIONAL TRANSPORTATION SAFETY BOARD**

### **Group Chairman's Factual Report**

## **AIR TRAFFIC CONTROL**

**CEN15FA316**

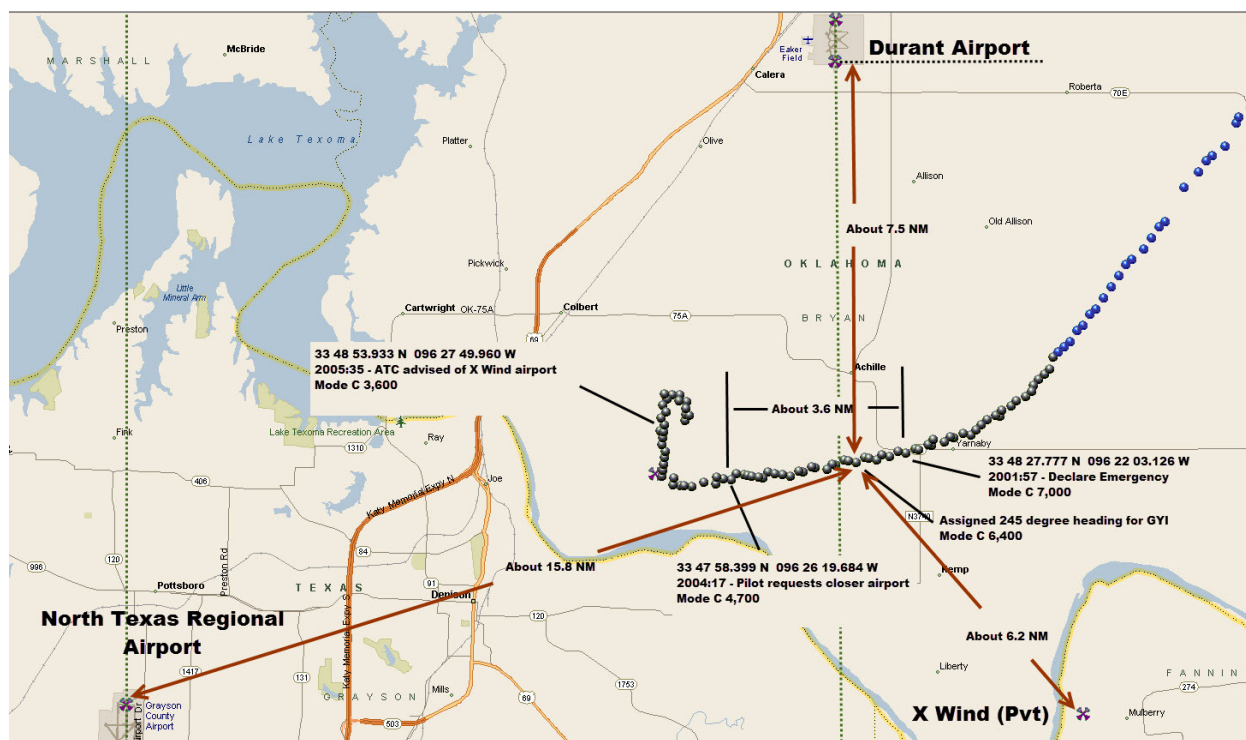
Radar data for this report was obtained from ZFW. Figure 1 illustrates the radar data superimposed on a map with GYI, DUA, and XWinds (Crosswinds Airport) identified. When the air traffic controller issued the pilot a vector of 245 degrees to GYI, the aircraft was 15.8 nm from the airport. It was only 7.5 nm south of DUA. About 3.6 nm later, the pilot requested a closer airport and the air traffic controller advised the pilot of the location of DUA.

**Figure 1 - N252G as the pilot was turned onto the final approach course.**

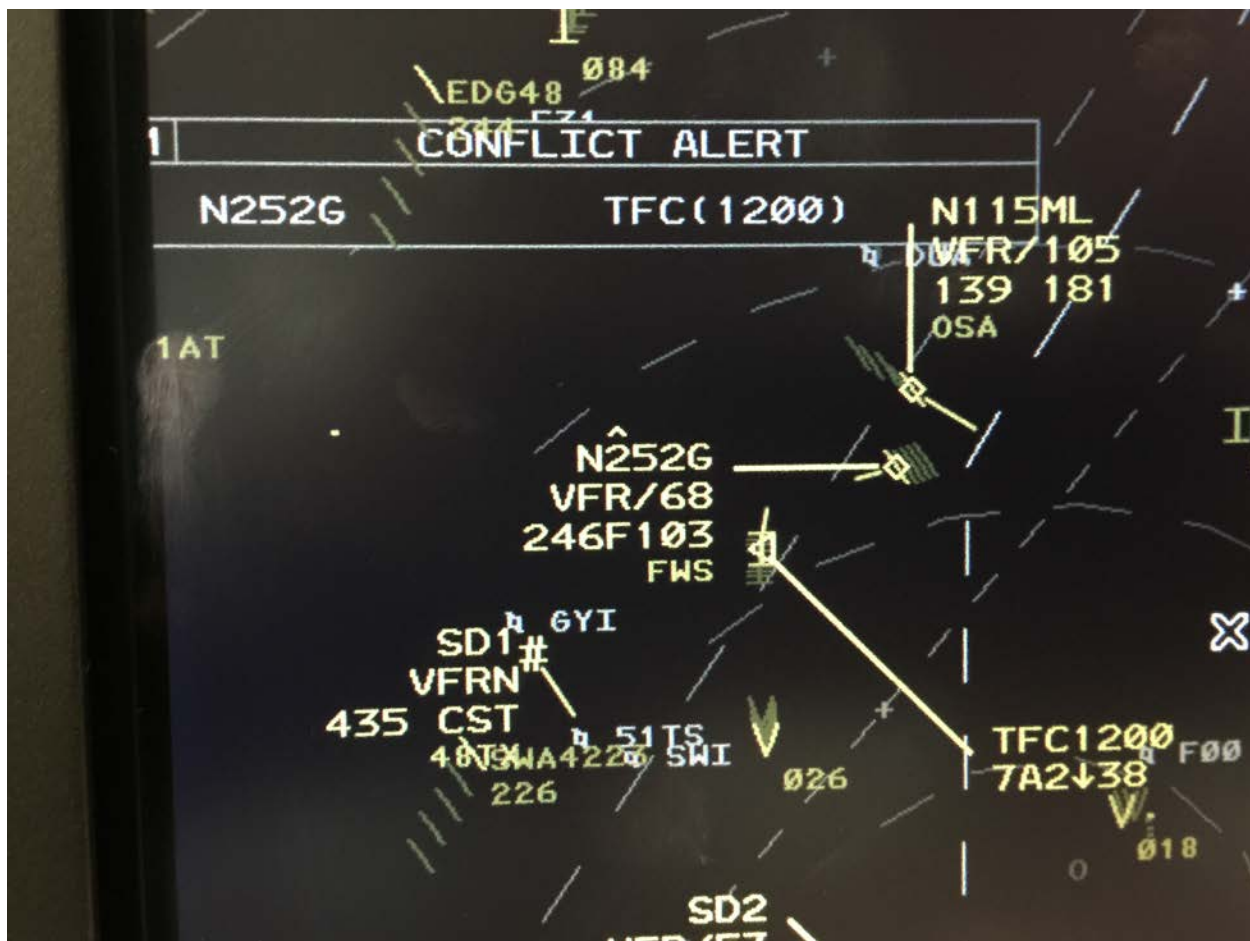
Figure 2 is a picture from the Enroute Automation Modernization (ERAM) radar display showing the location of N252G shortly after the pilot declared an emergency, and before the controller issued the 245° vector to GYI.

Figure 2 – Position of N252G at 1502:14 after declaring emergency but before being issued vectors.

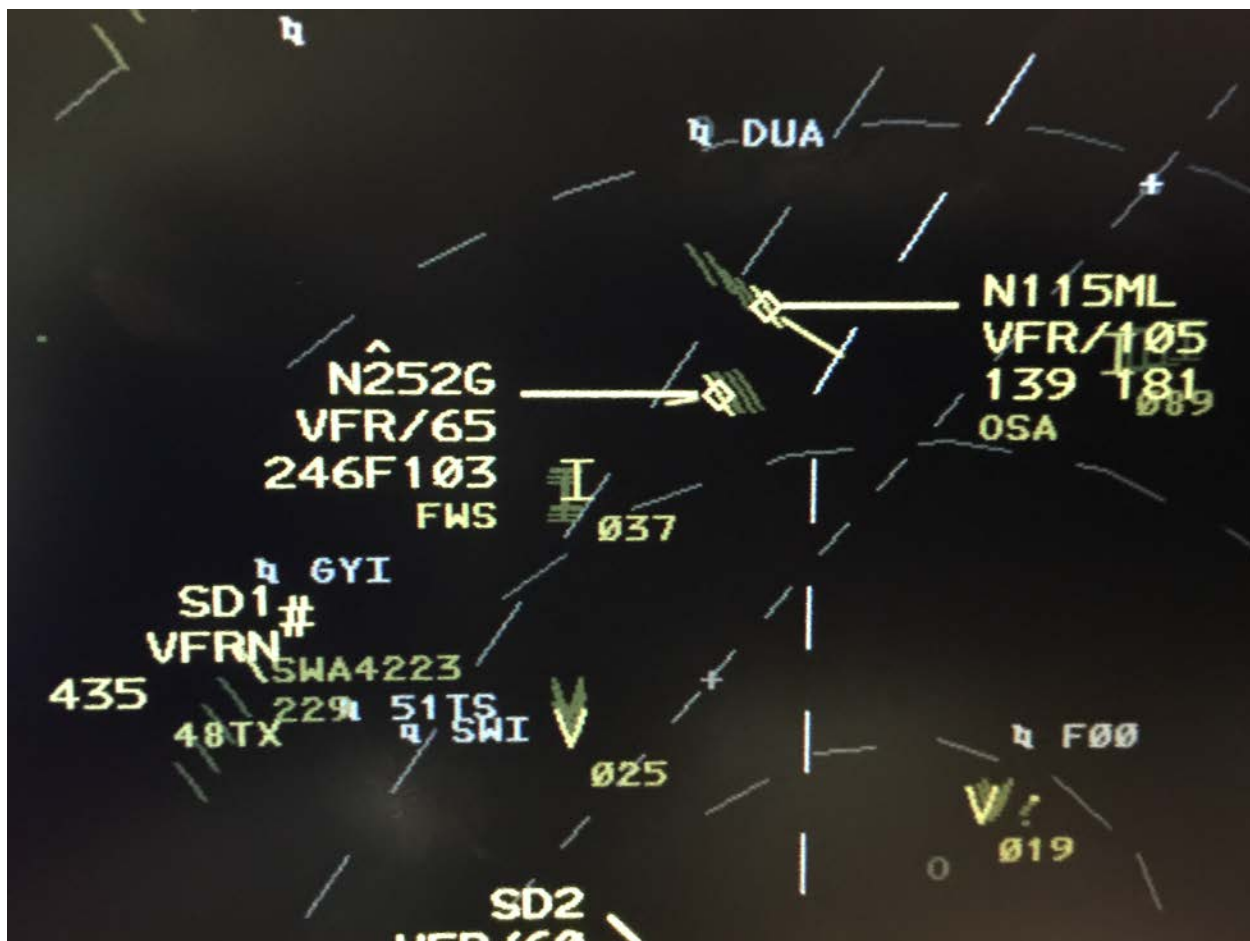
Figure 3 is a picture from the ERAM display showing the location of N252G after receiving the 245° vector to GYI.

Figure 3 - The radar position of N252G at 1502:29 after receiving a vector to GYI.

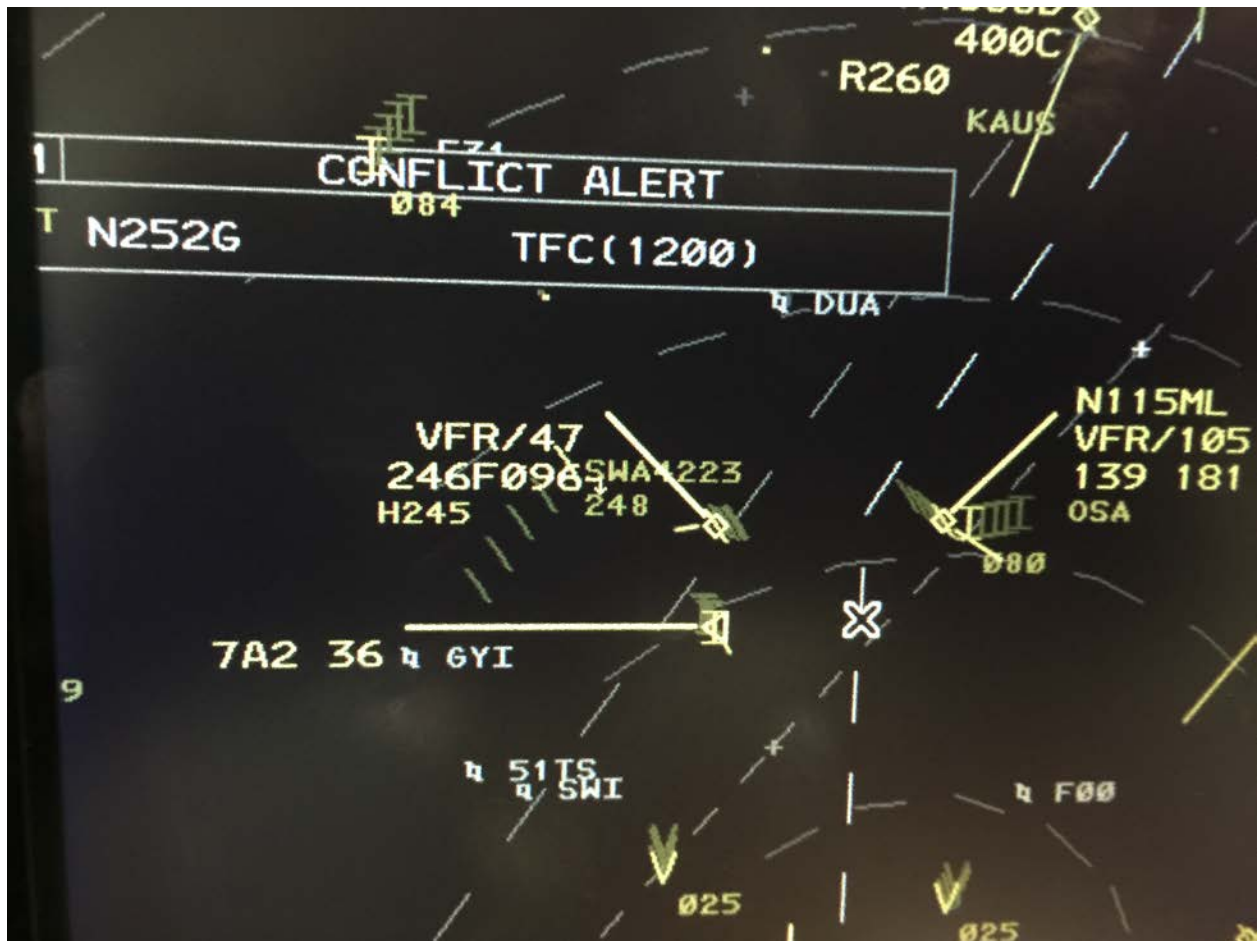
Figure 4 is a picture of the ERAM display showing the location of N252G after the pilot asked for a closer airport.

Figure 4 - The radar position of N252G at 1504:18 after pilot requested a closer airport; the aircraft is indicated by the "VFR/47" data tag.

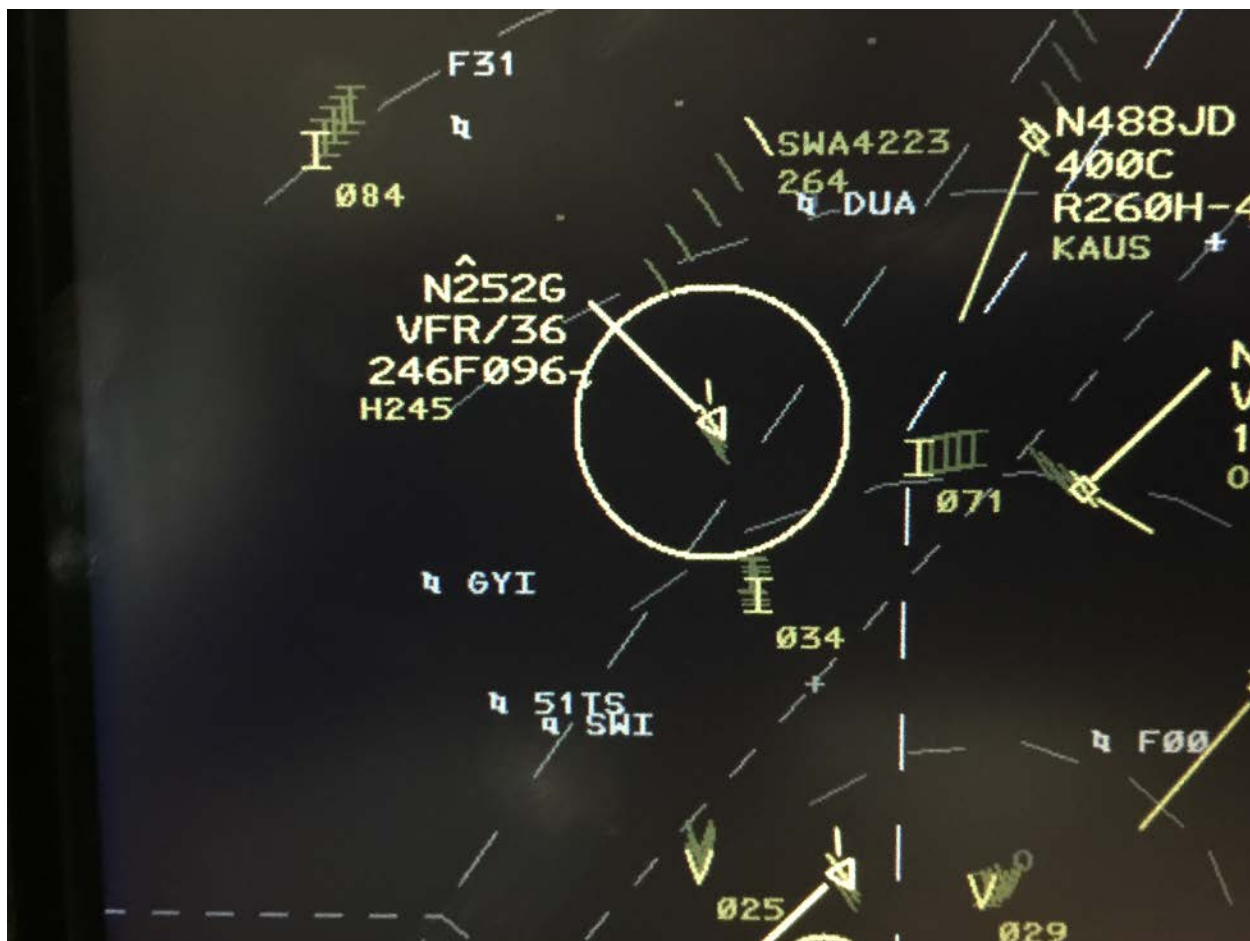
Figure 5 is a picture of the ERAM display showing the location of N252G after the ZFW air traffic controller had told the pilot that the XWind airport was 1 mile behind him.

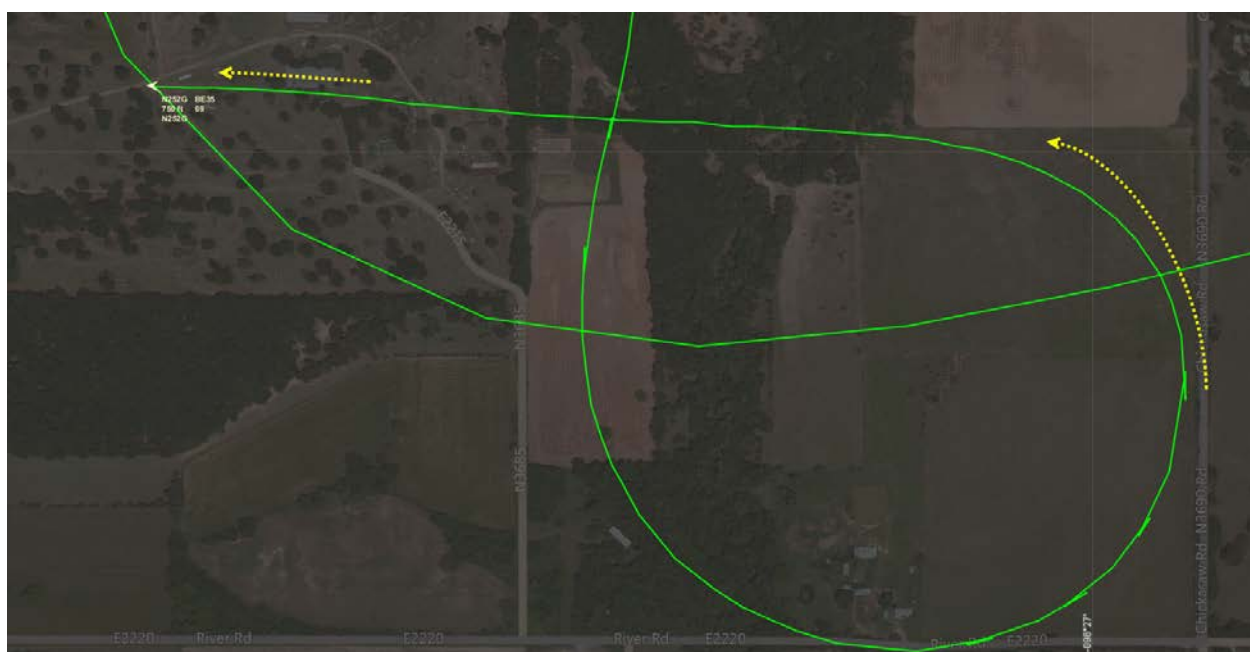
Figure 6 is a picture of the track data overlaid onto a commercially available map showing the final segment of the accident flight.
