# Continental Motors

## ENGINE FIELD INSPECTION REPORT

| ENGINE MODEL | IO470K3 |
| CMI FILE NUMBER | 15-122 |

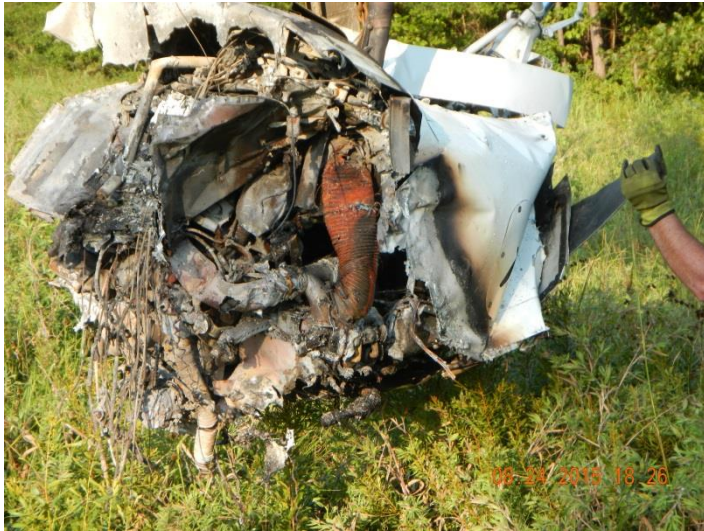
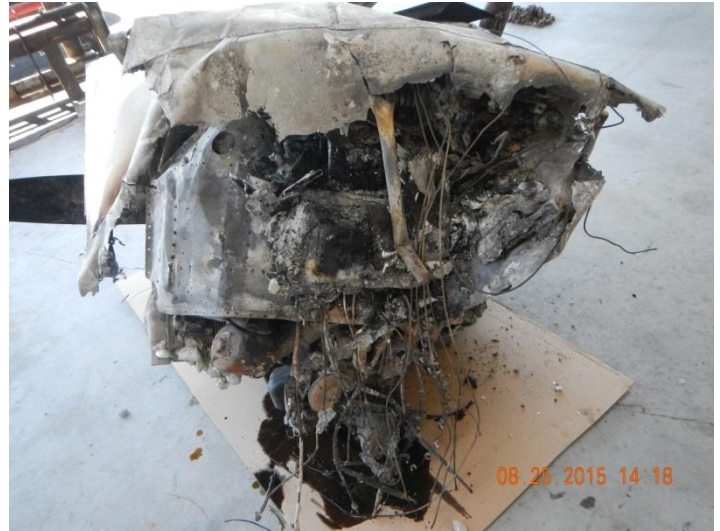
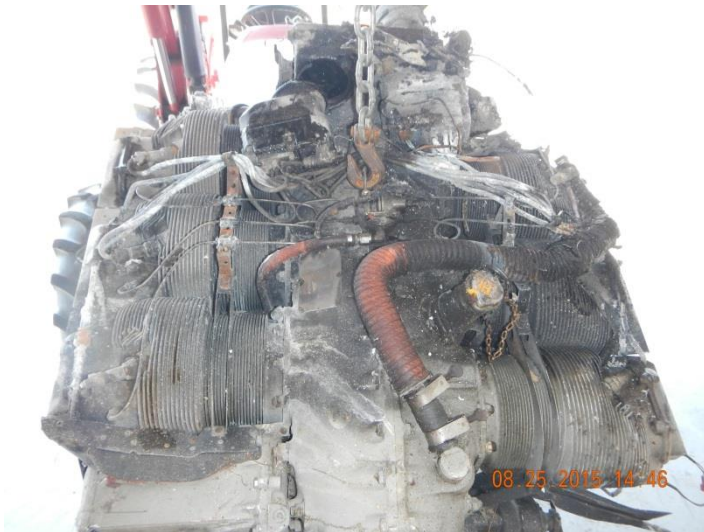
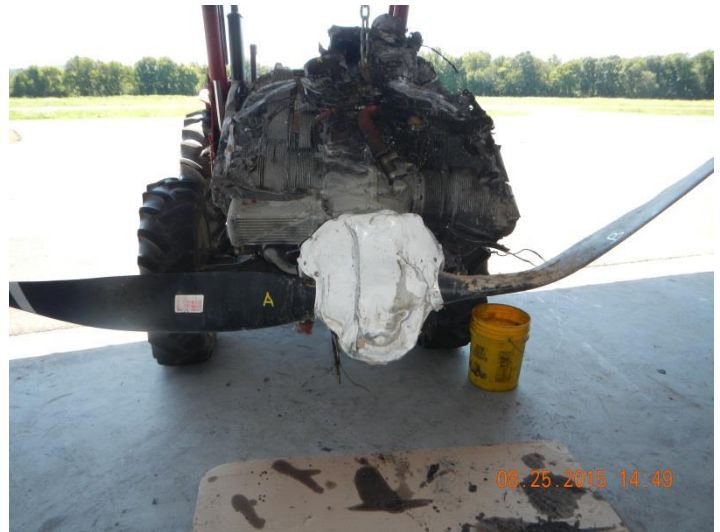
At the accident site, the engine remained encased in the impact damaged cowlings. The propeller remained attached to the crankcase. The engine crankcase was intact. The engine sump was intact with the exception of the broken engine mounts. The lower portion of the engine and oil sump was thermally damaged due to a post impact fire.

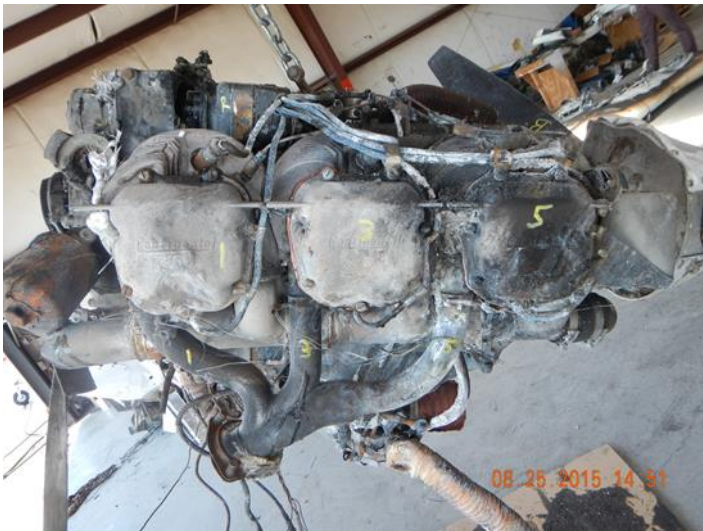
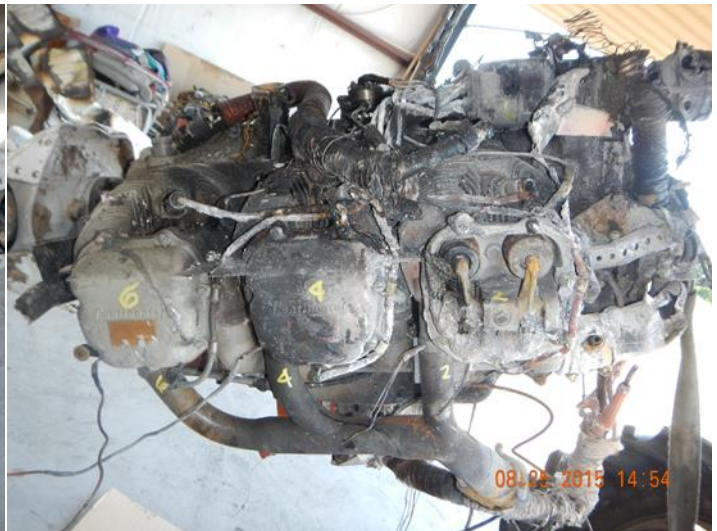
#### EXHAUST SYSTEM

**Condition:** The individual exhaust tubes remained attached to each cylinder. The tubes and collector exhibited impact damage but remained intact. The right and left mufflers/tail pipes were impact damaged and were removed to facilitate transportation of the engine from the accident site to the recovery site.

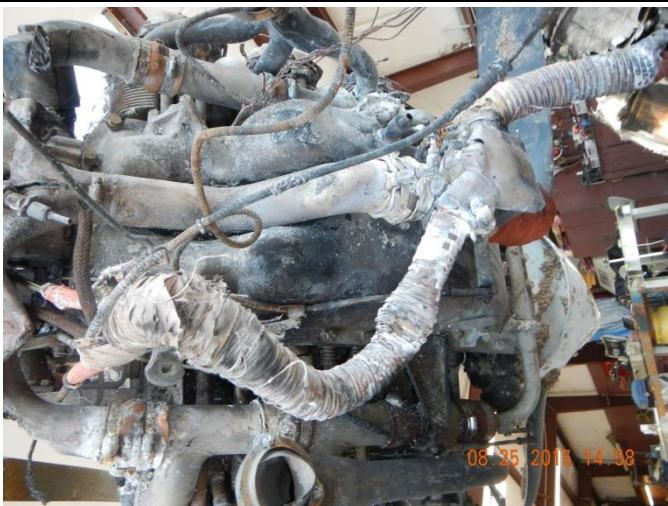
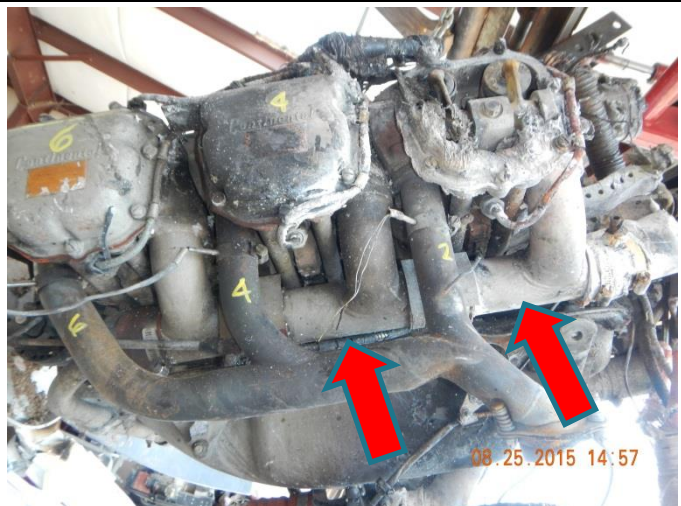
#### INDUCTION SYSTEM

**Condition:** The induction manifold tube assemblies remained intact with thermal damage to the rubber intake hoses. The rear wye pipes (induction riser) were/was thermally damaged. Arrows point to induction components.

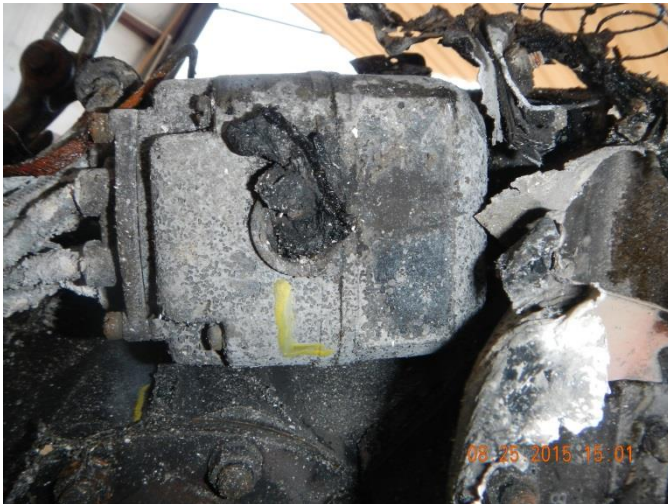
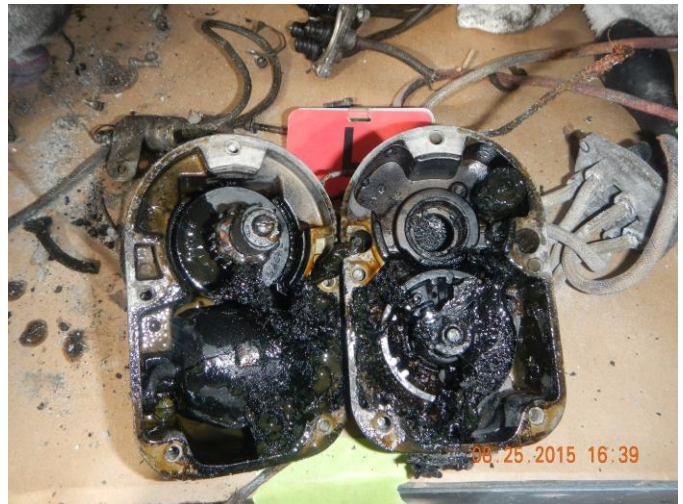
| LEFT MAGNETO | Manufacturer: Bendix (TCM) | P/N: Undetermined | S/N: Undetermined |

| LEFT MAGNETO | Manufacturer: Bendix (TCM) | P/N: Undetermined | S/N: Undetermined |
|---|---|---|---|
| Condition: | The left magneto remained attached to its mount but received thermal damage. The cover was removed to reveal thermally damaged internal components. | | |

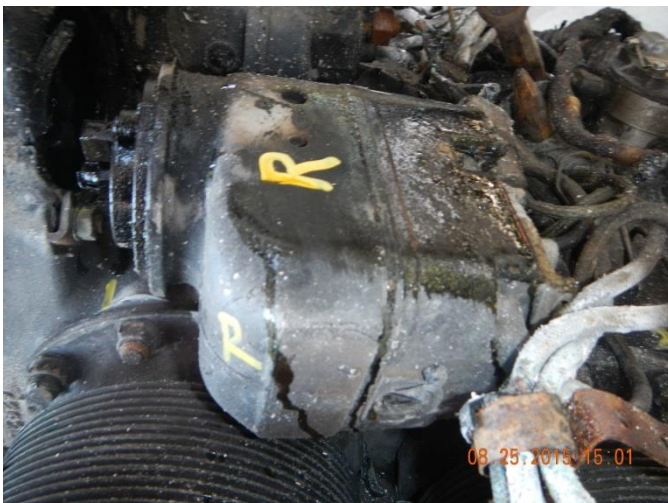
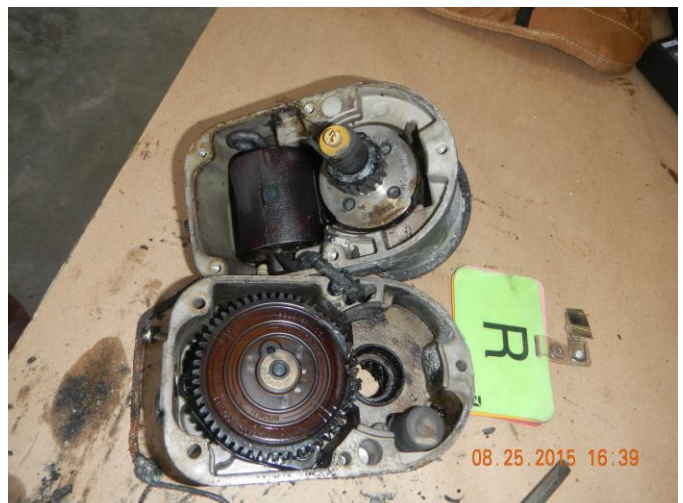
| RIGHT MAGNETO | Manufacturer: Bendix (TCM) | P/N: Undetermined | S/N: Undetermined |

| RIGHT MAGNETO | Manufacturer: Bendix (TCM) | P/N: Undetermined | S/N: Undetermined |
|---|---|---|---|
| Condition: | The magneto separated from its mount. The cover was removed to reveal thermally damaged internal components. | | |

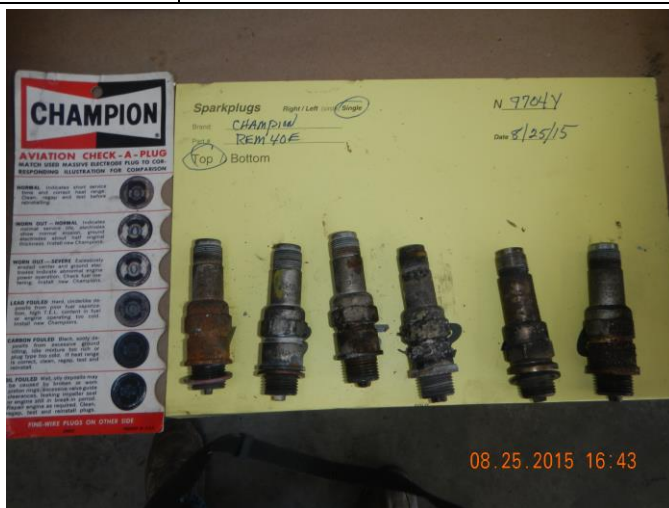
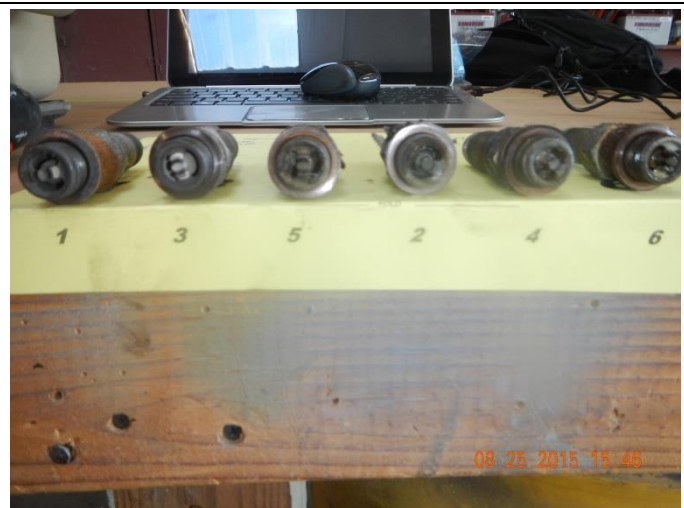
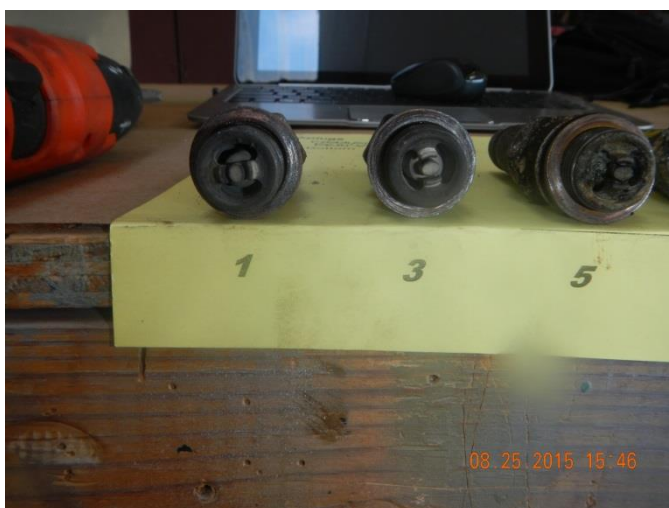
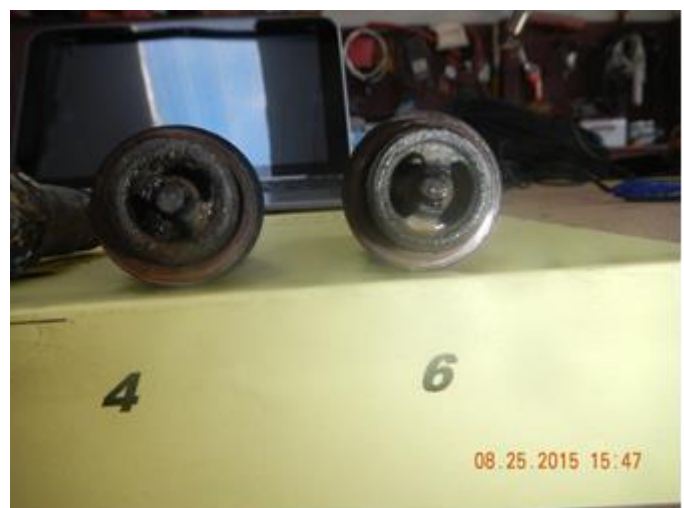
## SPARK PLUGS

When compared to a Champion "Check A Plug" chart, the sparkplugs were found to be in "worn out- normal" condition. Sparkplugs 2, 4 and 5 contained a substance which resembled fire- fighting foam. Note: the engine was found at the accident site in an inverted position where it remained for two days.

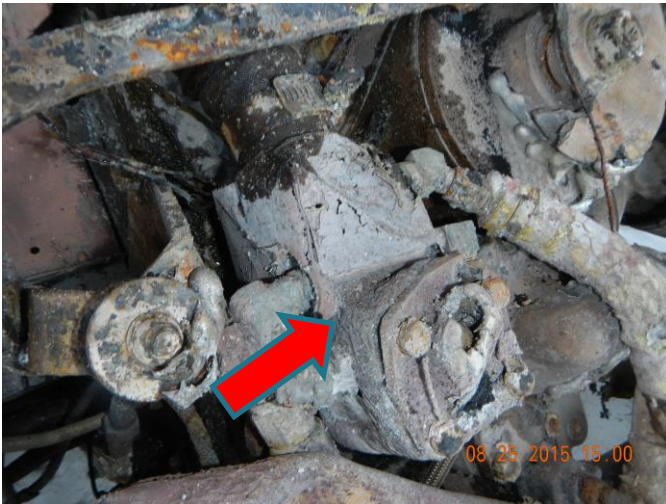
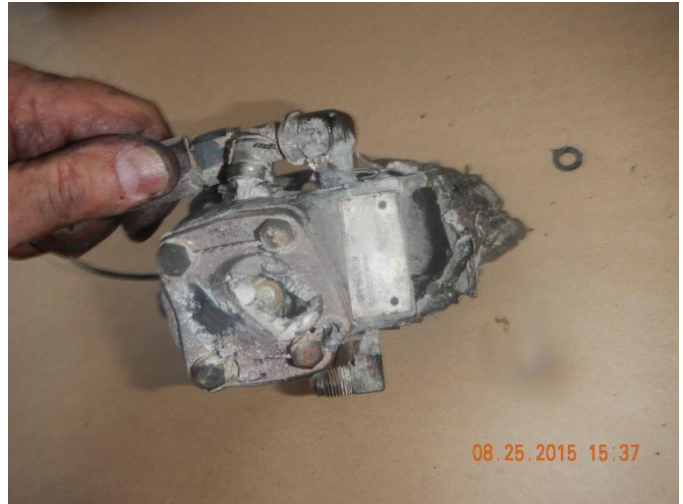
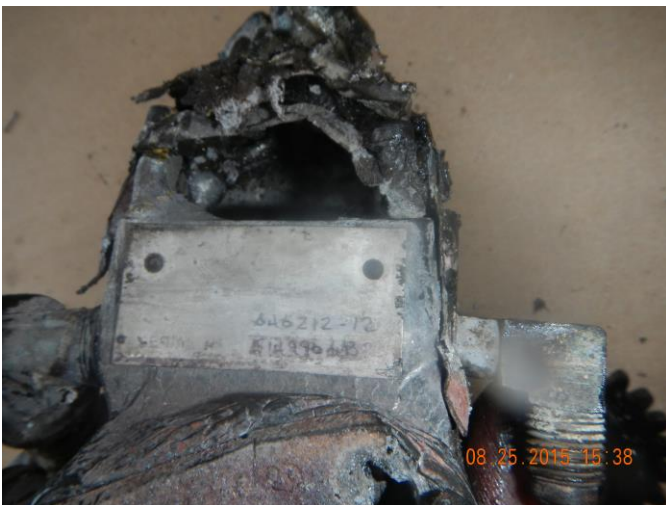
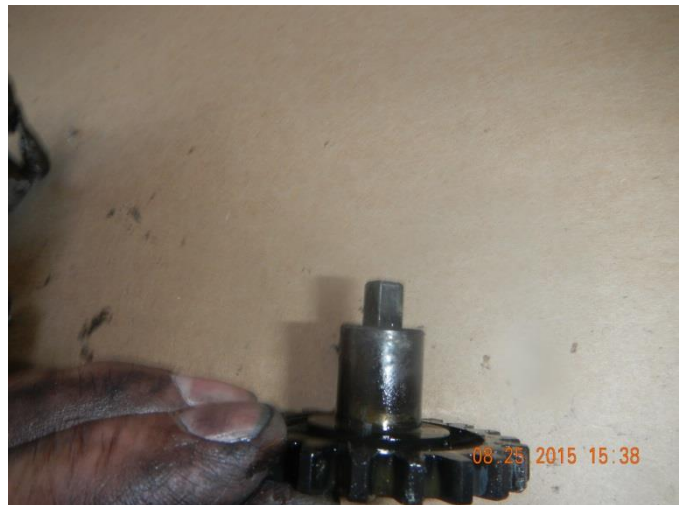
### FUEL PUMP

The engine driven fuel pump could not be manually rotated. The vapor tower and pressure adjusting screw and housing were compromised due to high thermal event. The drive gear and drive pin were intact. Overhaul records indicate that this pump was installed as overhauled at engine overhaul. Arrow points to fuel pump.

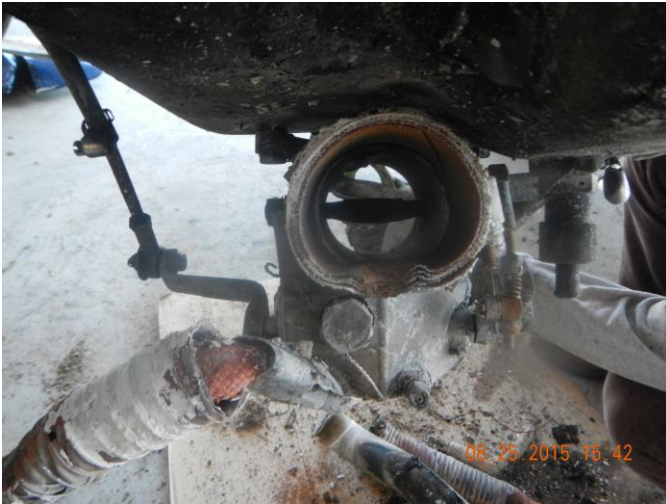
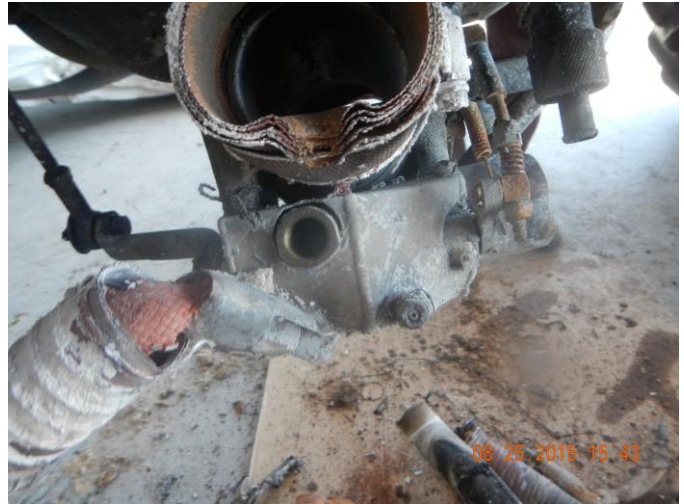
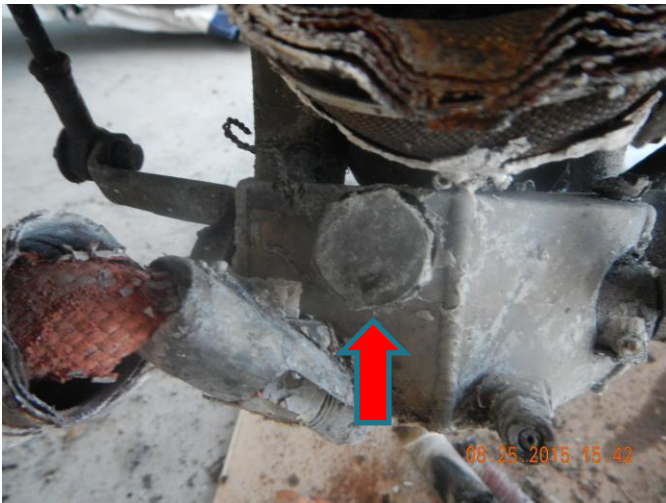
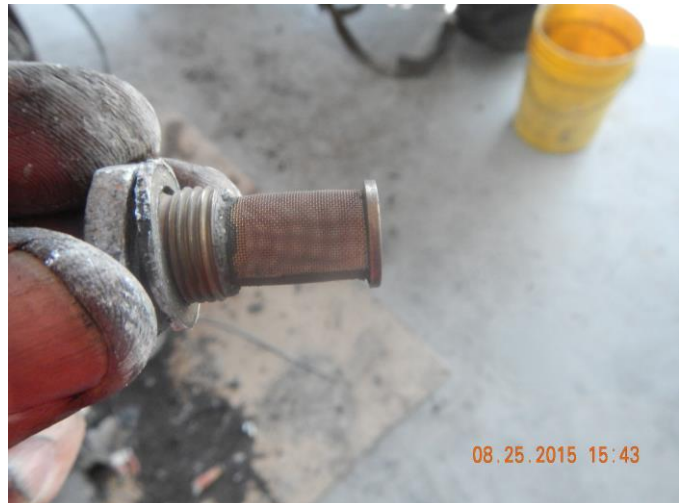
## THROTTLE BODY METERING UNIT

Condition: The throttle body and metering unit remained attached to the lower sump mount. The unit was thermally damaged due to heat from the post impact fire. The throttle plate was fully open and frozen in position. The throttle and mixture arms were intact and secured. The fuel screen was removed and inspected. No contaminants were present. Red arrow points to installed fuel screen.

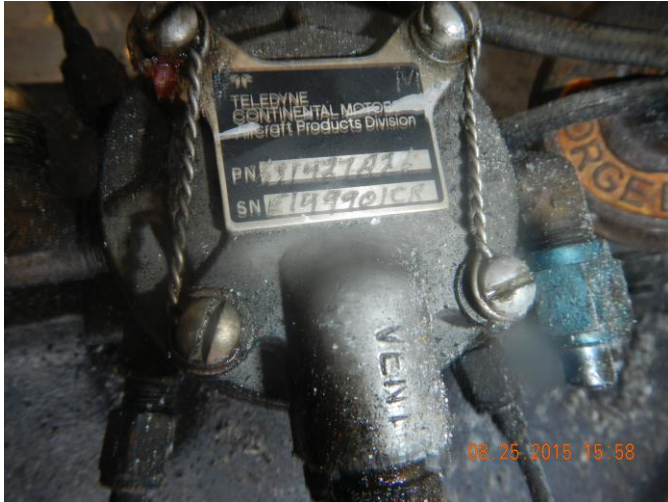
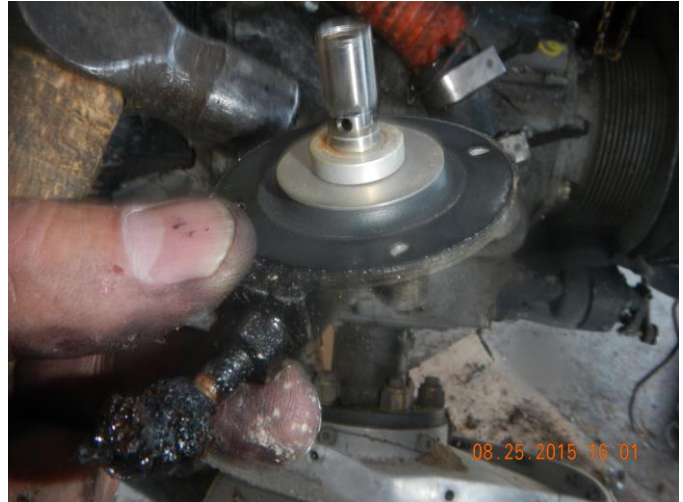
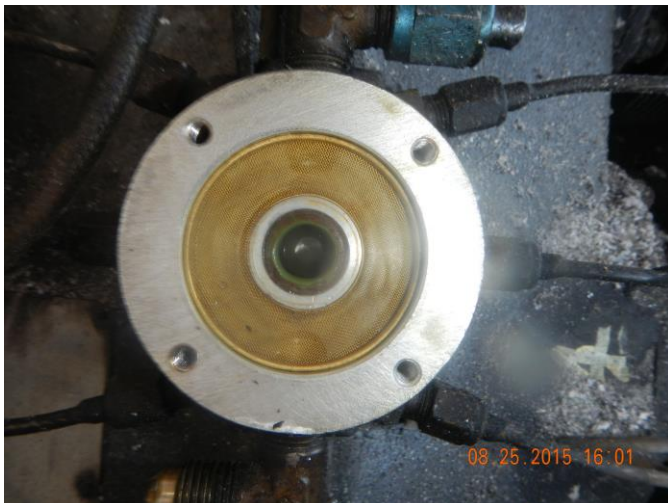
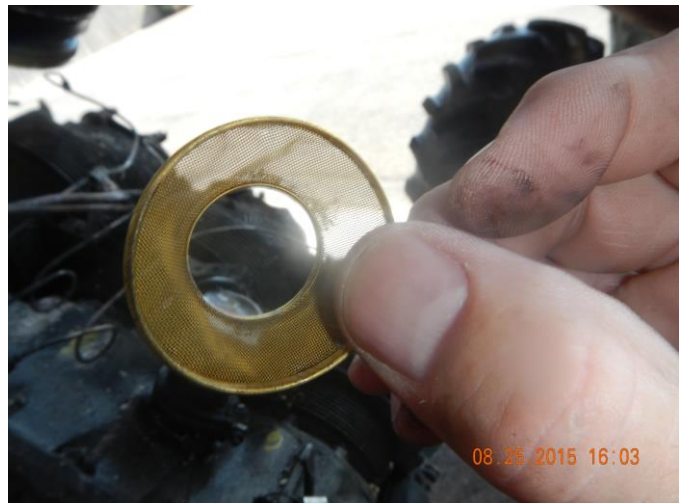
## FUEL MANIFOLD VALVE

Condition: The safety wire and lead seal were cut and the top cover removed. No contamination was found. No residual fuel was present. The fuel screen was clean.

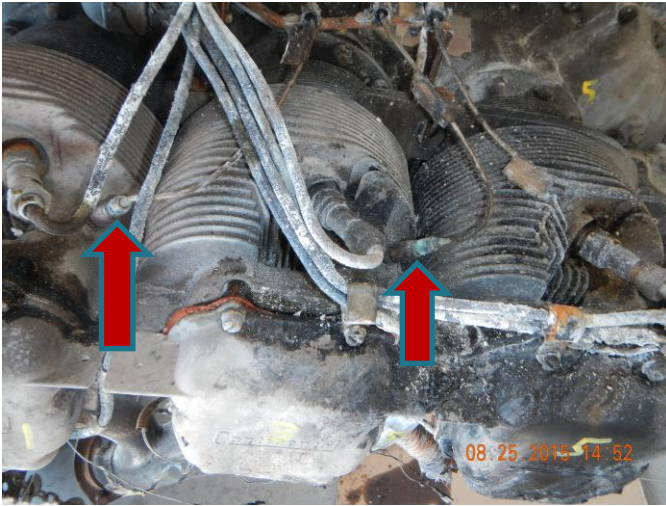
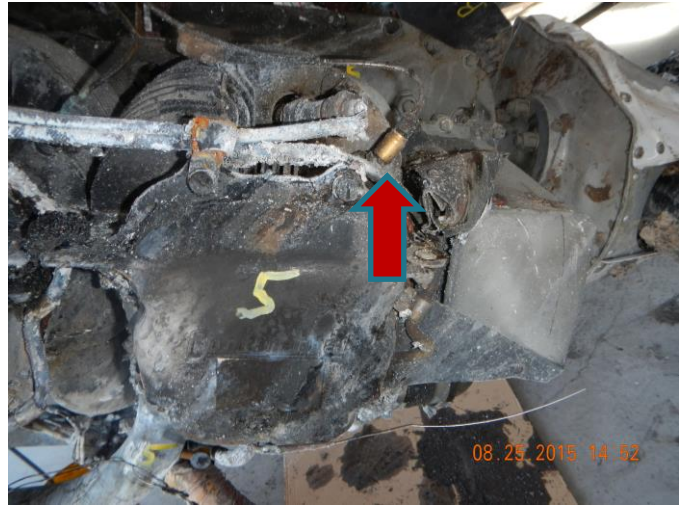
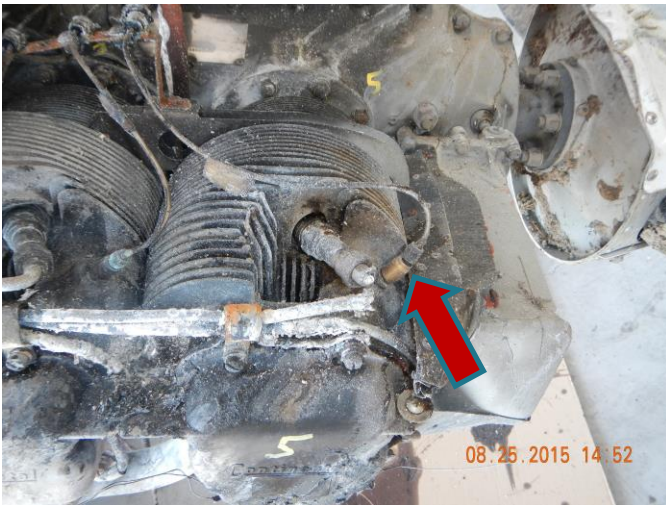
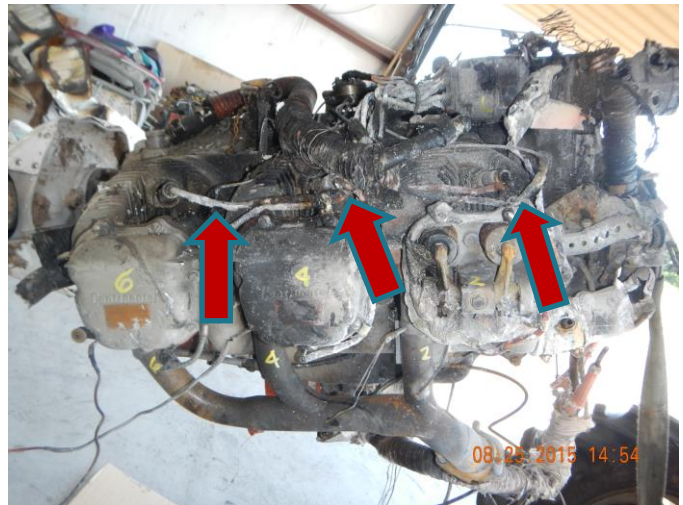
## FUEL NOZZLES AND LINES

Condition: The GAMI fuel injectors remained intact and secured in each respective cylinder head except # 5 fuel nozzle which was impact damaged. Red arrows point to individual fuel injectors as installed into cylinder heads.

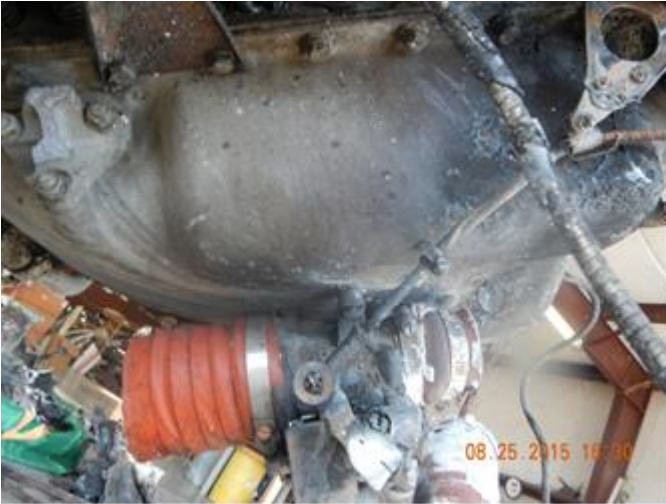
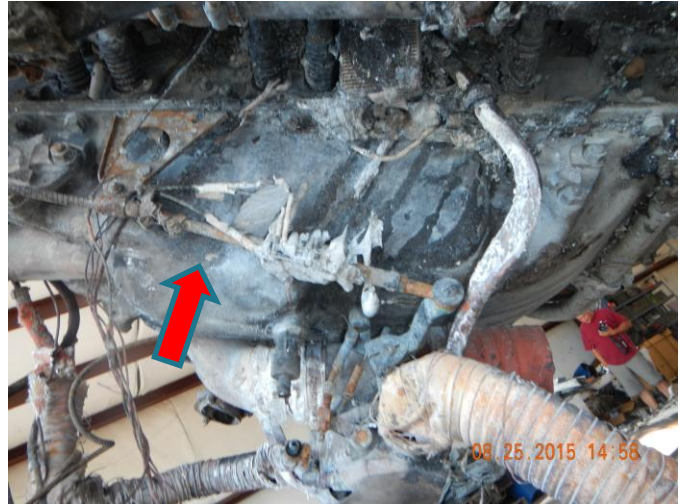
#### OIL SUMP

Condition: Intact with the exception of three broken engine mounts. The sump was thermally damaged. Red arrow points to the oil sump.

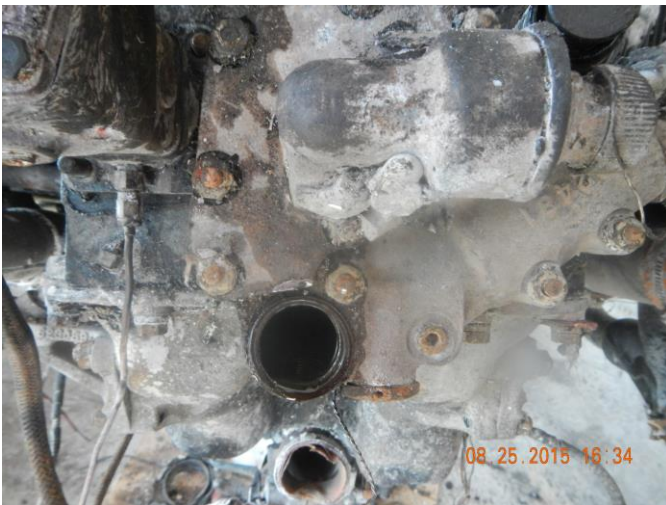
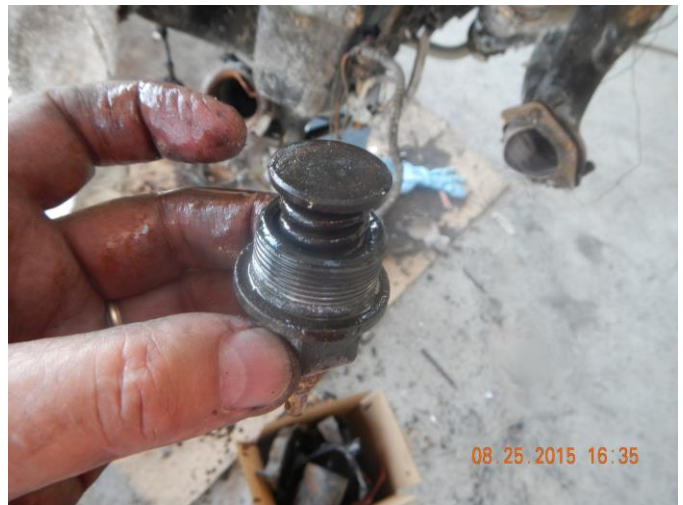
#### OIL PUMP

Condition: The oil pump remained intact with thermal damage. The oil pressure relief valve was removed and inspected. The plunger and spring were intact.

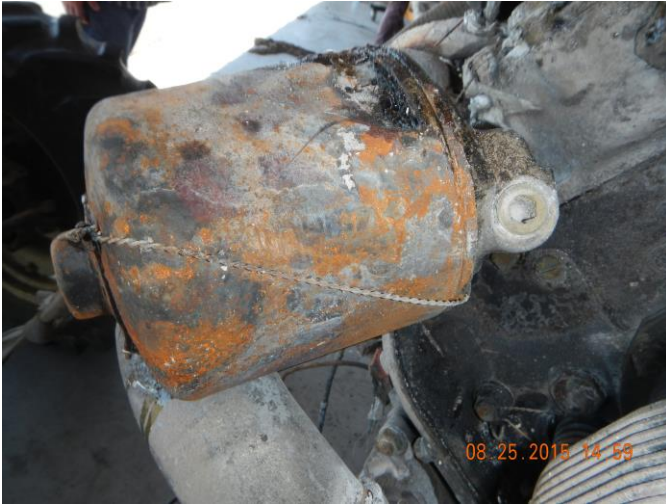
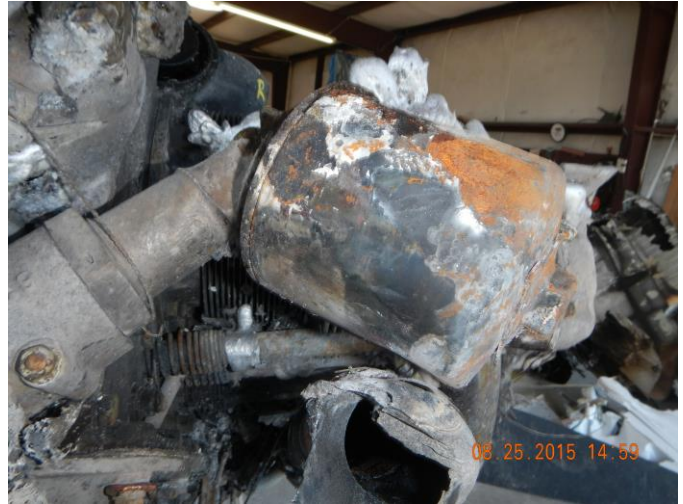
## OIL FILTER

Condition: The oil filter exterior canister was thermally damaged. Security wire was intact.

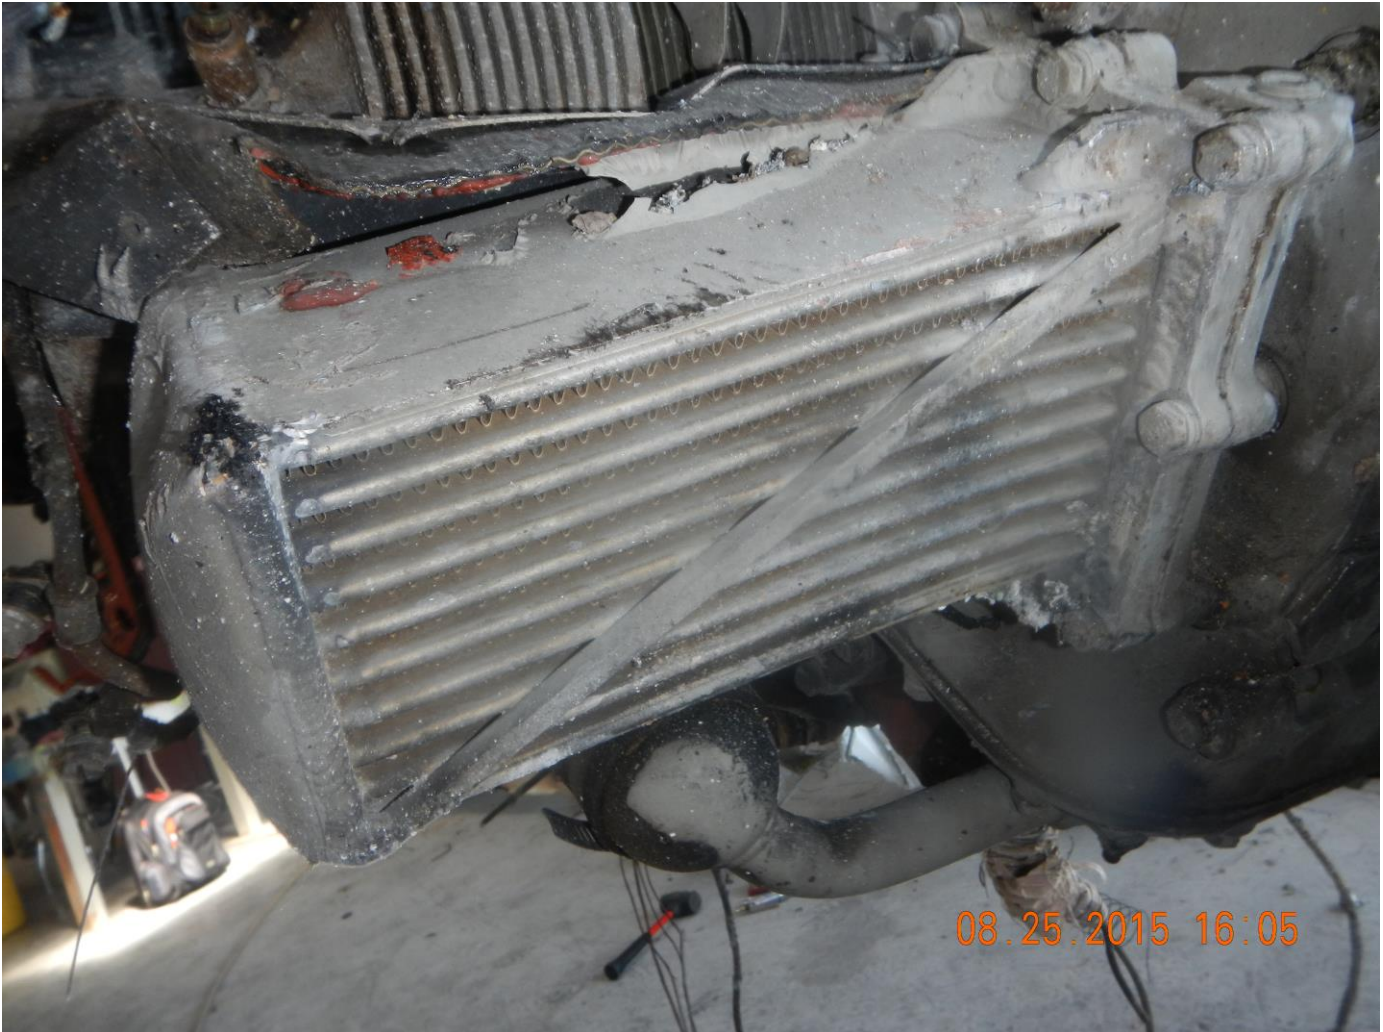
## OIL COOLER

Condition: No visible damage was noted

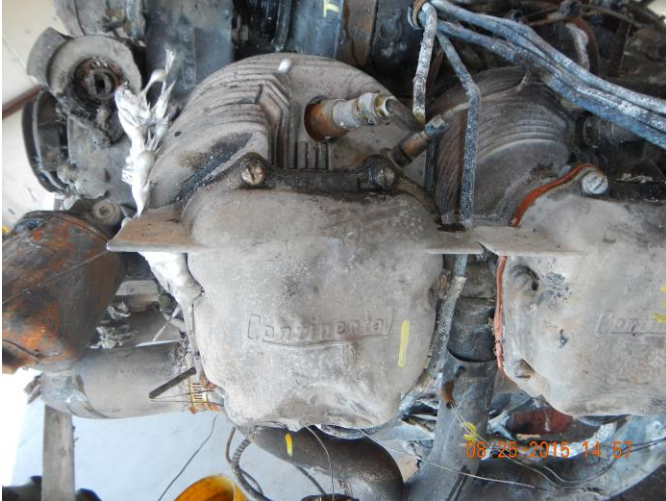
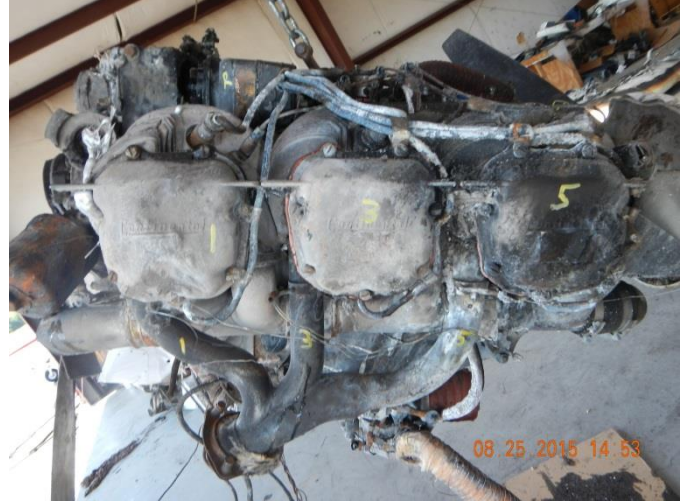
| CYLINDER #1 | PN 655475 | | |

| CYLINDER #1 | PN 655475 | | |
|---|---|--|--|
| Condition: | Thermal damage to rocker cover was noted. A lighted borescope inspection was performed. Intake and exhaust valves were intact with normal combustion signatures. Piston crowns and cylinder walls appeared normal. | | |

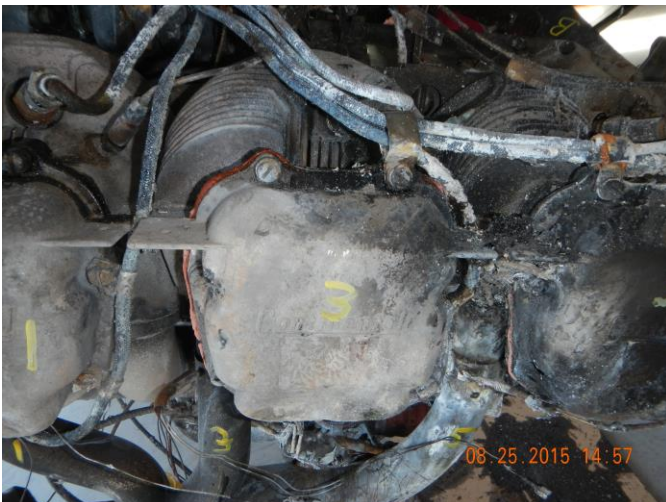
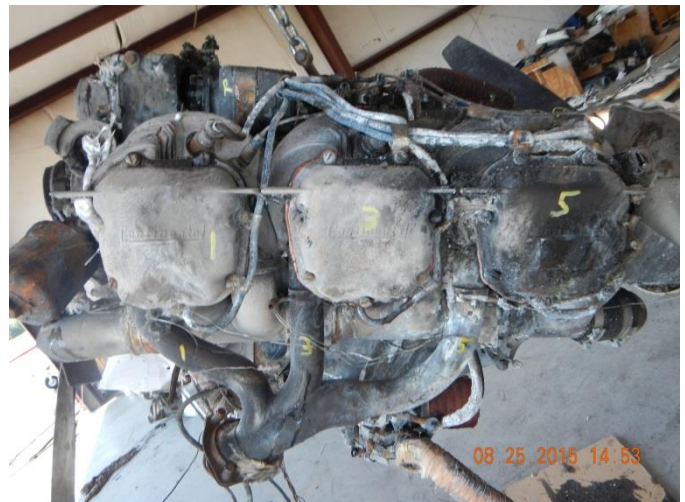
| CYLINDER #3 | PN 655475 | | |

| CYLINDER #3 | PN 655475 | | |
|---|---|--|--|
| Condition: | Thermal damage to rocker cover was noted. A lighted borescope inspection was performed. Intake and exhaust valves were intact with normal combustion signatures. Piston crowns and cylinder walls appeared normal. | | |

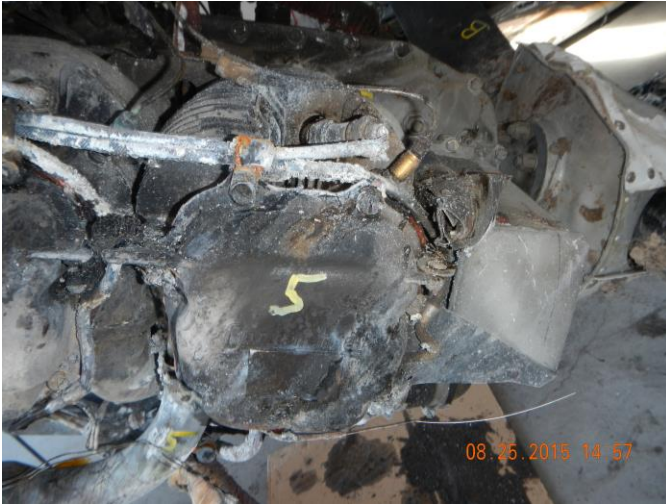
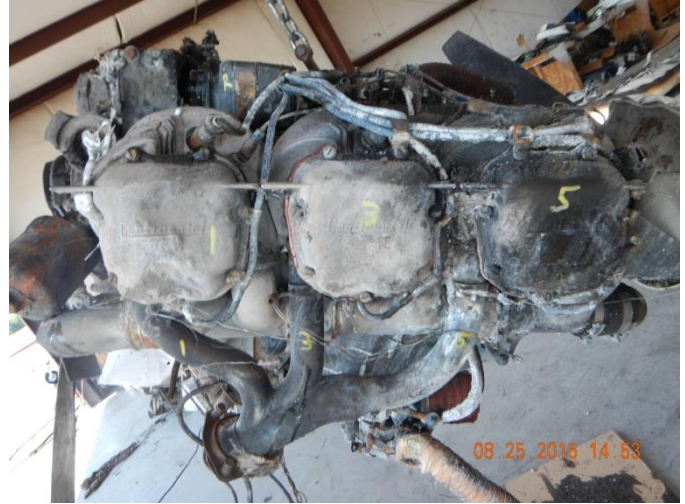
| CYLINDER #5 | PN 655475 | | |

| Condition: | Heavy thermal damage to rocker cover was noted. Impact damage to cooling fins. A lighted borescope inspection was performed. Intake and exhaust valves were intact with normal combustion signatures. Piston crowns and cylinder walls appeared normal. |

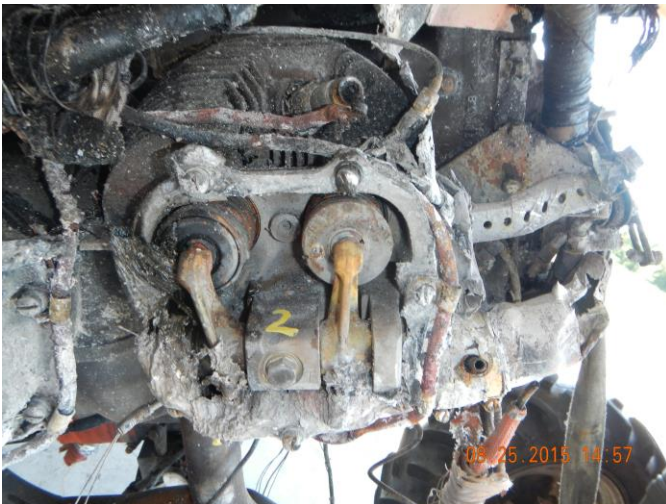
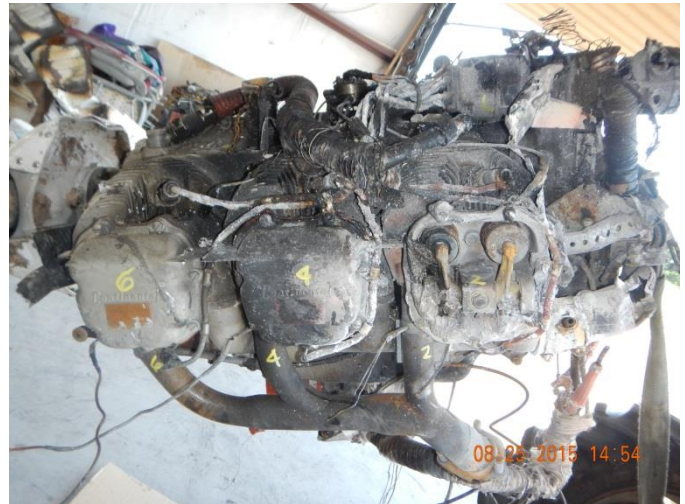
| CYLINDER #2 | PN 655475 | | |

The engine was rotated manually and thumb compression was achieved with the exception of cylinder 2. The intake and exhaust rocker arms were removed from cylinder 2 and the valves were manually staked. When the engine was again manually rotated all cylinders including cylinder 2 exhibited thumb compression.

| Condition: | Thermal damage to cylinder head was noted. Rocker cover separated. A lighted borescope inspection was performed. Intake and exhaust valves were intact with normal combustion signatures. Piston crowns and cylinder walls appeared normal. |

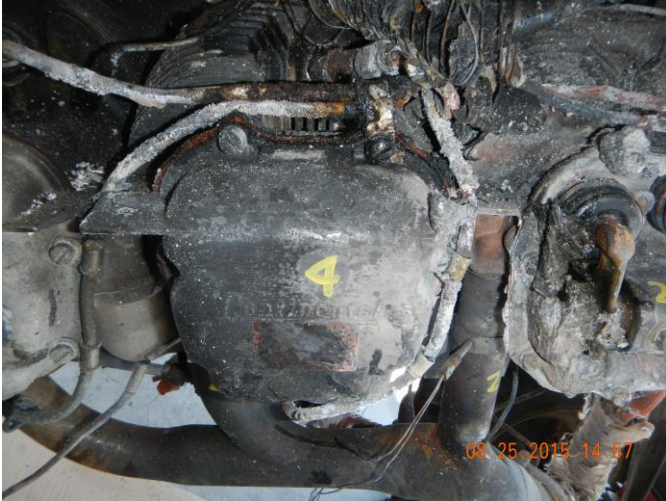
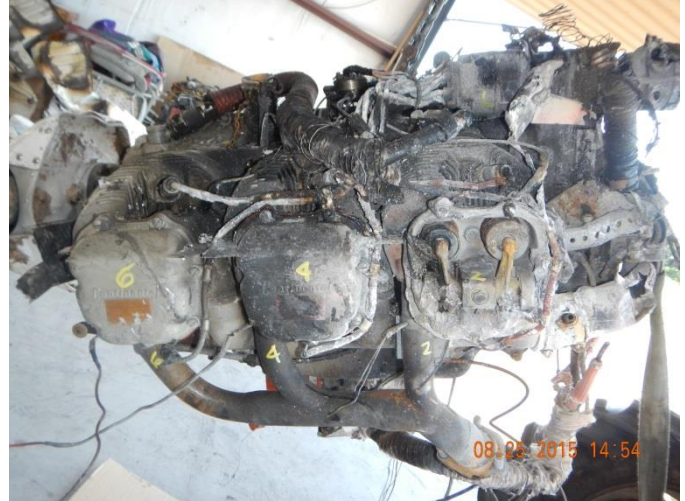
| CYLINDER #4 | PN 655475 | | |

| Condition: | Thermal damage to rocker cover was noted. A lighted borescope inspection was performed. Intake and exhaust valves were intact with normal combustion signatures. Piston crowns and cylinder walls appeared normal. |

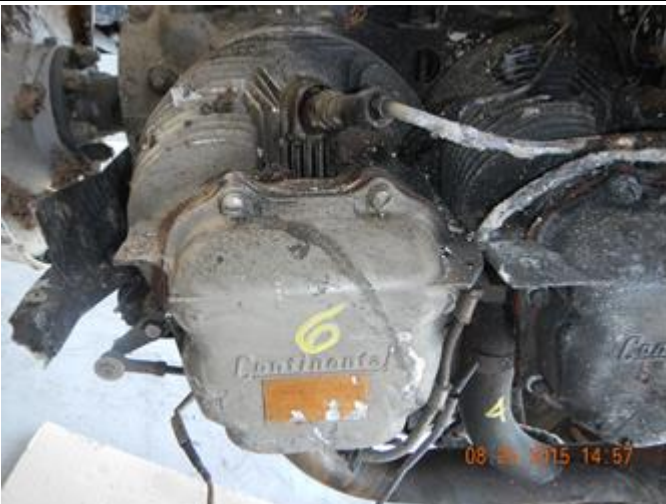
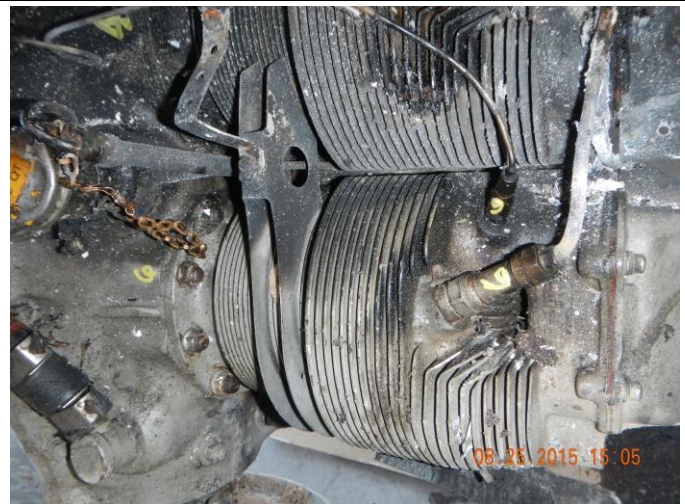
| CYLINDER #6 | PN 655475 | | |

| Condition: | Light thermal damage to cylinder head was noted. A lighted borescope inspection was performed. Intake and exhaust valves were intact with normal combustion signatures. Piston crowns and cylinder walls appeared normal. |

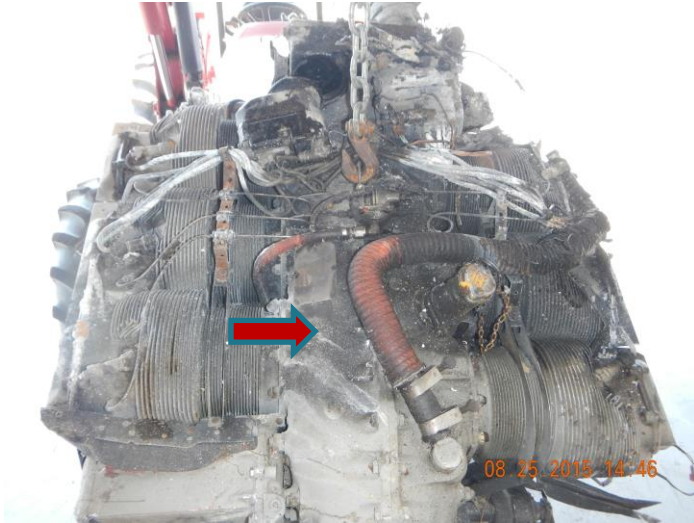
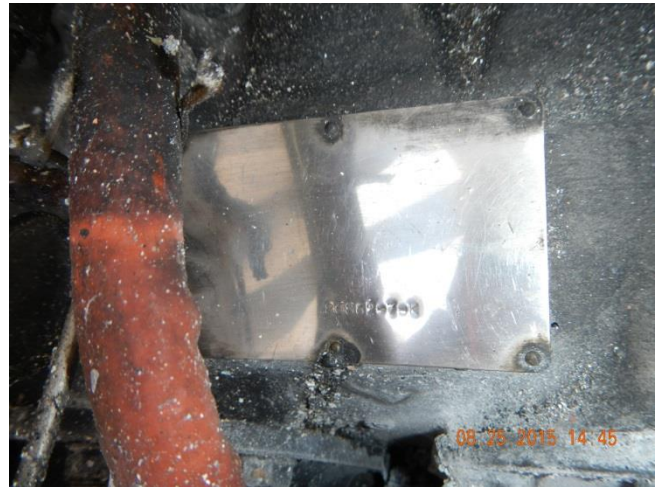
### CRANKCASE ASSEMBLY

| Condition: | No damage was indicated other than sooting and thermal damage due to heat from post impact fire. Red arrow points to crankcase assembly. | | | |

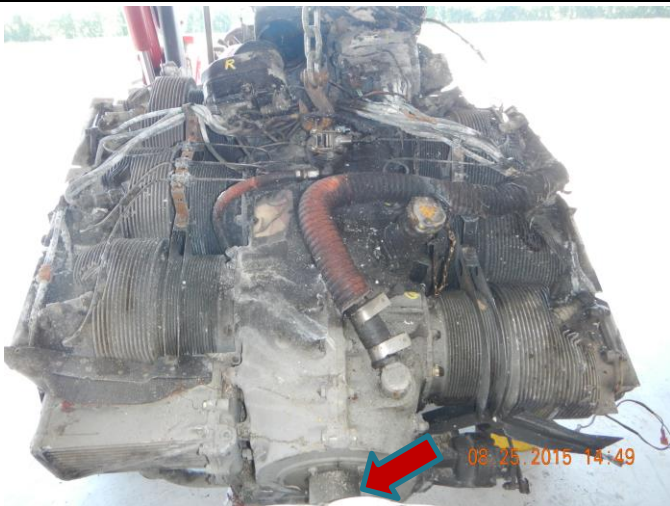
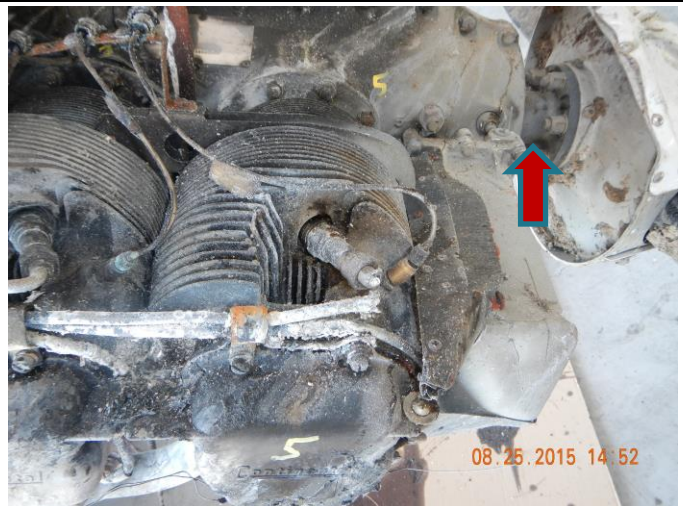
### CRANKSHAFT ASSEMBLY

| Condition: | The crankshaft flange appeared undamaged. Crankshaft continuity was determined when the engine was manually rotated. Red arrows point to exposed crankshaft at propeller flange. | | |

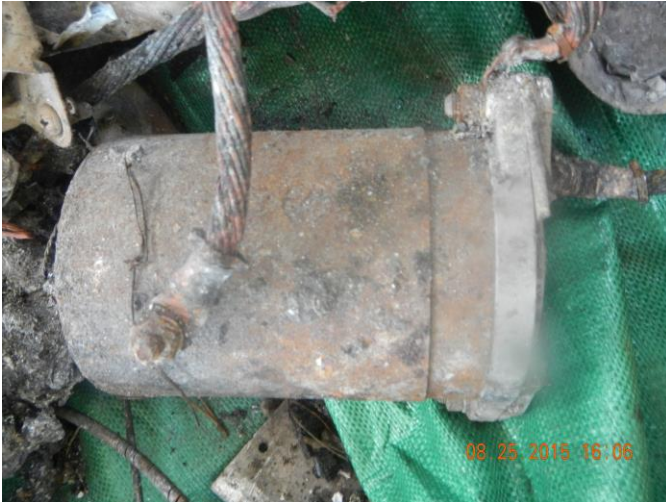
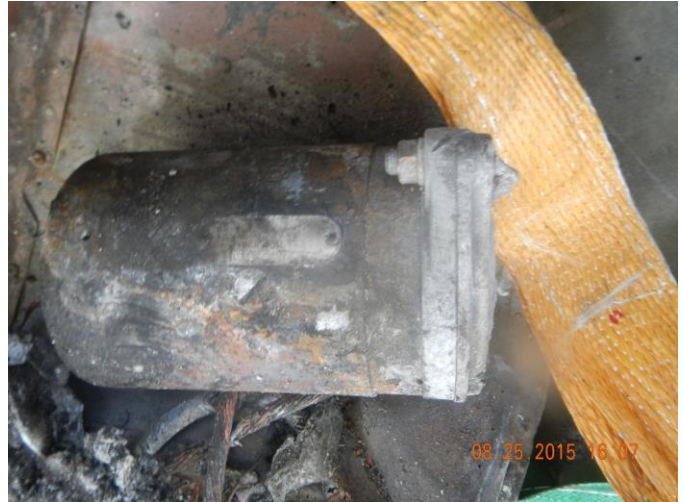
**STARTER**

The starter motor separated from its mount and was recovered in the wreckage. The case was impact damaged and thermally damaged.

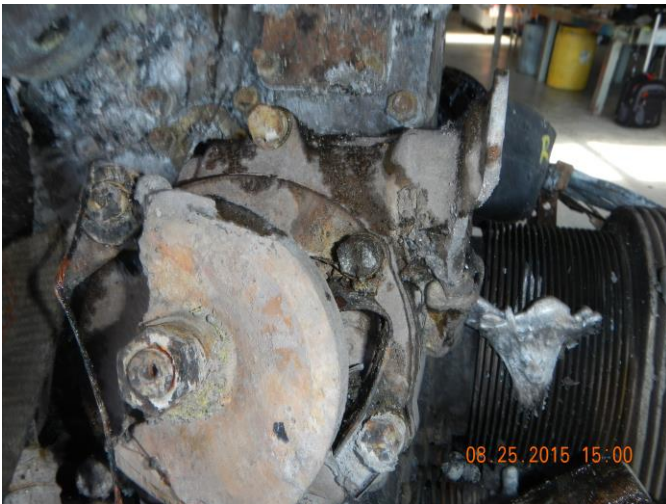
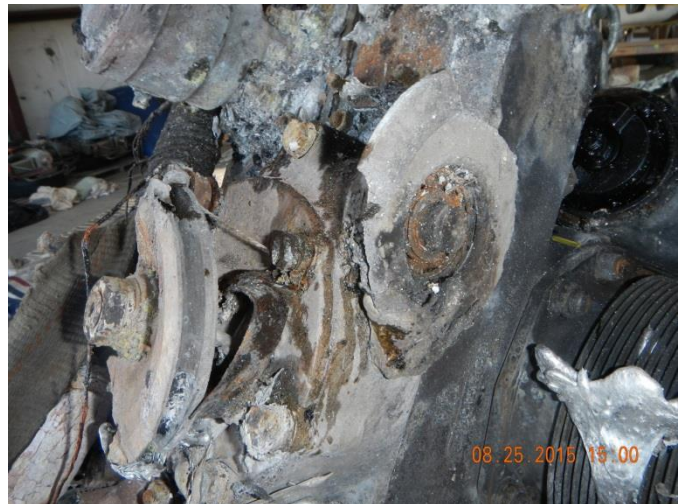
**STARTER ADAPTER**

The starter adapter remained installed and intact with thermal damage to case. The alternator drive pulley was broken. The starter adapter was removed to facilitate manual rotation of the engine. The starter adapter would not rotate manually due to mechanical/impact and thermal damage.
