# Continental Motors

## ENGINE FIELD INSPECTION REPORT

| ENGINE MODEL | IO470K3 |
| CMI FILE NUMBER | 15-122 |

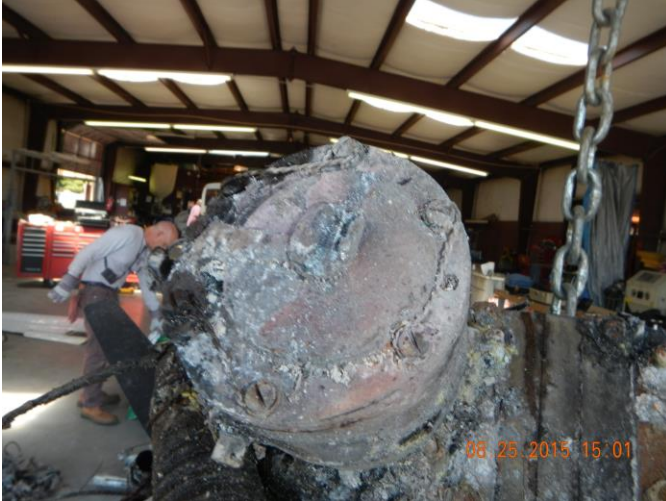
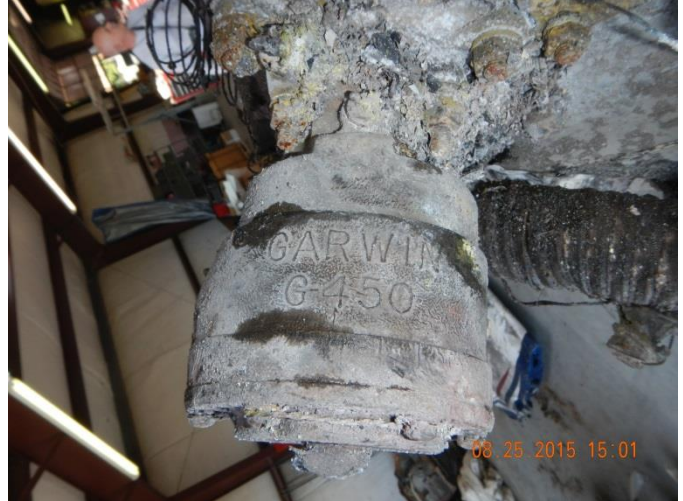
| Condition: | The "wet type" vacuum pump remained attached to its mount but was thermally damaged. The pump was removed but would not rotate manually. | | |

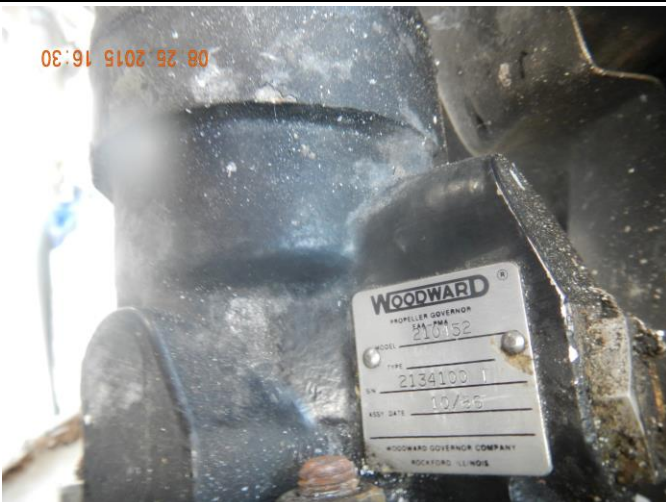
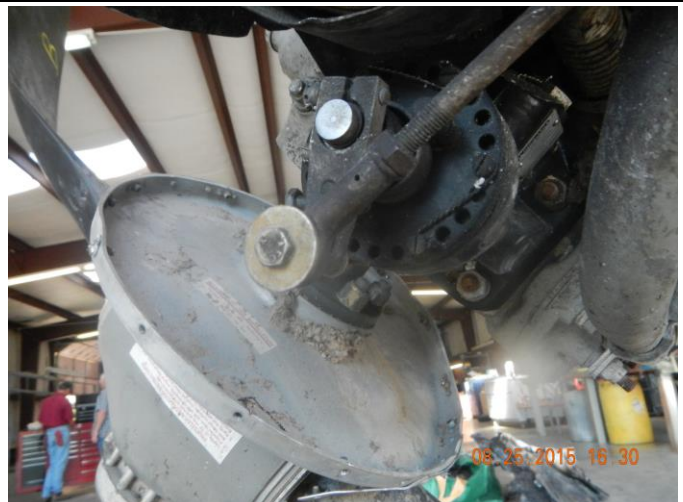
| Condition: | The propeller governor remained attached to its mount and appeared undamaged. | | |

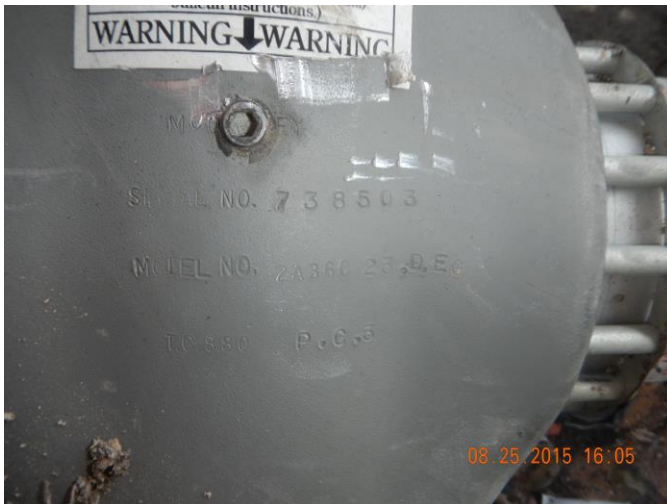
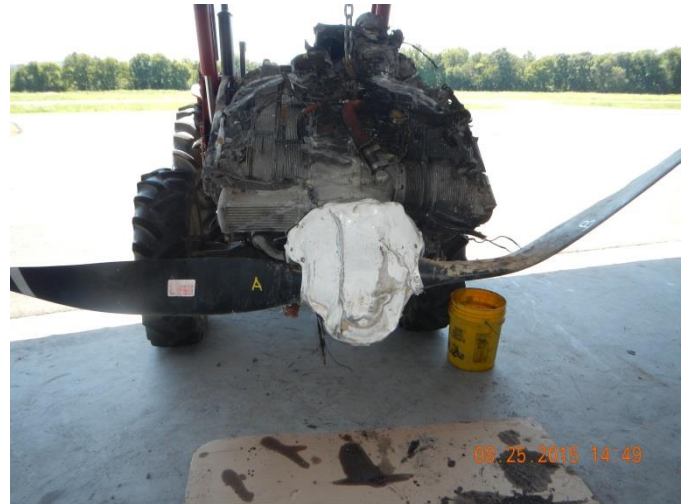
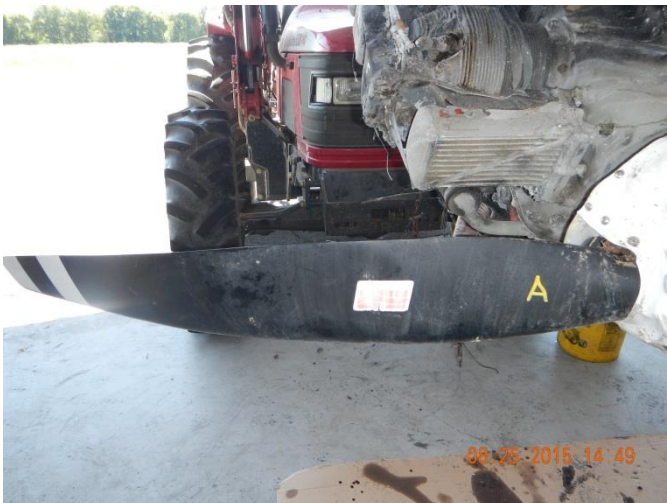
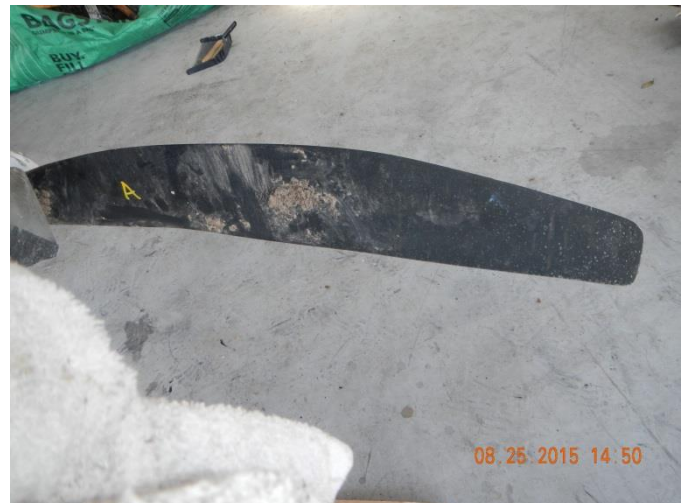
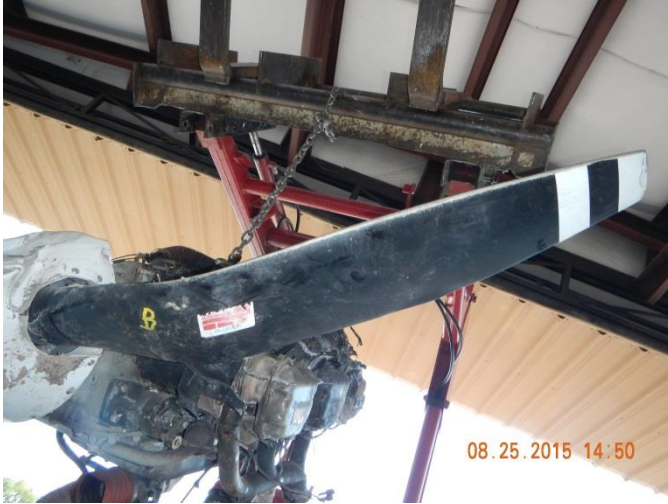
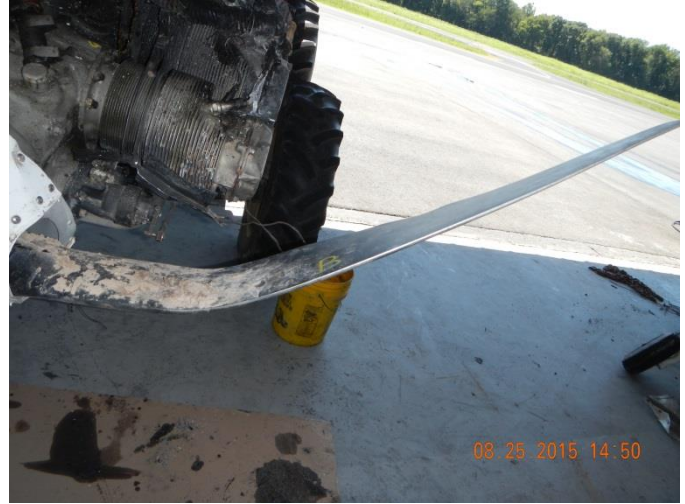
**PAGE 24 of 25****PROPELLER**

The propeller remained attached to the crankshaft flange. Both propeller blades were arbitrarily marked with an "A" or "B" for photo identification. Both blades exhibited slight rearward bending patterns due to impact with the ground. There were no scratches or gouges on the blades leading edges or cambered surfaces. The aluminum spinner was crushed rearward with no evidence of rotation.
