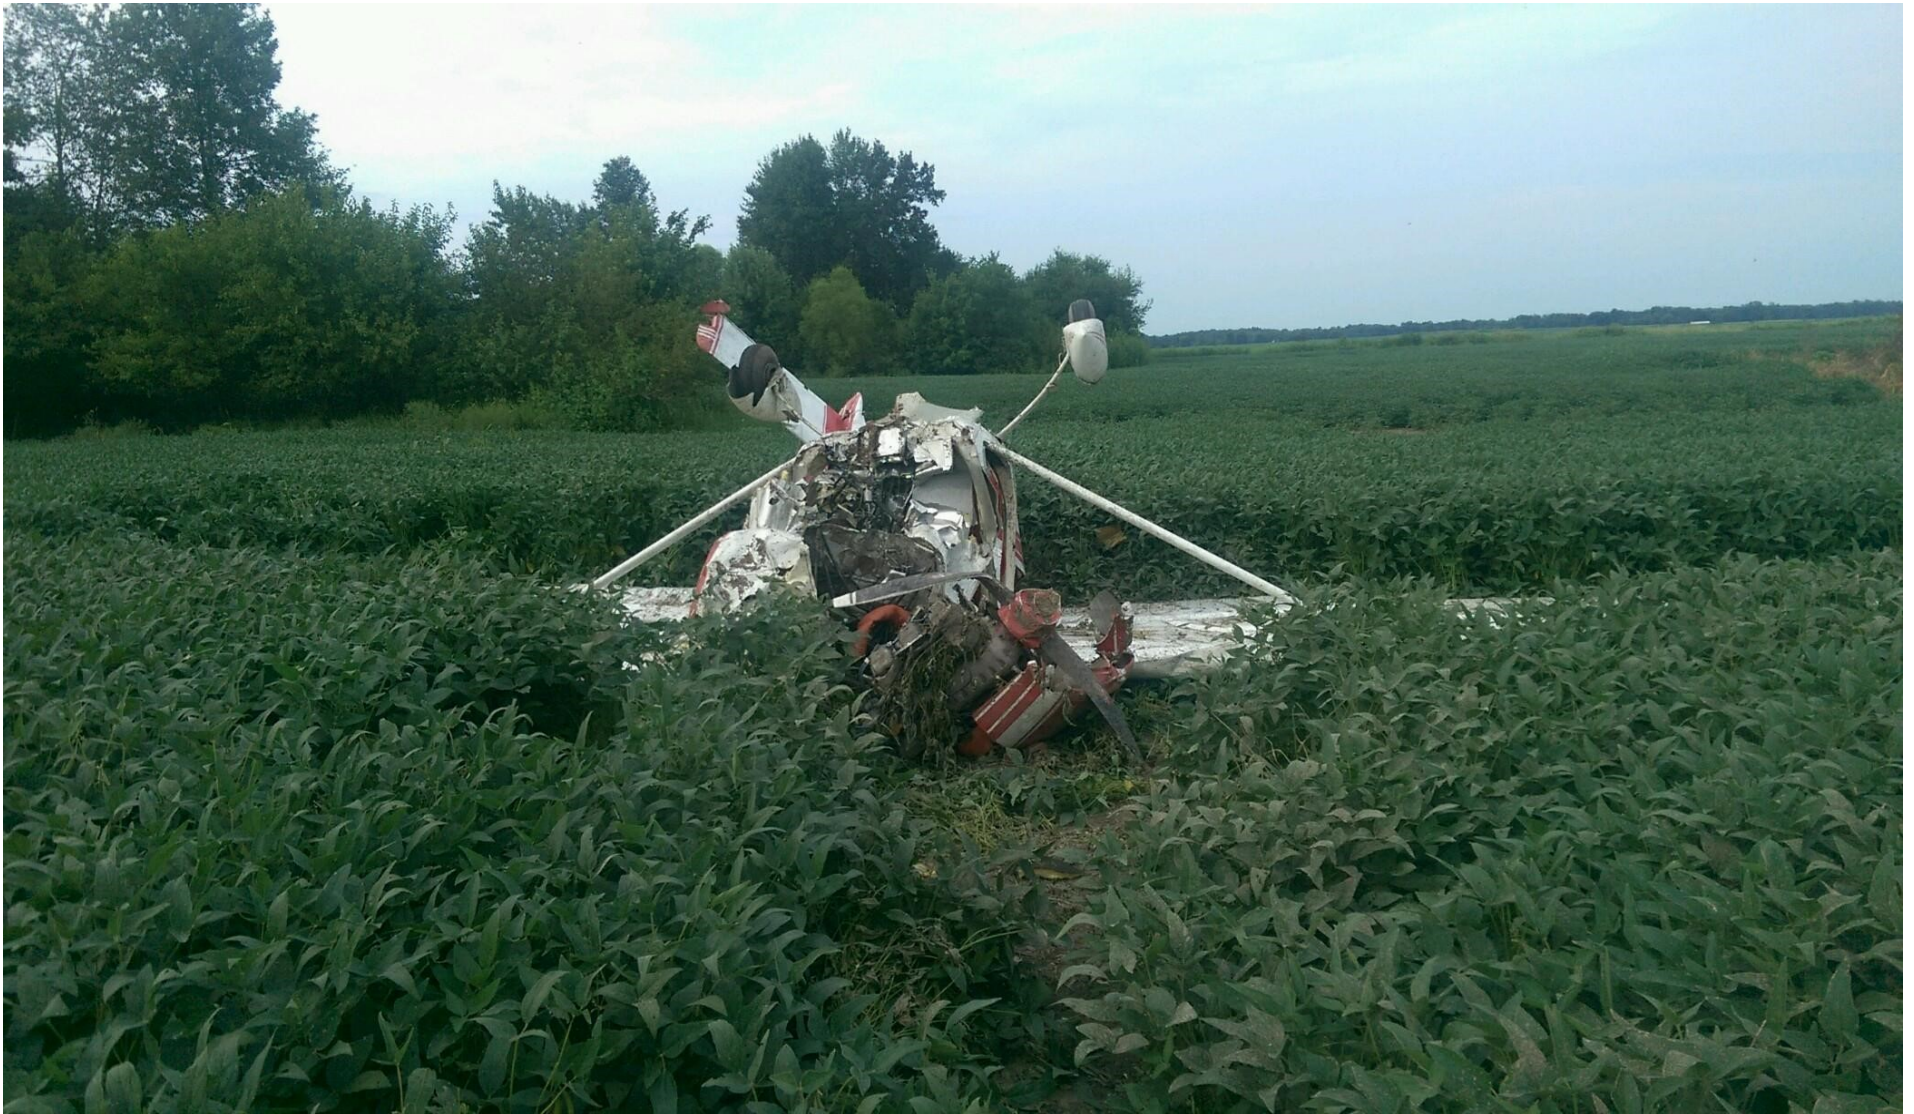
**Photo 1 - Main Wreckage at Accident Site Front View**

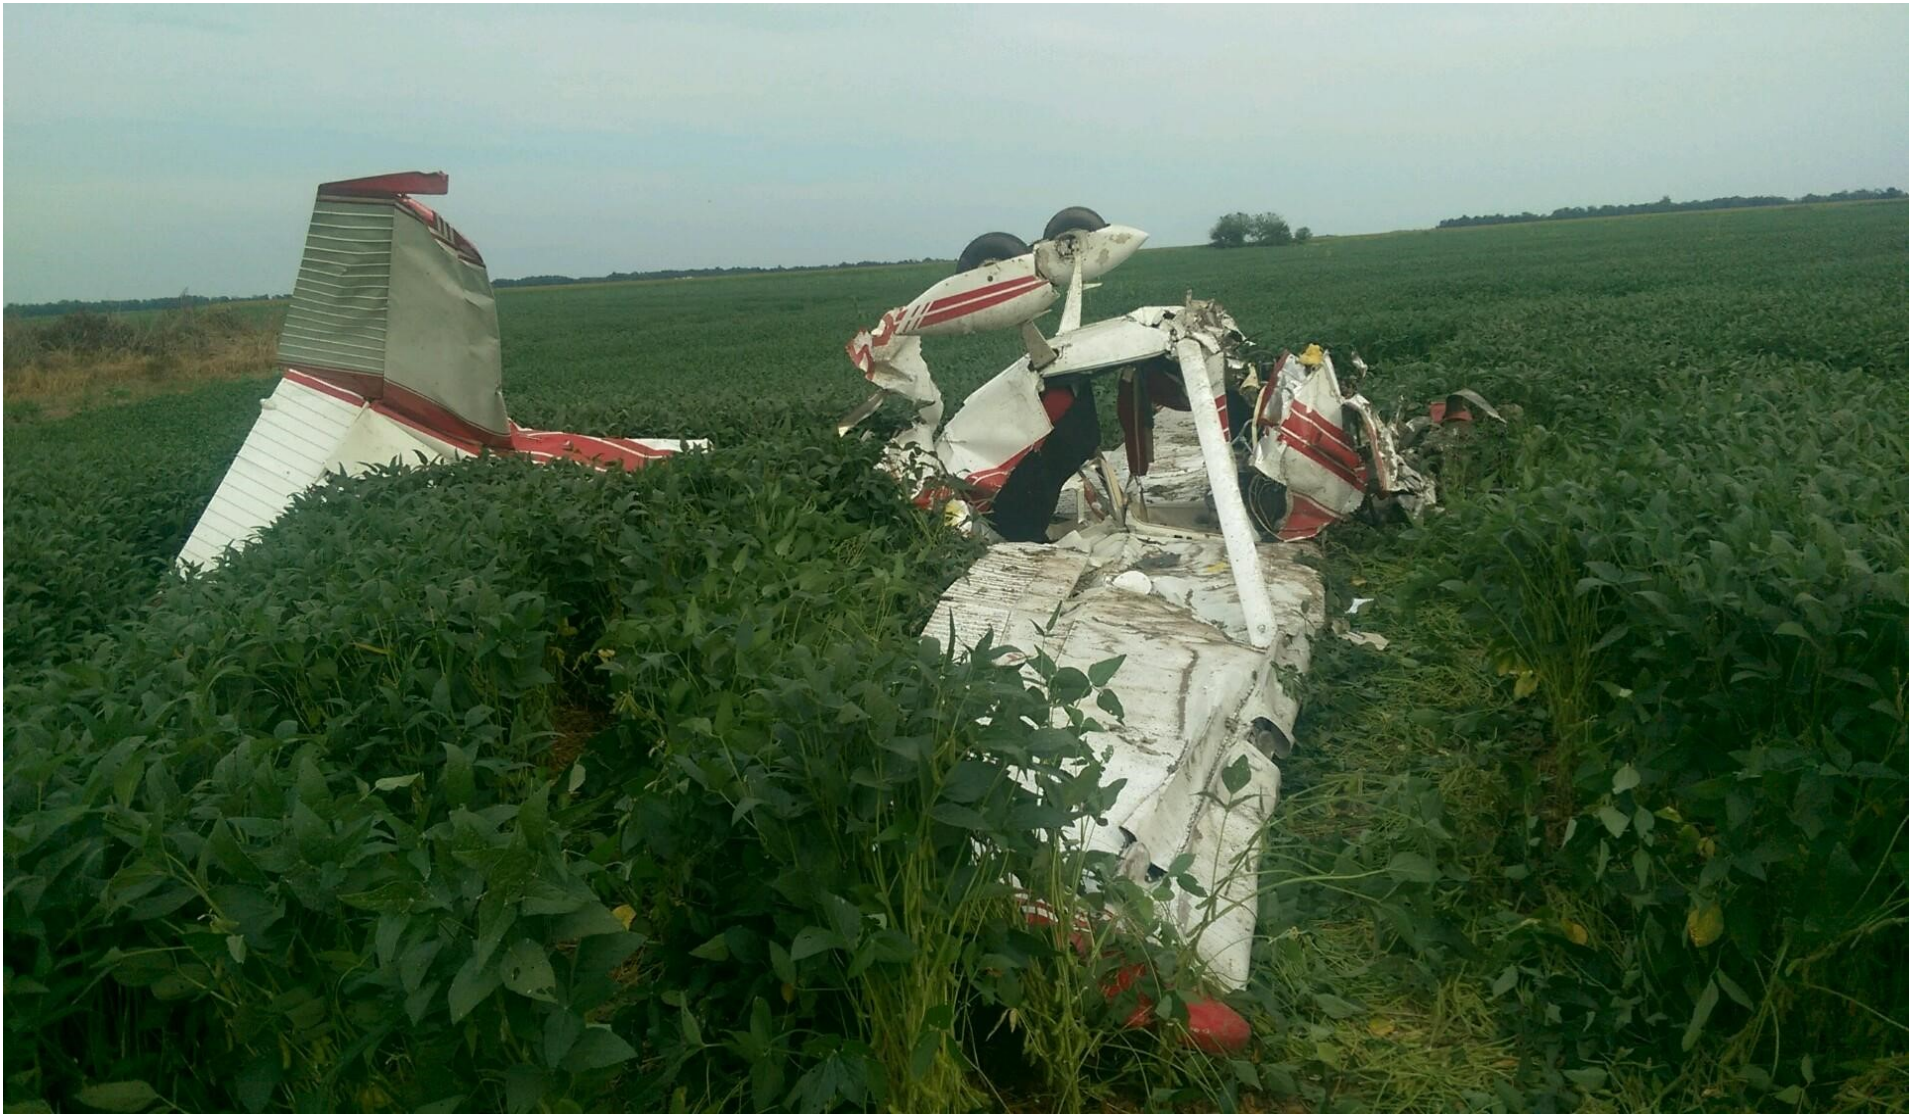
**Photo 2 - Main Wreckage at Accident Site Side View**

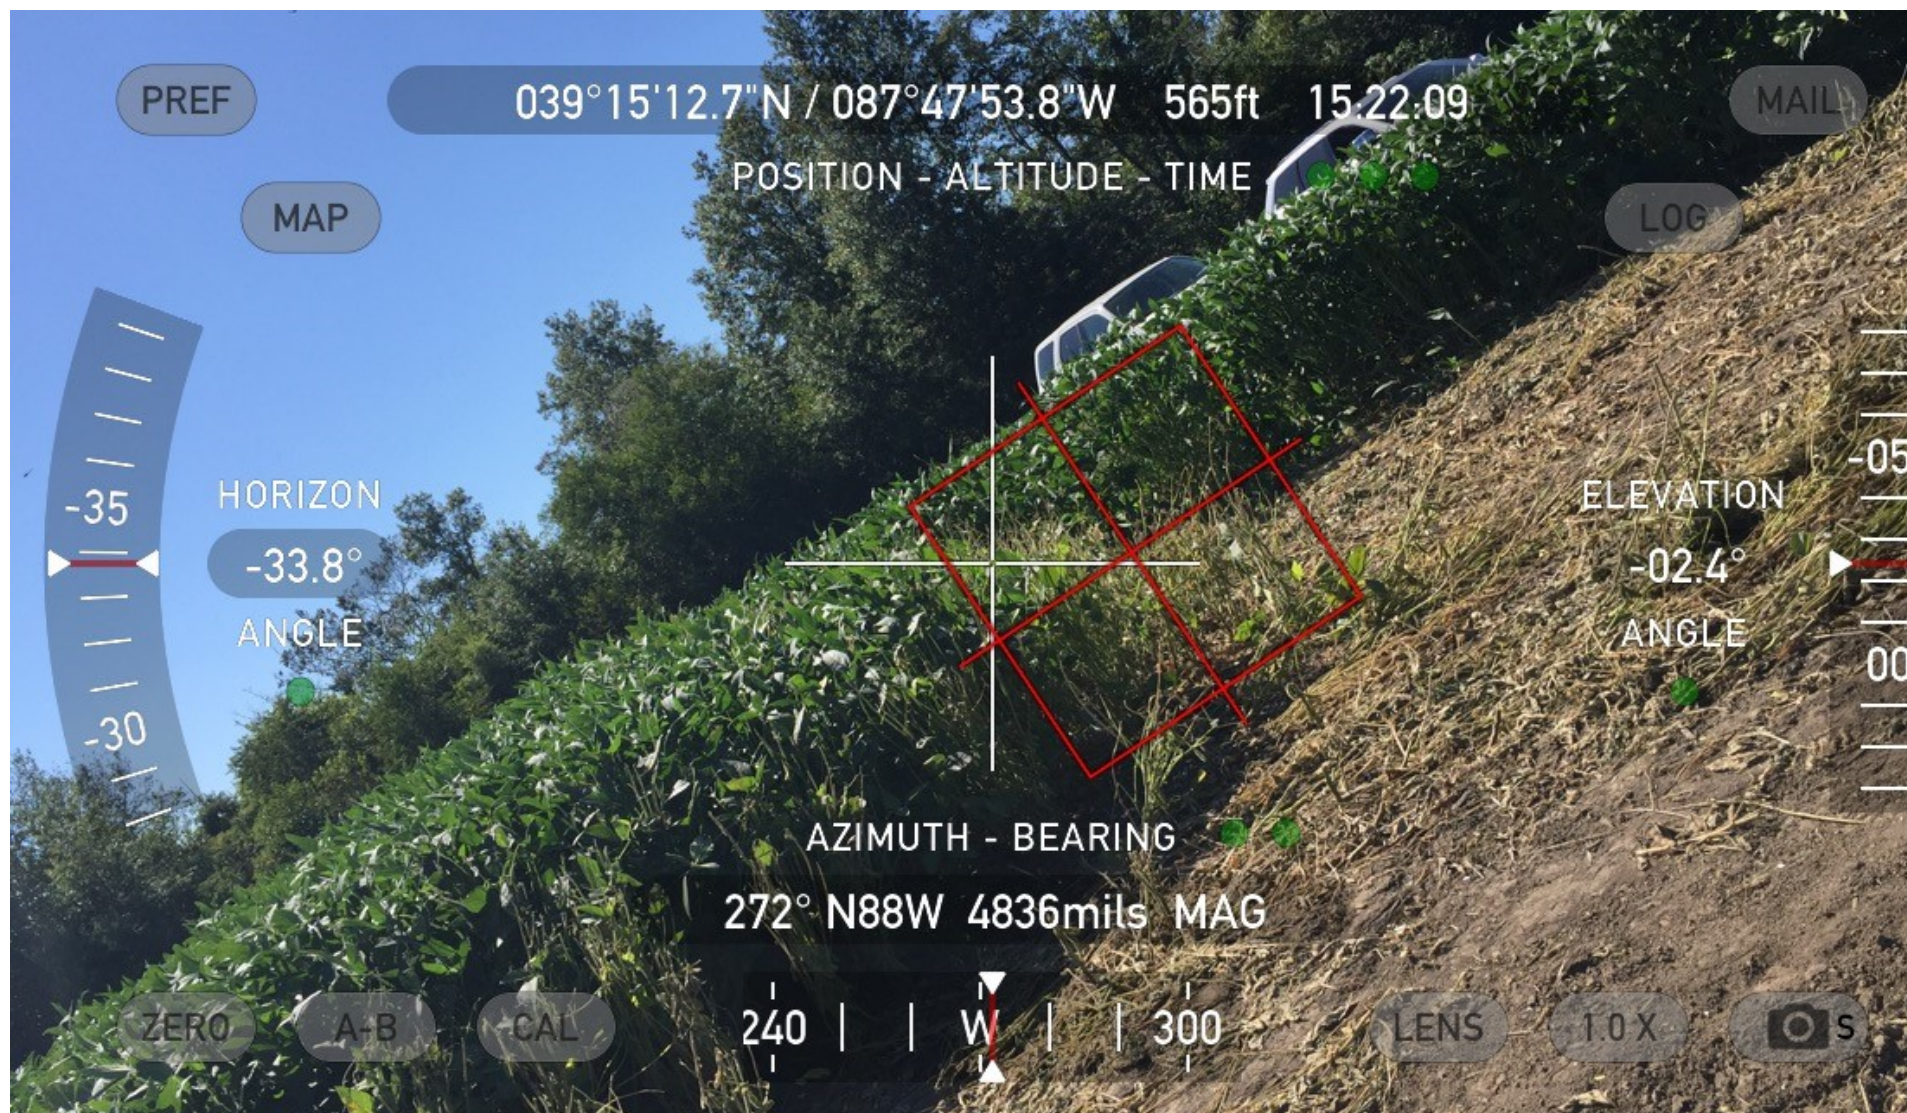
**Photo 3 - Initial Ground Scar Evidence of Impact Angle**

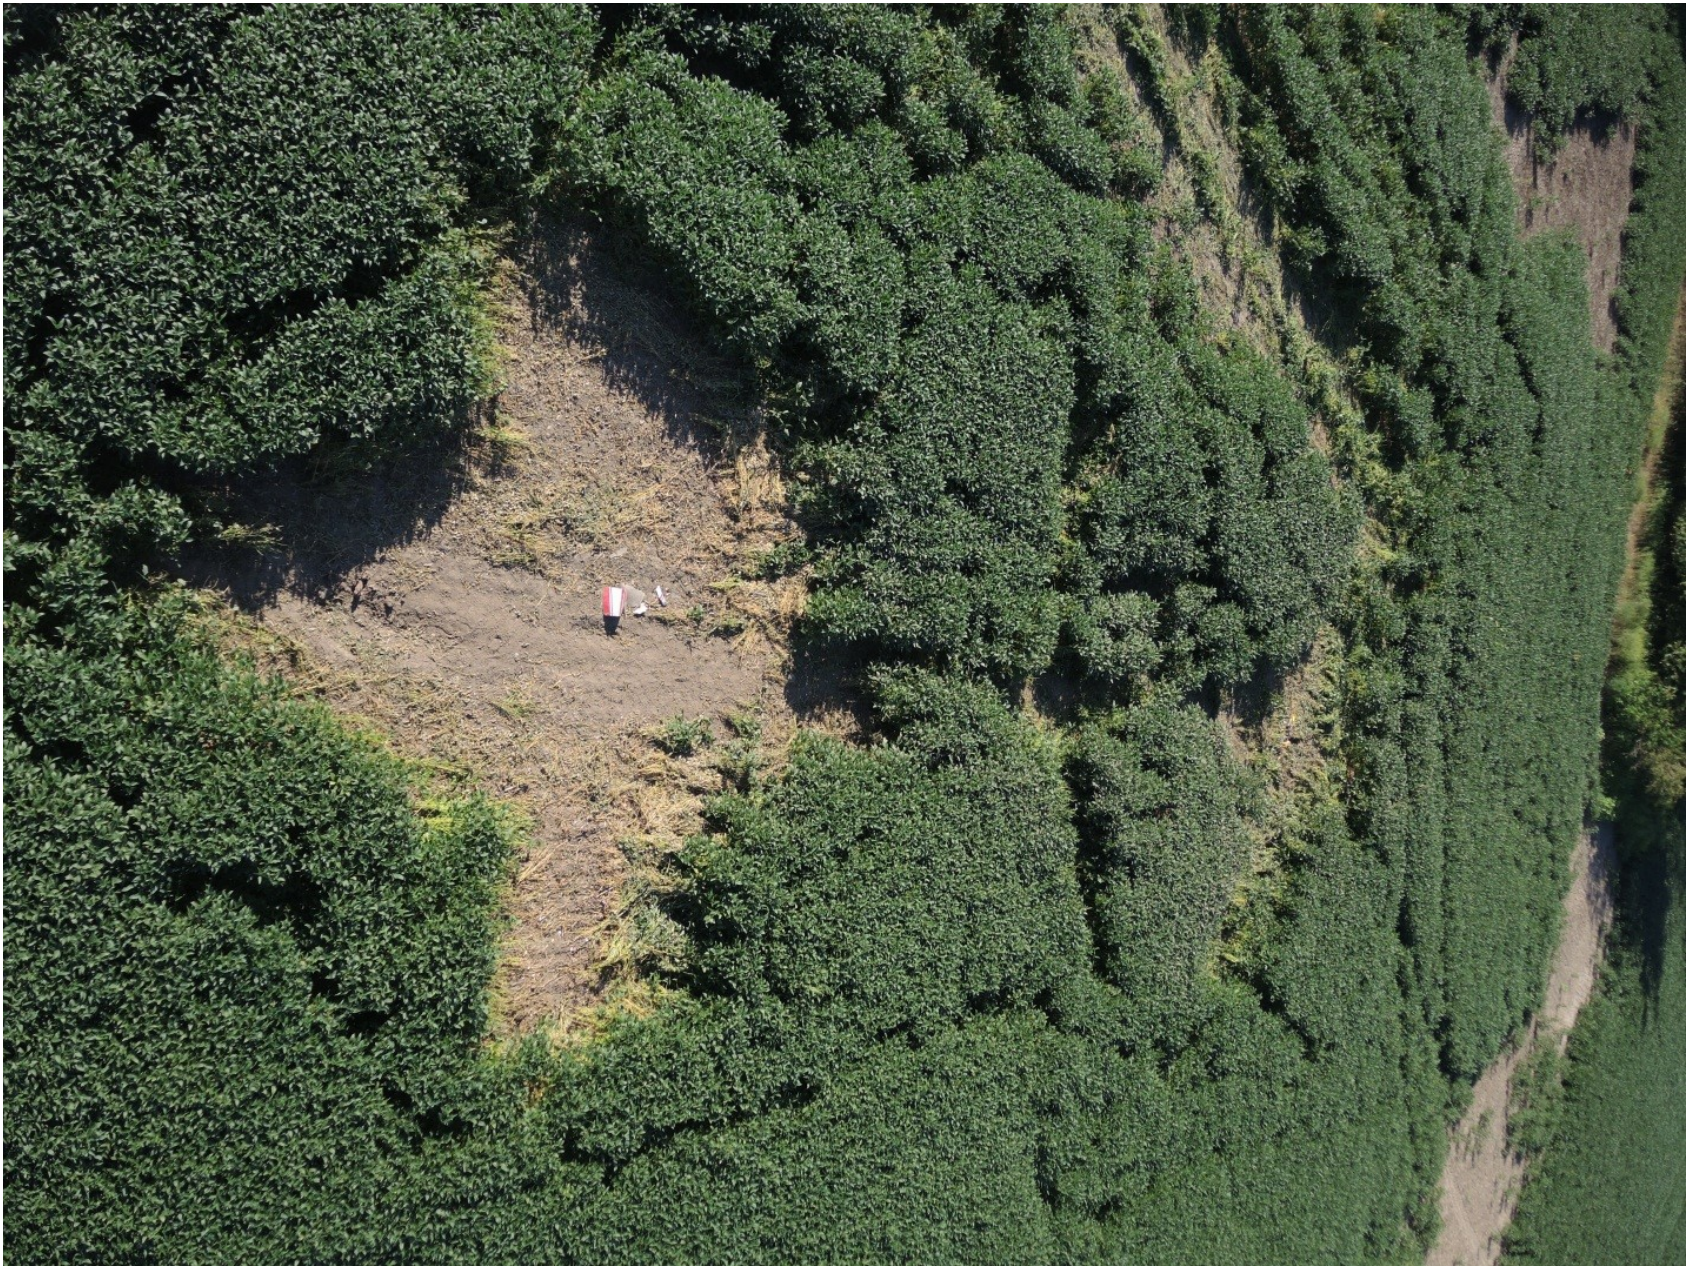
**Photo 4 - Aerial View of Accident Site Ground Scars**

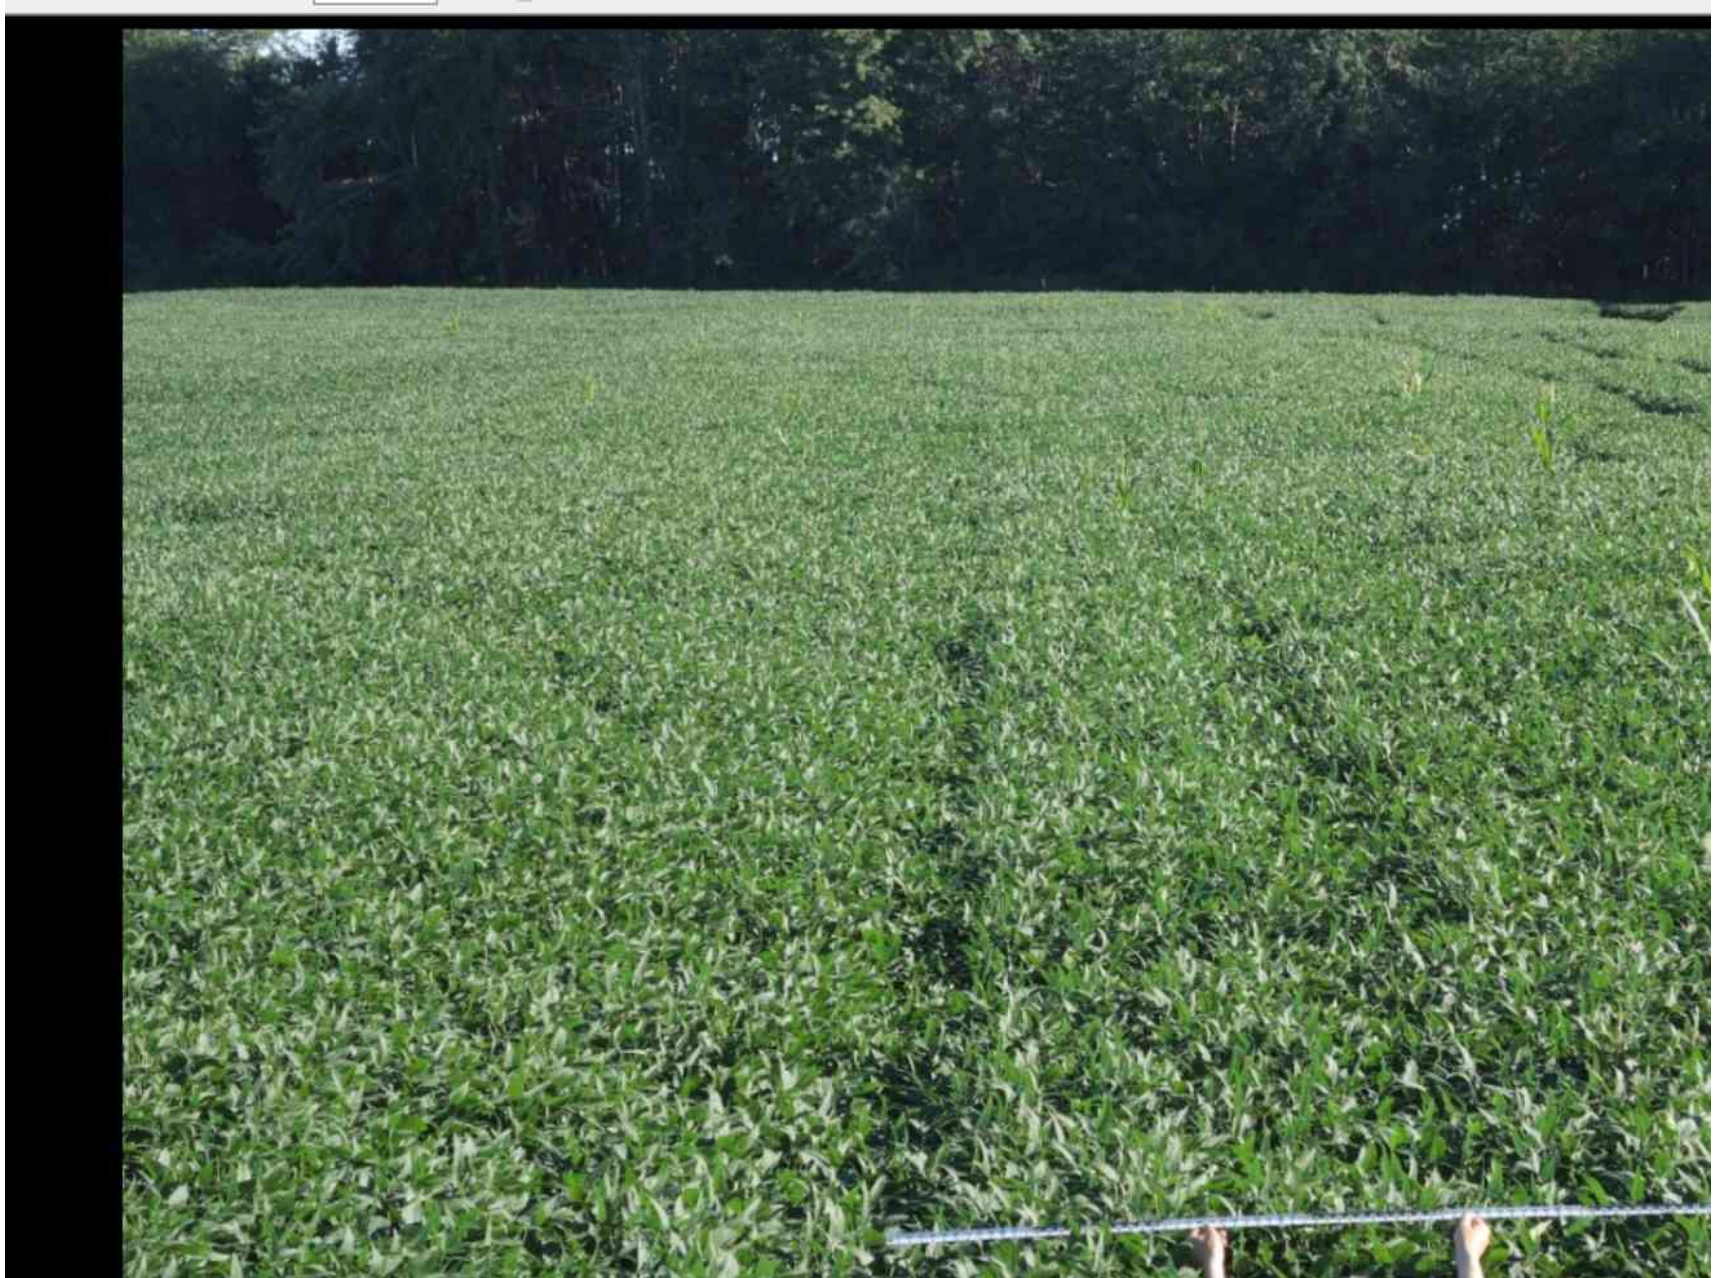
**Photo 5 - Track Marks (correlating to the nose and left main landing gear) Prior to Initial Impact Ground Scar**

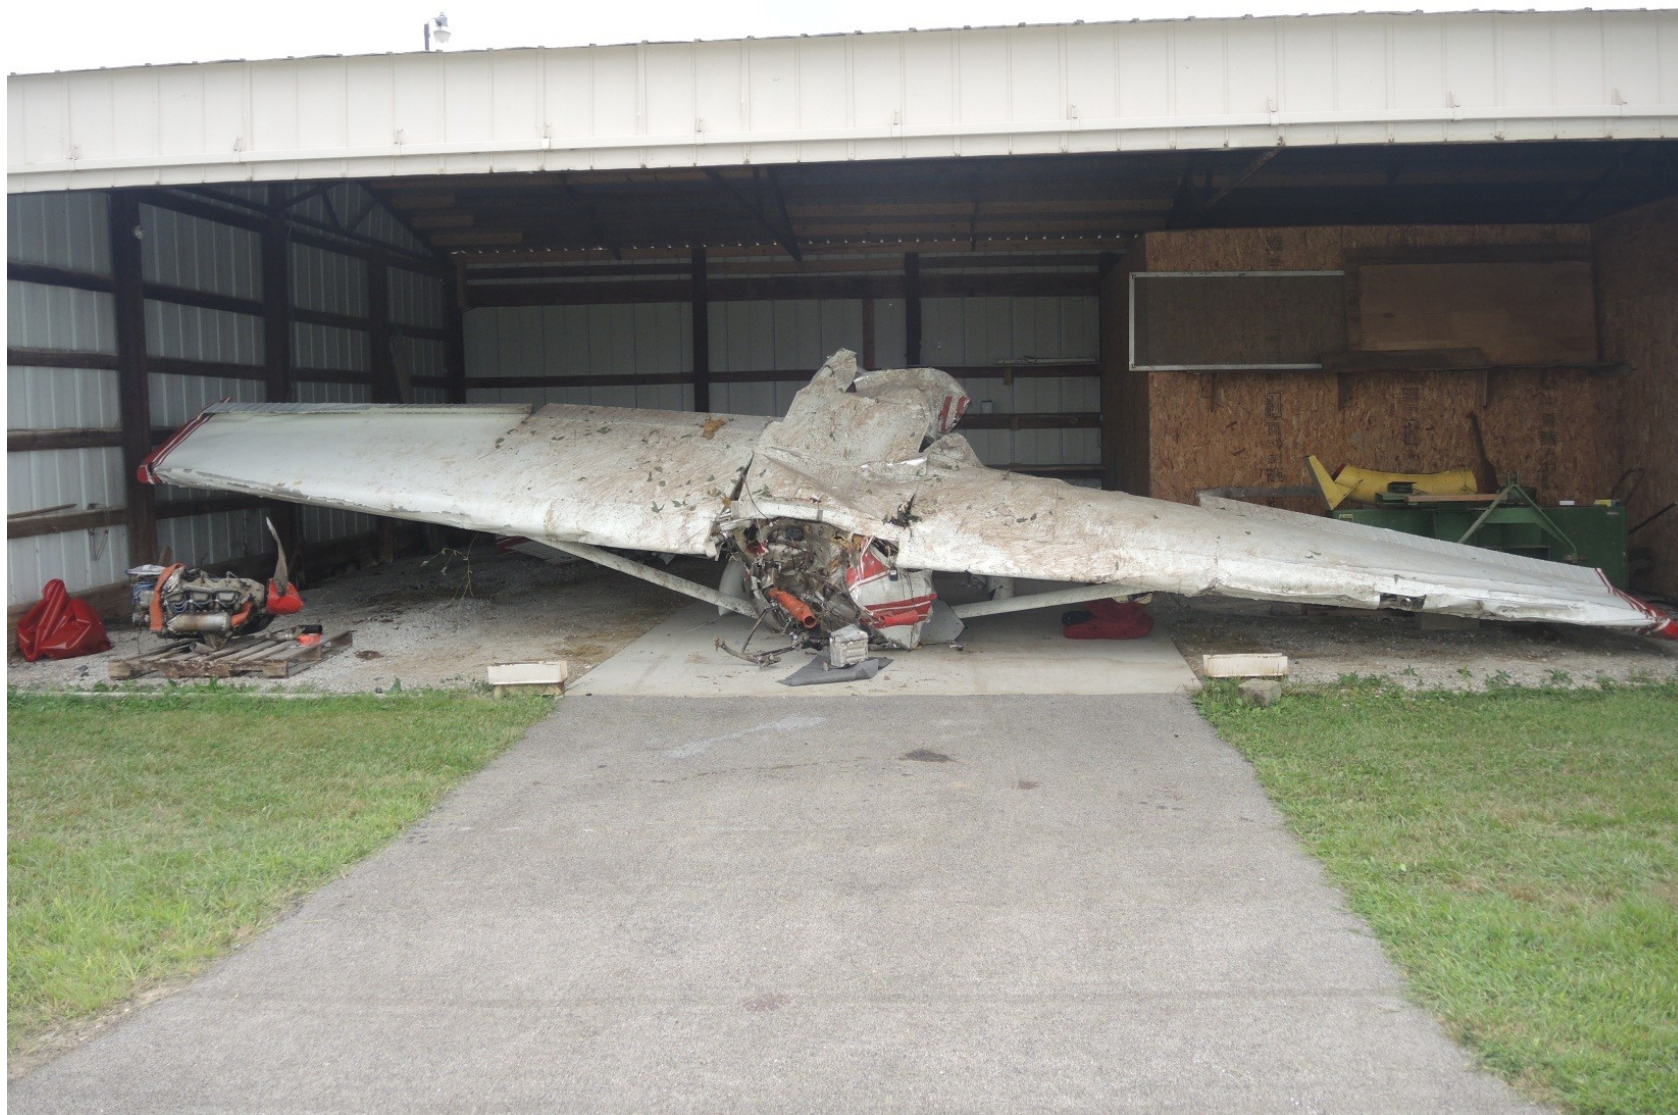
**Photo 6 - Recovered Wreckage at Casey Municipal Airport Secure Hangar**

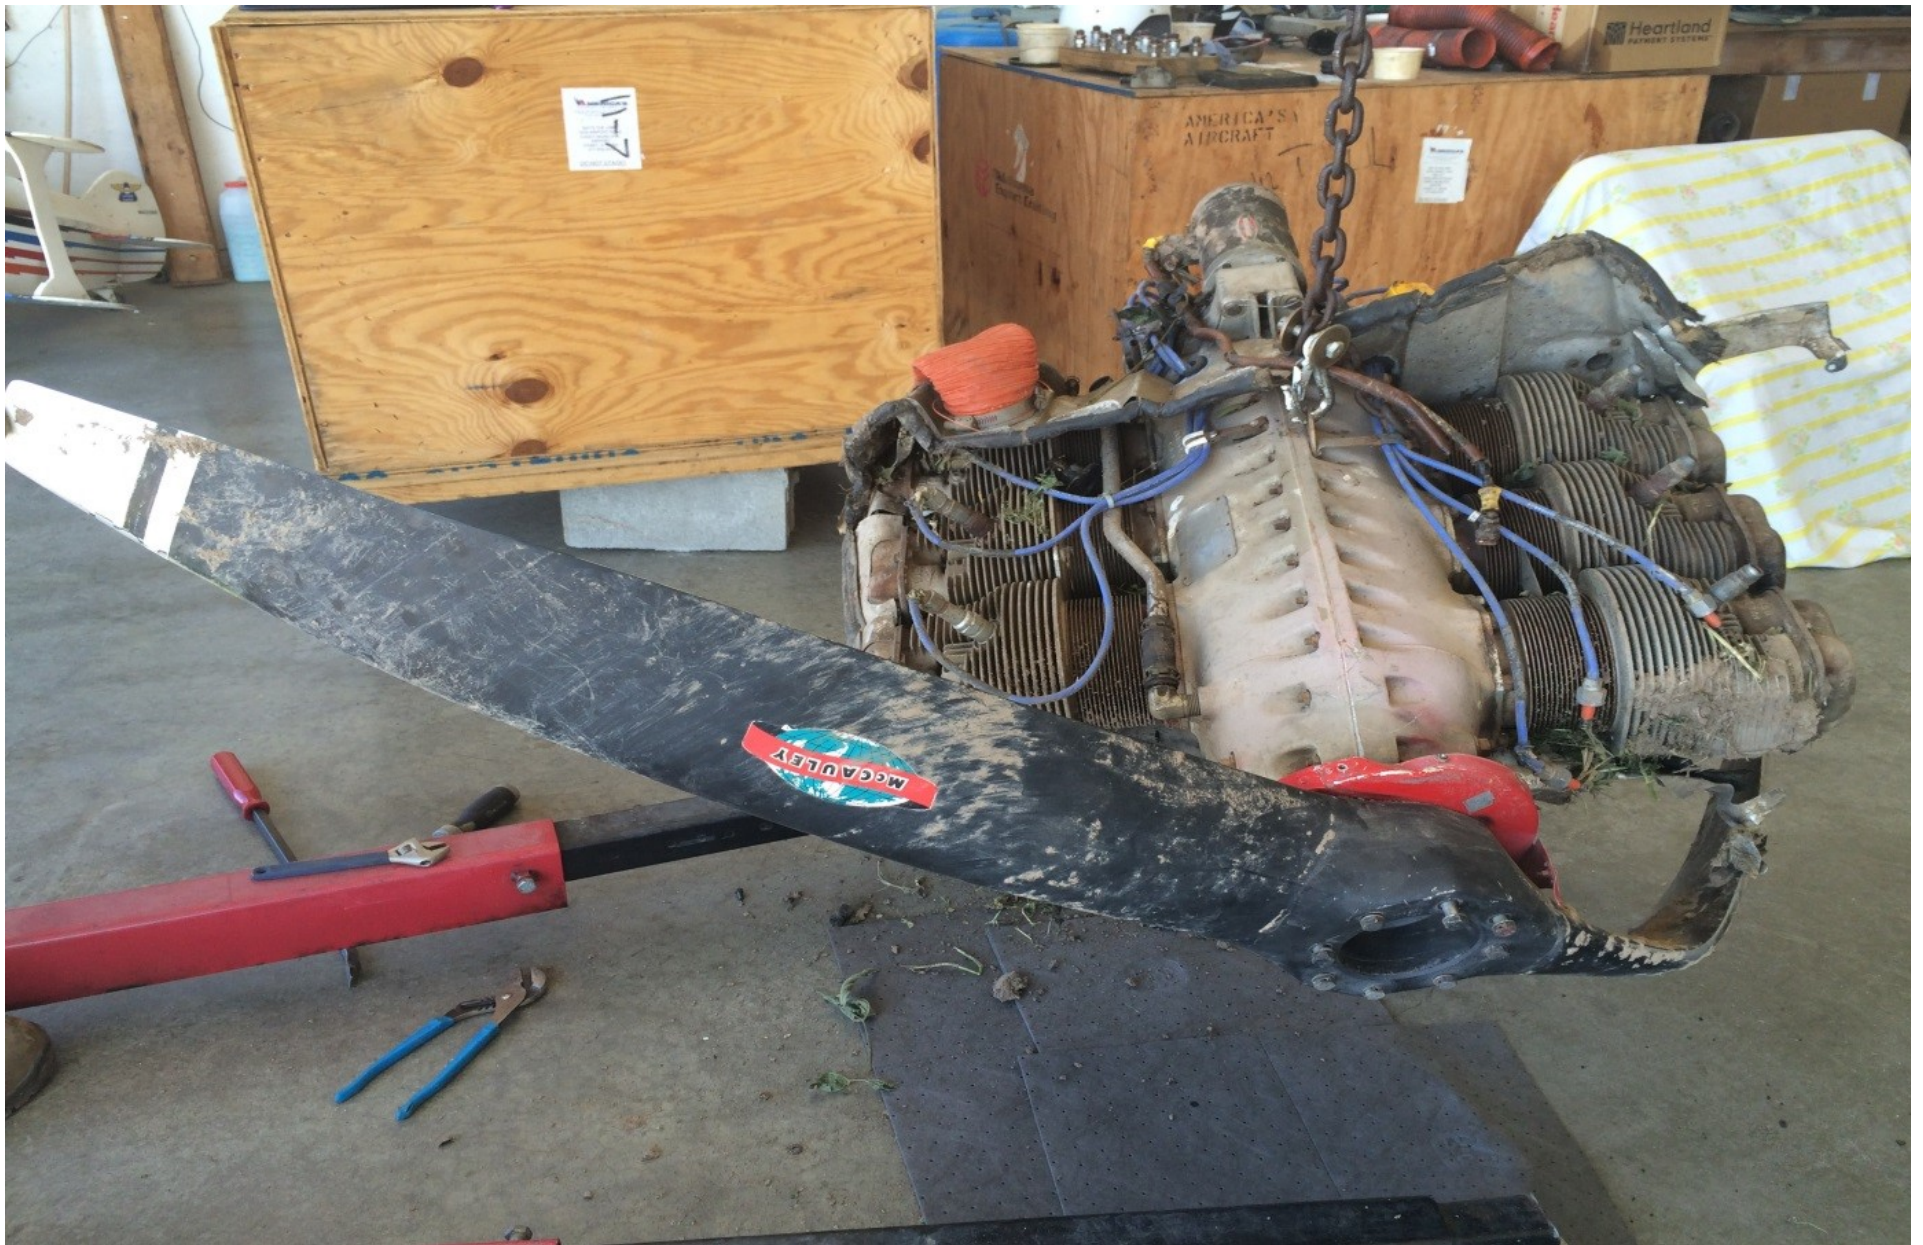
**Photo 7 - Engine and Propeller Assembly**

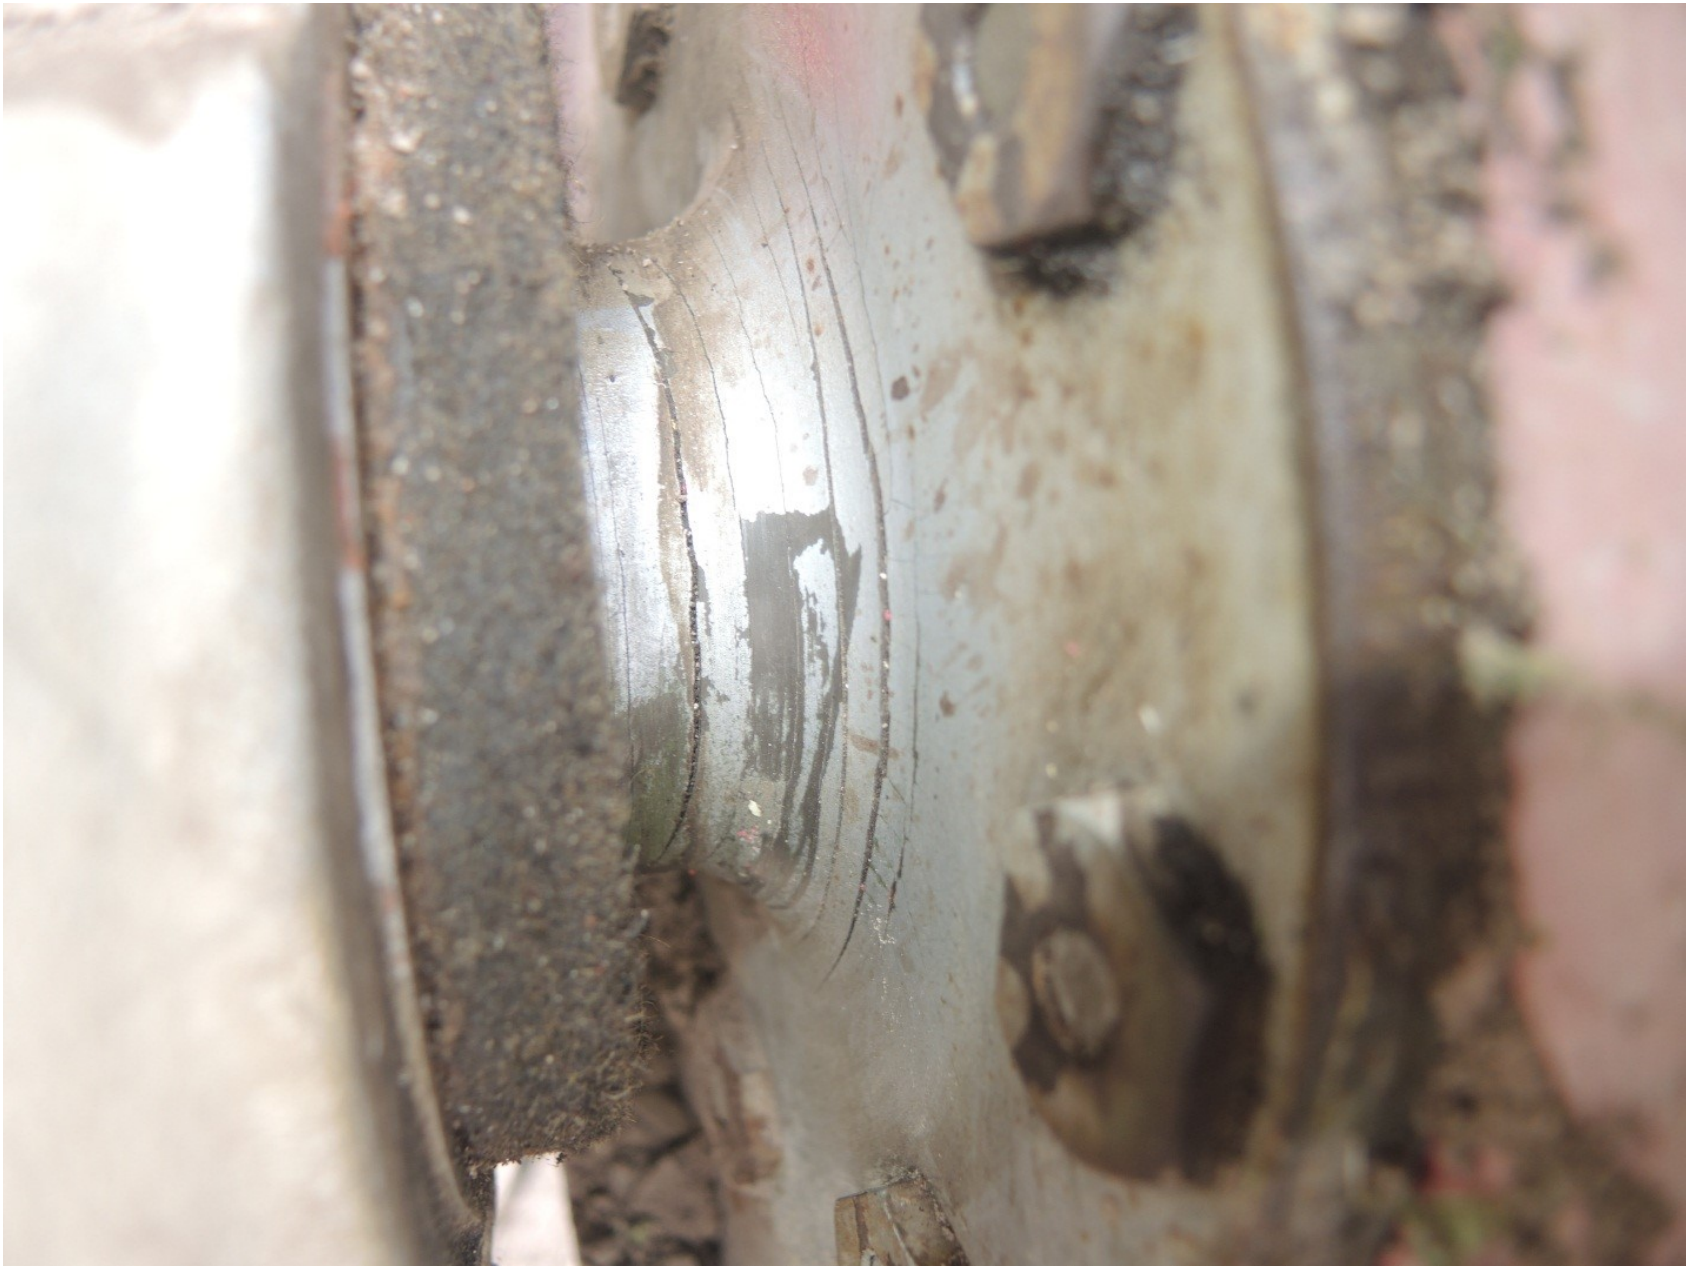
**Photo 8 - Torsional Stress Mark Signatures on the Engine Crankshaft Propeller Flange**
