CESSNA AIRCRAFT COMPANY

Model No.: 310Q

Report No.: 02-87-017

Examination of a Damaged Elevator Trim Tab Assembly from a Crashed  
M310Q Aircraft, N7648Q

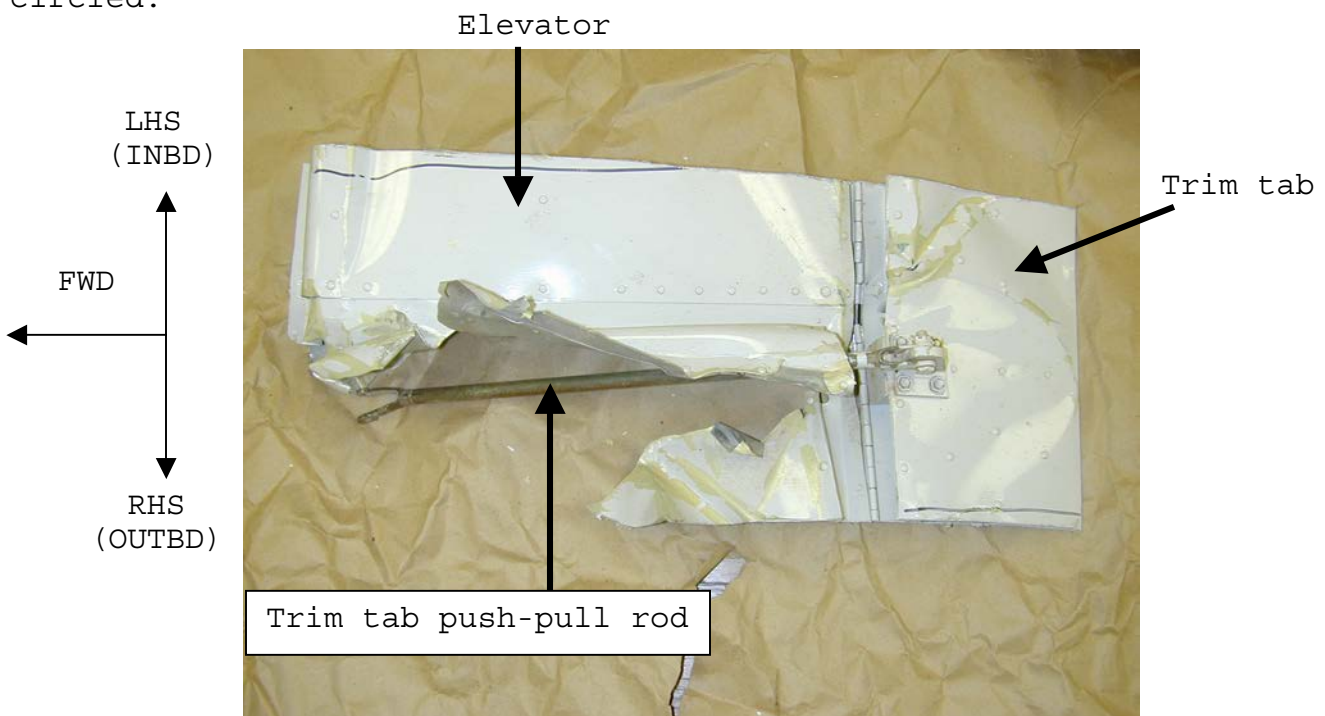
The elevator trim tab assembly is located on the RHS elevator as shown in Figure 1. The sample which was submitted to M&P consisted of a portion of the elevator and trim tab approximately 8 inches wide, along with the push-pull rod and the trim tab actuator outer housing, as shown in Figure 2. The 8 inch wide sample was heavily damaged, exhibiting torn and bent metal components and an overall soiled appearance with light corrosion of the internal areas.

Figure 2. View of the underside of the elevator trim tab sample.

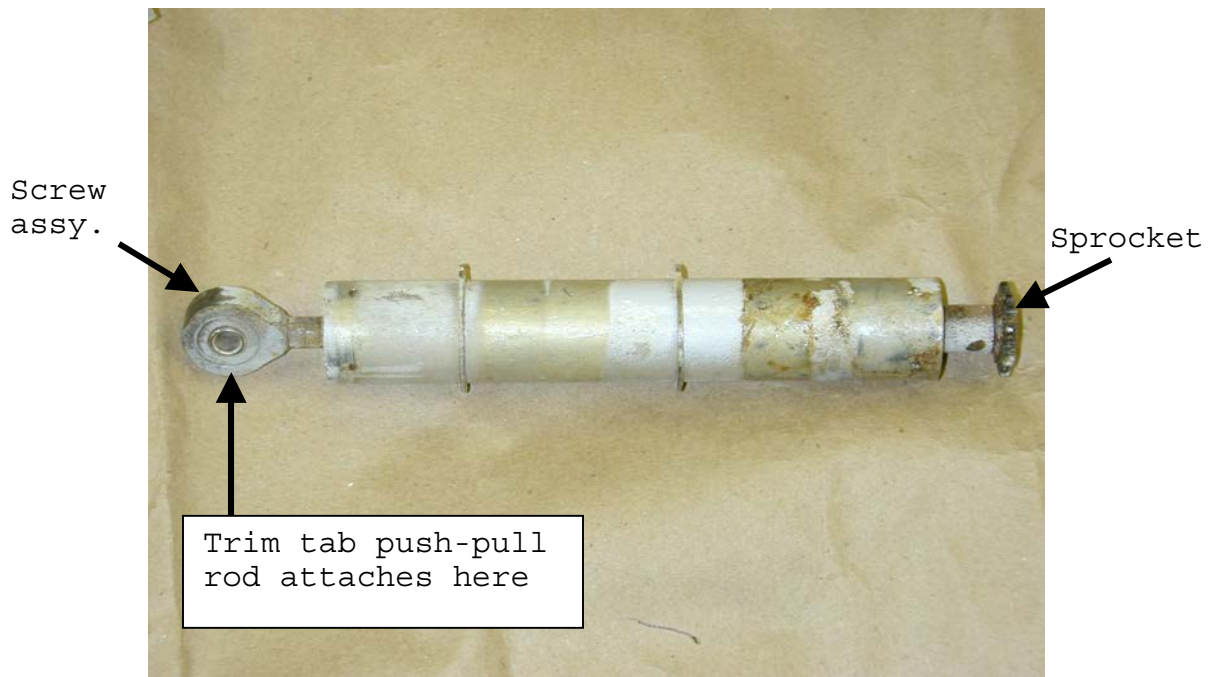
There was very little damage, other than normal wear and tear present on the trim tab actuator.

The trim tab actuator, shown in Figure 3, was in a moderately worn condition, and was not attached to the trim tab push-pull rod. It was reported that the push-pull rod and the actuator were found to be disconnected at the crash site. The forward clevis of the push-pull rod attaches to the actuator by a bolt, which was not found at the crash site. The bolt would have been held in place by a castellated nut and cotter pin, similar to the attachment at the aft trim tab clevis, as shown in Figure 4.

Figure 3. View of the trim tab actuator, with the various components labelled.

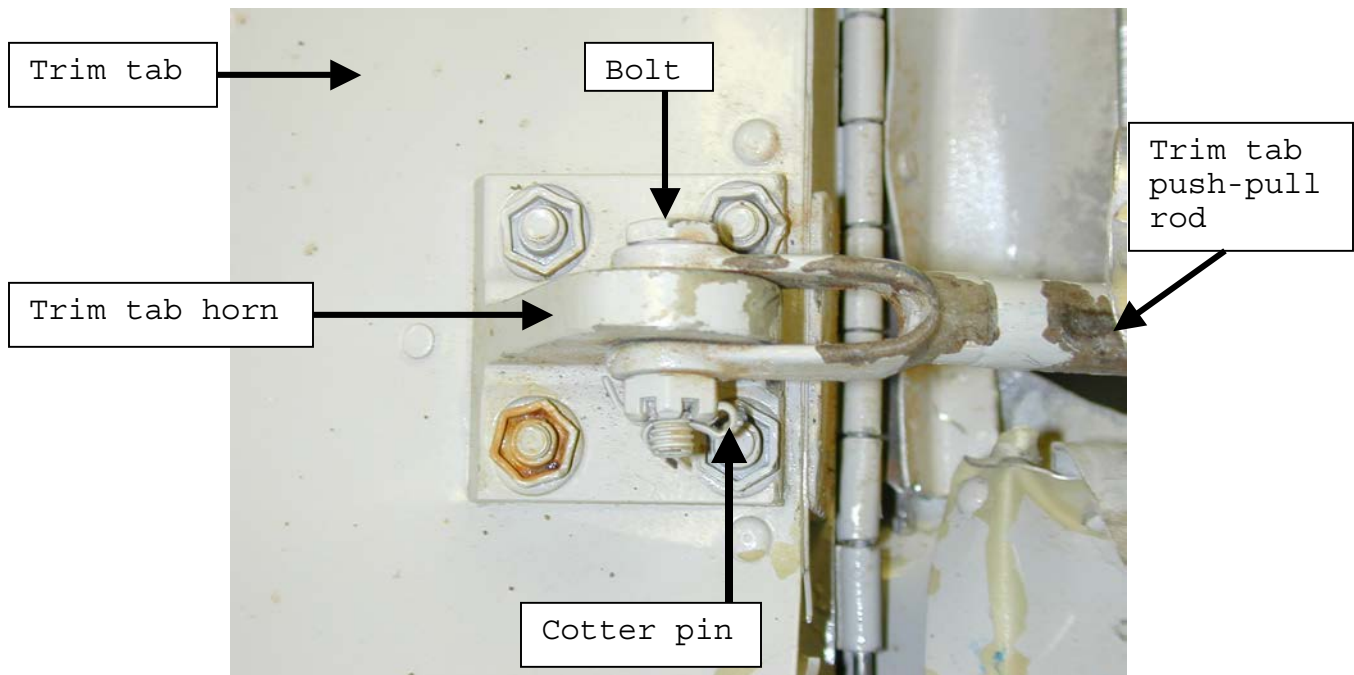
Figure 4. View of the attachment of the trim tab push-pull rod to the horn on the trim tab, in the condition in which the part was received.

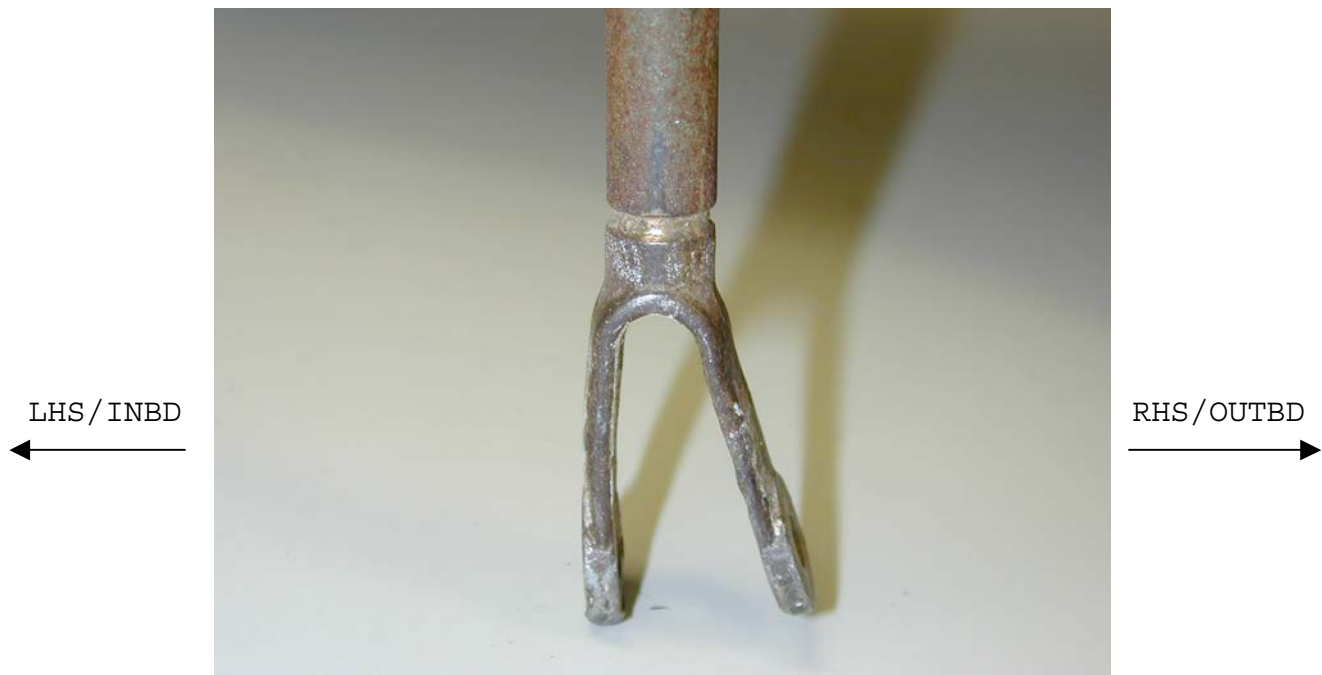
The trim tab push pull rod consisted of a steel tube, 0.38 inches OD by approximately 11 inches long, with steel clevises silver brazed to each end of the tube. The clevis on the push-pull rod was spread open approximately 0.3 inches, as shown in Figure 5. There were some wear marks on the end of the clevis fork, as shown in Figure 6. There was also some slight wear on the underside of the rod near the clevis, as shown in Figure 7. Examination of a similar M310 aircraft showed that the rod passes through the elevator spar through an opening; the worn area would have corresponded with the opening, as shown in Figure 8. It was also noted that on the representative M310 aircraft, there was nothing in contact with the ends of the clevis fork. Light wear marks were also found on the inner surface of the clevis, as shown in Figure 9. The marks on the inner surface of the clevis corresponded in shape and configuration with the screw assembly of the actuator, as shown in Figure 10.

Figure 5. View of the forward clevis of the trim tab push-pull rod, which was spread open approximately 0.3 inches. Magnification: x1.4.

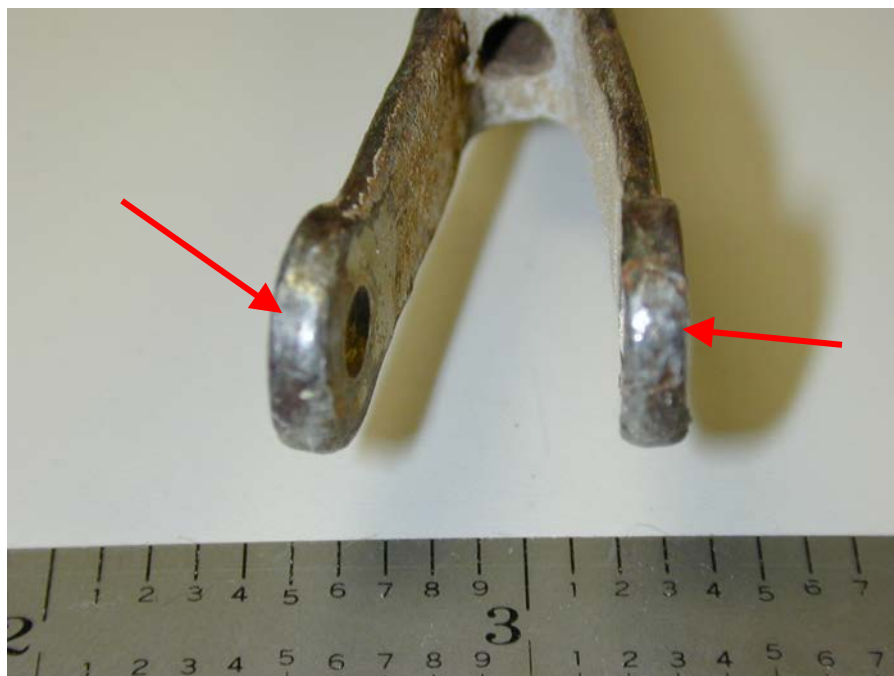
Figure 6. Close-up view of the ends of the forward clevis forks, showing some non-corroded worn areas (arrows). Magnification: x2.45.

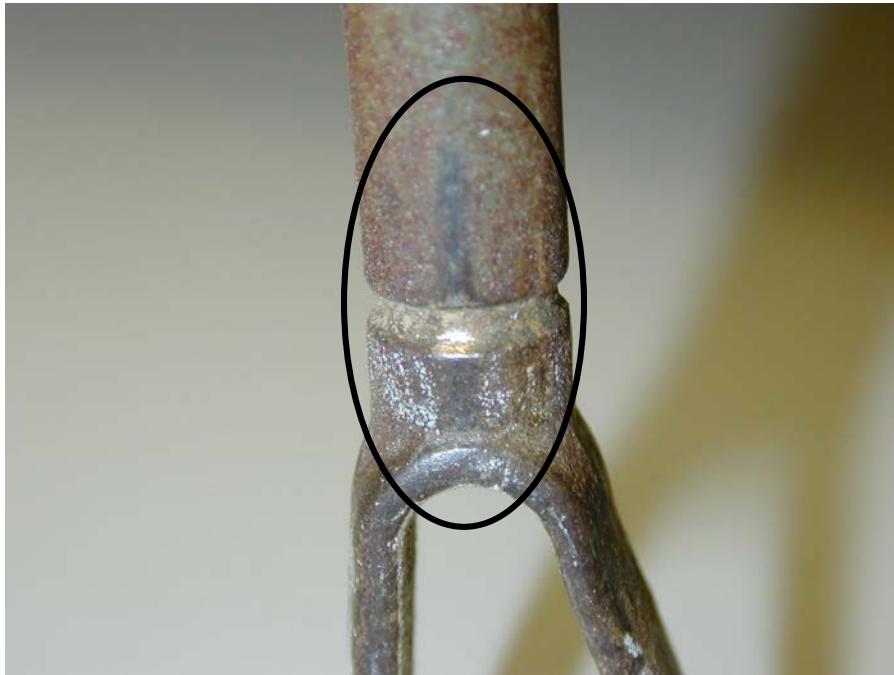
Rub marks on the opening of the forward elevator spar correspond to rub marks found on the underside of the trim tab push-pull rod. The geometry of the assembly in its current condition would allow the forward clevis to fall behind the forward elevator spar.

Figure 7. View of the underside of the trim tab push-pull rod showing light wear (circled). Magnification: x2.8.

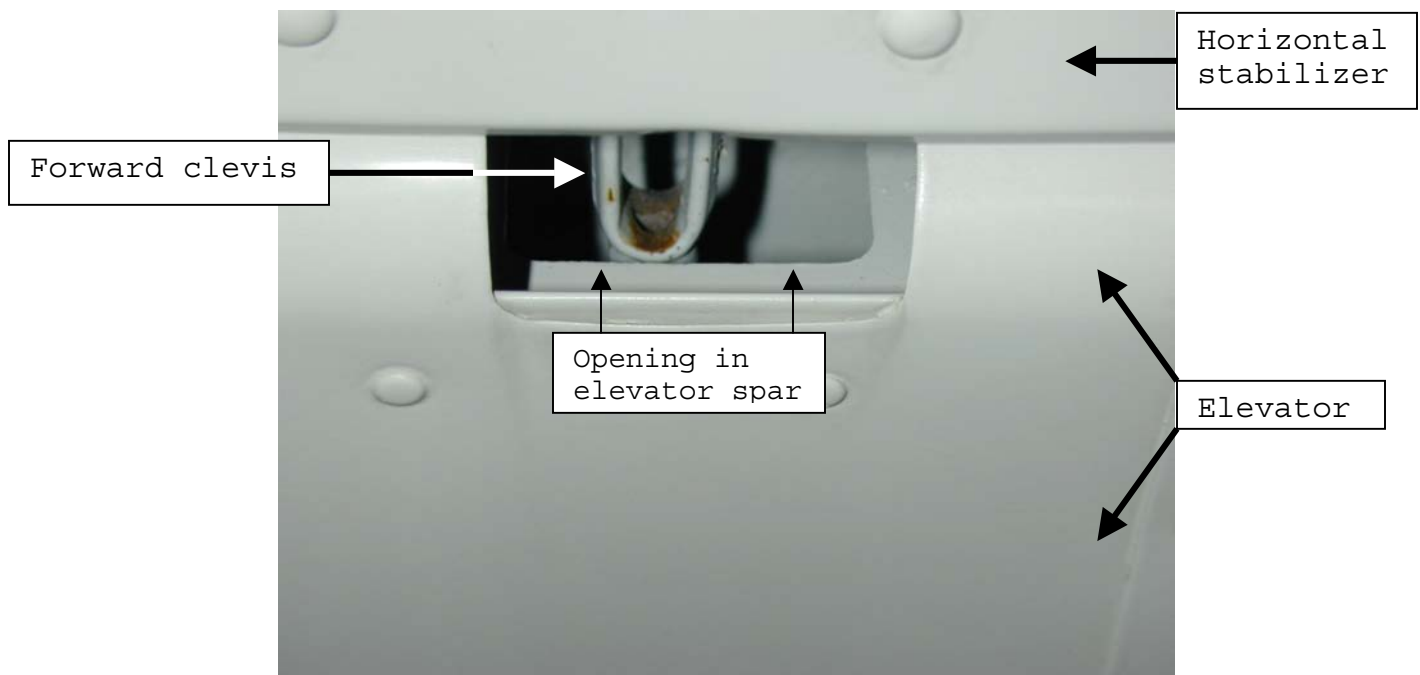
Figure 8. View of a trim tab actuator rod clevis on a representative M310 aircraft. Note the proximity of the clevis to the opening in the elevator spar.

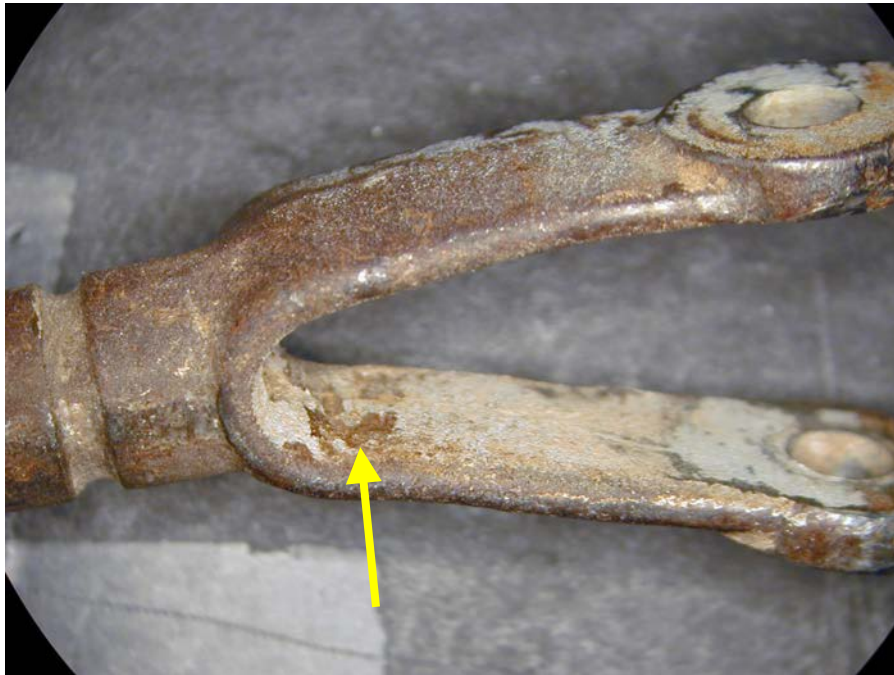
Figure 9. Close up view showing light wear marks on the inner surface of one of the forward clevis (arrow). Magnification: x2.9.

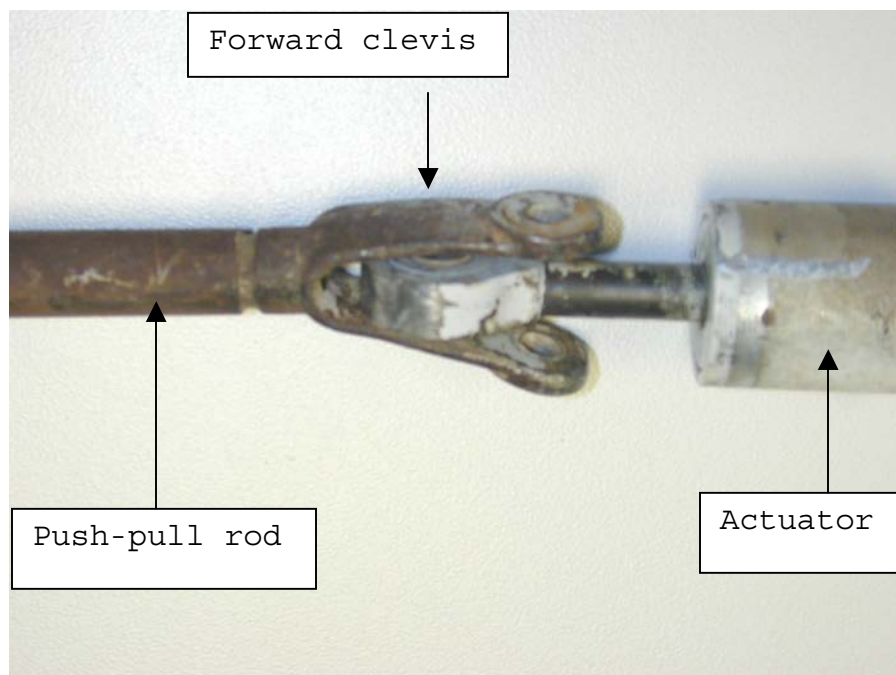
Figure 10. View showing how the screw assembly corresponds with the location of the wear marks on the inner surface of the forward clevis. Magnification: x1.16.

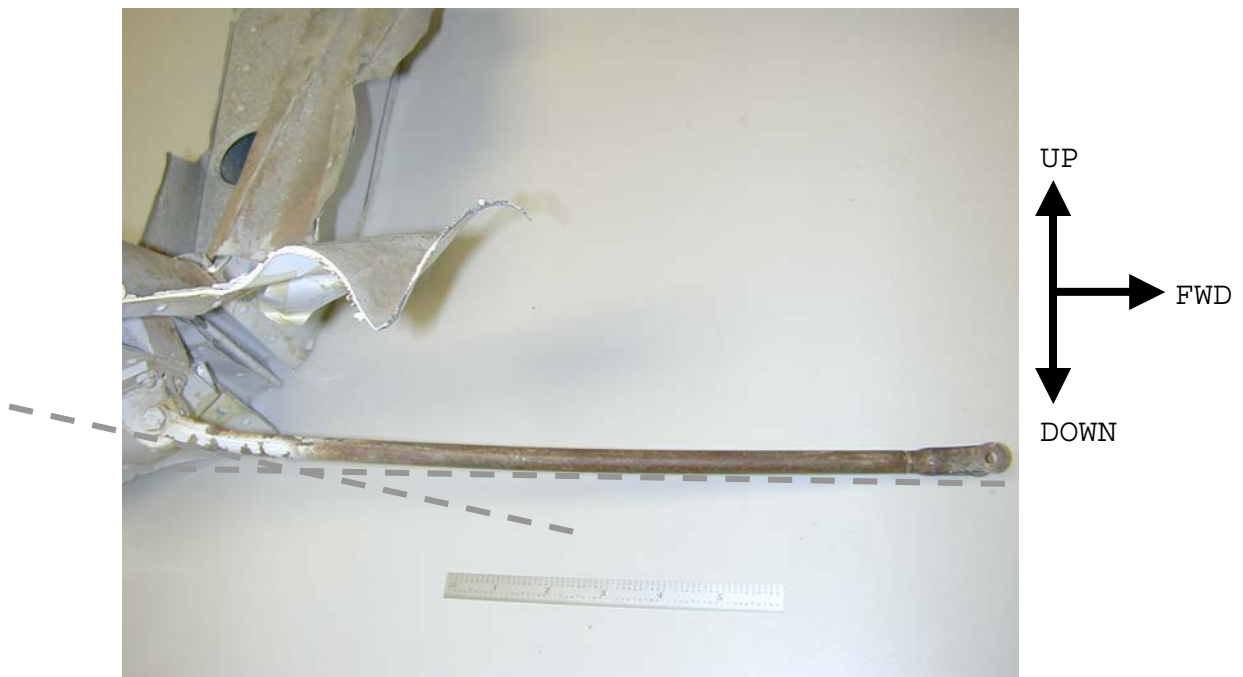
The trim tab push-pull rod was bent upward, with indentations present on the aft clevis and the tab horn. This type of damage

is consistent with the trim tab being in the full up position (elevator full down) at the time of the crash. The force of the crash would have been the most likely cause of this damage.

The push-pull rod was slightly bent upward, as shown in Figure 11. Close examination of the clevis at the aft end showed that it was lightly corroded in a similar manner as the remainder of the rod. Indentation marks were found on the upper side of the clevis, which corresponded with indentations found on the tab horn, as shown in Figures 12a, 12b, and 12c. The indentations on the tab horn were also not corroded. The retaining bolt in the trim tab horn did not appear to be bent, and the cotter pin was intact. The horn bearing was corroded, but not seized.

Figure 11. View of a trim tab actuator rod. Note that the rod has been bent upward near the trim tab.

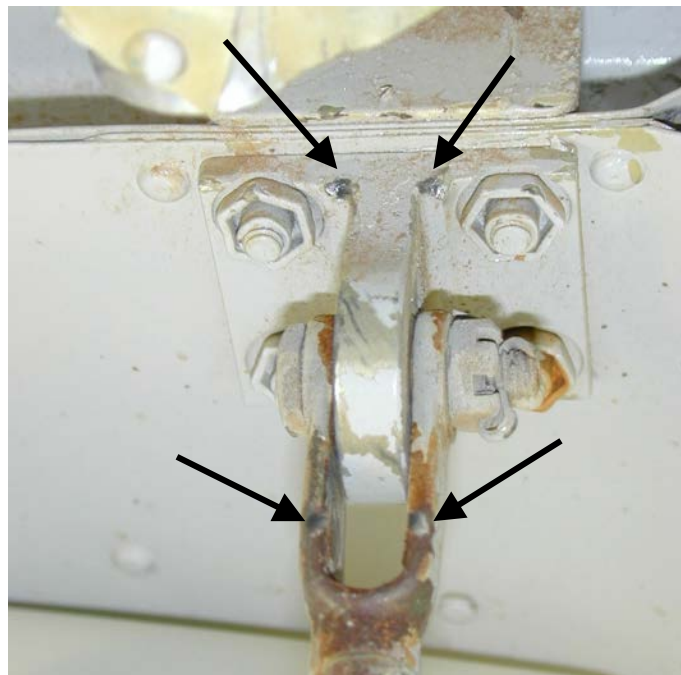
Figure 12a. View of the aft clevis, showing indentation markings on the clevis forks and on the tab horn (arrows). The trim tab rod has been moved downward approximately 90° from its actual orientation for this photo. Magnification: x1.48.

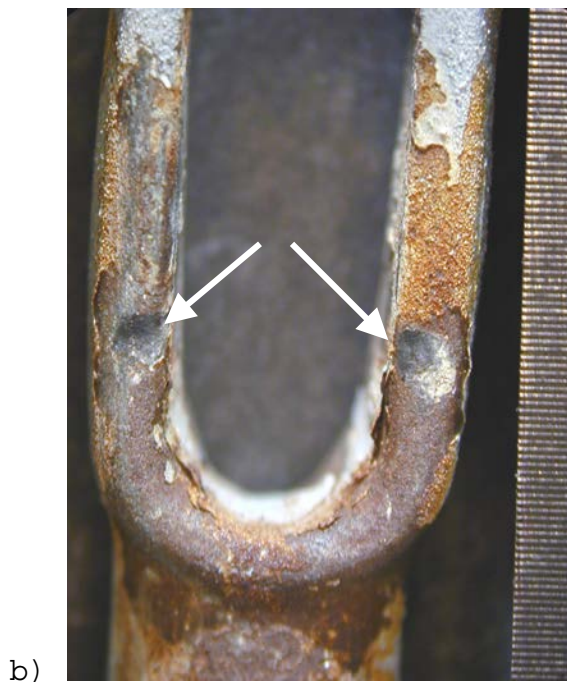
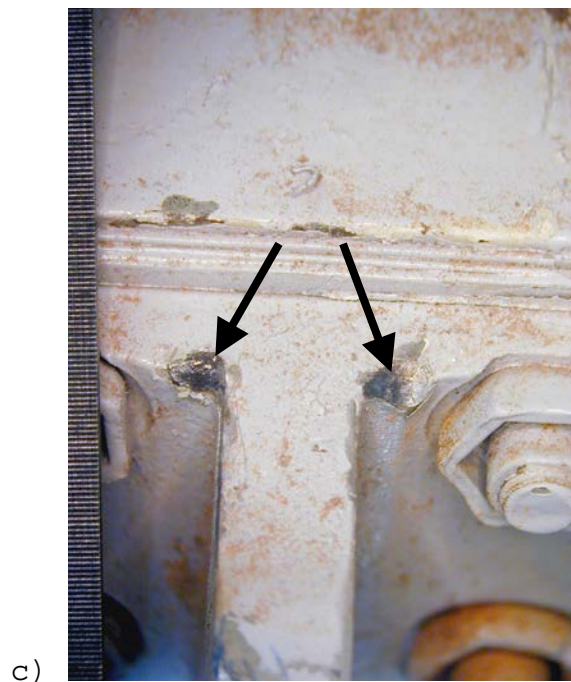
Figure 12b and 12c. Close-up views of the aft clevis (b) and the trim tab horn (c), showing the un-corroded indentation markings (arrows). Magnifications: x4 (b) and x2.8 (c).

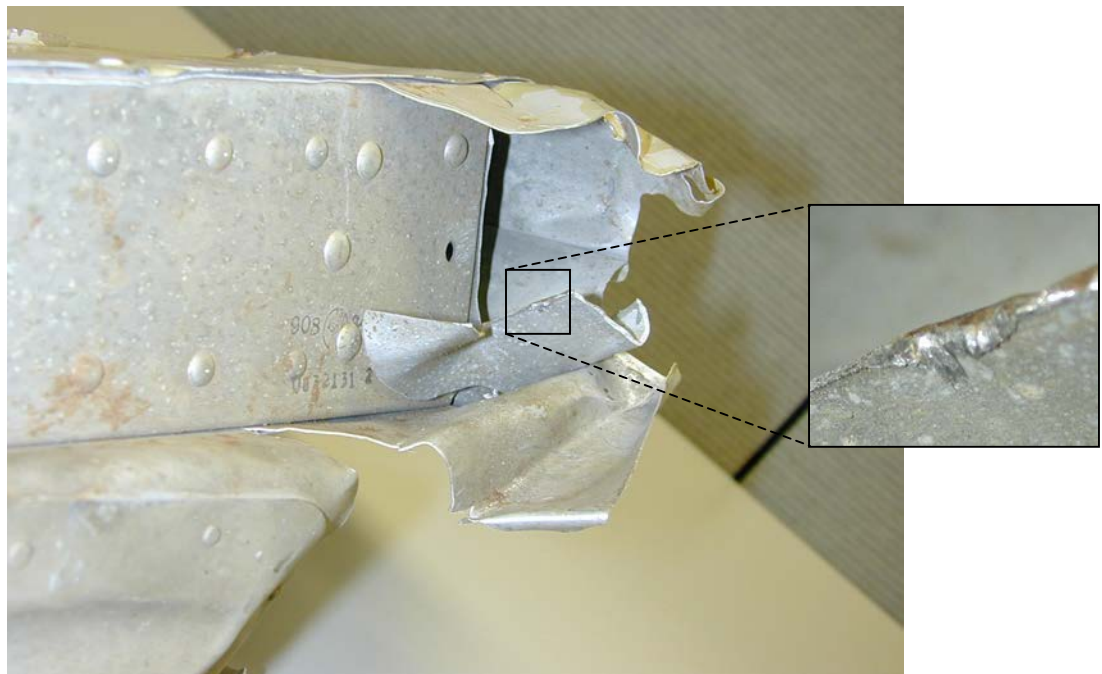
The structure of the trim tab and the elevator was heavily damaged upon receipt in M&P. Movement of the sheet metal components was generally toward the rear of the aircraft. Attention was focused on the area where the trim tab push-pull rod attaches to the actuator. A rub mark was found on the lower side of the opening in the elevator spar, as shown in Figure 13, which corresponds to the rub mark found on the push-pull rod (Figure 7).

Figure 13. View of the opening in the elevator spar, showing rubbing wear on the lower edge (inset). Magnification: x2.6 (inset).

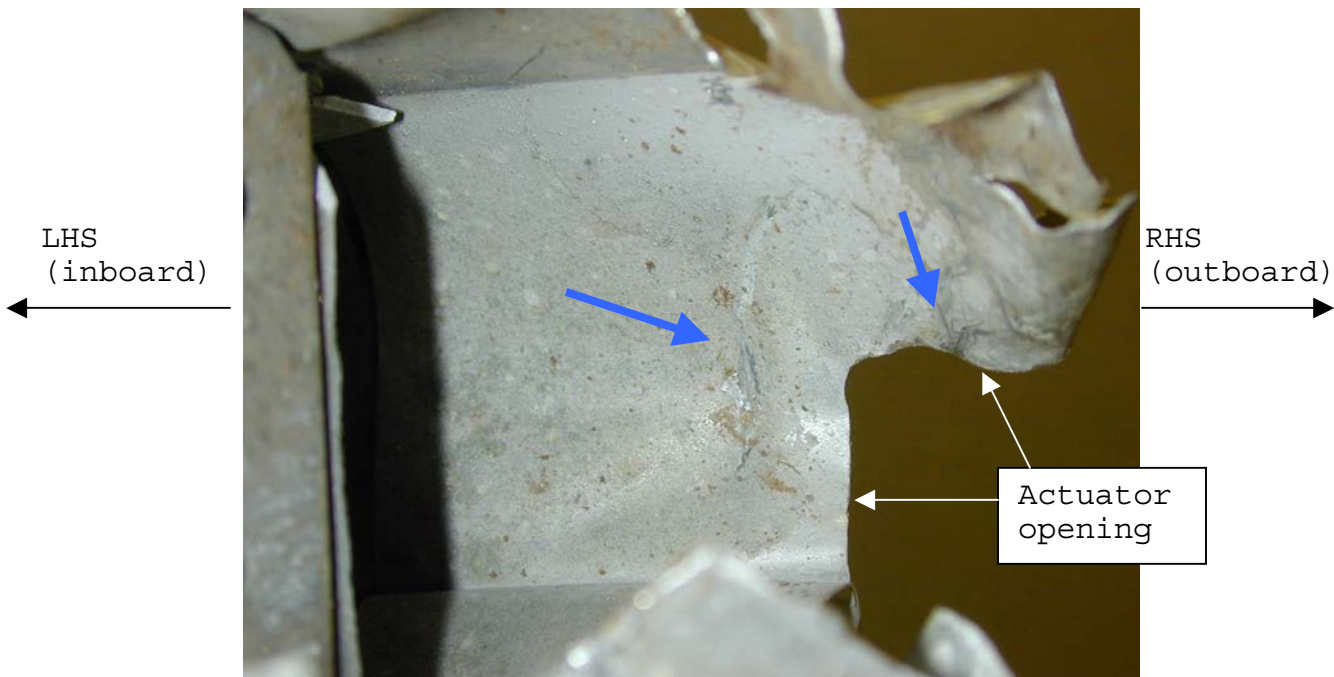
Indentations were found on the leading edge of the elevator, as shown in Figure 14. The indentations on the elevator leading edge were slightly inboard of the opening for the trim tab actuator, and corresponded to the spread-open clevis of the push-pull rod, as shown in Figure 15. It was noted that the indentations did not correspond to the non-deformed aft clevis.

Figure 14. View from within the elevator structure, looking forward at the inner surface of the leading edge. The blue arrows denote indentations on the leading edge. Magnification: x1.3.

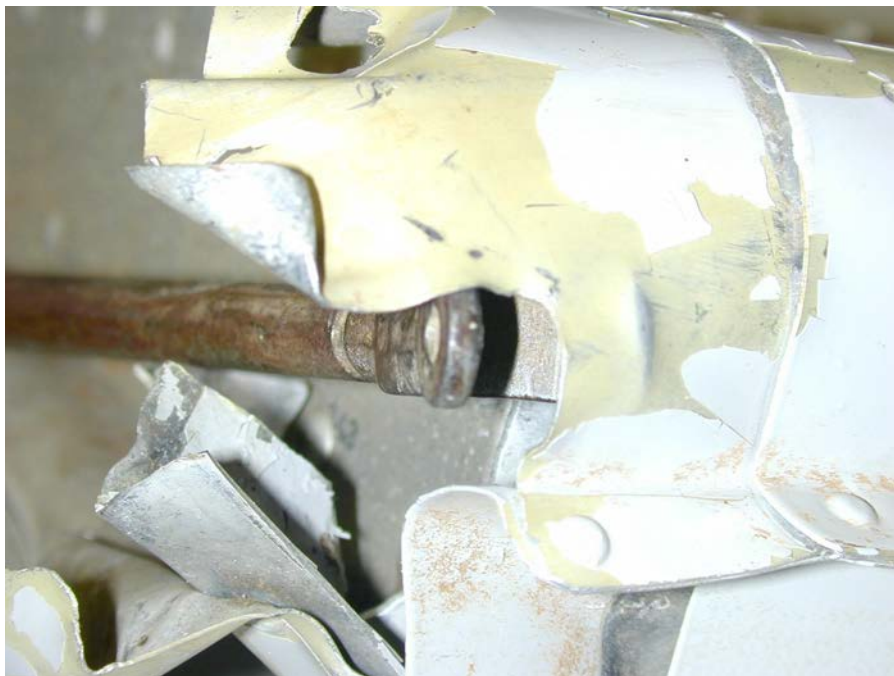
Figure 15. View of the lead edge of the elevator, looking aft, showing the indentations and the corresponding positions of the legs of the forward trim tab actuator clevis.

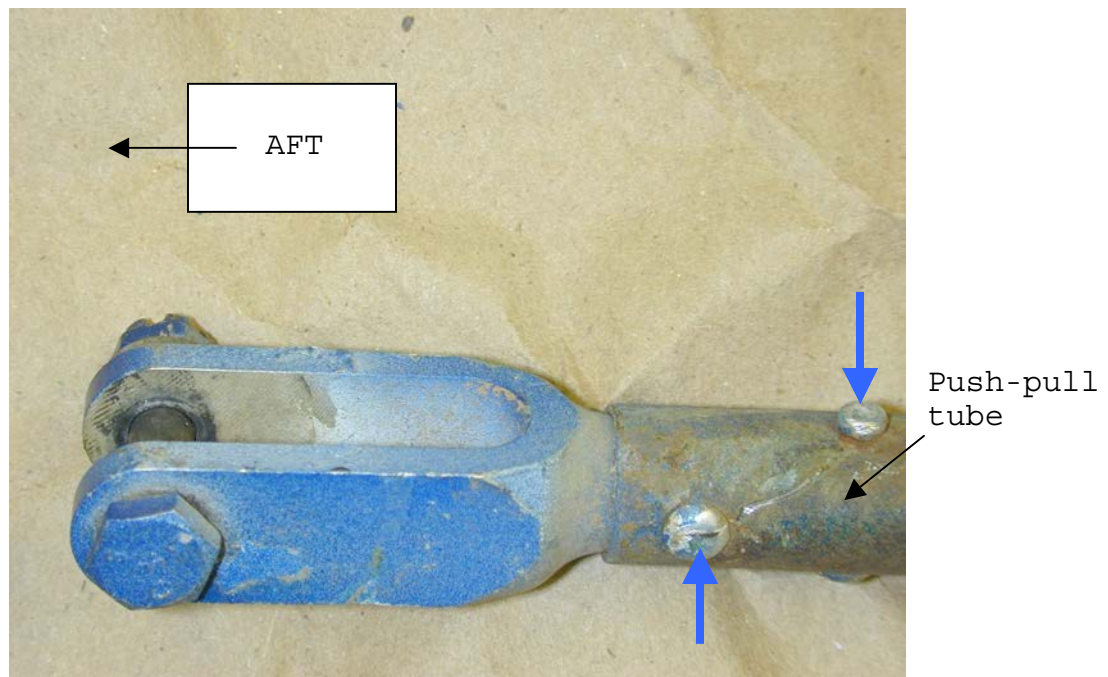
Figure 16. View of the aft clevis of the elevator push-pull tube. The aluminum clevises were fastened to the elevator push-pull tube with two rivets each (arrows). Magnification: x1.3.

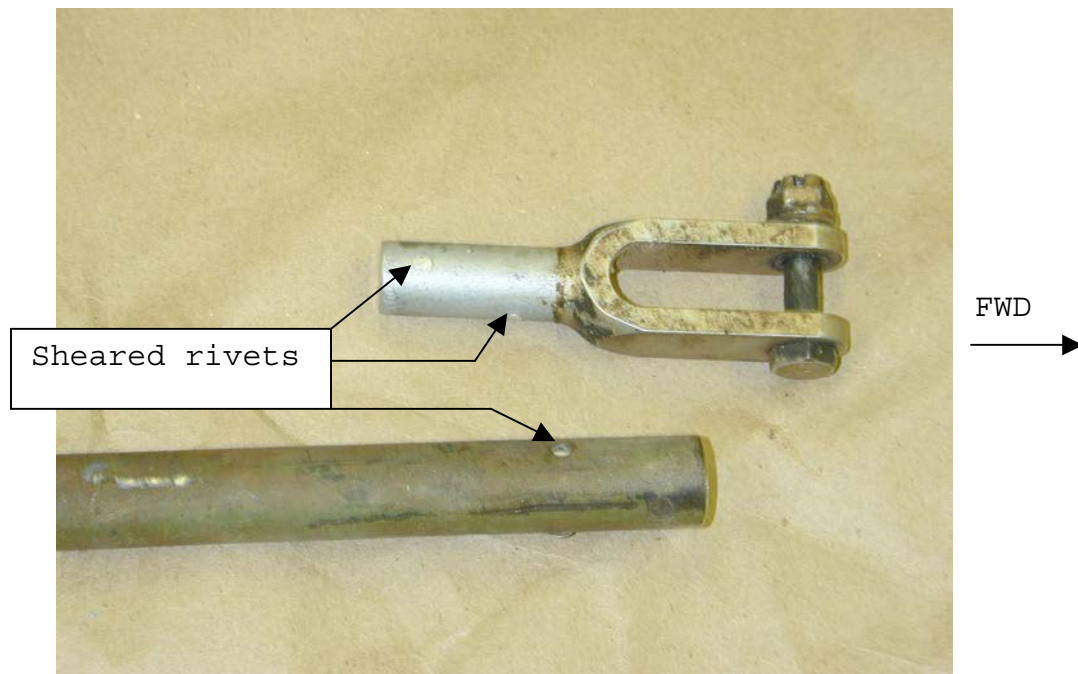
The forward elevator push-pull tube clevis was separated from the tube. The attaching rivets fractured due to shearing, with the shearing direction indicative of relative twisting between the tube and the clevis. It was not possible to determine with certainty whether or not this occurred before or during the crash. However there were markings in the vicinity of the rivet fracture surfaces which are indicative of various relative positions of the tube with the clevis.

The elevator push-pull tube had been cut into two pieces to facilitate shipping. The push pull tube consisted of a steel tube, 0.625 inch OD by approximately 23.5 inches long with aluminum clevises at each end. The aluminum clevises were held in place by 2 aluminum rivets each, as shown in Figure 16. At the forward end, the clevis had become separated from the tube, with both rivets sheared off, as shown in Figure 17.

Figure 17. The forward clevis was separated from the elevator push-pull tube, with both rivets sheared away.

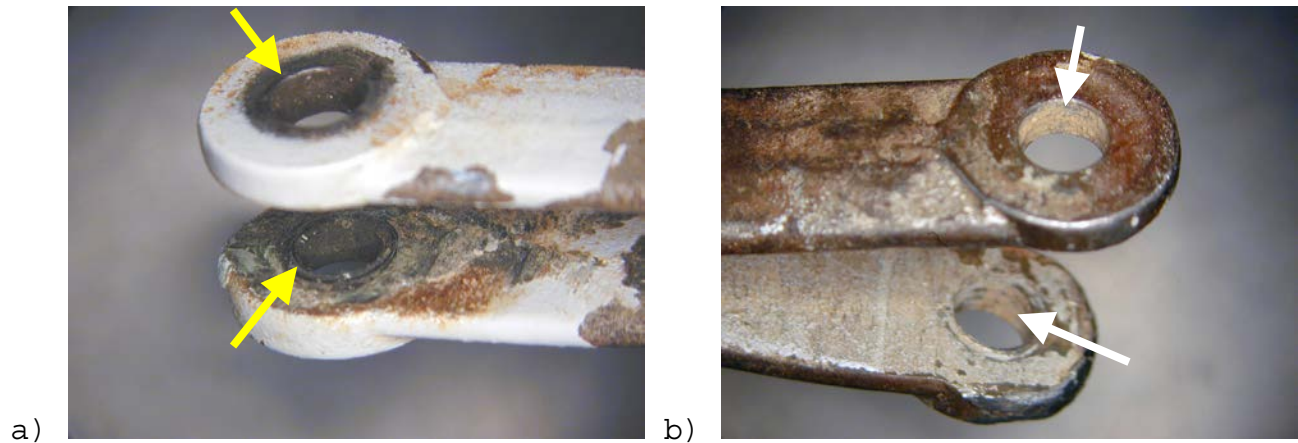
The forward clevis of the trim tab push-pull rod was not connected to the actuator, and the attaching bolt was missing, however the aft bolt was in place. The bore of the attaching bolt holes of the forward clevis were dry and lightly oxidized, however the bore of the aft clevis attaching bolt holes were coated in a dark oily substance. The lack of lubricant on the forward clevis could have been due to the loss of the forward attach bolt some time prior to the crash. The forward clevis legs were spread open by approximately 0.3 inches, however it could not be determined what would have caused this. Indentation markings on the inner surface of the leading edge of the elevator were made after the clevis was spread open.

The forward clevis of the trim tab push pull rod was examined under light microscopy. Attention was focused on the bore of the attaching bolt hole. No scratches or markings were found on the bore of the forward clevis. The bore was lightly oxidized, and exhibited some dry powdery substance resembling dust or iron oxide, as shown in Figure 18. The aft clevis was also examined, and the bore of the attaching bolt hole was found to be coated with a dark greasy substance, with no dust or iron oxide present. This is also shown in Figure 18.

Figure 18. Views of the trim tab clevises, a) aft and b) forward. Note the presence of dark oily deposits on the bore of the attaching bolt hole at the aft clevis (yellow arrows) however at the forward clevis there was a dry, dusty iron oxide present (white arrows). Magnification: x2.5.

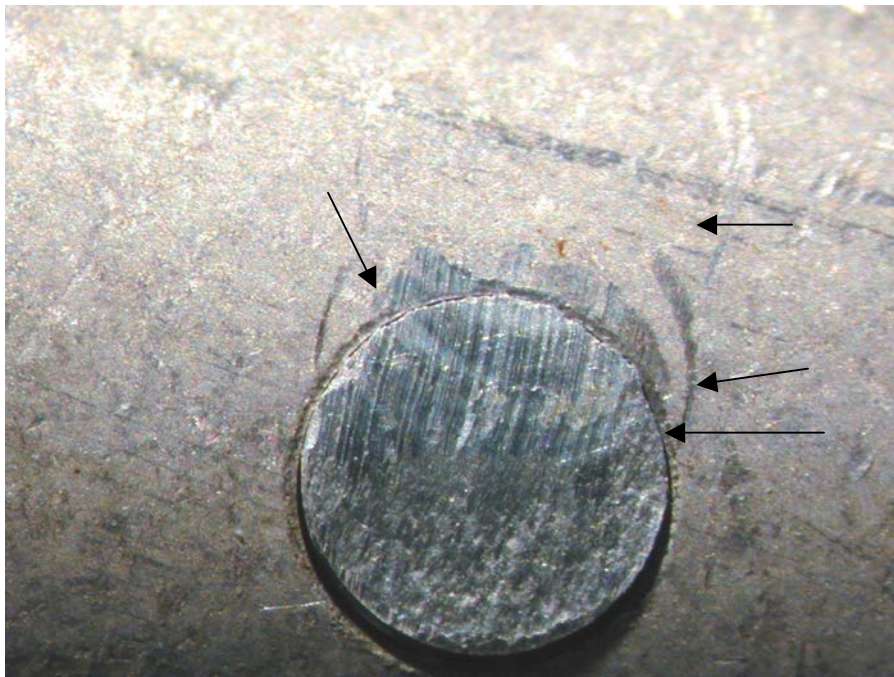
The sheared attaching rivets of the forward clevis were examined using the scanning electron microscope (SEM). The appearance of the fracture surfaces of the rivets indicates that they had broken in one shearing motion. The shear direction of the rivets indicates that the push-pull tube had twisted in relation to the clevis, causing the rivets to shear off. Slight angular displacement of the tube in relation to the clevis was evident by the presence of witness marks on the rivet fracture surfaces, as shown in Figure 19.

Figure 19. Magnified view of one of the sheared attaching rivets in the forward elevator push-pull tube clevis. The arrows point to witness marks made by the mating portion of the rivet denoting various positions of the tube relative to the clevis. Magnification: x15.
