# NATIONAL TRANSPORTATION SAFETY BOARD

## MATERIALS LABORATORY FACTUAL REPORT

Report No. 15-055

Place : West Memphis, Arkansas  
Date : October 15, 2014  
Vehicle : Cessna P210, N731QV  
NTSB No. : CEN15LA015  
Investigator : Courtney Liedler, ASI-DEN

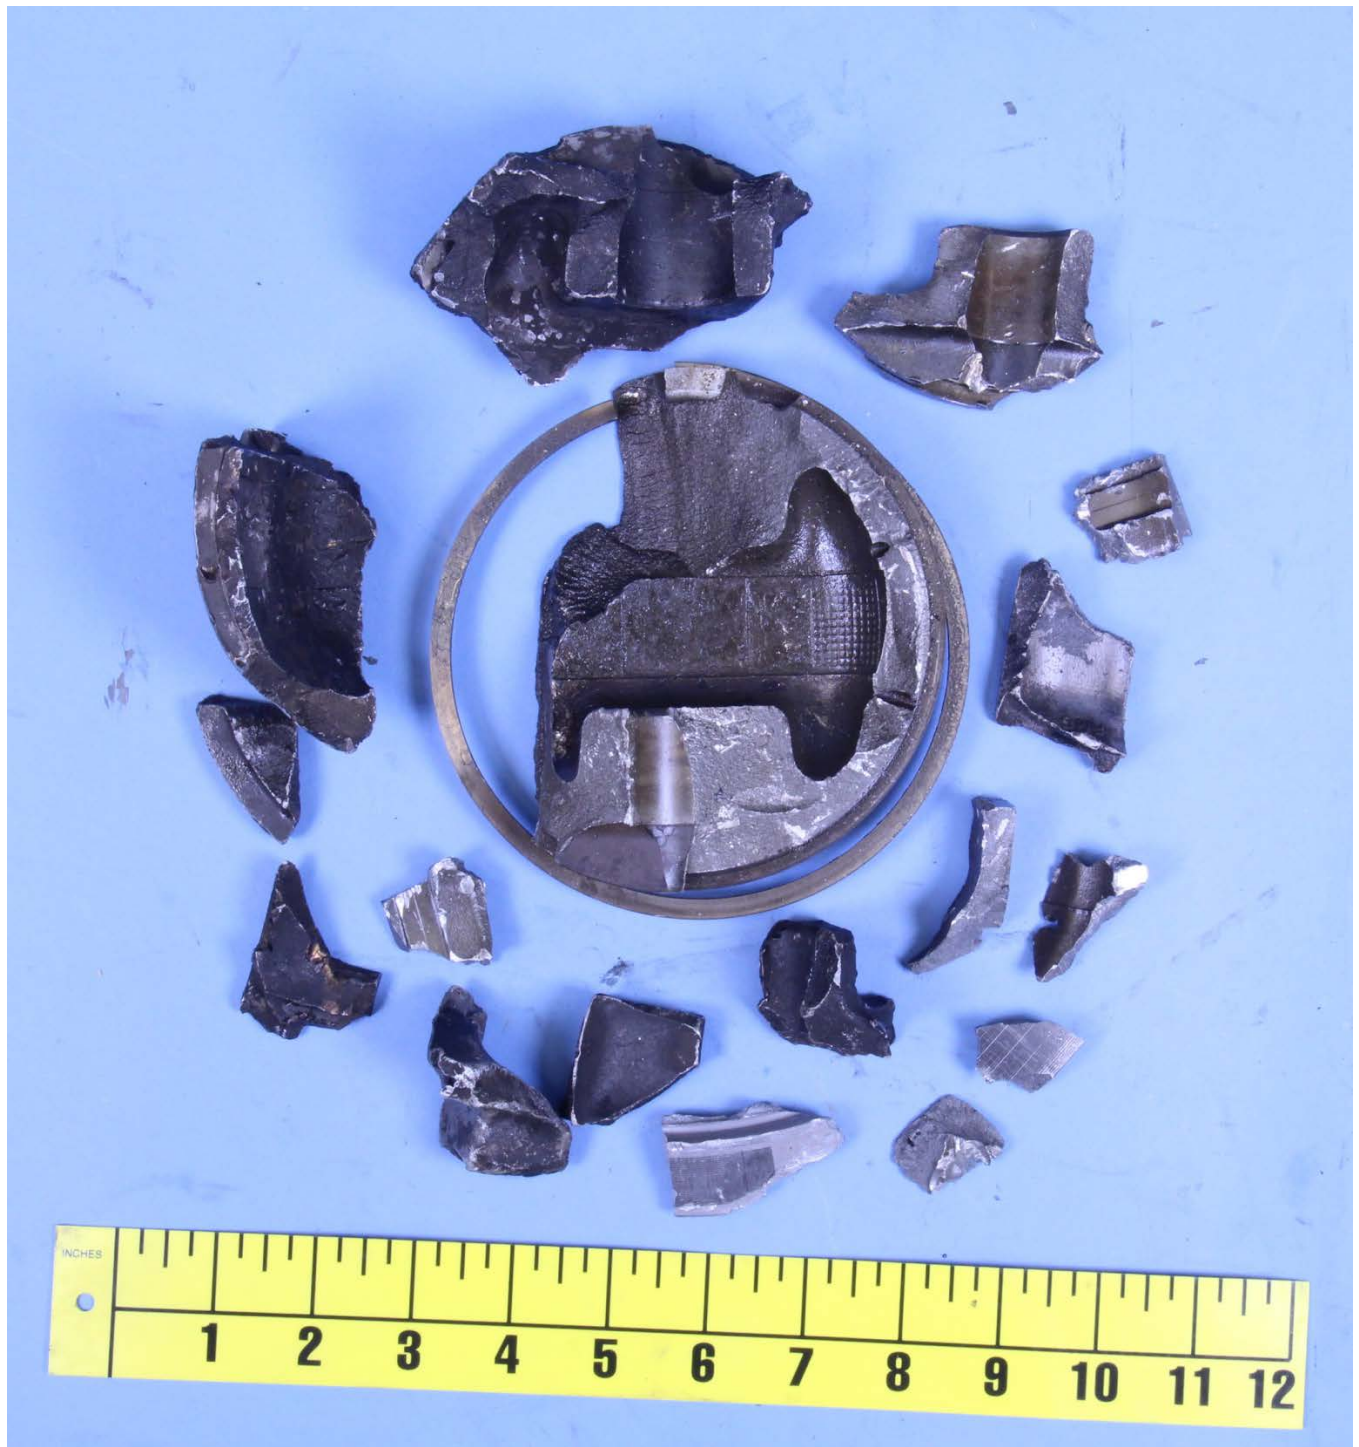
The pieces of the #2 piston are displayed in figure 1. The piston was broken into multiple pieces as shown. The pieces comprised the entire head and estimate 50% of the skirt. The majority of both pin bosses was also present. The entire upper compression ring was also received but no other rings or pieces.

Visual and magnified optical examinations revealed features and patterns indicative of overstress separation on all of the received piston fractures. Some of the pieces were darkly colored consistent with baked on oil deposit while other mating pieces were clean. The crown of the piston was clean and had small valve dents corresponding to the intake and exhaust valve locations. The crown was marked "654857C" and "U 07EKG".

Figure 1. An overall view of the piston fragments including the top compression ring.

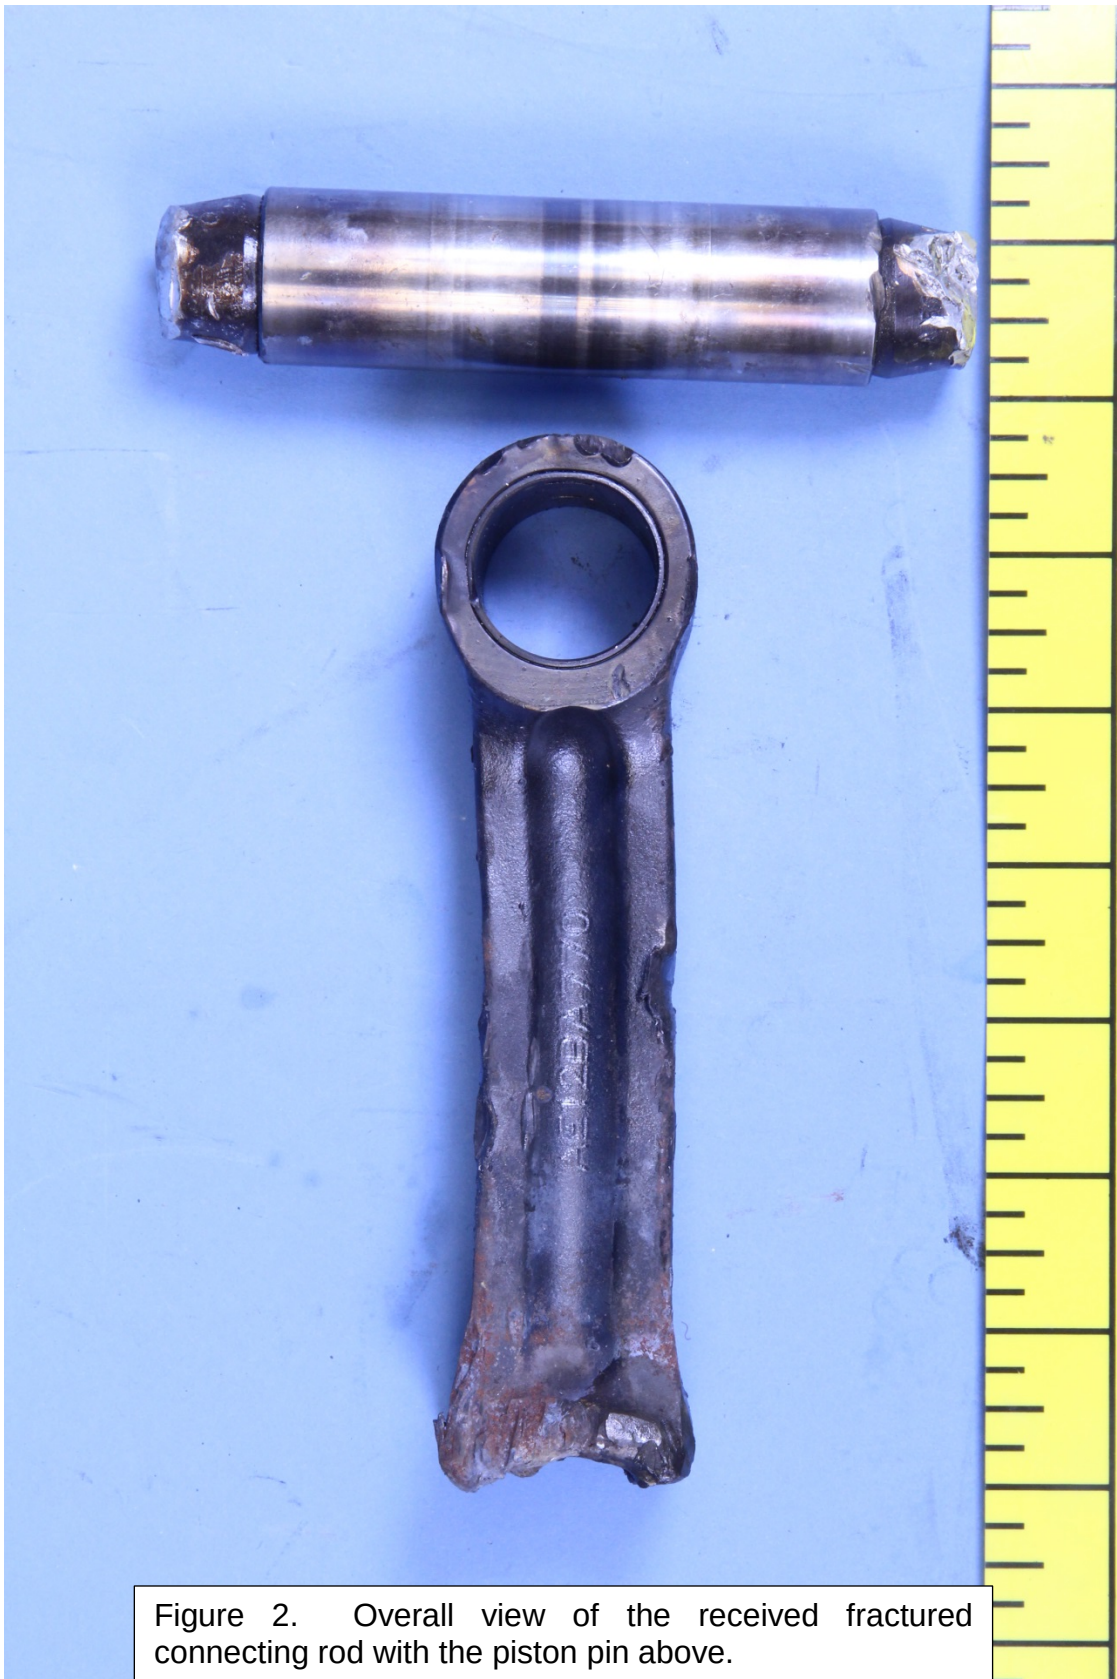
The #2 connecting rod and piston pin are shown in figure 2. The pin was intact but the aluminum pin plugs were mechanically damaged as shown. The connecting rod was fractured through both main bearing straps. The fracture features were partially obscured by post fracture mechanical damage but the visible fracture features were consistent with bending overstress separations. The adjacent area of the rod displayed surface coloration and oxide formation consistent with exposure to very high temperatures. The bearing surface of the rod showed heavy flow and smearing of the material. The rod was impression marked "AE12BA770" on one side and "050B0616126-Y" in raised letters on the other side.

Figure 2. Overall view of the received fractured connecting rod with the piston pin above.
