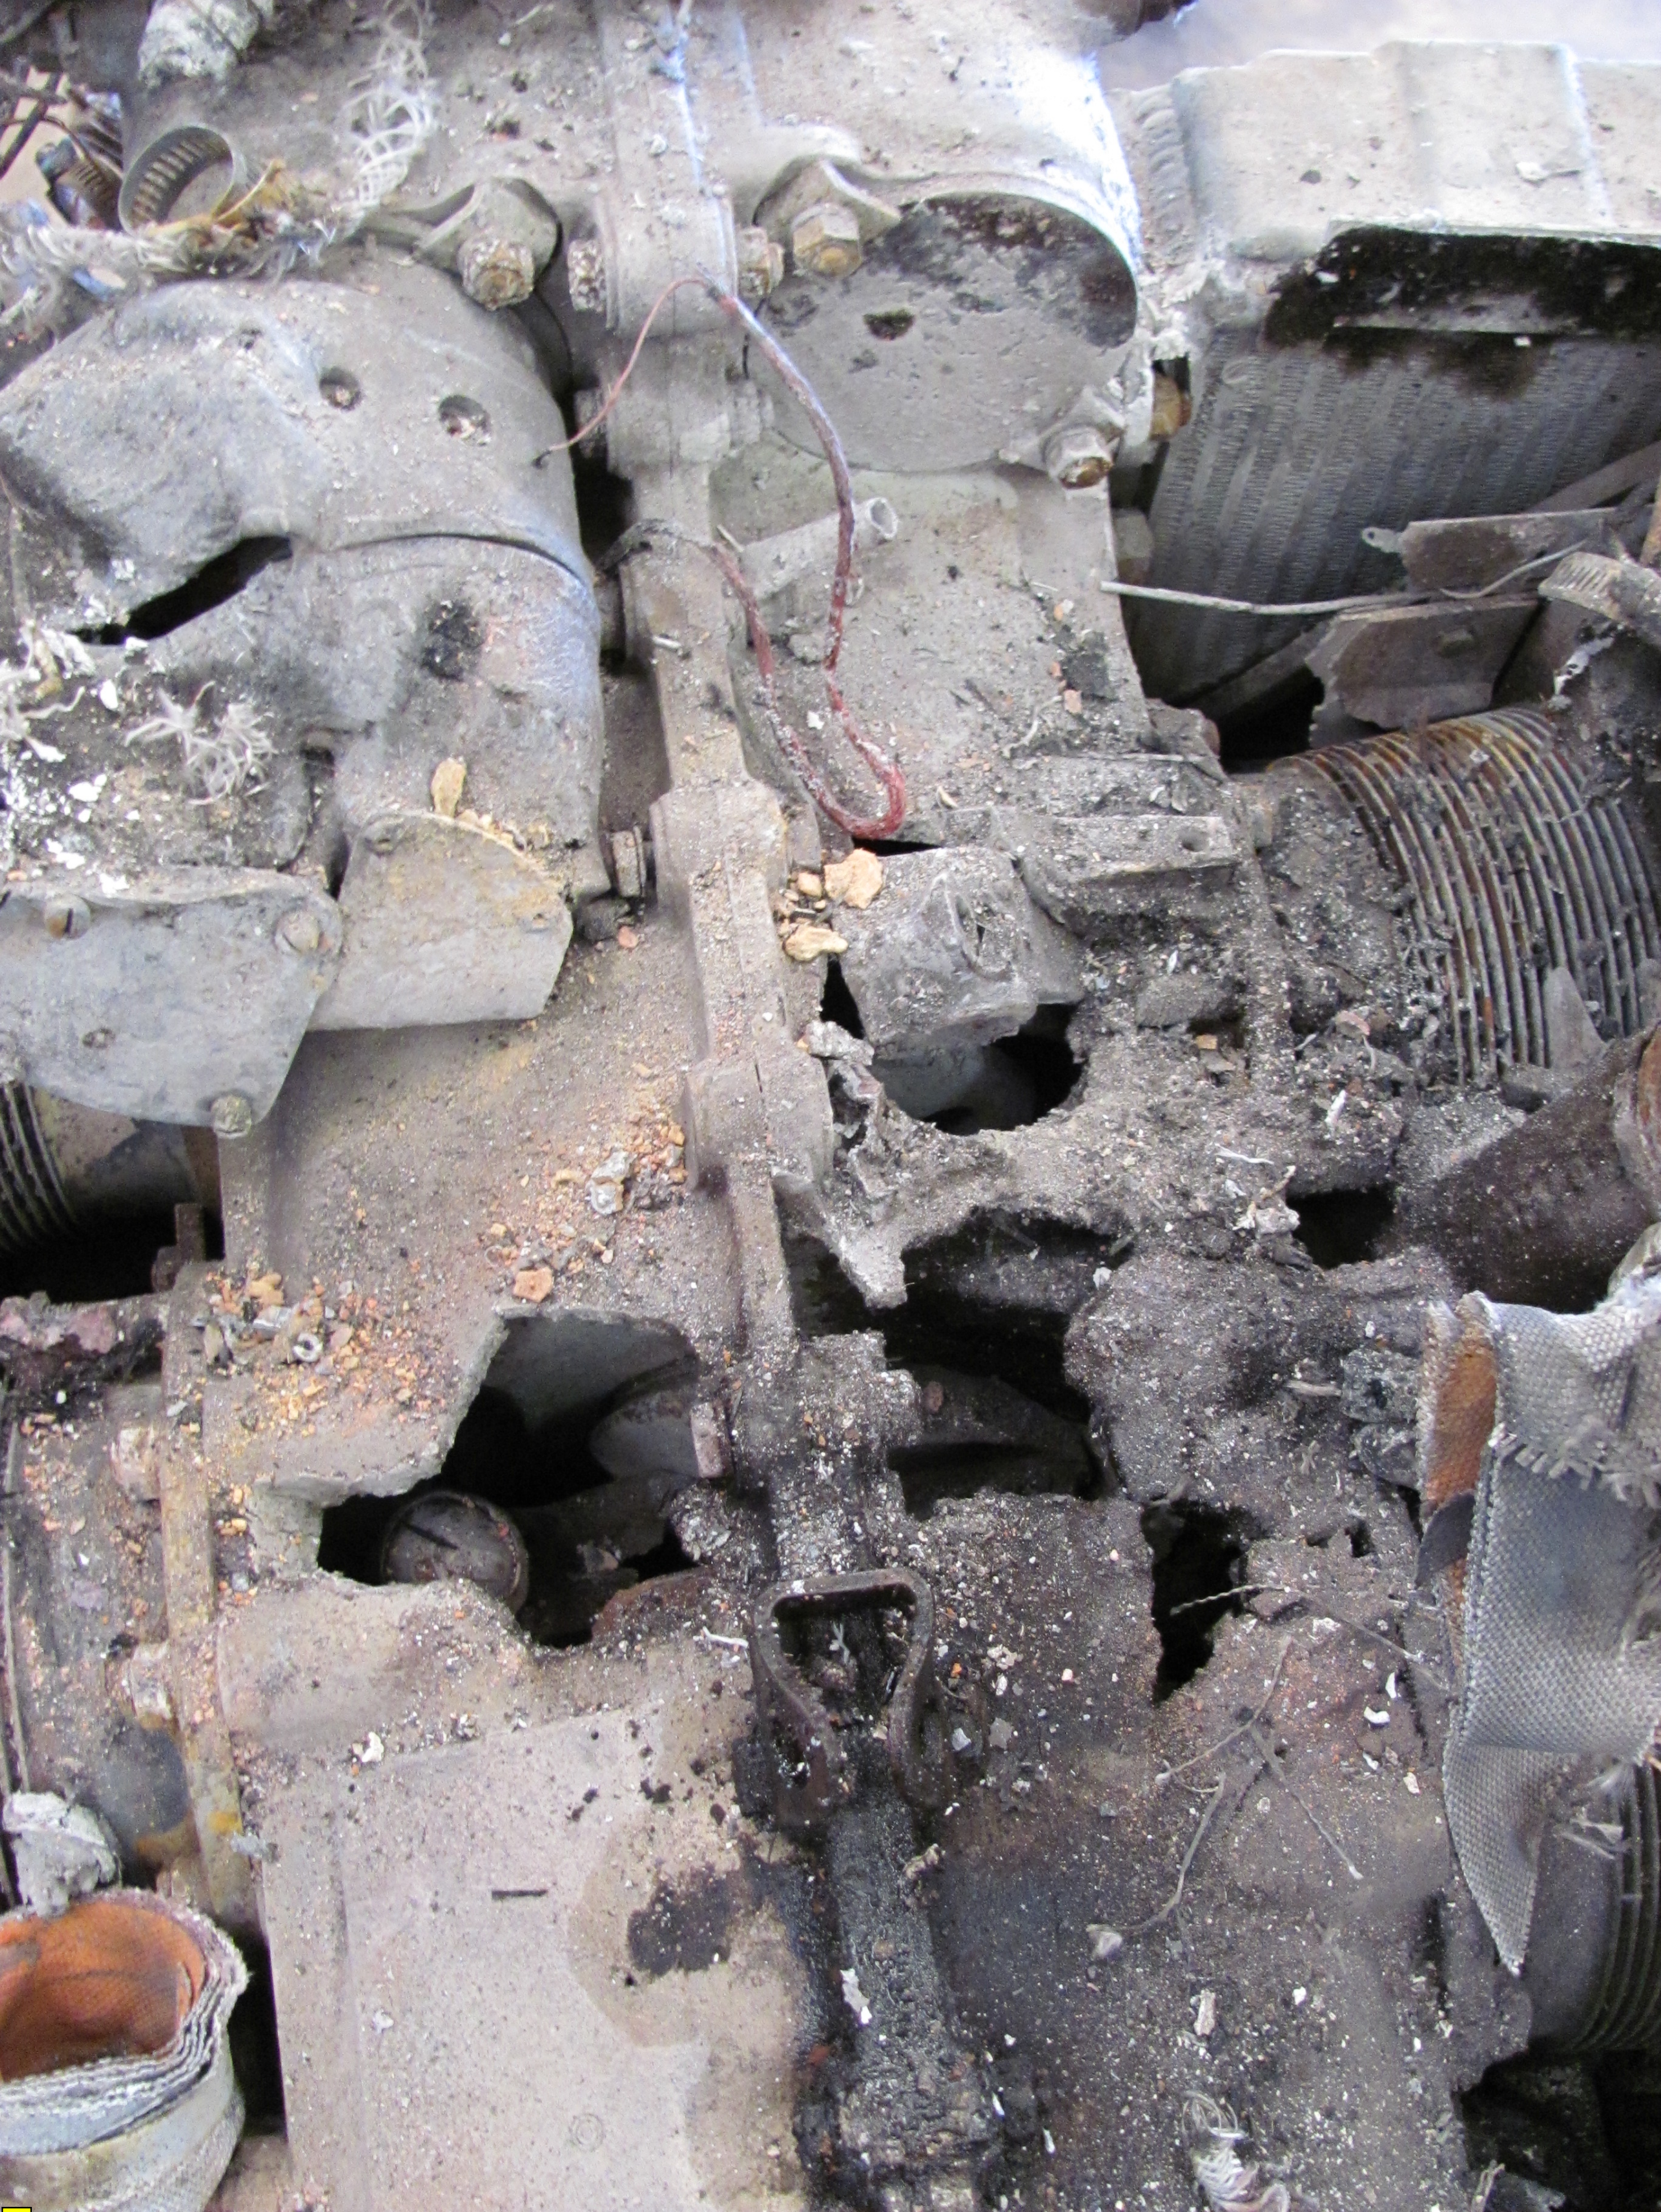
Photo 2 - Holes in Engine Crankcase (top view)
