# NATIONAL TRANSPORTATION SAFETY BOARD

## MATERIALS LABORATORY FACTUAL REPORT

Report No. 15-029

Place : The Woodlands, Texas  
Date : January 16, 2015  
Vehicle : Baker Bobby J Safari, N416JB  
NTSB No. : CEN15LA104  
Investigator : Courtney Liedler, AS-CEN

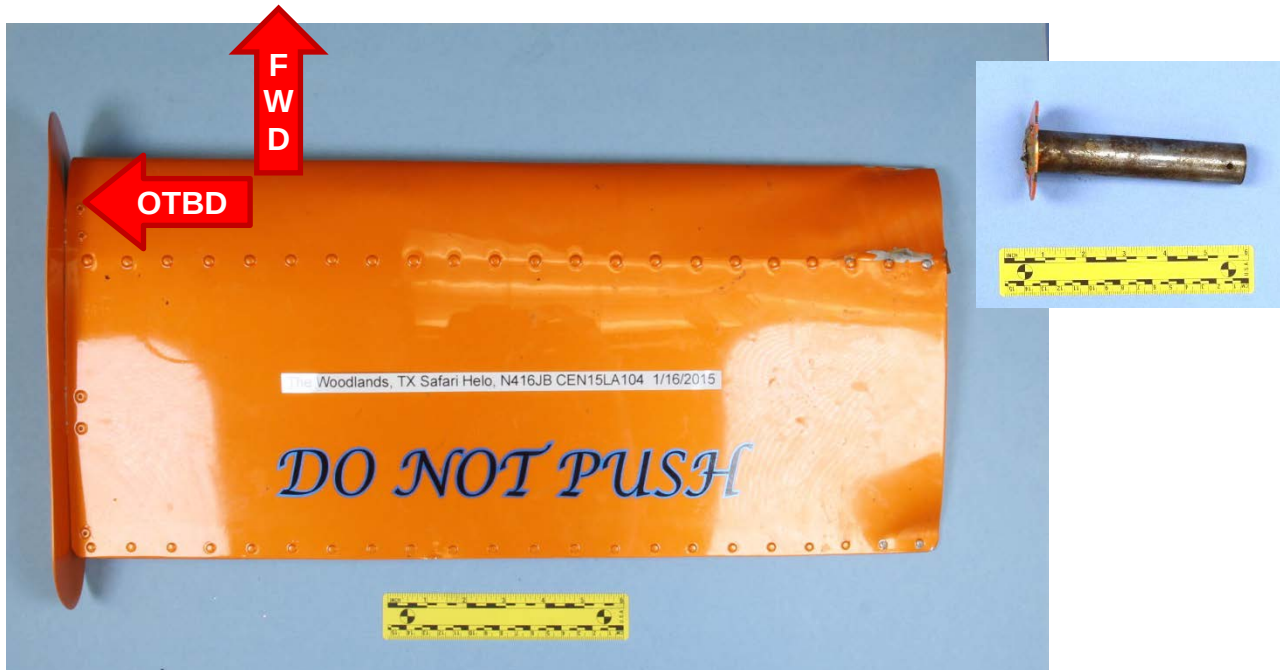
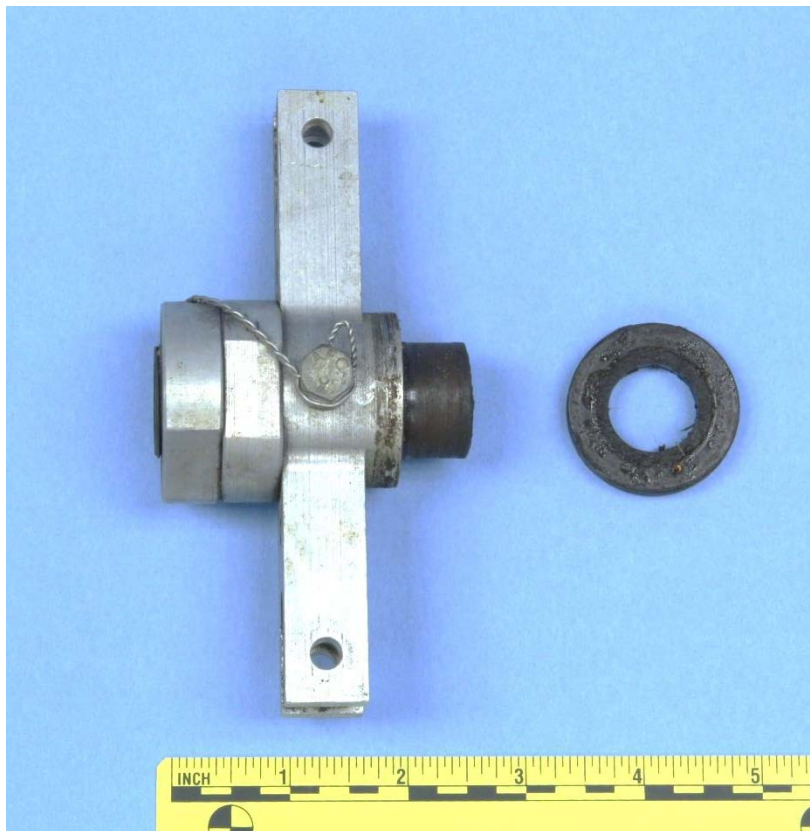
The as-received components are displayed in figure 1. With the horizontal stabilizer at top and the tail rotor cross below. The spar tube of the stabilizer was fractured just outboard of the locating flange and adjacent to the inboard edge of the airfoil section. The forward side of the end plate was bent slightly outboard but no impact damage was apparent on either the end plate or the airfoil skin of the stabilizer. The airfoil section and the mounting tube portions were received separately. The phenolic sleeve on the tail rotor cross was fractured at the end flange. Examination of the flange fracture revealed a brittle overstress separation with no indications of discontinuities.

Figure 1. Overall views looking down onto the horizontal stabilizer at top with separated spar (insert) and the tail rotor cross at left with fractured phenolic slider.

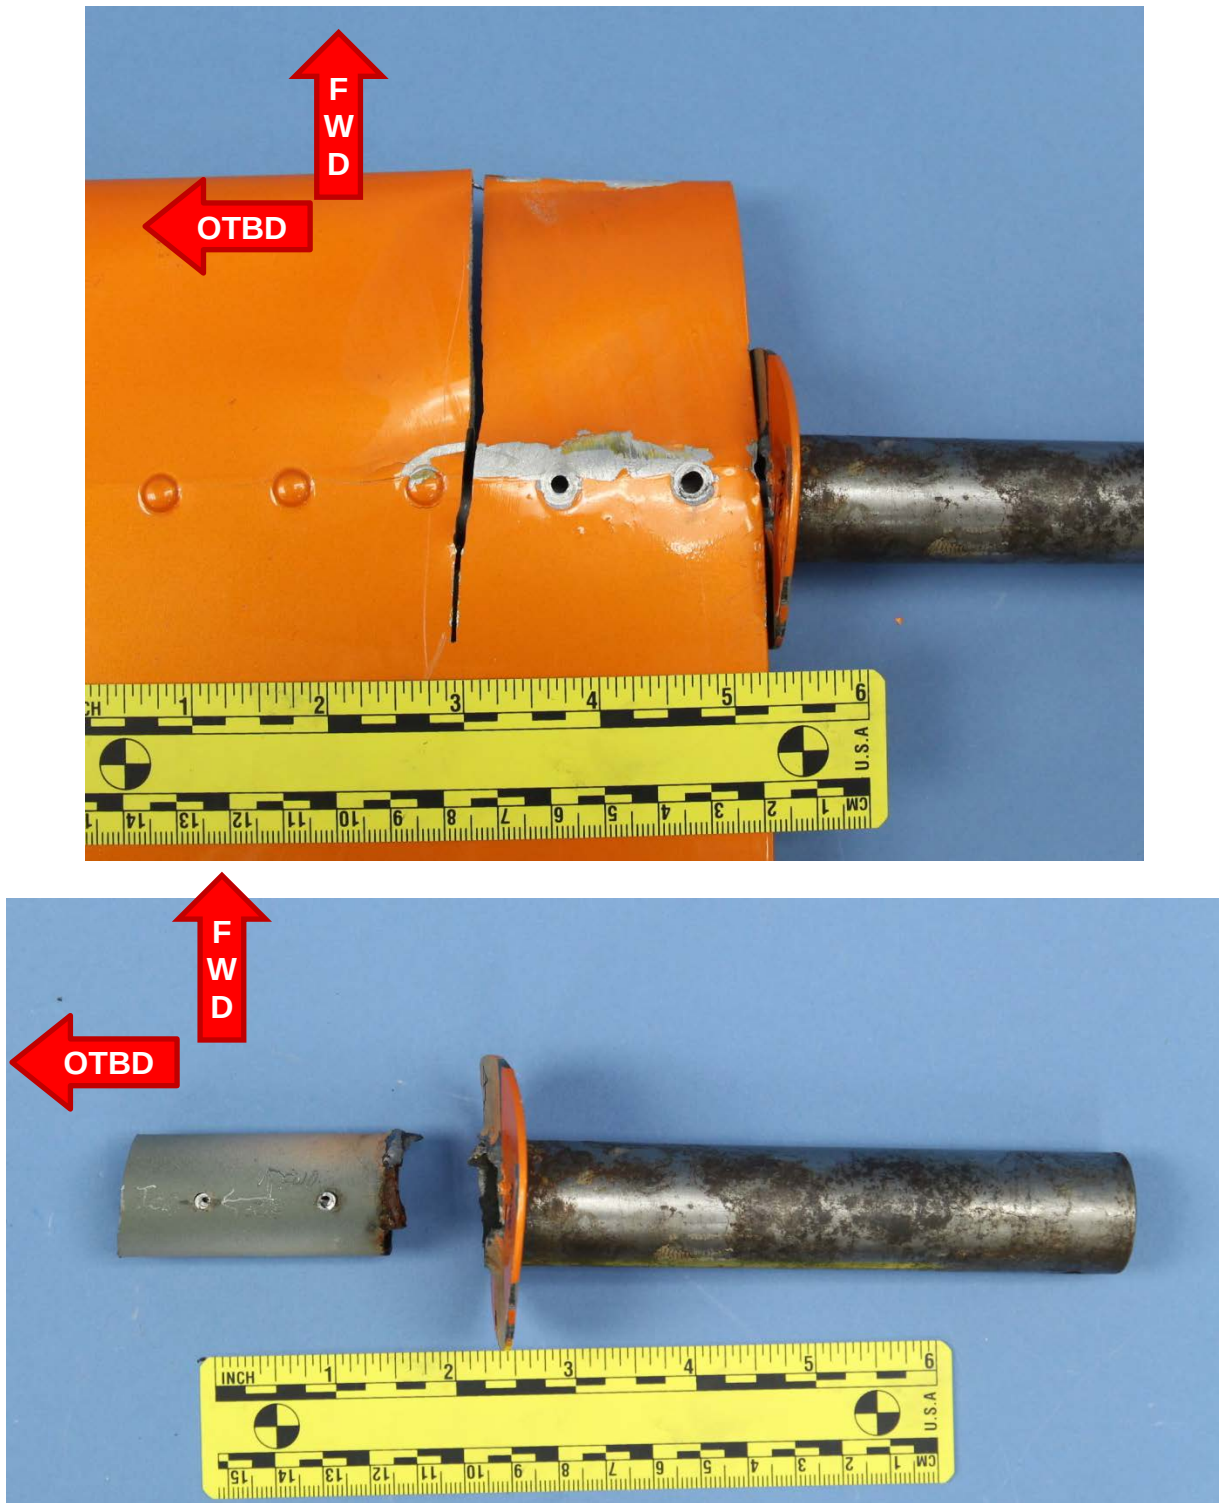
As manufactured, the locating flange of the spar is welded (on the outboard side) to the spar tube and positioned immediately adjacent to the inboard edge of the airfoil skin as shown in the upper view of figure 2. As assembled, the fracture location and weld are partially hidden by the airfoil skin and not directly visible. The airfoil skin and the spar were saw-cut and the four inboard rivets (two top two bottom) were removed to separate the outboard spar fracture face as shown in the lower view of figure 2.

Figure 2. Upper view shows the separated inboard portion of the spar with the locating flange positioned against the airfoil skin as normally assembled (mating spar piece has been removed). Lower view displays the removed section of spar (left) with mating fracture on inboard piece.

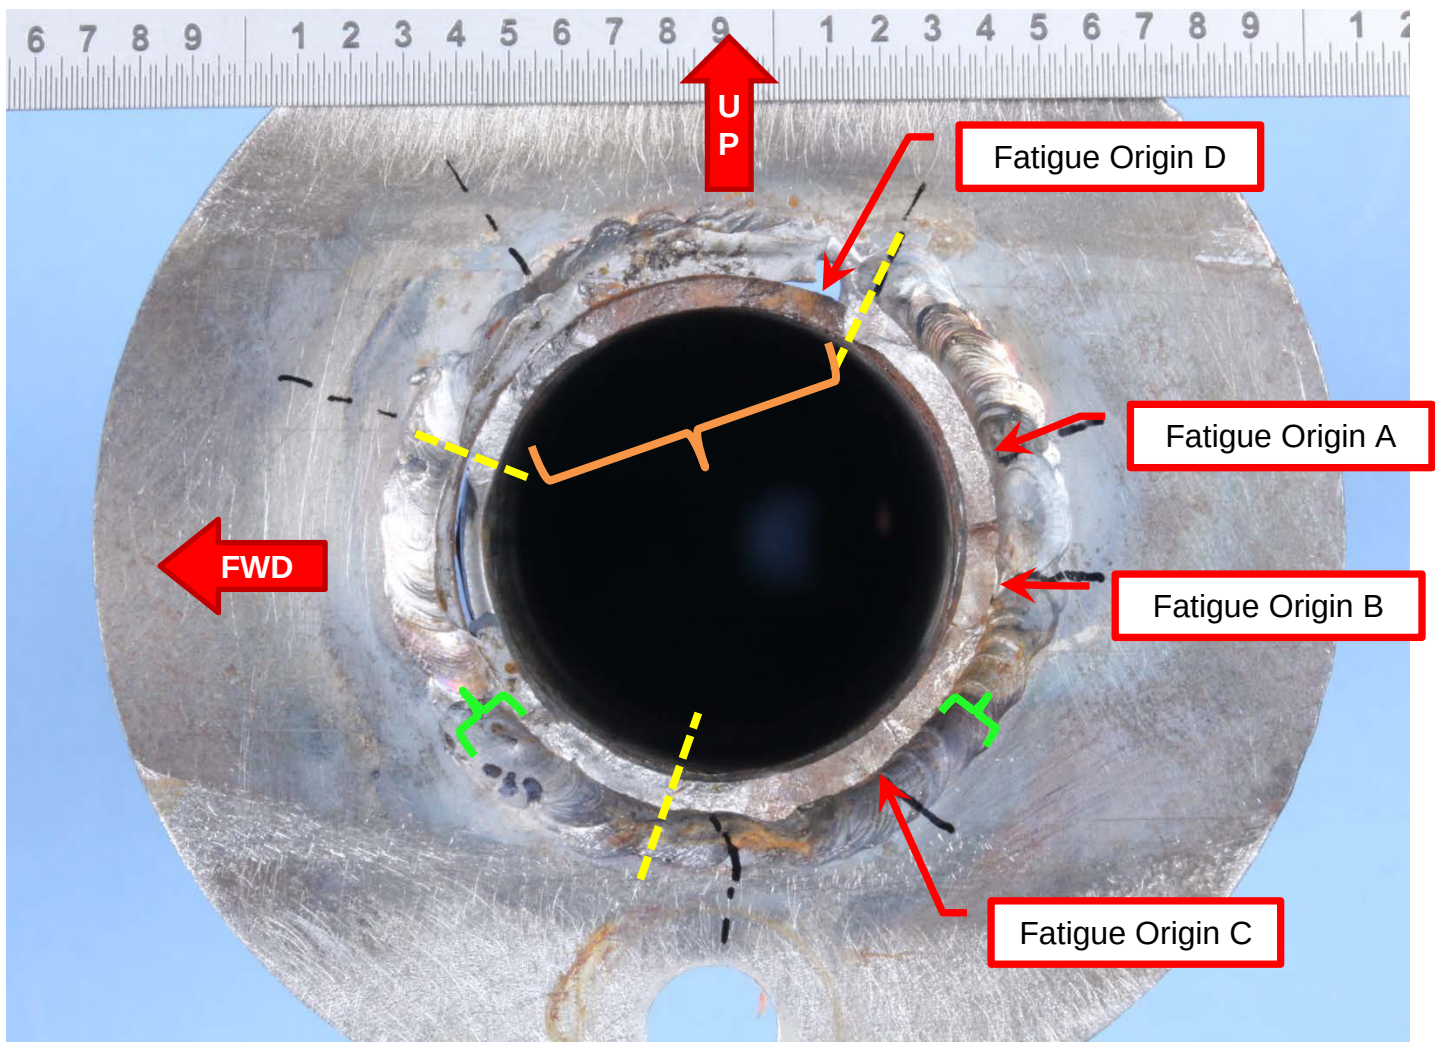
The majority of the fracture followed the outboard edge of the locating flange weld. As initially received, large areas of both fracture faces were obscured by red and brown corrosion products. Cleaning with Evapo-Rust<sup>1</sup> followed by ultrasonic cleaning in

acetone removed the majority of the corrosion deposits and the paint from the fracture and flange as shown in figure 3.

Magnified optical examinations of the fracture surfaces identified features consistent with fatigue cracking. Three fatigue origins were found on the outer surface of the spar tube at the outboard toe (edge) of the assembly weld, denoted fatigue origins "A", "B" and "C" in figure 3 and shown in greater detail in figure 4. The fatigue propagated generally radially through the wall thickness with some circumferential spreading. The fatigue cracking progressed through about half of the total spar cross section, indicated by the dashed yellow lines. The fatigue origins and propagation were all on the aft portion of the spar. No corrosion or other obvious damage was apparent at any of the origins.

Examinations also uncovered a rust-covered crack slightly inboard of and undercutting the main fracture plain, as shown in figure 5. The undercutting crack intersected the outboard fatigue and formed part of the overall fracture. This portion of the fracture is indicated in figure 3 by the orange bracket and extended the total extent of the fatigue content of the fracture to about 2/3 of the total spar cross section. Magnified examinations of the crack faces without opening revealed fatigue features with at least one fatigue origin on the outer surface of the spar, fatigue origin "D" in figure 3. The crack morphology visible in figure 5 was consistent with additional fatigue origins in the unopened portion of the crack.

Figure 3. A view of the inboard fracture face of the spar with weld (green brackets) and locating flange. Fatigue origins A, B, C and D are denoted. From the origins the fatigue extends to the dashed yellow lines. Orange bracket indicates the exposed portion of the inboard crack.

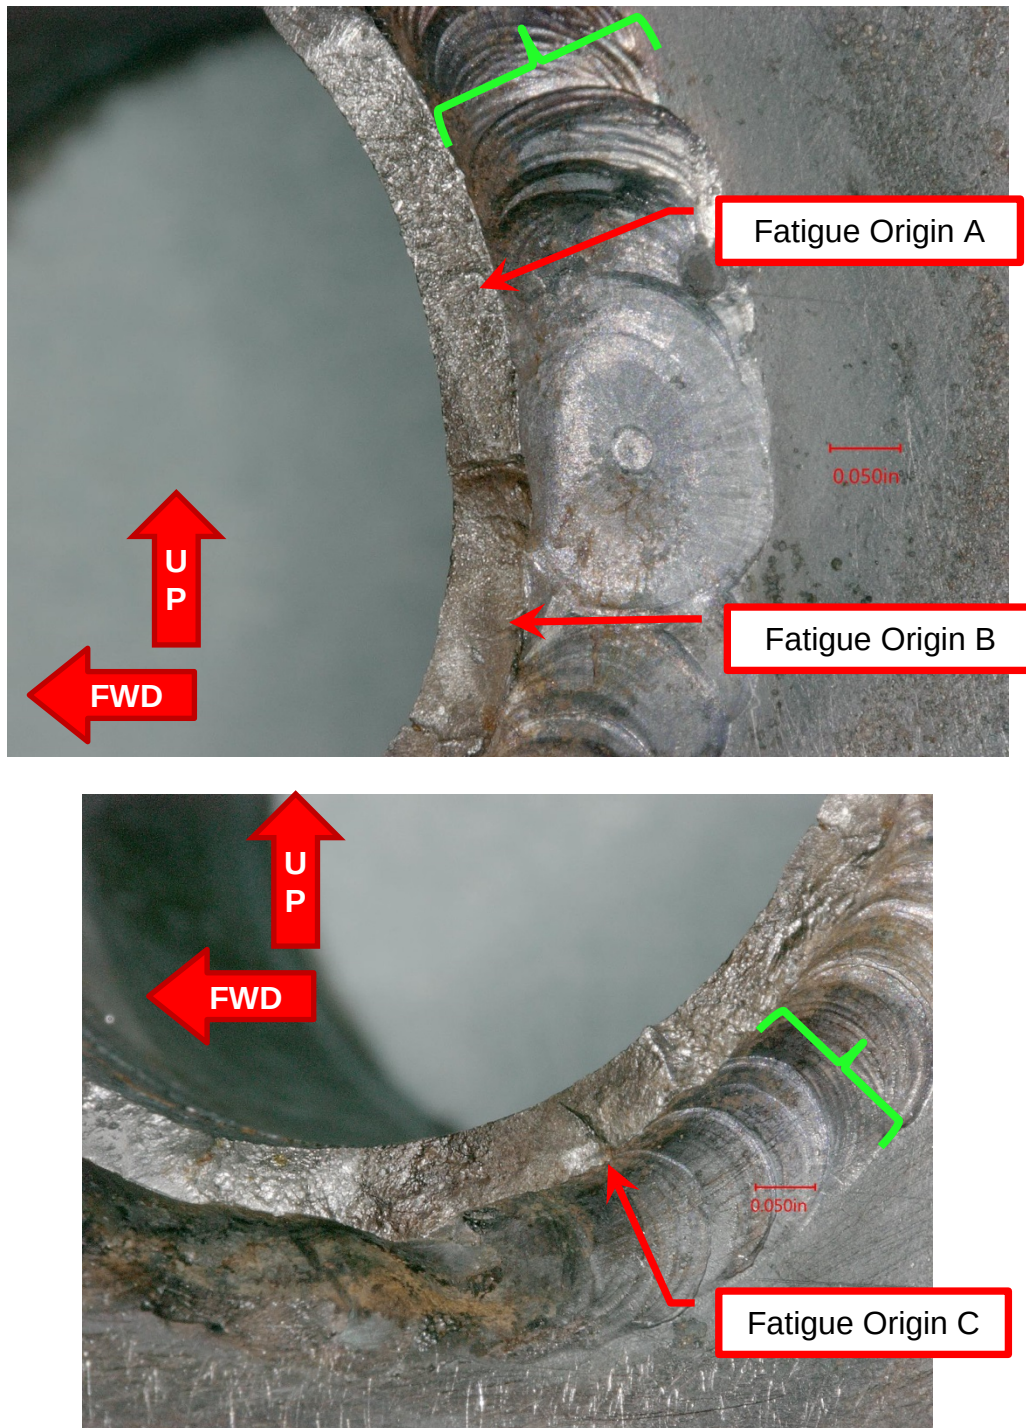
Figure 4. Closer views of fatigue origins A, B (top) and C (lower). The weld bead is denoted by the green brackets.

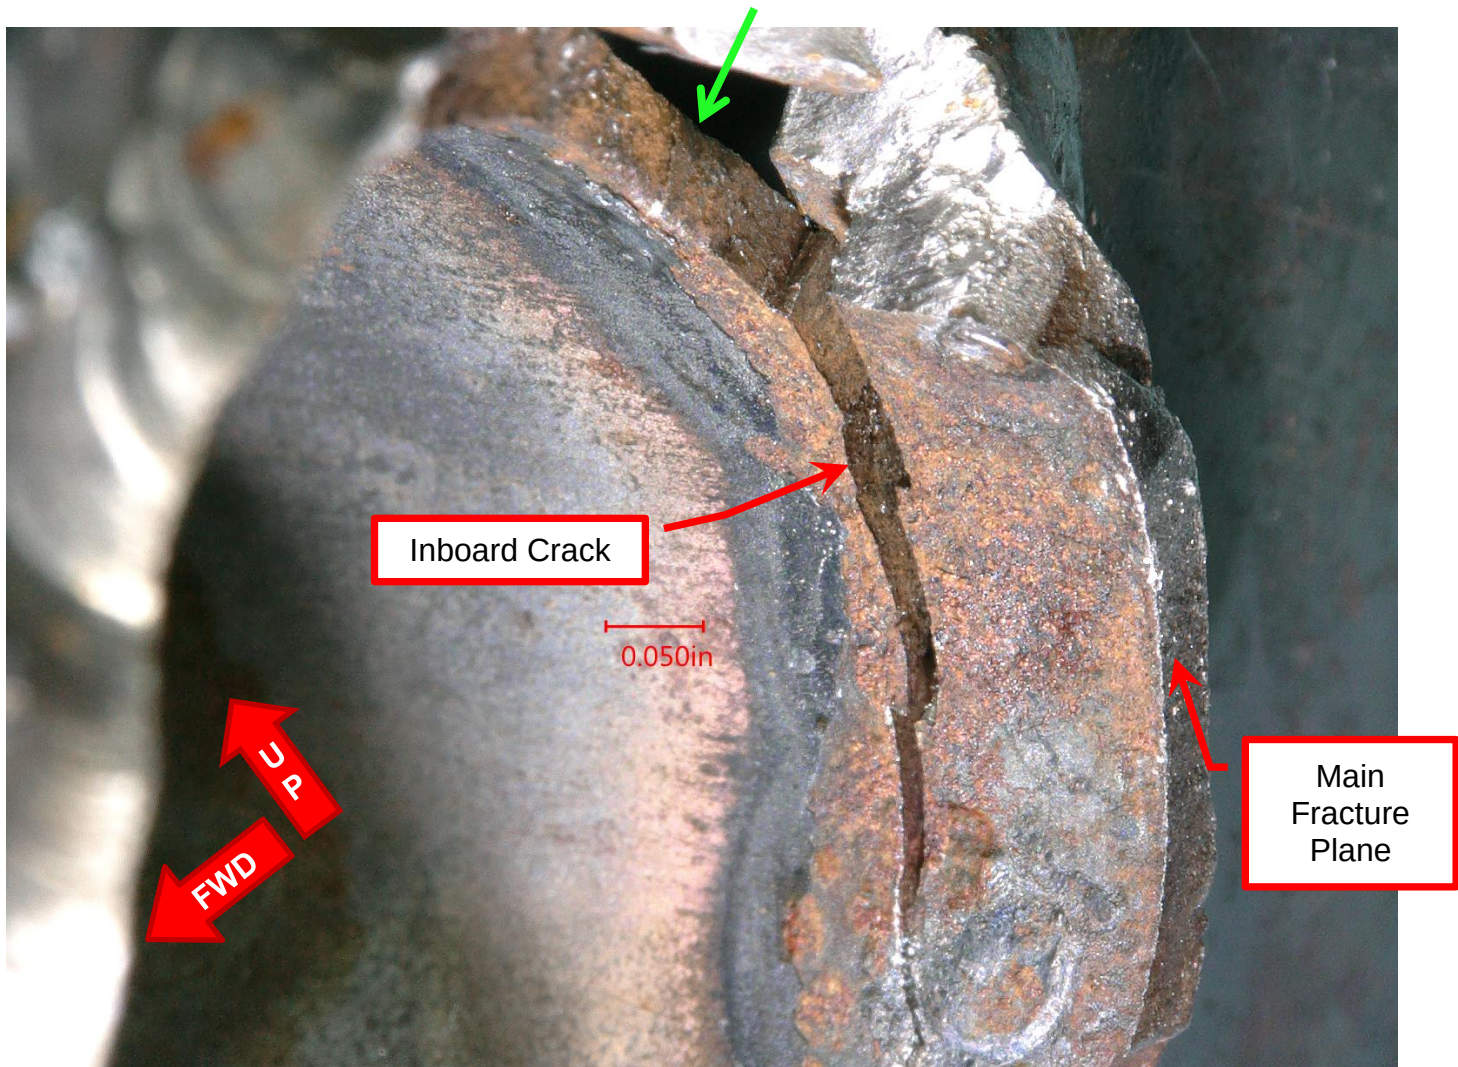
Figure 5. Oblique view looking inside the spar tube at the crack inboard of the main fracture plane. Note the corrosion. Green arrow indicates one origin on inboard crack.

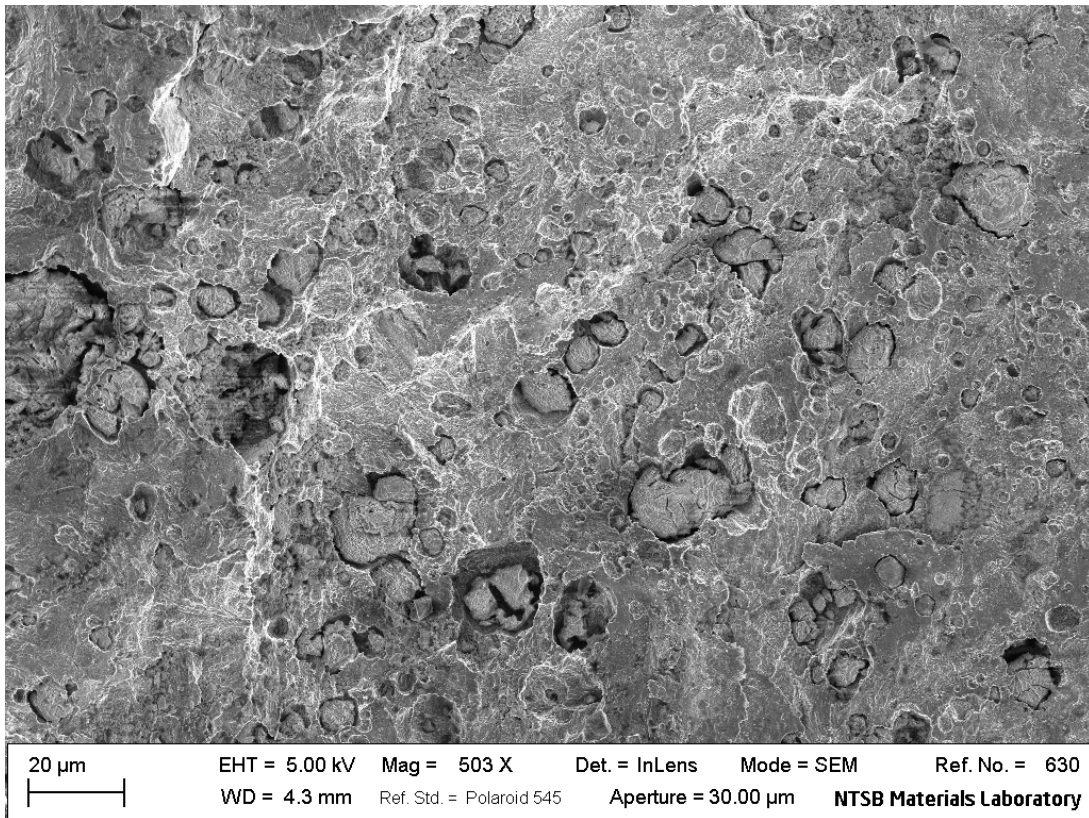
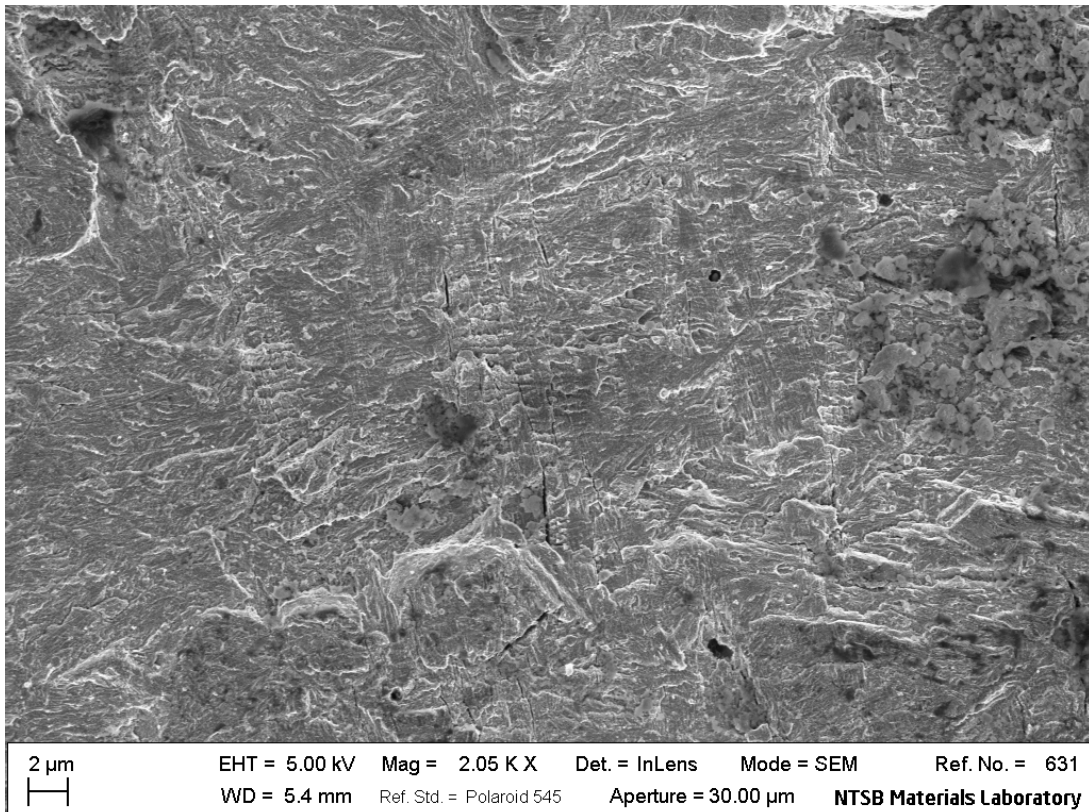
The inboard fracture face was viewed using a scanning electron microscope (SEM) after it was cleaned and the corrosion removed. The fracture area near fatigue origin "A" displayed a corrosion-damaged surface as shown in the upper view of figure 6. Fracture surfaces near fatigue origins "B" and "C" were much less damaged by corrosion and displayed features consistent with fatigue cracking in alloy steels as shown in the lower view of figure 6.

Figure 6. SEM views of corrosion damage near origin "A" at top and typical fatigue features near origin "B".
