## **NATIONAL TRANSPORTATION SAFETY BOARD**

### **IGNITION SYSTEM EXAMINATION**

**CEN15LA104**

Location: Woodlands, Texas  
Date: January 16, 2015  
Aircraft: BAKER BOBBY J SAFARI, Registration: N416JB  
NTSB IIC: Courtney Liedler

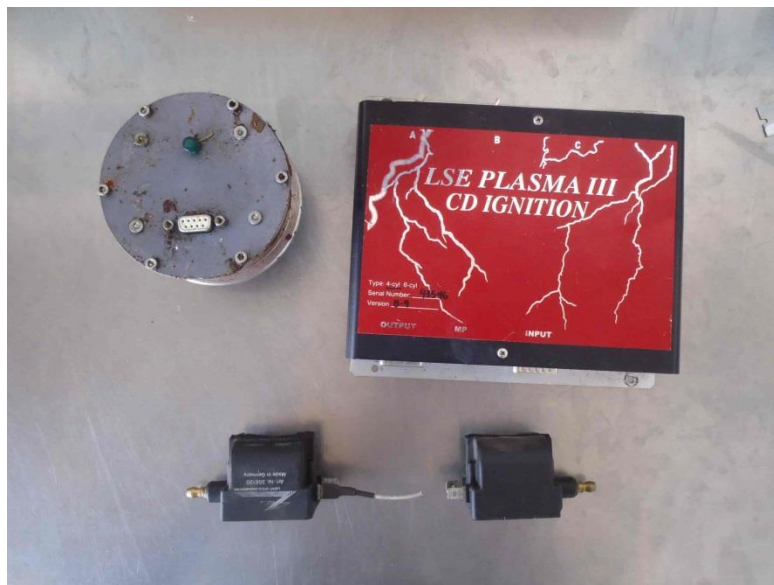
Photo 1 - Examined Components

Examination of the ignition components (Photo 1) was conducted on March 31, 2015 at the facilities of Light Speed Engineering in Santa Paula, California. No evidence of preimpact mechanical malfunction was noted during the examination.

Two coils were examined, and both had sustained damage resulting in the separation of one of their spark plug towers (Photo 1). Each unit was connected to an exemplar ignition system, and both produced spark between their output terminals as the exemplar Hall Effect module was triggered.

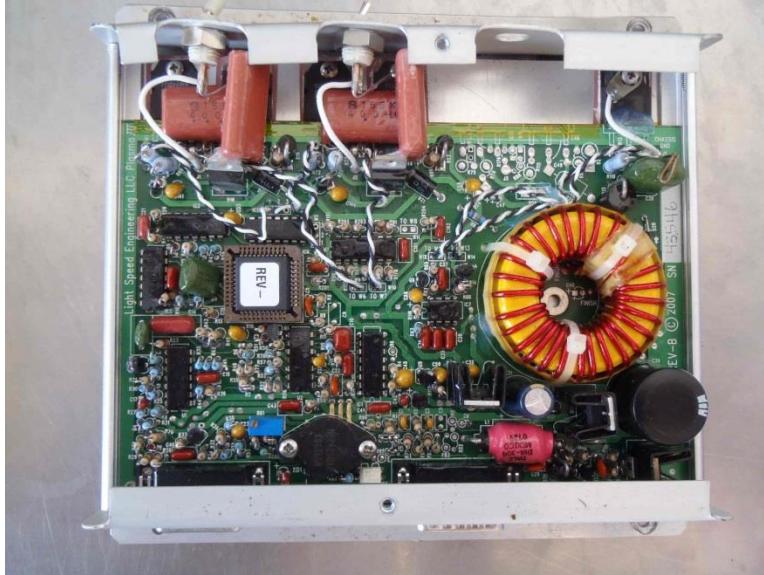
Photo 2 - Plasma III Unit With Lid Removed

The unit's case exhibited deformation to the mounting tabs, and compression damage to the top case, such that an imprint of internal components was observed. Both coil output BNC connector casings were damaged, with only the internal pins remaining. The case was removed and internal components examined. No damage was noted (Photo 2).

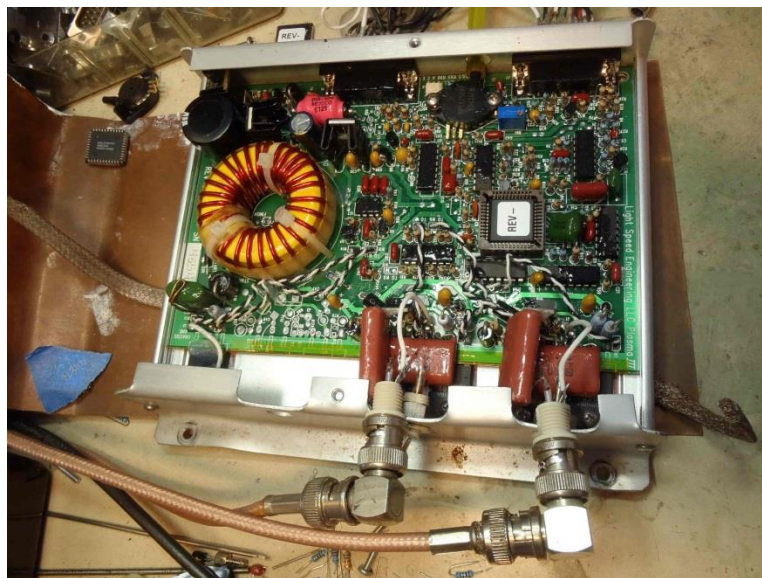
Photo 3 - Plasma III Unit on Test Bench with Replacement BNC Sockets

Both damaged BNC connectors were replaced with new items (Photo 3), and the unit was connected to a test bench and operated at engine speeds of between 190 and 3,000 rpm. The current draw at idle was 0.2 amps, and 1.5 amps at 3,000 rpm. According to the Light speed

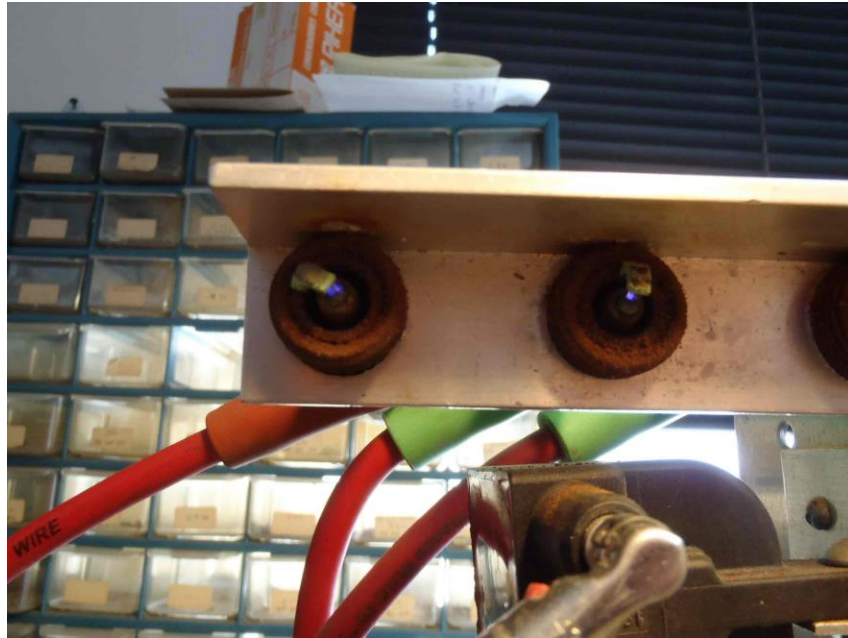
Photo 4 - Test Bench Spark Plugs

representative, these were nominal current draw values. Sparks were observed on the test bench spark plugs throughout operation at all tested engine speeds (Photo 4). The manifold pressure input was adjusted, and the ignition timing advanced appropriately.

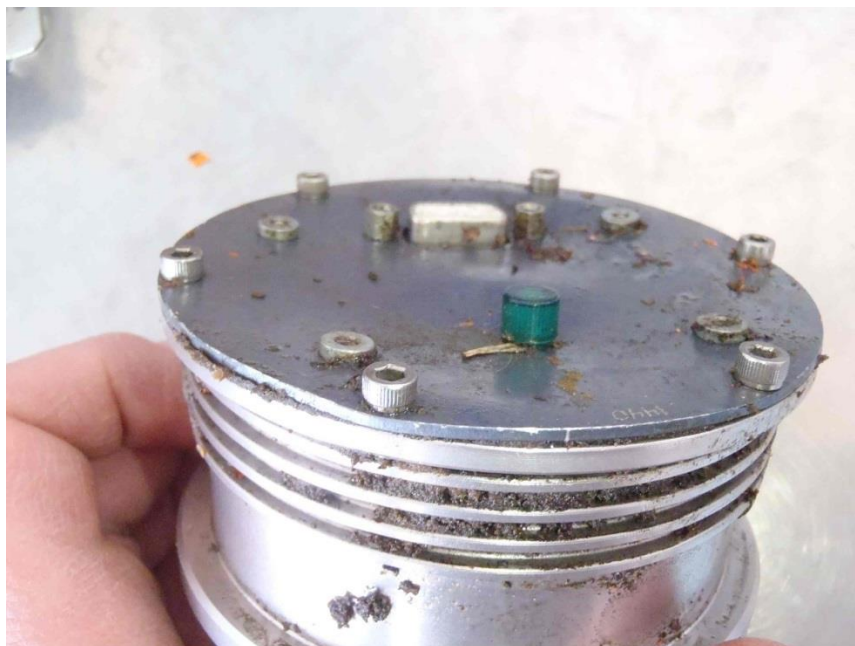
Photo 5 - Hall Effect Module

The Hall Effect module sustained crush damage to its upper lid (Photo 5). Removal of the lid revealed that three of the sensors had separated from the sensor board (Photo 6). The rotor exhibited rotational scoring. The damage was determined to be consistent with crush damage exhibited on the case, forcing contact between the circuit board rotor while the rotor was rotating (Photo 7). The rotors magnet was intact.
