# Continental Motors

## ENGINE FIELD RUN REPORT

| ENGINE MODEL | IO-240-B3B |
| FILE NUMBER | 14-385 |

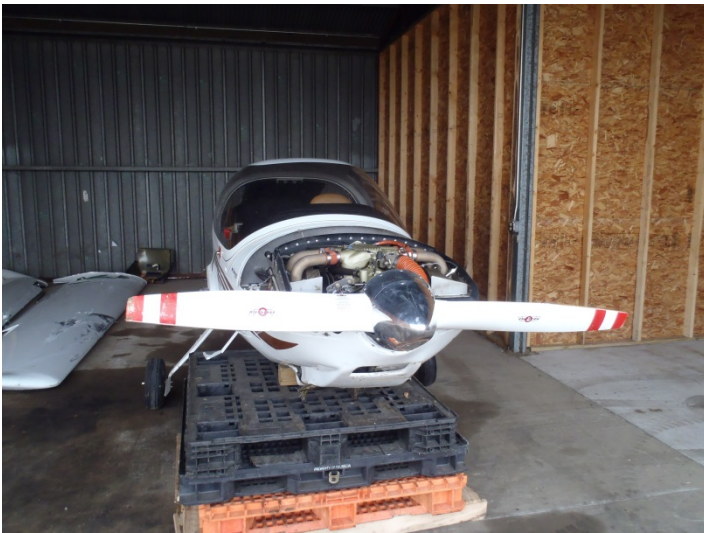
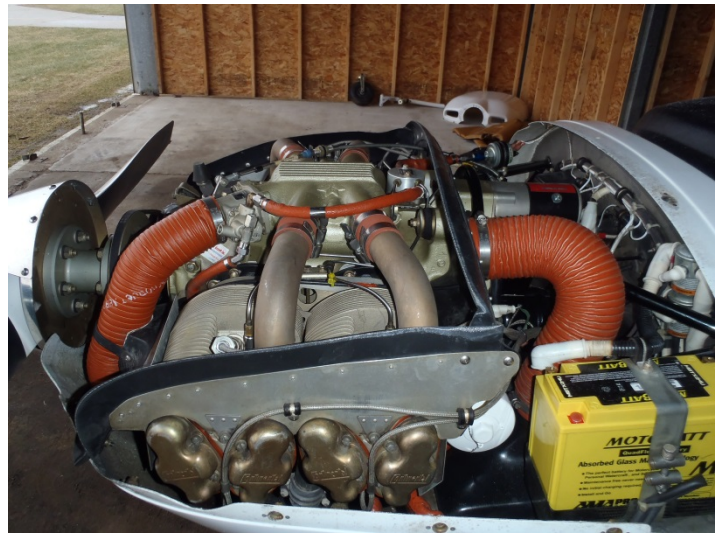
The air intake filter was inspected and it was noted there was a very large piece of ice that covered approximately 75% of the air intake. It was also noted that there were several pieces of loose ice located in the bottom cowling. The alternate air door was inspected and it was noted that the door operated normally. There were no further anomalies noted with the intake system.

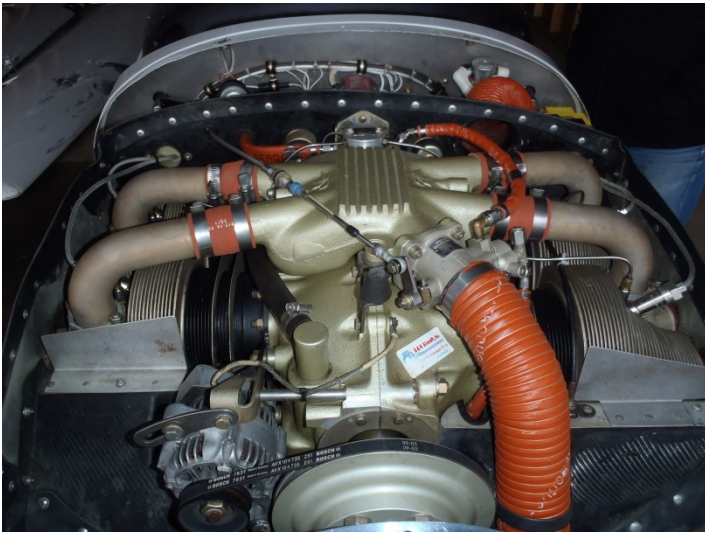
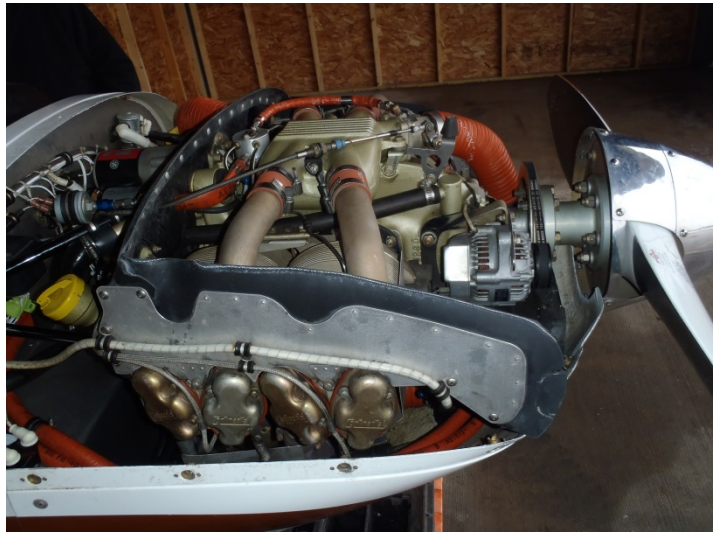
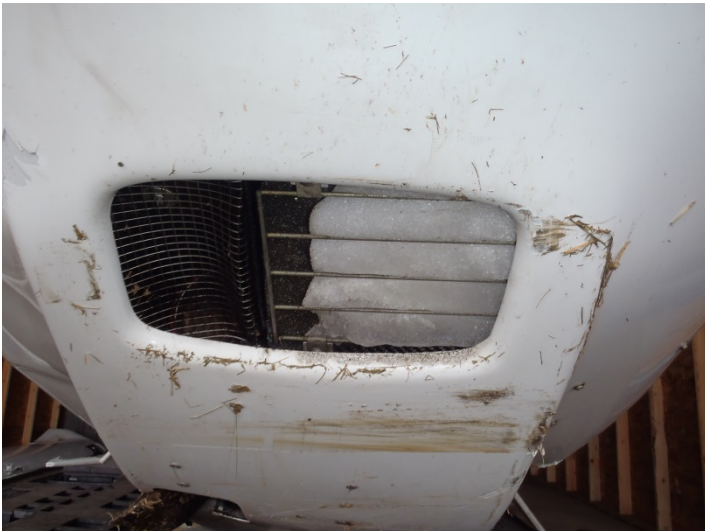
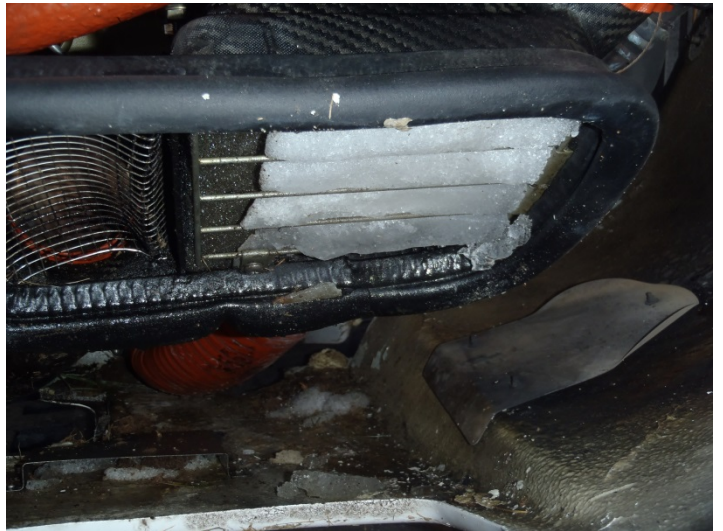
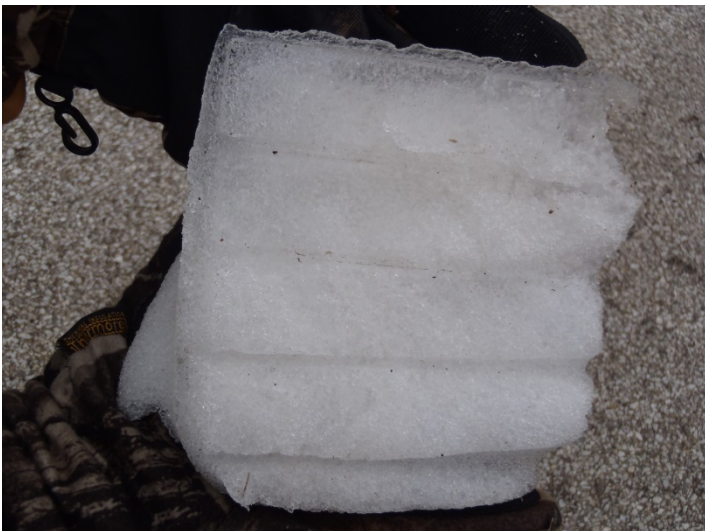
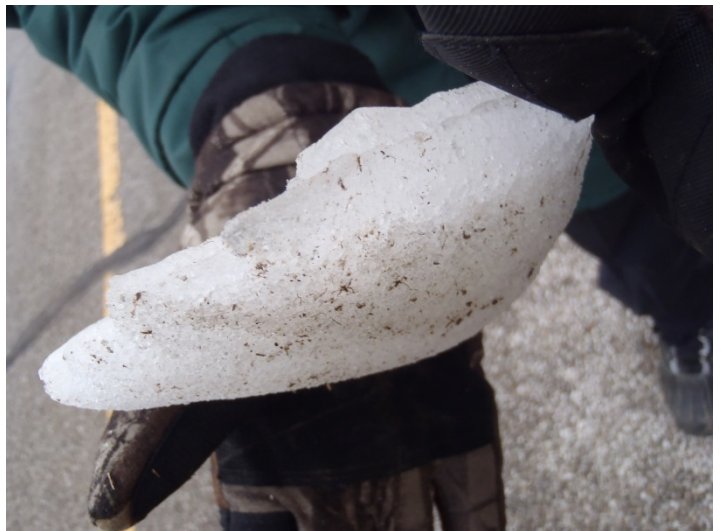
The engine remained attached to the airframe and sustained some impact damage to the exhaust system; the remaining engine components were undamaged. The two blade propeller remained attached to the crankshaft and displayed impact damage signatures; one of the blades displayed a crack near the root of the propeller blade.

The exhaust system displayed impact damage signatures to the exhaust outflow pipe; the very end of the outflow pipe was crushed and had debris consistent with dirt and grass inside the outflow pipe. There were no anomalies noted with the exhaust system.

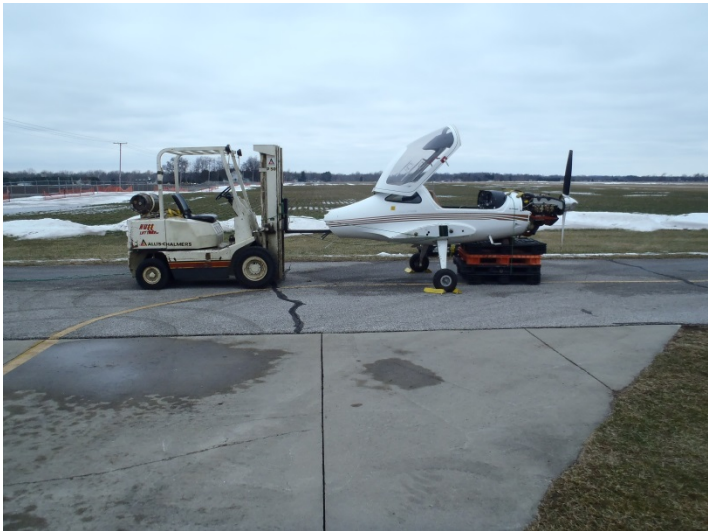
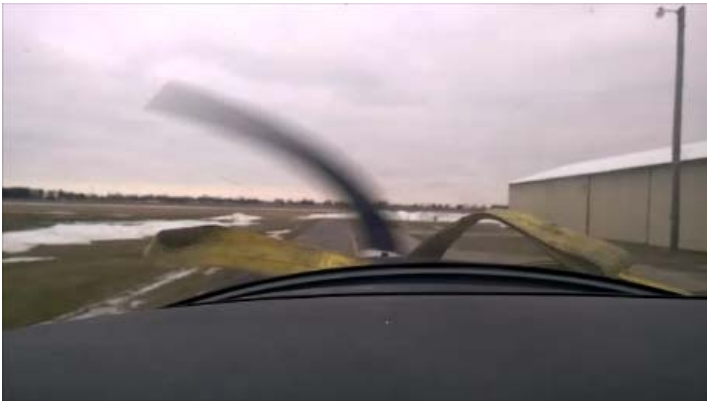
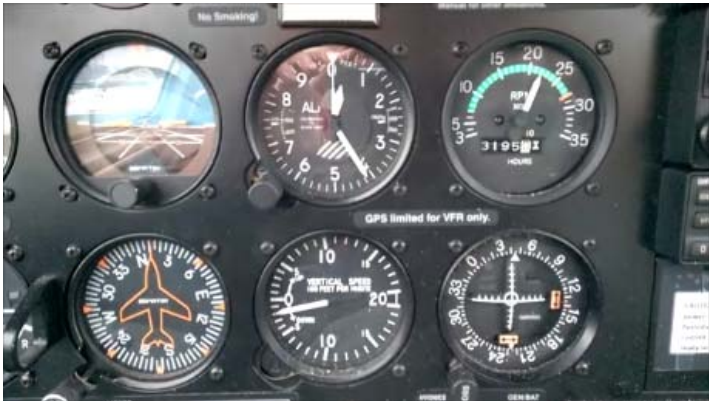
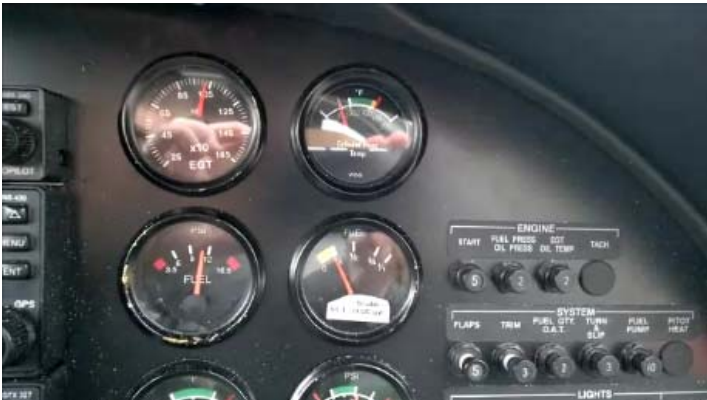
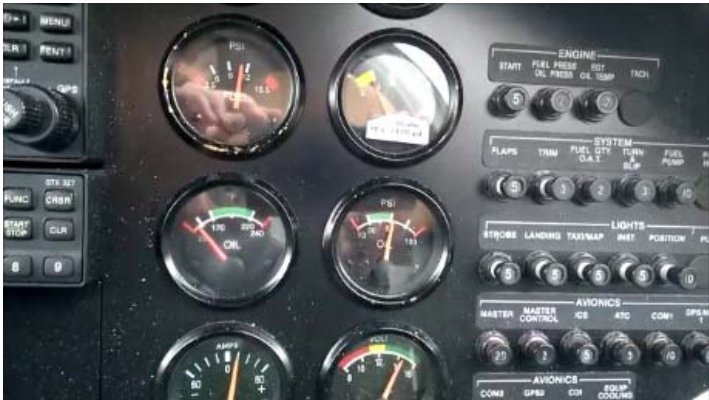
The residual ice that remained attached to the air intake filter was not disturbed for the initial run. The engine started normally; the engine ran at 1200 RPM for approximately 15 minutes to allow the engine to warm to operating temperature. The engine was then operated at multiple RPM settings; the engine was capable of running at all tested RPM settings. The alternate air door was opened and the engine was operated at multiple RPM settings; there was no noticeable difference in engine performance with the alternate air door open or closed. The engine was shut down and the block of ice was removed from the air intake. The engine was operated at multiple RPM settings and it was noted that the engine was capable of running at all tested RPM settings. Due to the fact that the aircraft was equipped with a fixed pitch propeller the maximum RPM that the engine was able to achieve was 2200 RPM which is acceptable according to the DA20-C1 Flight Manual (minimum 2000 RPM for takeoff). The engine run was limited in time due to the impact damage to the propeller.

With the exception of the excessive ice buildup on the engine intake system there were no anomalies noted that would have prevented the engine from normal operation or production of rated horsepower.
