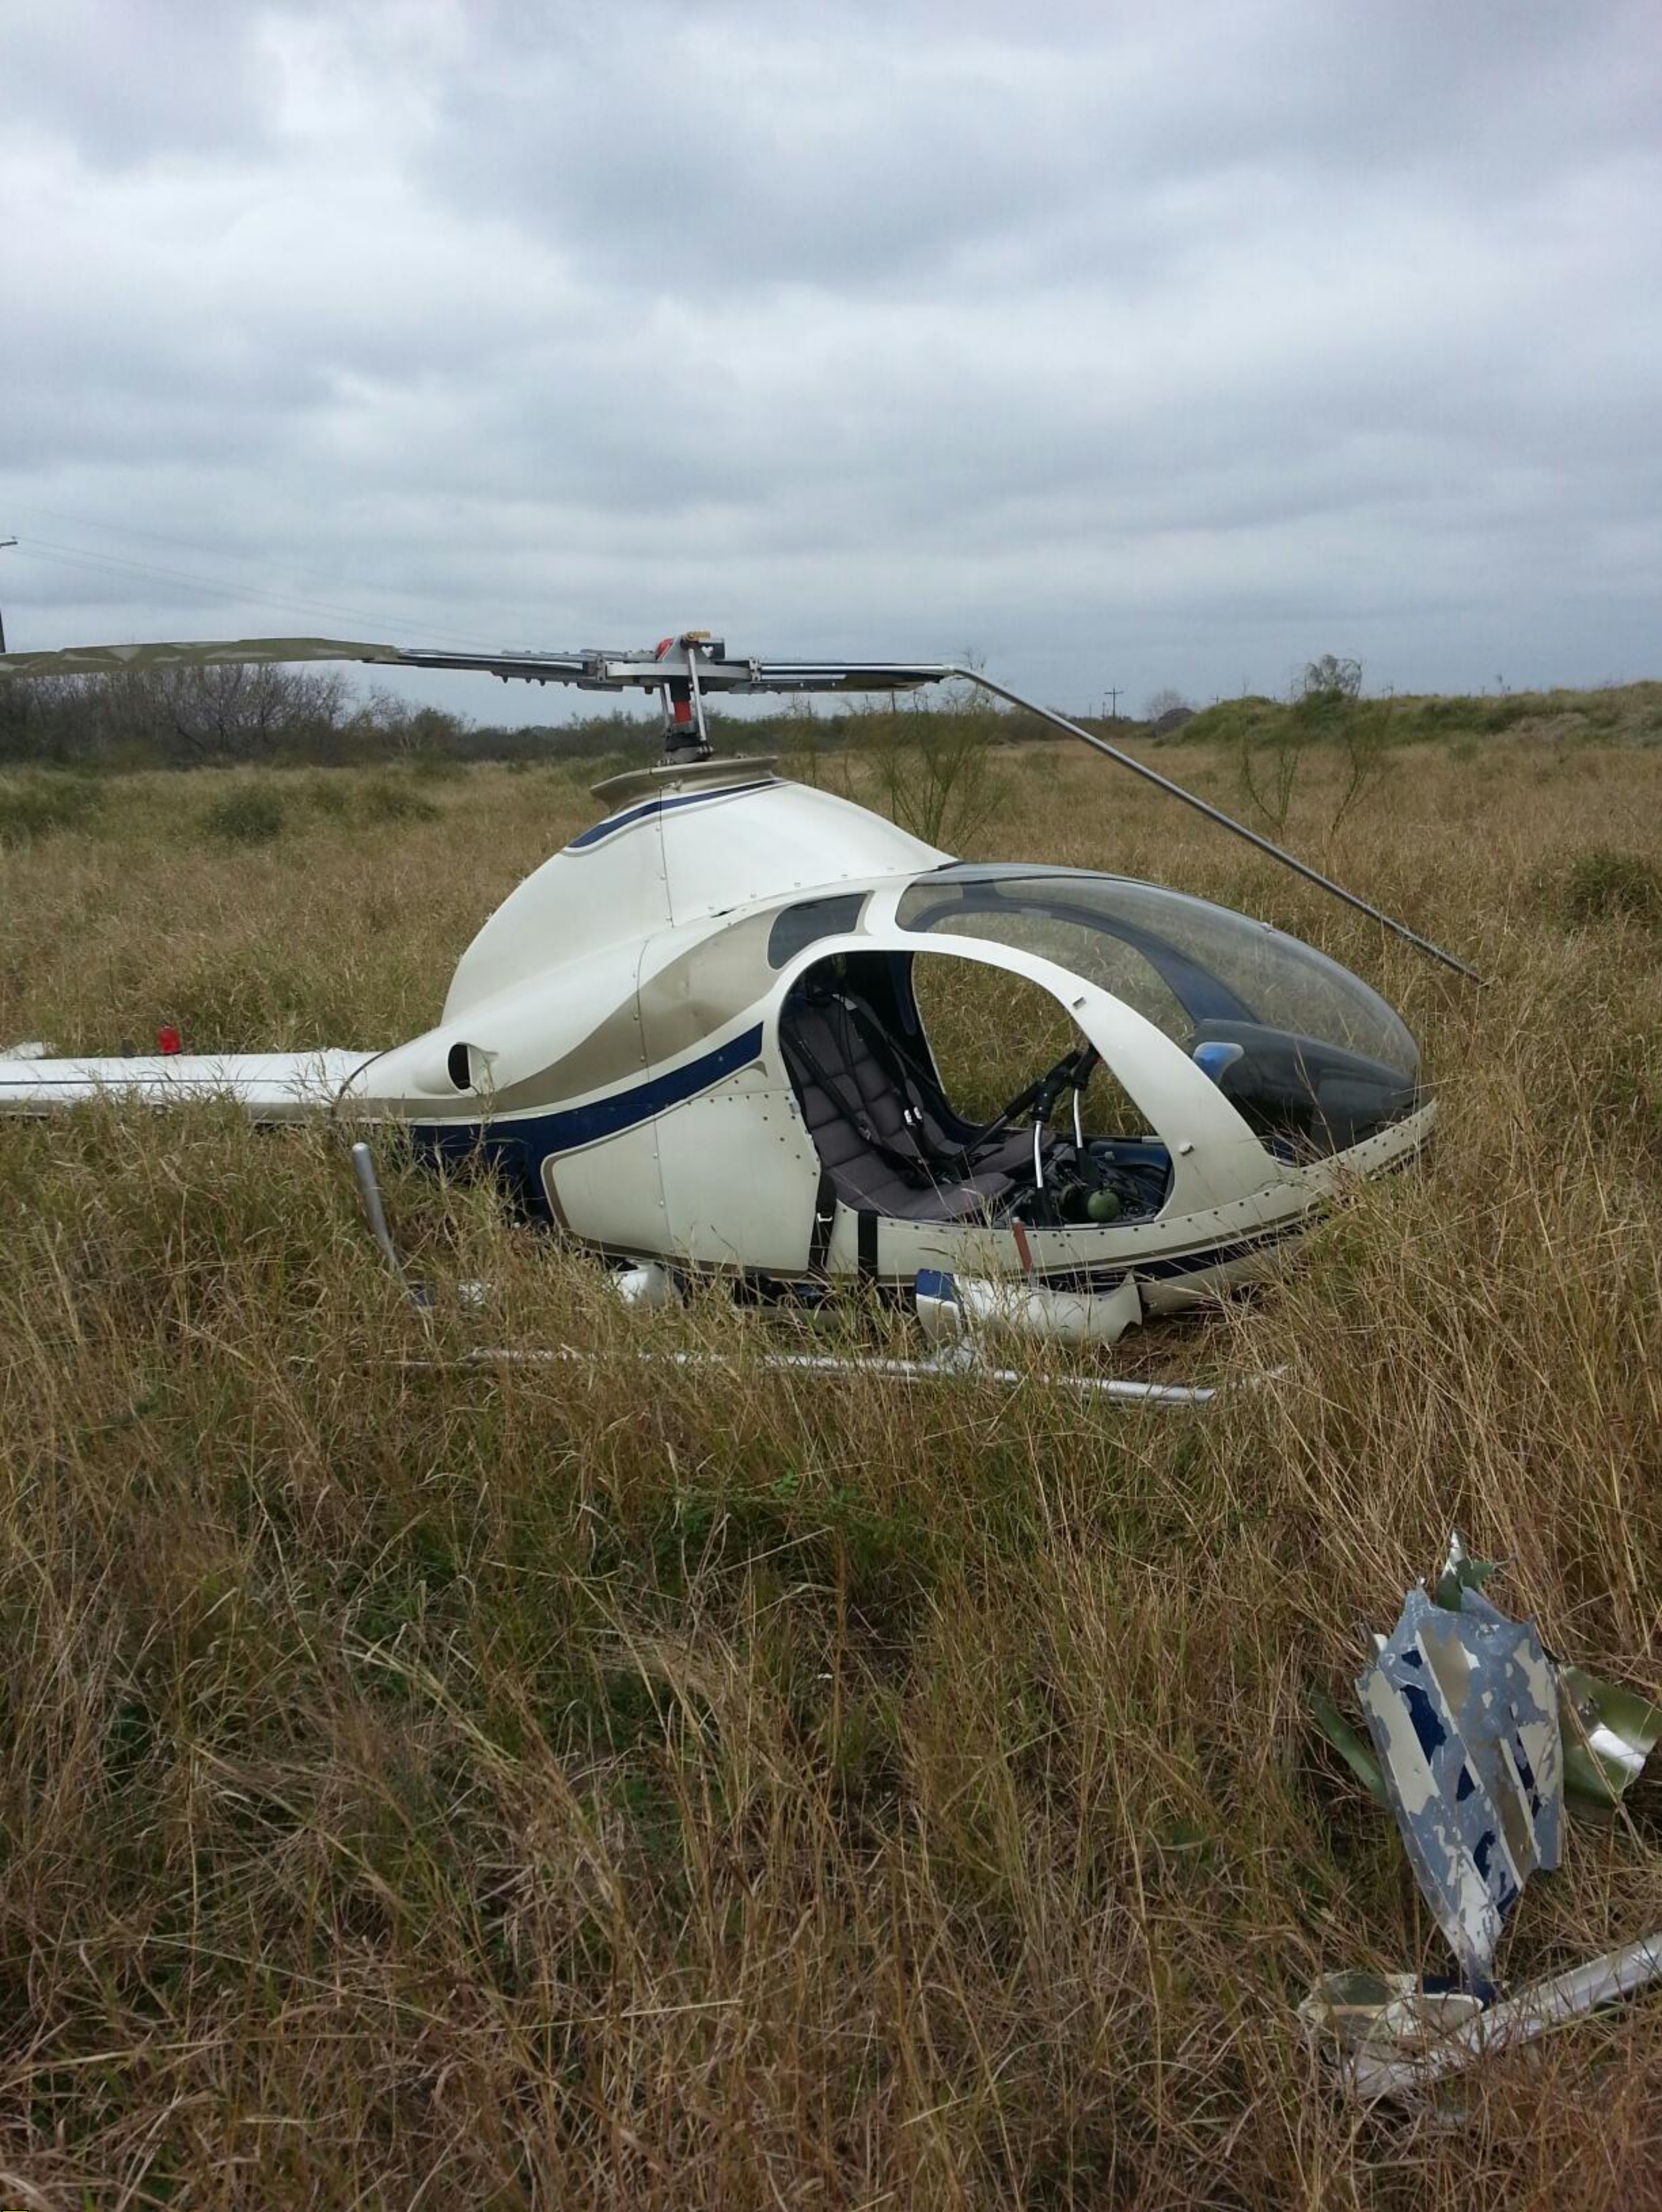
Photo 2 - Closer view shows bent rotor blades and buckled skids
