**NATIONAL TRANSPORTATION SAFETY BOARD**

**Computed Tomography Specialist's Factual Report**

CEN-15-LA-146

Location: Haviland, Kansas  
Date: February 13, 2015  
Time: about 2330 central standard time  
Vehicle: Piper PA-28R-180 airplane, N3918T

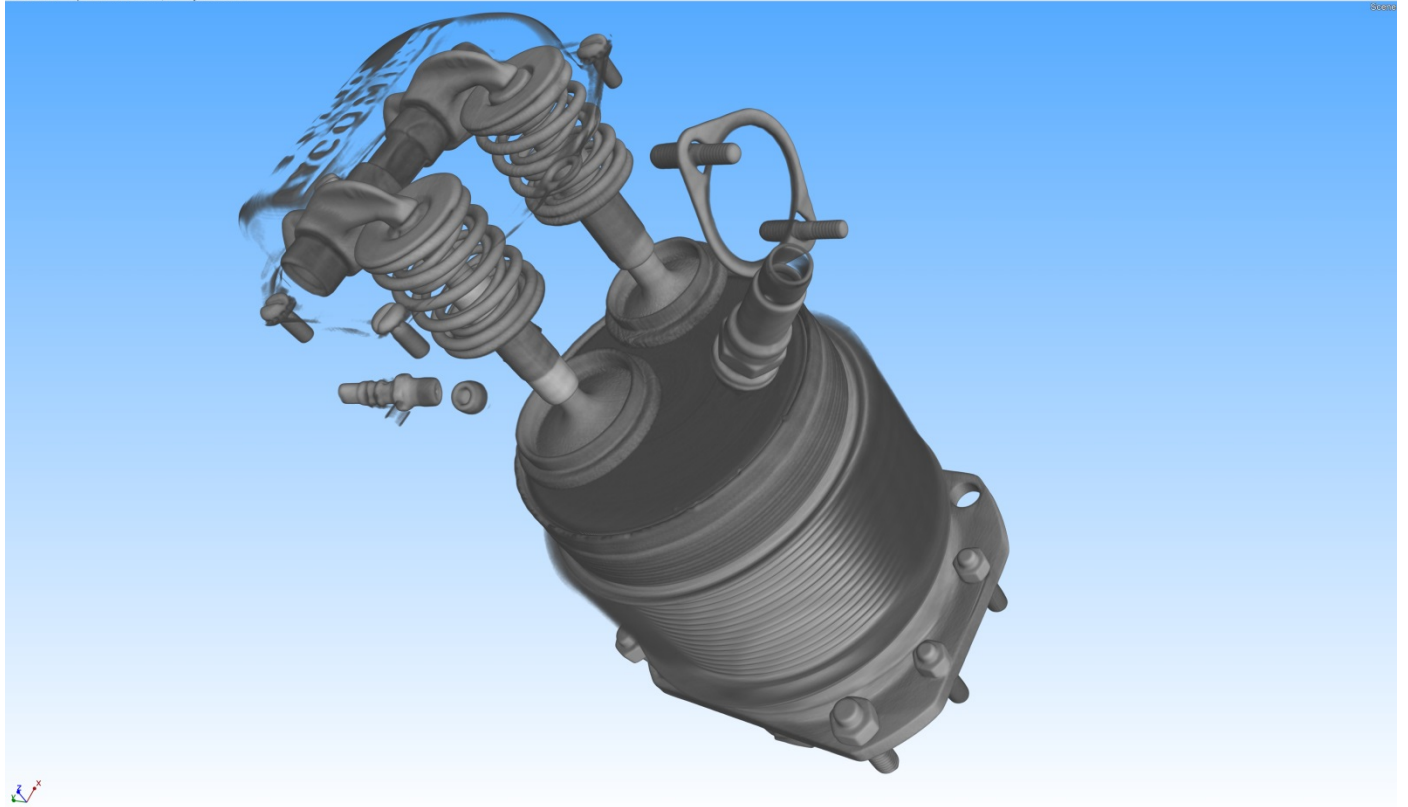
Figure 5  
Cylinder head – High density items

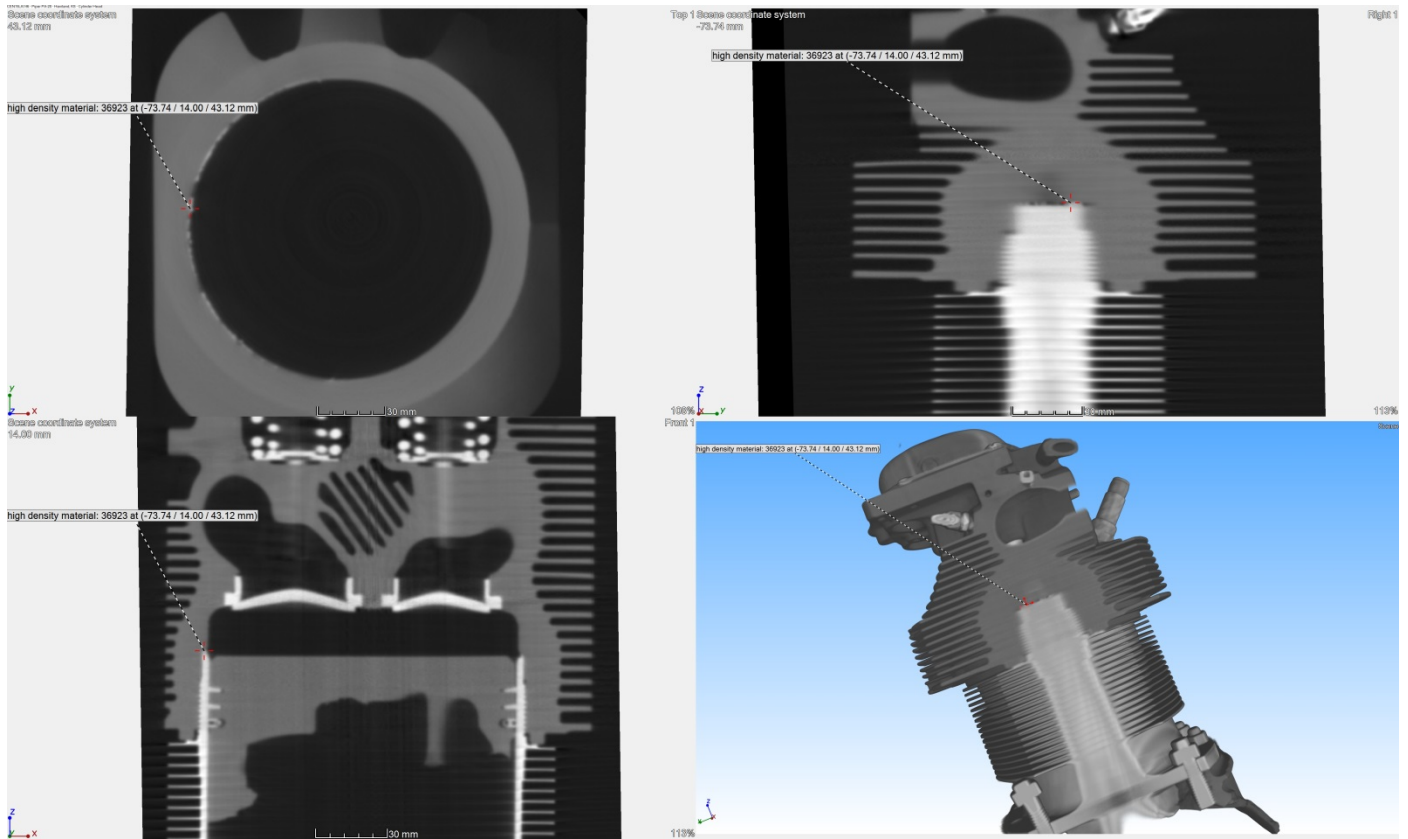
Figure 11  
Cylinder head – High density material

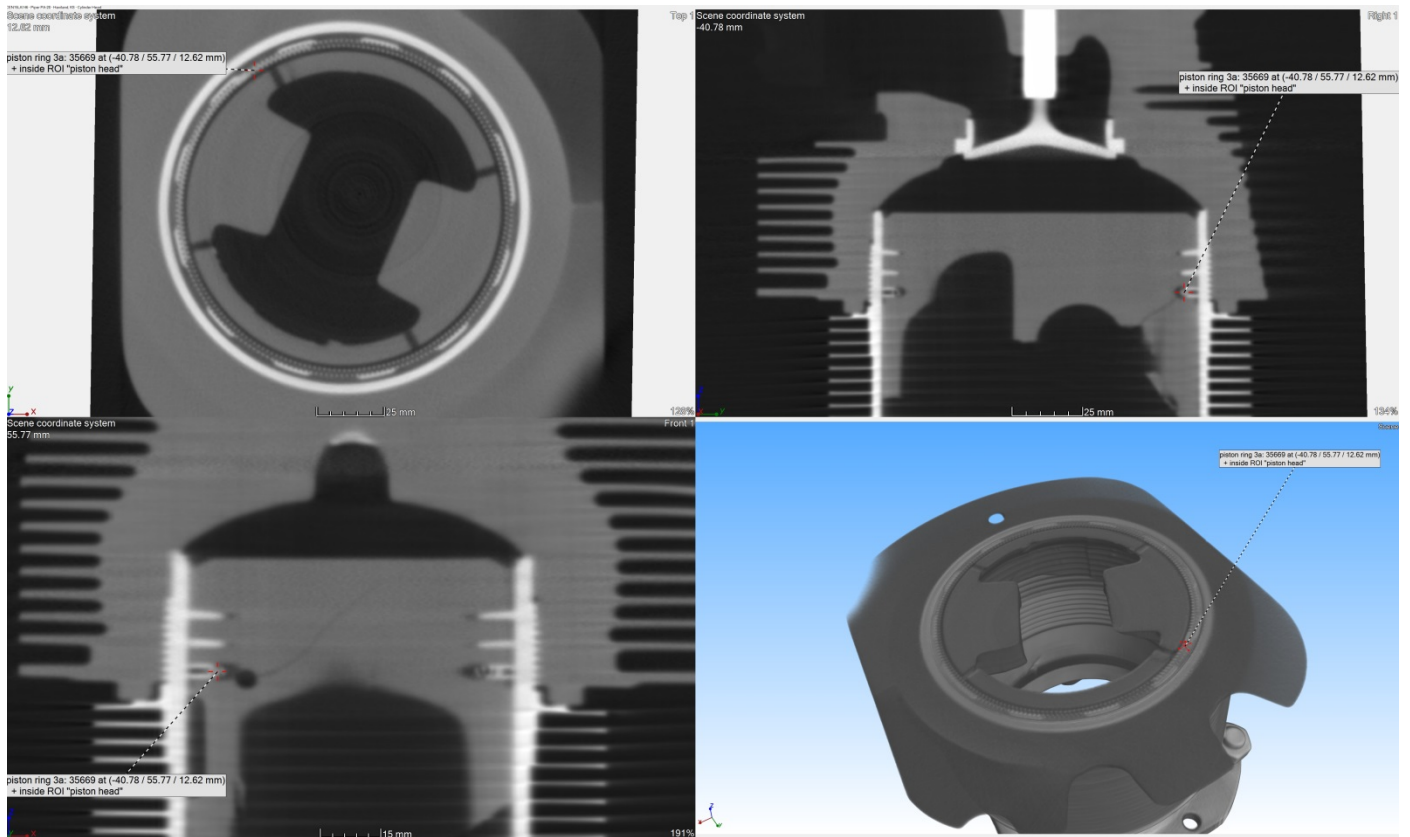
Figure 15  
Cylinder head – Piston ring 3 – crack indications

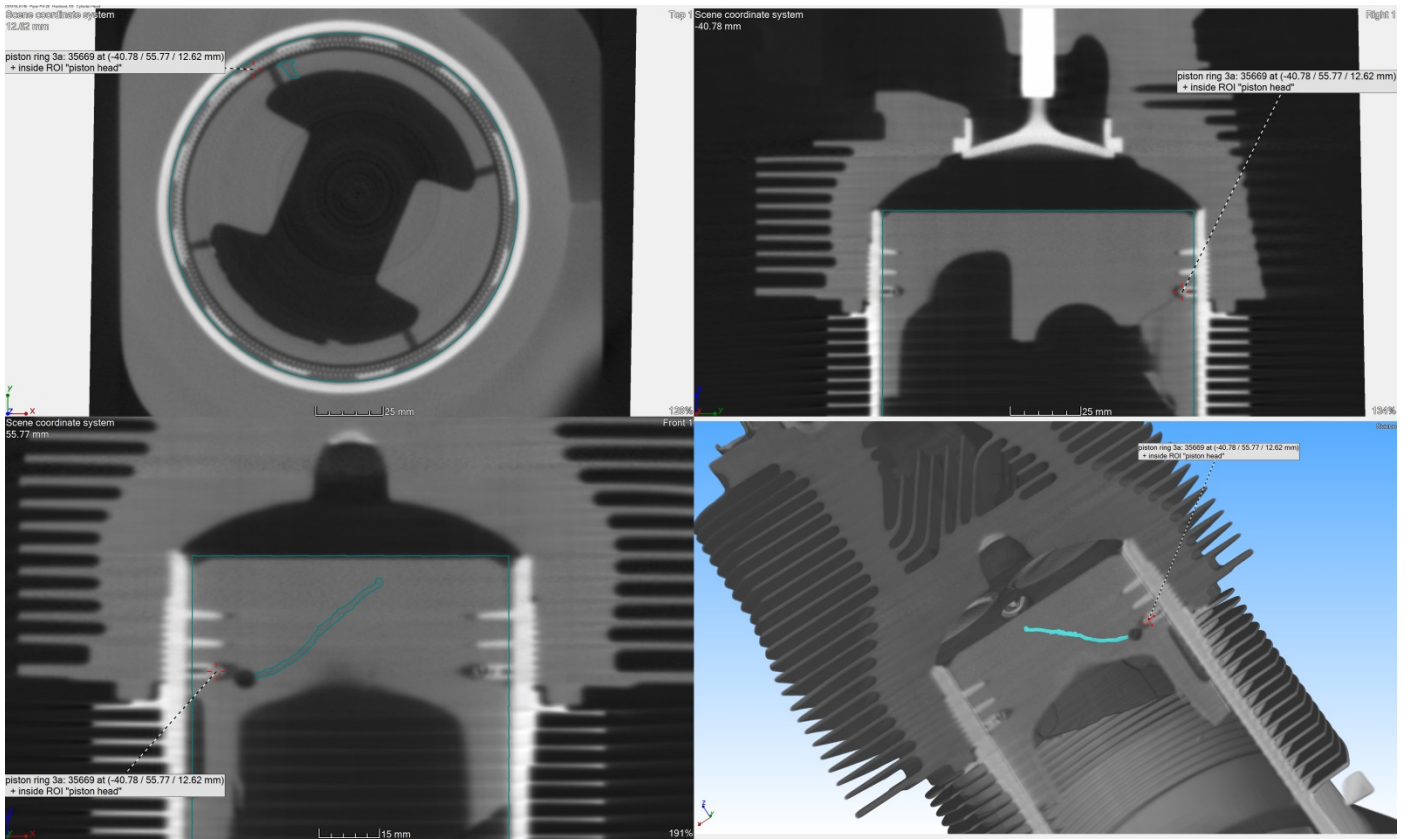
Figure 18  
Cylinder head – Piston ring 3 – view 3 with highlighted crack indication

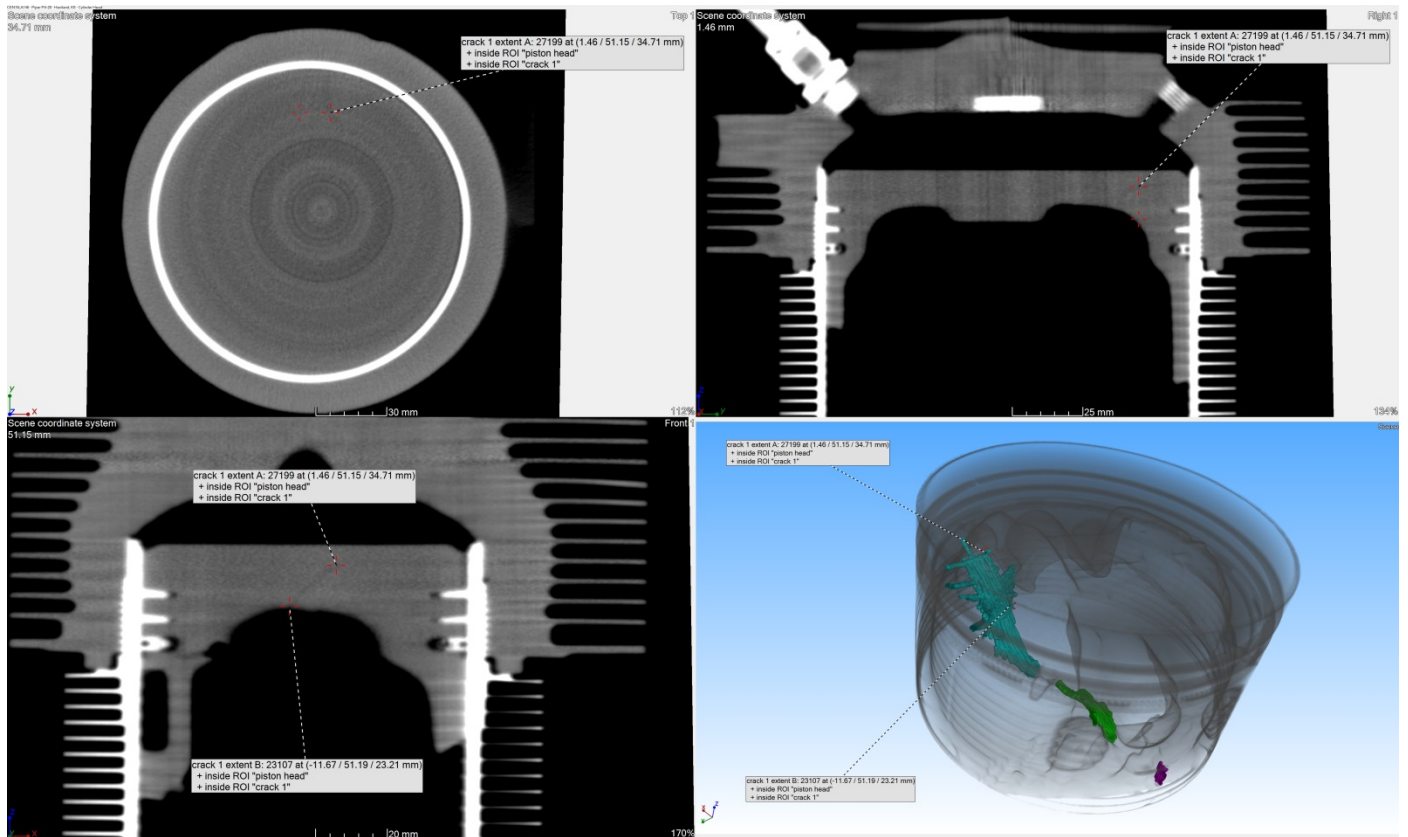
Figure 19  
Cylinder head – Crack 1 – extent A and B

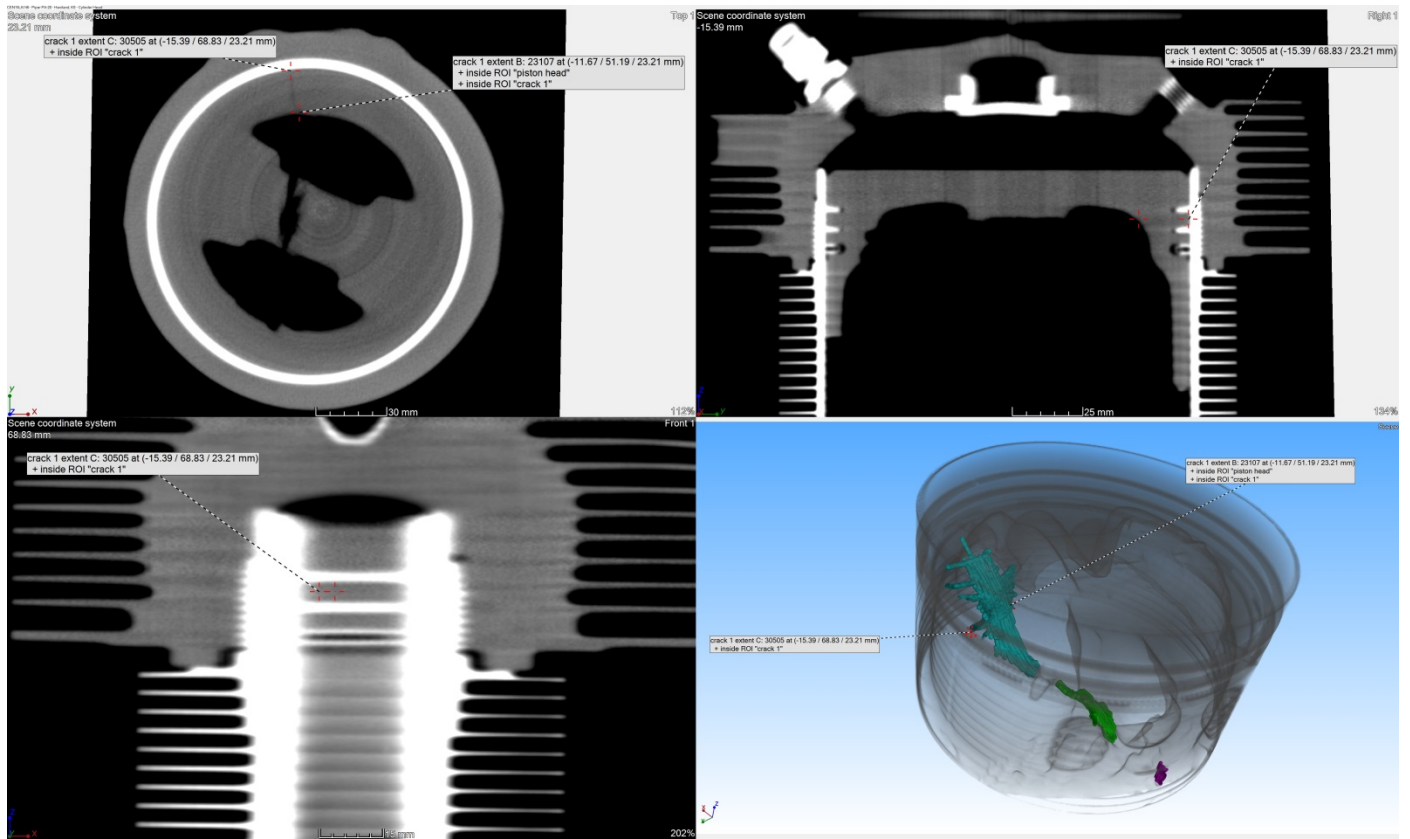
Figure 20  
Cylinder head – Crack 1 – extent B and C

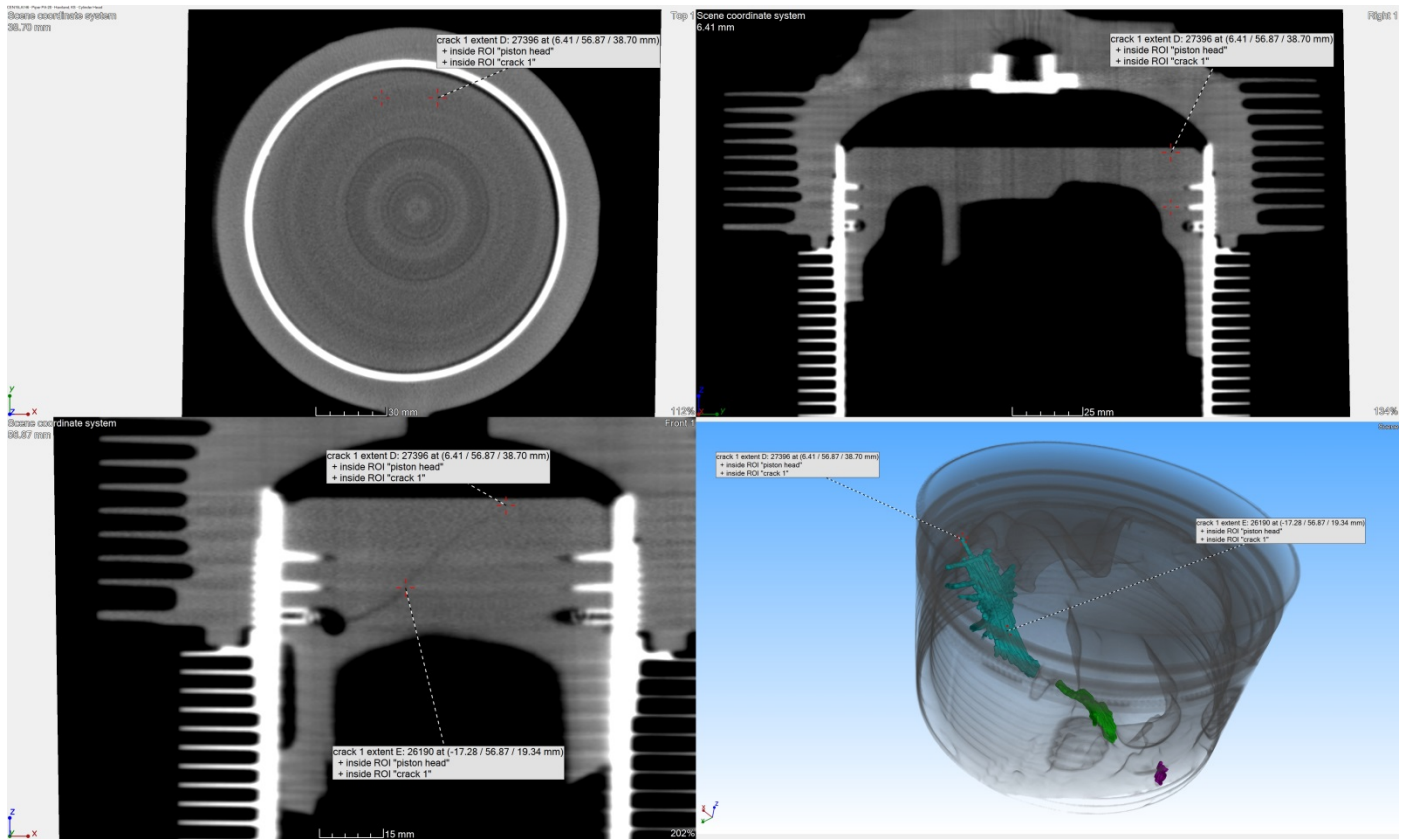
Figure 21  
Cylinder head – Crack 1 – extent D and E

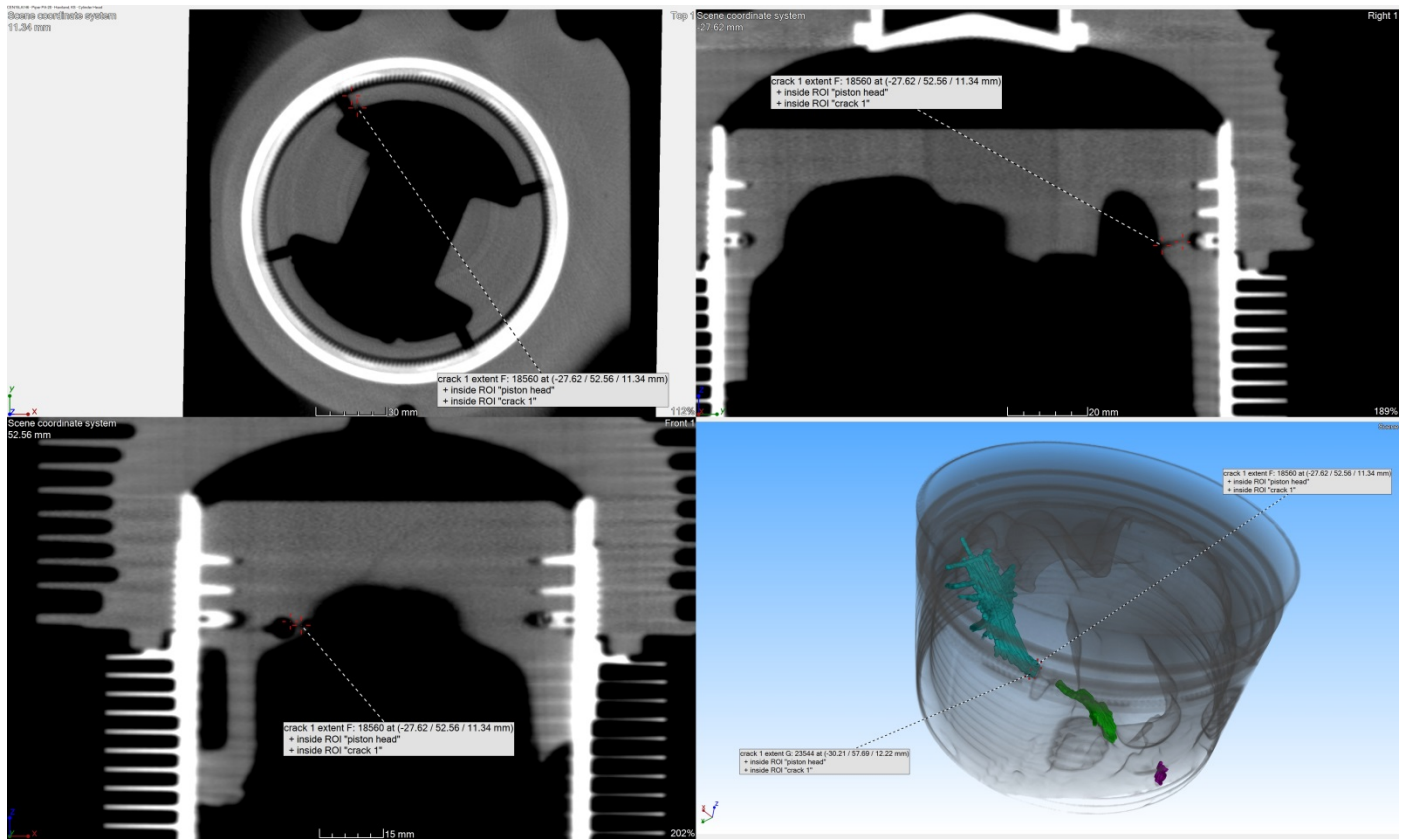
Figure 22  
Cylinder head – Crack 1 – extent F and G

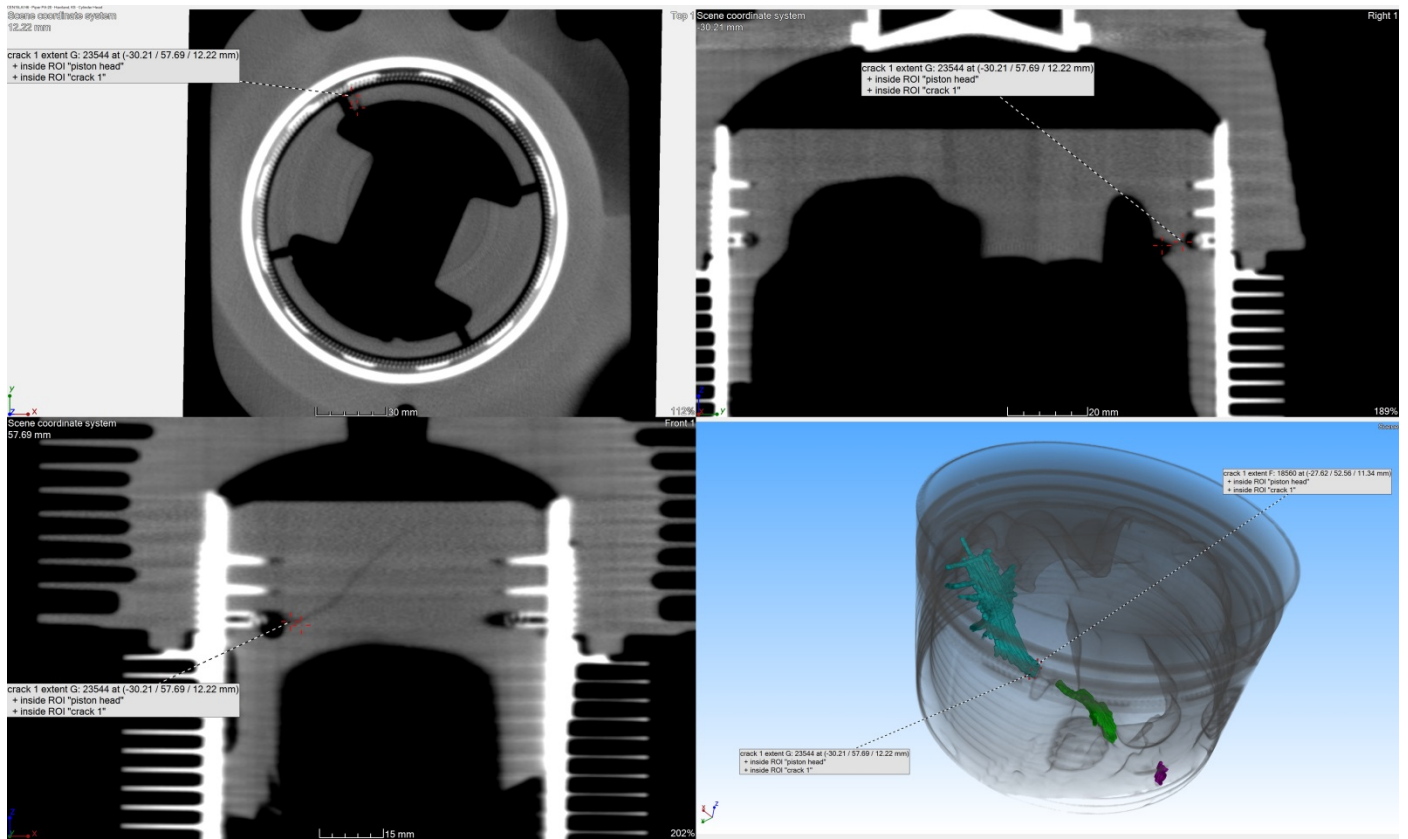
Figure 23  
Cylinder head – Crack 1 – extent F and G – view 2

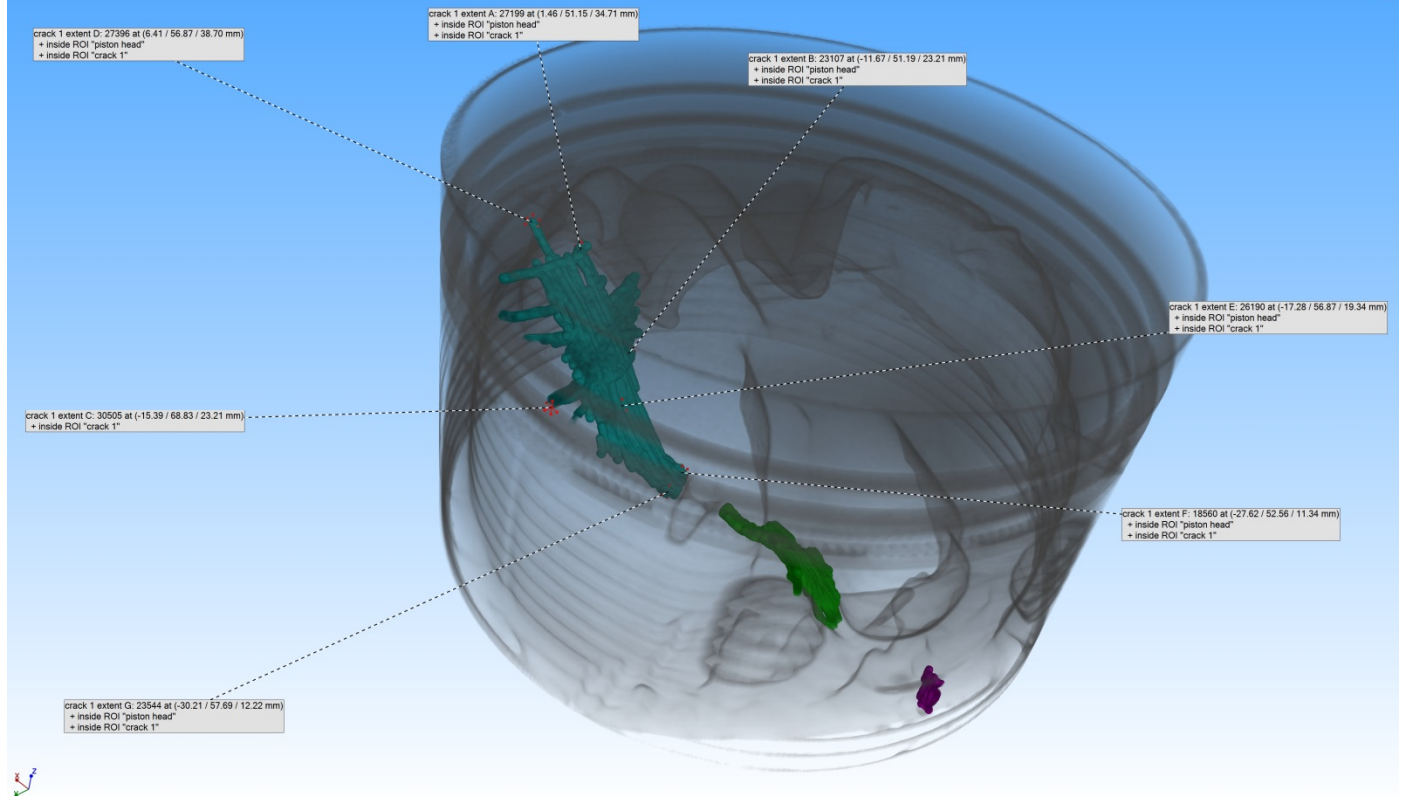
Figure 24  
Cylinder head – Crack 1 – overall view

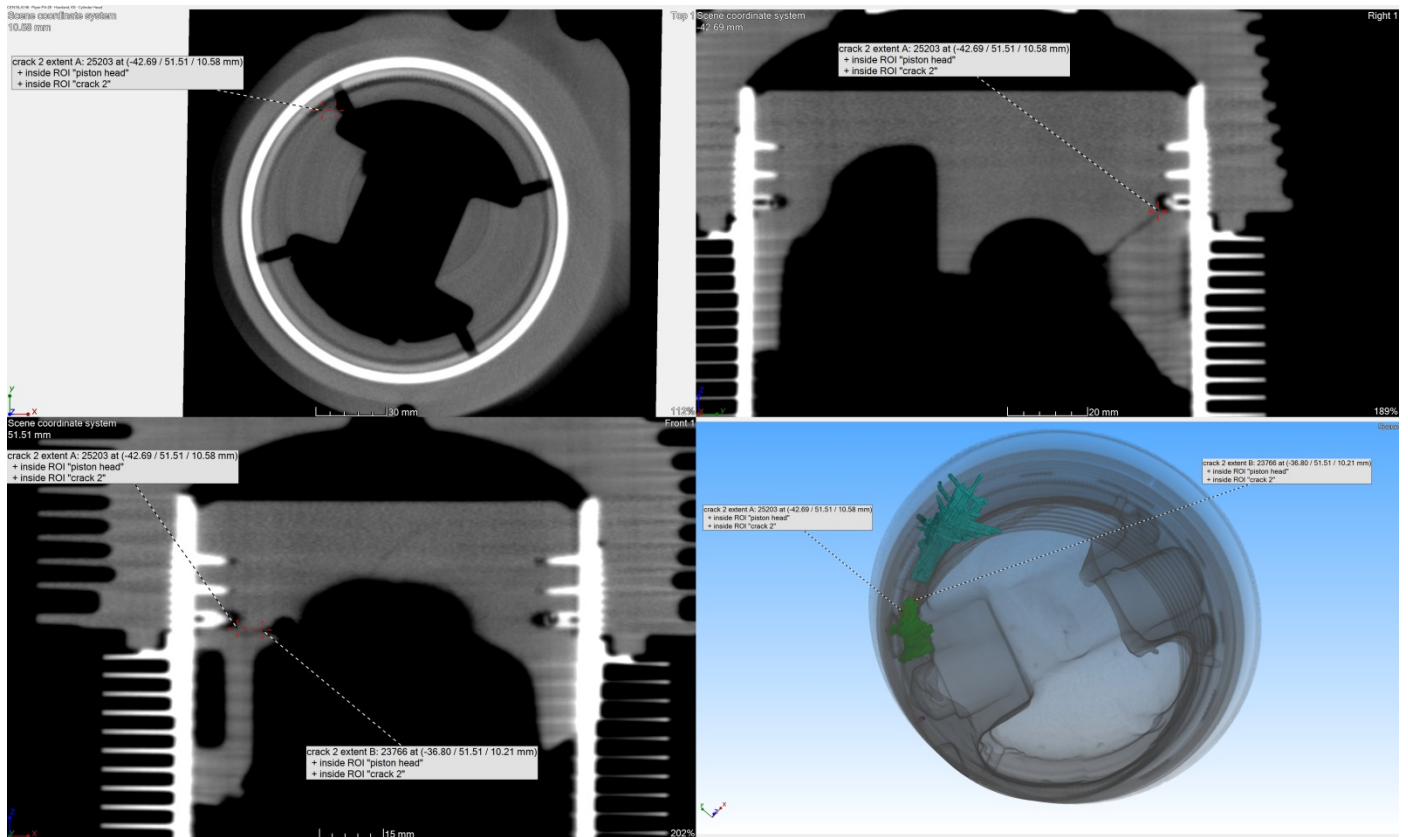
Figure 25  
Cylinder head – Crack 2 – extent A and B

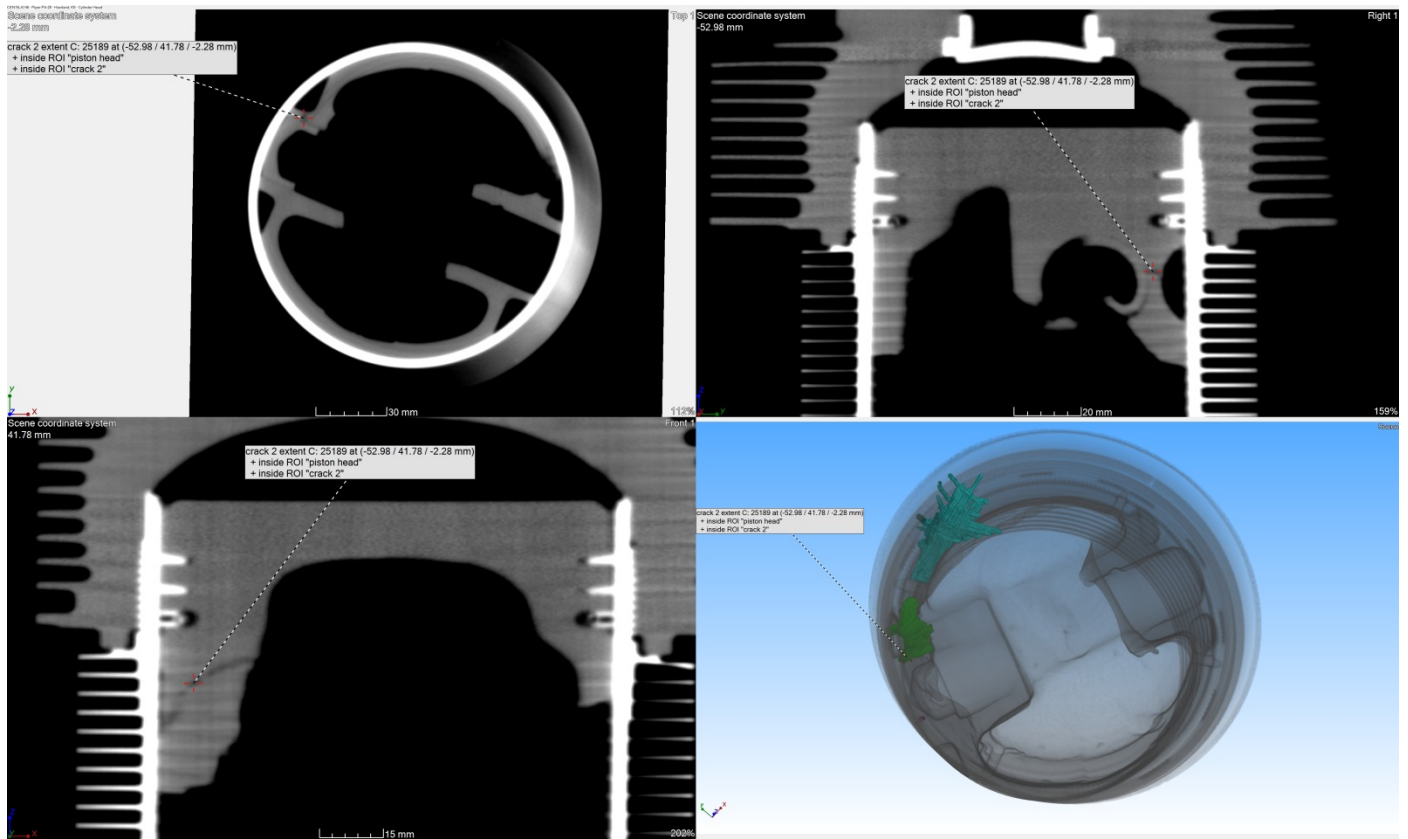
Figure 26  
Cylinder head – Crack 2 – extent C

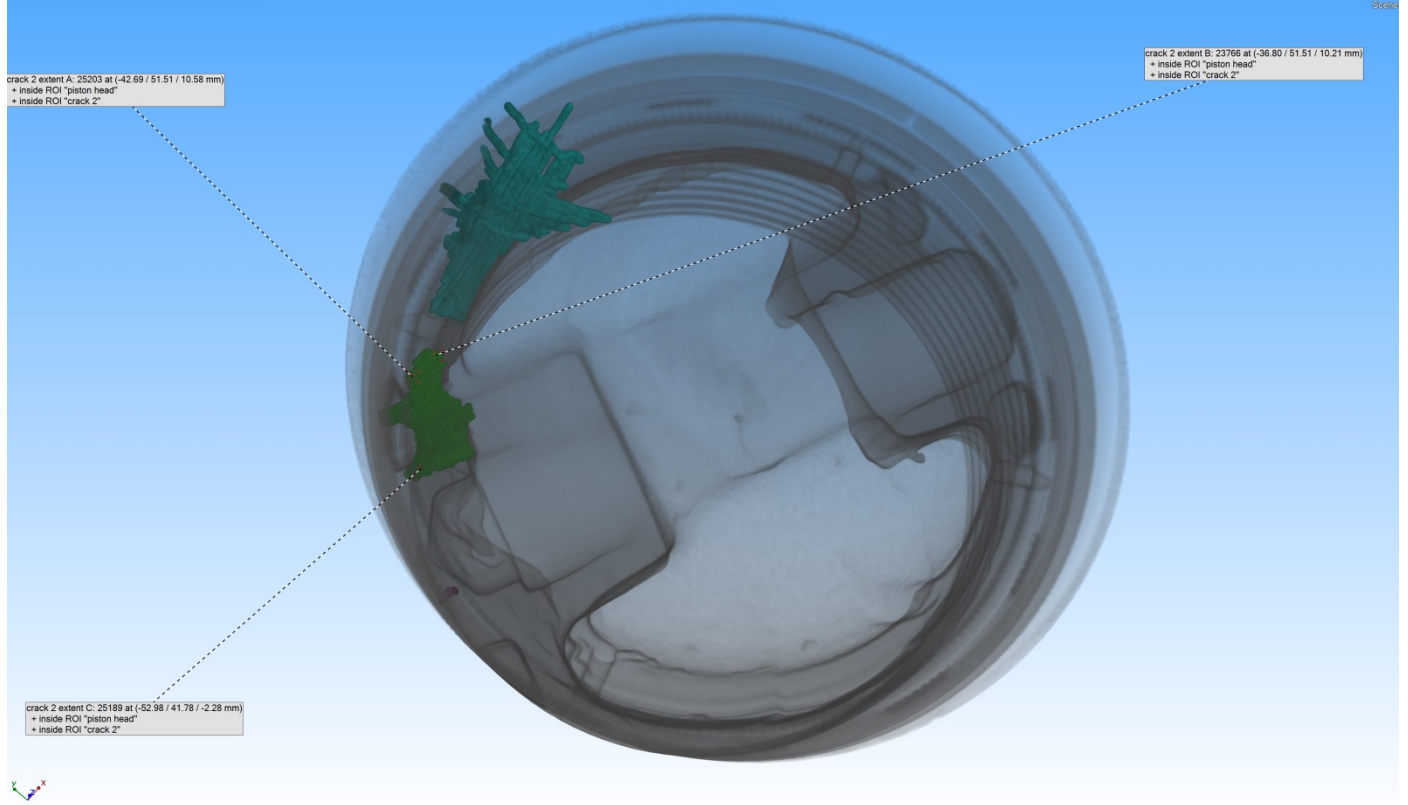
Figure 27  
 Cylinder head – Crack 2 – overall view

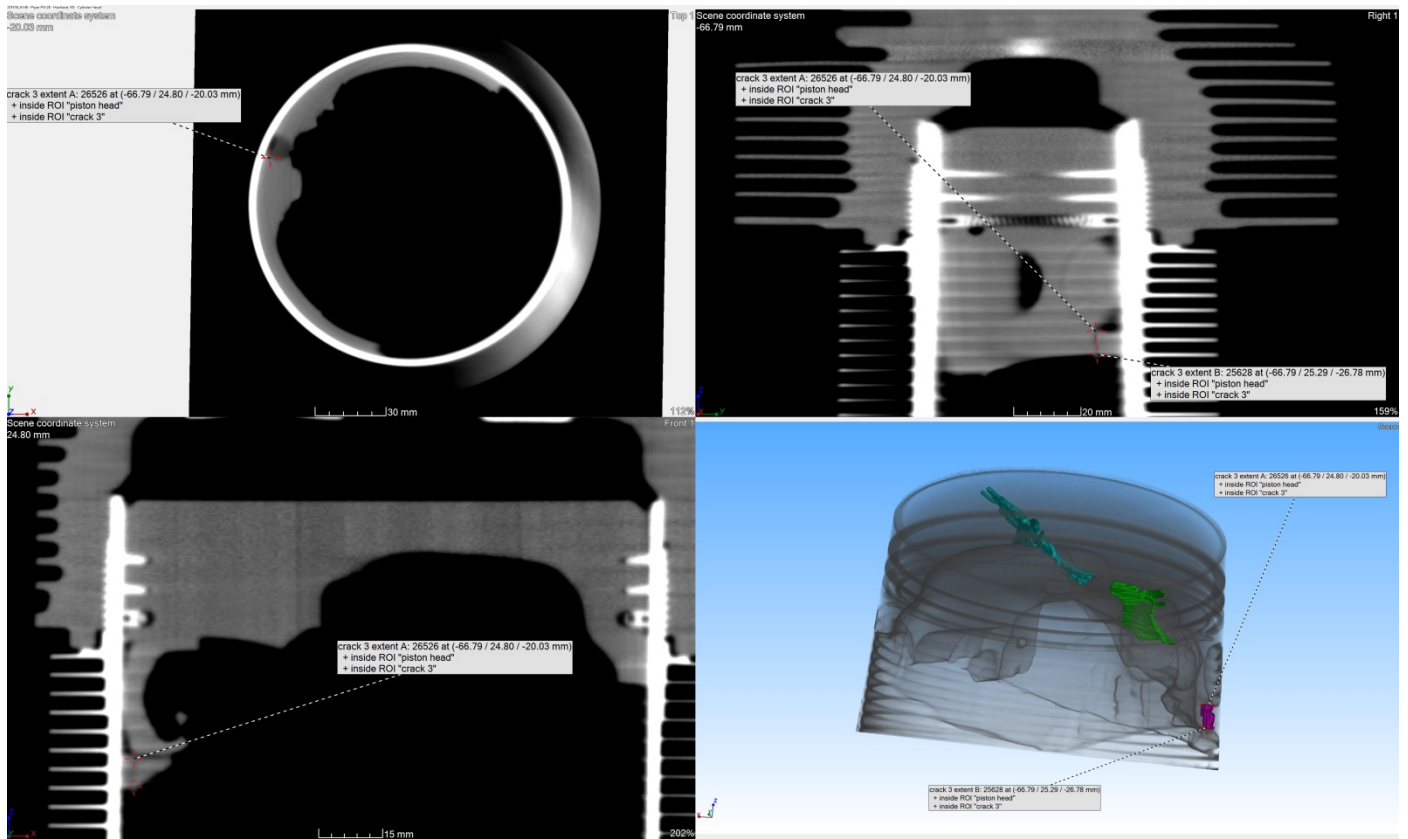
Figure 28  
Cylinder head – Crack 3 – extent A and B

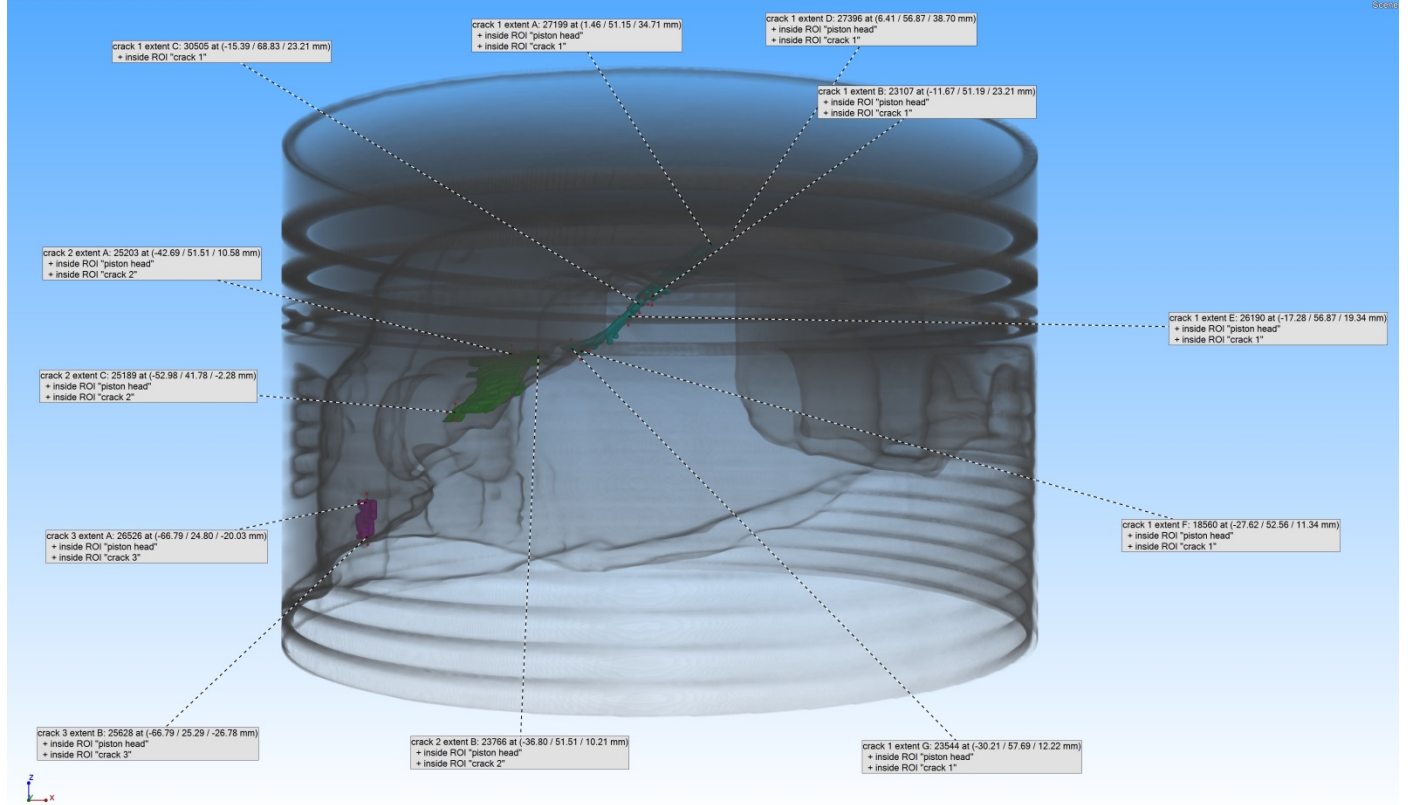
Figure 29  
Cylinder head – All cracks – side 1

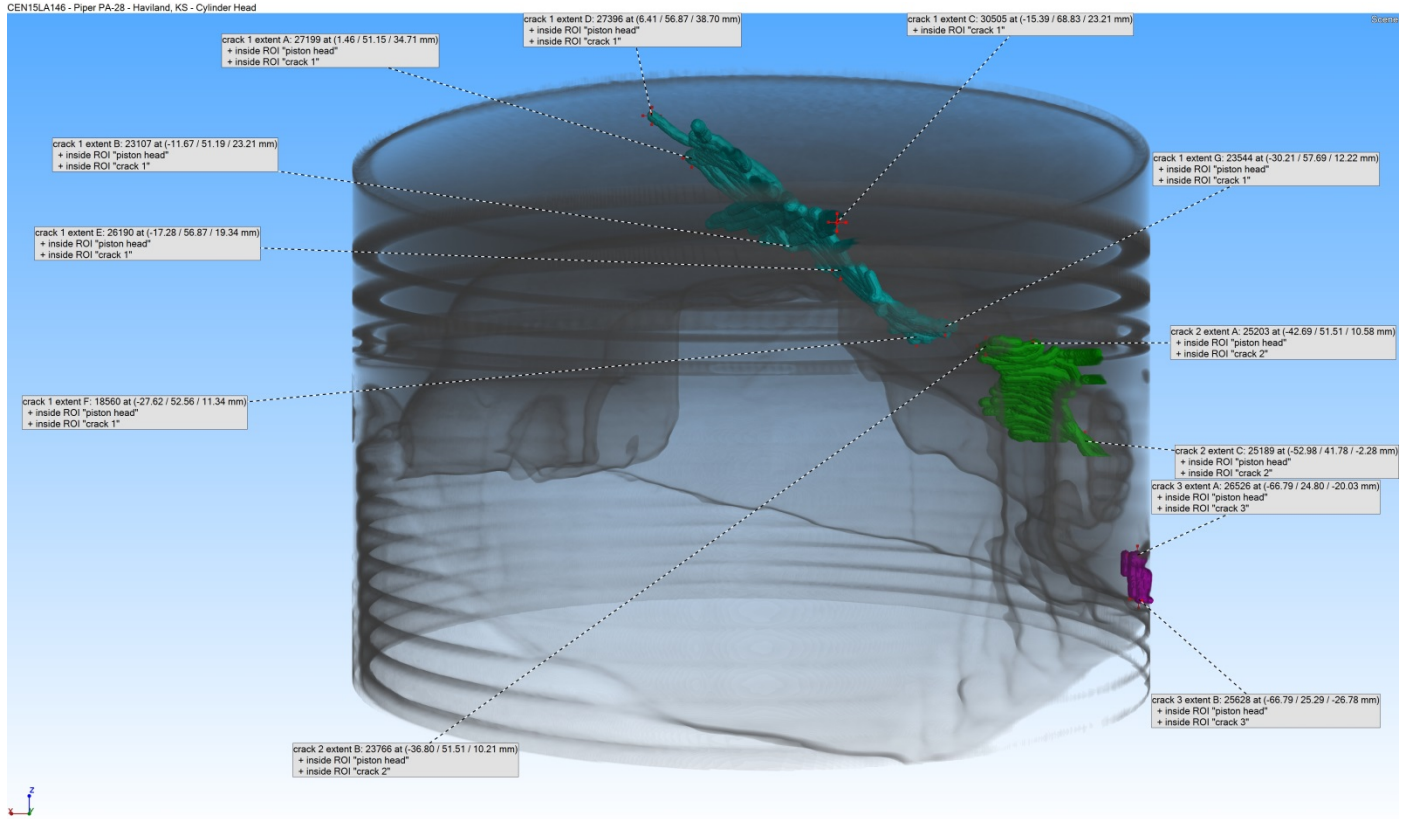
Figure 30  
Cylinder head – All cracks – side 2

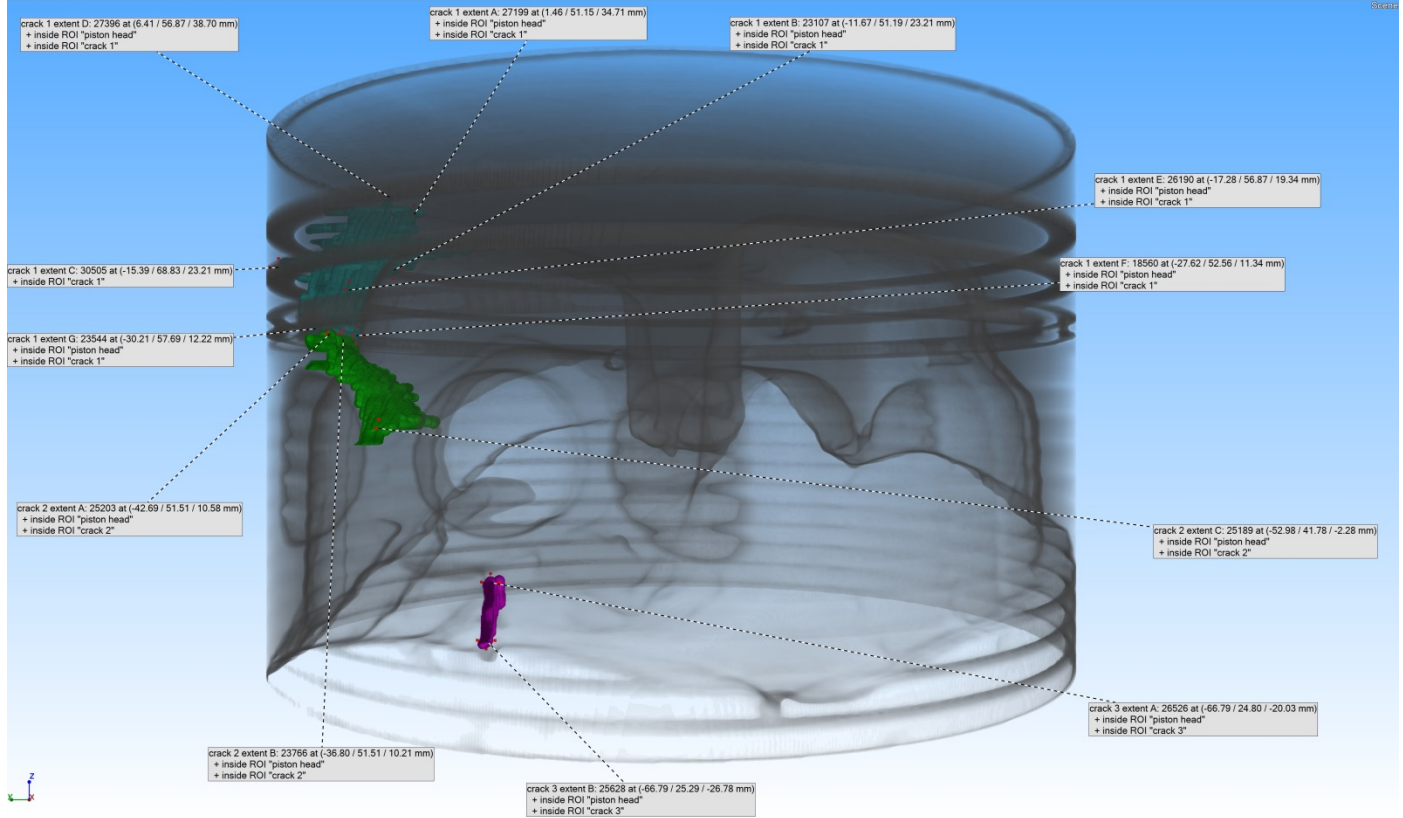
Figure 31  
Cylinder head – All cracks – side 3

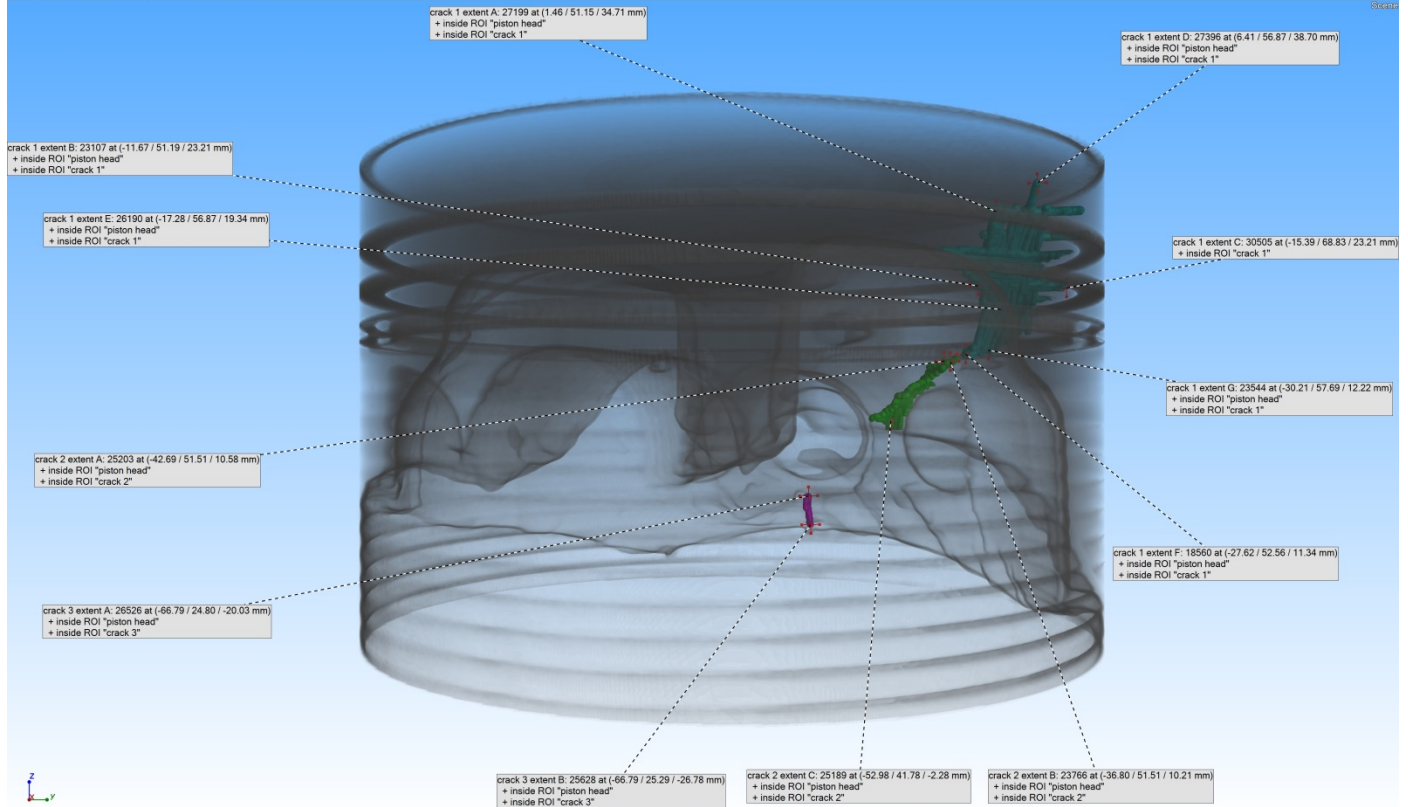
Figure 32  
Cylinder head – All cracks – side 4

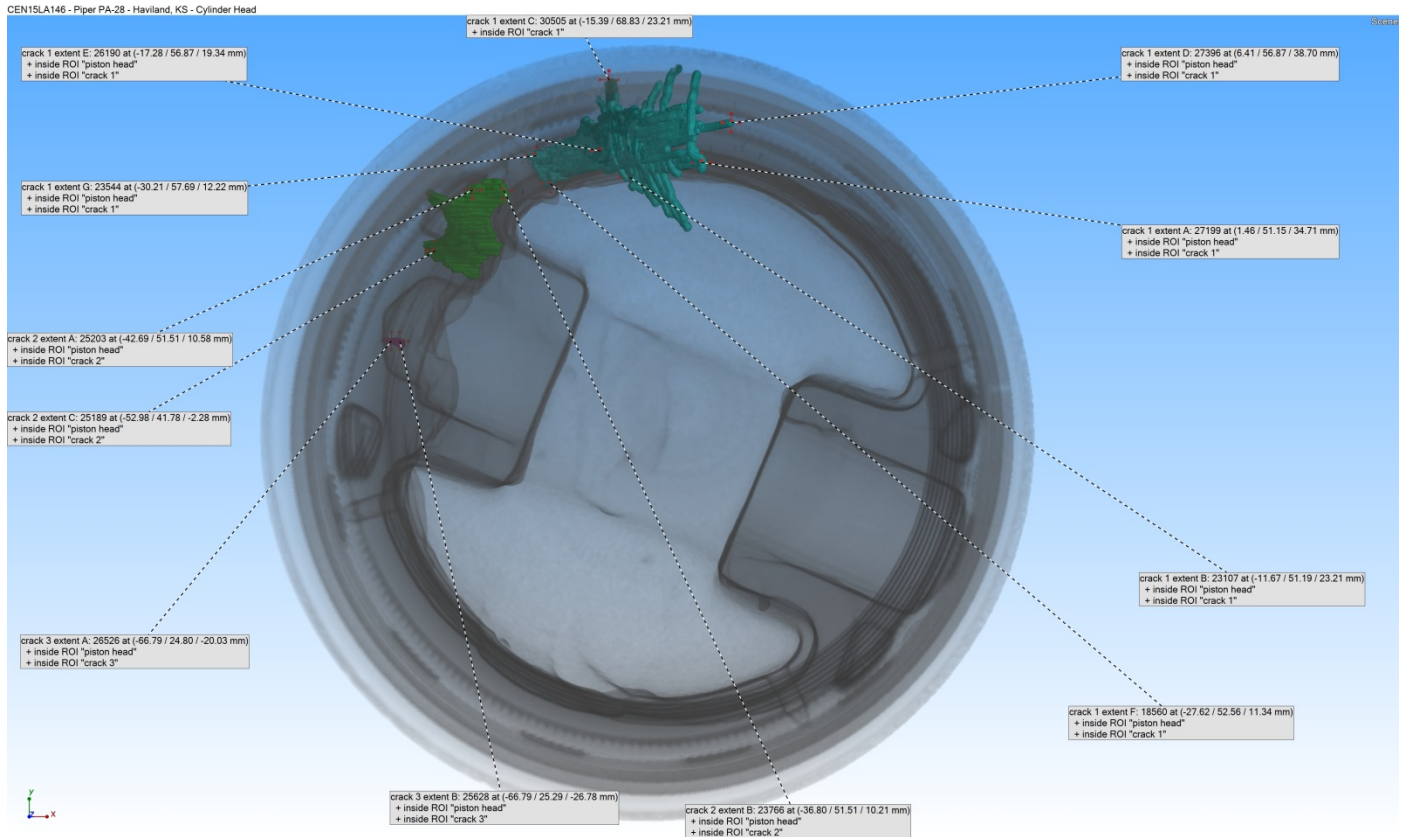
Figure 33  
Cylinder head – All cracks – from top
