**NATIONAL TRANSPORTATION SAFETY BOARD**

**Computed Tomography Specialist's Factual Report**

CEN-15-LA-146

Location: Haviland, Kansas  
Date: February 13, 2015  
Time: about 2330 central standard time  
Vehicle: Piper PA-28R-180 airplane, N3918T

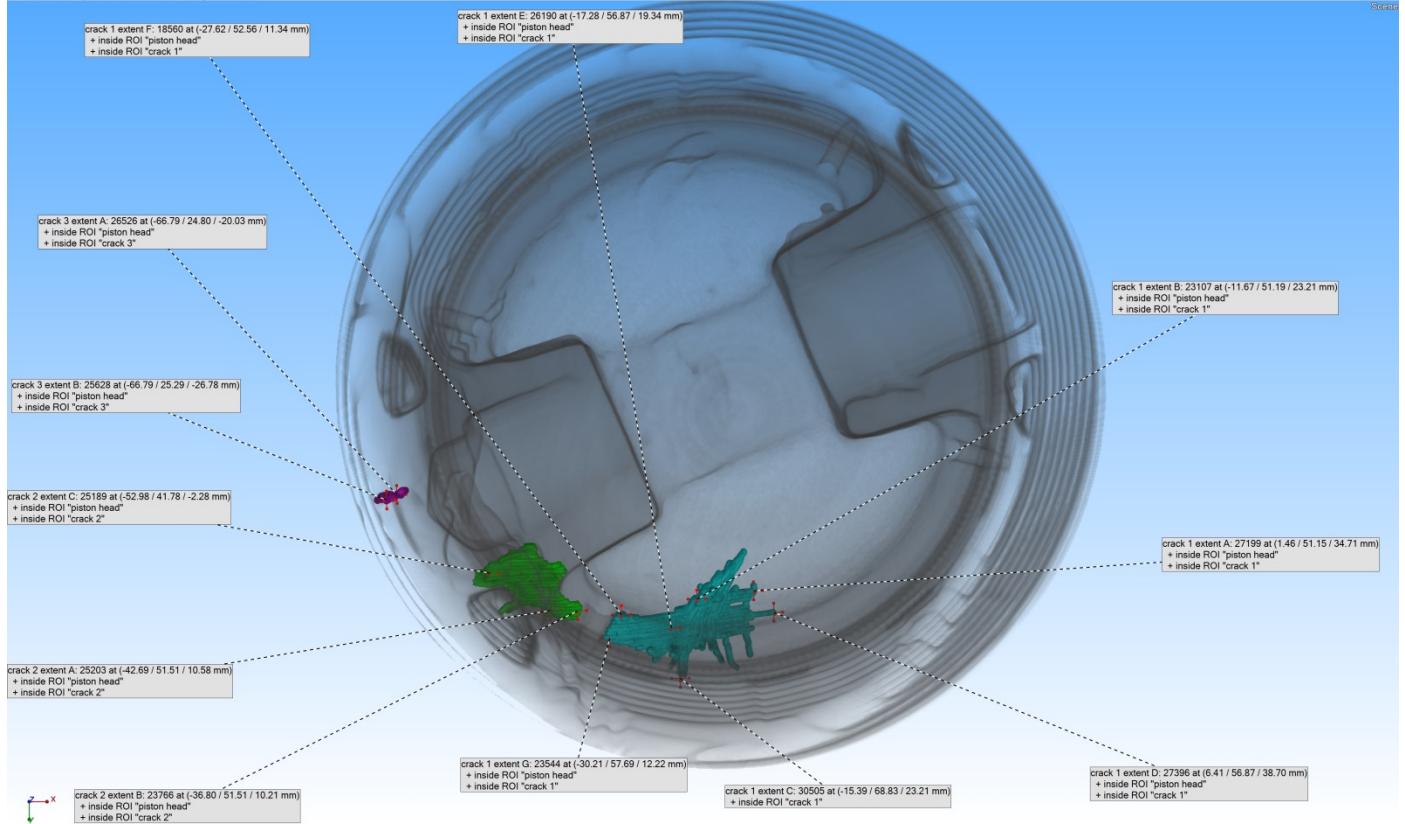
Figure 34  
Cylinder head – All cracks – from bottom

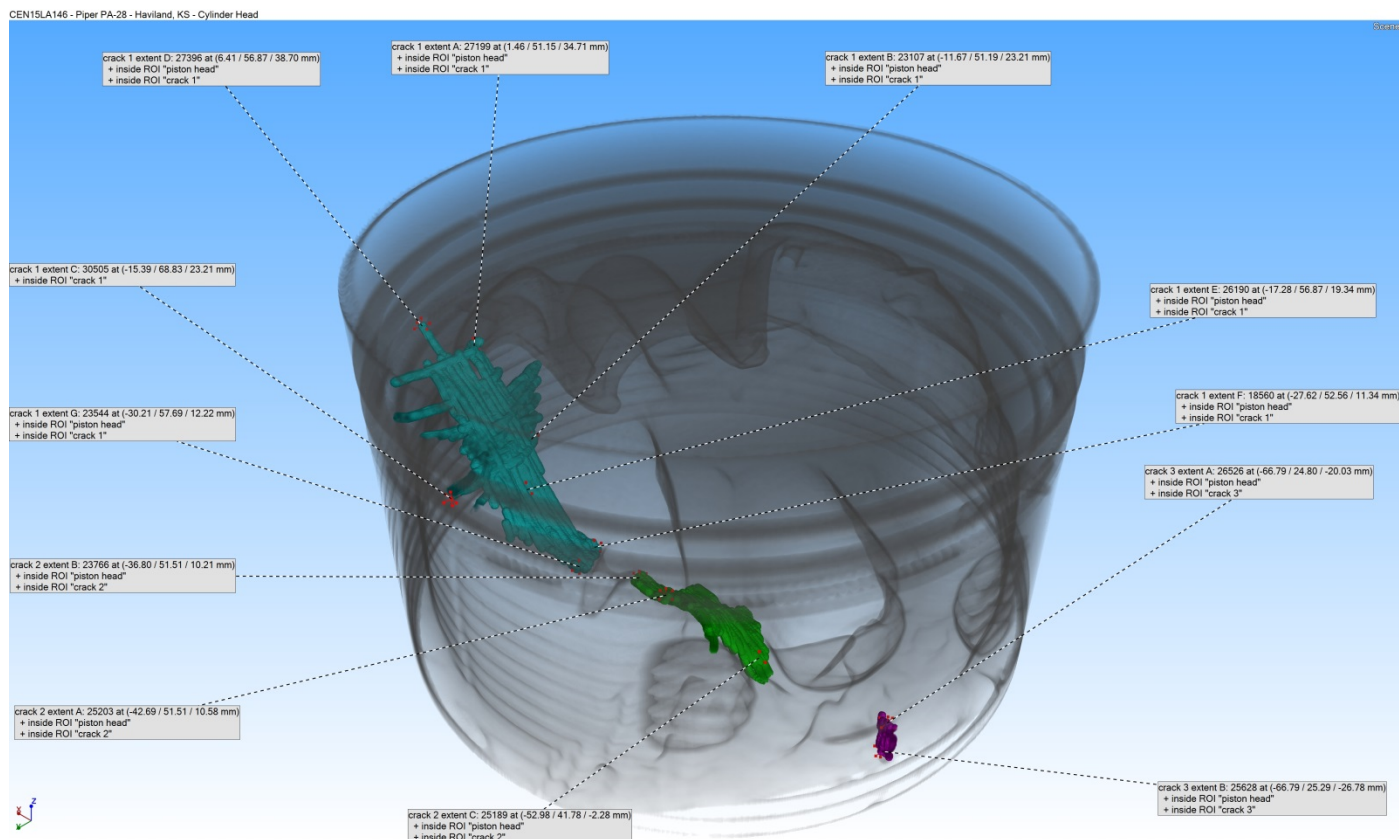
Figure 35  
Cylinder head – All cracks – three quarter view

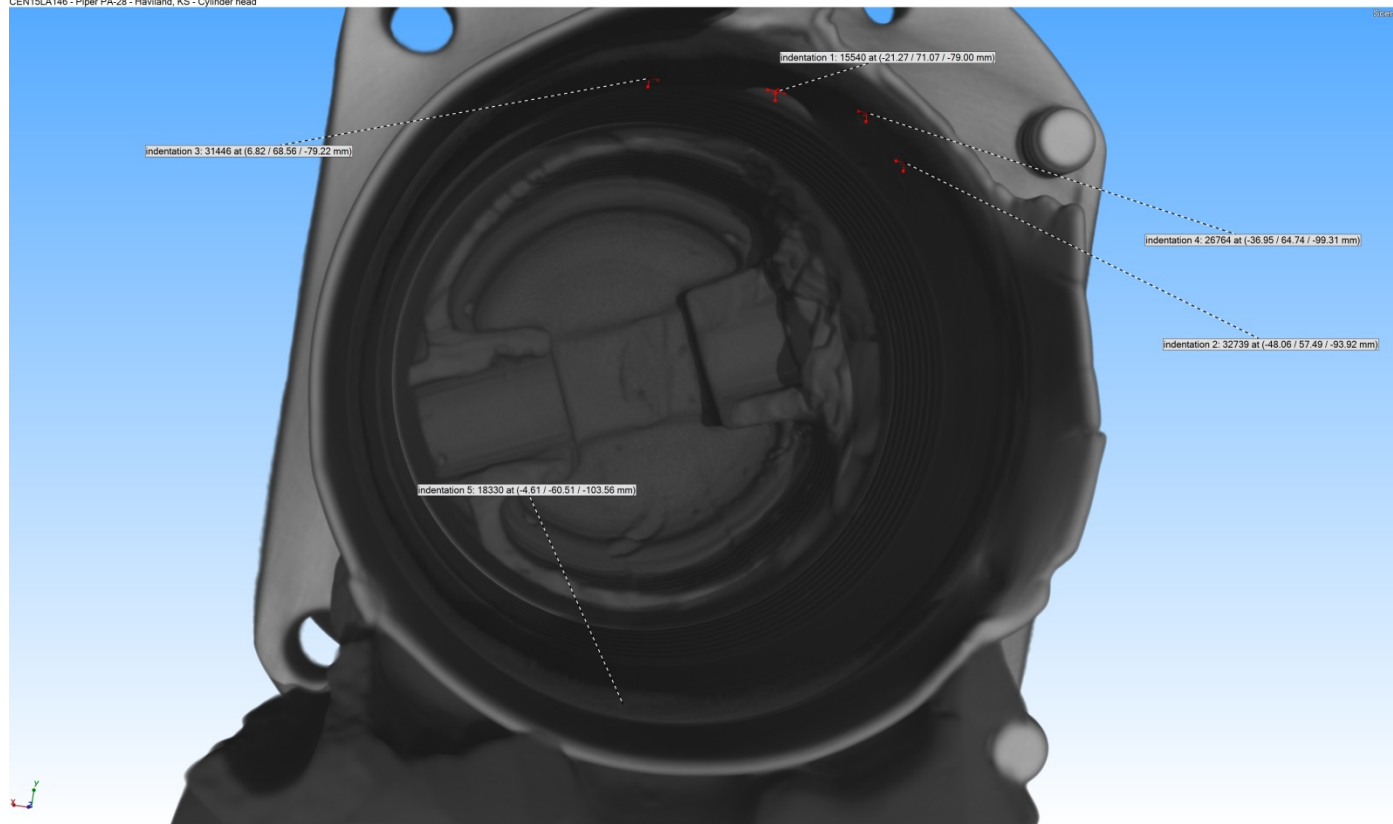
Figure 36  
Cylinder head – Wall indentations - overview

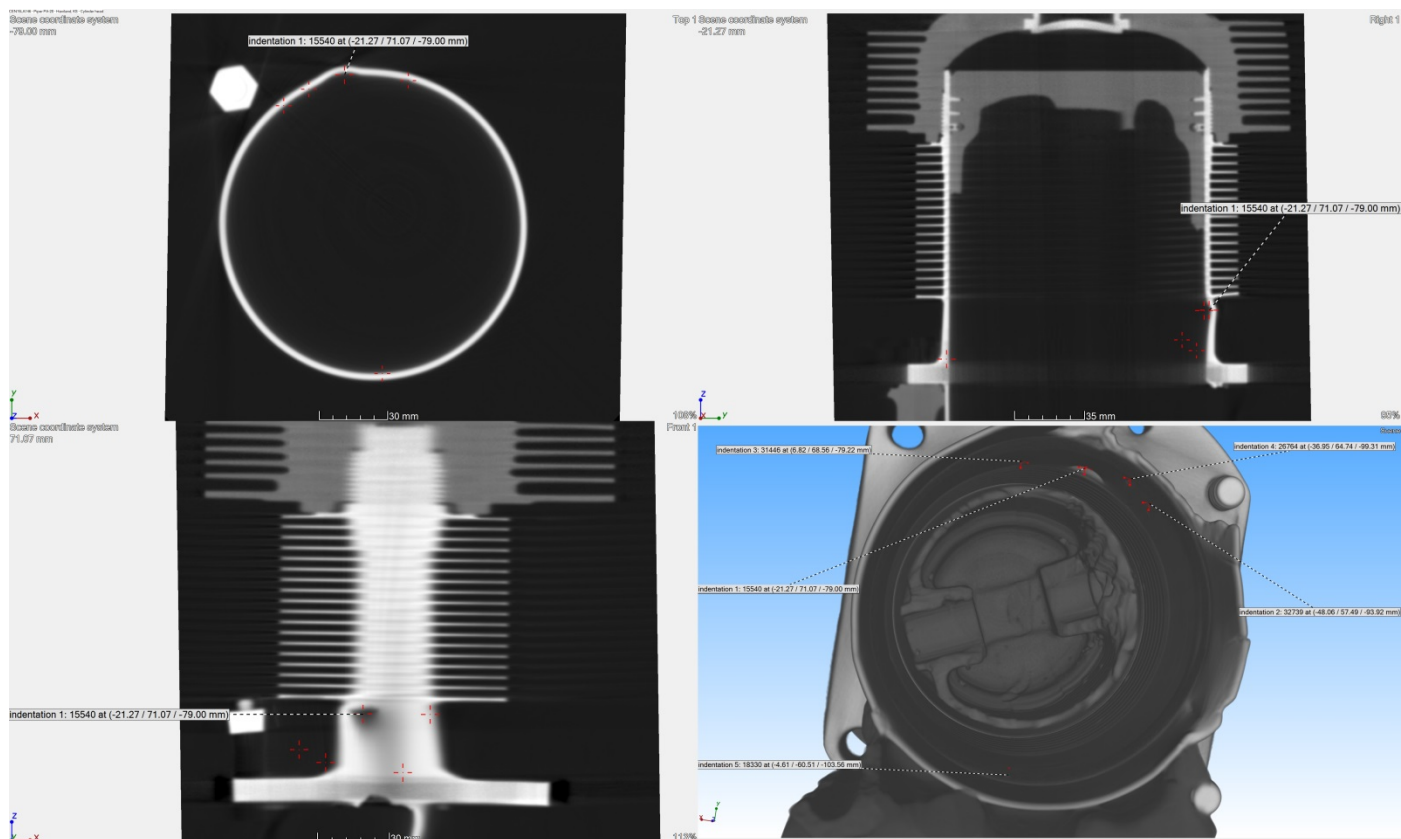
Figure 37  
Cylinder head – Wall indentations – indentation 1 close up view
