## REPORT 1508-3

- 1.0 SCOPE: This report describes the engine tear-down accomplished on the Lycoming IO-360-B1E S/N L-4412-51A from Pi-180 S/N 28R-30255 that had been involved in an engine failure accident.

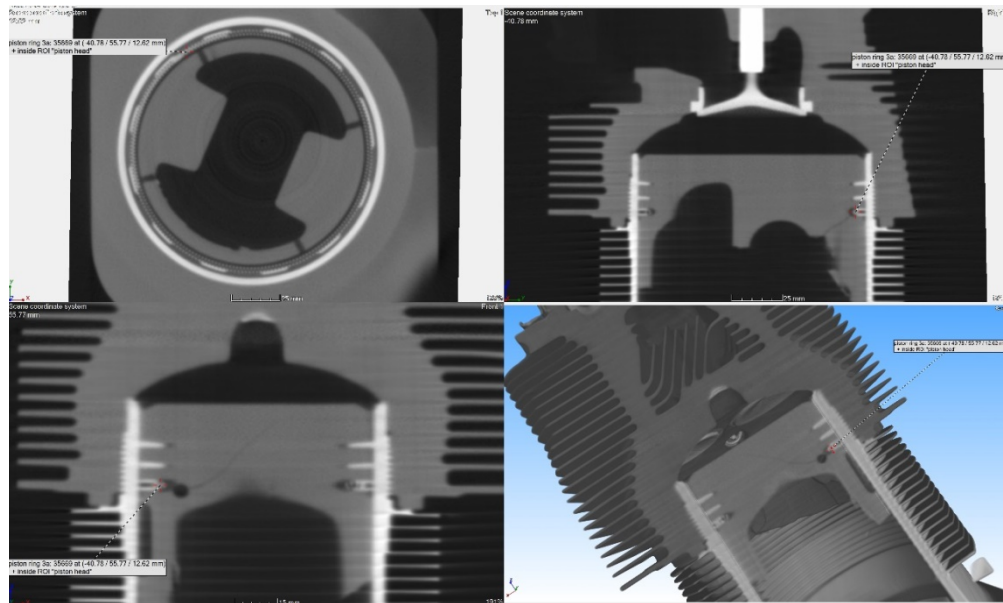
Photograph 1

The #4 cylinder was shipped to the NTSB Laboratory where computed tomography (CT) images were made prior to removal of the piston during the engine tear-down. This photograph is an image of the #4 cylinder showing the upper portion of the piston that was still installed. The piston rings are visible and some fractures in the piston are also visible

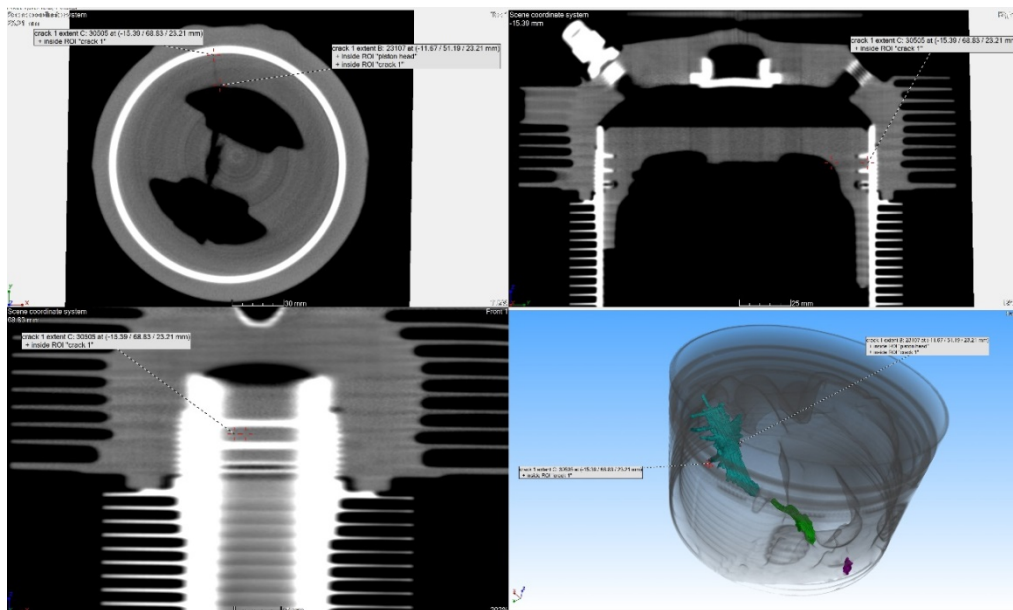
Photograph 2

. This image shows cross sections and an image of cracks in the piston while it was still in the cylinder.

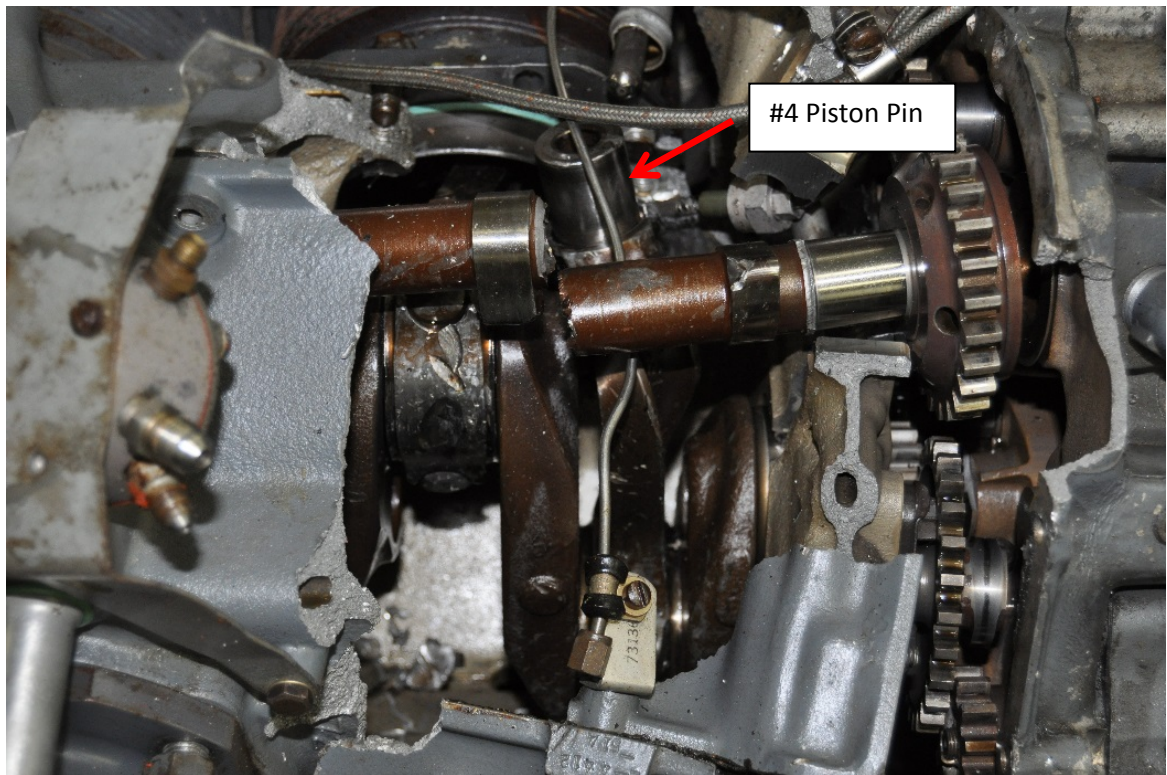
- 4.0 TEARDOWN AND OBSERVATIONS:
  - 4.1 The engine was removed from the shipping crate, and damage to the engine crankcase was immediately obvious with a large hole in the crankcase between the #4 and #3 cylinders. The camshaft was separated behind the #3 & #4 intake lobe and the #4 connecting rod was severely bent with the piston pin still in the connecting rod small end. The camshaft showed severe impact damage with the aft section displaced toward the #4 cylinder (rear left side from back of engine) along with segments of the crankcase.

Photograph 5.  
View of damage from #4 cylinder position.

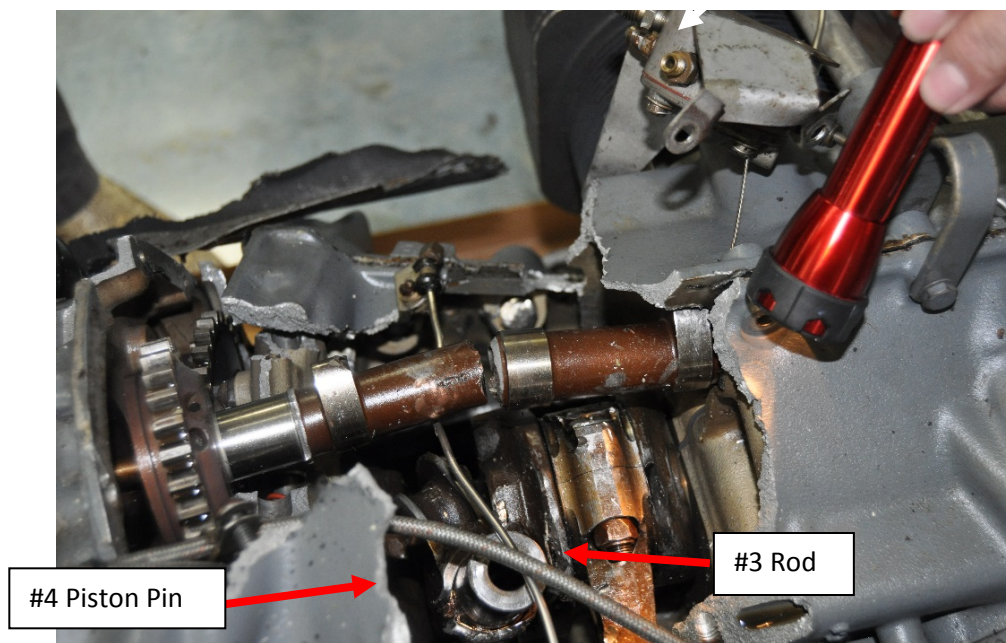
- 4.3 The top right anchor thrubolt<sup>1</sup> shows some stretching and part of the fracture surface is separated in a flat pattern perpendicular to the length of the thrubolt. Some of the cylinder studs were missing, but one ½ inch stud was identified as from the #4 cylinder. A portion of the fracture surface of that stud is granular and is broken perpendicular to the length of the stud as shown in Photograph 6 in the Addendum (center fastener).

Photograph 6  
View of damage from #3 cylinder side.

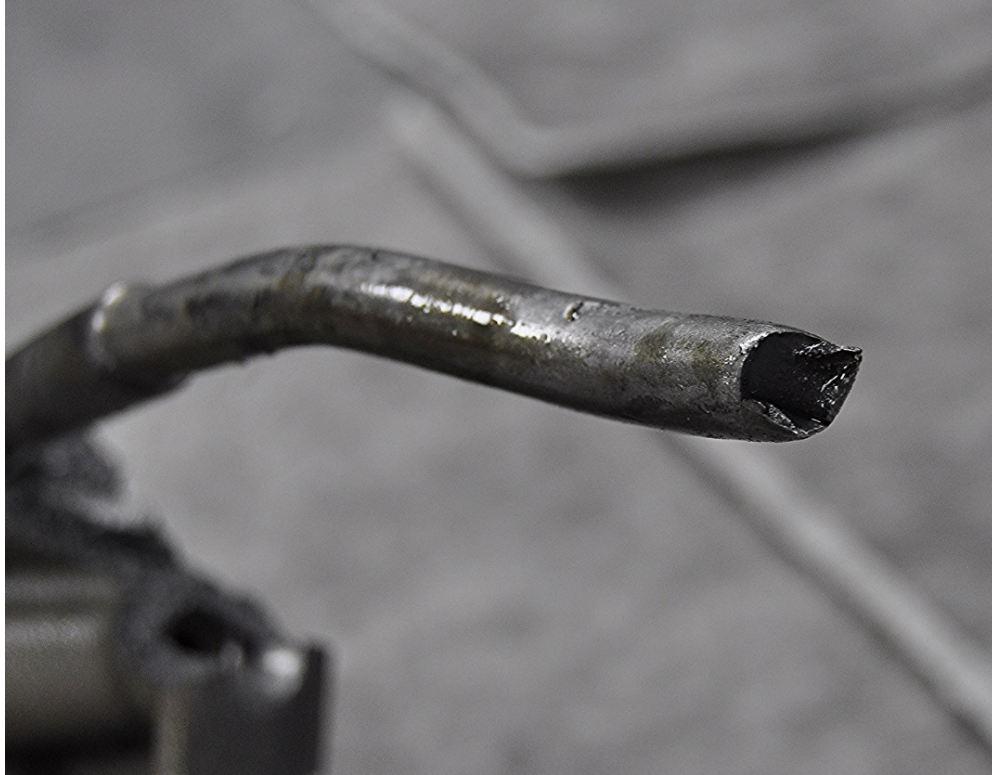
Photograph 7

Upper #4 cylinder thru-stud showing marks on the diameter, some necking and fracture surface with a majority of the fracture perpendicular to the loading (along length).

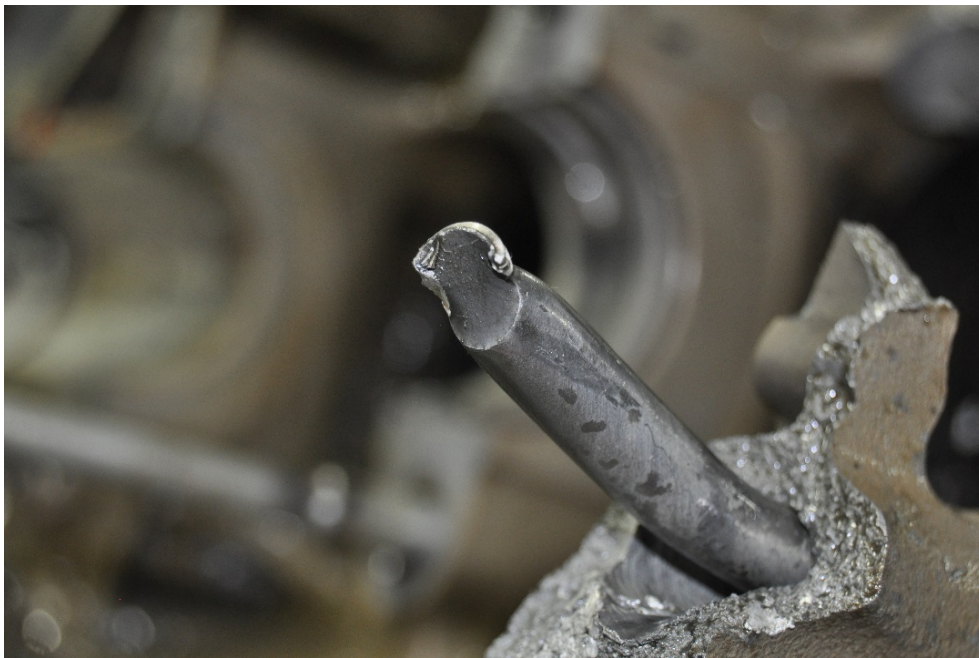
Photograph 8

Lower #4 cylinder anchor throbolt. Fracture surface is angled to the length of the throbolt.

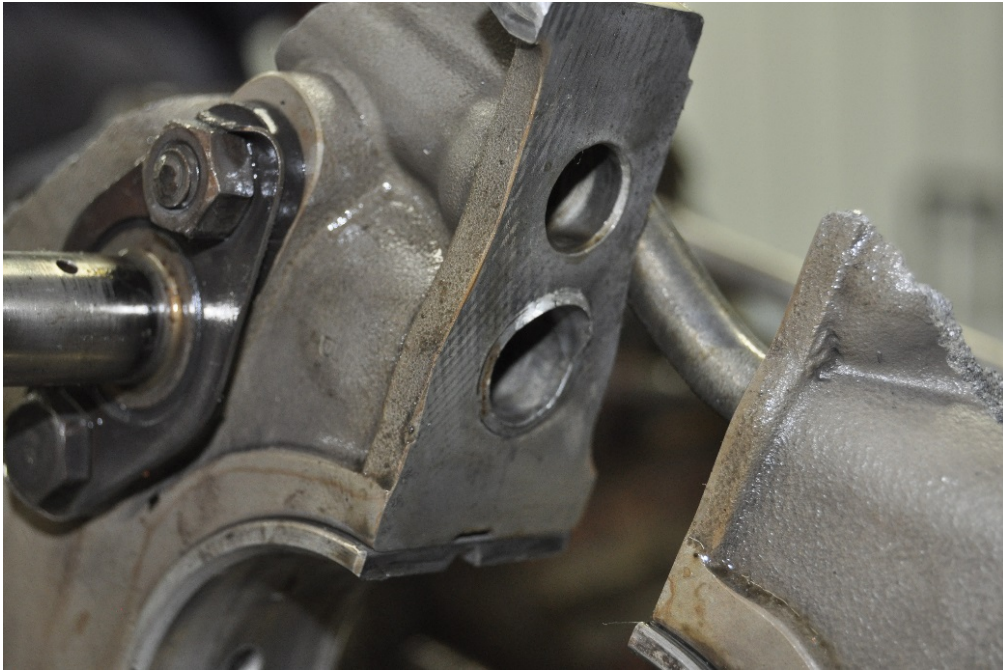
Photograph 9

- 4.4 The Number 4 cylinder deck (upper broken out section) shows some fretting, with some more at the upper right anchor thrubolt. The body fit hole at the parting line on the broken out section of the crankcase above the #4 cylinder has significant deformation.

Crankcase parting line at #4 cylinder anchor stud hole. Some parting line fretting and distortion around and in the anchor thru-bolt hole are visible.

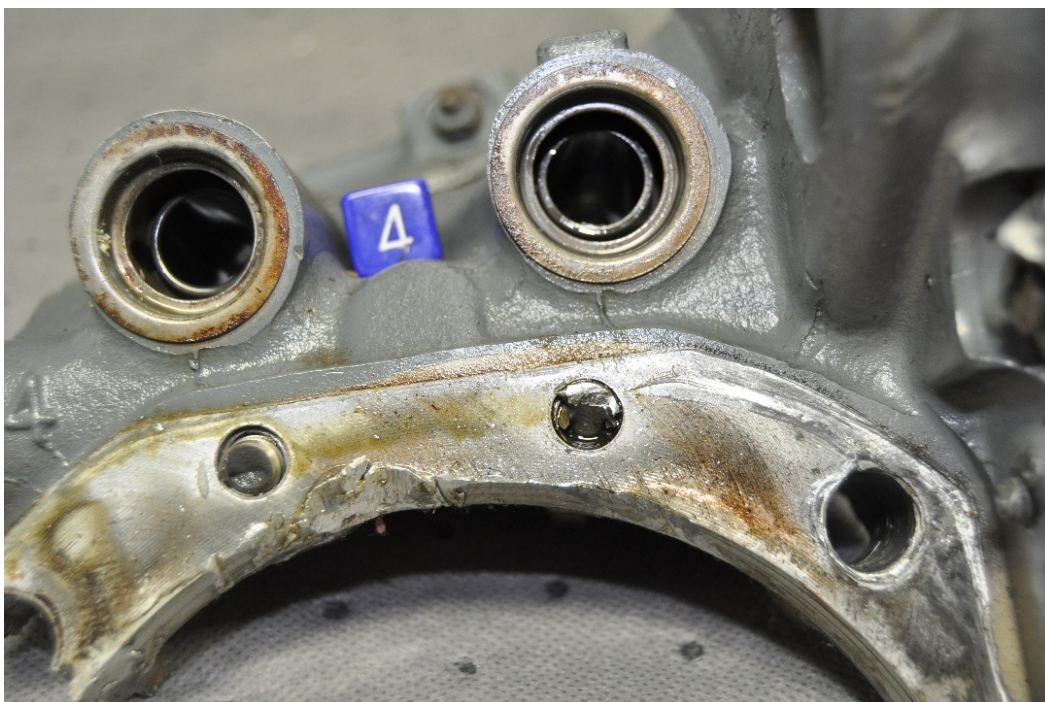
Photograph 11

#4 deck section showing fretting and wear at the upper thru-stud.

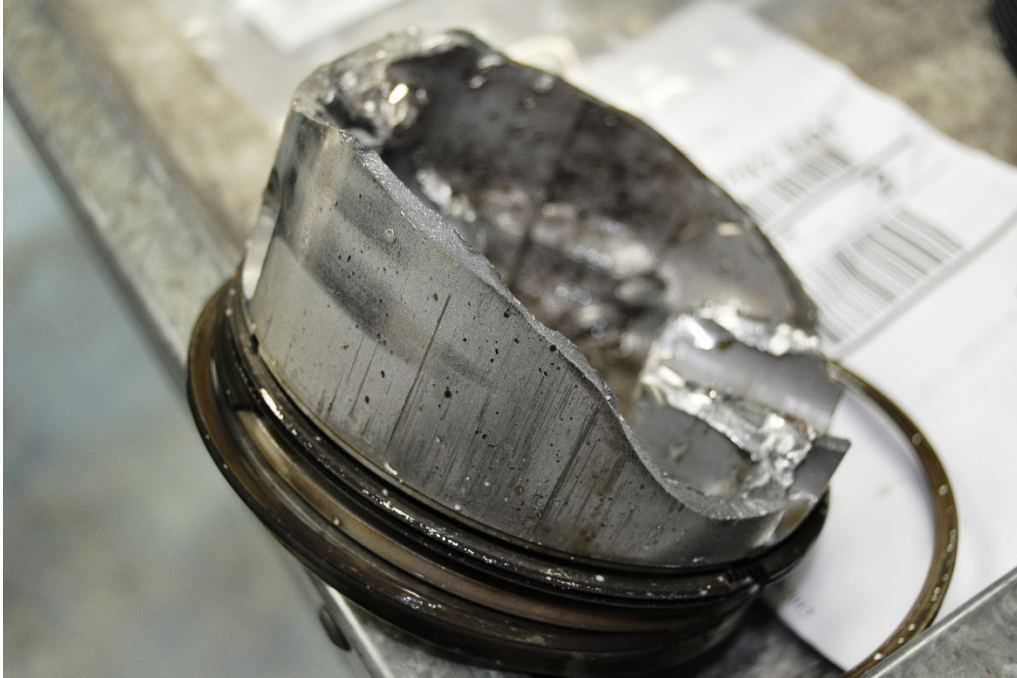
- 4.5 There were loose studs and nuts on the other cylinders, but these are considered to be caused by the very high energy crankcase fractures.
- 4.6 The #4 piston was fractured around the skirt and through the pin bosses. The skirt fracture surfaces show some evidence of progressive crack propagation. The remaining skirt portions showed some debris marks and some burnishing from loading against the bore.

Photograph 13  
Outside view of #4 piston

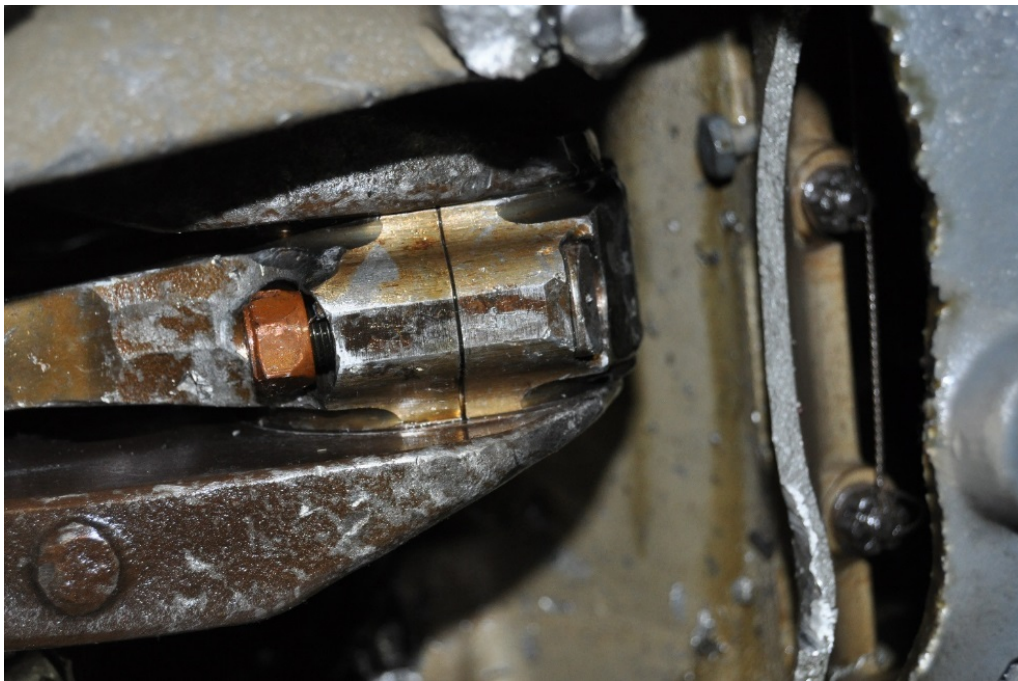
- 4.7 The nut on one side of the #4 connecting rod was not tight as shown in Photograph #4. However, the rod cap fasteners experienced extremely high impact tensile loading, and the loose nut is considered to be the result of that impact. However, there was no evidence of bearing and crankshaft journal distress (Reference Photographs 13 and 15).

Photograph 14  
#4 connecting rod bolt and loose nut. After the nut was removed, the bolt revealed deformed threads from the failure event.

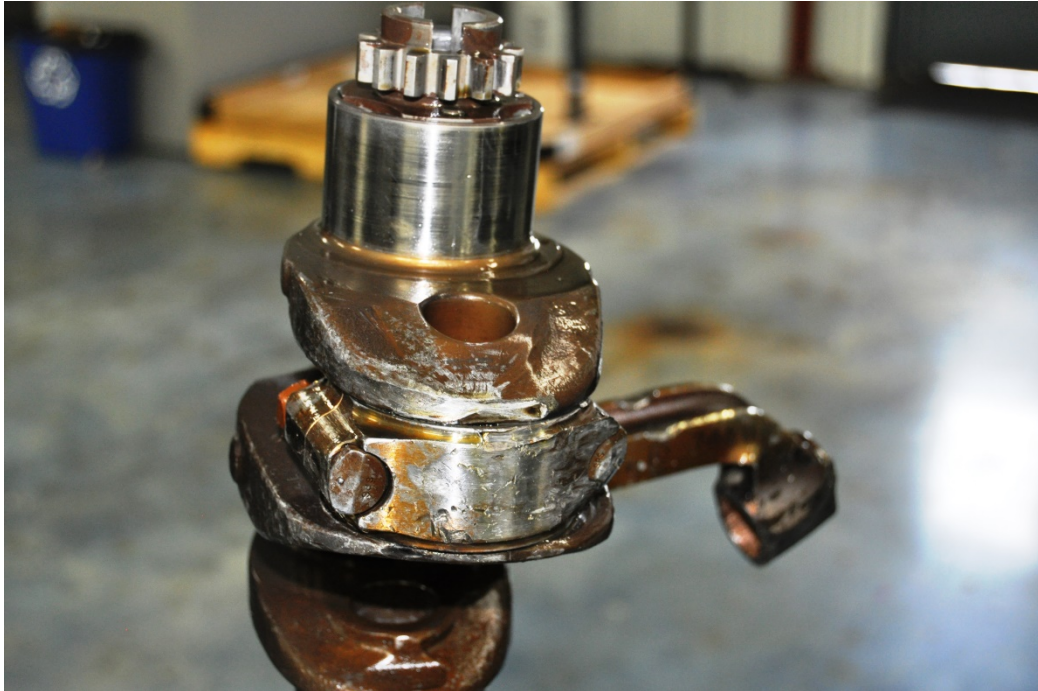
Photograph 15

#3 connecting rod still installed on the crankshaft. No significant damage to the crankshaft bearing journals.

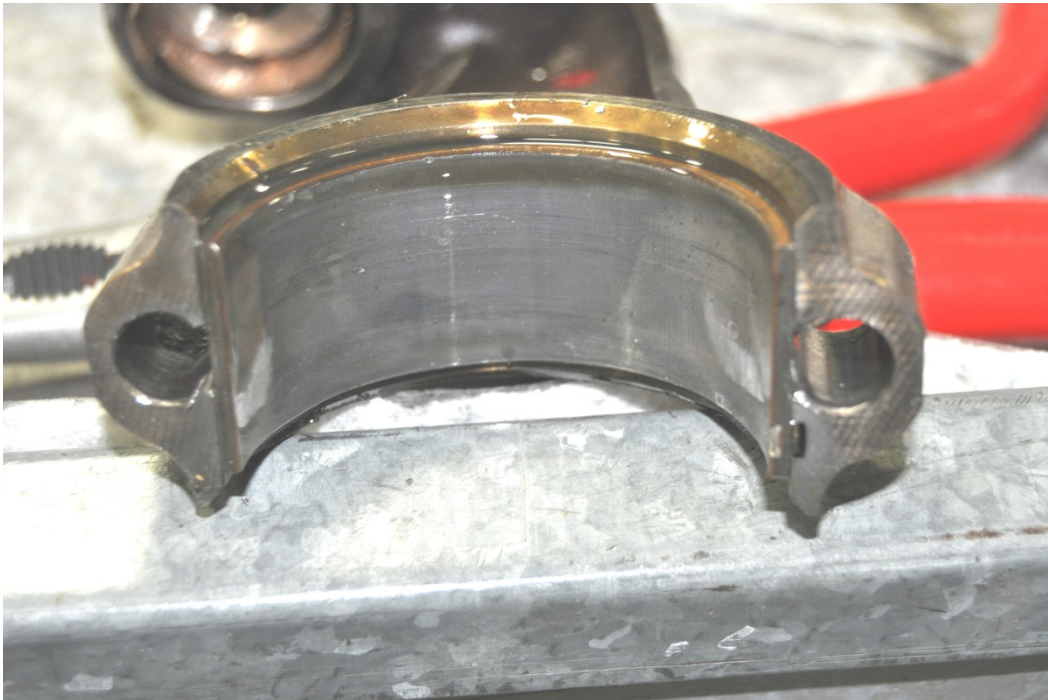
Photograph 16

#4 upper connecting rod bearing with normal wear pattern for time in service

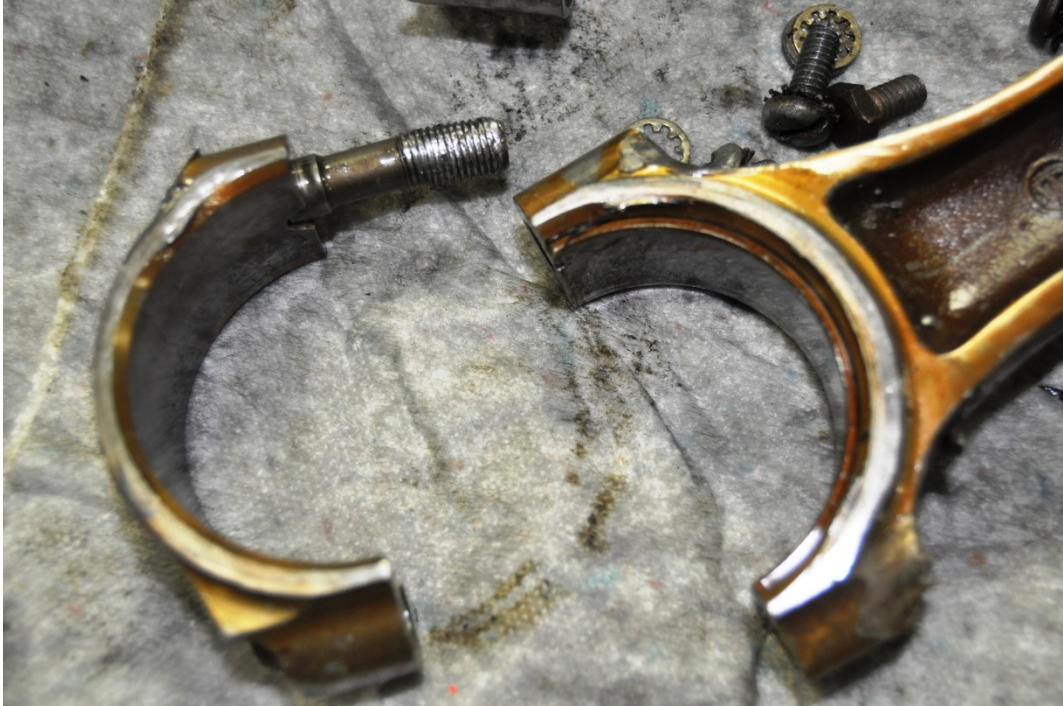
Photograph 17

The threads on the rod bolt are stripped and there is some damage to the thrust faces of the #4 connecting rod

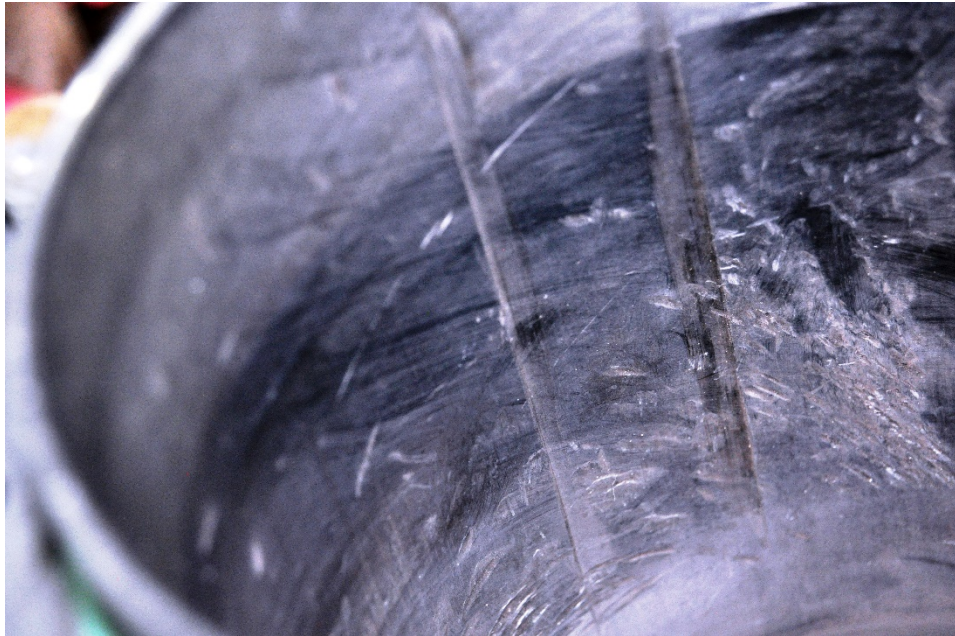
Photograph 19

- 4.8 Cylinders #1 through #3 all showed some degree of bore glaze (coating of carbonized oil), but the worst was cylinder #3.
- 4.9 The #3 cylinder bore had score marks in line with the piston pin plugs. The piston pin plugs had damage, and one of them had a wear ridge around the outer periphery. There was additional damage to the #3 cylinder bore that could not be matched to geometry of the piston pin while it was in the operation position in the piston.

The bore of the #3 cylinder shows evidence of blow-by during operation and scar marks from the piston pin plugs.

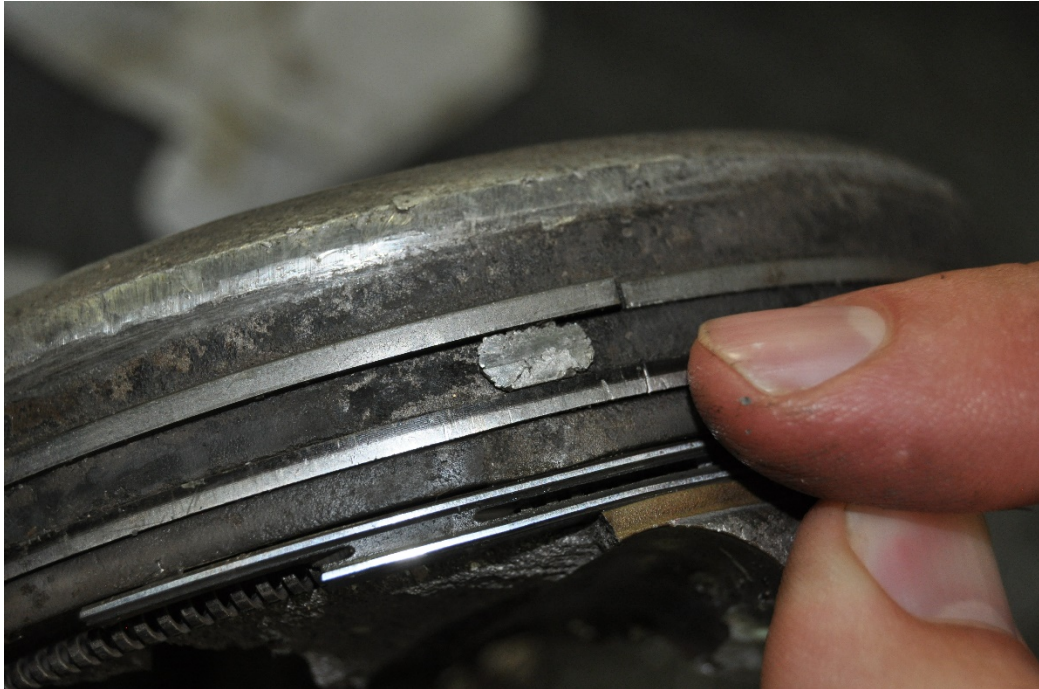
Photograph 21

Close up of the #3 piston. There is a wear pattern at the top of the upper ring land, some mashed aluminum found between the top and second compression rings.

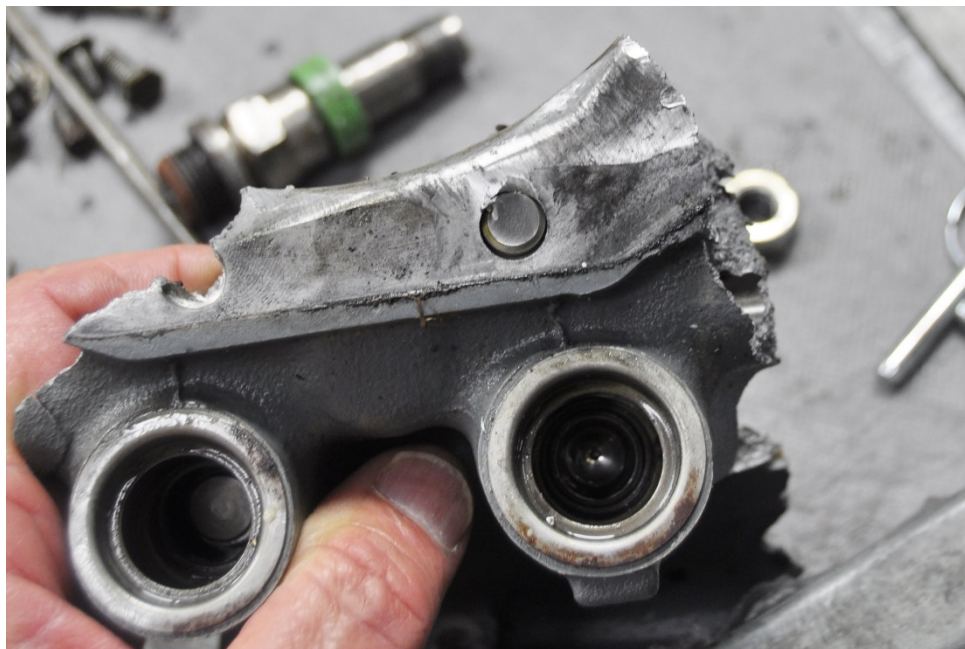
Photograph 22

Upper #3 cylinder deck segment. There appears to be a residue along the edge of the cylinder flange

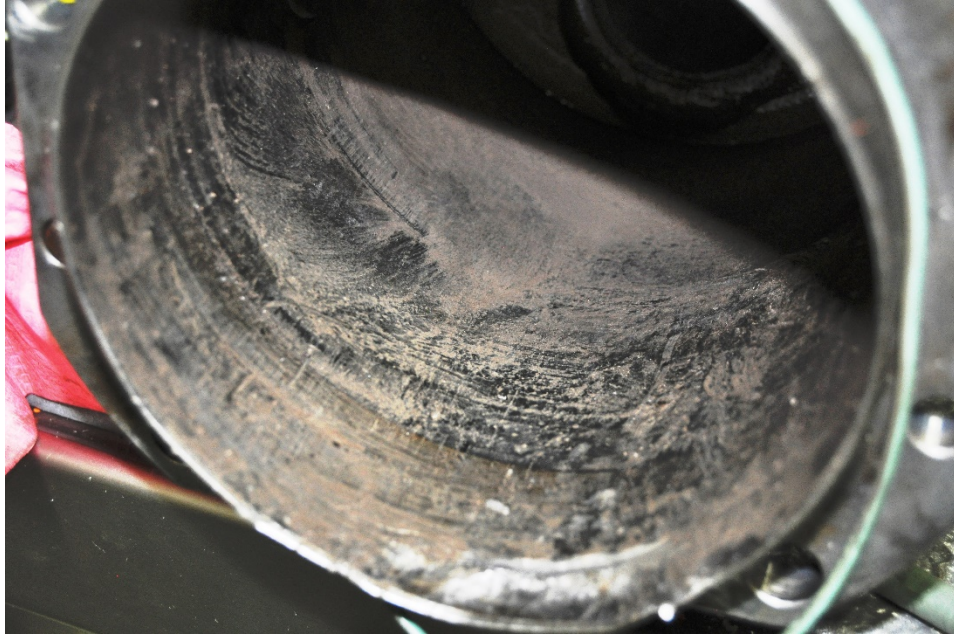
Photograph 23

Another view of the #3 cylinder bore showing the glazed bore with distress indications

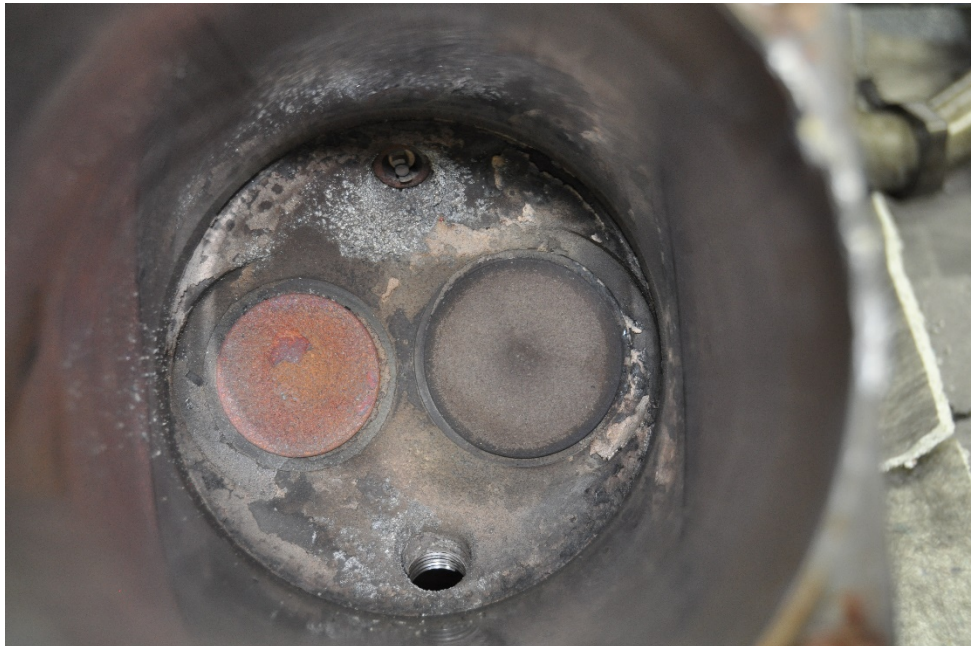
Photograph 24

View of the #1 cylinder combustion chamber. The combustion chamber shows some metal splatter around the spark plugs.

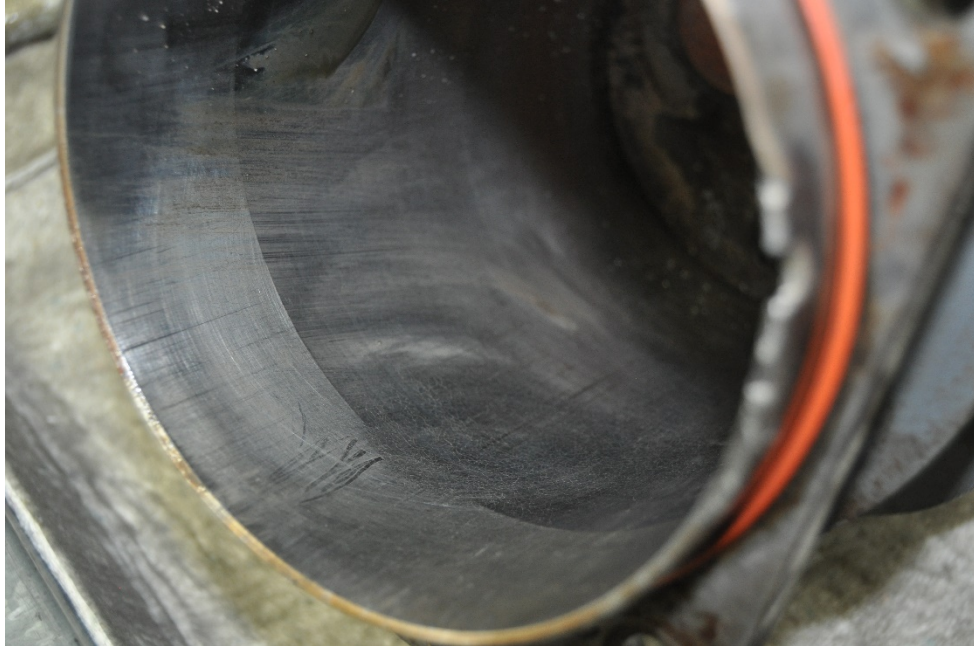
Photograph 25

View of the #1 cylinder bore showing a more normal bore condition with some bore glaze.

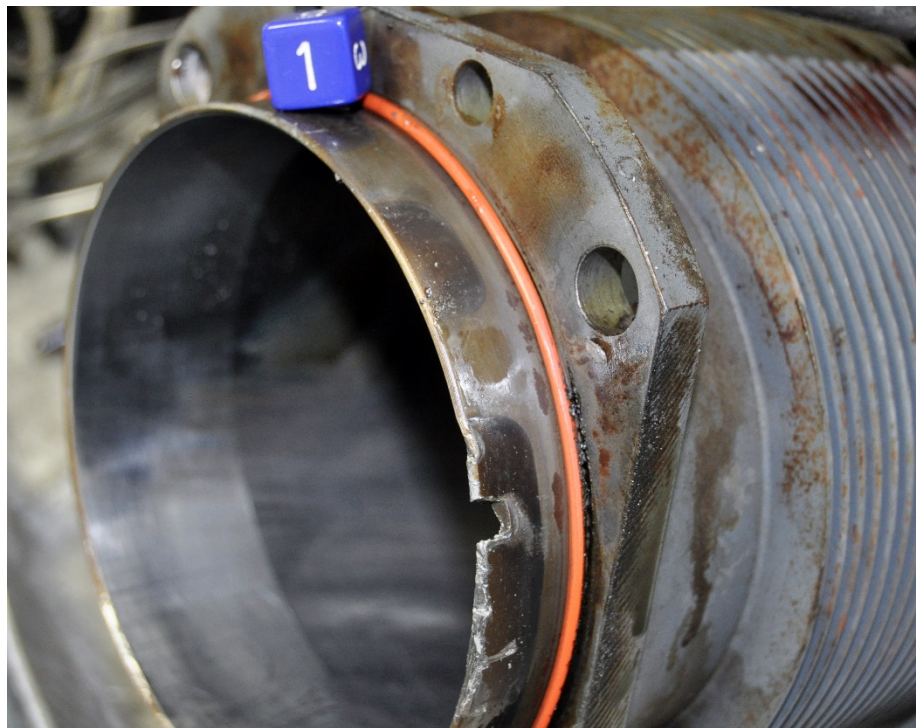
Photograph 26

Another view of #1 cylinder.  
Note the residue at the  
cylinder base seal (O-Ring).

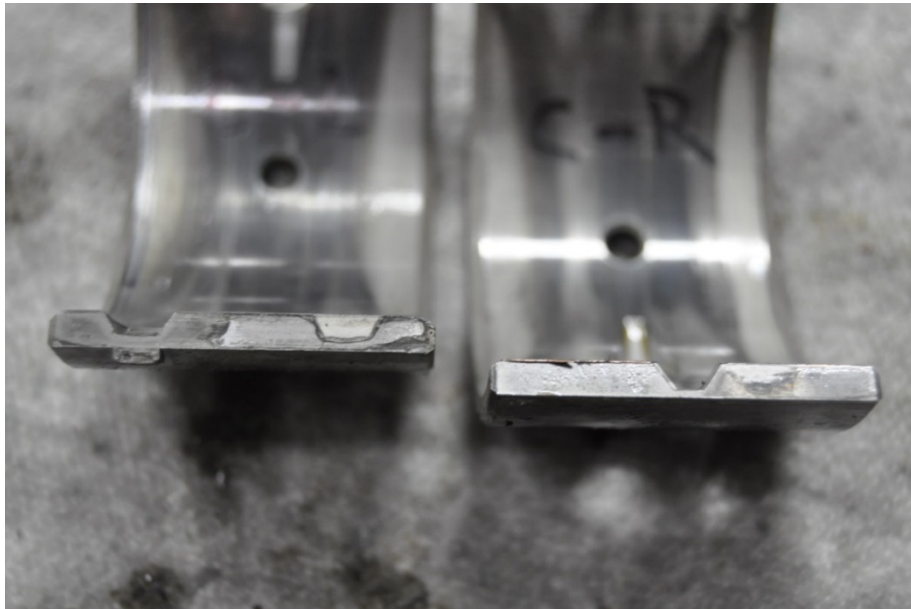
Photograph 28

Center main bearings show normal wear. The condition of the bearings shows that the failure sequence progressed from root cause to engine stoppage before debris was circulated through the bearings

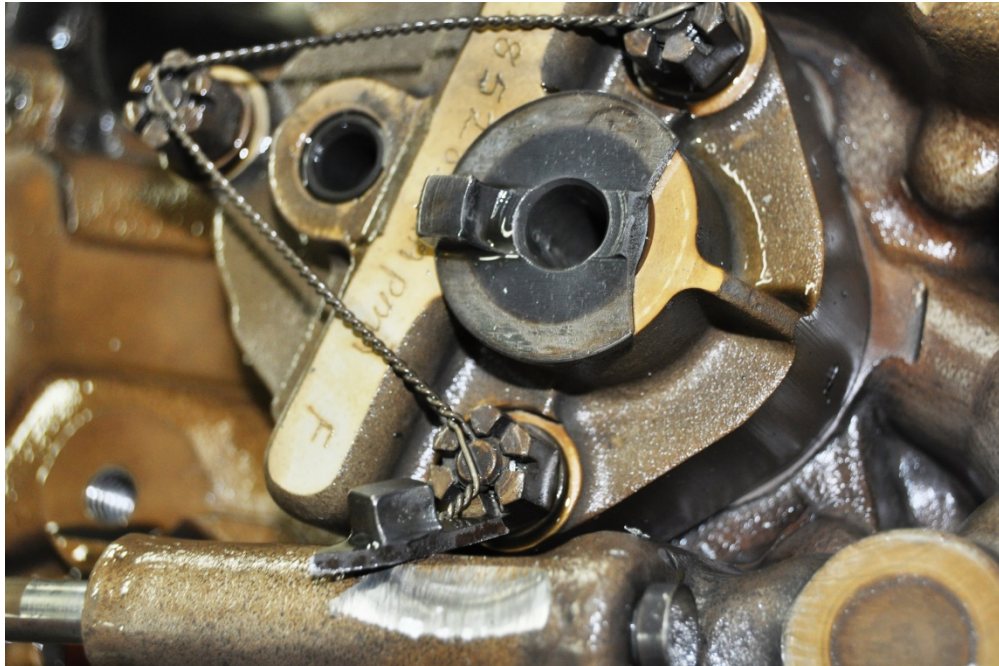
Photograph 29  
View of oil pump housing and drive shaft with broken tang.

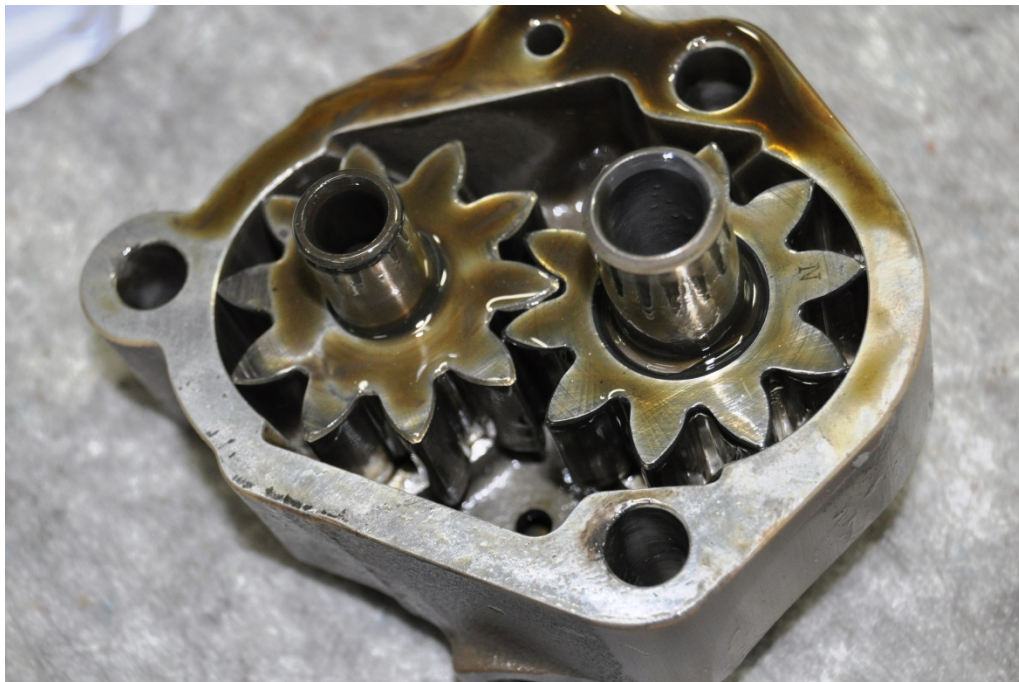
Photograph 29  
Interior of oil pump with no indications of significant debris circulating through the pump.
