## ACCIDENT REPORT

NTSB #: CEN15LA182

AIRCRAFT: AT-400 400-0504 N136DB

REPORT BY: Kyle Schroeder  
Inc.

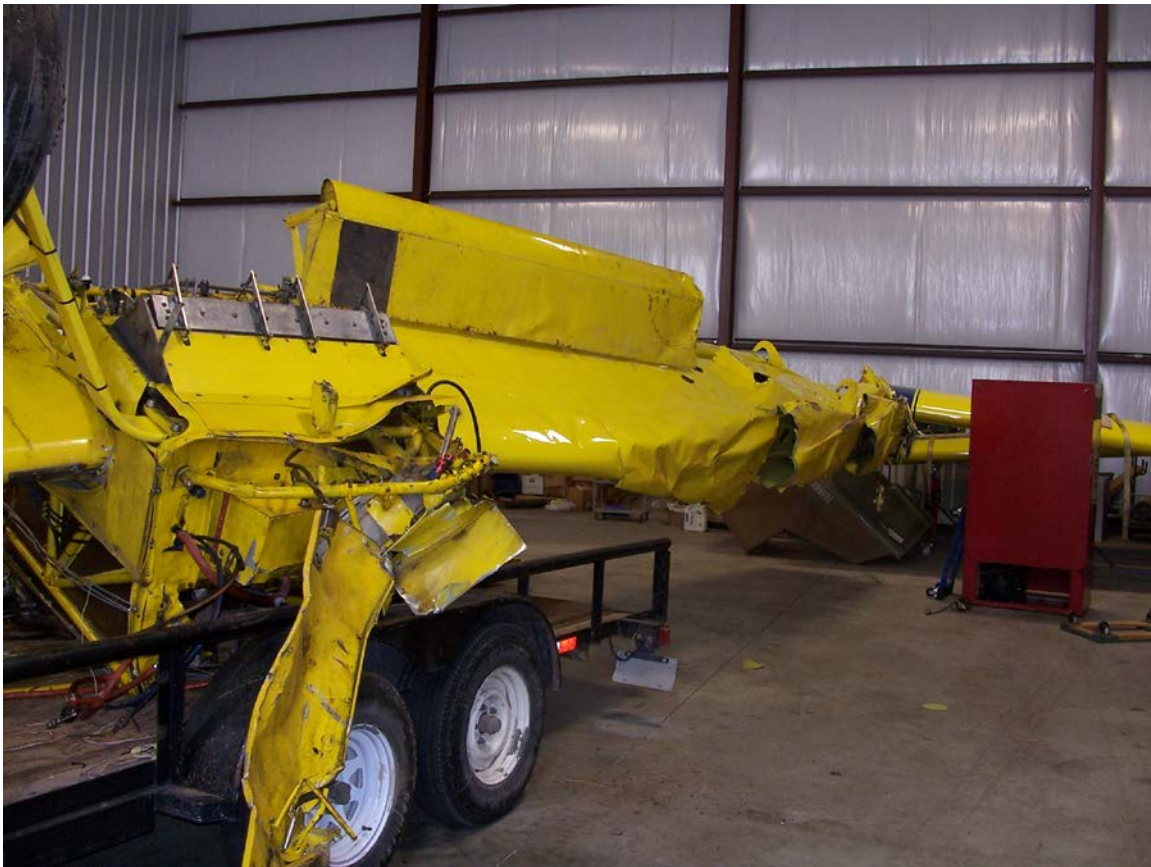
**Condition of Wreckage As Examined  
(Mid Fuselage and R/H Wing Shown)**

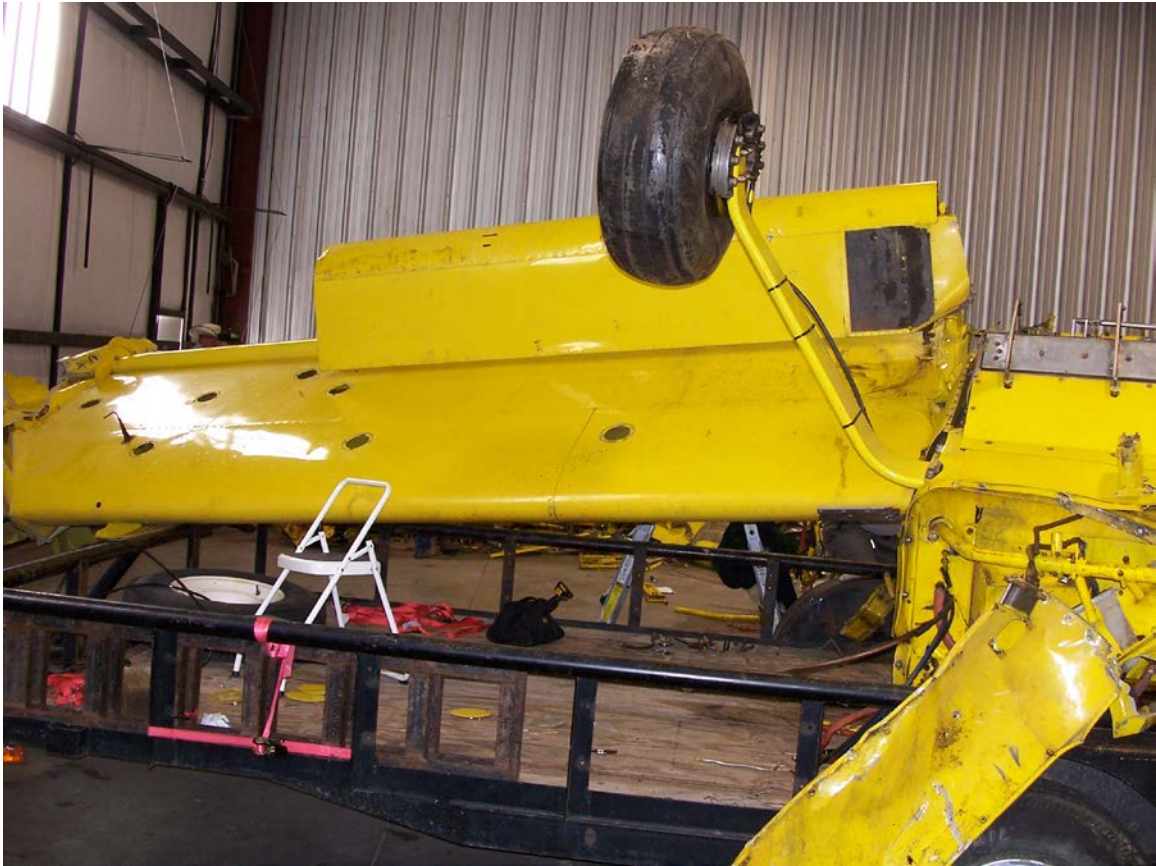
**Condition of Wreckage As Examined  
(Mid Fuselage, L/H Main Landing Gear, and L/H Wing Shown)**

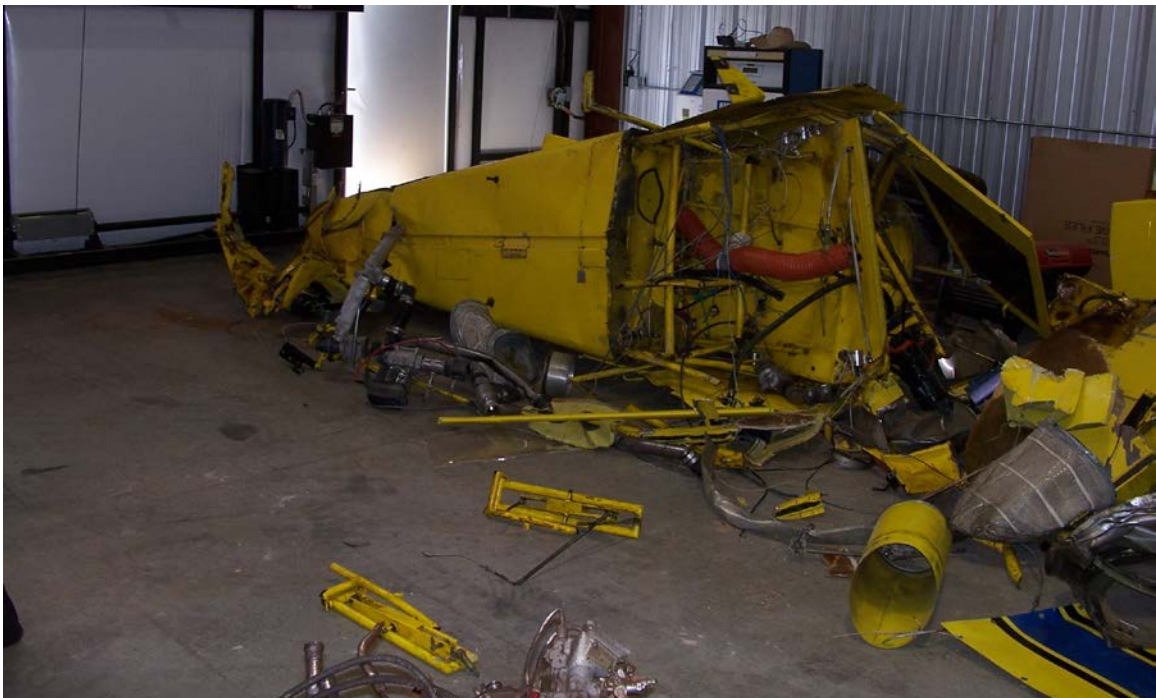
**Condition of Wreckage As Examined  
(Aft Fuselage and Misc. Debris Shown)**

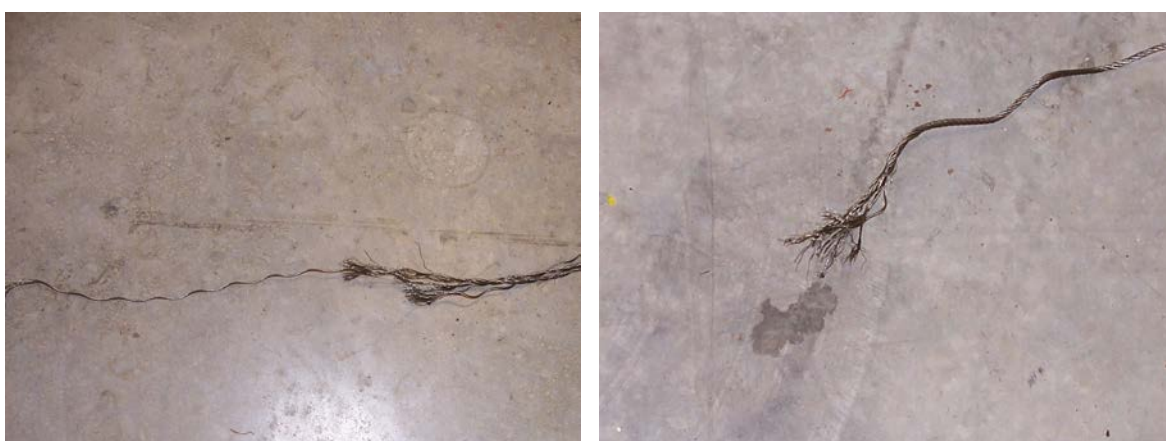
Control continuity of the rudder control system was analyzed. All hardware and components of the rudder control system were properly installed. Both rudder cables showed signs of failure due to tensile overload. See figures below.

**Ends of Rudder Cables**

**(Lefthand cable shown on left, righthand cable shown on right)**

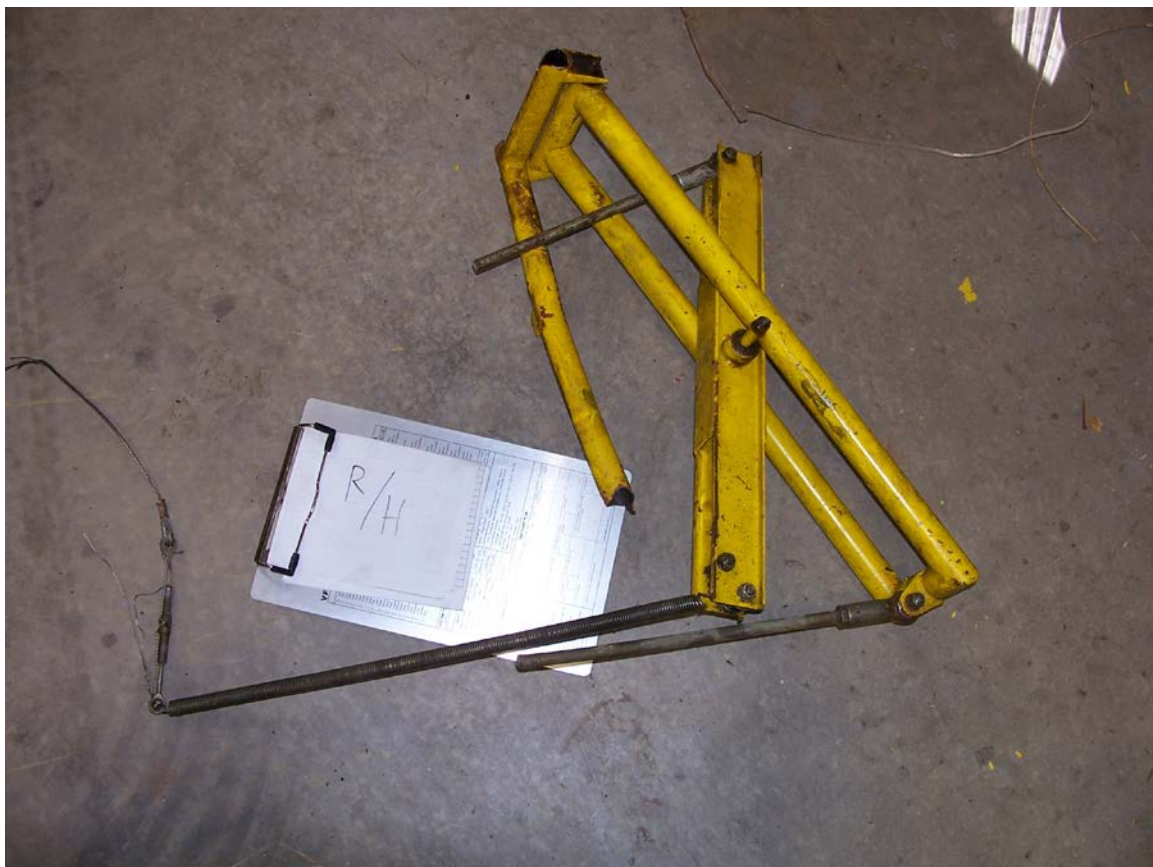
For the righthand aileron control system, all hardware was found properly installed on the bellcrank and moveable frame. There is a long pushrod that connects the bottom of this bellcrank and is routed through the wing toward the righthand aileron. The inboard rodend bearing of this pushrod was found with the outer race separated. The inner race remained installed on the pivot bolt on the bellcrank. From this pushrod to the aileron, control continuity was confirmed by observing proper aileron movement due to movement of the pushrod.

**Righthand Aileron Bellcrank and Moveable Frame**

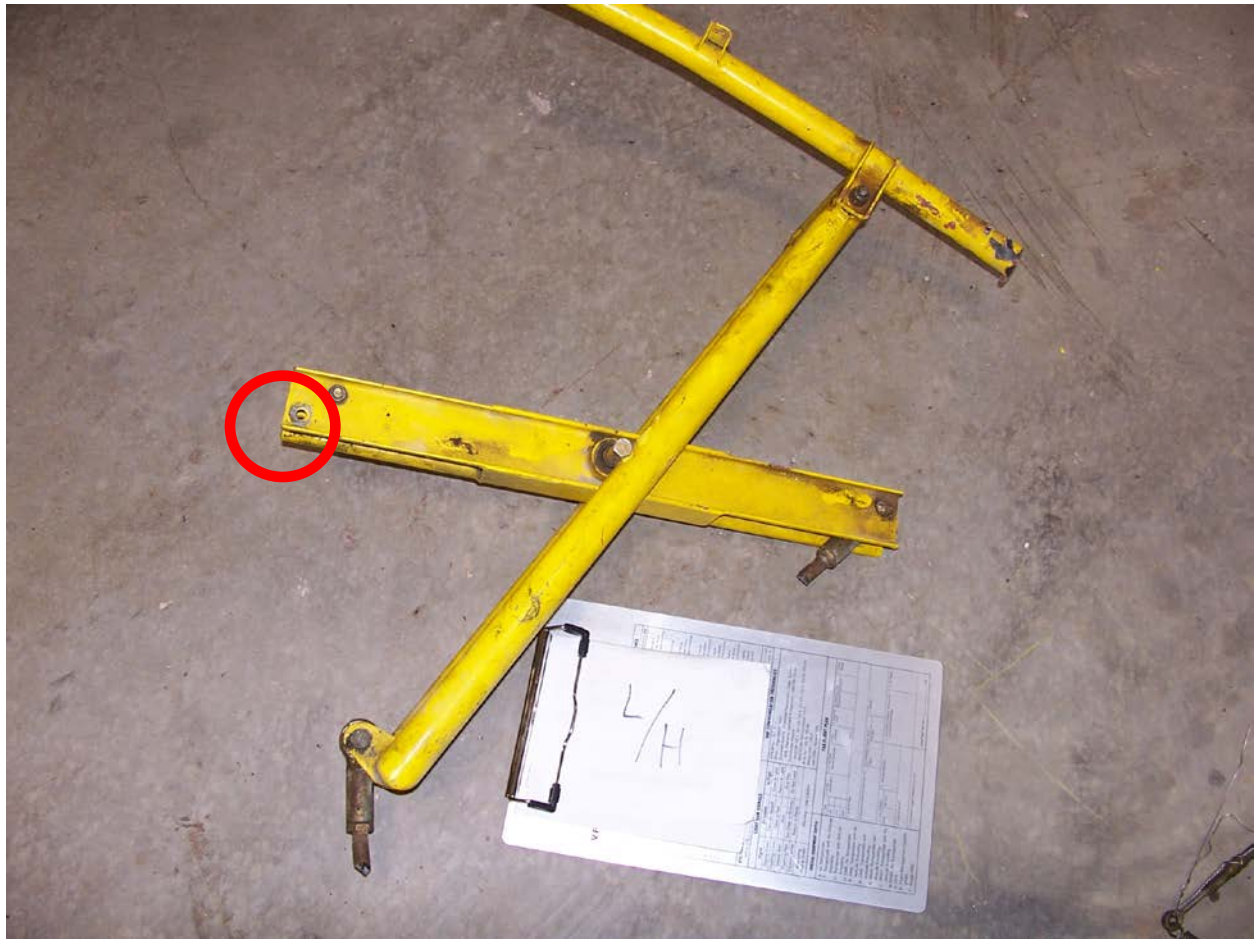
For the lefthand aileron control system, the bellcrank and moveable frame were also found with all hardware installed, except for the lower clevis bolt connecting to the long aileron pushrod. The clevis bolt was not found installed or in the wreckage. The expected location for this bolt is circled in red in the following picture.

**Righthand Aileron Bellcrank and Moveable Frame**

There was no evidence on the aileron bellcrank or pushrod end of any stress large enough to fracture the bolt in question. The pushrod end was filled with dirt/debris during the inspection.

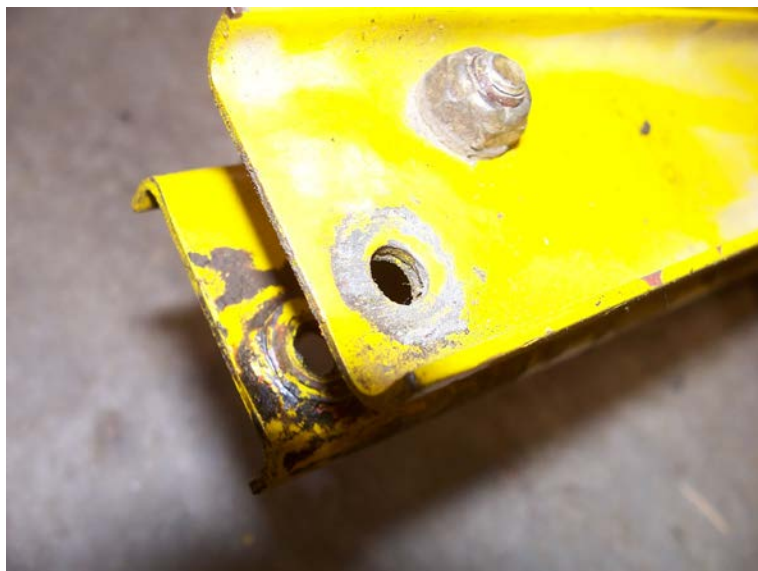
**Closeup View of Righthand Aileron Bellcrank**

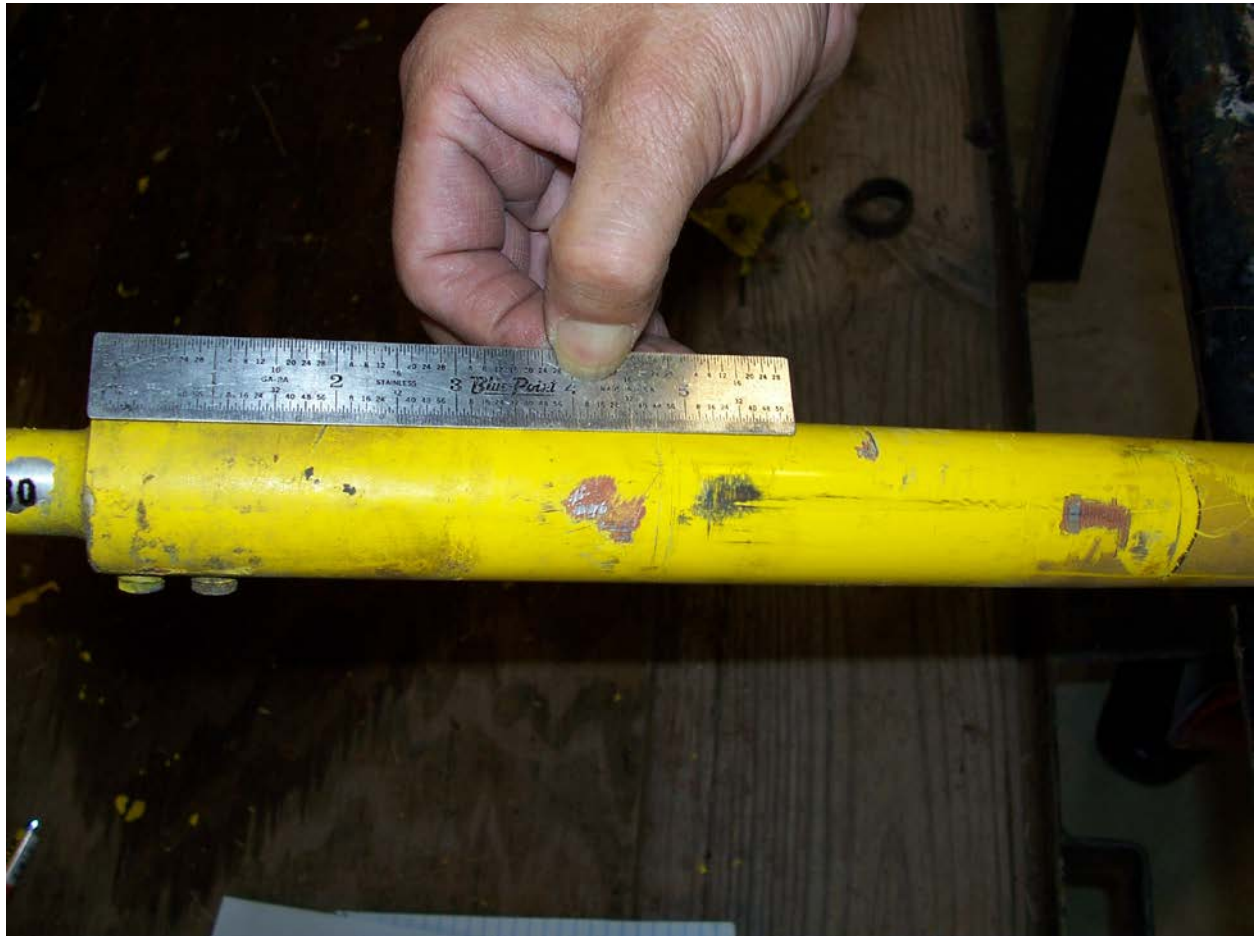
The long pushrod was removed from the lefthand wing and examined. There were several fresh marks on the inboard end of the pushrod. These marks were spaced approximately the same as the inboard ribs that surround this pushrod. This is a possible indication that the inboard end of the pushrod was disconnected from the aileron bellcrank and chafed against the ribs as the lefthand aileron "flapped" up and down.

**Inboard end of long aileron pushrod (p/n 70013-1) showing fresh chafe marks**
