## **Component Examination**

### **C018-1 Clutch**

## **C051 -2 Actuator**

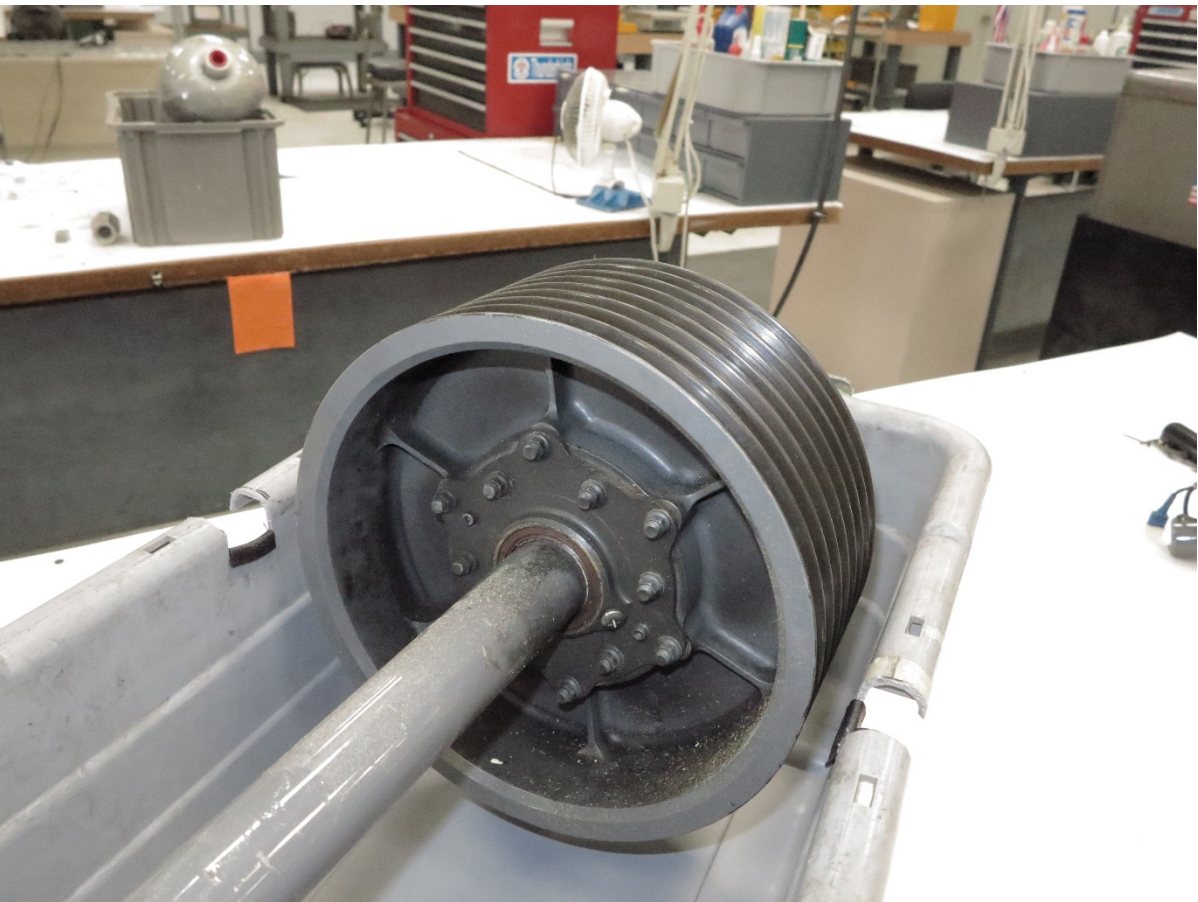
Visual examination of the clutch assembly revealed an excessive amount of oil on the forward face of the sheave and around the aft yoke. Both retainers had broken paint around the seals consistent with the seals being replaced since new.

Oil on forward face of sheave.

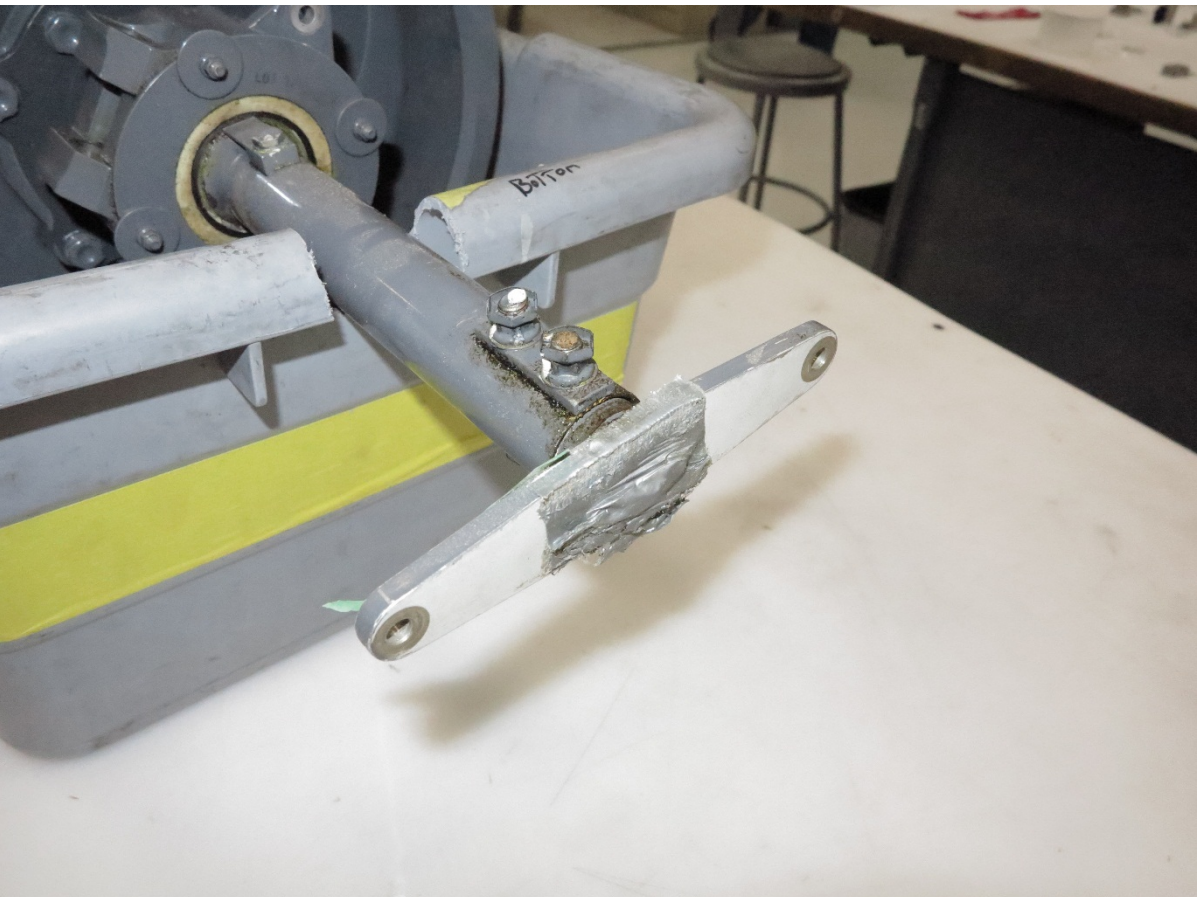
The clutch assembly was disassembled. A small amount of oil was present inside the shaft between the aft plug and the aft yoke indicating that the plug had been leaking.

Oil around aft yoke area.

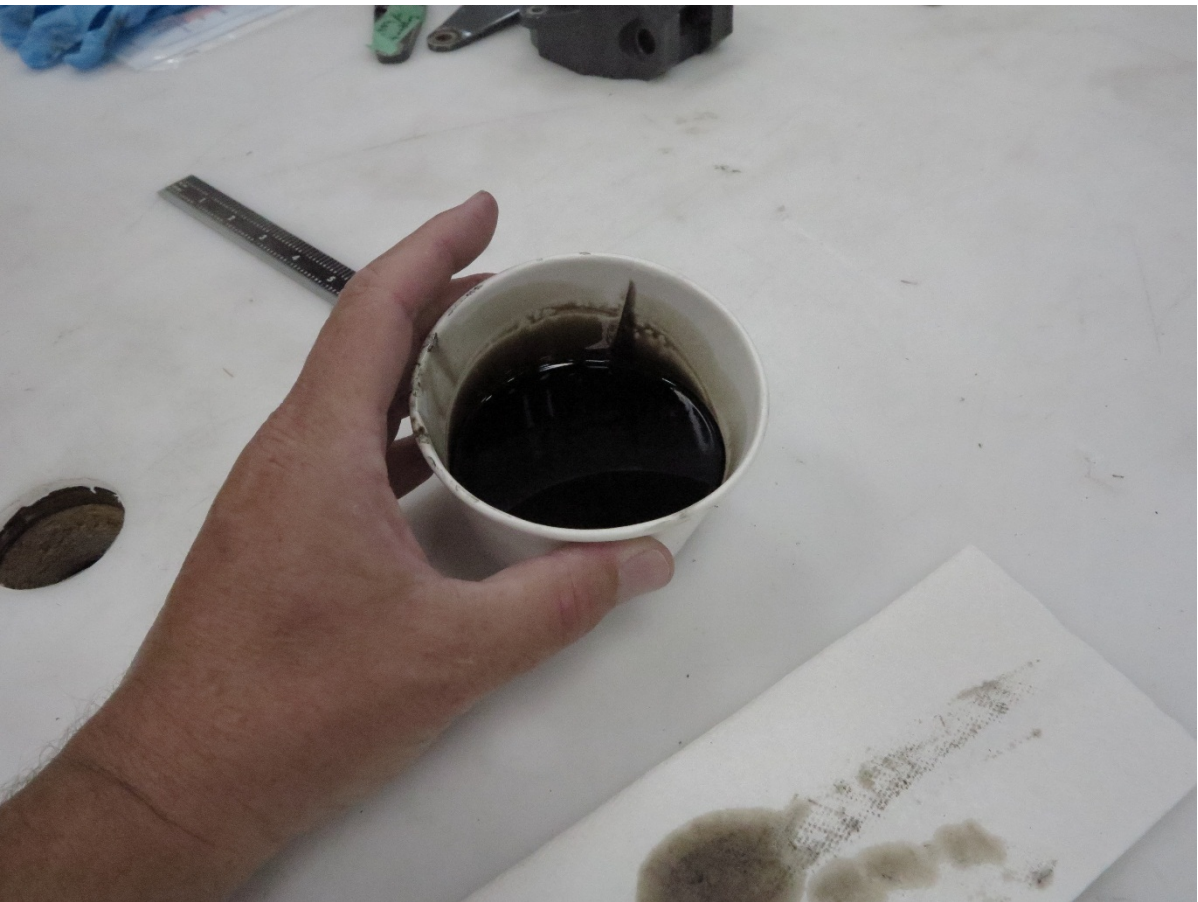
The oil was drained from the clutch assembly into a filter and cup. The amount removed appeared to be the proper quantity. Very small metallic flakes were caught in the filter. The oil was dark but did not smell burnt.

Oil drained from clutch assembly.

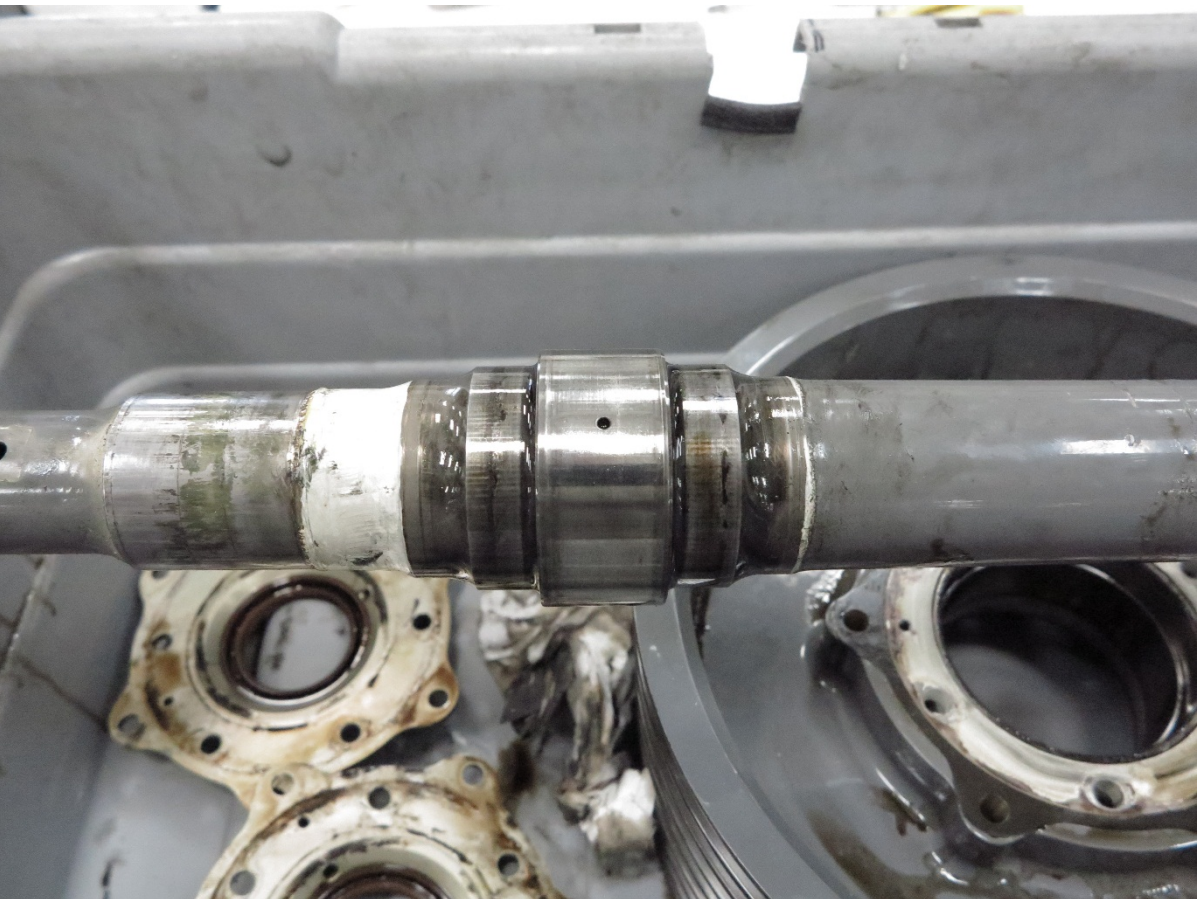
Visual inspection of the sprag revealed no anomalies. The shaft and the inside surface of the sheave had slight impressions matching the size and spacing of the sprags, consistent with an over-torque event.

Sprag surface of clutch shaft.

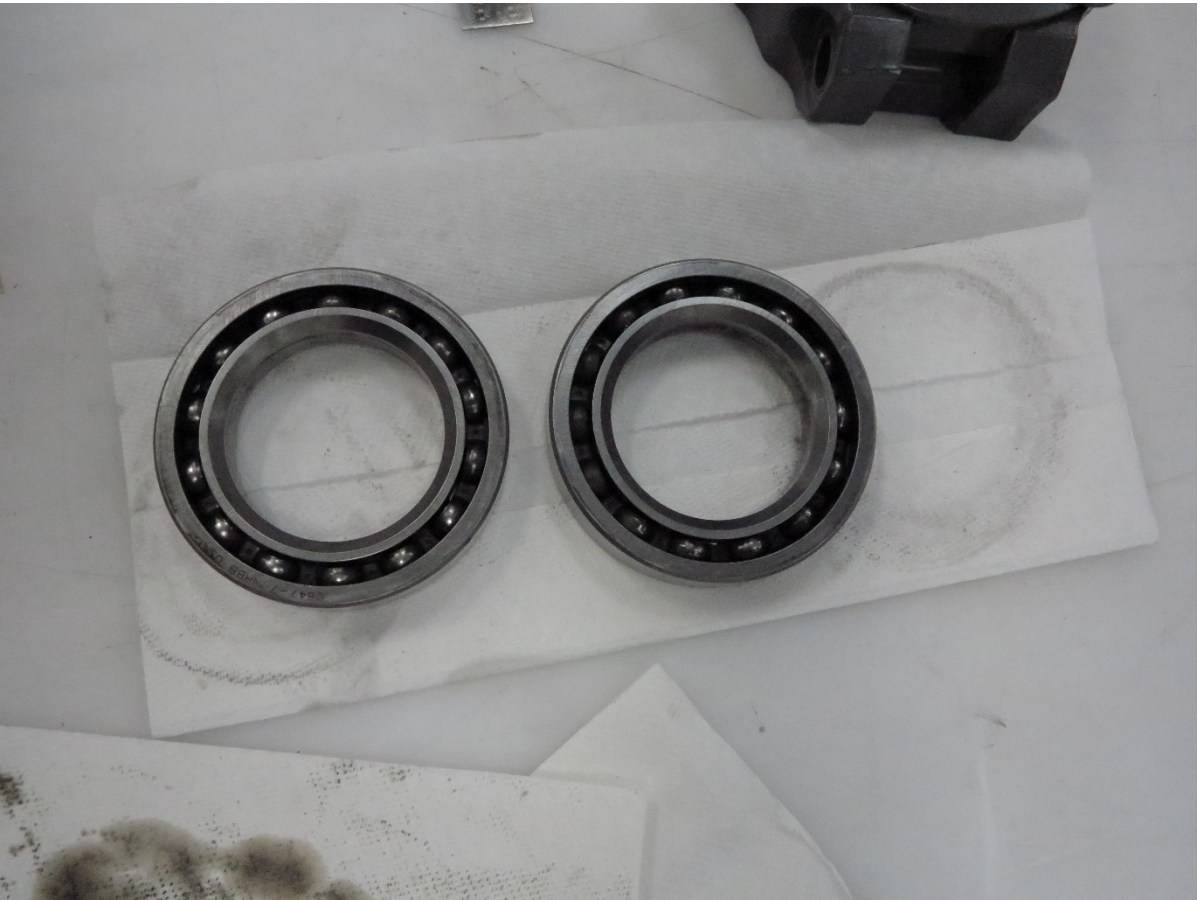
Both bearings felt rough when rotated by hand. Both bearings were flushed with solvent into a filter and cup. Three small metallic flakes were caught in the filter.

Both bearings rotated smoother but still had areas of slight roughness. A visual inspection of the bearing races using a 10x eye loupe revealed no damage or discoloration.

Sheave support bearings.

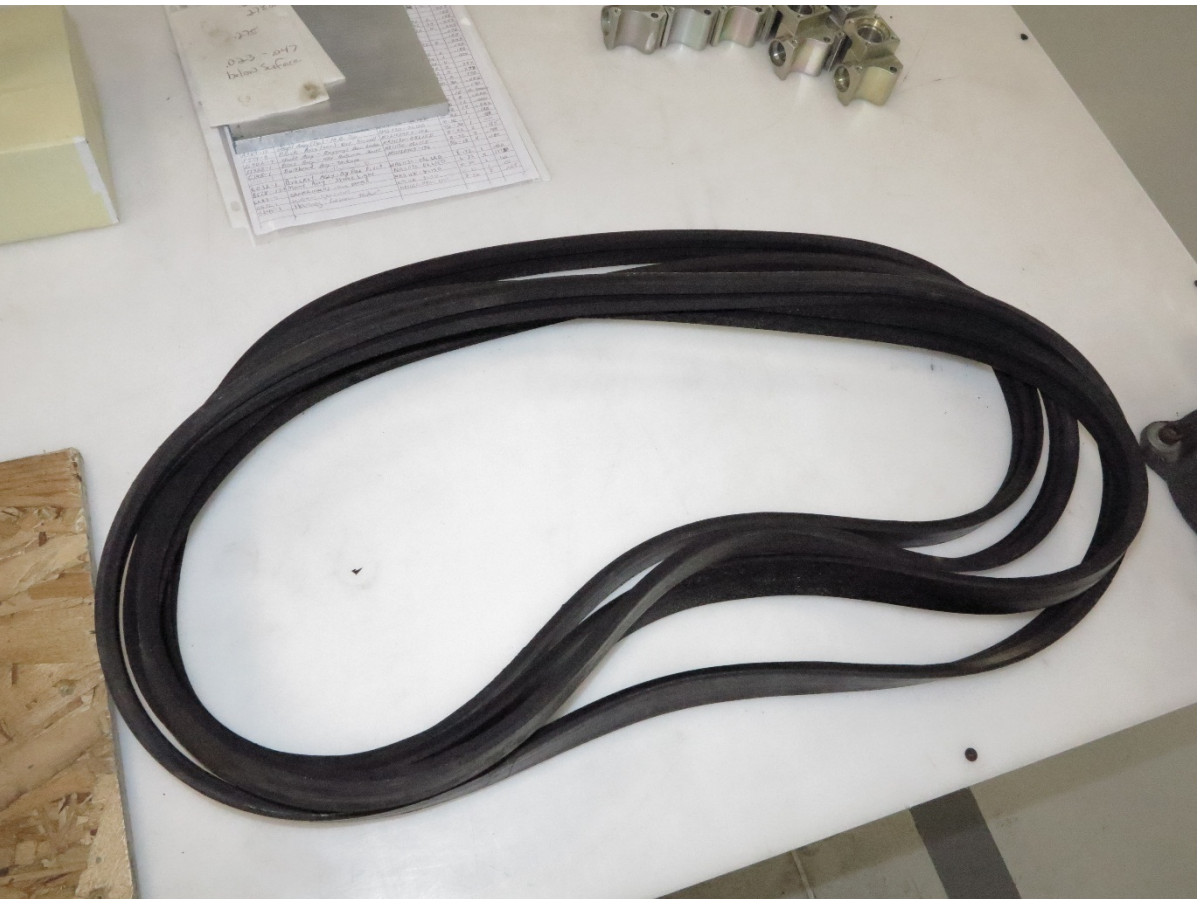
Visual inspection of the V-belts revealed small cracks in the contact surface on two of the belts. The wear on all four belts appeared to be consistent with the reported time in service.

V-belts.

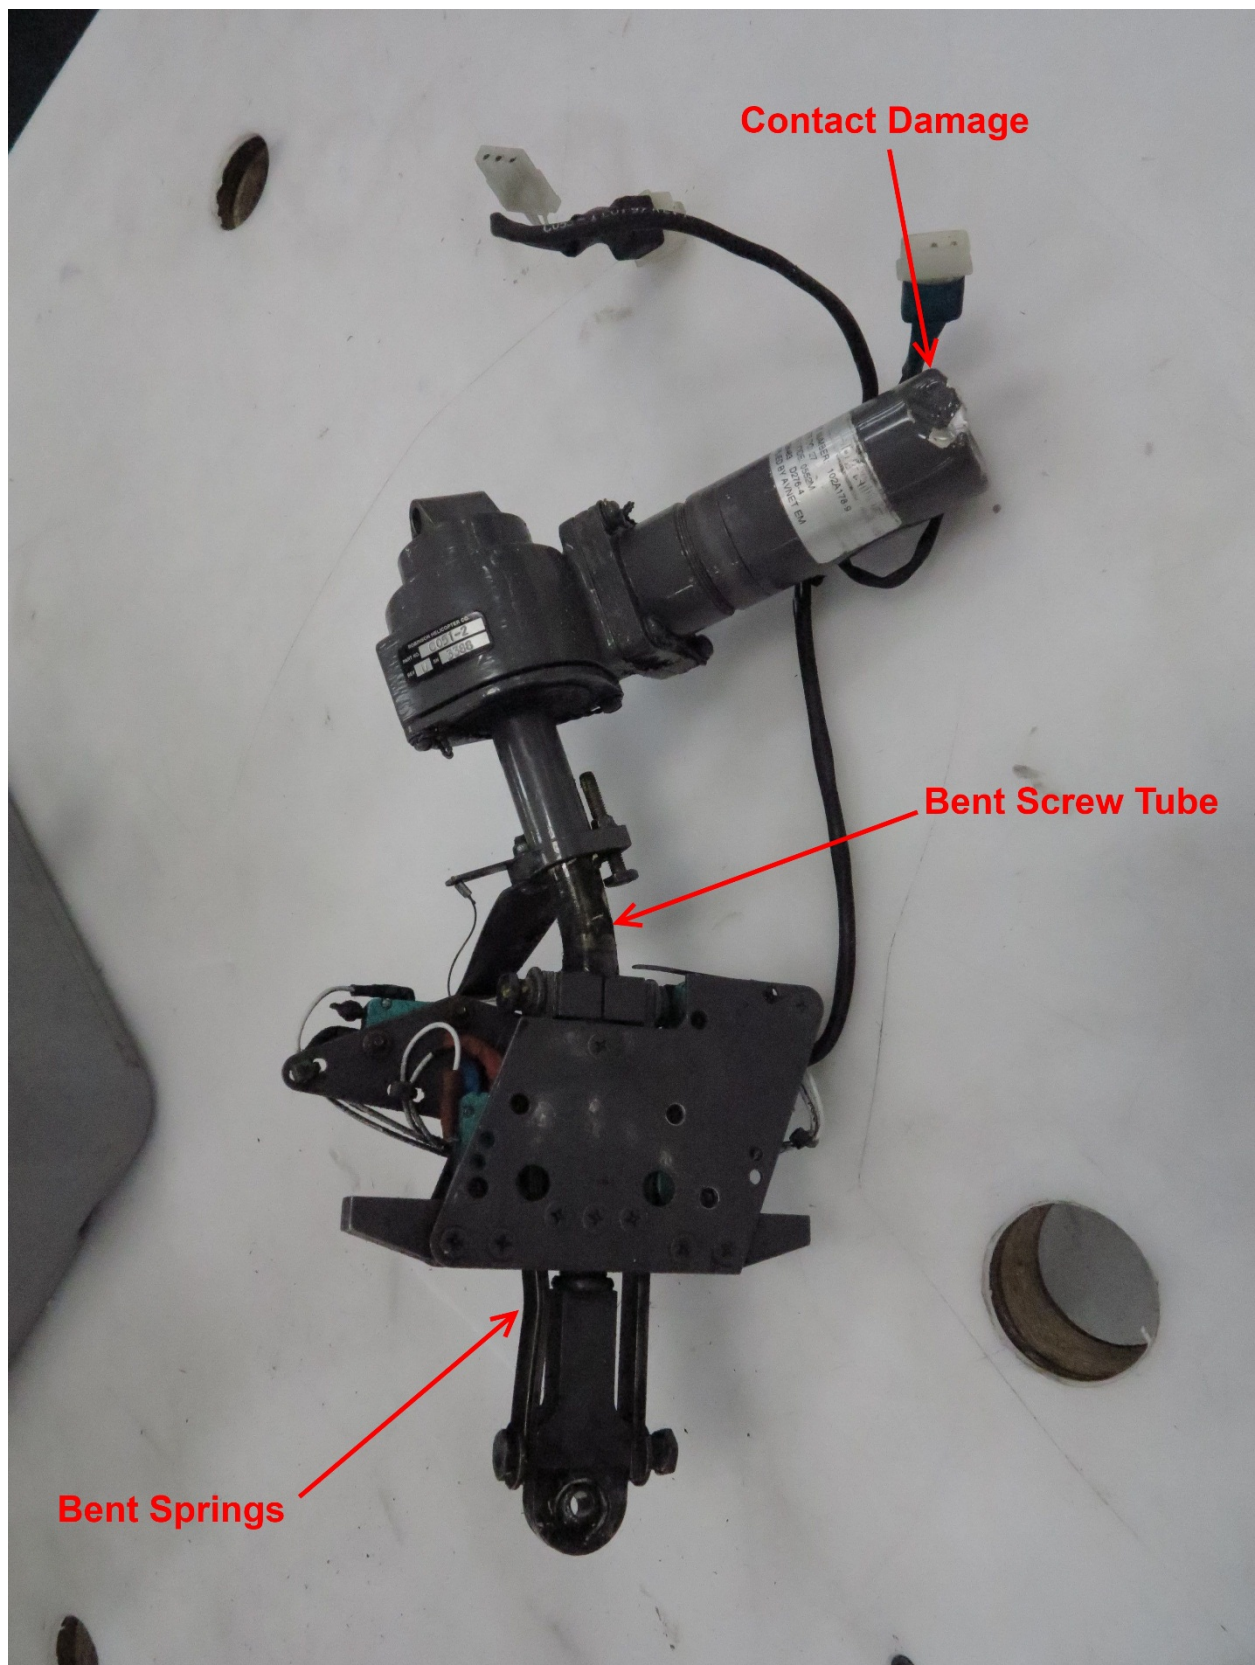
Visual examination of the actuator revealed impact damage to the end of the motor. The screw tube was bent to the left (looking forward) and the left side stack of springs were also bent.

Damage to actuator assembly.

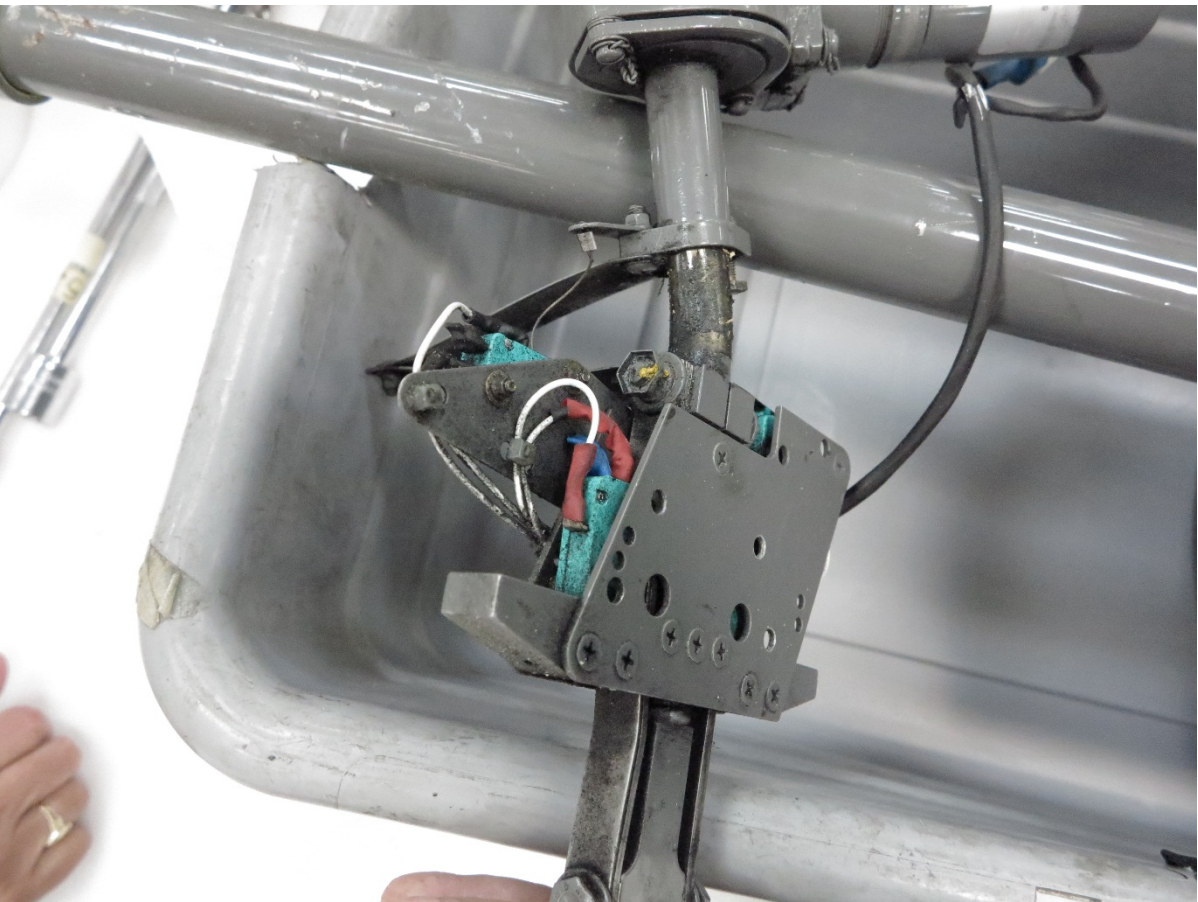
The heat shrink on both spring switches was red and blue in color (factory heat shrink is black).

Red and blue heat shrink on spring switches.

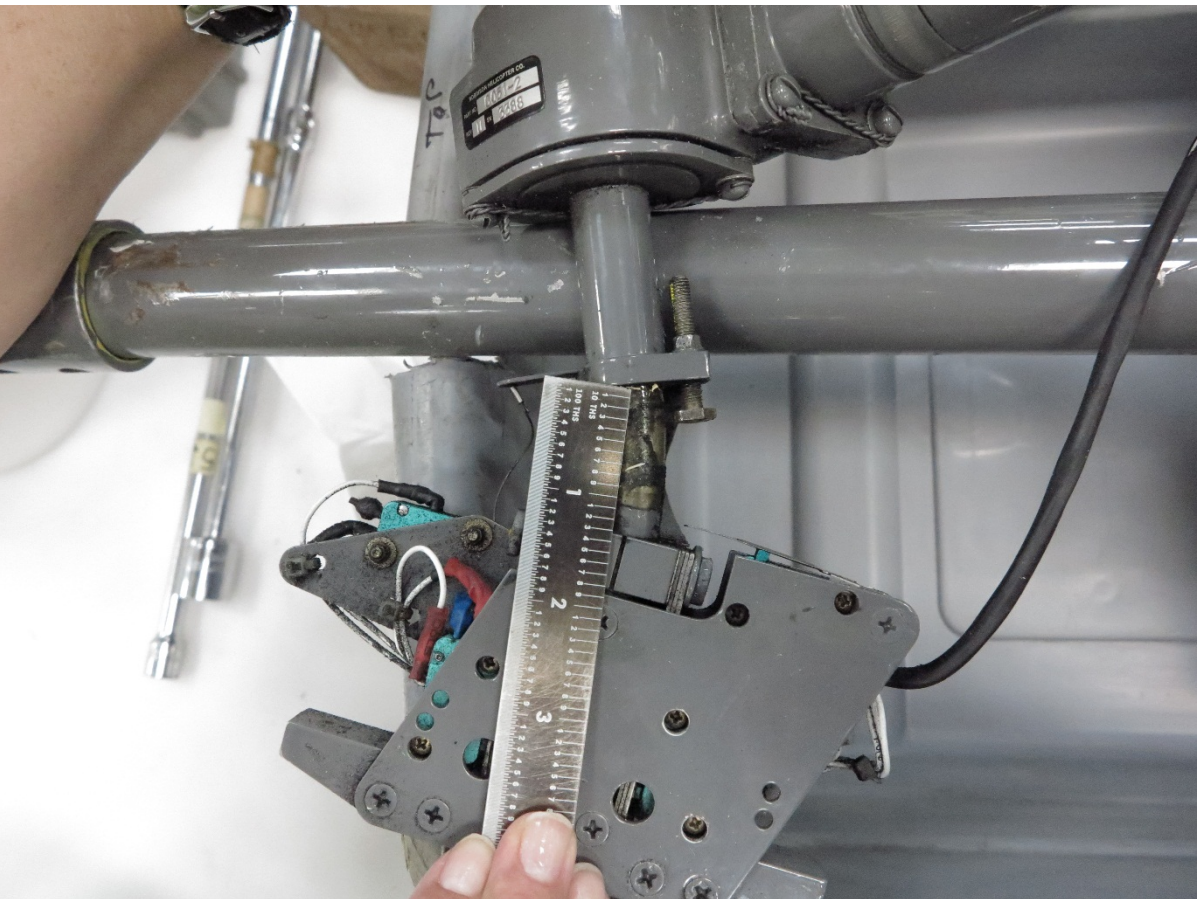
The extension distance was approximately 1.3" measured between the scissor mounting blocks (typical extension is .08" – 1.1"). The down limit adjustment screw was extended approximately 0.4".

Extension distance between scissor blocks.

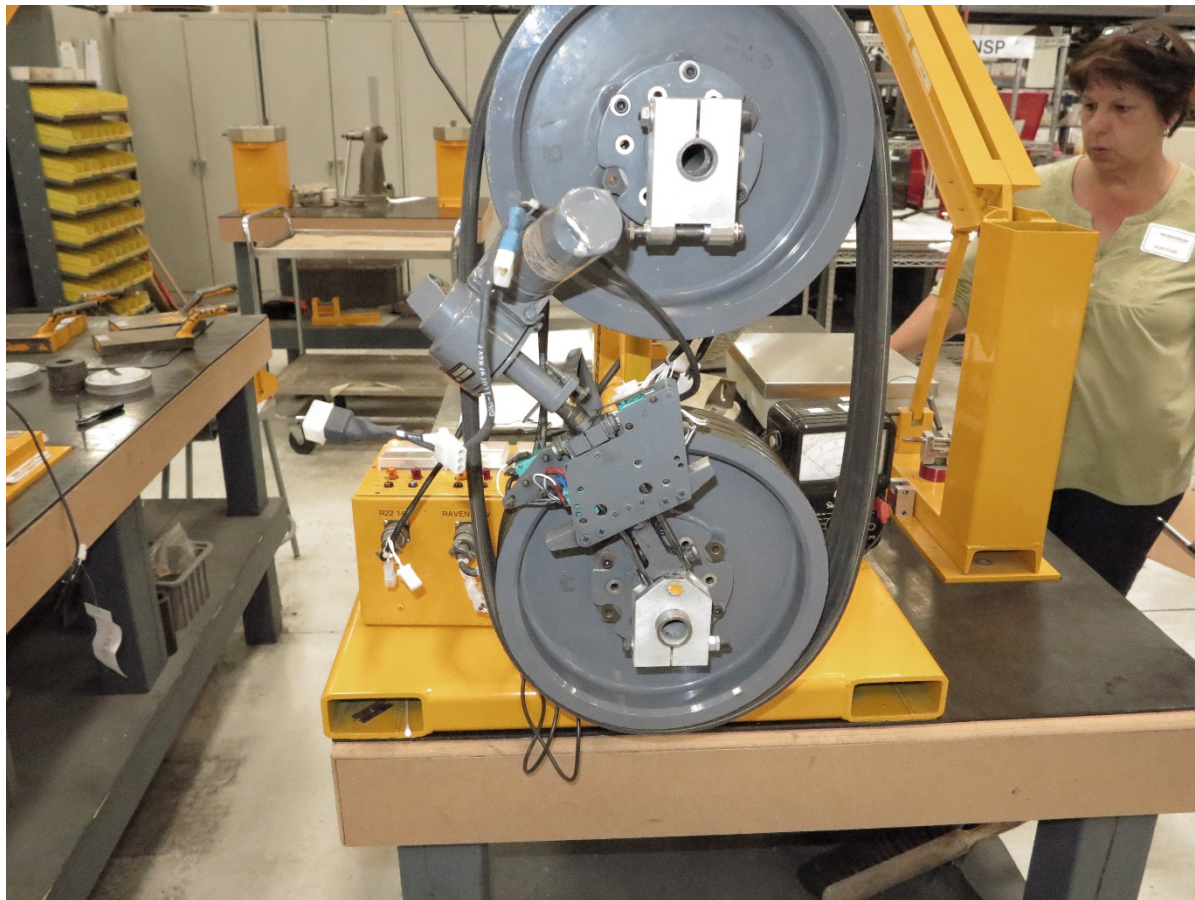
The actuator was connected to a test fixture and power was applied. The motor rotated in both directions, raising and lowering the upper section, with no anomalies. All four switches operated properly. The setting and function of the springs could not be determine due to the damage to the assembly.

Actuator on test fixture.
