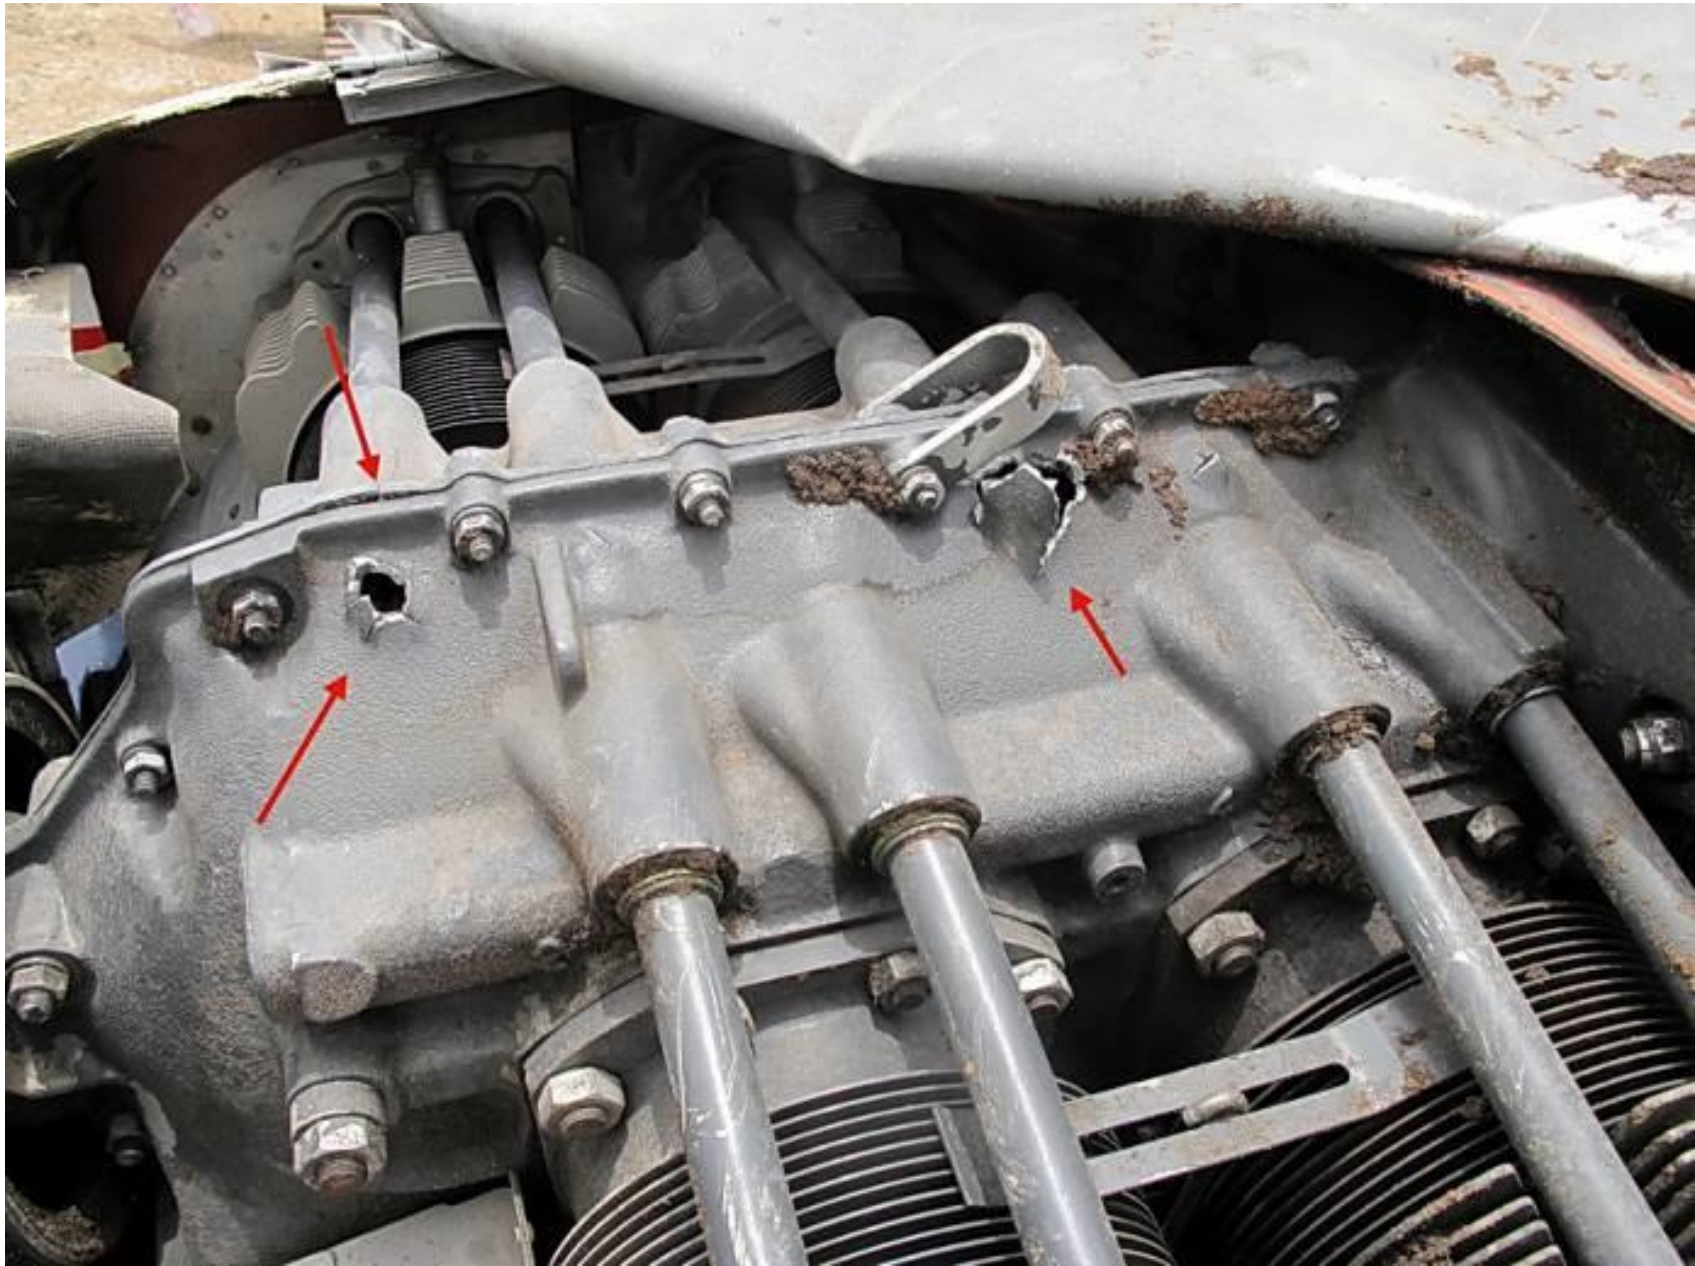
**Photo 1 – engine showing 2 holes in crank case**

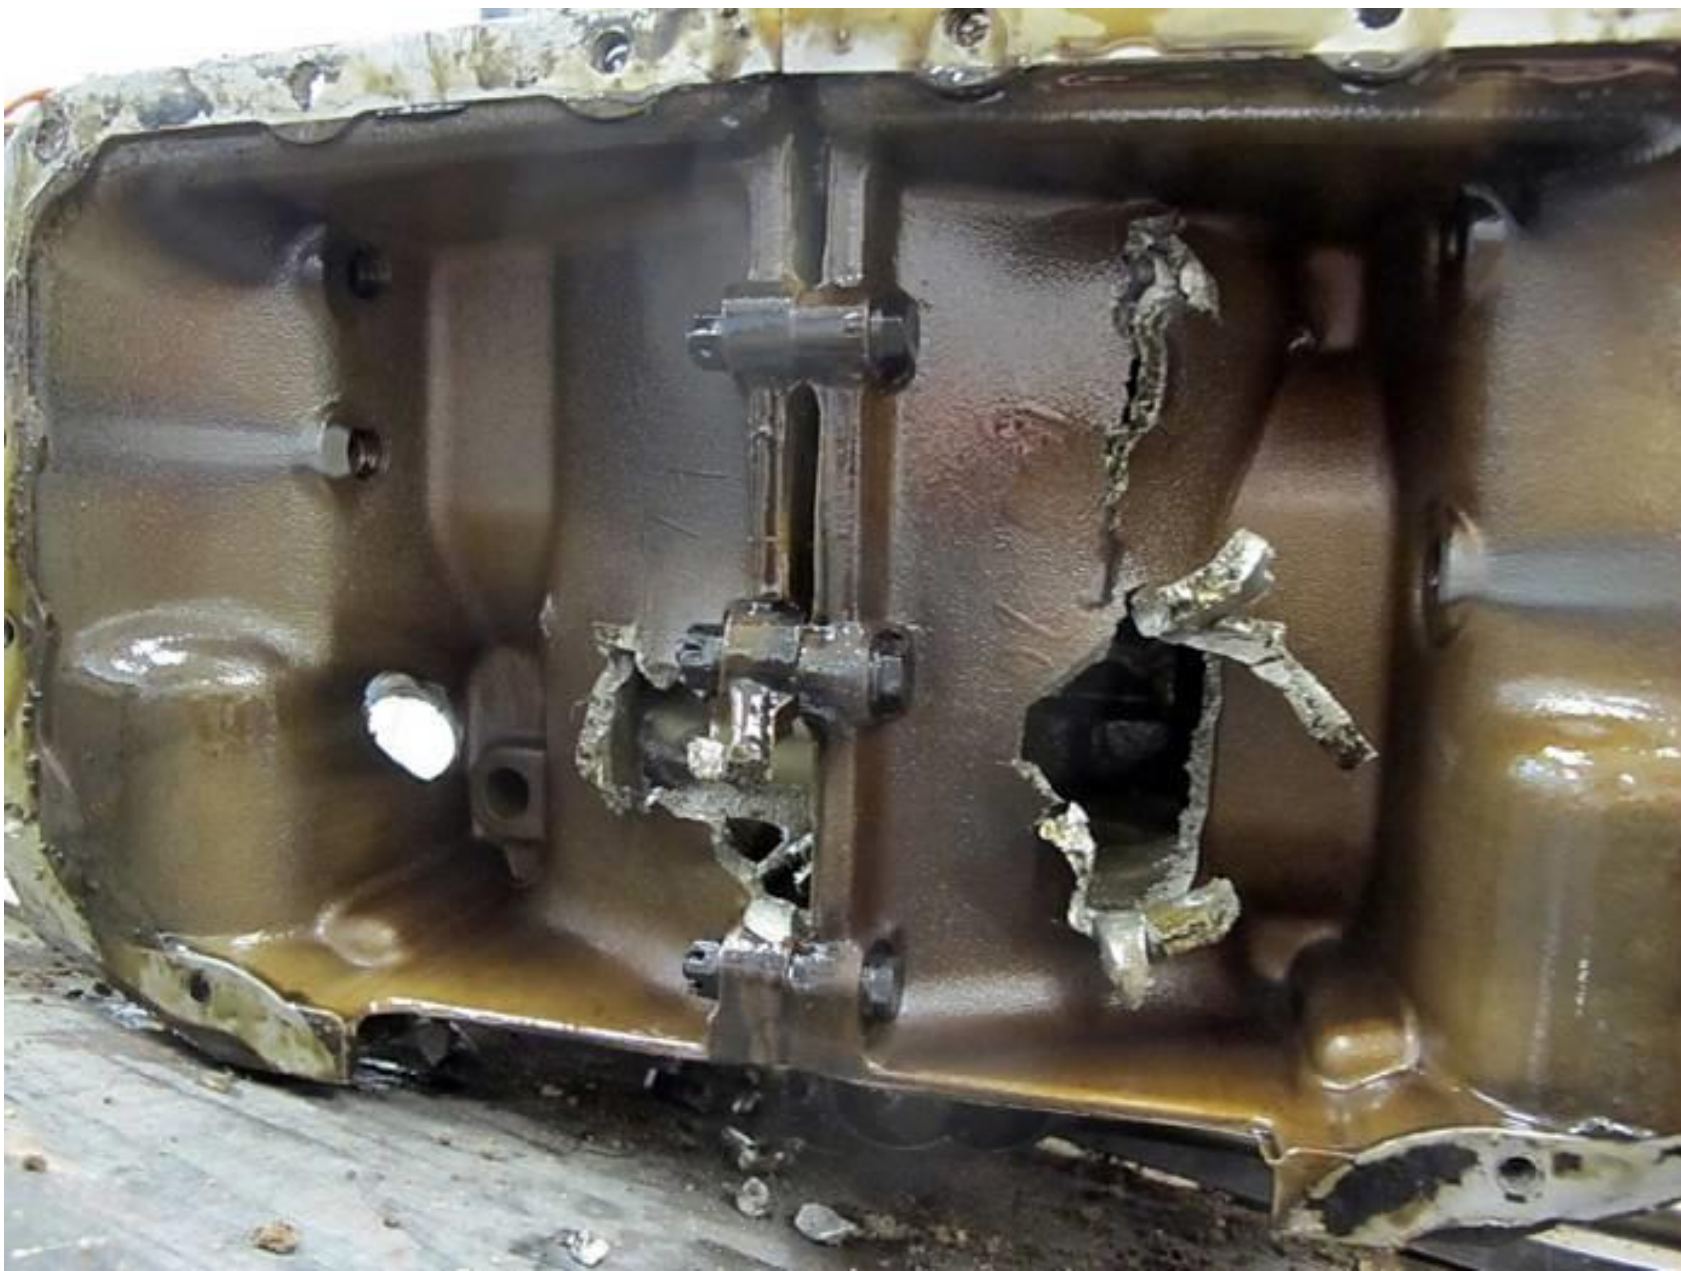
**Photo 2 – view of damage to crankcase**

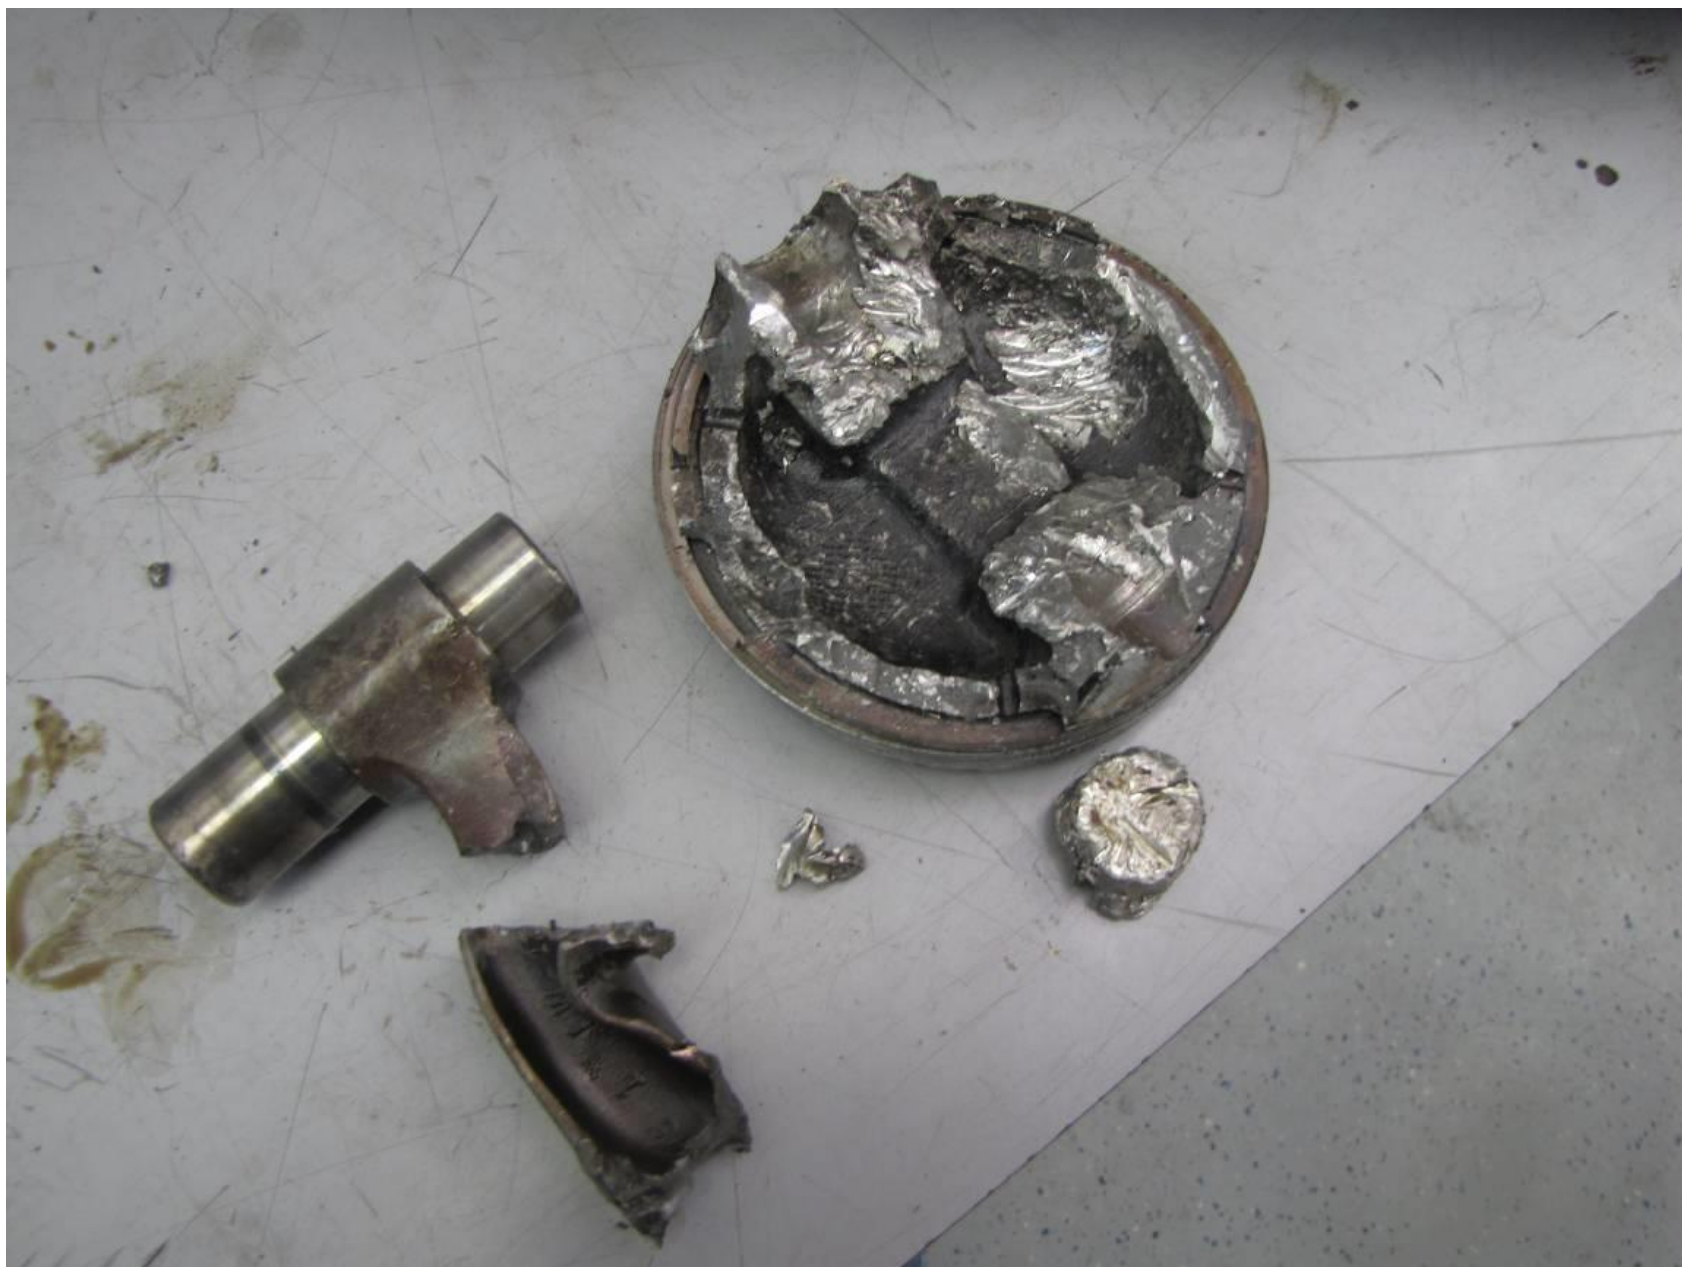
**Photo 3 - #4 piston, connecting rod, and piston plug**
