# NATIONAL TRANSPORTATION SAFETY BOARD

## MATERIALS LABORATORY FACTUAL REPORT

Report No. 16-043

Place : Ranger, Texas  
Date : May 11, 2015  
Vehicle : Piper PA-28-161, N3024S  
NTSB No. : CEN15LA228  
Investigator : Michael Folkerts, AS-CEN

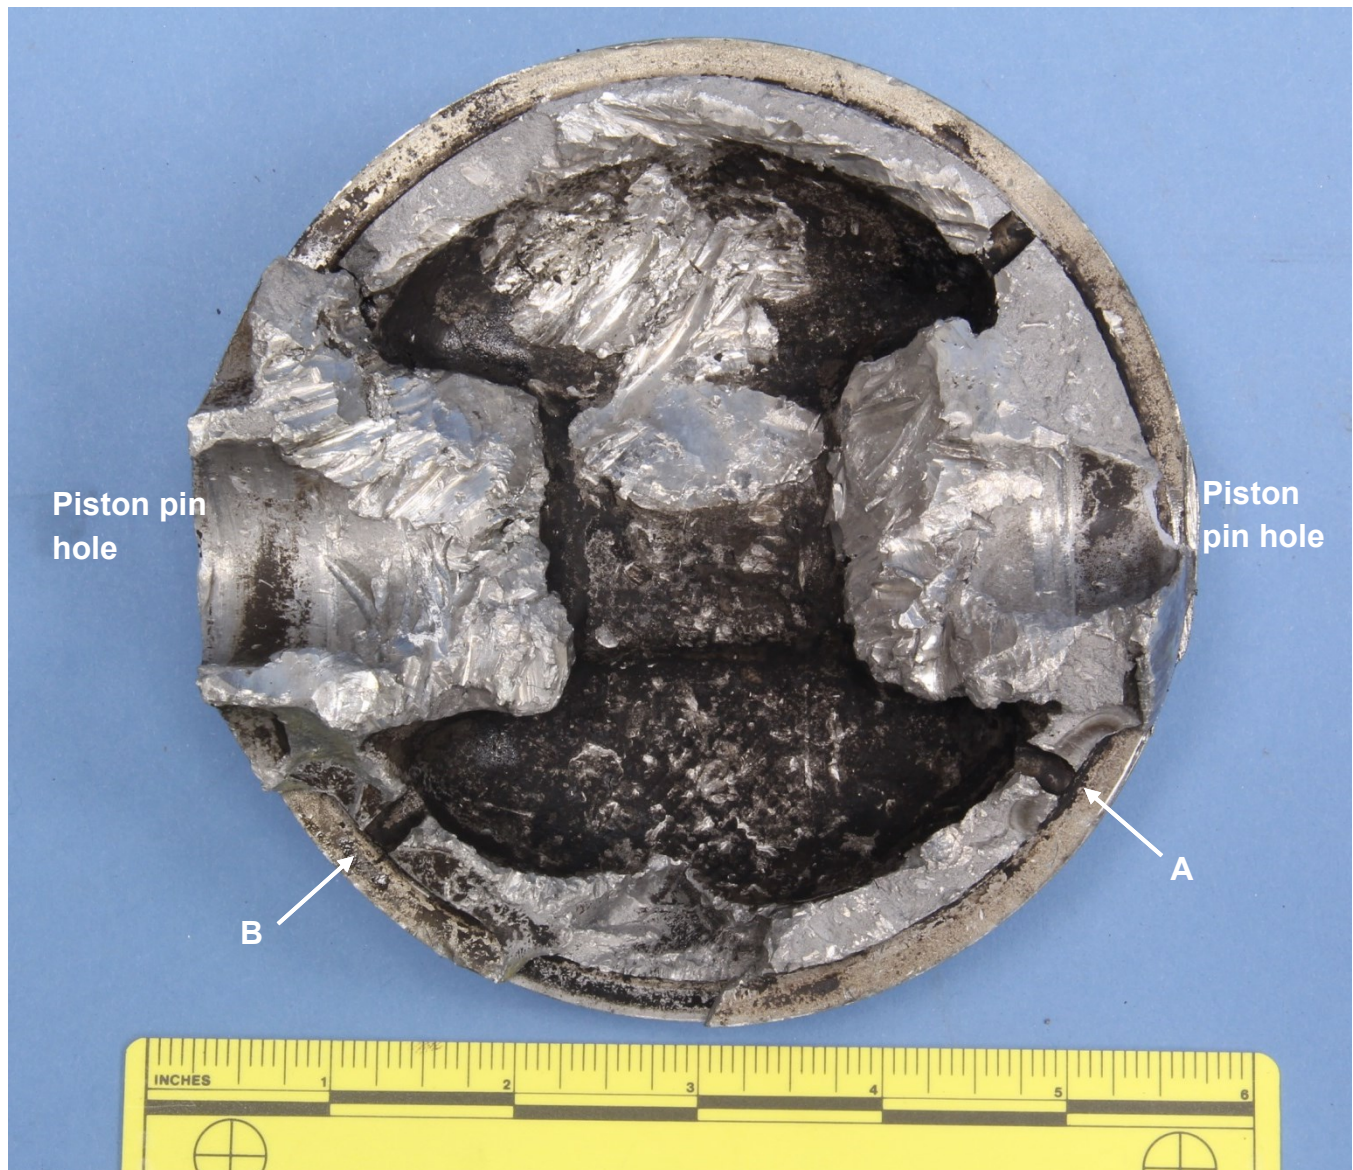
Figure 1 shows the #4 piston crown from the underside, as received. The lower portions of the crown had fractured, which were submitted as extra debris. The debris, as well as much of the piston, exhibited smearing and batter consistent with post-failure impact inside the reciprocating engine. Of note on the piston crown underside were two

thumbnail-shaped cracks, each located about an oil drain hole along the top oil groove on the piston circumference.

Figure 1 – The underside of the piston crown, as received. The two fatigue cracks are highlighted at the oil drain holes (arrows) where they were located.

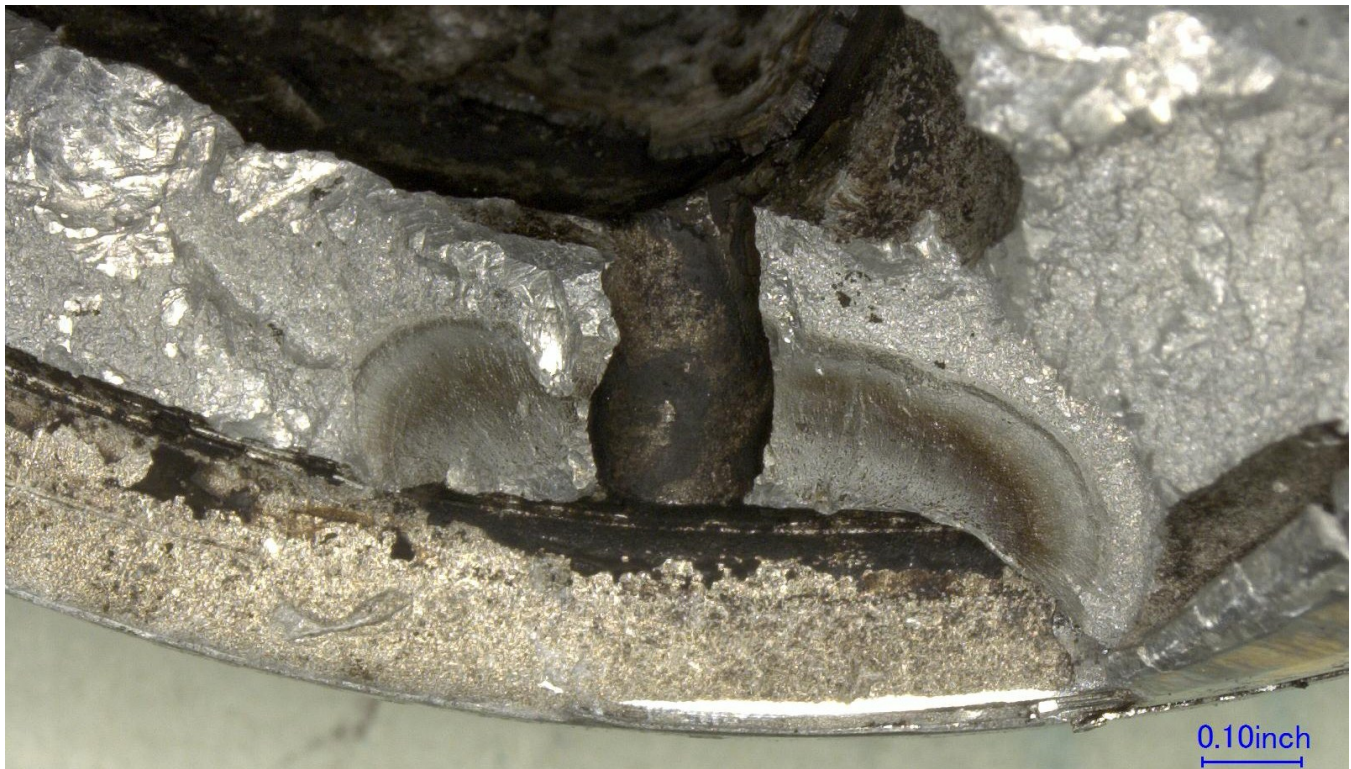
The two thumbnail cracks were labeled A and B for the purposes of this report. Figure 2 illustrates thumbnail crack A on the piston crown. This crack experience less damage than the other thumbnail crack (labeled B). Crack A exhibited crack arrest marks, consistent with progressive fracture. Closer examination of the crack features found that they had propagated from initiation sites along the circumferential oil groove, at or near the oil drain hole (Figure 3).

Figure 2 – Closer view of fatigue crack A, as labeled on Figure 1.

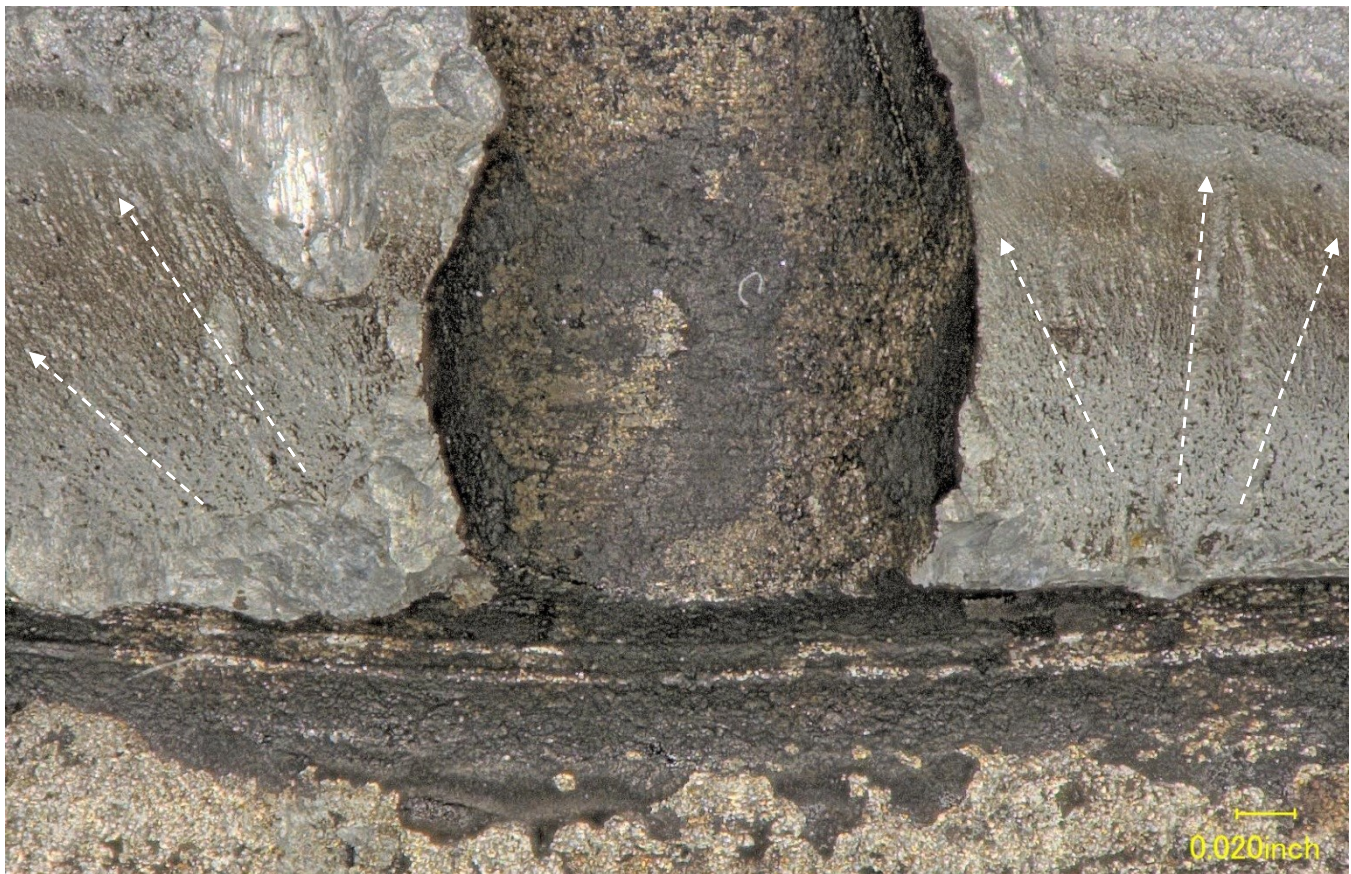
Figure 3 – Closer view of the oil hole from Figure 2, showing the crack initiation sites. The arrows denote crack direction.

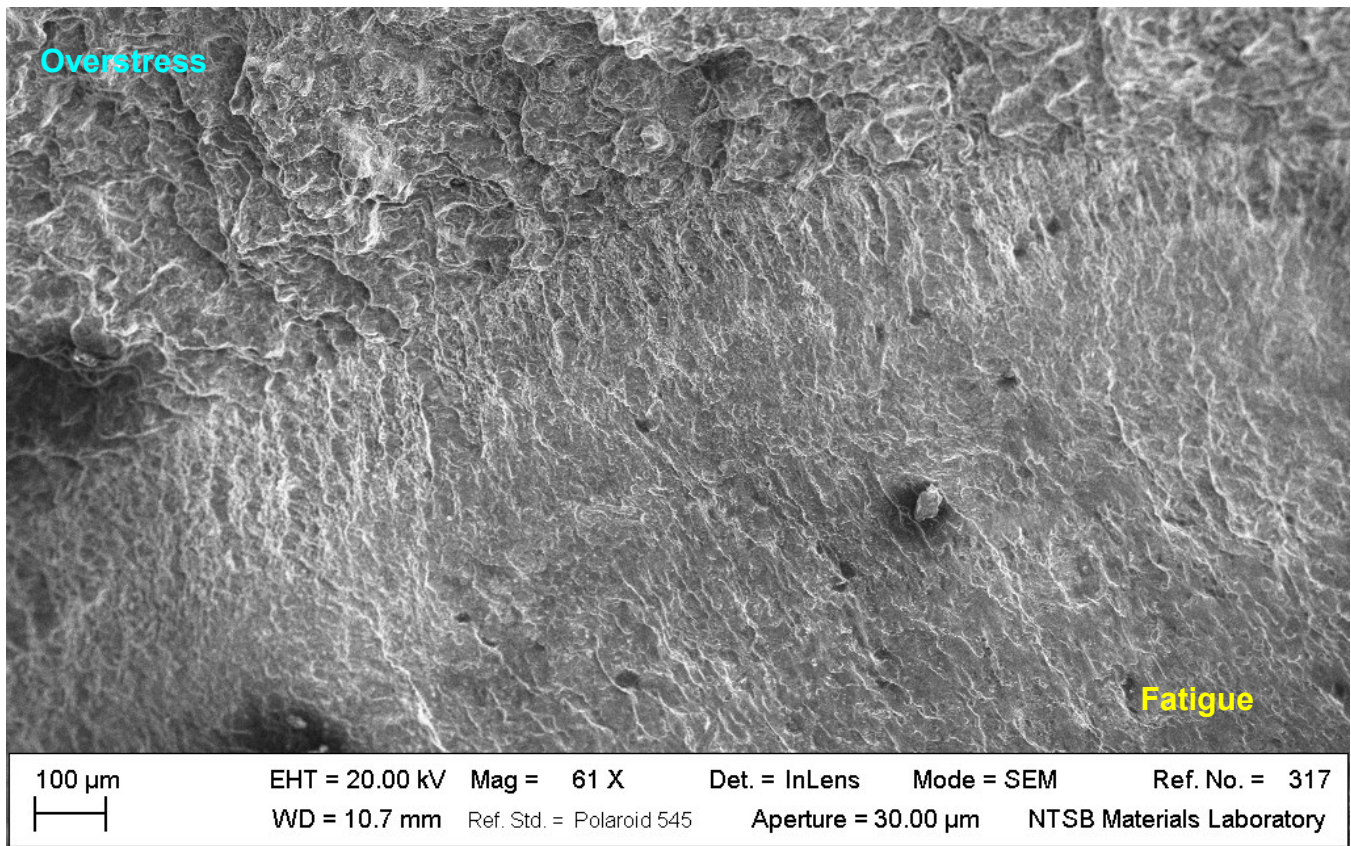
Examination of thumbnail crack A using a scanning electron microscope (SEM) revealed fatigue striations, which were not readily observable at the end of the fatigue crack (see Figure 4 and Figure 5). Figure 6 shows a closer view of one of the crack initiation sites (located at the corner of the oil drain hole). This and the opposite crack initiation sites had been obliterated by post-fracture smearing damage and batter, and could not be used to determine the cause of fatigue crack initiation. Outside of the fatigue cracks, dimple rupture, consistent with overstress fracture, was observed (Figure 7).

Figure 4 – Secondary electron (SE) micrograph of the end of the fatigue crack A.

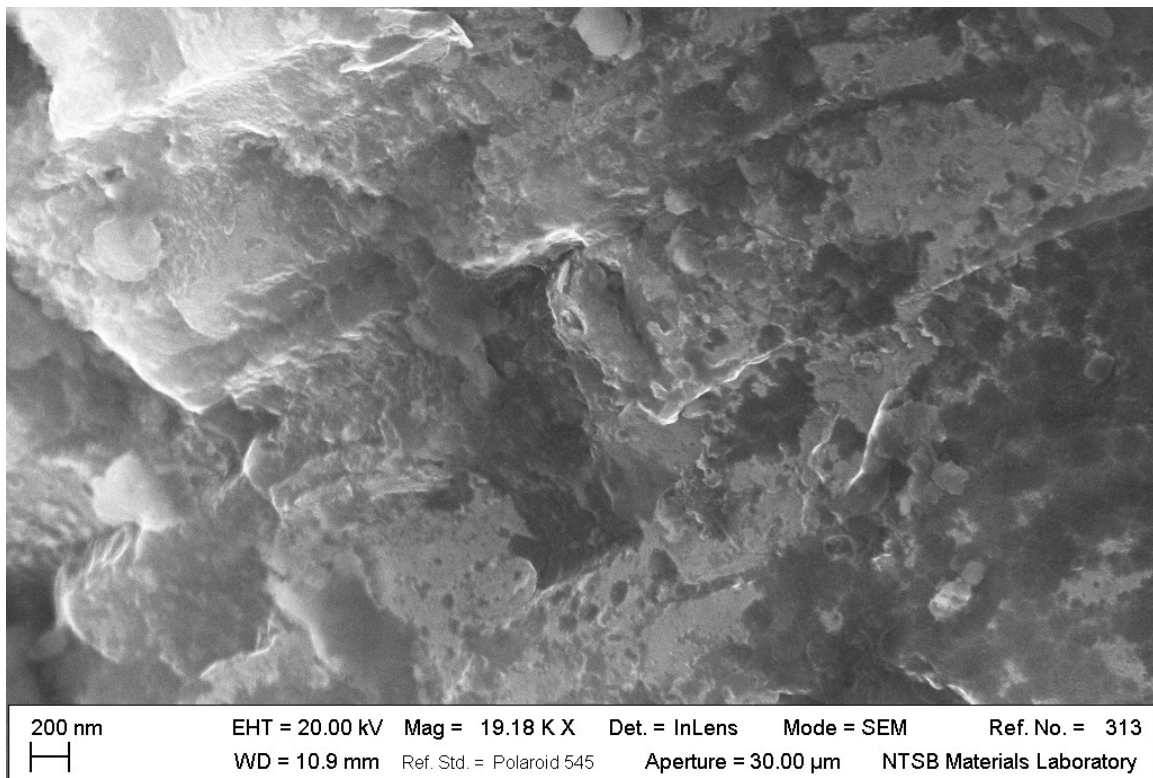
Figure 5 – SE micrograph showing a closer view of the multiple fatigue striations in fatigue crack A.

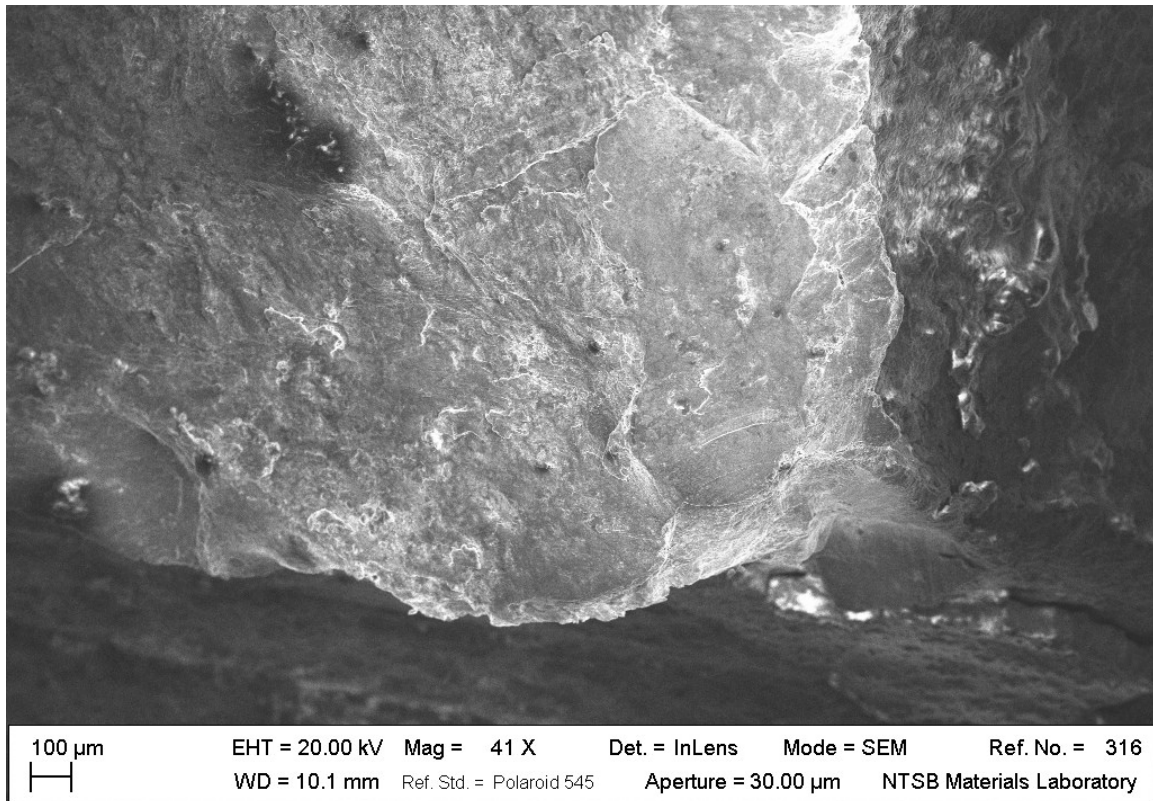
Figure 6 – SE micrograph showing the corner crack initiation of fatigue crack A at the oil drain hole.

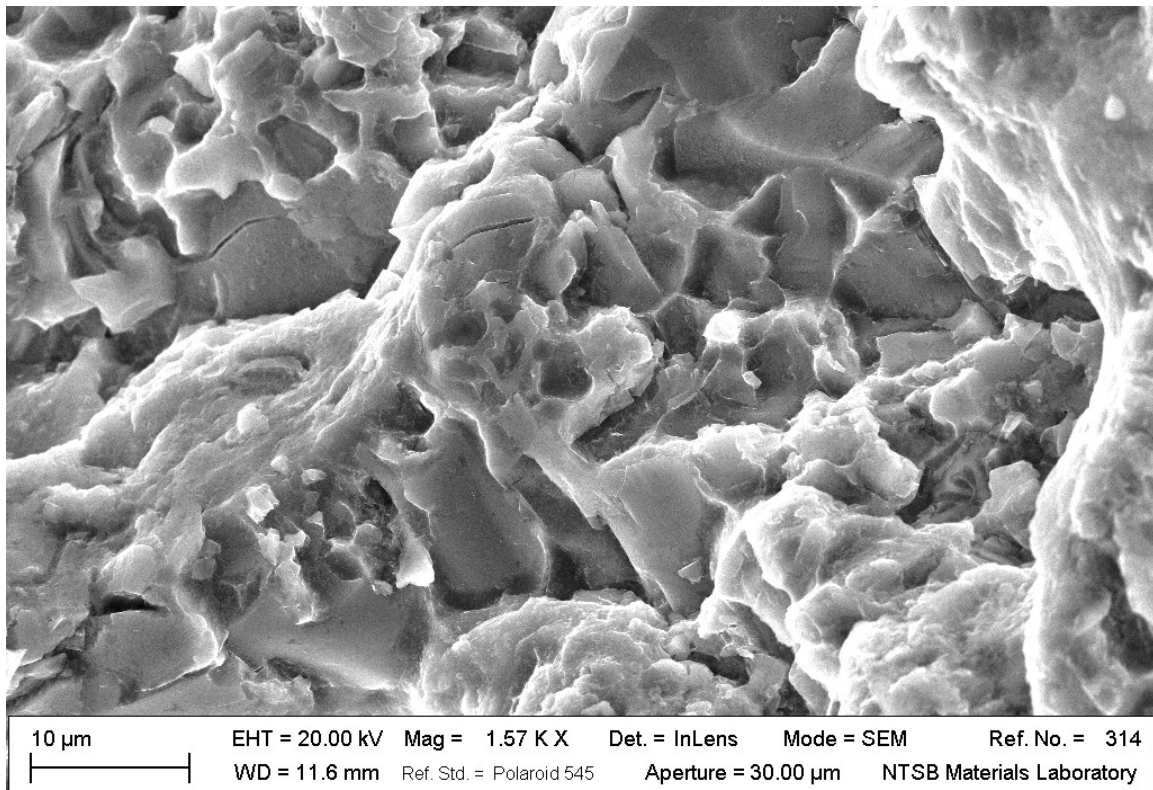
Figure 7 – SE micrograph showing dimple rupture, consistent with overstress, preceding the termination of fatigue crack A.

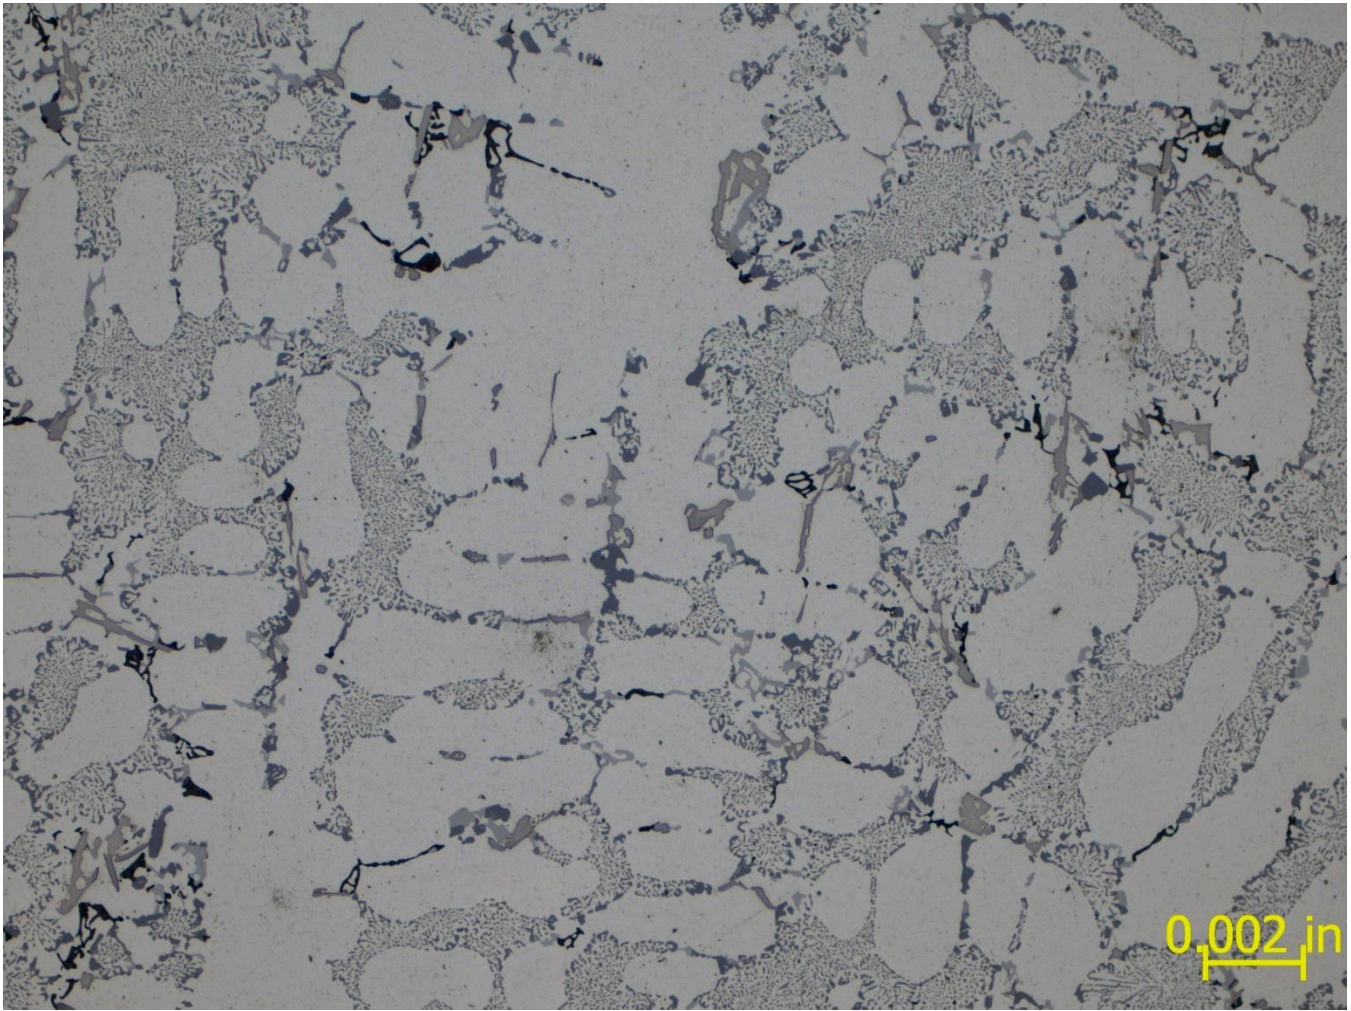
The chemical composition of the piston crown was inspected using energy dispersive x-ray spectroscopy (EDS) and x-ray fluorescence (XRF). The composition was consistent with a high-silicon aluminum casting alloy. A portion of the piston crown was sectioned, mounted, and polished. Figure 8 shows the typical microstructure of the part, which was consistent with a cast aluminum alloy. The hardness was inspected per ASTM E18.<sup>2</sup> The hardness of the section averaged 65 HRE. The electrical conductivity of the part was inspected per ASTM E1004.<sup>3</sup> The conductivity averaged 38.5% IACS.

Figure 8 – Bright-field metallograph of the piston, showing a dendritic solidification microstructure with high-silicon second phases, typical of cast aluminum alloys (as-polished, ~100X).

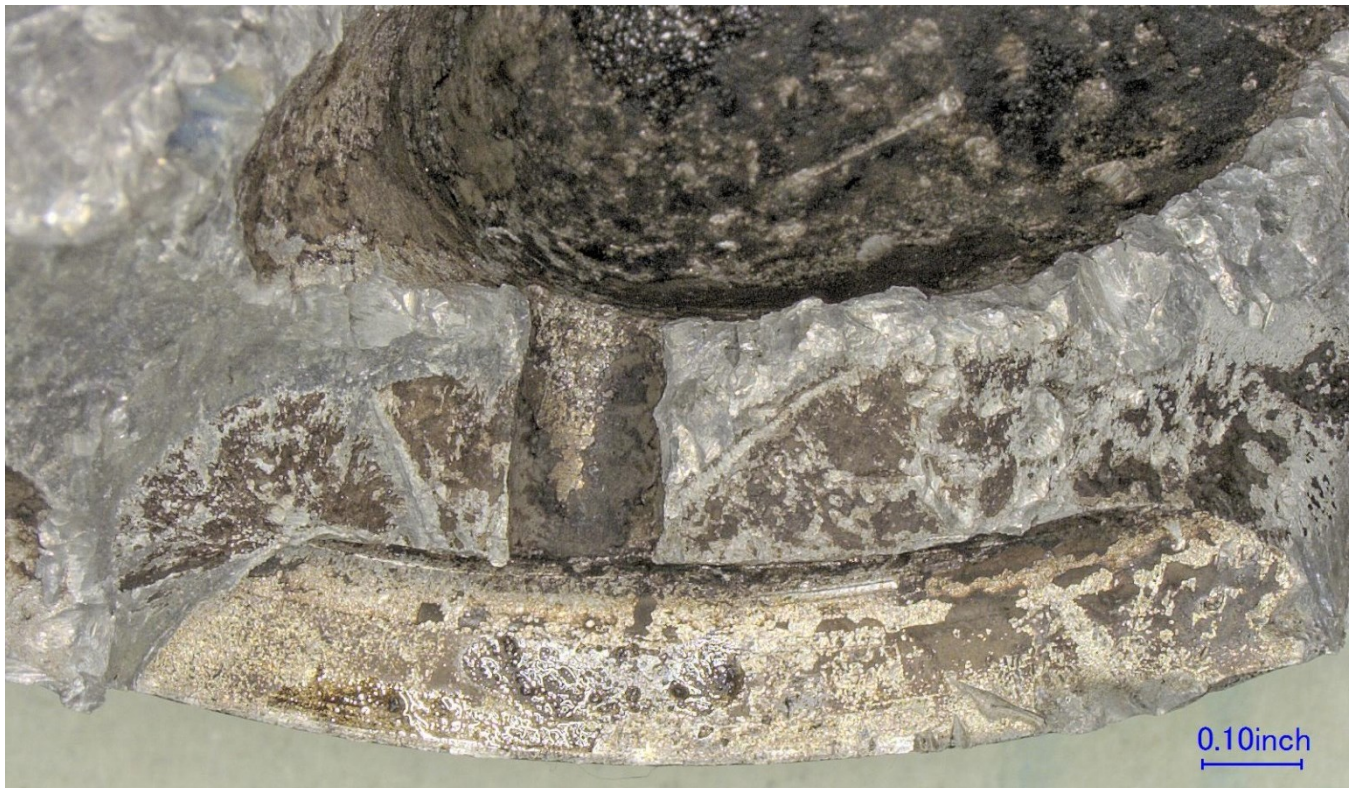
Thumbnail crack B, shown in Figure 9, was the larger of the two cracks. The damage to this crack obscured many of the fracture features. As with crack A, this crack exhibited features consistent with fatigue cracking that initiated at the circumferential top oil groove on the piston. Examination of the fatigue crack initiation sites found that they had been damaged such that they did not yield any conclusive information about the crack initiation mechanism (see Figure 10).

Figure 9 – Closer view of fatigue crack B, as labeled on Figure 1.

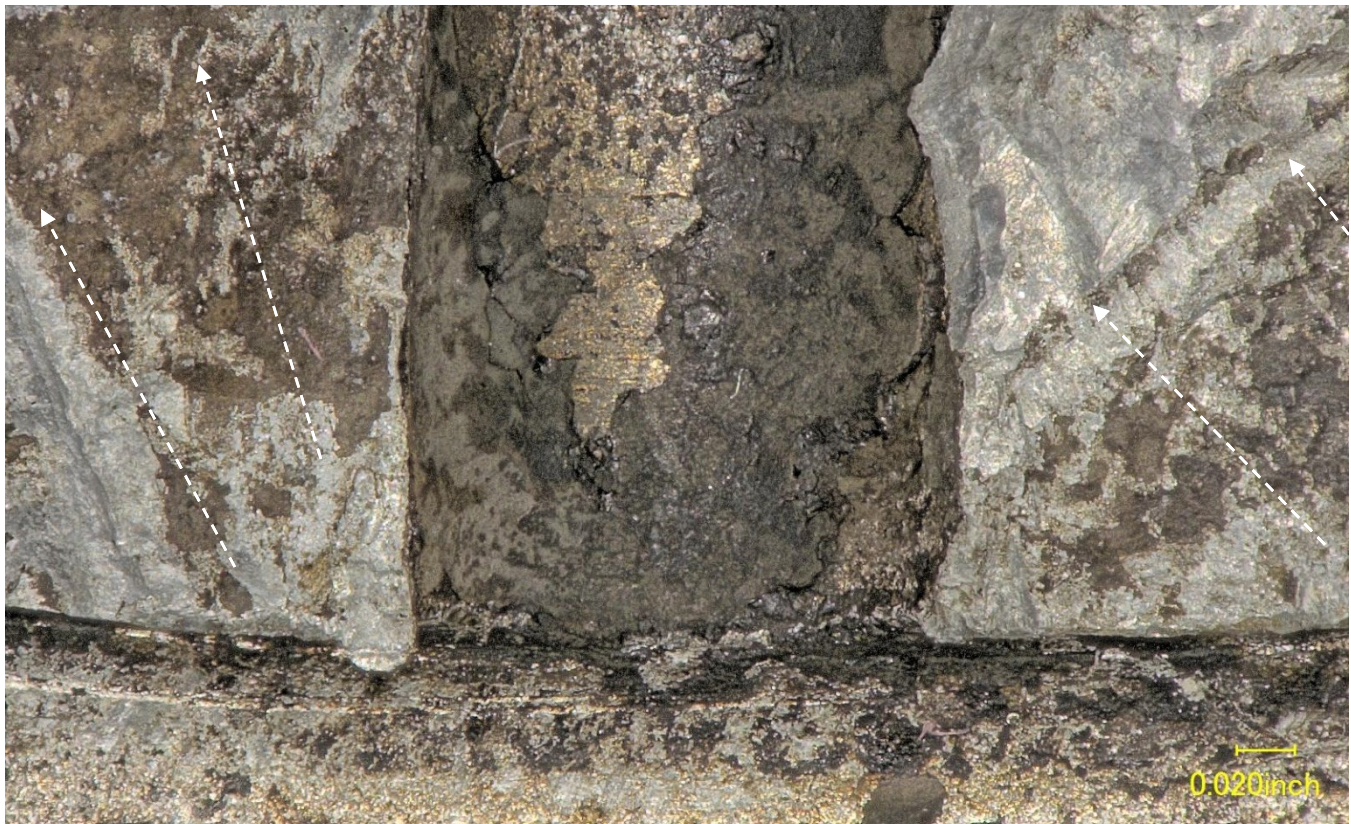
Figure 10 – Closer view of the oil hole in Figure 9, showing one of the crack initiations sites.

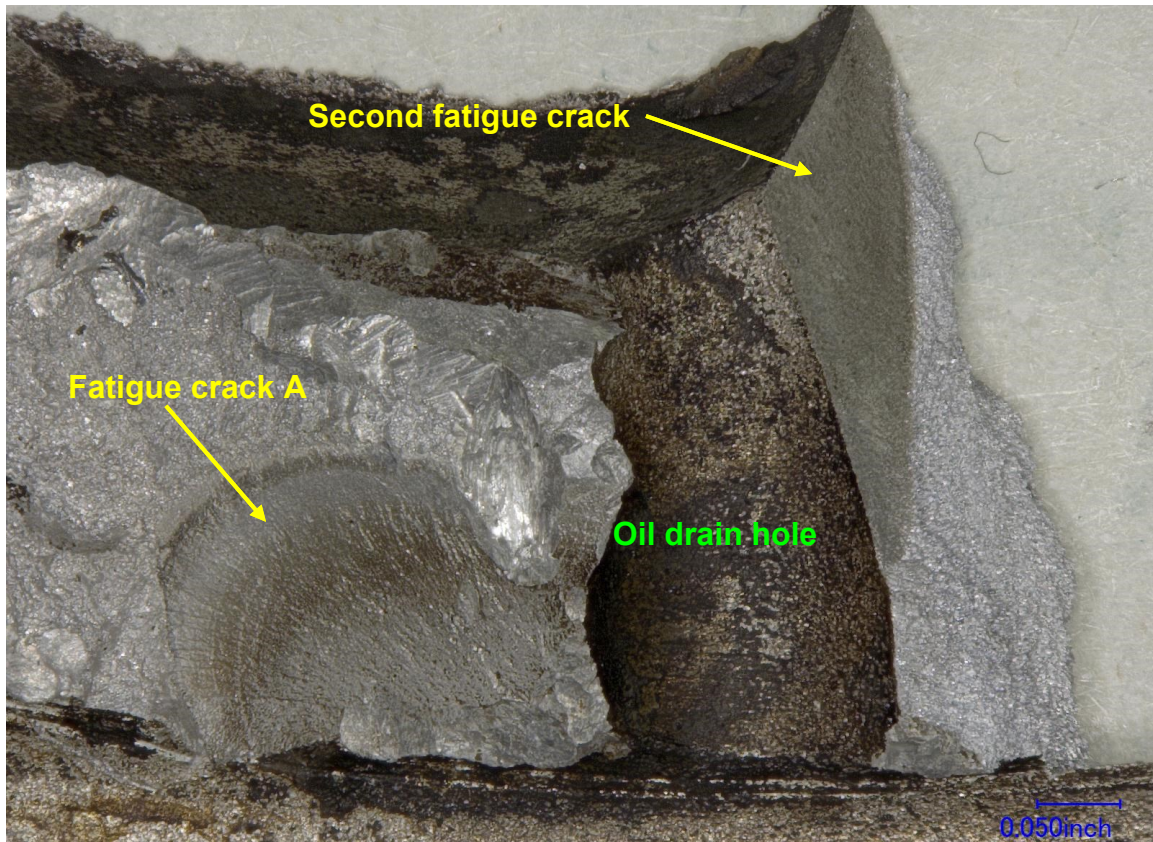
Upon sectioning and handling fatigue crack A, the specimen fractured along the oil drain hole. This unintended laboratory fracture revealed a second fracture surface, consistent with a second progressive crack (see Figure 11 and Figure 12). When inspected using a SEM, this second crack was revealed to exhibit fatigue striations (as shown in Figure 13). Examination of the crack arrest marks and fatigue striations found that this second crack had propagated from multiple crack initiation sites along the oil drain hole and the inside surface of the piston crown. Most of these initiation sites had been damaged, consistent with post-fracture damage.

Figure 11 – Fatigue crack A, after a portion fractured from handling, revealing a second fatigue crack.

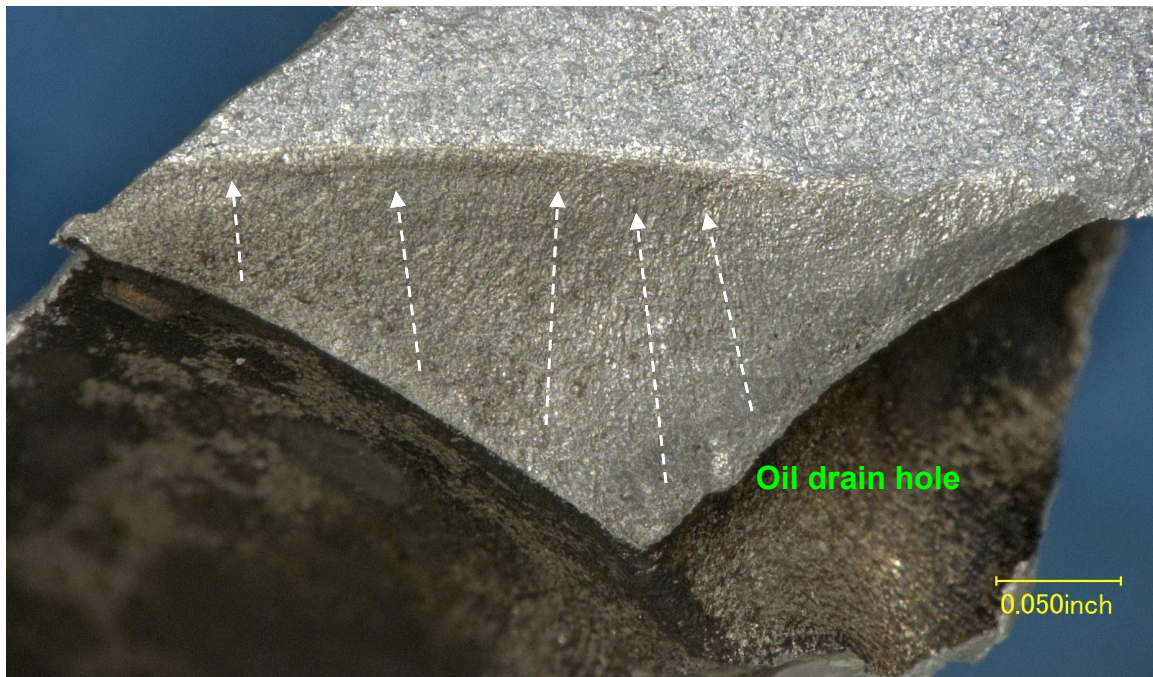
Figure 12 – Closer view of the second fatigue crack from Figure 11, showing the crack growth direction (arrows).

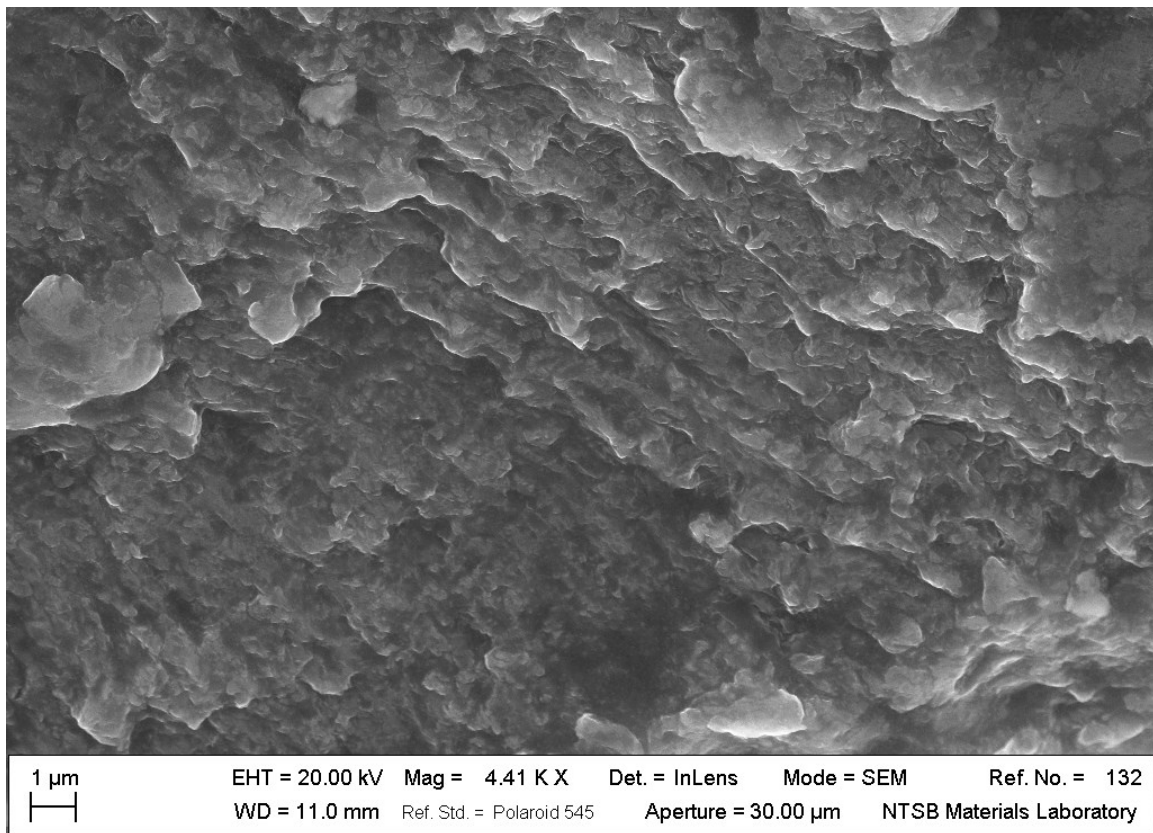
Figure 13 – SE micrograph of the 2<sup>nd</sup> fatigue crack near fatigue crack A.

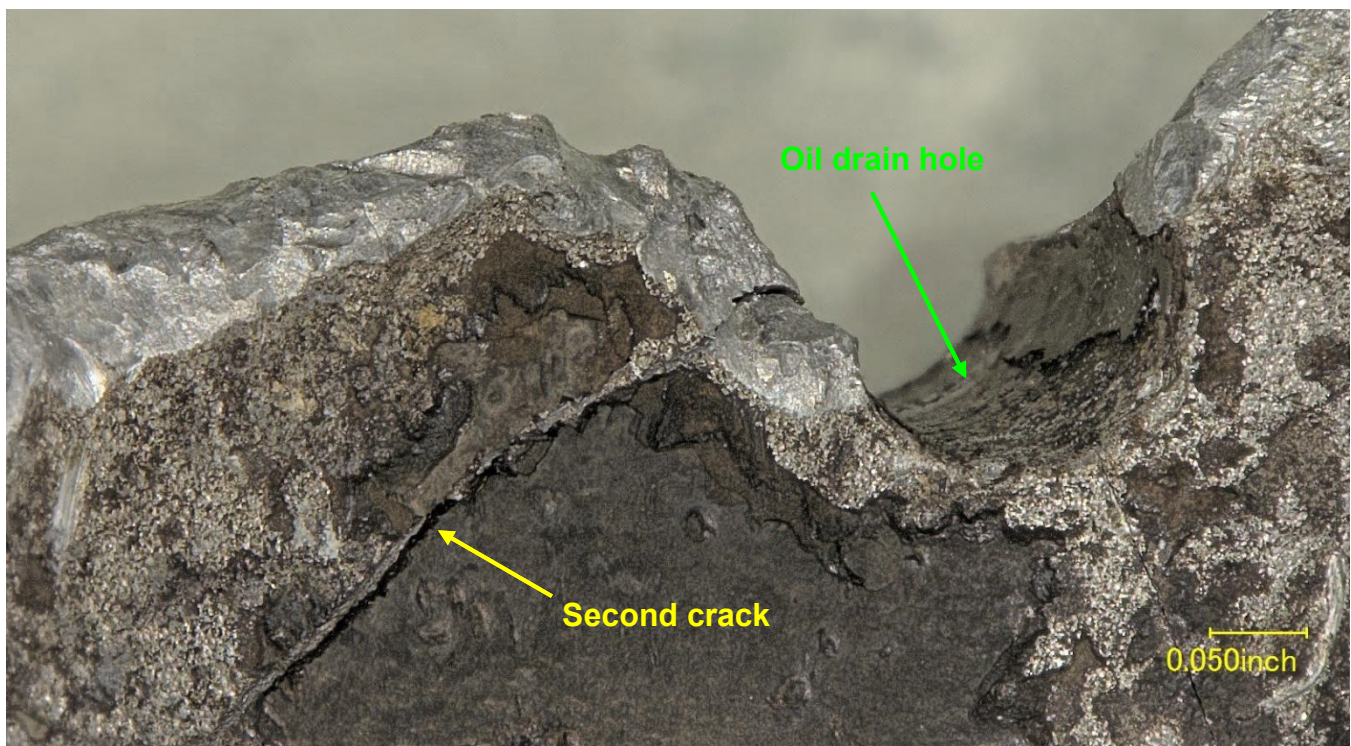
Examination of the area near fatigue crack B revealed that there was also a second crack present (see Figure 14). The features of this crack were consistent with having initiated along the oil drain hole, propagating diagonally inward towards the crown surface.

Figure 14 – The sectioned piston crown piece containing fatigue crack B (not pictured), viewed from the inside out, showing a crack propagating from the oil drain hole where fatigue crack B initiated.

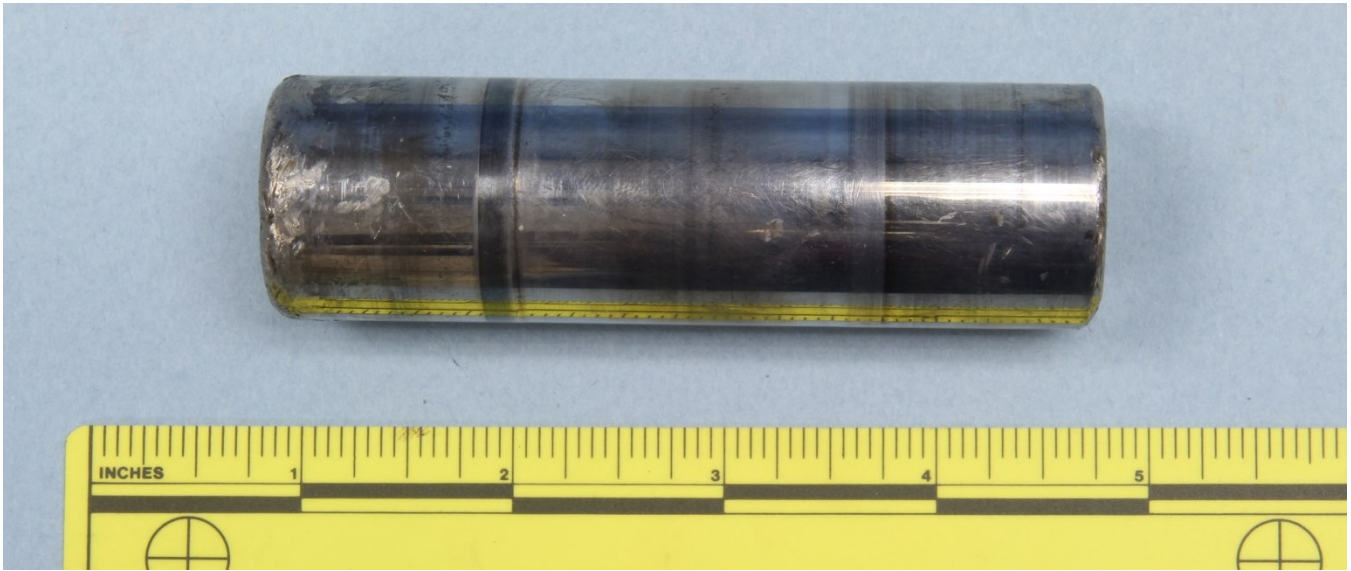
The piston pin and connecting rod from the #4 piston location were inspected to determine if this accident bore similarity to a previous engine failure in which the piston pin fractured.<sup>4</sup> The piston pin is displayed in Figure 15. The barrel of the pin exhibited some discoloration and circumferential wear, consistent with the prior position of the attached connecting rod.

However, the surface of the pin was generally smooth, containing no missing material that would have been consistent with corrosion pits, gouging, or spalling. The condition of this piston pin was inconsistent with the one that failed in the aforementioned previous investigation.

Figure 15 – The piston pin, after disassembly and cleaning.

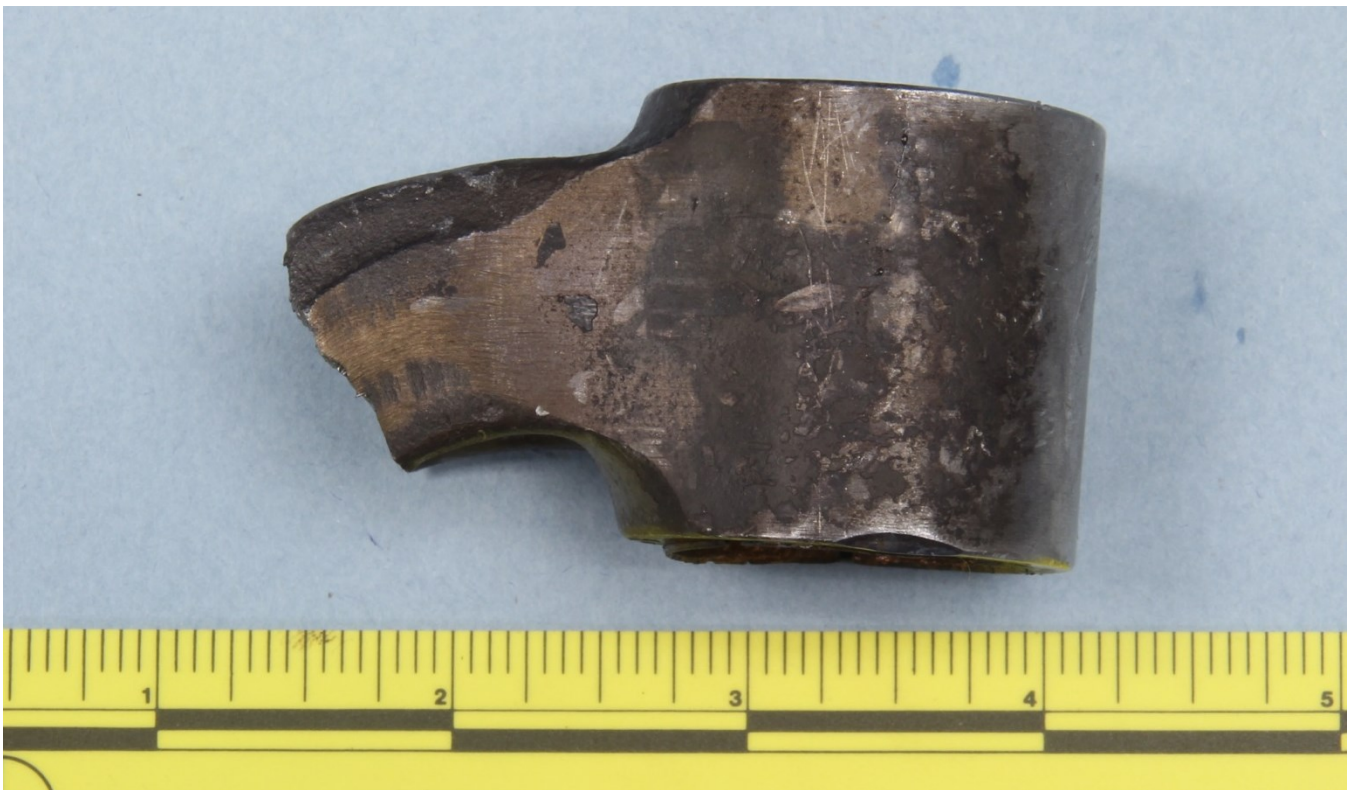
The fractured pieces of the connecting rod are illustrated in Figure 16 and Figure 17. The connecting rod fragment that was attached to the piston pin had been bent along the fracture location. The other fragment, from the connecting rod shaft, had fractured in two places and twisted. One of the shaft fragment fracture surfaces exhibited features consistent with overstress. The other fracture had been damaged by post-fracture smearing.

Figure 16 – The connecting rod fragment that was attached to the piston pin, after cleaning and disassembly.

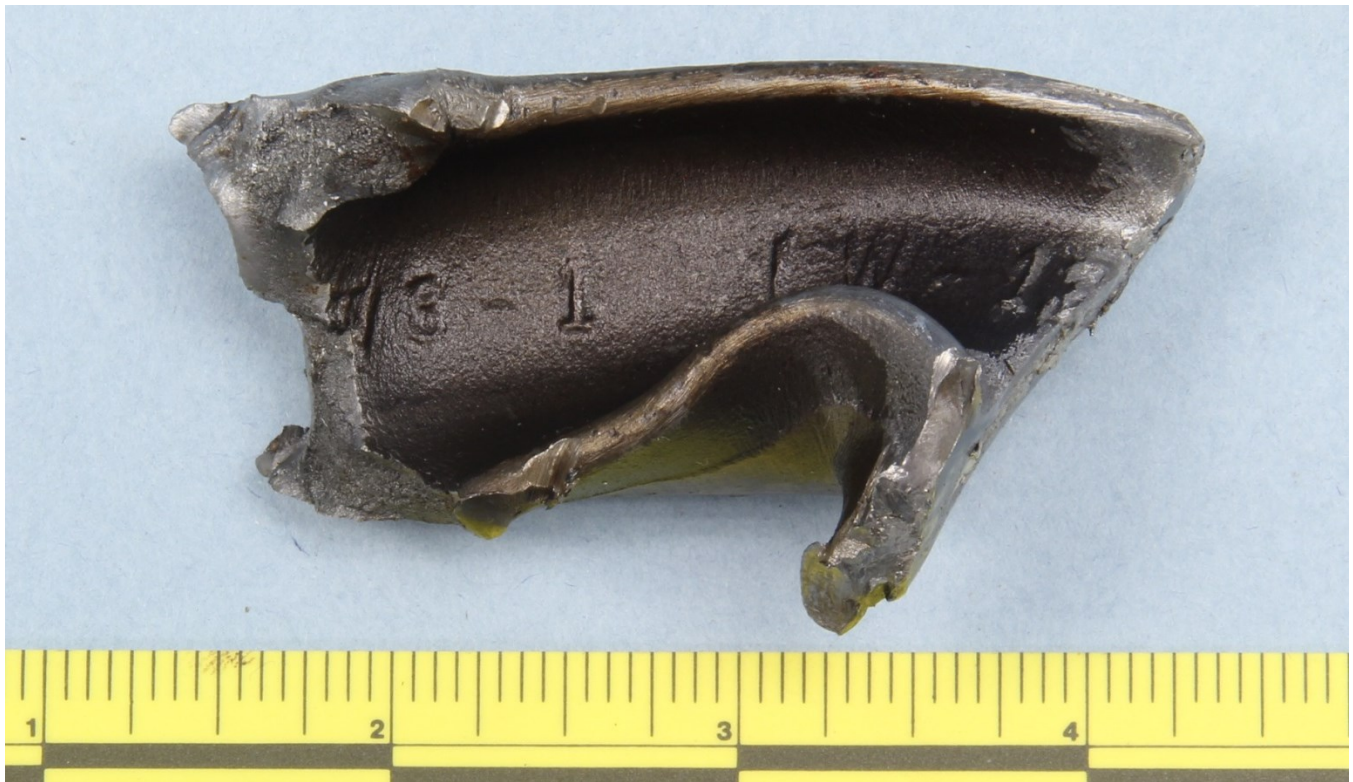
Figure 17 – Fragment of the shaft from the connecting rod, as received.

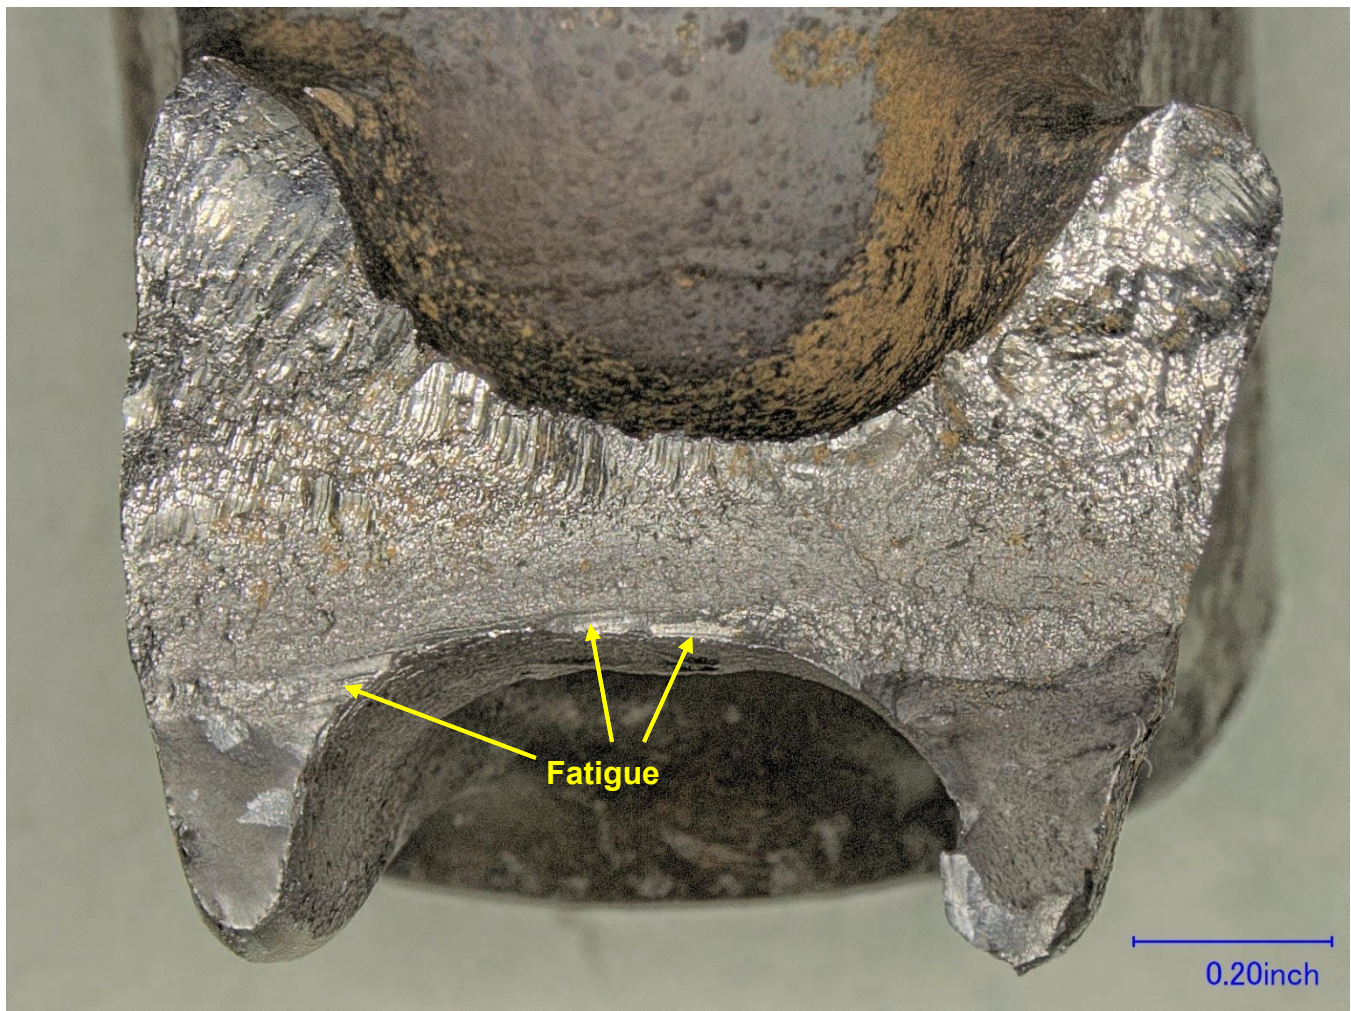
The fracture surface of the connecting rod fragment closest to the piston crown is highlighted in Figure 18. Most of the fracture surface exhibited a rough, tortuous texture, consistent with features typical of overstress failure. However, some of the regions on the fracture surface along the tensile portion of the bend exhibited crack arrest marks, consistent with progressive fracture. These areas are highlighted on Figure 18.

Figure 18 – Closer view of the fracture surface of the connecting rod fragment from Figure 16. The small regions of containing fatigue features (see Figure 19) on the tension side of the bending are labeled (yellow arrows).

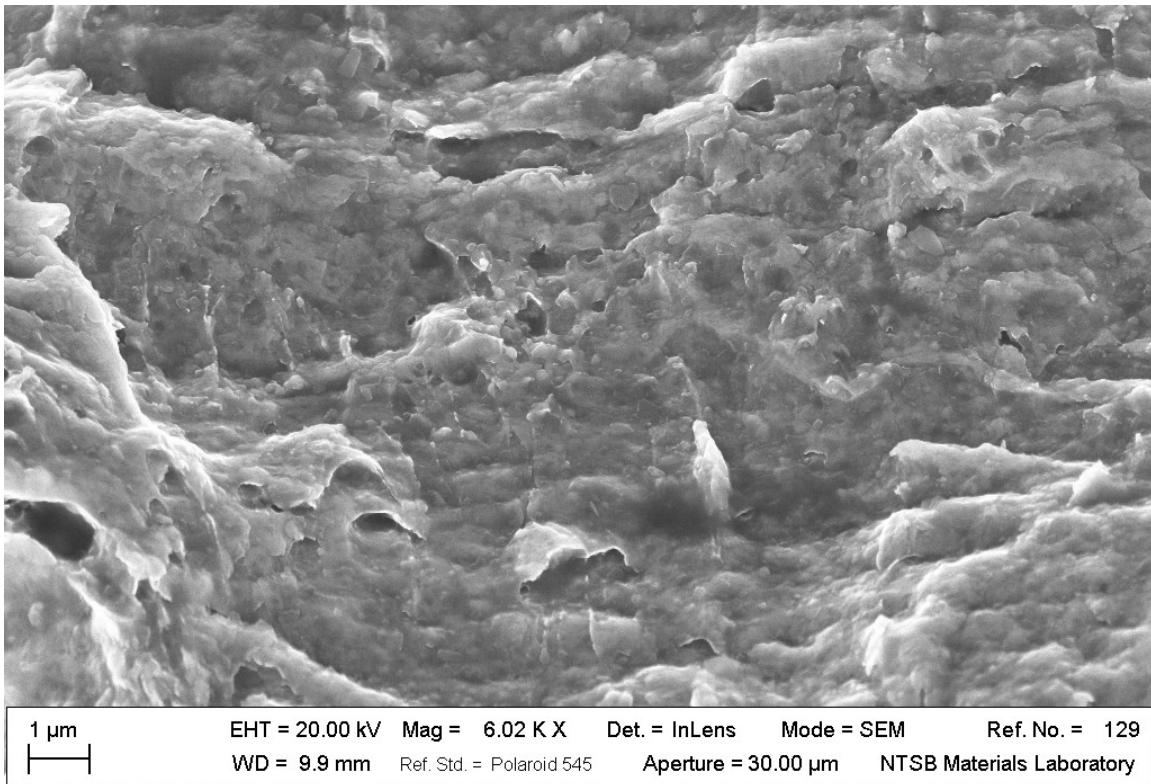
Examination using a SEM found the progressive regions to exhibit striations consistent with fatigue crack propagation (Figure 19). The fatigue striations observed were limited to small regions denoted in Figure 18. The remaining undamaged portions of the connecting rod fracture surface exhibited slanted dimple rupture, consistent with shear or multiple-direction overstress (see Figure 20).

Figure 19 – SE micrograph of the fatigue regions of the connecting rod fracture surface.
