# NATIONAL TRANSPORTATION SAFETY BOARD

## MATERIALS LABORATORY FACTUAL REPORT

Report No. 16-043

Place : Ranger, Texas  
Date : May 11, 2015  
Vehicle : Piper PA-28-161, N3024S  
NTSB No. : CEN15LA228  
Investigator : Michael Folkerts, AS-CEN

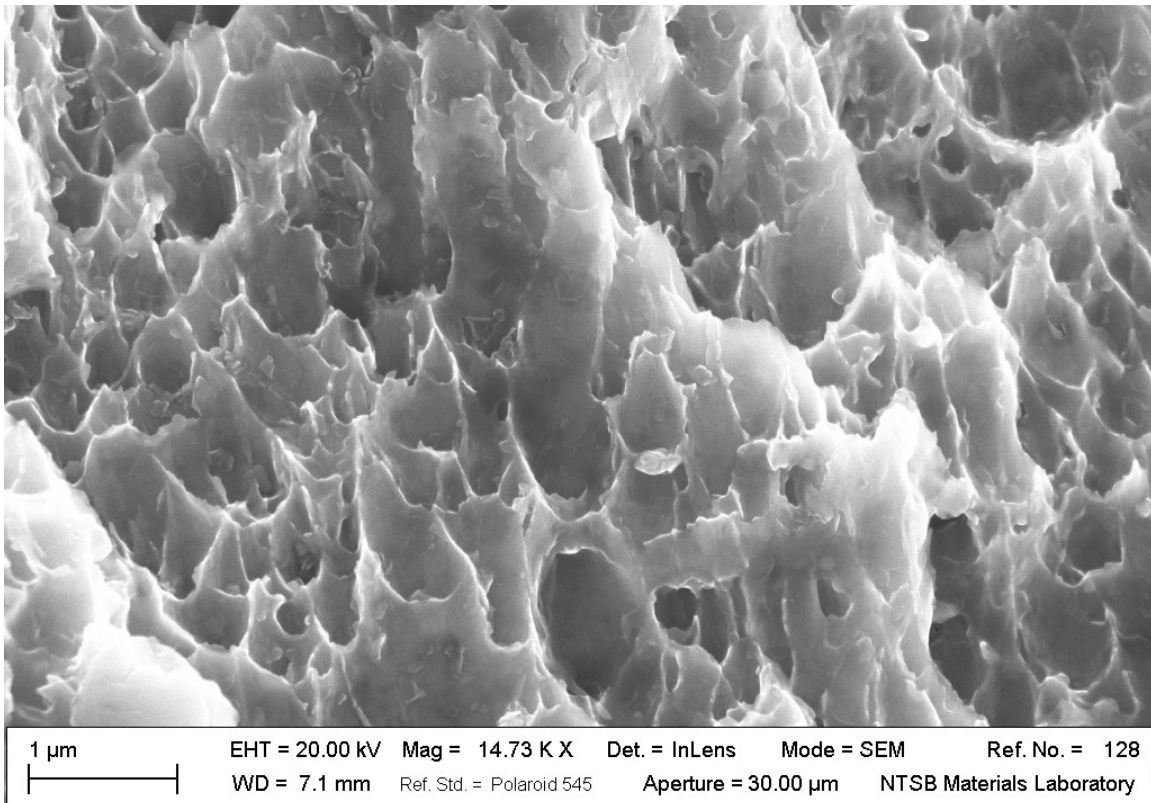
Examination using a SEM found the progressive regions to exhibit striations consistent with fatigue crack propagation (Figure 19). The fatigue striations observed were limited to small regions denoted in Figure 18. The remaining undamaged portions of the connecting rod fracture surface exhibited slanted dimple rupture, consistent with shear or multiple-direction overstress (see Figure 20).

Figure 20 – SE micrograph of the overstress regions on the connecting rod fracture surface.
