## ENGINE FIELD INSPECTION REPORT

| ENGINE MODEL | O-300-D |
| FILE NUMBER | 15-008 |

| EXAMINATION | | ACCIDENT DATA | |
|---|---|---|---|
| DATE | 7/16/2015 | NTSB ACCIDENT # | CEN15LA298 |

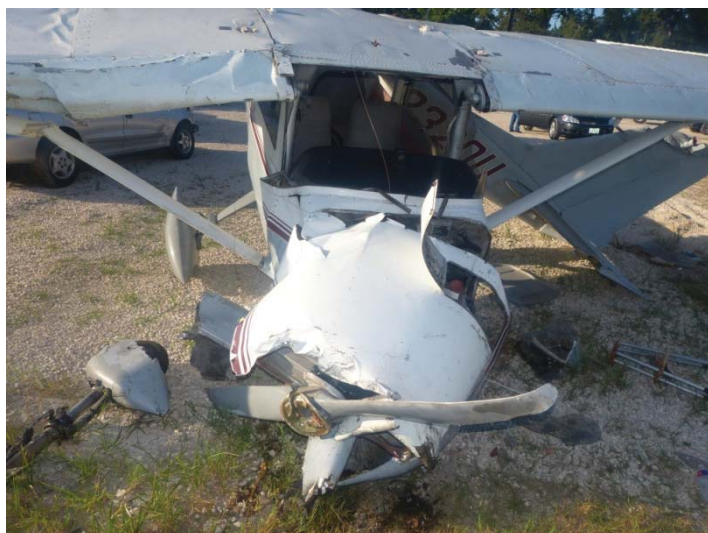
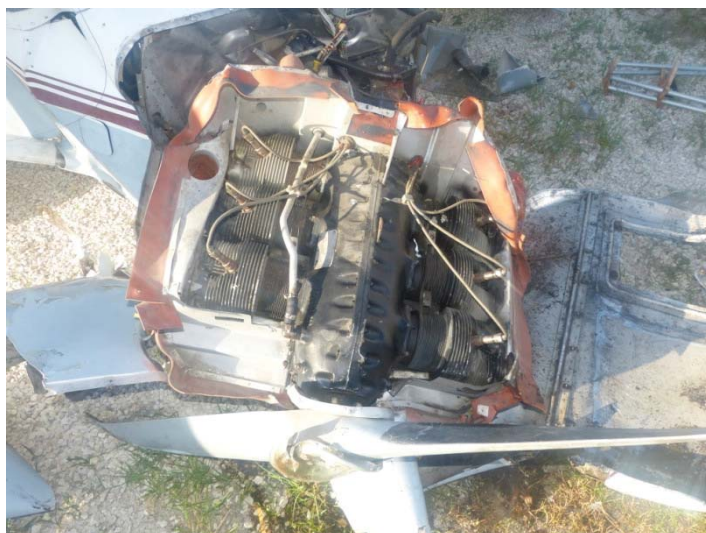
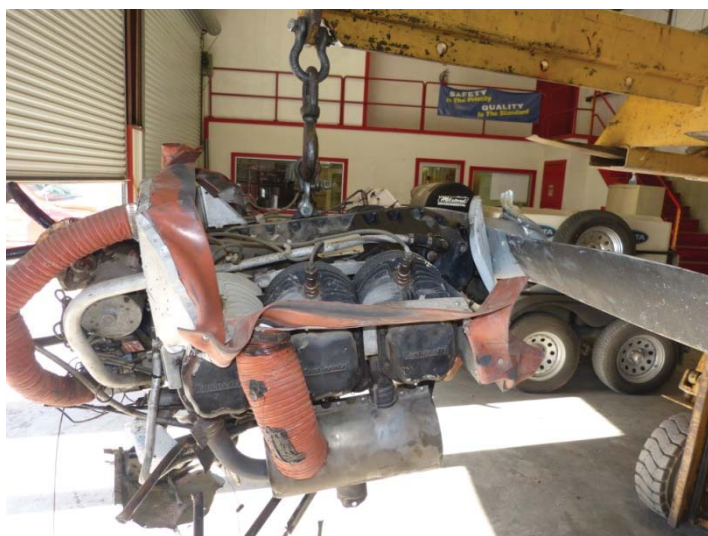
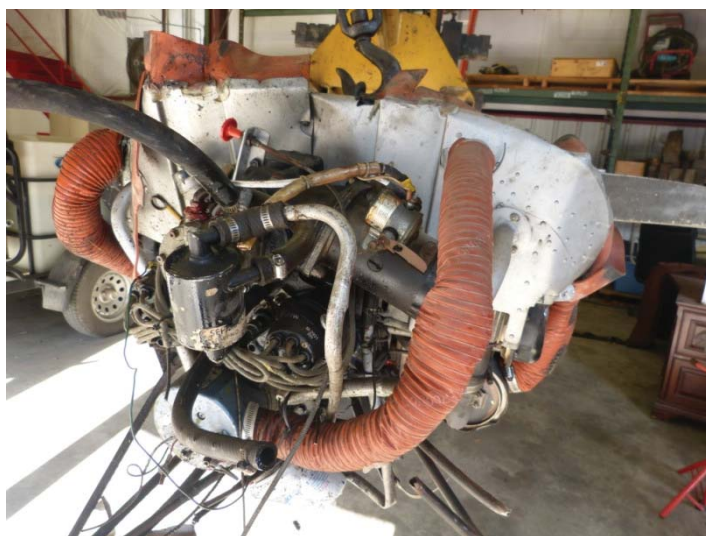
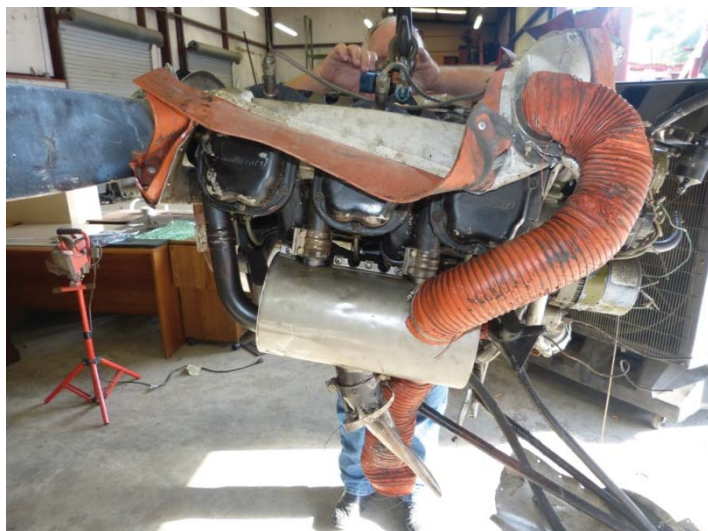
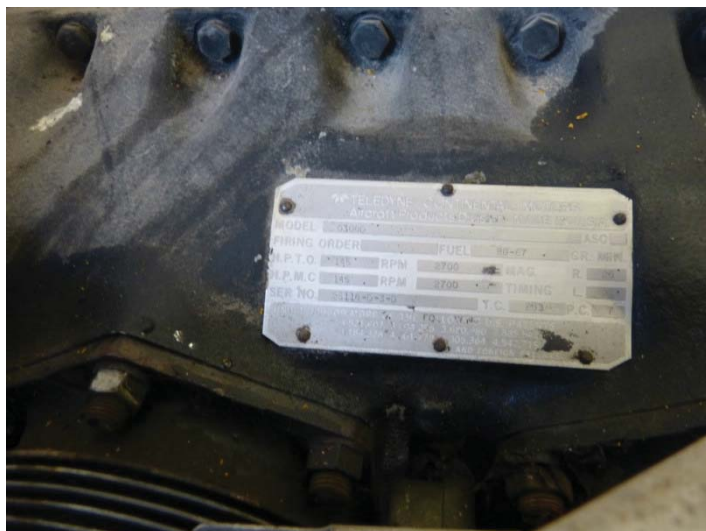
The engine was intact with all of the accessories attached. The engine intake air box was crushed and separated from the carburetor. The oil filter was partly crushed, exposing the filter element. Both mufflers had impact damage, and the number six cylinder rocker cover was impact damaged.

The top spark plugs and rocker covers were removed from the engine. The cylinders were examined using a lighted boroscope. All of the cylinder domes and pistons had normal combustion deposits. All of the valves were in place and not damaged. The crankshaft was rotated using the propeller. Continuity was confirmed to all of the cylinders and to the rear of the engine. Good thumb compression was obtained on all of the cylinders. Both magnetos sparked at all ignition leads when the crankshaft was rotated.

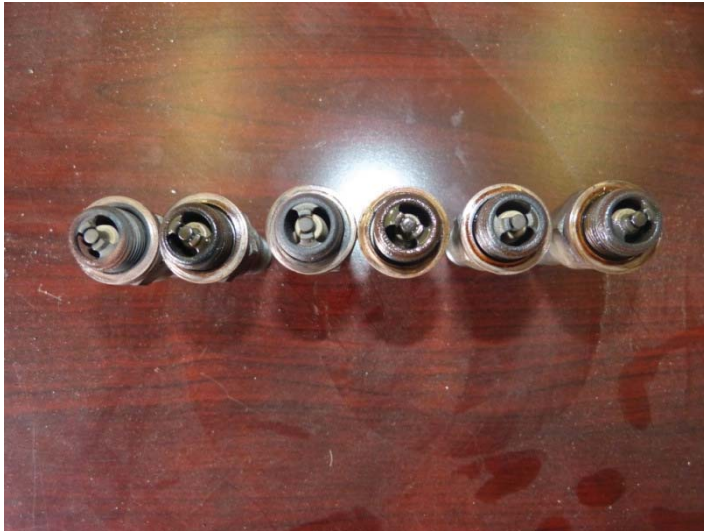
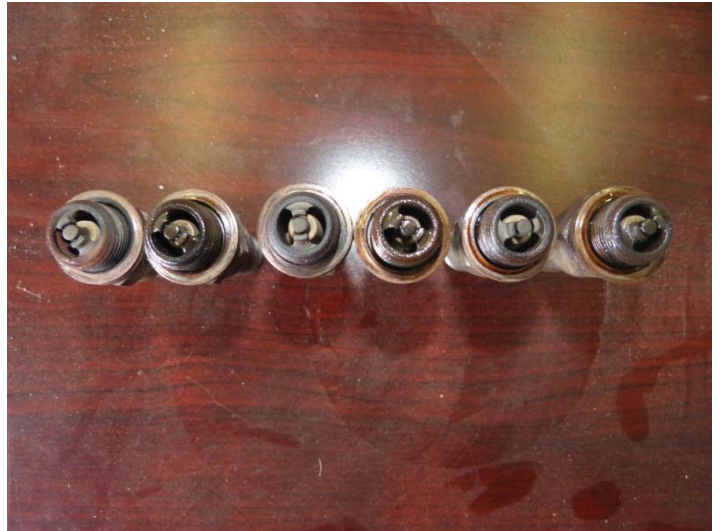
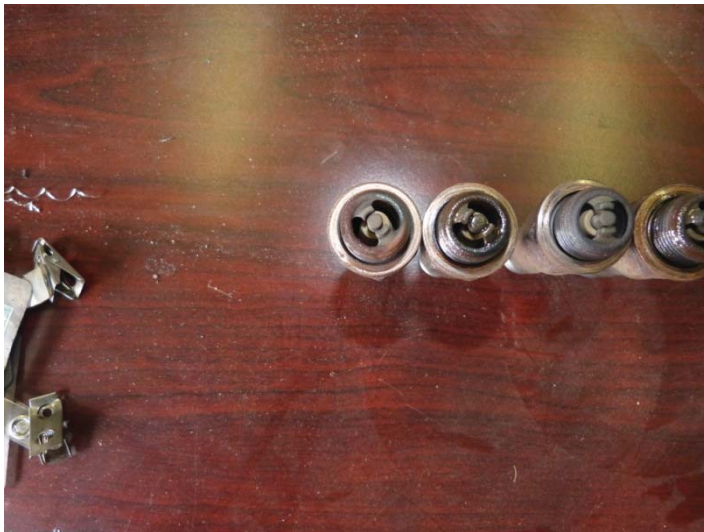
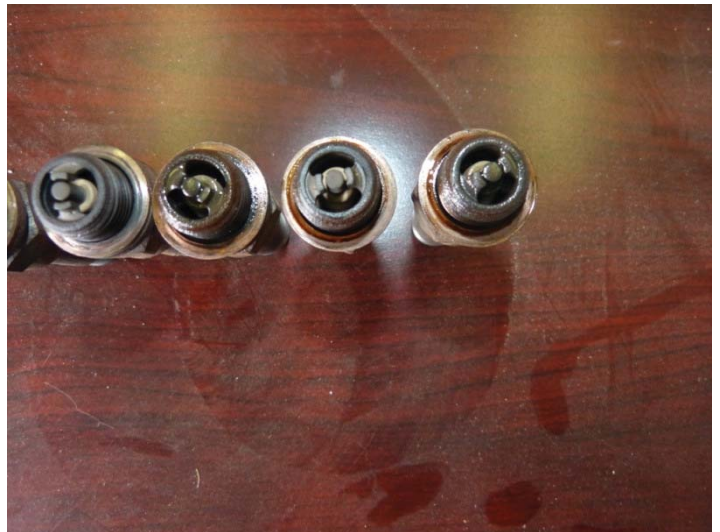
Spark Plugs: Autolite UREM-40E

The top spark plugs were removed and examined. They had normal wear then compared to the Champion Check-A-Plug comparison card. They had light gray deposits in the electrode areas. Spark plugs two, four and six had oil deposits in the electrode areas.

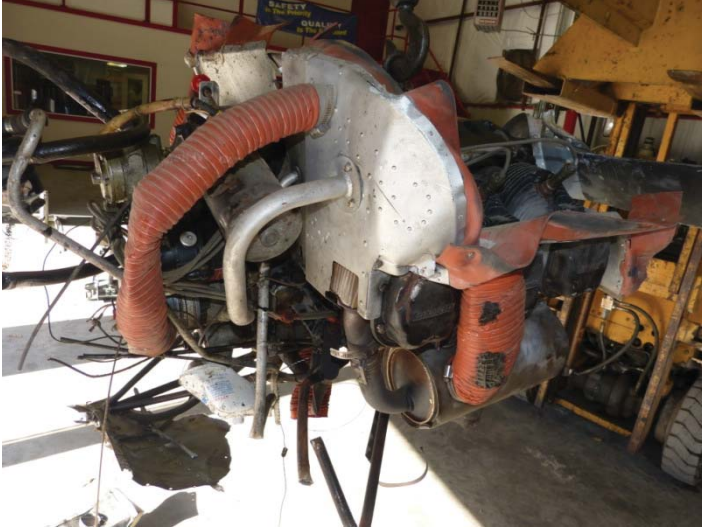
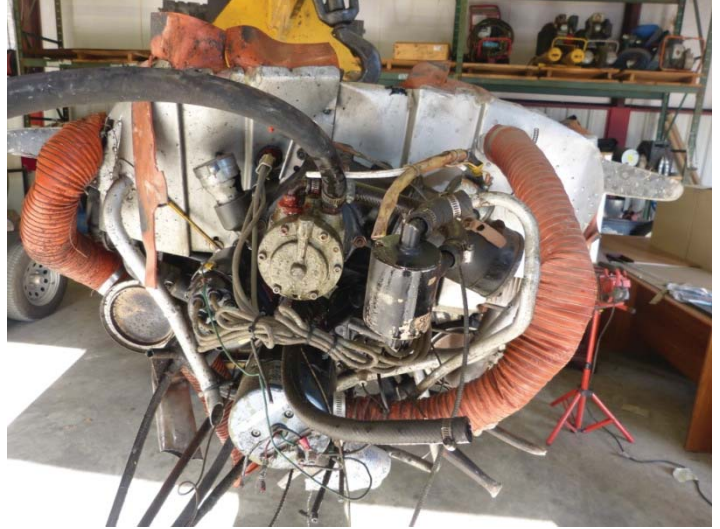
Magnetos: Left, Slick-6364, SN-0508793

Both magnetos were in place and not damaged. Both impulse couplings snapped at top dead center on the number one cylinder when the crankshaft was rotated. Both magnetos sparked at all ignition leads when the crankshaft was rotated.

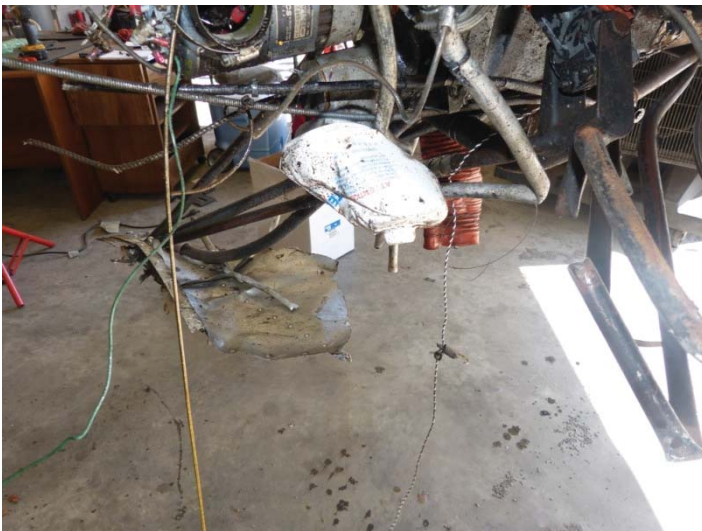
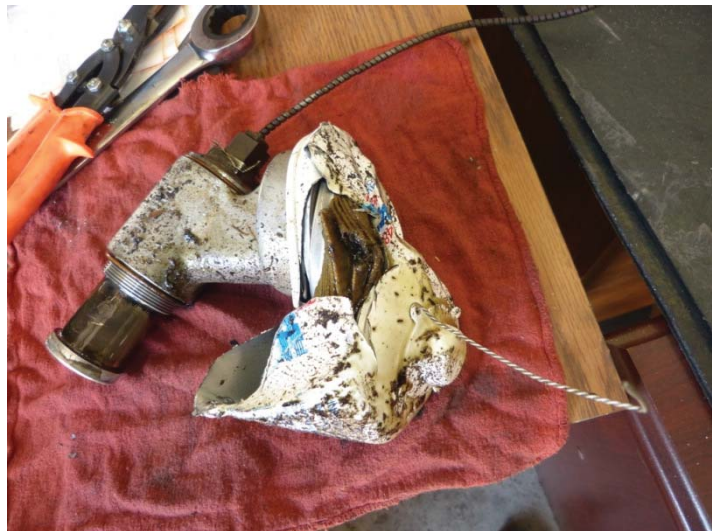
Oil Filter: Tempest

The numbers 6/16/15, 5245.5 were written on the side of the filter. The oil filter was attached, but was partly crushed exposing the filter element. The oil filter was opened and no metal particles were observed on the filter element.

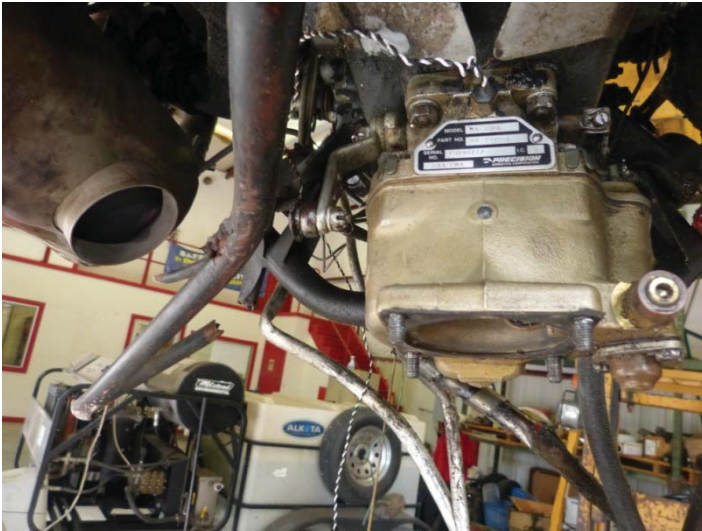
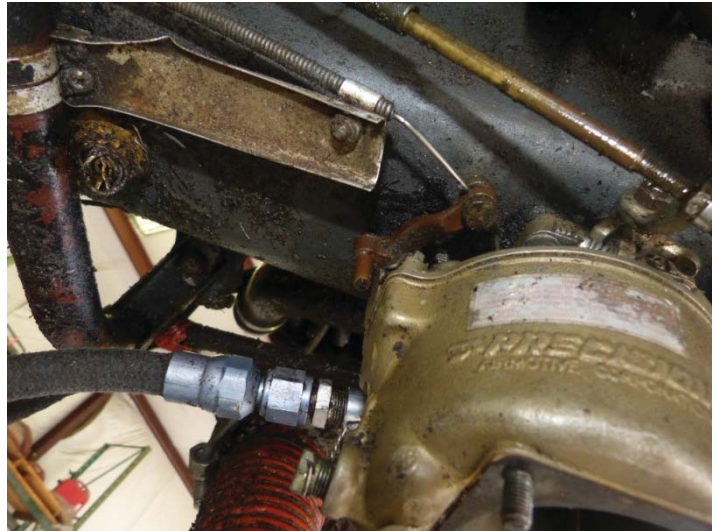
Carburetor: Marvel Schebler MA-3SPA, PN-10-4895-1, SN-75093717

The carburetor was in place and not damaged. The carburetor air box was separated and crushed. The carburetor heat actuating arm cable was attached and the arm was free to move. The throttle and mixture controls were hooked up and were free to move. The fuel screen was clean and clear. The float and needle valve were attached and were free to move. The needle valve seat was clean. The accelerator pump operated properly.

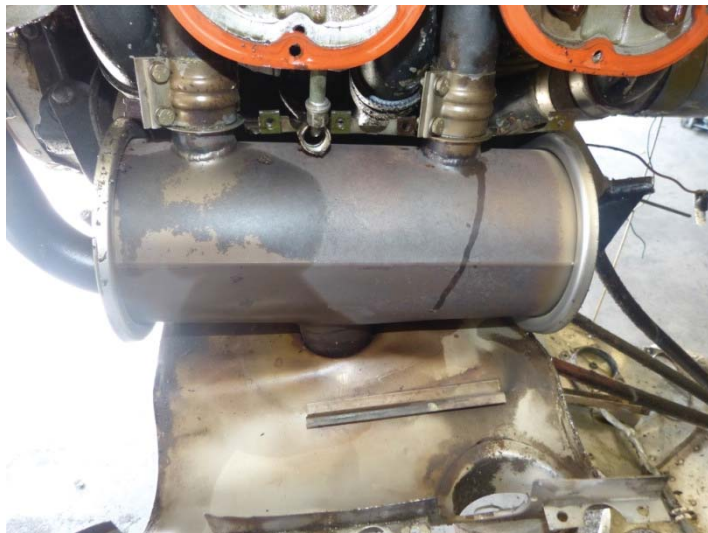
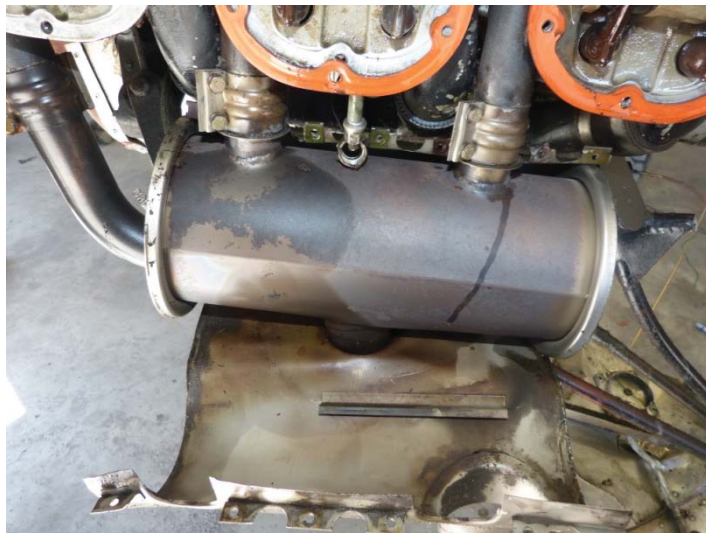
Mufflers: The mufflers were in place and had light impact damage. They were opened and examined and no internal damage was observed.

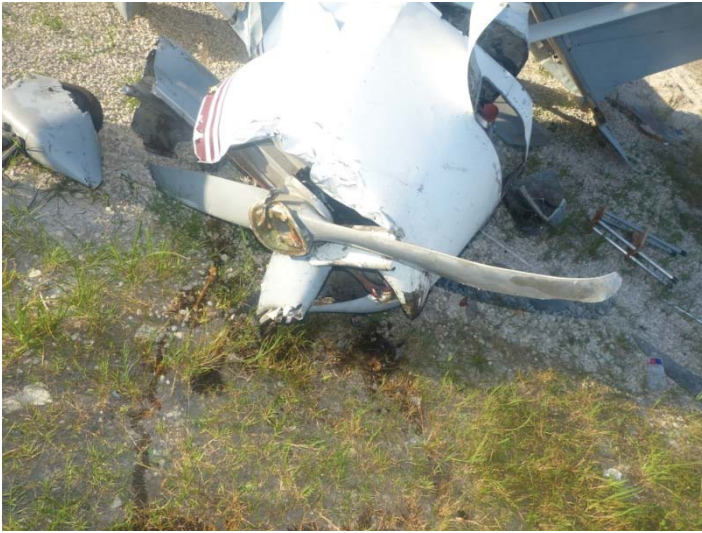
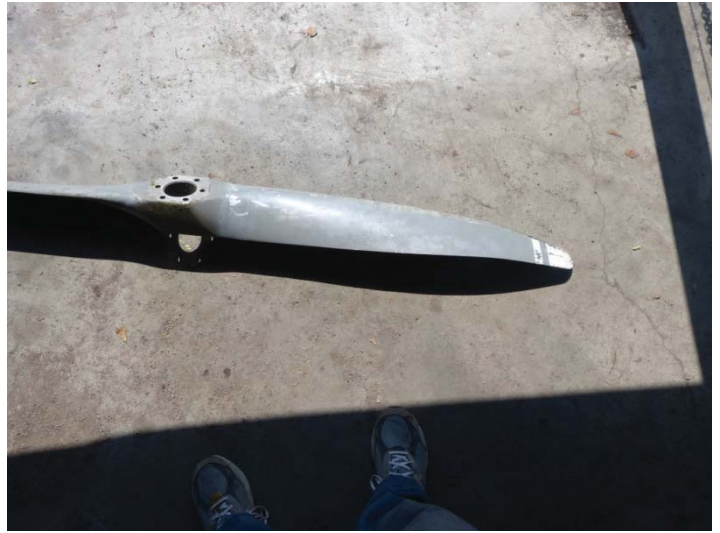
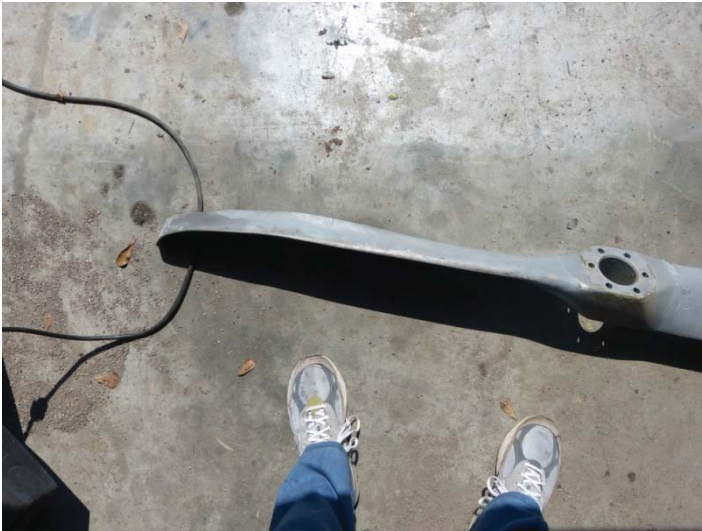
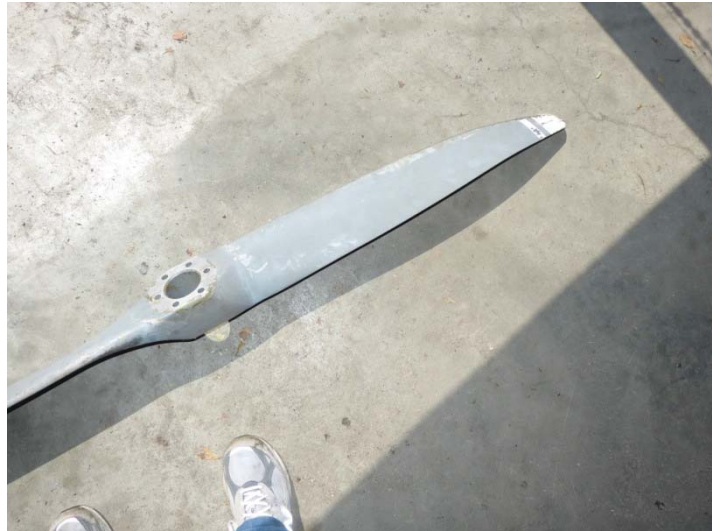
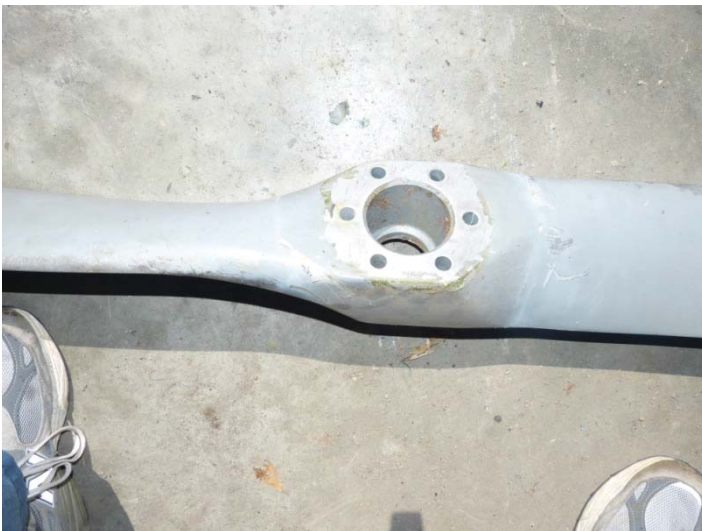
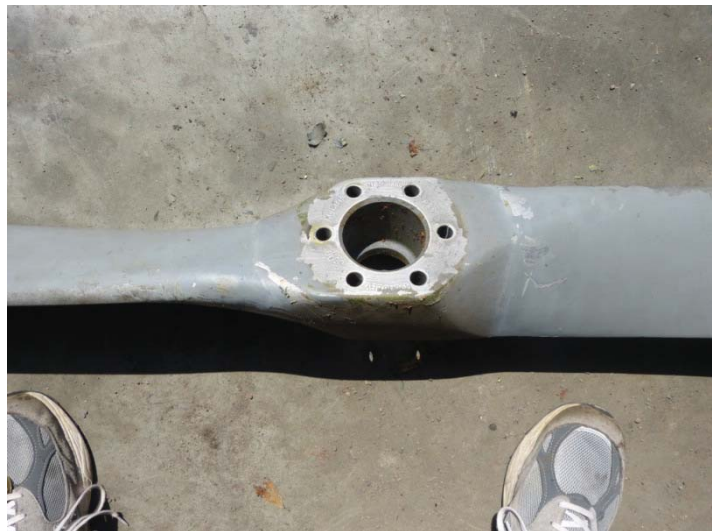
Propeller: McCauley, 1C172, SN-76865, DES7653

The propeller was in place on the crankshaft. The spinner was missing. Both blades were bent toward the non-cambered side near the tip.
