## **INVESTIGATION REPORT**

| <b>Aircraft Model:</b> | Clipper 582 | <b>Aircraft S/N</b> | Unknown |

| <b>Engine Type:</b> | Rotax 582 Mod 90 | <b>Engine TTSN</b> | Unknown |

| <b>RFS File number:</b> | 2015-030 | | |

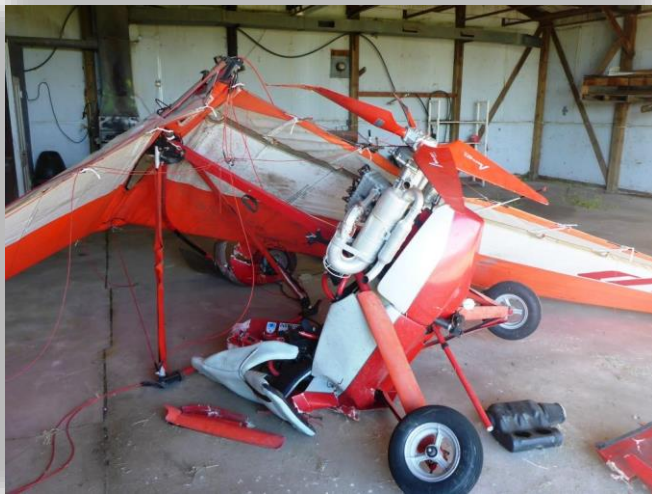
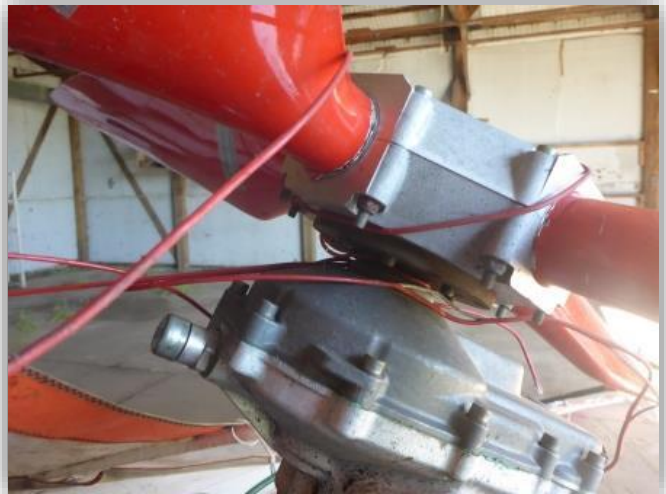
The aircraft sustained severe frontal impact damage. The Rotax 582 Mod 90 engine was still attached to its engine mount and appeared to be in good physical condition due to its location on the aircraft (Pusher Configuration). The intake silencer (Air box) was separated from the carburetors due to impact and was sitting next the aircraft wreckage on the hanger floor.

The wing cable cords were found wrapped tightly around the propeller shaft indicating the propeller was turning at the time of impact.

The coolant radiator was also separated from the airframe due to impact damage. All three propeller blades were still attached to the propeller hub but also sustained damage.

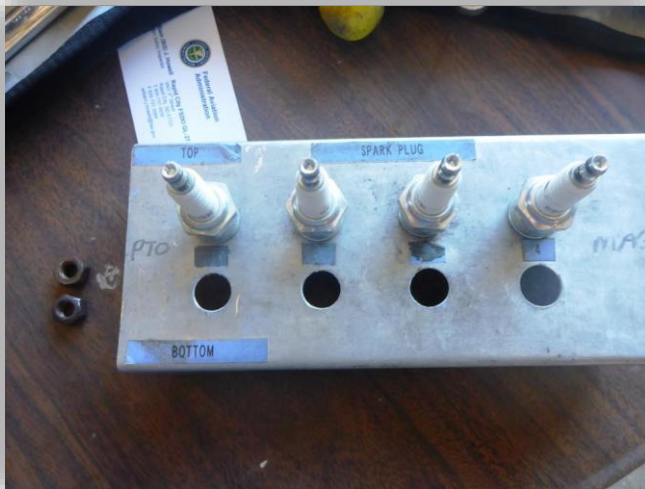
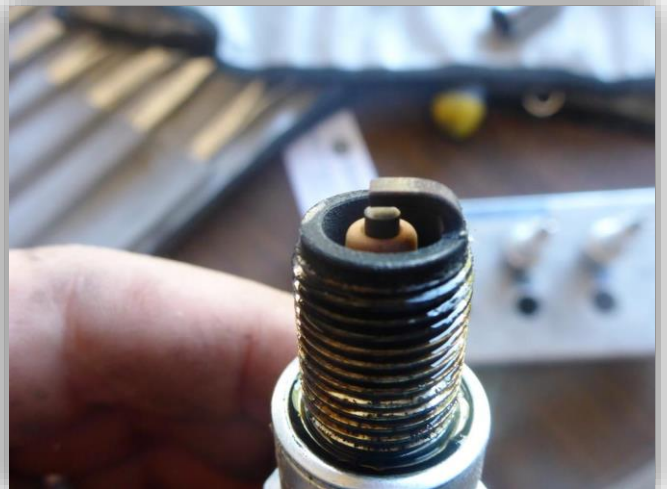
The spark plugs were in good physical condition but had removable resistor caps and a electrode gap of .032. Rotax states the spark plugs should not have a removable resistor caps and have an electrode gap of .018 - .020.

Insufficient spark plug gap can cause pre-ignition, detonation and even engine damage. Too much electrode gap can result in a higher rate of misfires, loss of power, plug fouling and poor fuel economy.

The spark plug electrodes were examined to determine proper carburetor calibration. The spark plug electrodes were brownish in color indicating that the correct carburetor calibration was established. No other anomalies were found with the spark plugs.

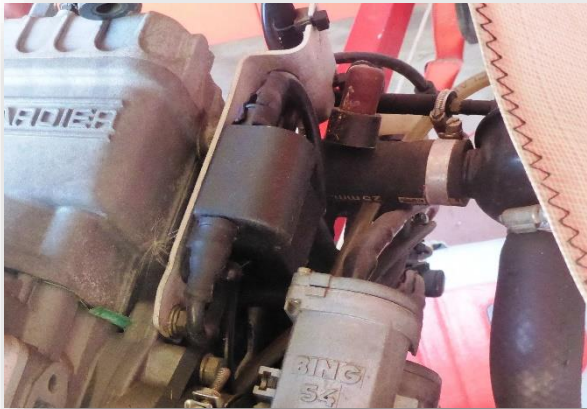
The ignition models and ignition wires were examined for condition and conformity. The ignition modules were the proper type and in good physical condition.

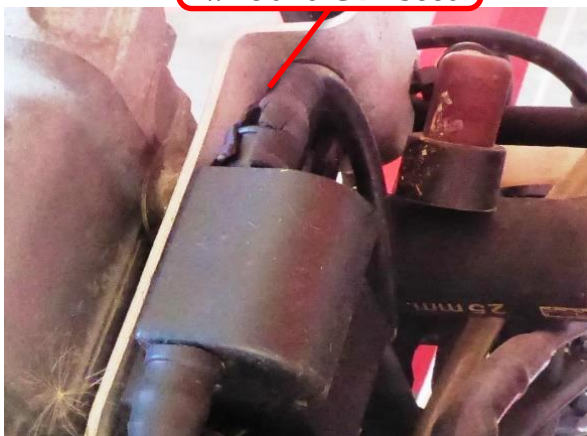
**Crack in Ignition wire and CDI boot**

A cracked boot was found on the # 4 MAG spark plug ignition wire. This boot is to protect the contacts from the elements. Rotax maintenance manual section **10.2) Maintenance schedule** it states that checking of the ignition system is to be done every 25 hours. (See **Appendix A for the Rotax Maintenance schedule**)

Rotax maintenance manual section **11.9) Check of the ignition system** states to “ Verify all electrical connections for good contact and ensure there are free of corrosion. Inspect the wiring for wear, damage and corrosion.

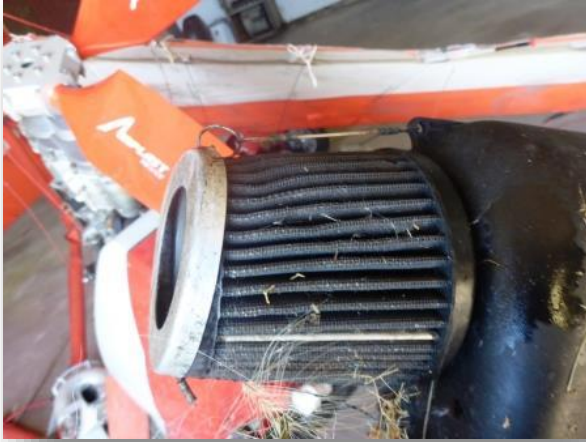
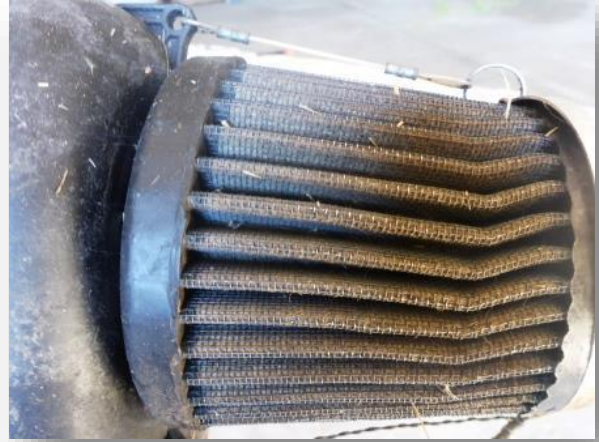
The air filter was examined for condition and conformity. The air filter was found to be dirty which would affect the overall performance of the engine.

In the Rotax operators manual section **10.3.2) Daily checks**, it states **WARNING:** Repair as necessary all discrepancies and shortcoming before flight. It also states to Verify security and condition of intake silencer and air filter.

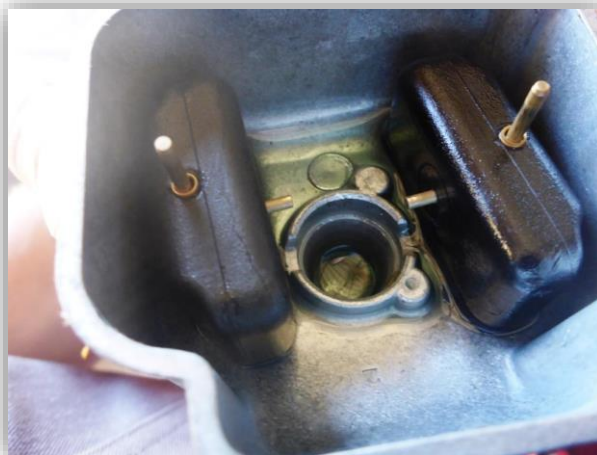
An optional intake silencer was installed on this aircraft. Installation of the intake silencer requires different carburetor main jetting. The main jet that is required to be installed when an intake silencer is used on a Rotax 582 engine is a #145 main jet.

No contamination was found and the main jet was #145 as required with the use of an intake silencer.

A small amount of blue tinged liquid constant with pre mix fuel was found contained within the MAG carburetor float bowl. No contamination was found and the main jet was #145 as required with the use of an intake silencer.

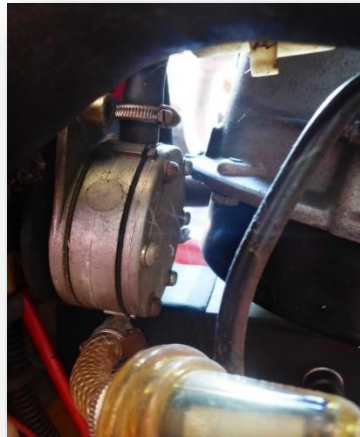
The fuel pump was examined for condition, proper type and mounting position. The fuel pump was the proper type and in good overall condition. It was mounted with the weep drain hole towards the bottom of the fuel pump as recommended in the Rotax installation manual. No anomalies were found with the fuel pump.

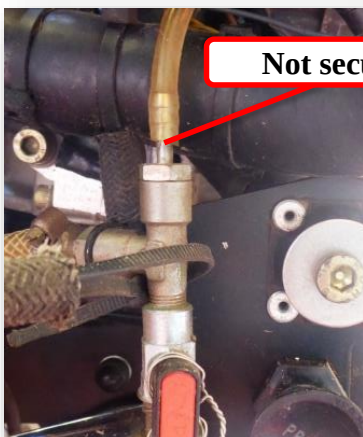
The fuel lines were examined for condition, security and proper routing. The fuel line from the fuel primer plunger to the fuel pump was not secured. In the Rotax repair manual section **10.2.5) Elimination of air leaks in the fuel line:** It states that "Some commercial clips are often not very satisfactory on small pipes, as they tend to tighten up oval, creating a possible leak. "Crimp on" clips can be unsatisfactory if incorrectly applied, and are difficult to remove for servicing. Replace all doubtful fuel line clamps with good quality approved ones." Rotax recommended clips are P/N 938 195 which are a spring type clamp.

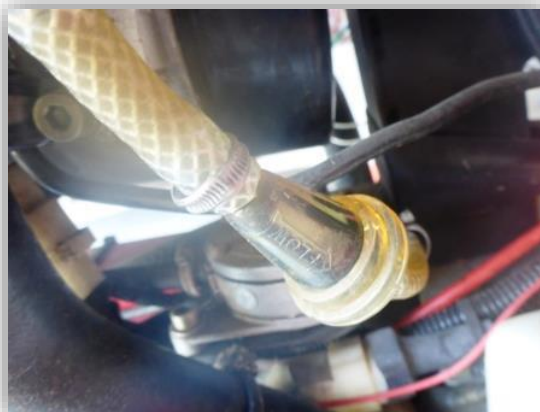
There was only one fuel filter installed on this aircraft ( 2 are required for dual carburetor set up). The fuel filter was examined for proper type and obstructions. No obstructions were seen. No further anomalies were seen with the fuel filter.

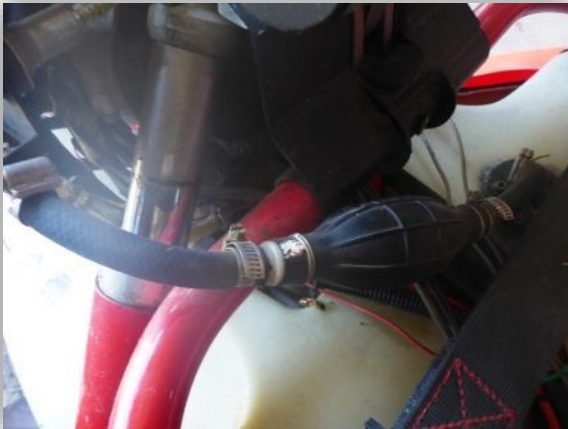
**Fuel Lines (Continued)** The fuel system was equipped with a primer bulb between the fuel tank and the fuel pump. Rotax does not state the use of a primer bulb in the Rotax installation manual. Primer bulb check valves can fail causing a blockage of fuel to the engine. It is standard practice and recommended that a by pass system be installed around the primer bulb with the use of a fuel valve as seen in the diagram below.

- No fuel line by-pass was found around the primer bulb. If the primer bulb check valve ever became dislodged it could block fuel flow to the carburetors.

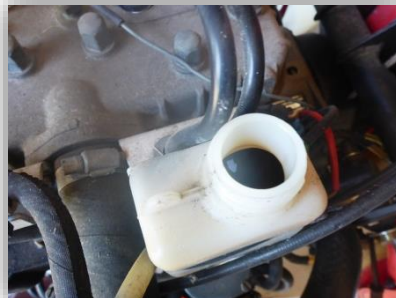
**Rotary Valve lubrication:** The Rotax 582 comes equipped with a separate rotary valve lubrication system. Inspection of this system did not indicate any anomalies and the tank still had evidence of oil contained within it.

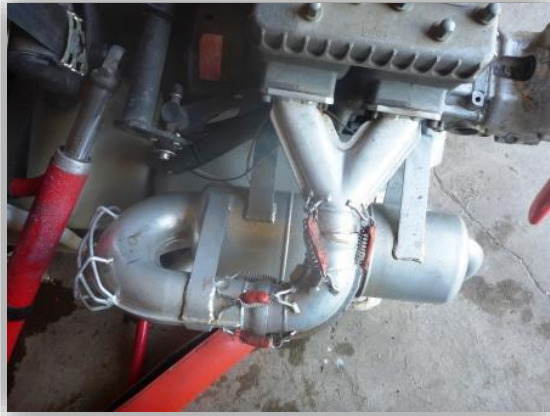
The exhaust system was examined for condition , modifications and the proper approved type. The exhaust appeared to be in good overall condition and of the proper type. No anomalies found with the exhaust system.

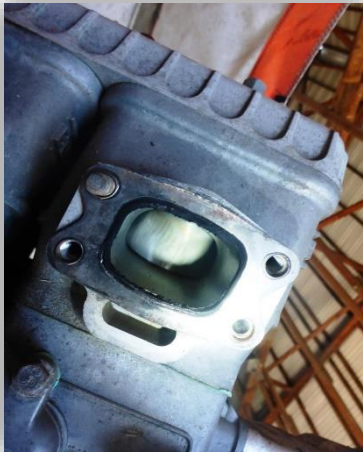
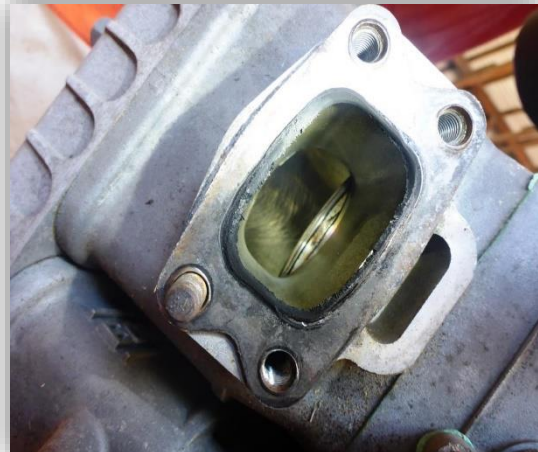
With the exhaust ports exposed the exhaust side of the Power take-off piston could be examined. No metal transfer, vertical scoring or seizure marks were seen on the exhaust side of the Power take-off piston.

The Power take-off piston rings were free in there respective ring land grooves and were in good overall condition. No anomalies were found on the exhaust side of the PTO piston.

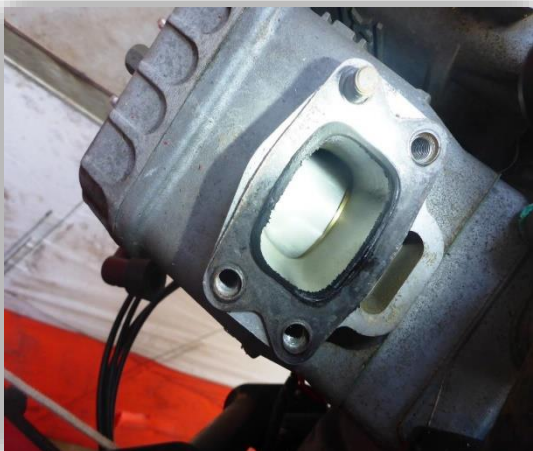
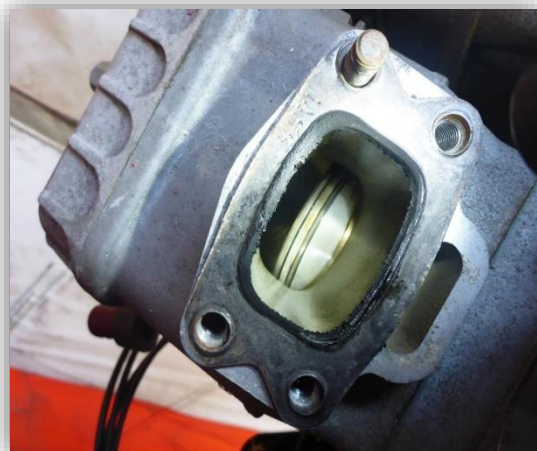
With the exhaust ports exposed, the exhaust side of the MAG piston could be examined. No metal transfer, vertical scoring or seizure marks were seen on the exhaust side of the Power take-off piston.

The MAG piston rings were free in there respective ring land grooves and were in good overall condition. No anomalies were found on the exhaust side of the MAG piston.
