# NATIONAL TRANSPORTATION SAFETY BOARD

## Onboard Image Recorder

**Specialist's Factual Report**  
**By Sean Payne**

Location: Humboldt, Iowa  
Date: August 9, 2015  
Aircraft: Larry D Erickson RAF 2000 GT  
Registration: N315LK  
Operator: Private  
NTSB Number: CEN15LA344

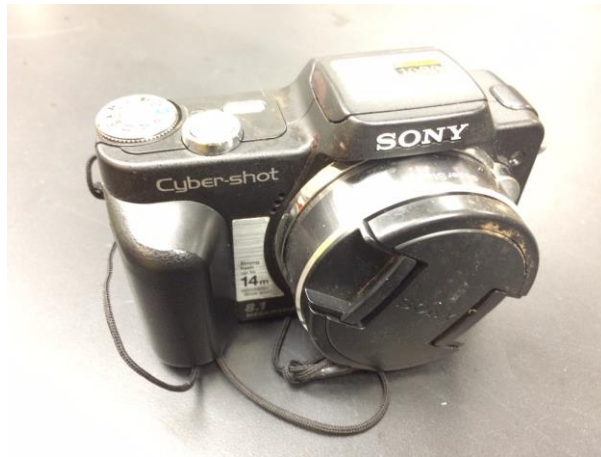
Upon arrival at the Vehicle Recorder Laboratory, an examination revealed the unit had sustained only light damage and information was extracted normally from the device's Memory Stick<sup>3</sup> flash<sup>4</sup> card.

**Figure 1.** Photo of undamaged unit
