| <div style="display: inline-block; vertical-align: middle;"> Rolls-Royce Corporation<br/> P.O. Box 420<br/> Indianapolis, Indiana 46206-0420 USA </div> | | <div style="display: flex; justify-content: space-between;"> <div> PAGE<br/><b>1</b> </div> <div> OF<br/><b>83</b> </div> </div> | <div style="text-align: center;"> REPORT NO.<br/> <b>15FA8-072-PR</b> </div> |
| <b>TITLE</b><br><br>METALLURGICAL INVESTIGATION OF A THIRD STAGE TURBINE WHEEL P/N 23065818 REMOVED FROM M250-C20J ENGINE CAE832989 OPERATED BY FLY HANGAR 13 LLC. | | PREPARED<br><br><div style="text-align: center;"><i>Signatures on File</i></div> | |

**Part Name:** Third Stage Turbine Wheel  
**Part Number:** 23065818  
**Part S/N:** X597059  
**Total Part Time:** 930 Hours (TSO)  
**Engine Model:** M250-C20J  
**Engine S/N:** CAE832989  
**Removal Station:** Rolls-Royce Corporation, Indianapolis, IN.  
**User:** Fly Hangar 13 LLC

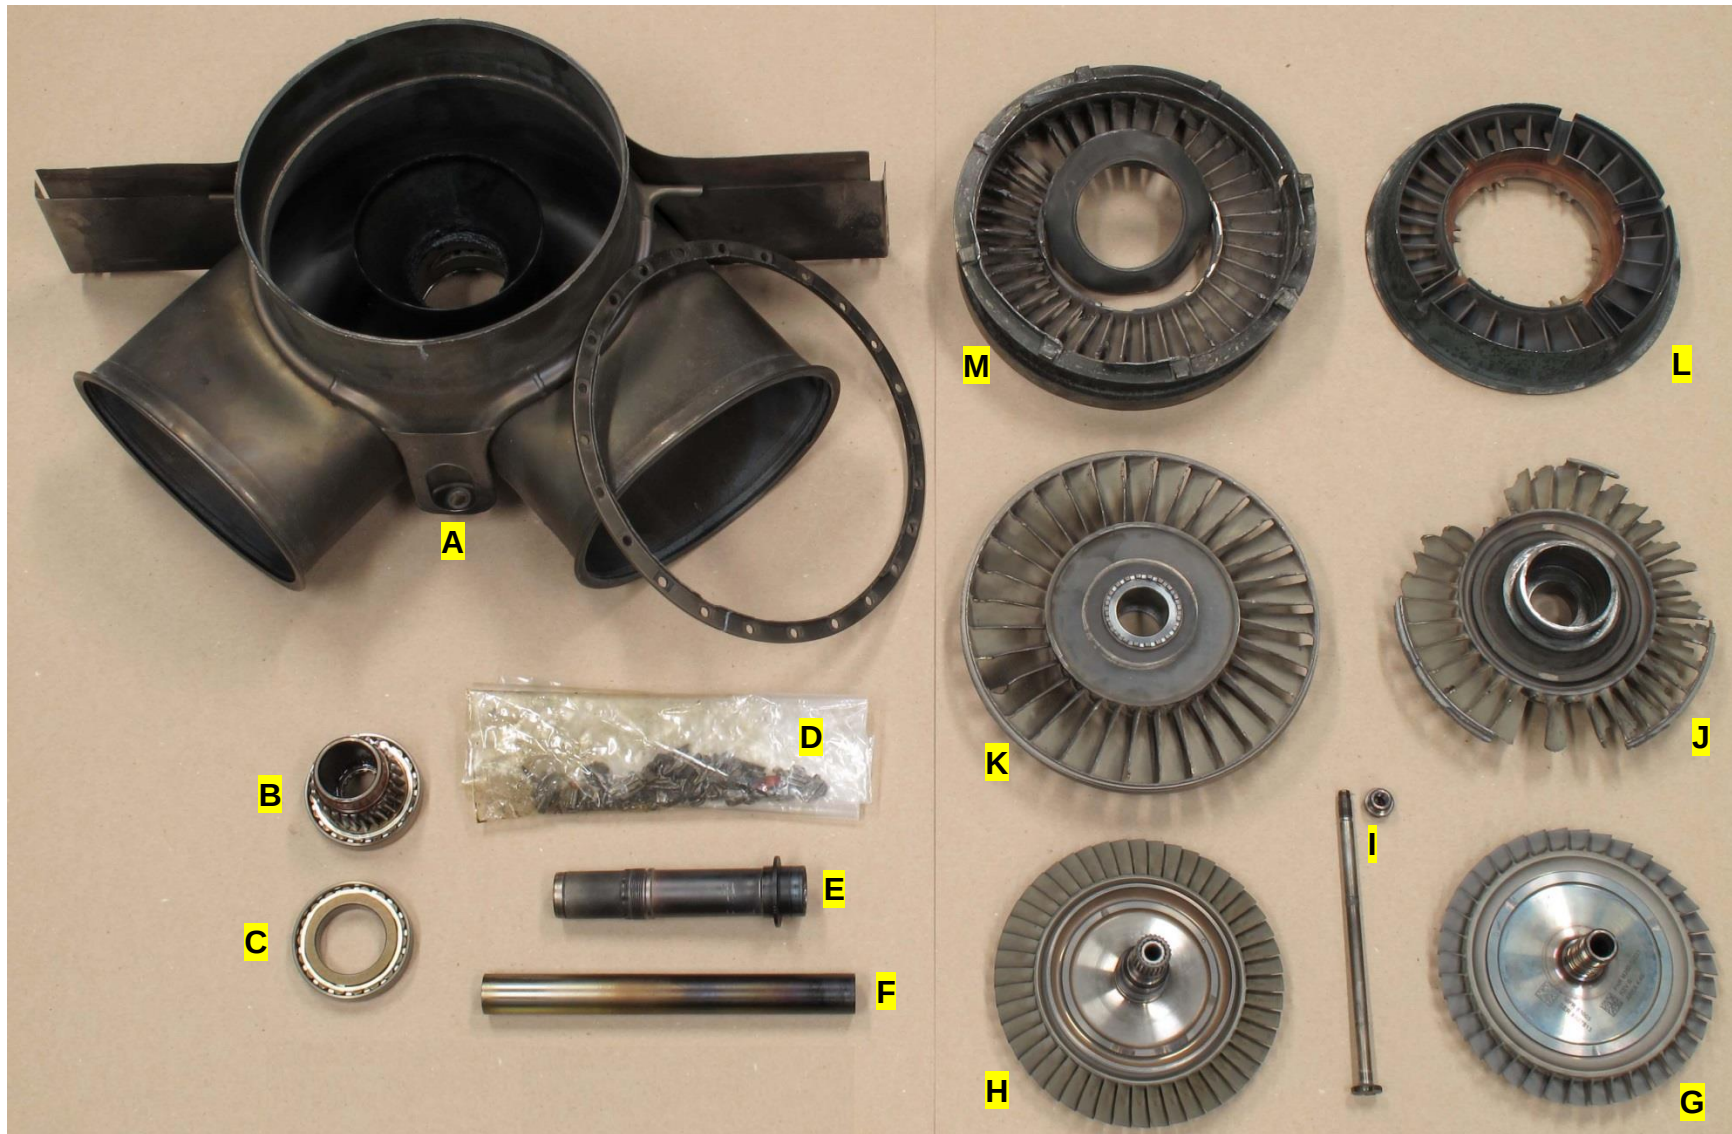
Table 1 lists the engine components submitted to the Rolls-Royce Corporation Materials Laboratory for detailed examination and metallurgical investigation. A photograph of the components in the as-received condition is shown in Figure 1.

Figure 1. Photograph showing the as-received condition of the engine components submitted to the laboratory.

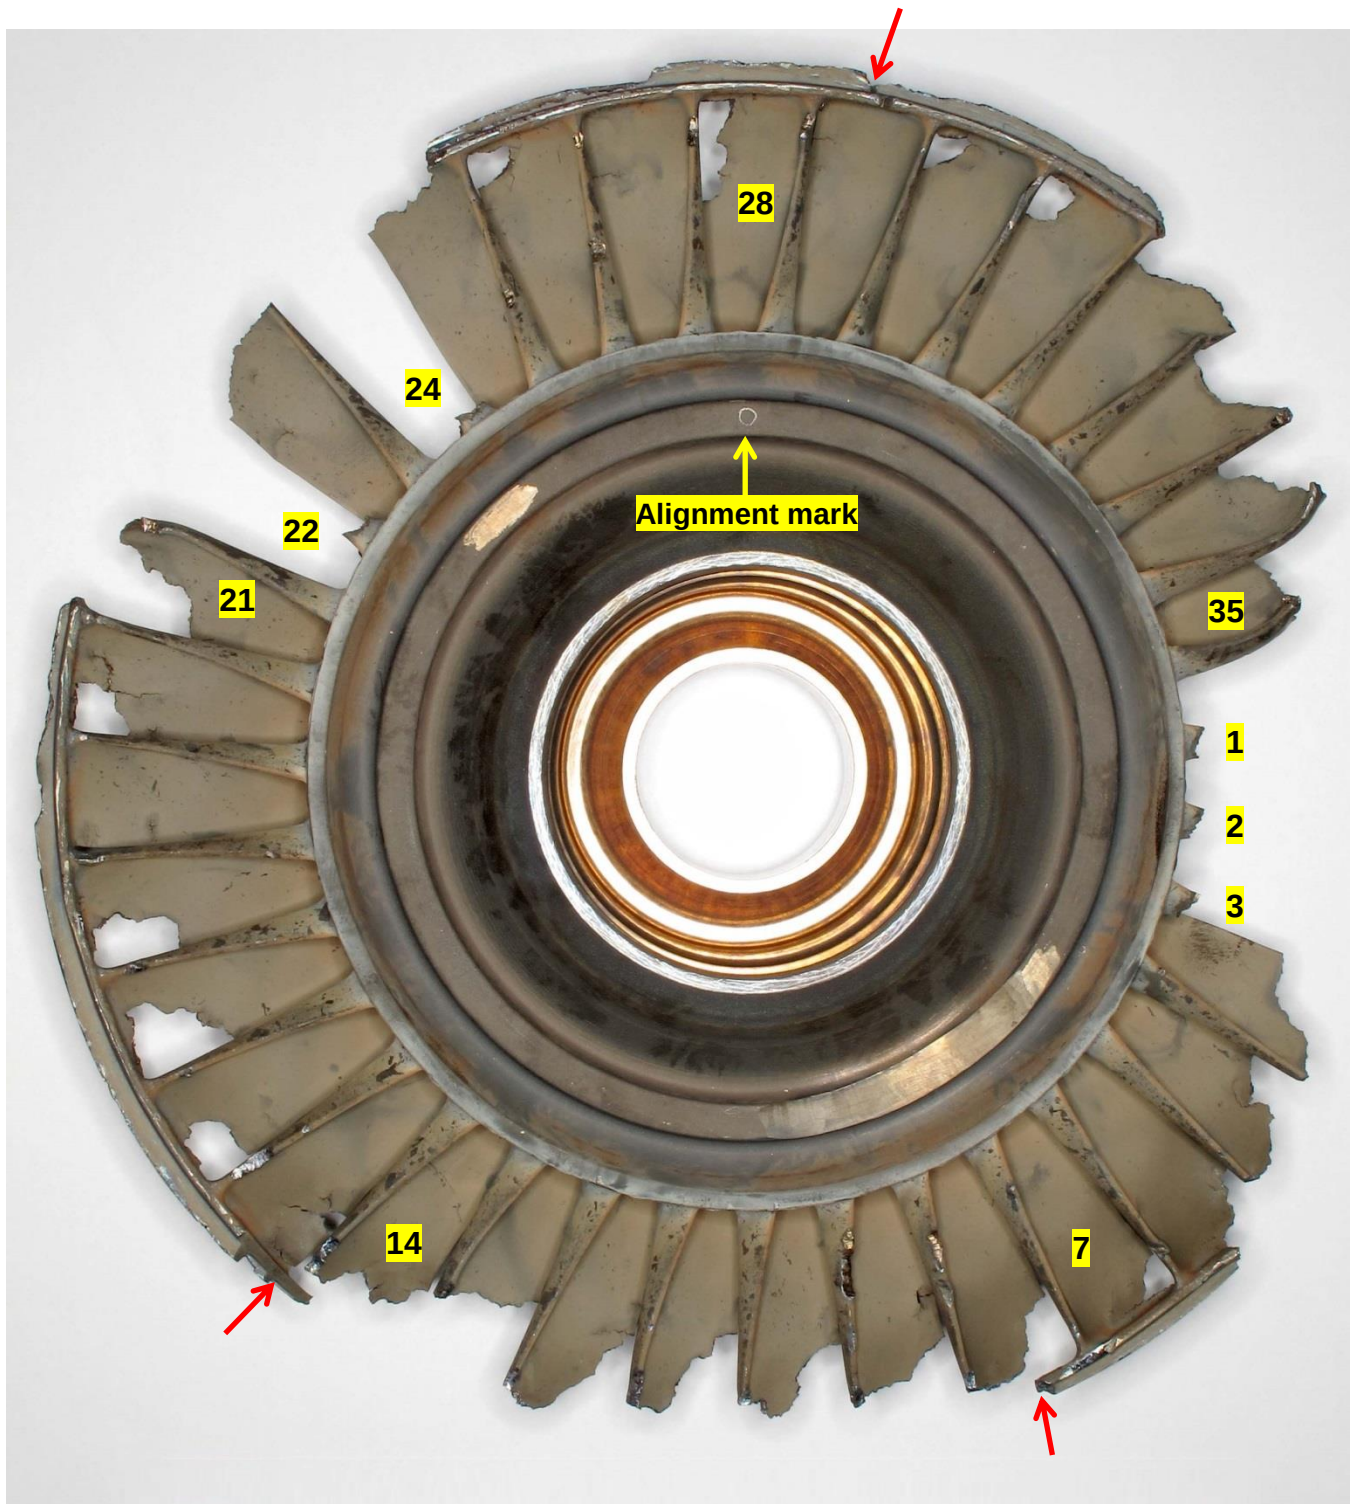
Figure 2 and Figure 3 show leading edge (aft looking forward) and trailing edge (forward looking aft) views of the third stage turbine wheel respectively. The blades were numbered sequentially clockwise (leading edge view) beginning with one of the fractured airfoils as shown in Figure 2. Five airfoils cracked and liberated just outboard of the rim at airfoil locations 1, 2, 3, 22, and 24. Remnants of the shroud revealed the original locations of three of the slots between airfoils 7 and 8, 14 and 15, and 28 and 29 indicating the fractures on airfoils 1 and 22 occurred on the trailing airfoil in the seven airfoil packet. Visual and fluorescent penetrant inspection (FPI) of the wheel revealed two additional rim cracks near the trailing edge radii of airfoils 8 and 15 (Figure 3).

**Figure 2.** Aft looking forward view of the third stage turbine wheel. Airfoil Nos. 1, 2, 3, 22, and 24 were liberated. The arrows point to the slot locations in the shroud.

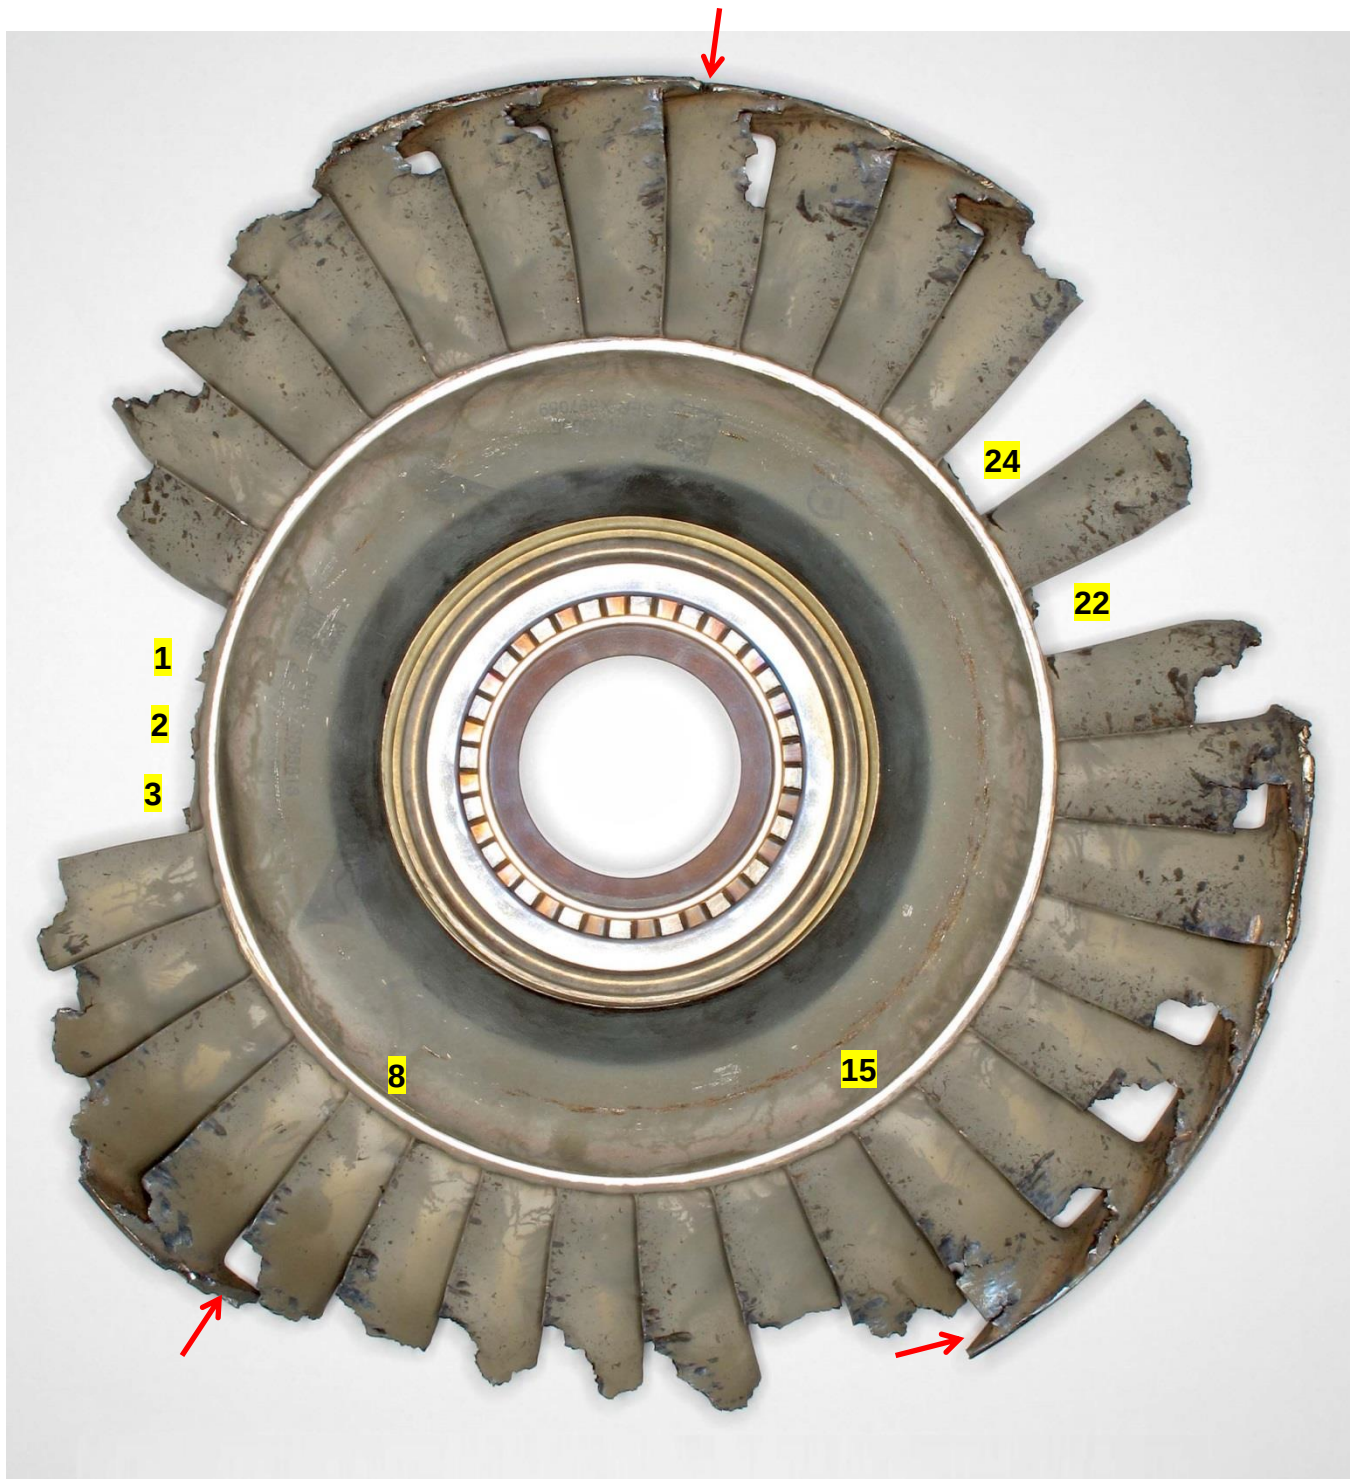
**Figure 3.** Forward looking aft view of the third stage turbine wheel. The arrows point to the slot locations in the shroud. Rim cracks were observed at airfoil Nos. 8 and 15.

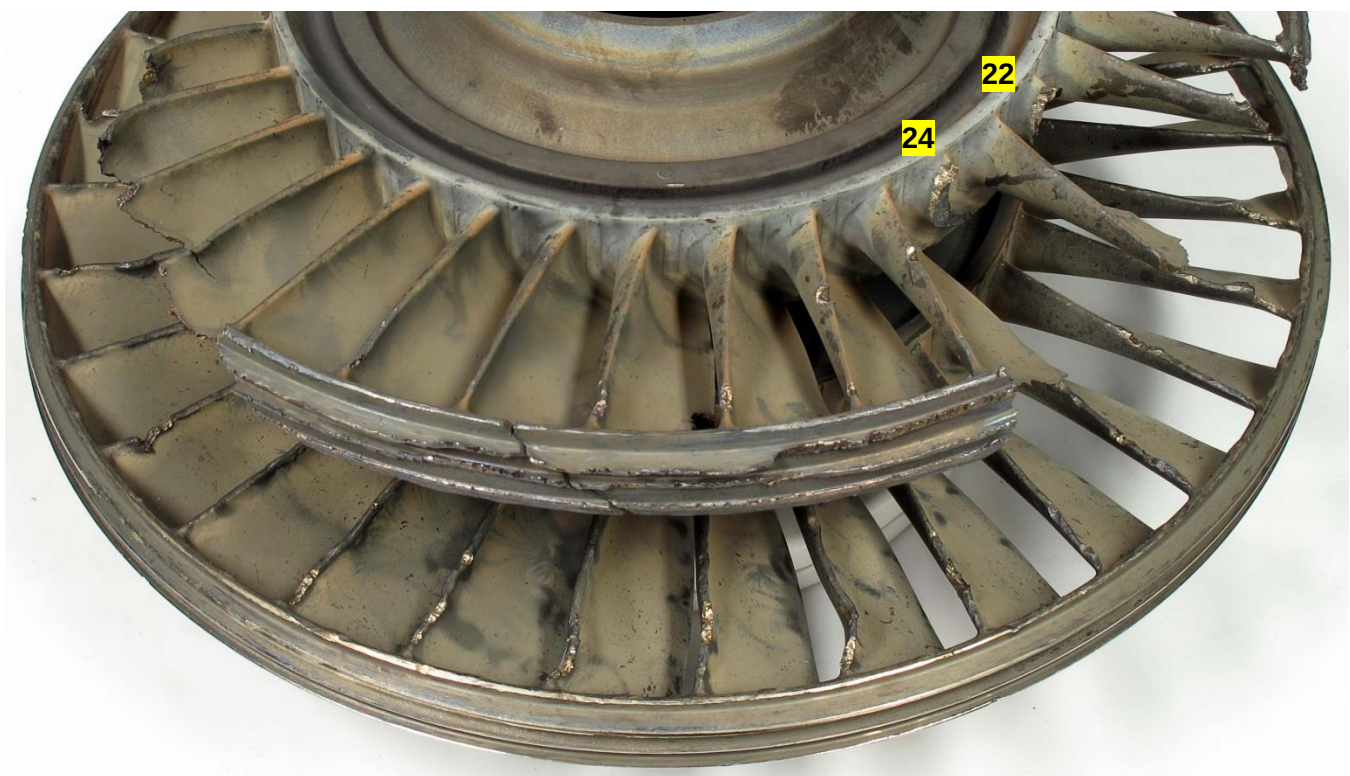
0-degrees

The third and fourth stage turbine wheels were reassembled using the alignment marks on the hub and photographs were taken at 90-degree intervals as shown in Figure 4 through Figure 7. The maximum wear damage on the inter-stage knife seals on the trailing edge side of the third stage wheel occurred between airfoils 8 through 12 (Figure 6), approximately 90-degrees clockwise (aft looking forward) from the fractured 1 through 3 airfoils.

**Figure 4.** Photographs of the third and fourth stage turbine wheels positioned together based on the alignment marks on the hub.

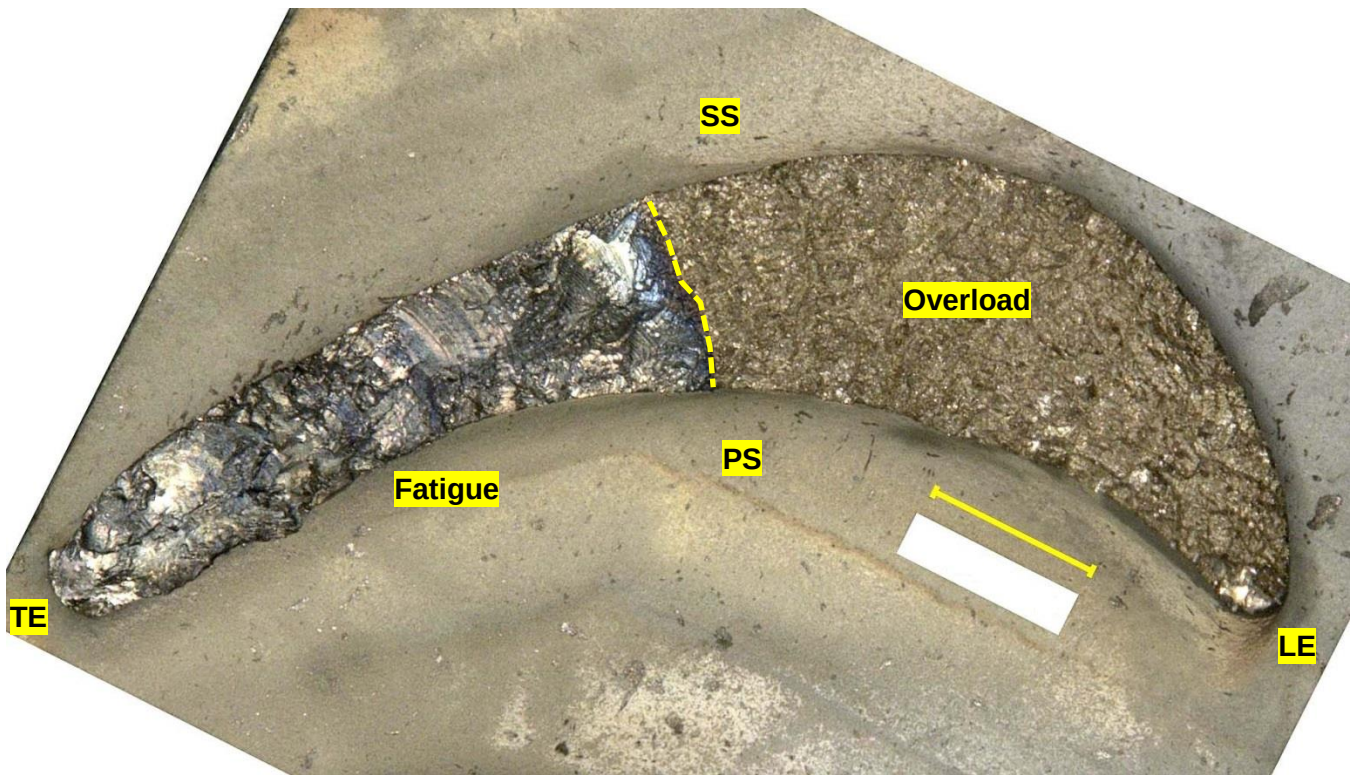
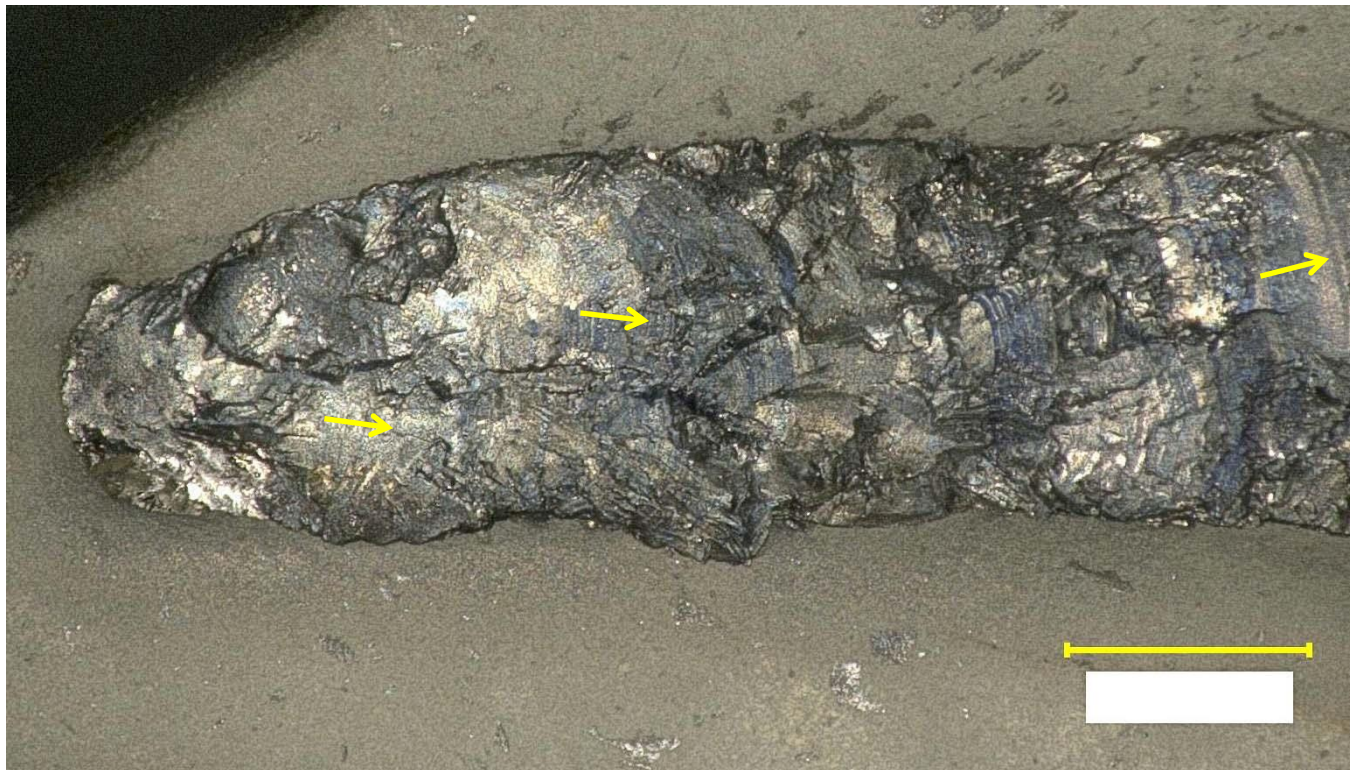
Figure 8 shows a radial view of the airfoil No. 1 fracture. The crack initiated from the trailing edge and progressed approximately 0.39 inch in fatigue to approximately mid chord of the airfoil before final

fracture occurred in overload. The rim surface was low angle lit to show the casting wax weld location in relationship to the airfoil trailing edge (Figure 9). The crack initiated approximately 0.024 inch above the rim and angled inward toward the rim as illustrated in Figure 10. Scanning electron microscope (SEM) images of the origin area are shown in Figure 11 through Figure 13. No obvious material anomalies were observed at the origin.

Figure 8. Photographs showing the fractured third stage turbine wheel airfoil No. 1.

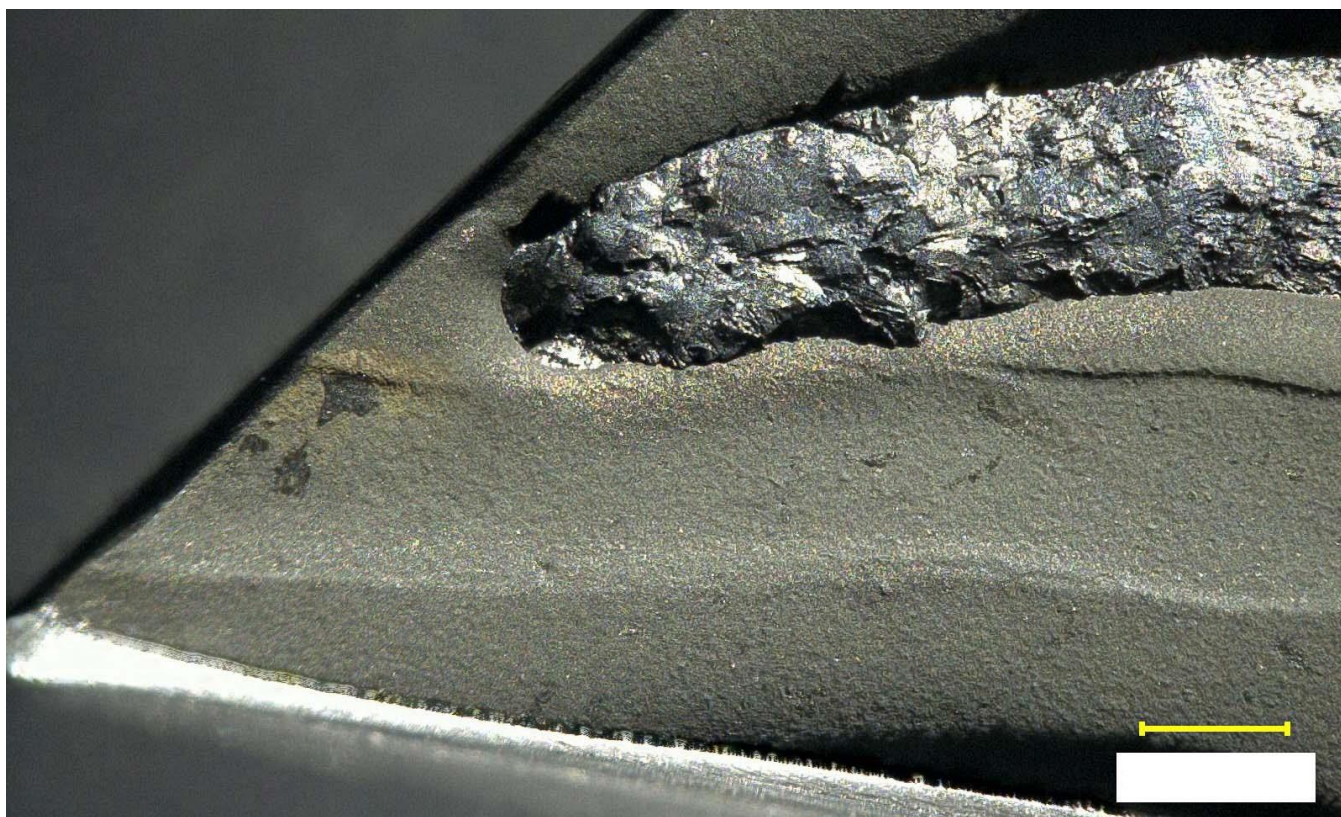
**Figure 9.** Low angle lighting showing the casting wax weld adjacent to the airfoil No. 1 trailing edge.

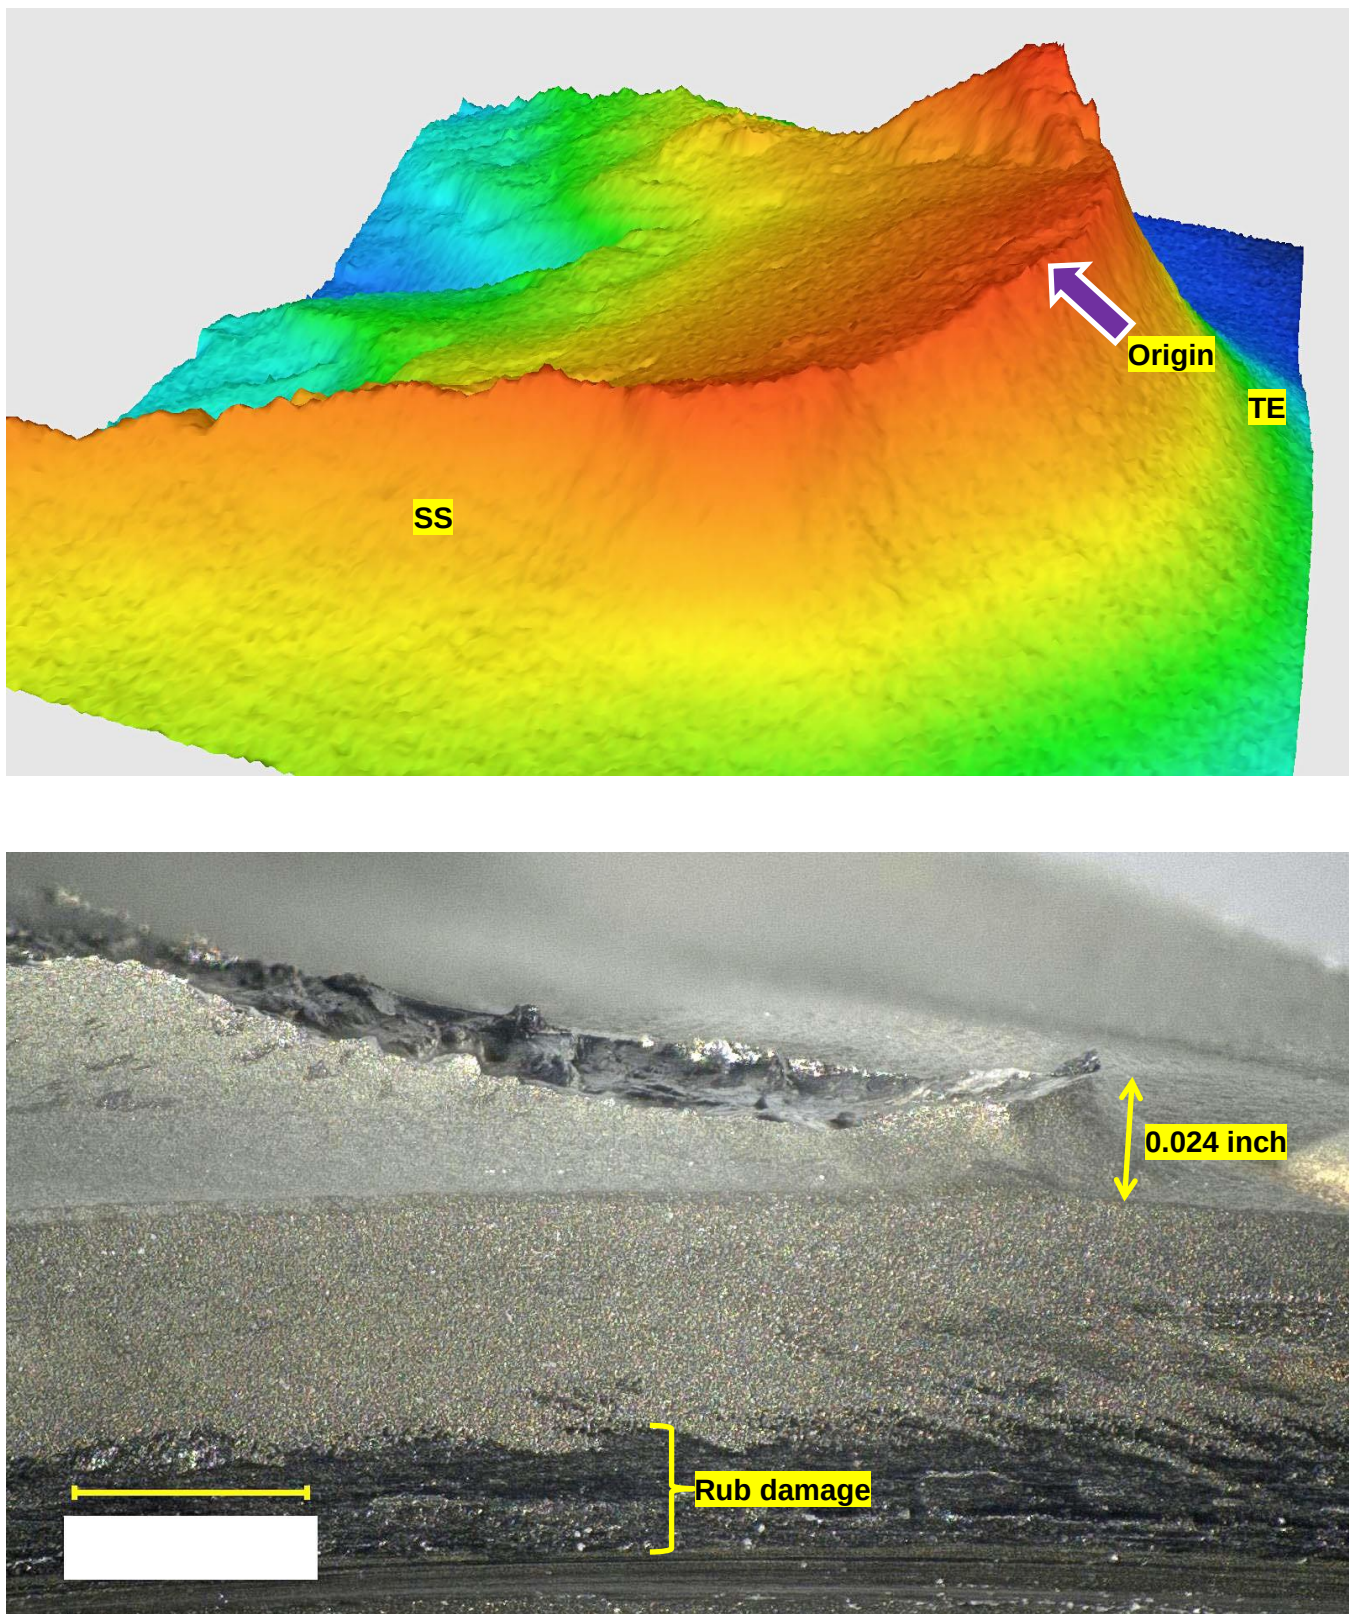
**Figure 10.** The lower image shows a view perpendicular to the trailing edge rim face of the airfoil No. 1 fracture. The upper image was generated with a confocal laser scanning microscope (CLSM) showing the orientation of the fatigue crack. Note the rub damage on the rim face.

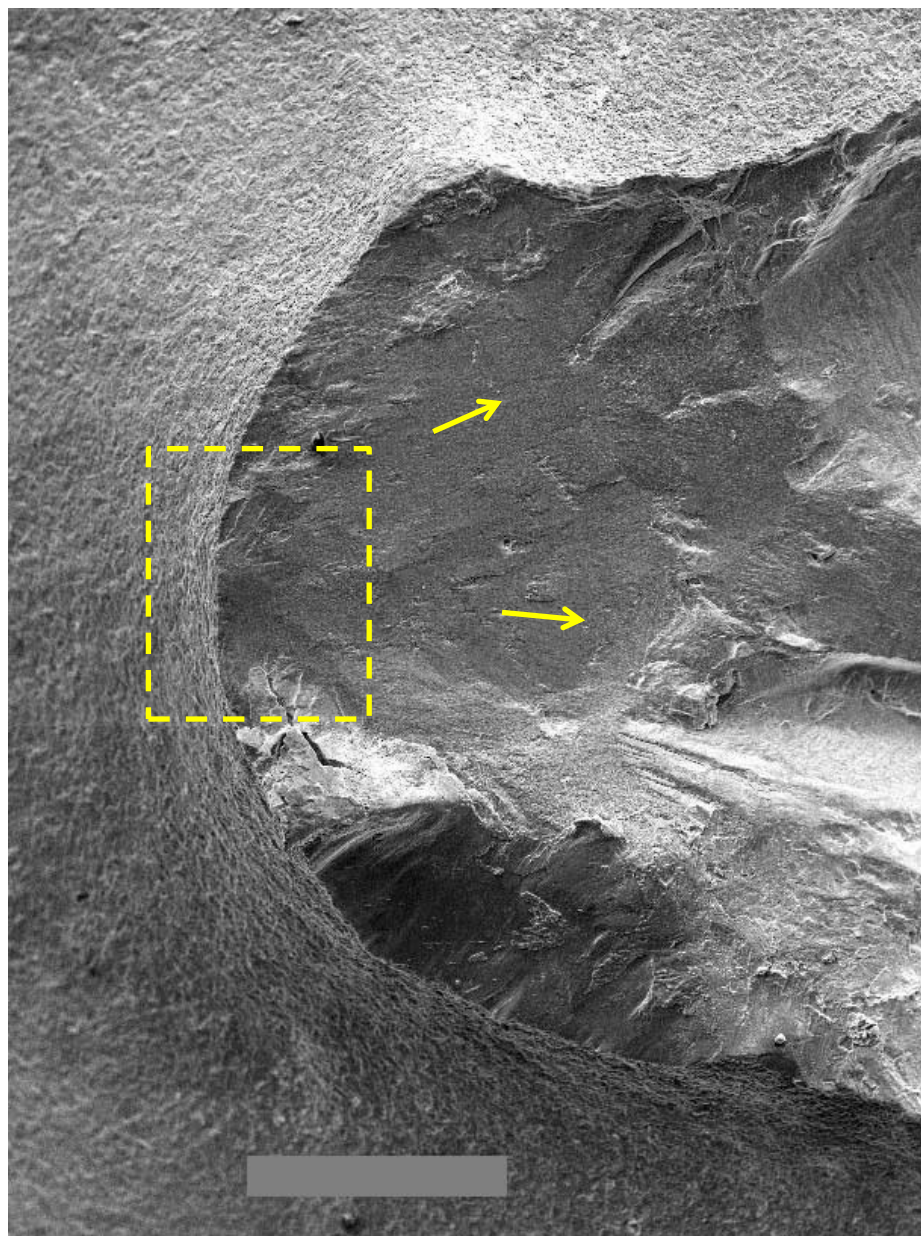
**Figure 11. SEM photograph of the airfoil No. 1 crack origin area. The arrows show the crack propagation directions. Detailed views of the fatigue origin are shown in the following figures.**

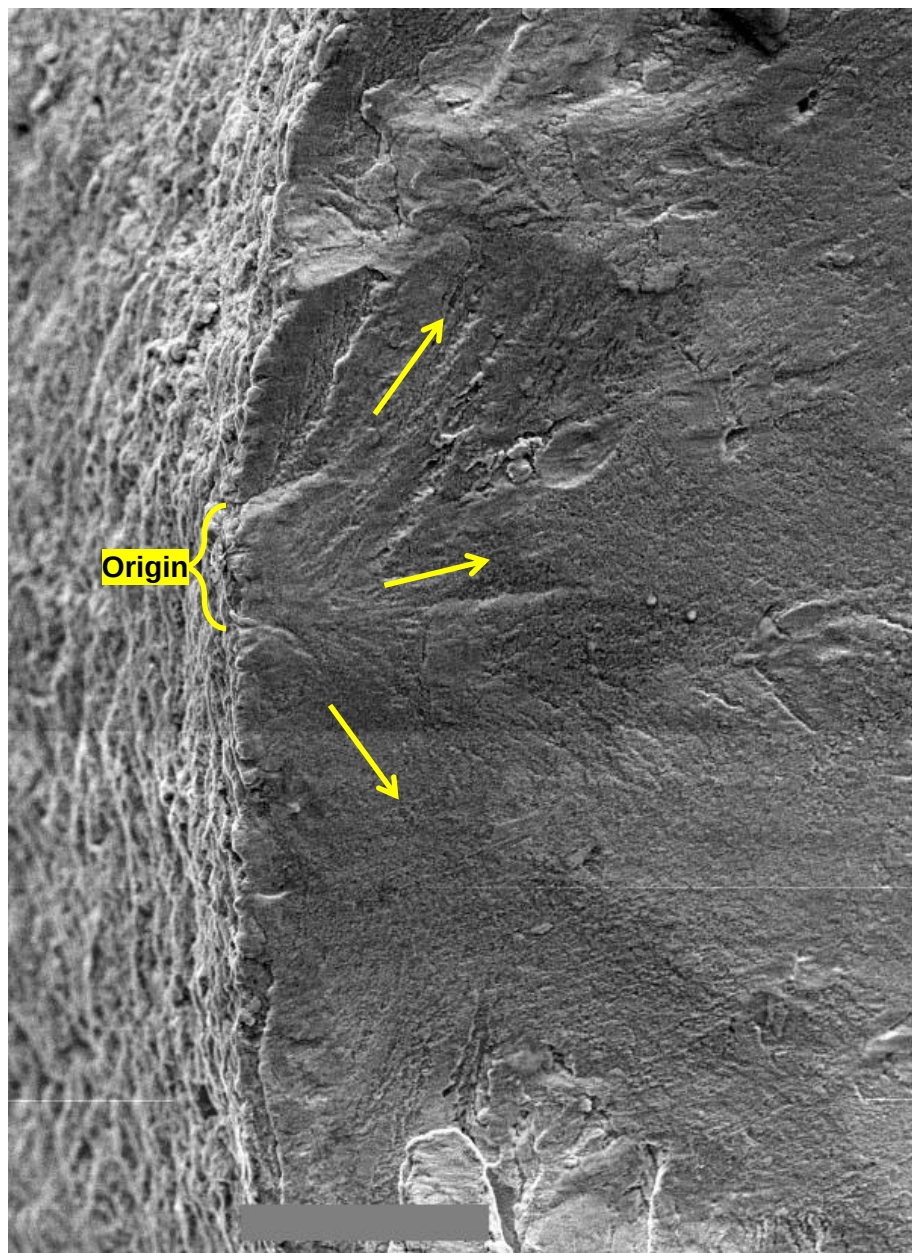
**Figure 12. SEM photograph of the airfoil No. 1 crack origin area. The arrows show the crack propagation directions. A detailed view of the fatigue origin is shown in the following figure.**

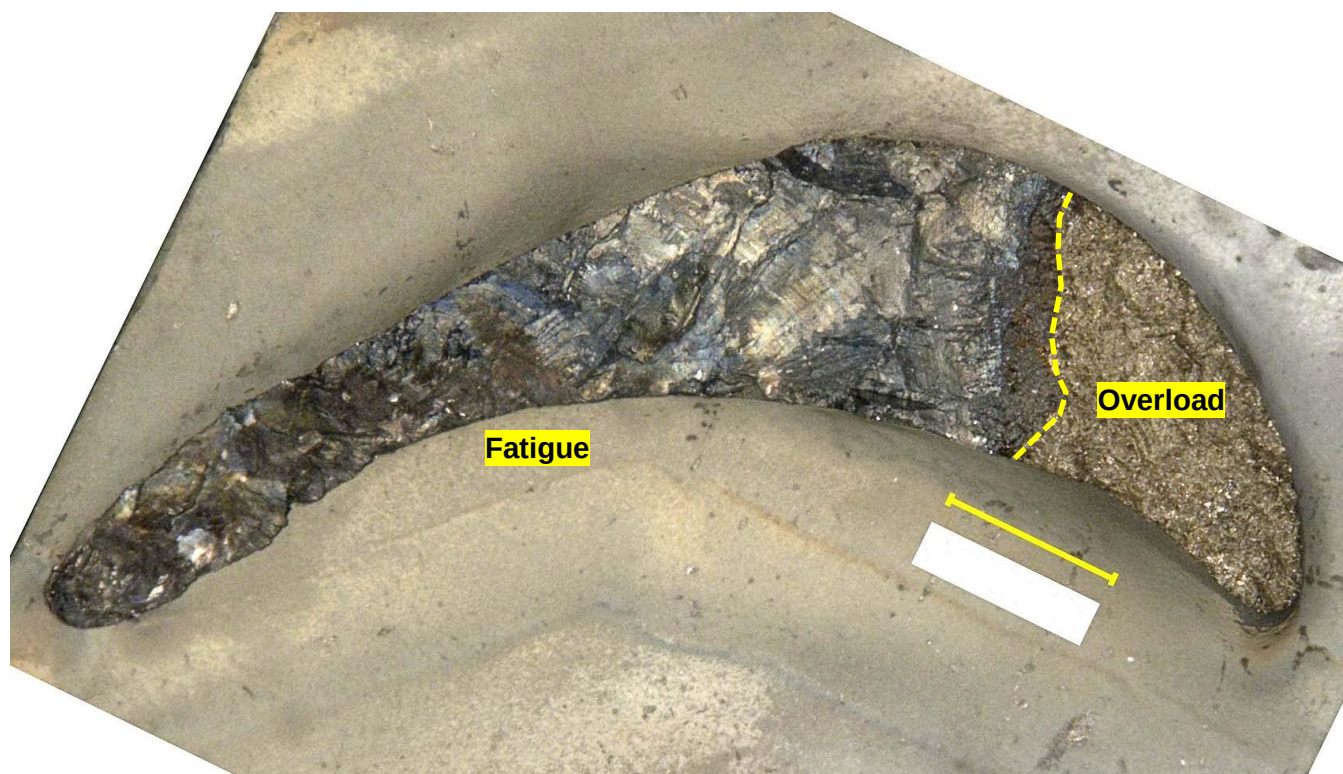
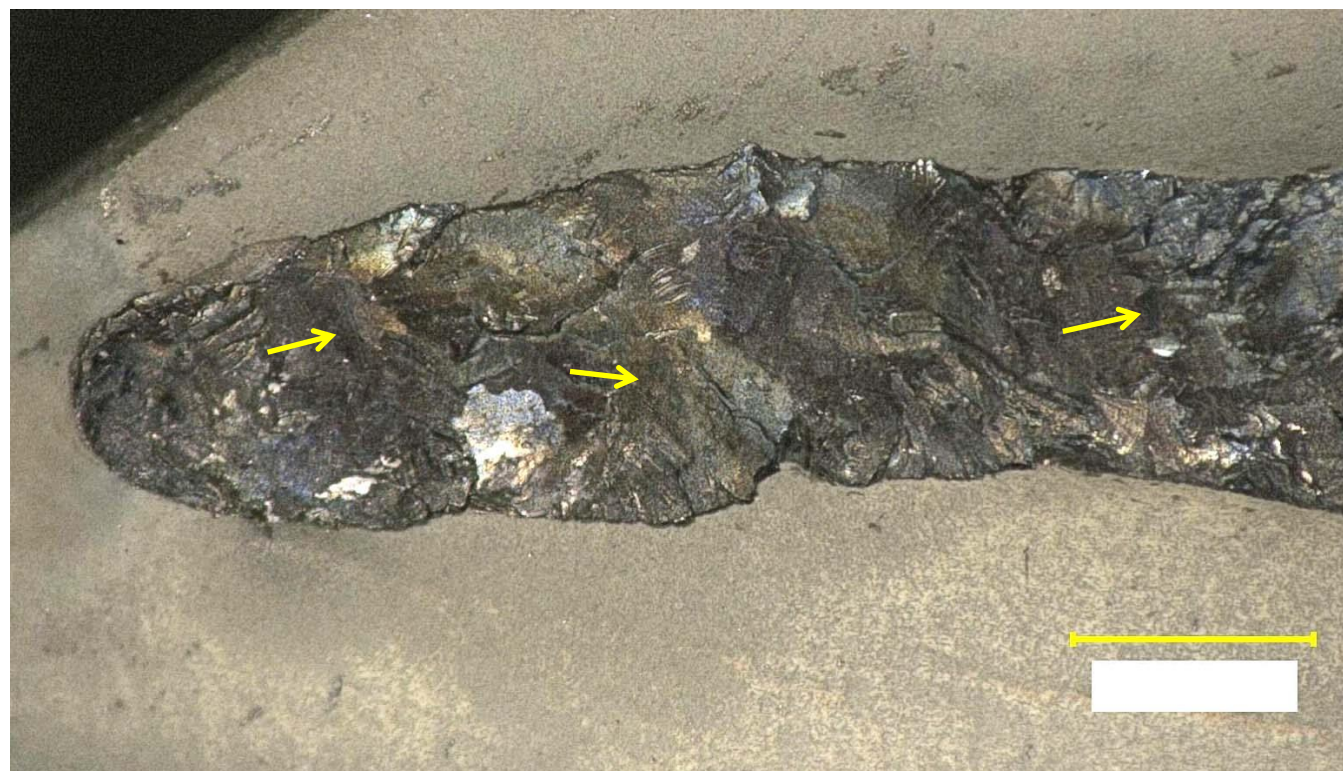
Figure 14 shows a radial view of the airfoil No. 2 fracture. The crack initiated from the trailing edge and progressed approximately 0.58 inch in fatigue before final fracture occurred in overload. The rim surface was low angle lit to show the casting wax weld location in relationship to the airfoil trailing edge (Figure 15). The crack initiated approximately 0.025 inch above the rim and angled inward toward the rim as illustrated in Figure 16. Scanning electron microscope (SEM) images of the origin area are shown in Figure 17 through Figure 19. No obvious material anomalies were observed at the origin. The dark spot on the photograph in Figure 19 is less dense debris deposited on the surface.

Figure 14. Photographs showing the fractured third stage turbine wheel airfoil No. 2.

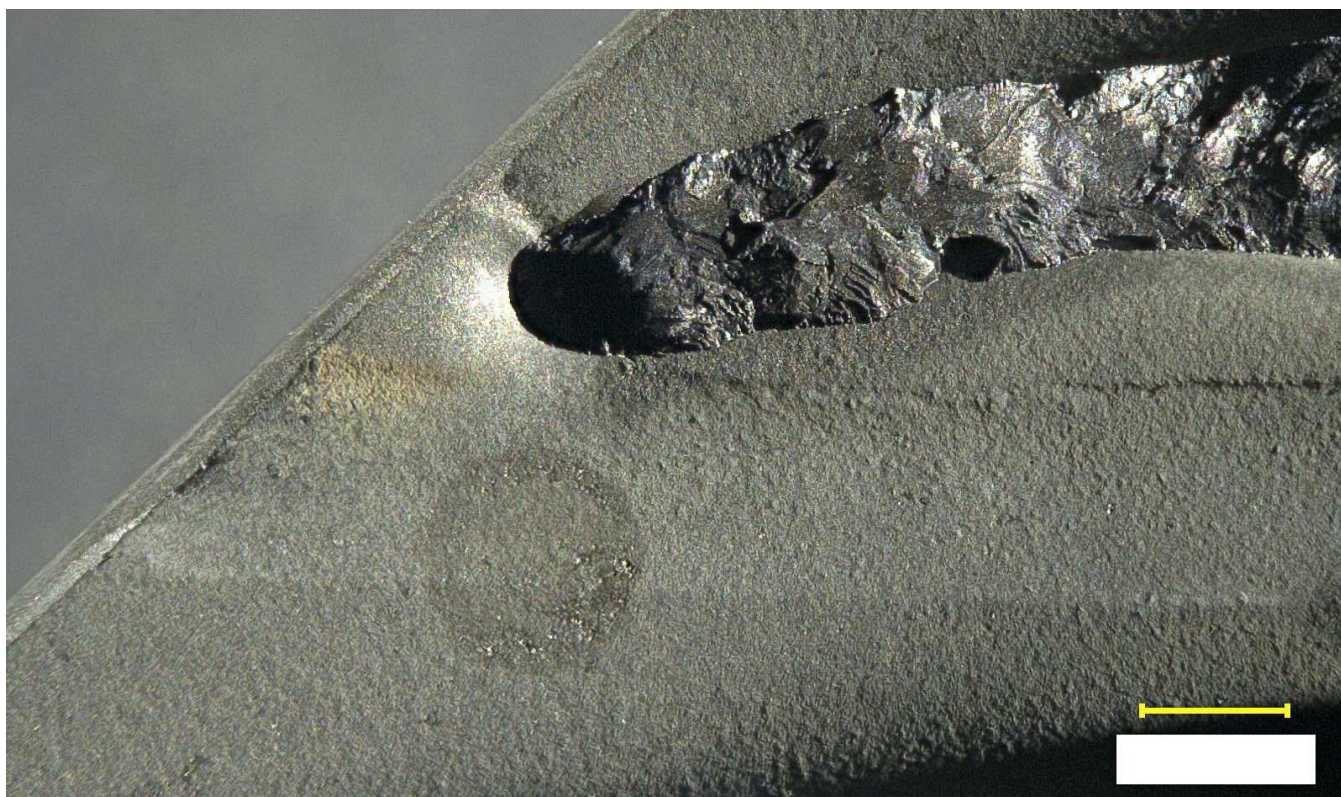
**Figure 15. Low angle lighting showing the casting wax weld adjacent to the airfoil No. 2 trailing edge.**

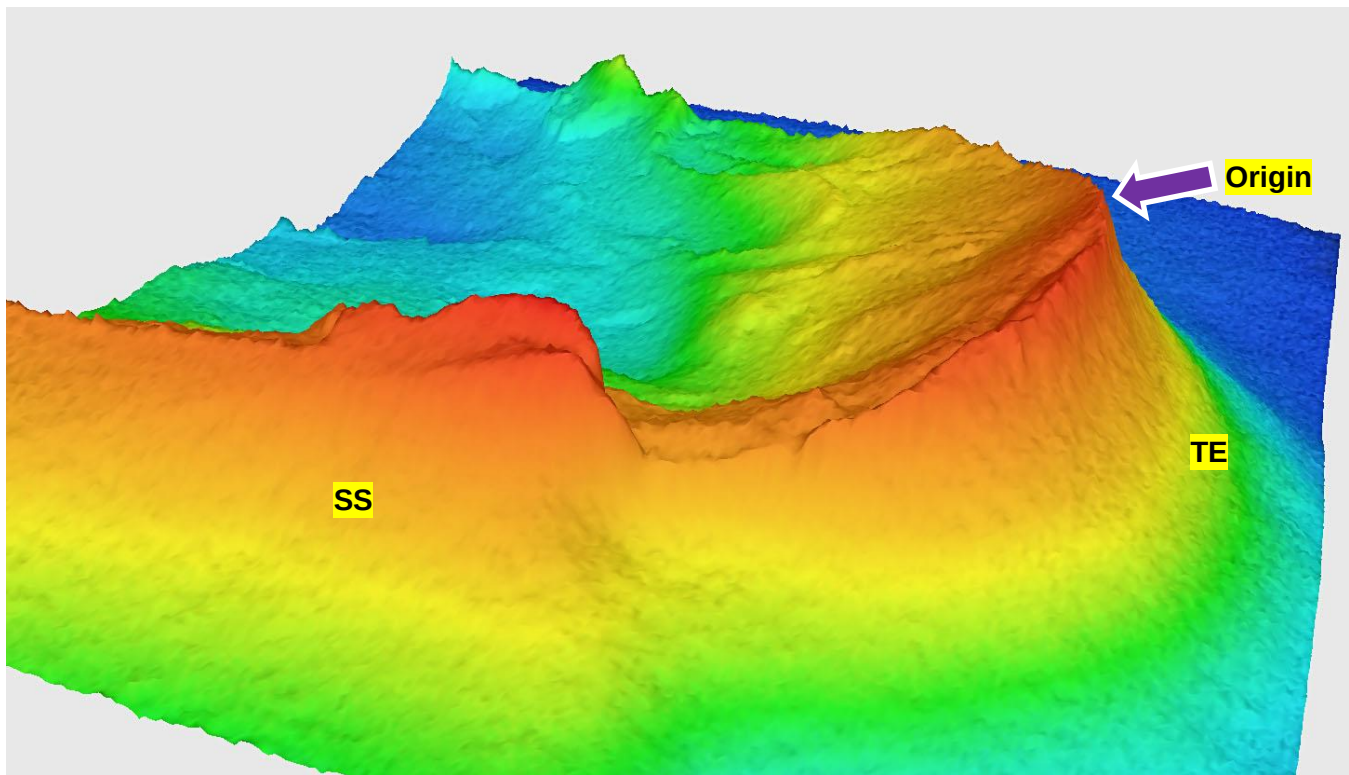
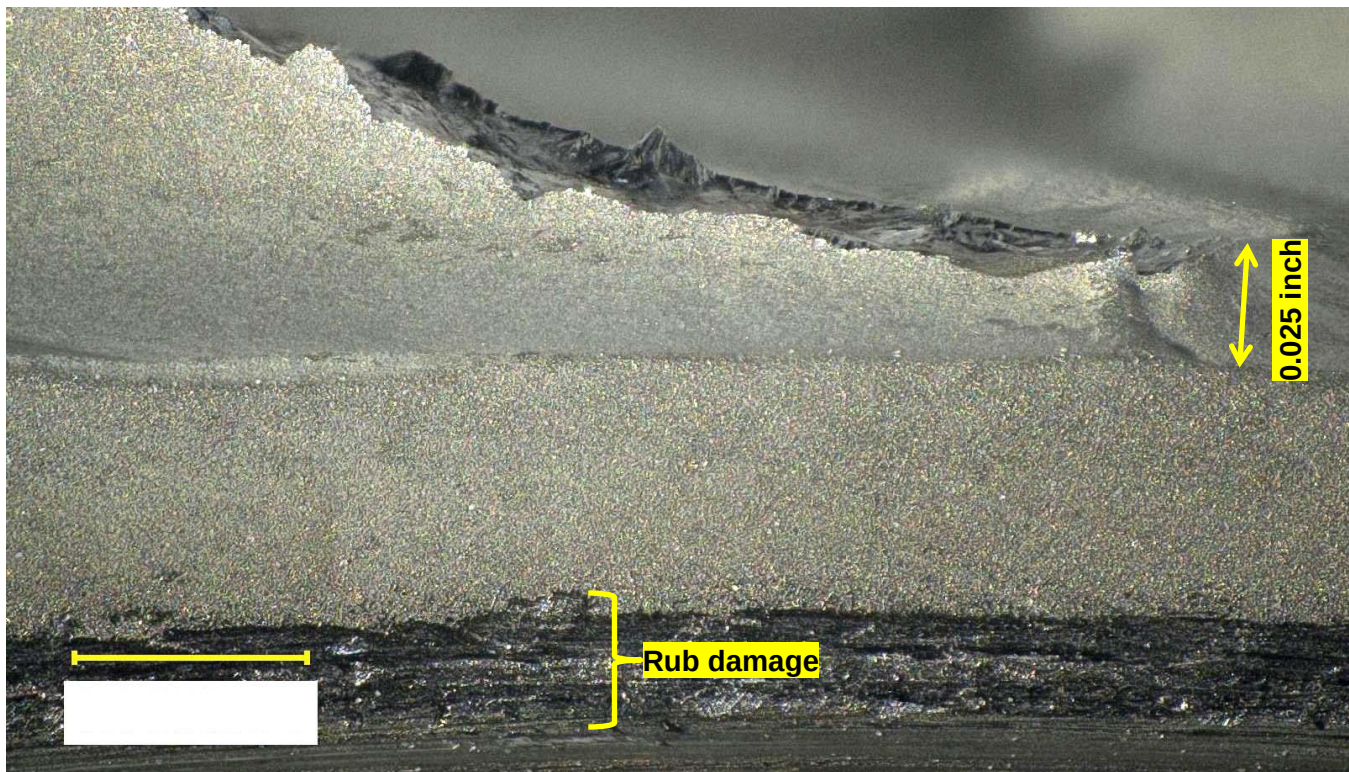
**Figure 16.** The lower image shows a view perpendicular to the rim face of the airfoil No. 2 fracture. The upper image was generated with a CLSM showing the orientation of the fatigue crack. Note the rub damage on the rim face.

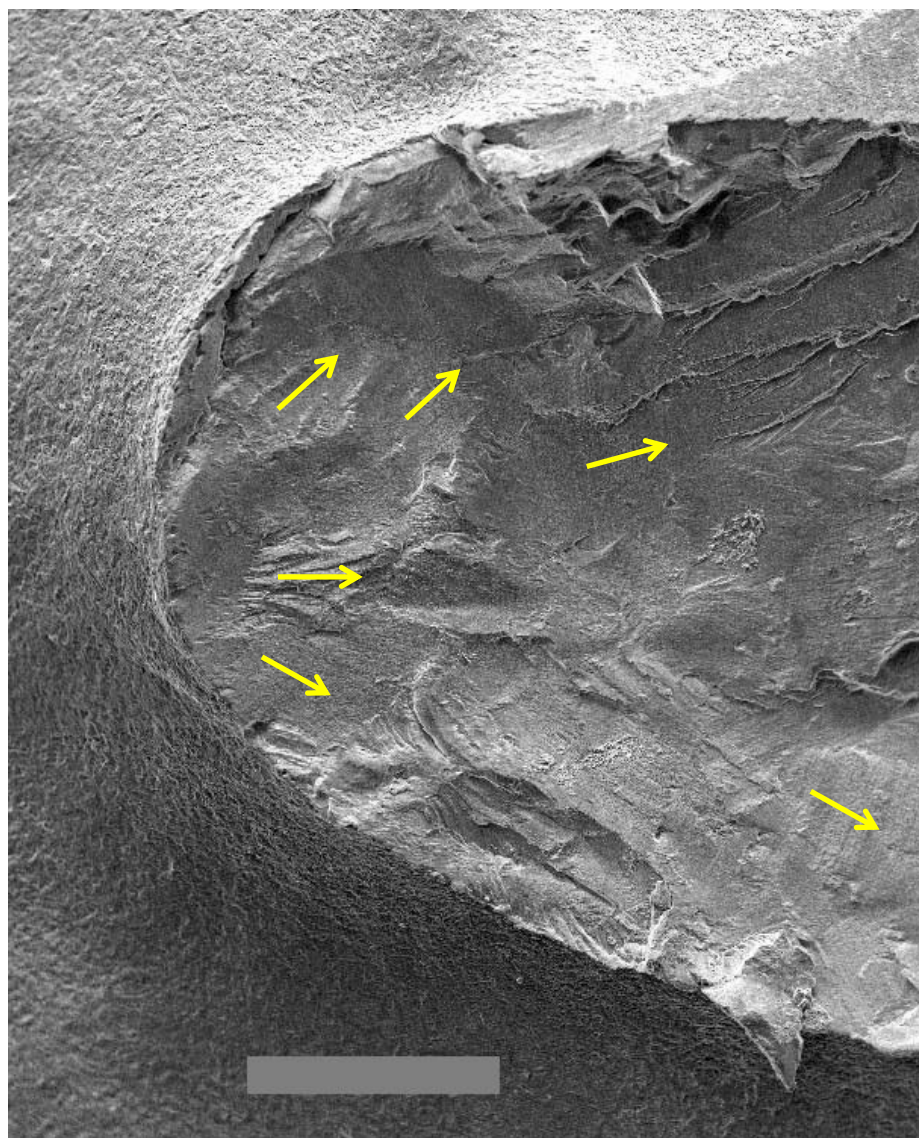
**Figure 17. SEM photograph of the airfoil No. 2 crack origin area. The arrows show the crack propagation directions. A detailed view of the fatigue origin is shown in the following figure.**
